**MALFUNCTION OF IGNITERS IN  
THE AMRA VARIABLE PARAMETER  
ROCKET ENGINE**

**TECHNICAL NOTE**

**MATERIALS ENGINEERING DIVISION  
U. S. ARMY MATERIALS RESEARCH AGENCY  
WATERTOWN, MASSACHUSETTS 02172**

Technical Note AMRA TN 65-06

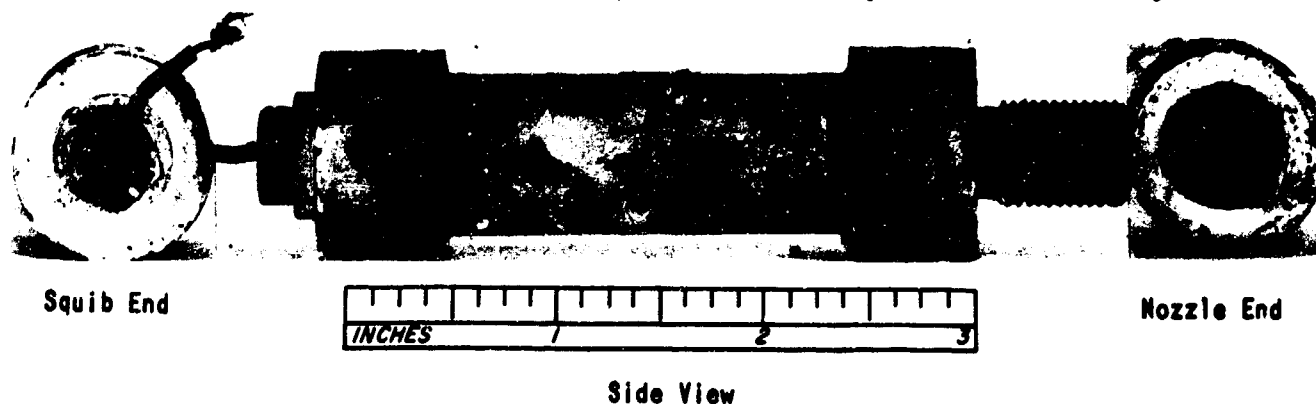
body can be removed intact from the engine. A satisfactory used igniter unit is shown in Figure 8. This igniter was one of the two utilized in test No. 1 and was easily removed from the side closure plate. Although the paint on the body was scorched, the steel body retained its physical

**Figure 8. VPRE TEST 1, EXHAUSTED IGNITER**

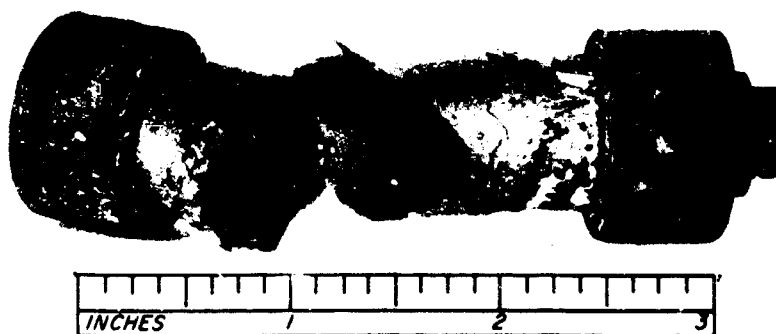
integrity. In contrast, the igniter body salvaged from the protective earth bank after the first test was blackened and scaled from overheating, its threaded nozzle section completely disintegrated, and its center body section almost eroded in half as shown in Figure 9. The igniters recovered from subsequent tests were similar in appearance except that the

**Figure 9. VPRE TEST 1, ERODED IGNITER**
