THE GREAT ALASKA EARTHQUAKE

Volume II

Illustrations and Maps

TECHNICAL REPORT NO. AFWL-TR-65-92, Vol II

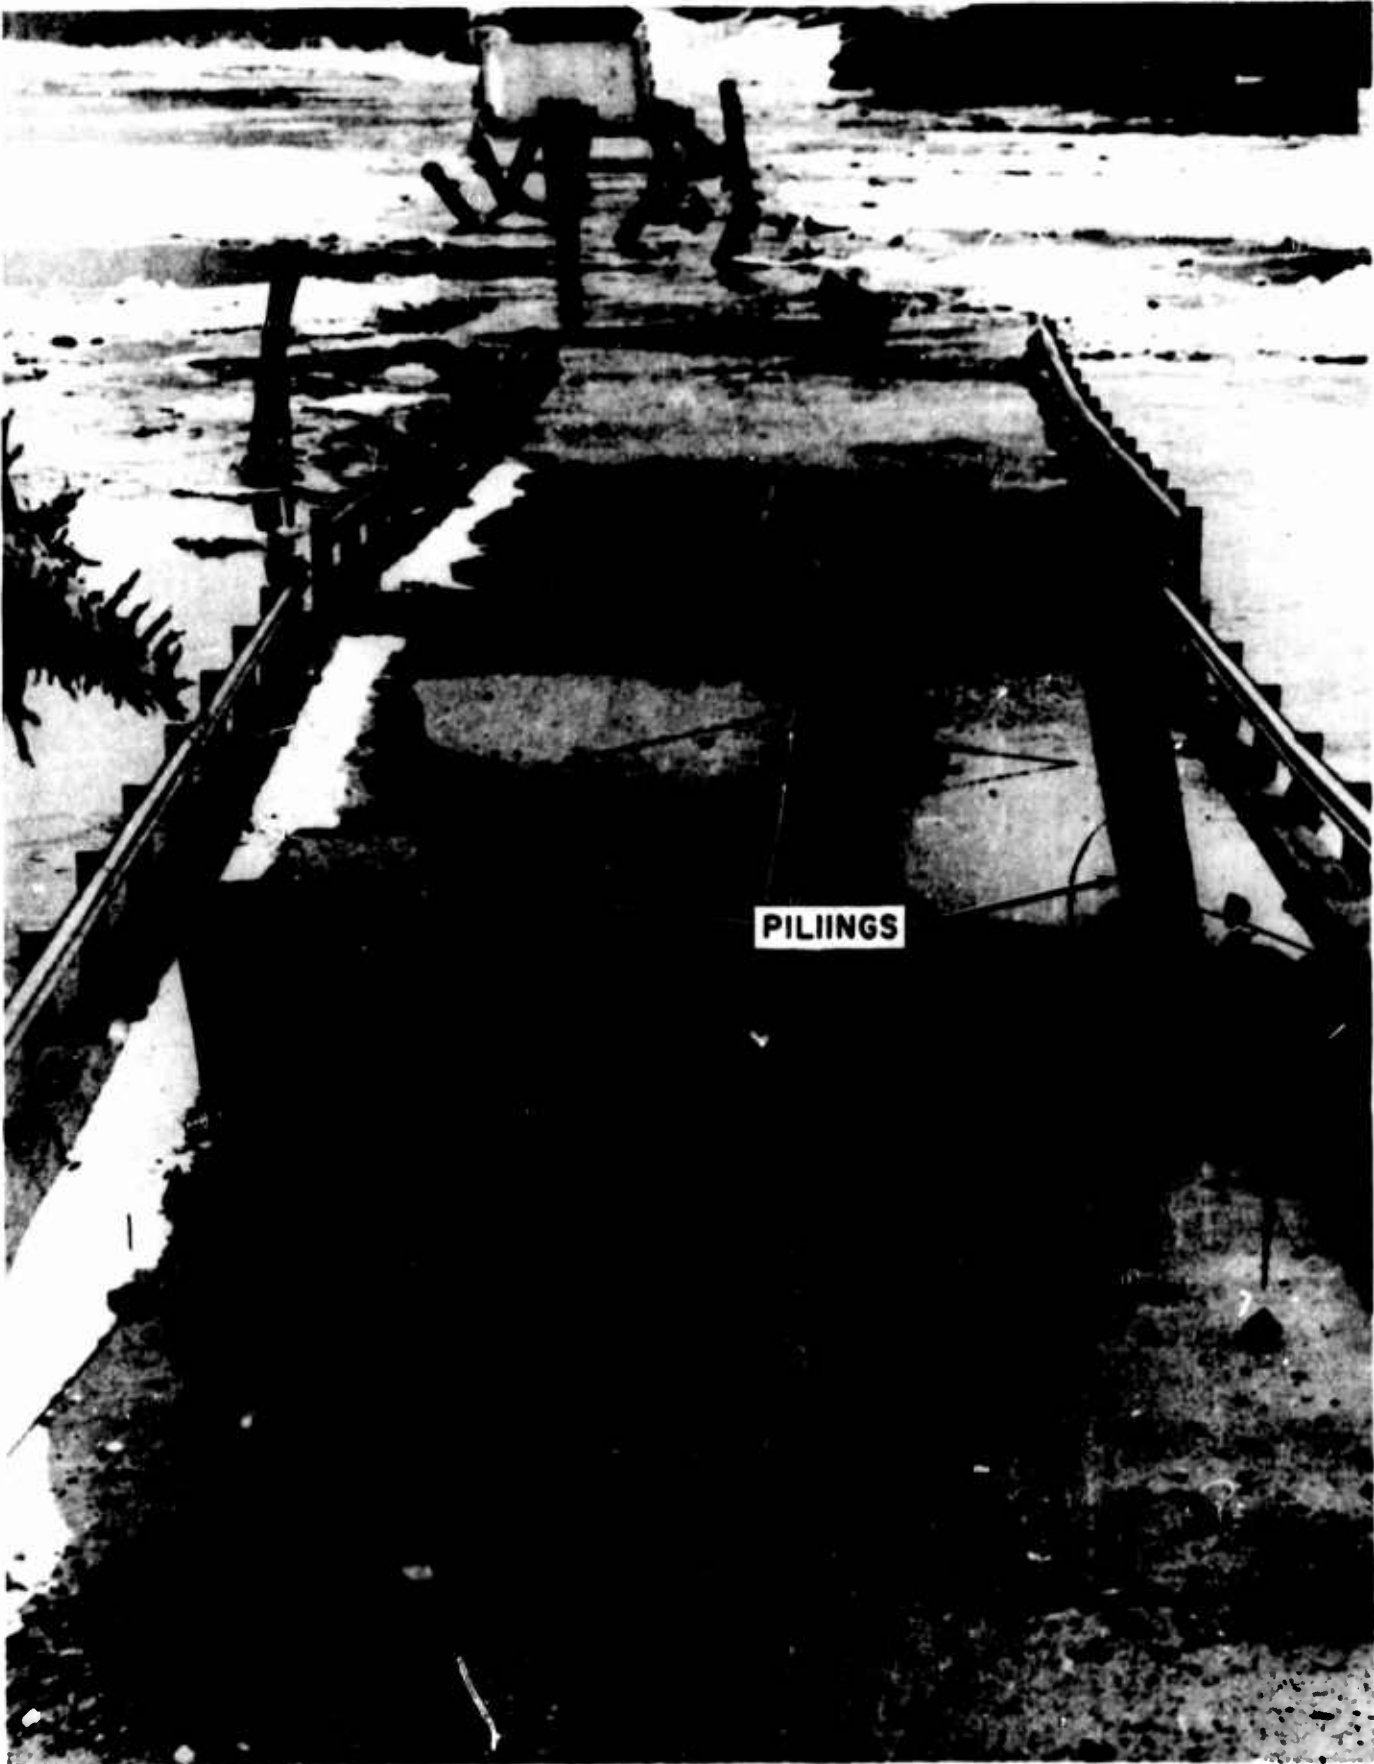
Figure 15. A Damaged Bridge, Anchorage to Seward Highway

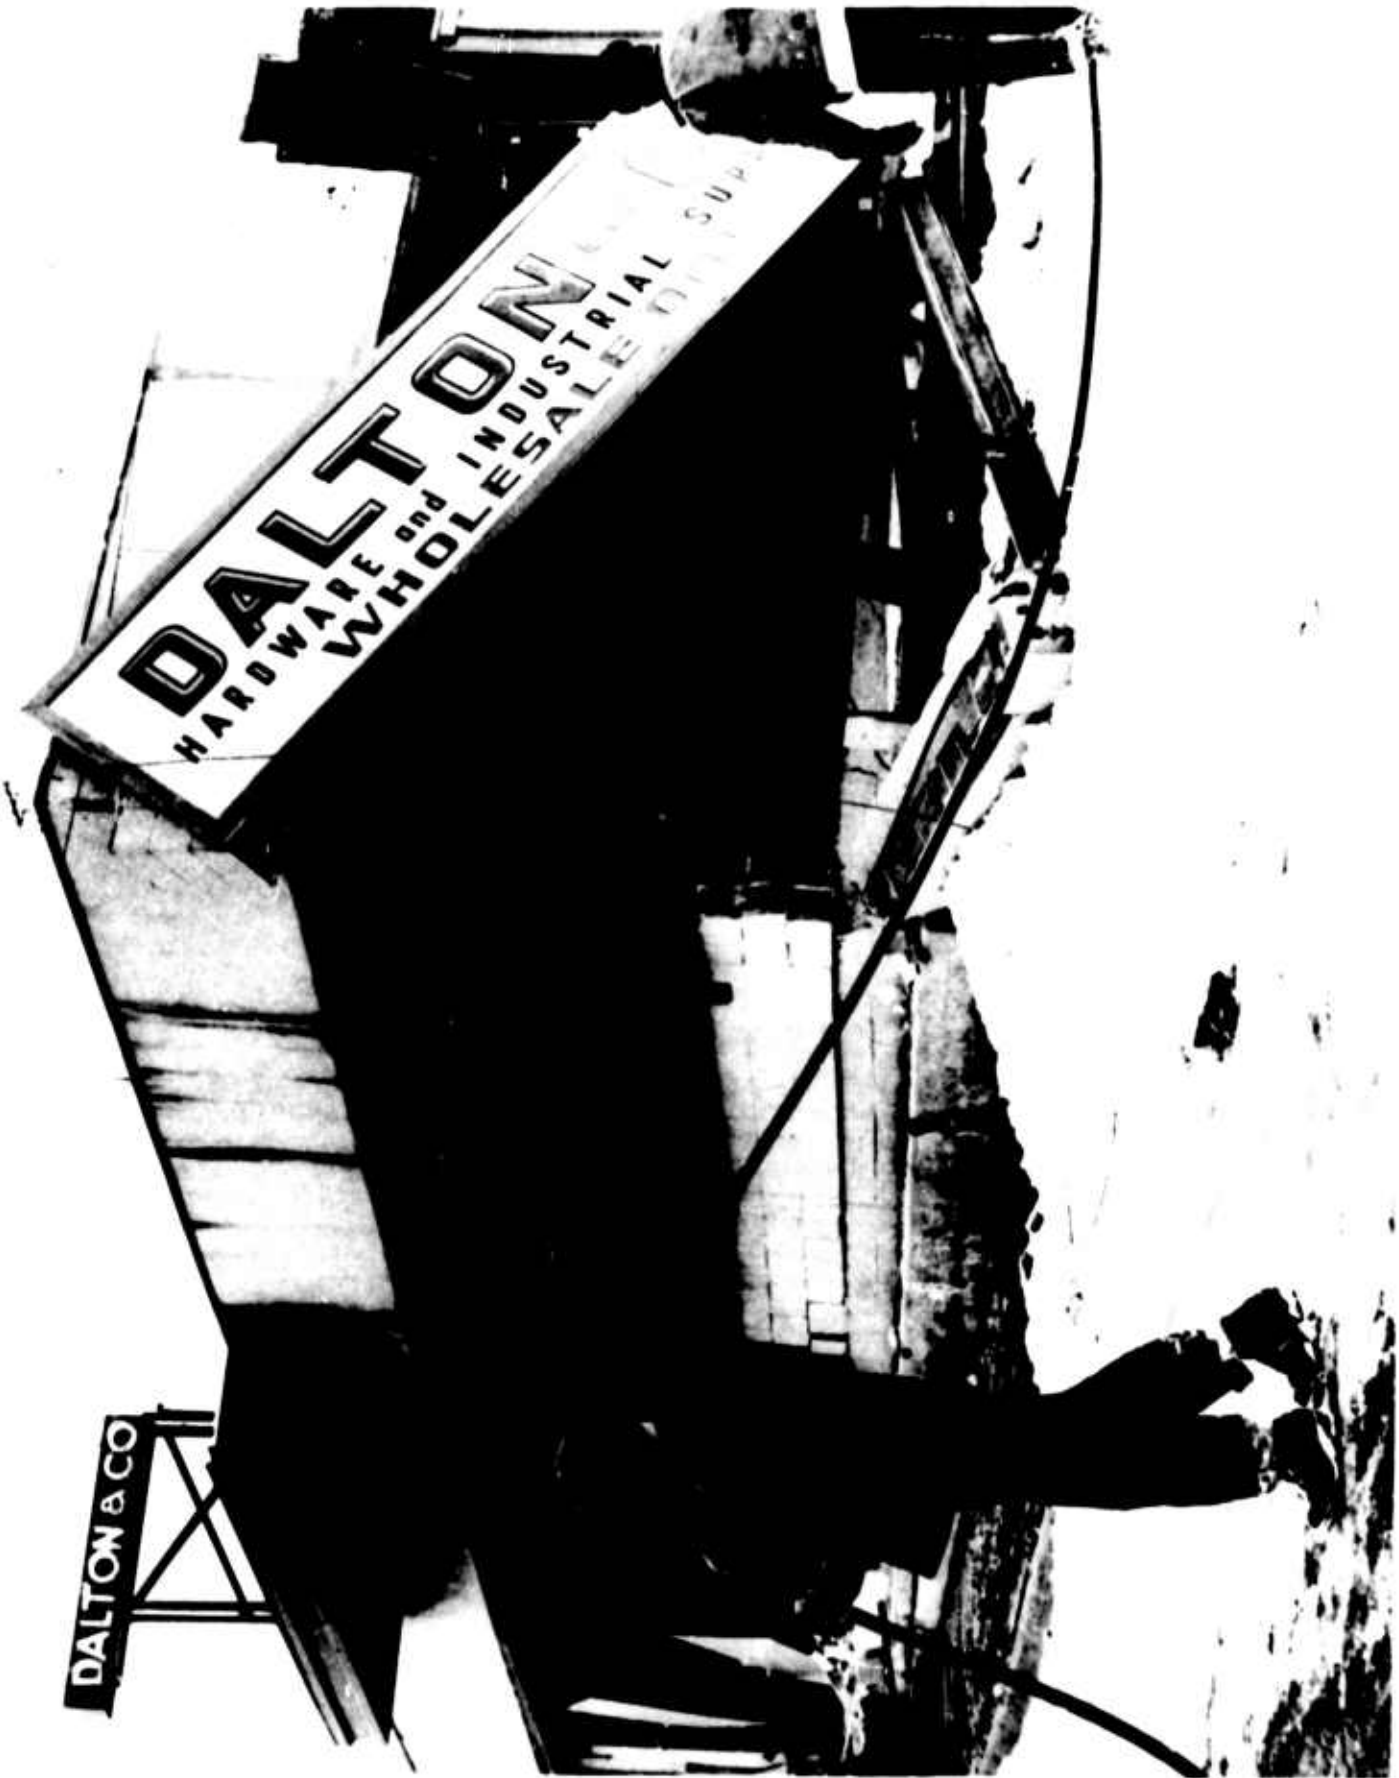
Figure 66. Fourth Avenue Slide (Dalton and Company building, destroyed by pressure ridge north of Second Street)

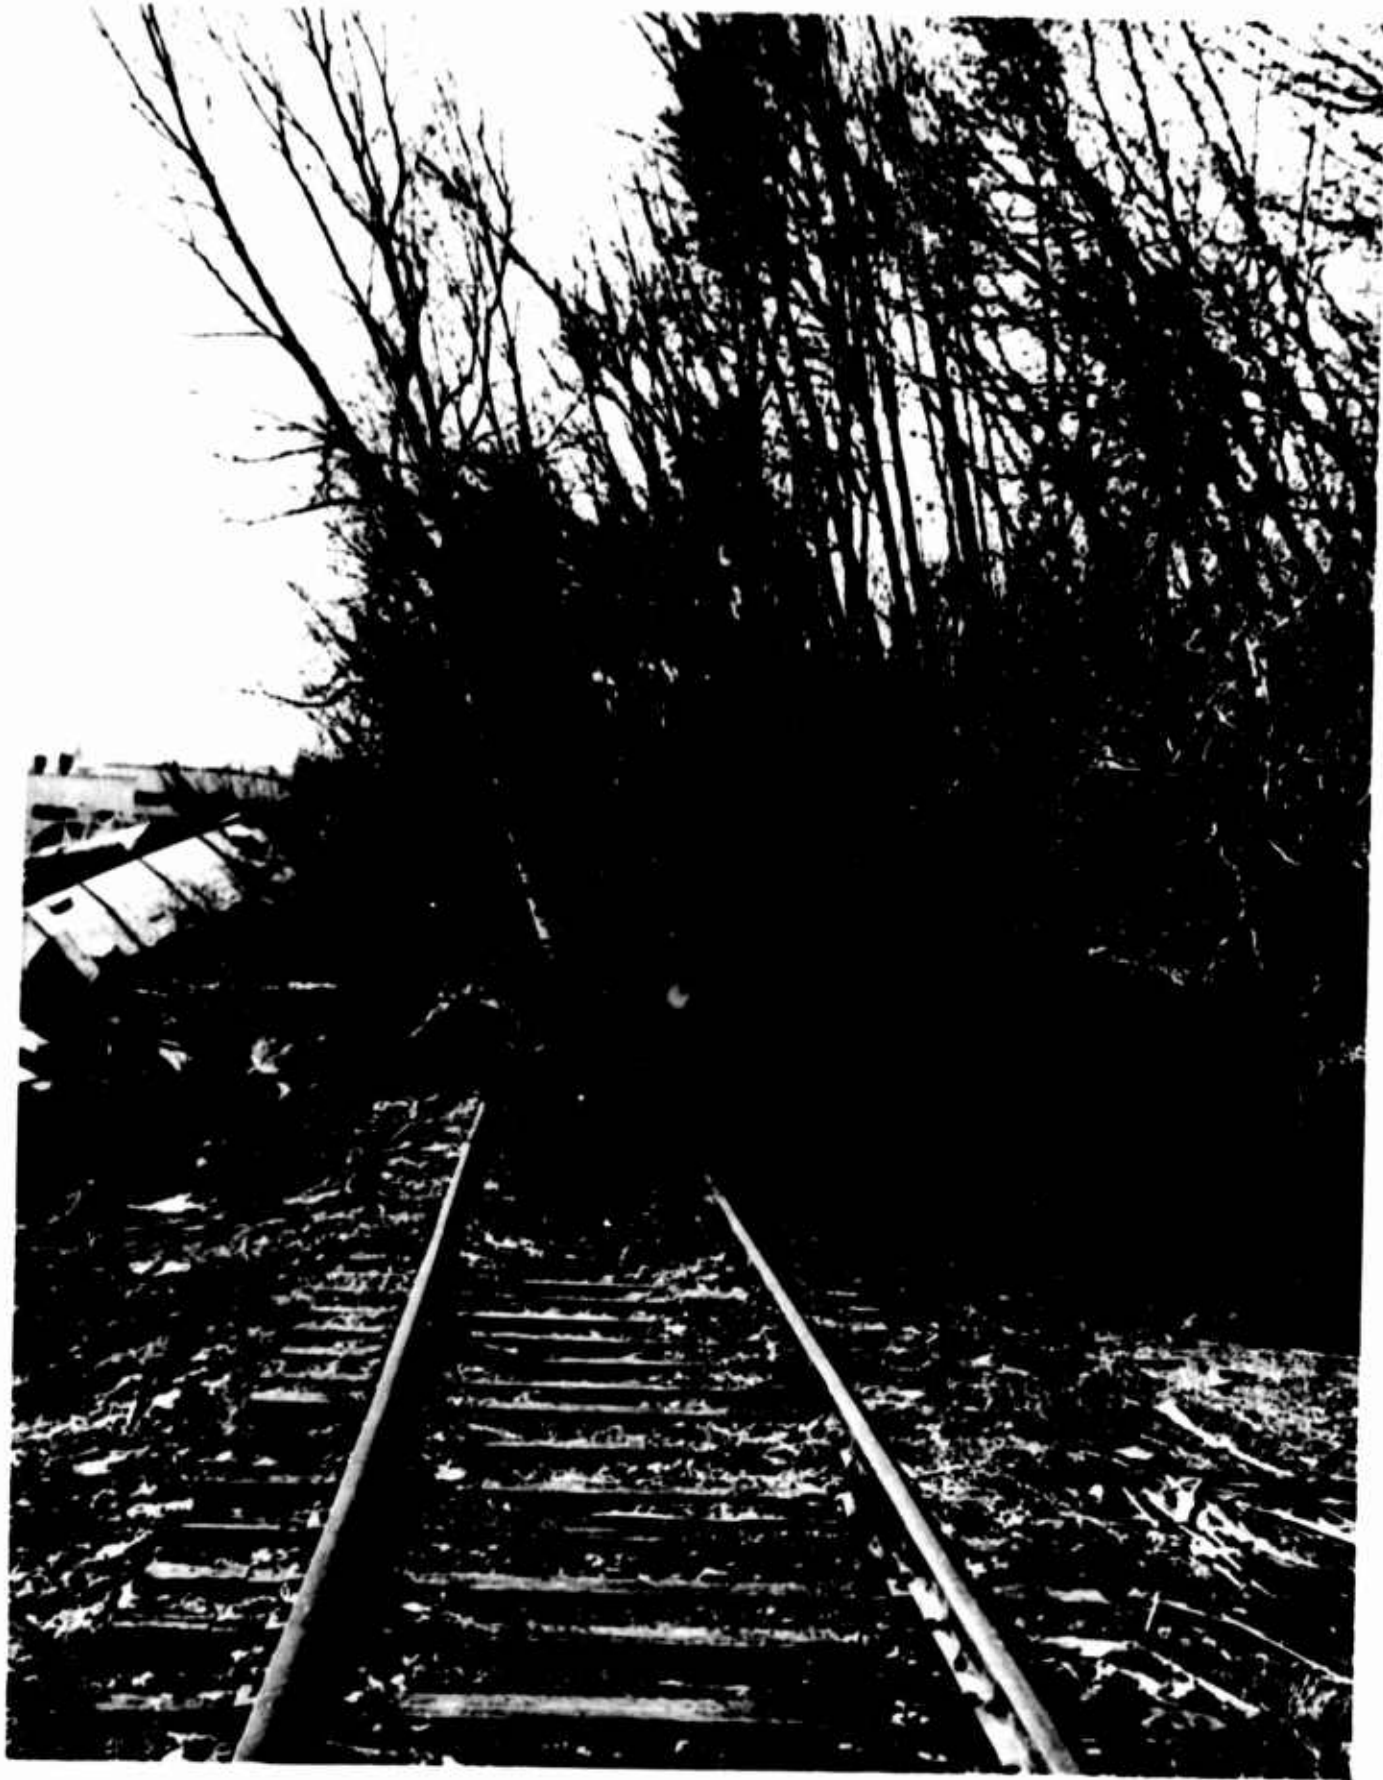
Figure 112. Government Hill Slide (Alaska Railroad track covered by a pressure ridge)

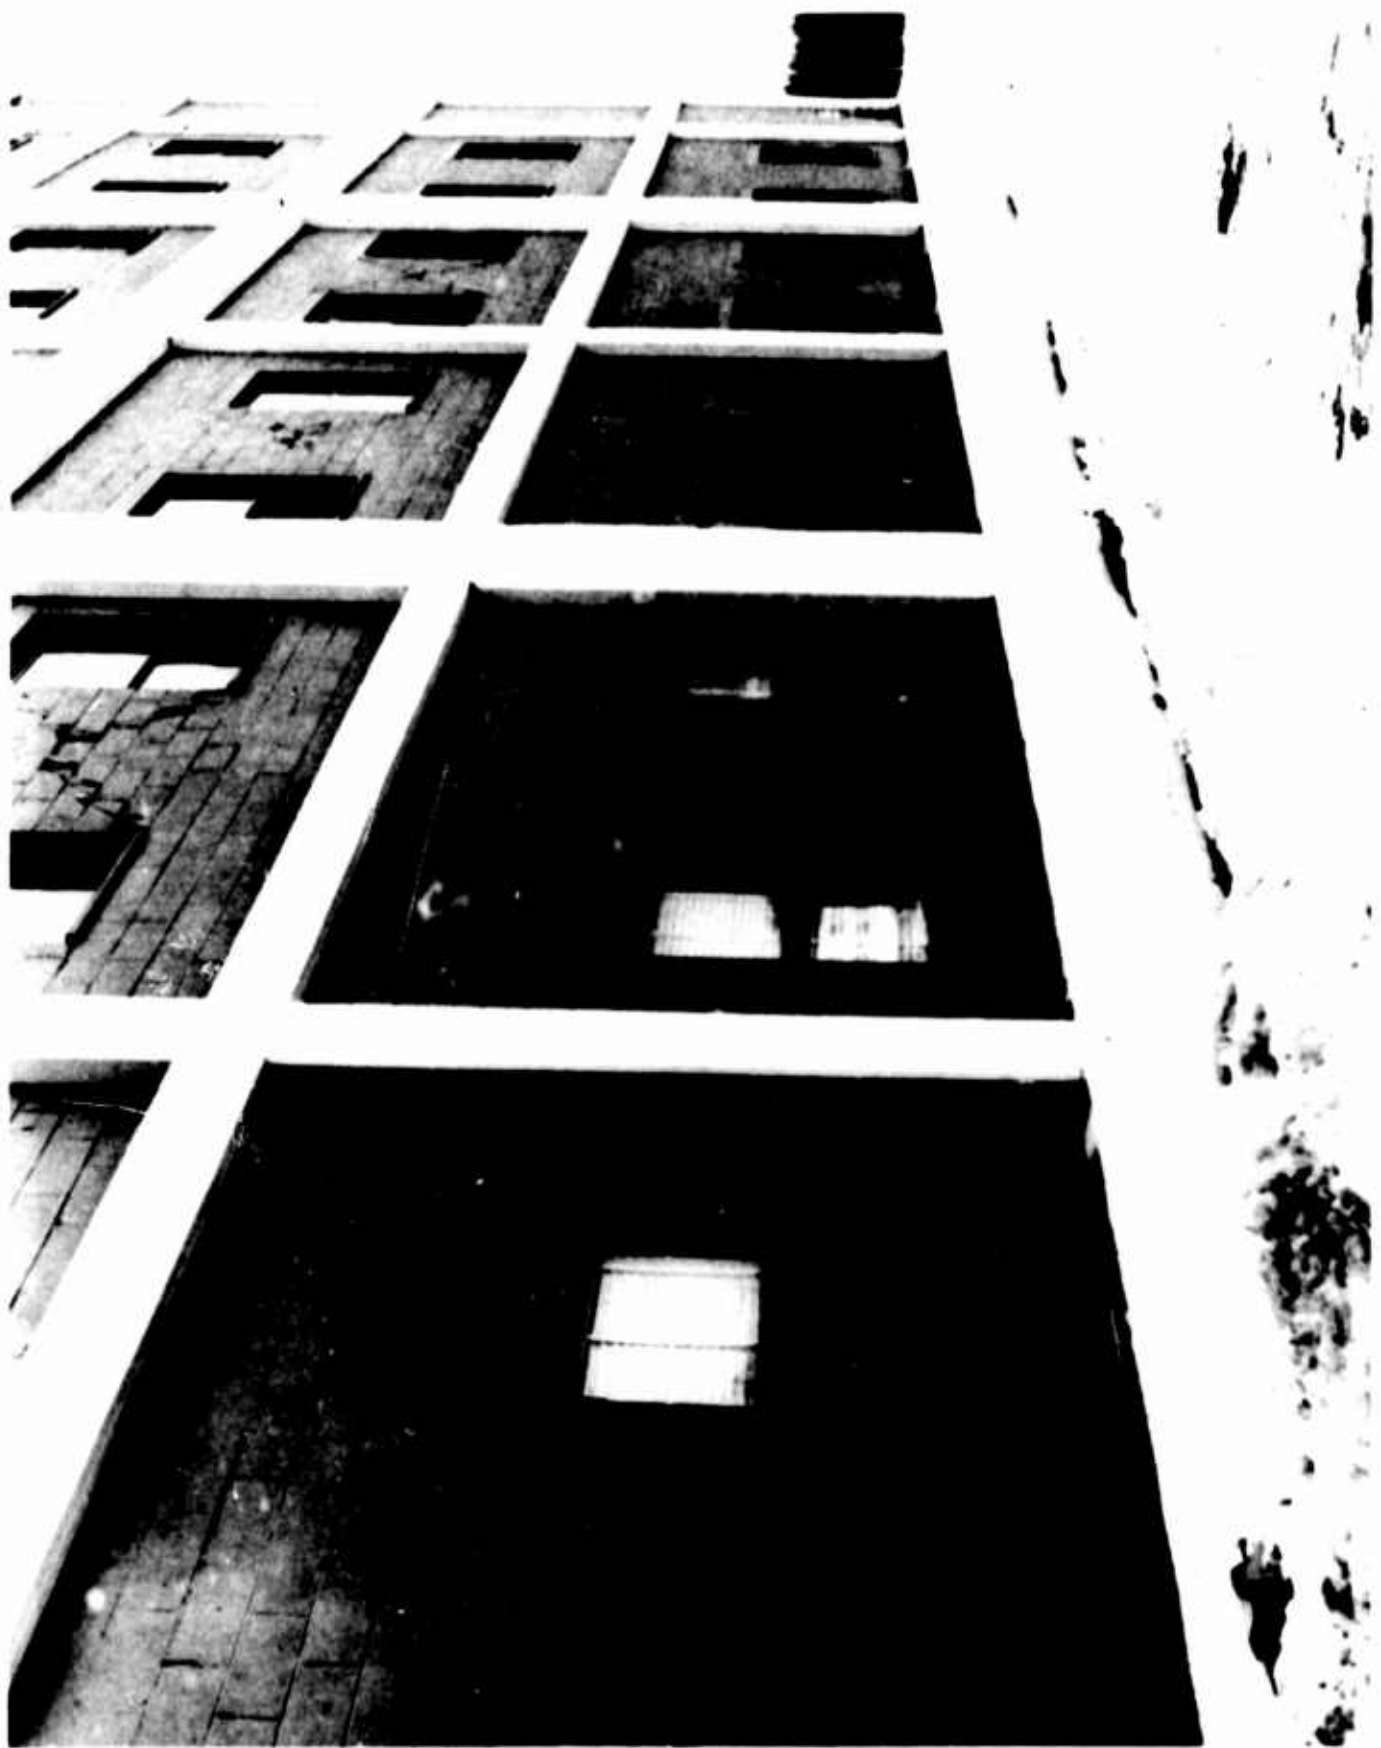
Figure 120. Elmendorf AFB Hospital (Diagonal tension cracks in masonry-filler walls)

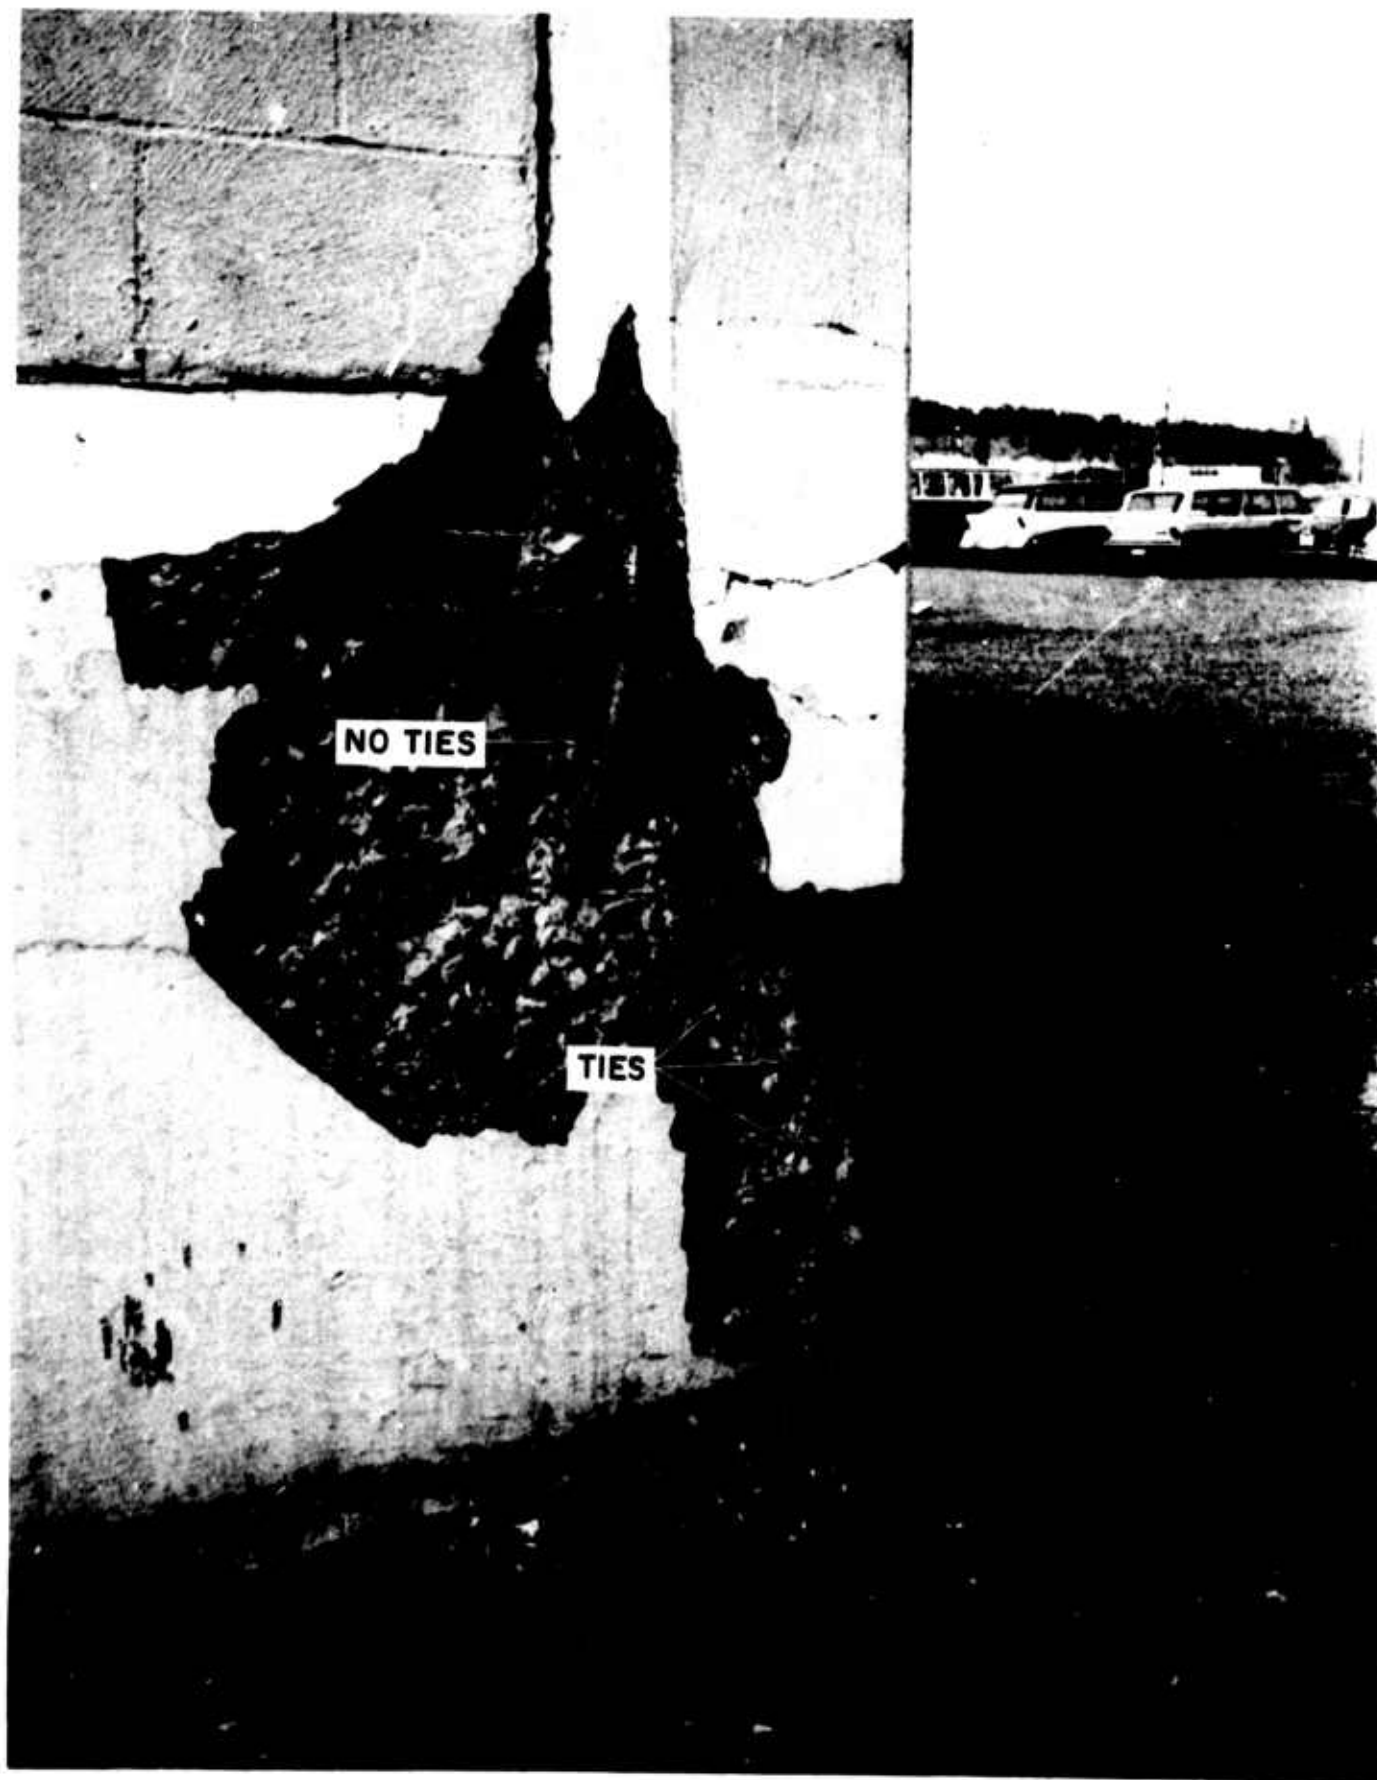
Figure 126. Elmendorf AFB 750-Man Barracks (Column shear failure at first-floor level in northeast corner of Building 31-250. Notice absence of ties in failure zone.)

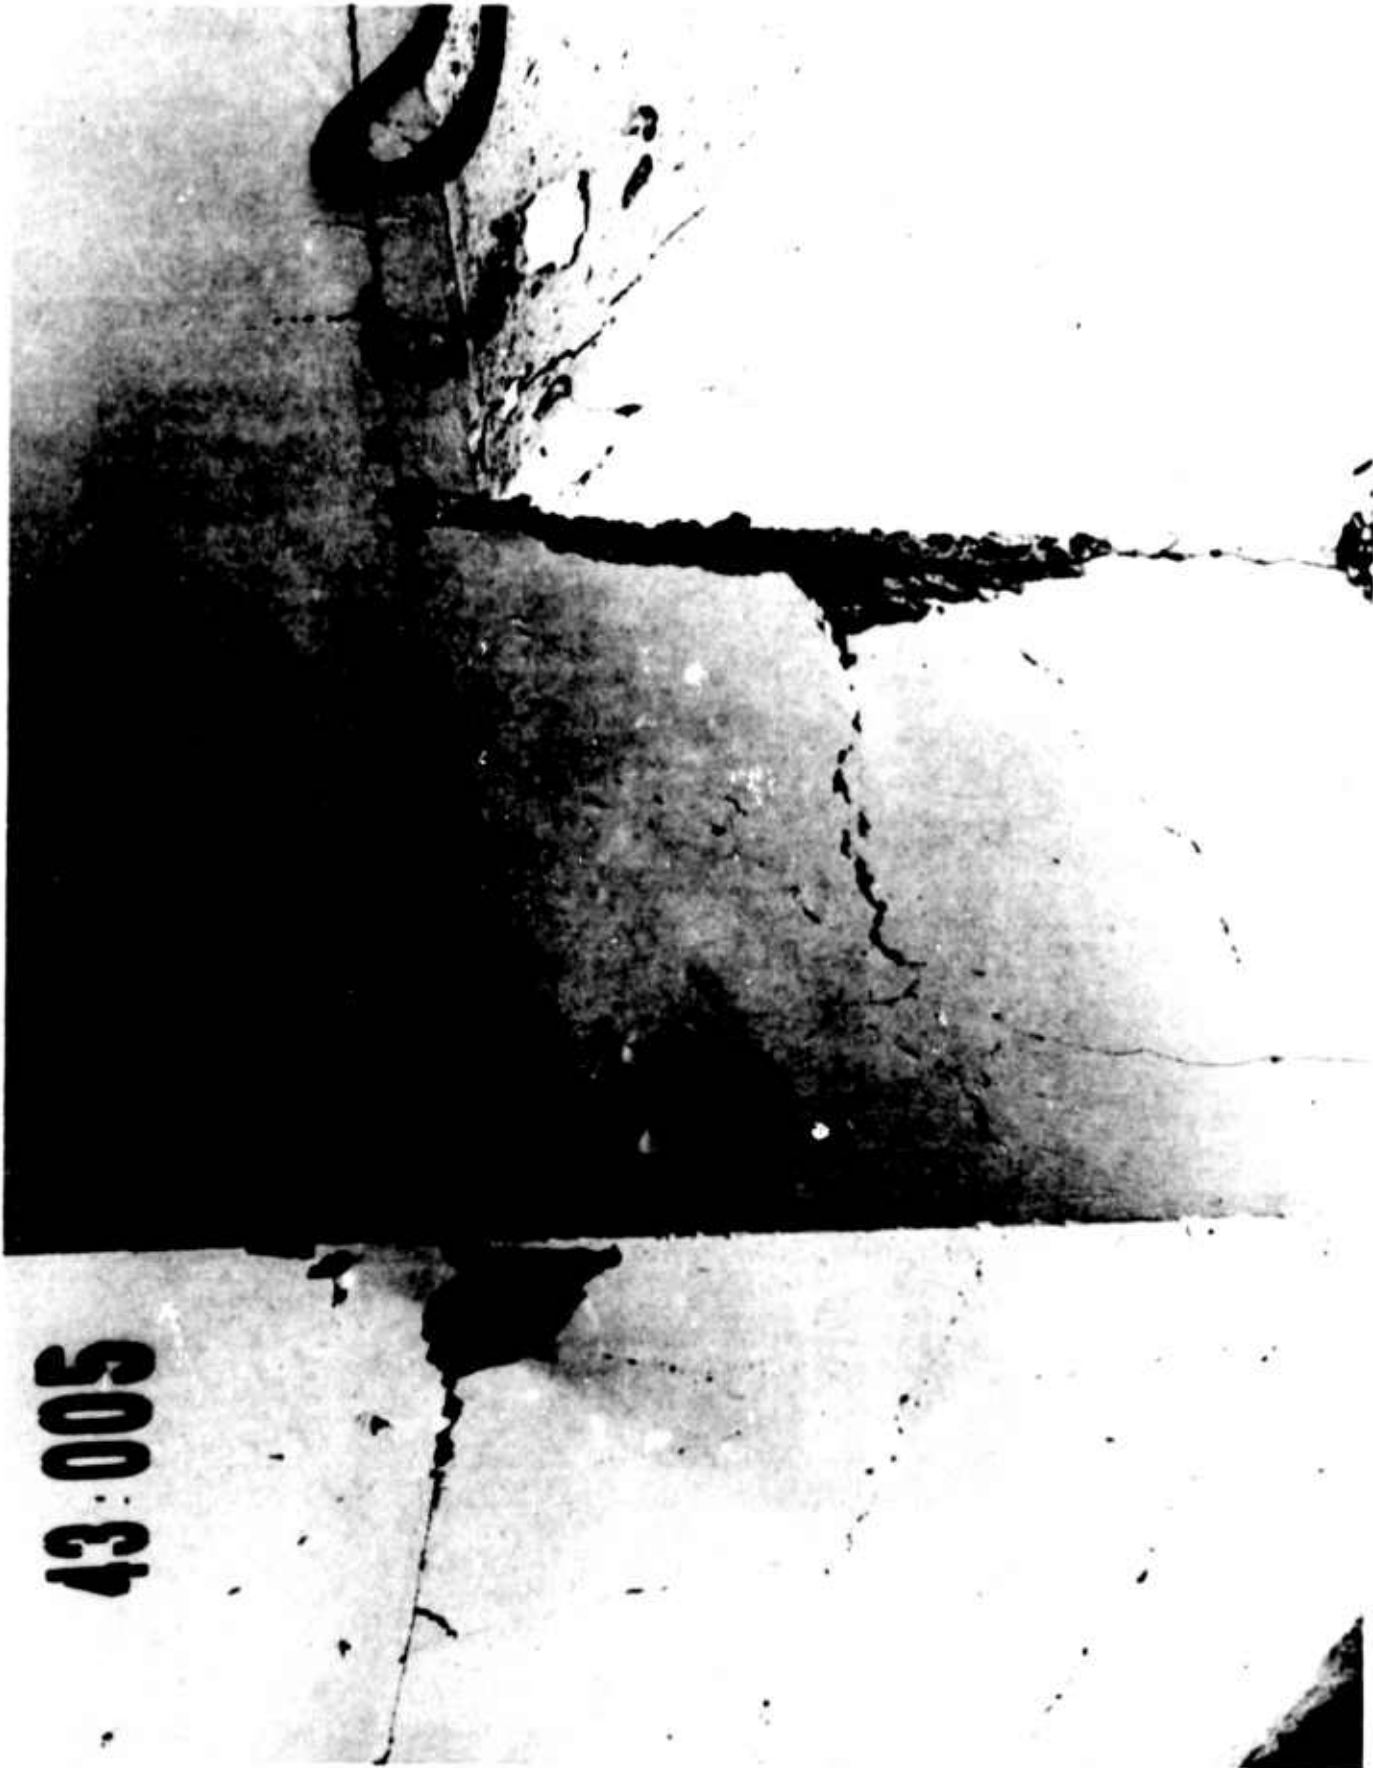
Figure 130. Elmendorf AFB Aircraft Control Tower (Closeup of horizontal crack following a construction joint at southeast corner of tower. Note spalling of paint and concrete.)

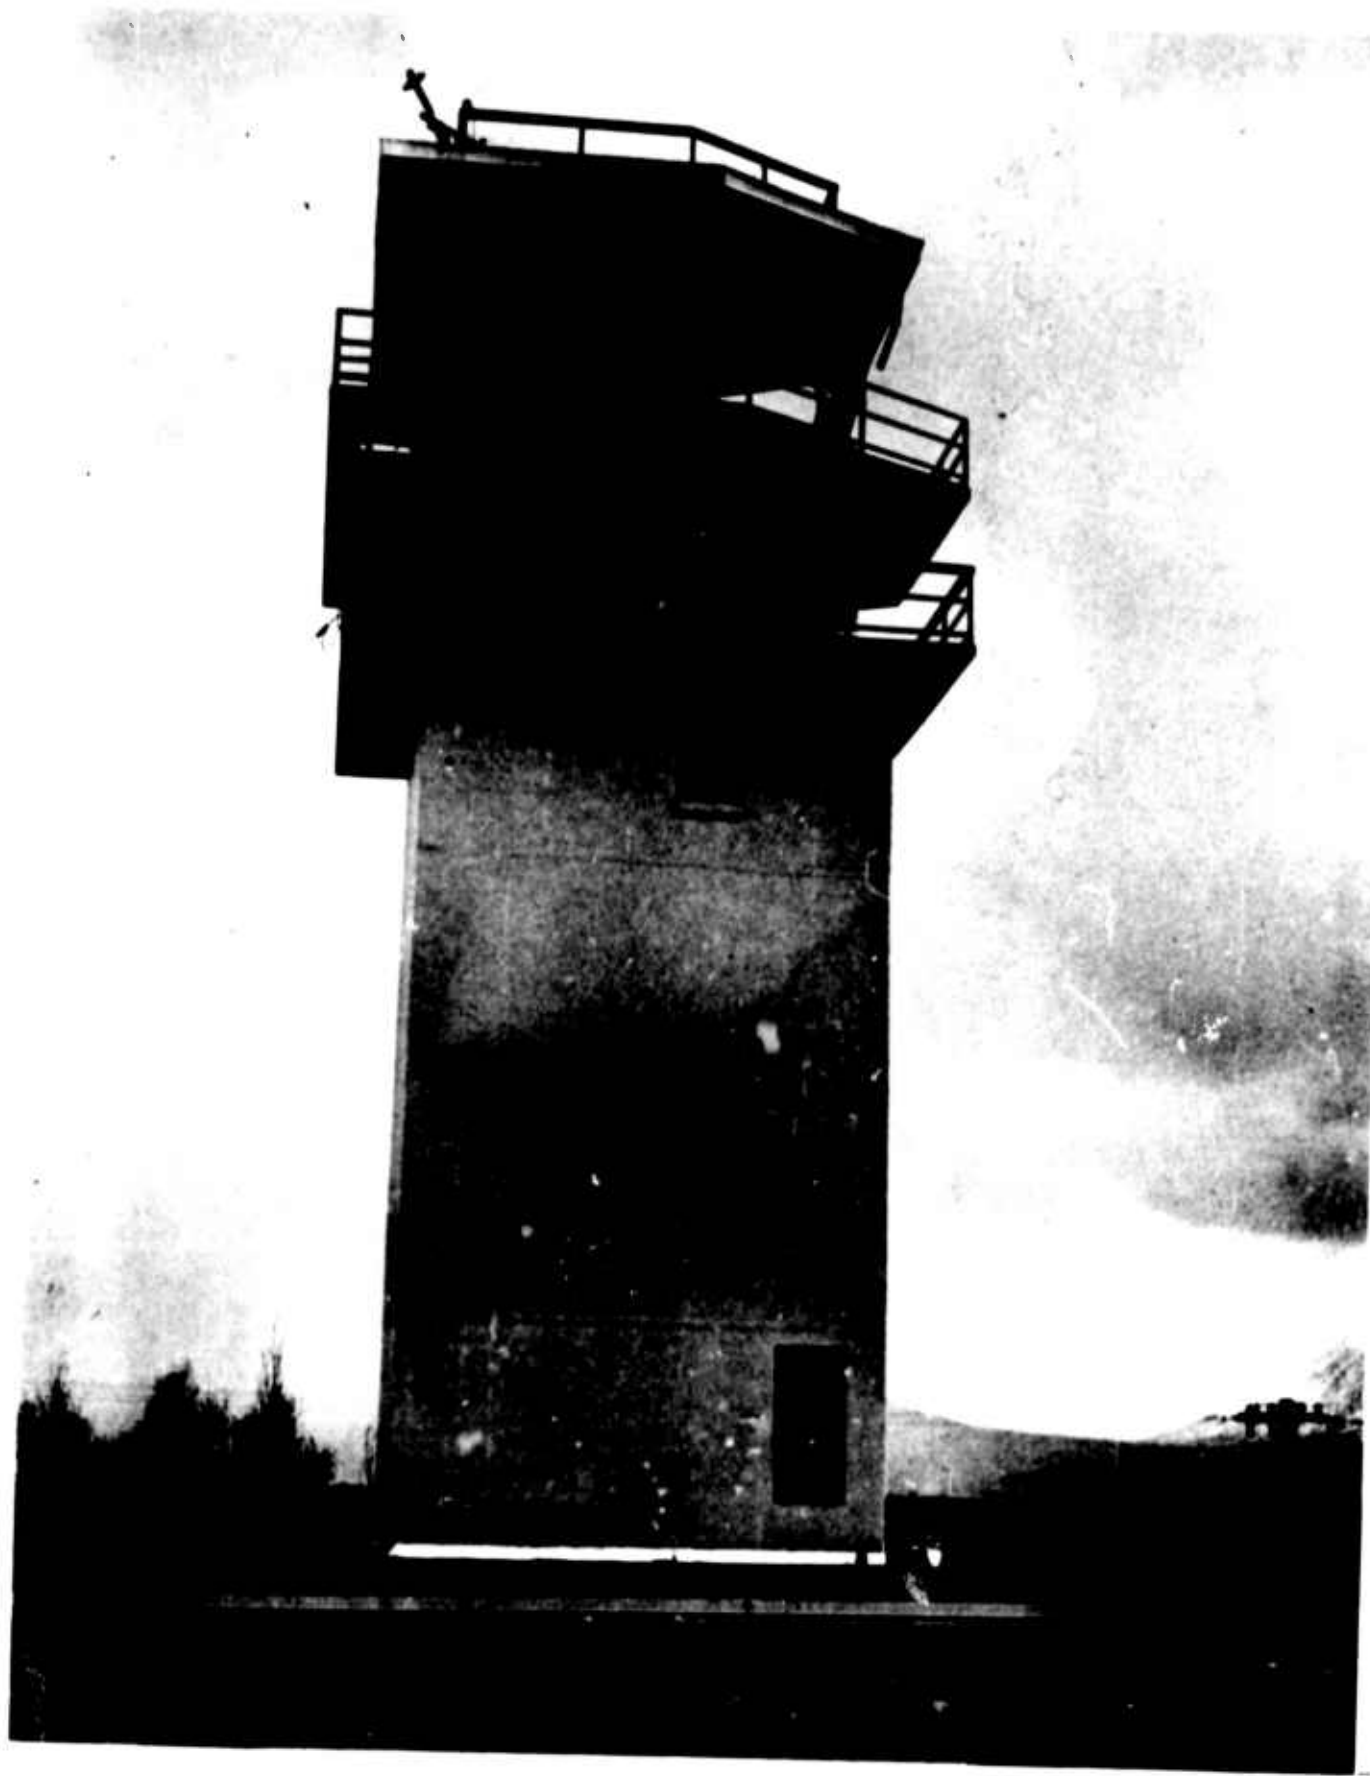
Figure 132. Elmendorf AFB Aircraft Control Tower
(West wall of tower above level of Communications Building roof)

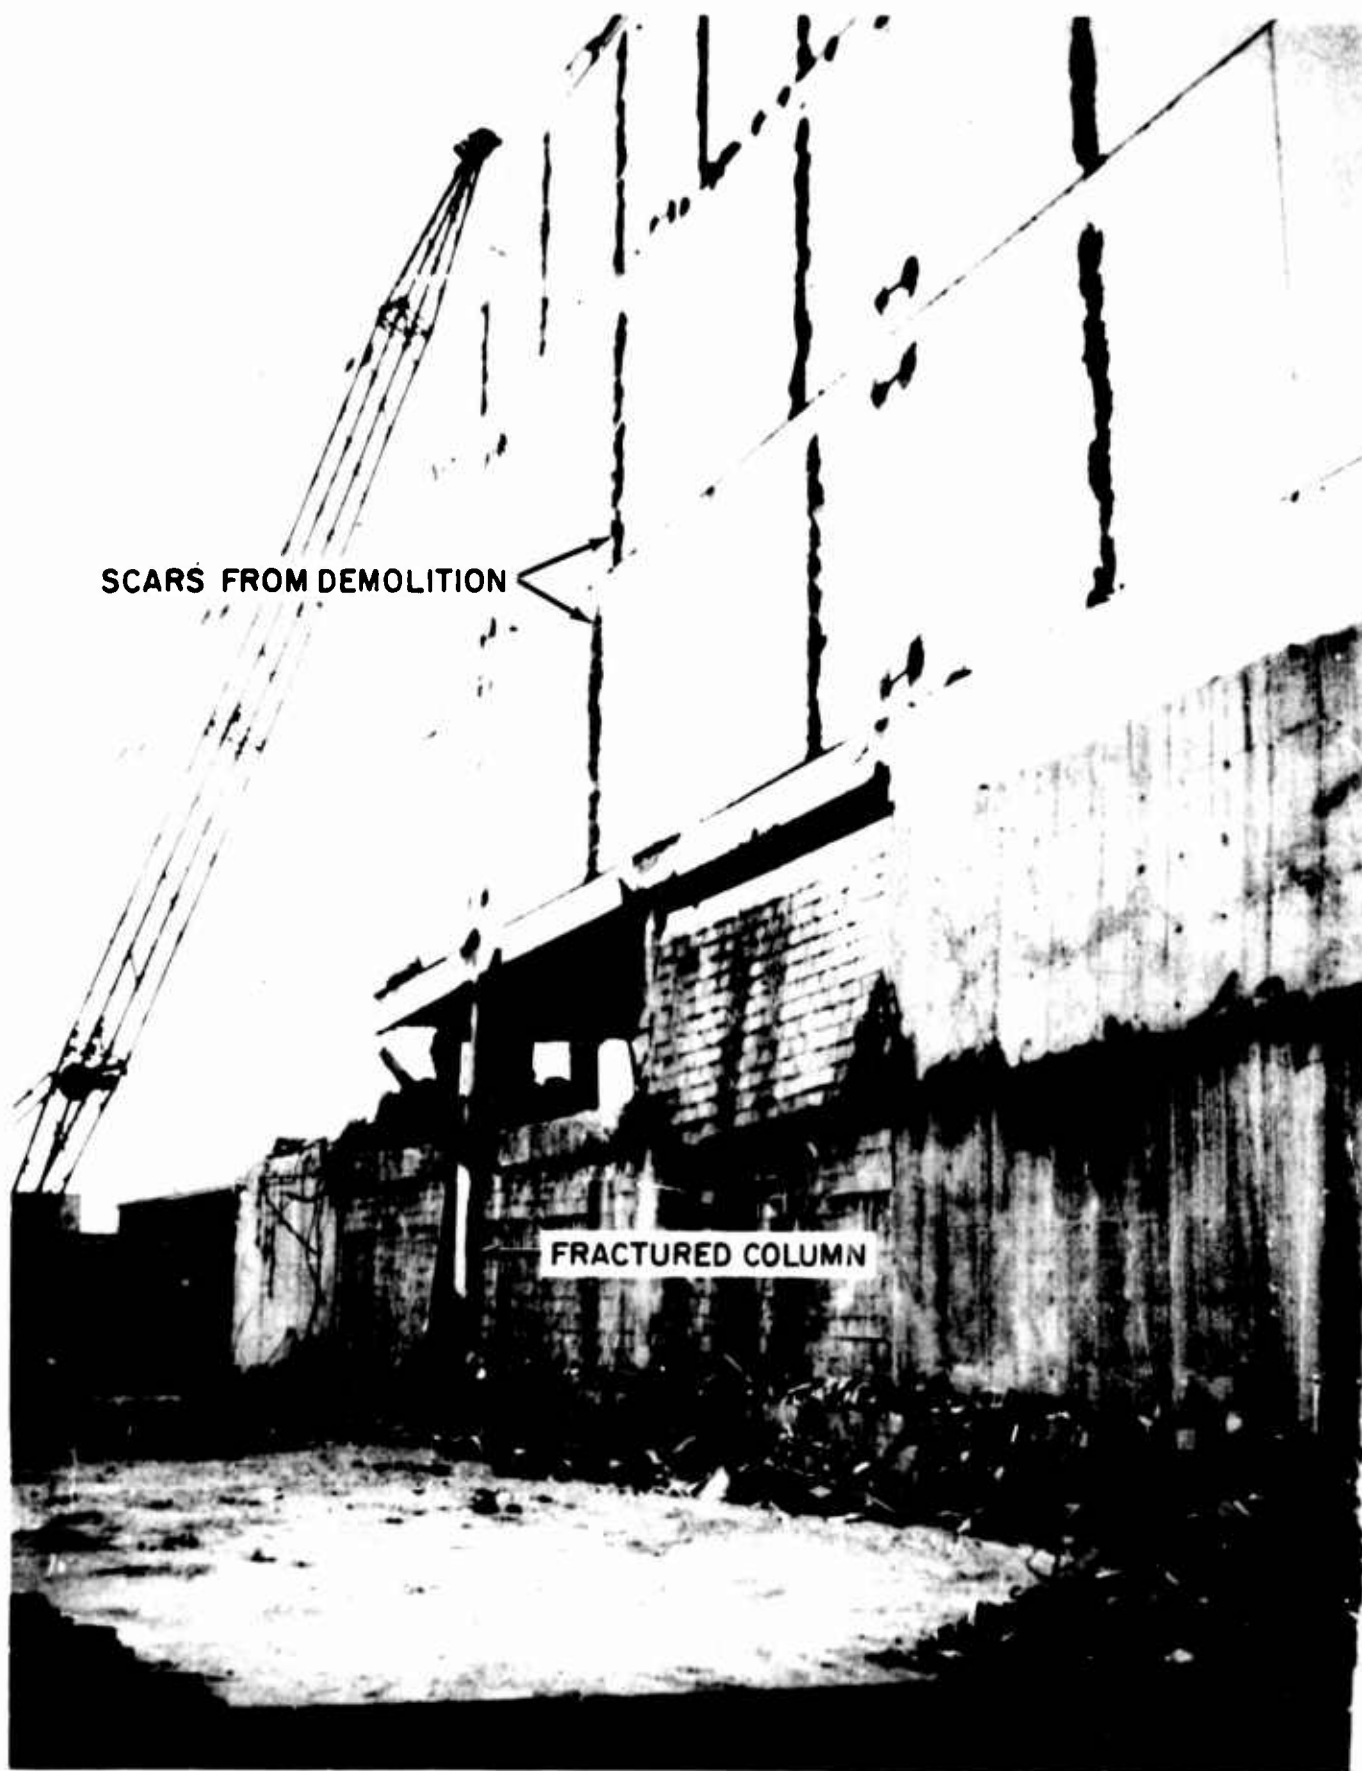
Figure 142. J. C. Penney Building (West side of the structure during demolition showing unseated shear panels and fractured column. Adjacent building has been razed to make room for demolition operations.)

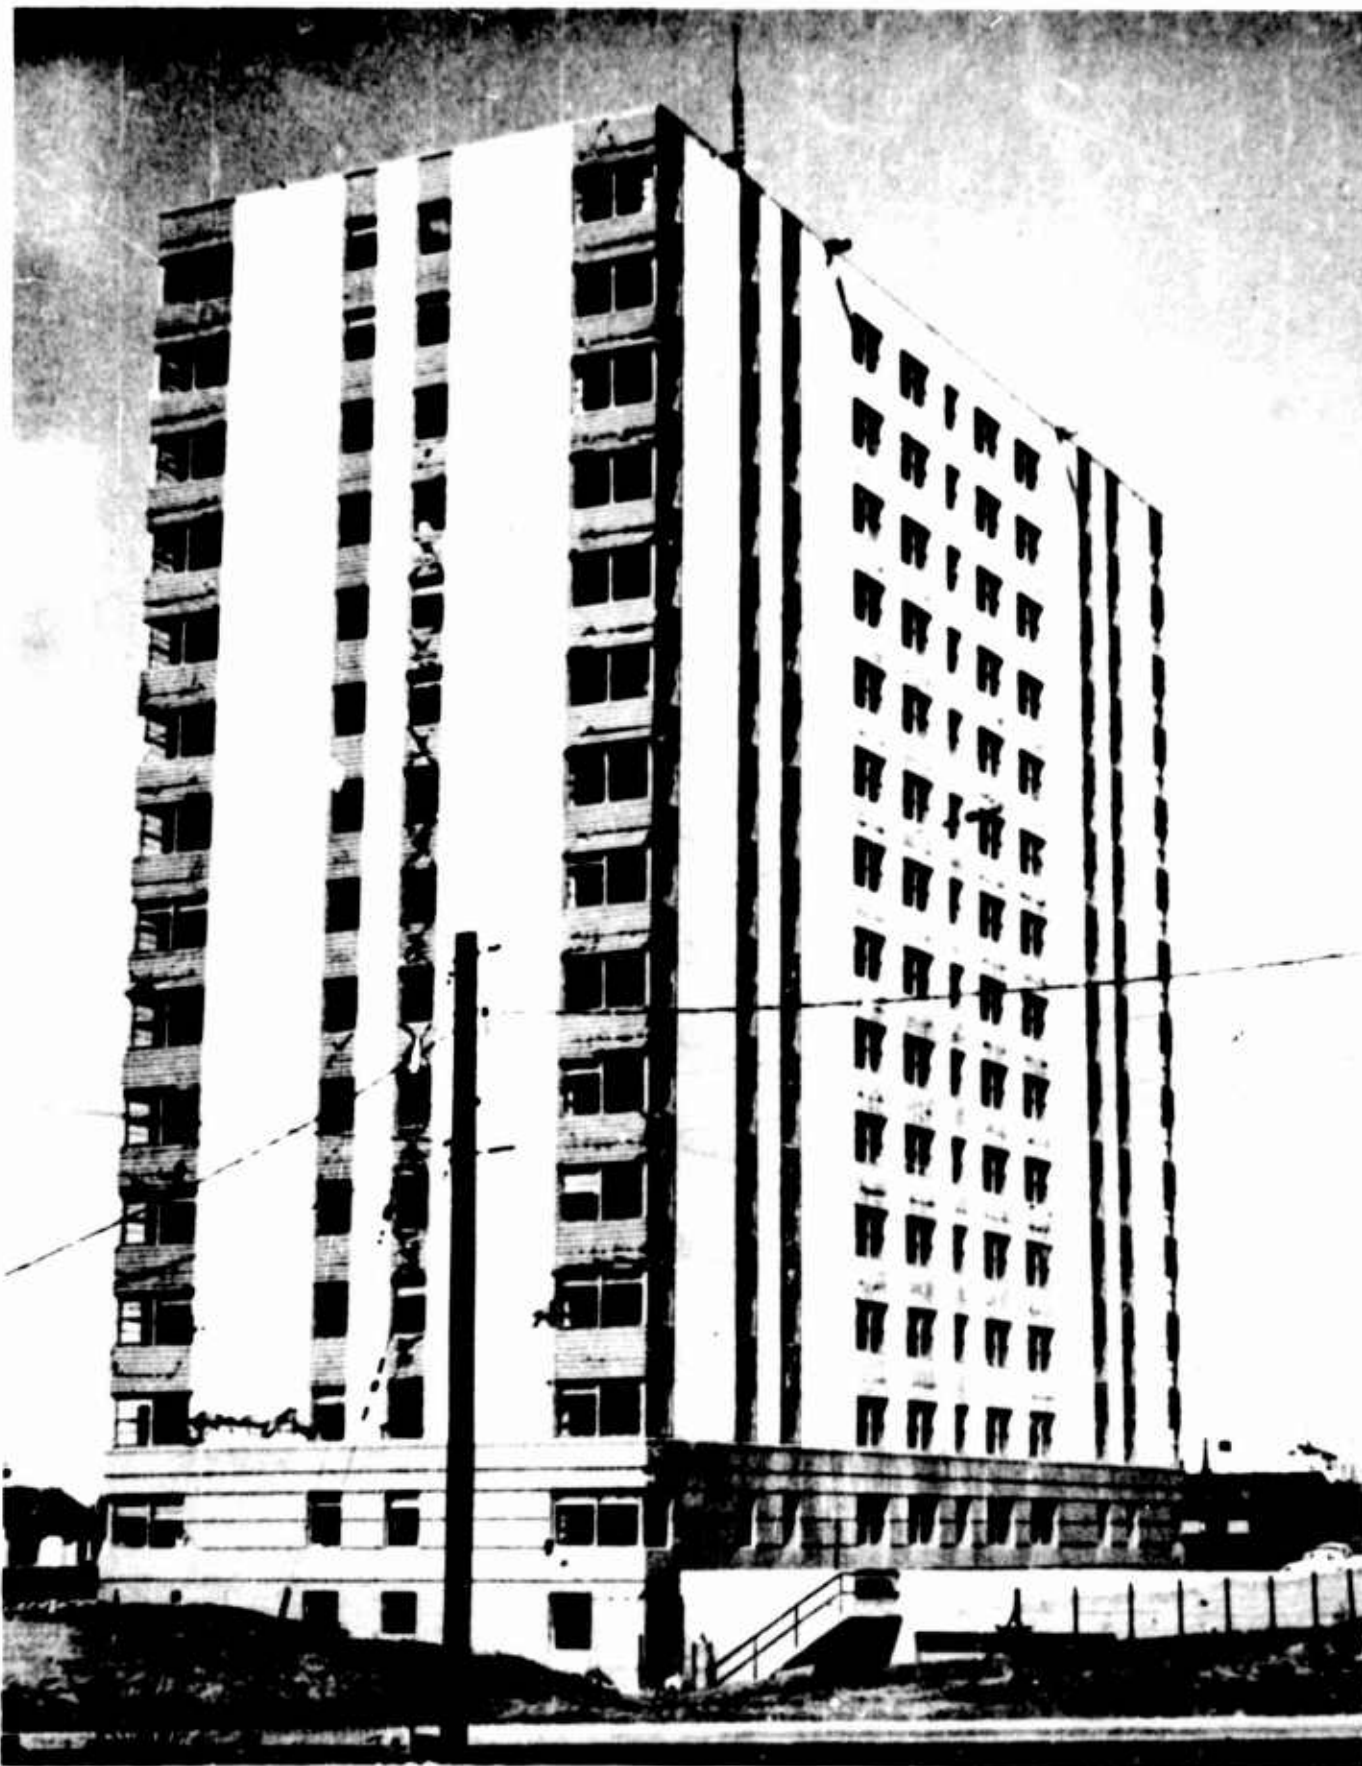
Figure 147. Twelve-Hundred L Street Apartments
(South side of the structure showing column wall fracture midway between the
second- and third-floor levels)
