THE GREAT ALASKA EARTHQUAKE

Volume II

Illustrations and Maps

TECHNICAL REPORT NO. AFWL-TR-65-92, Vol II

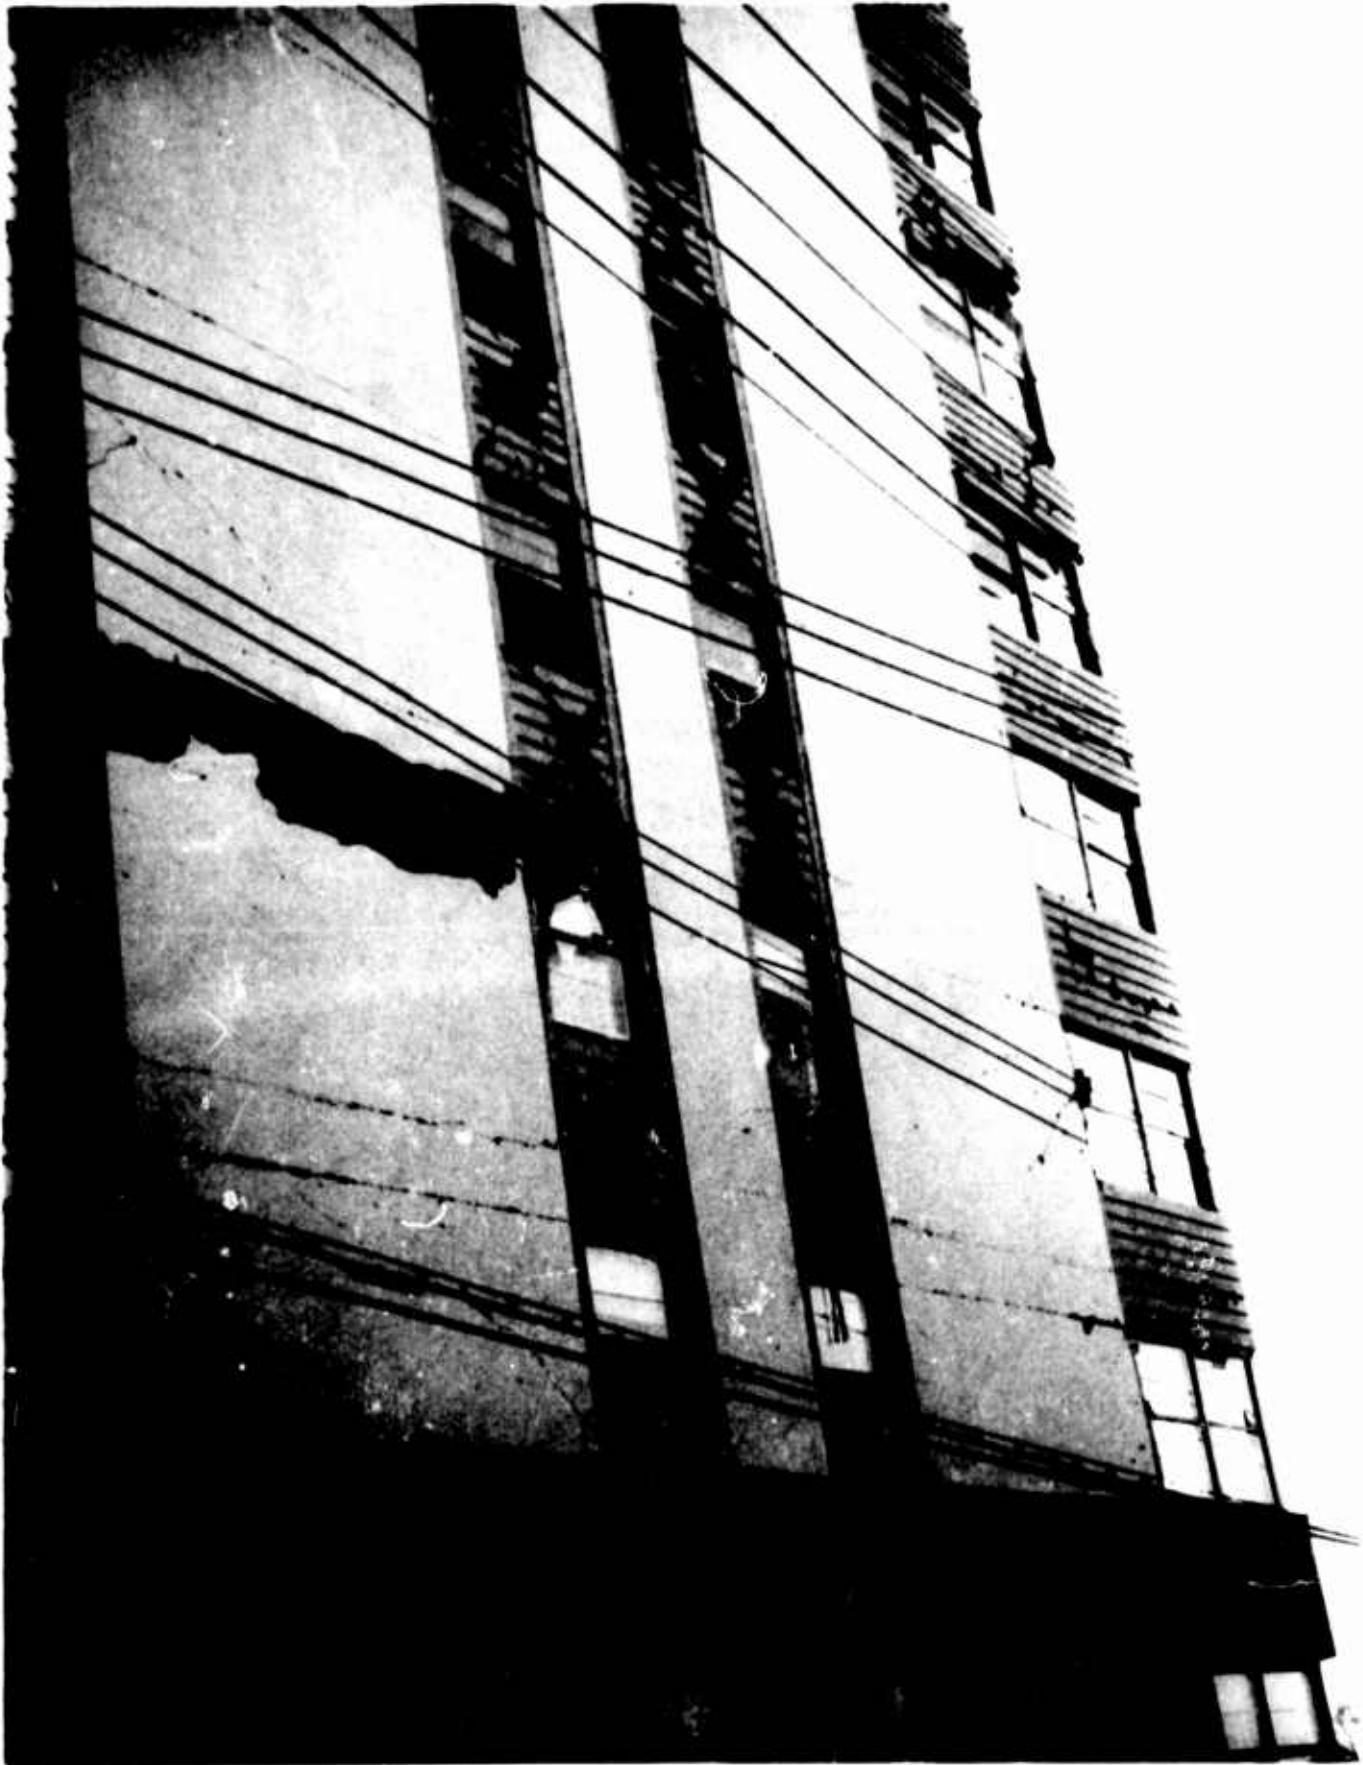
Figure 148. Mount McKinley Building (Exterior closeup of column wall fractures)

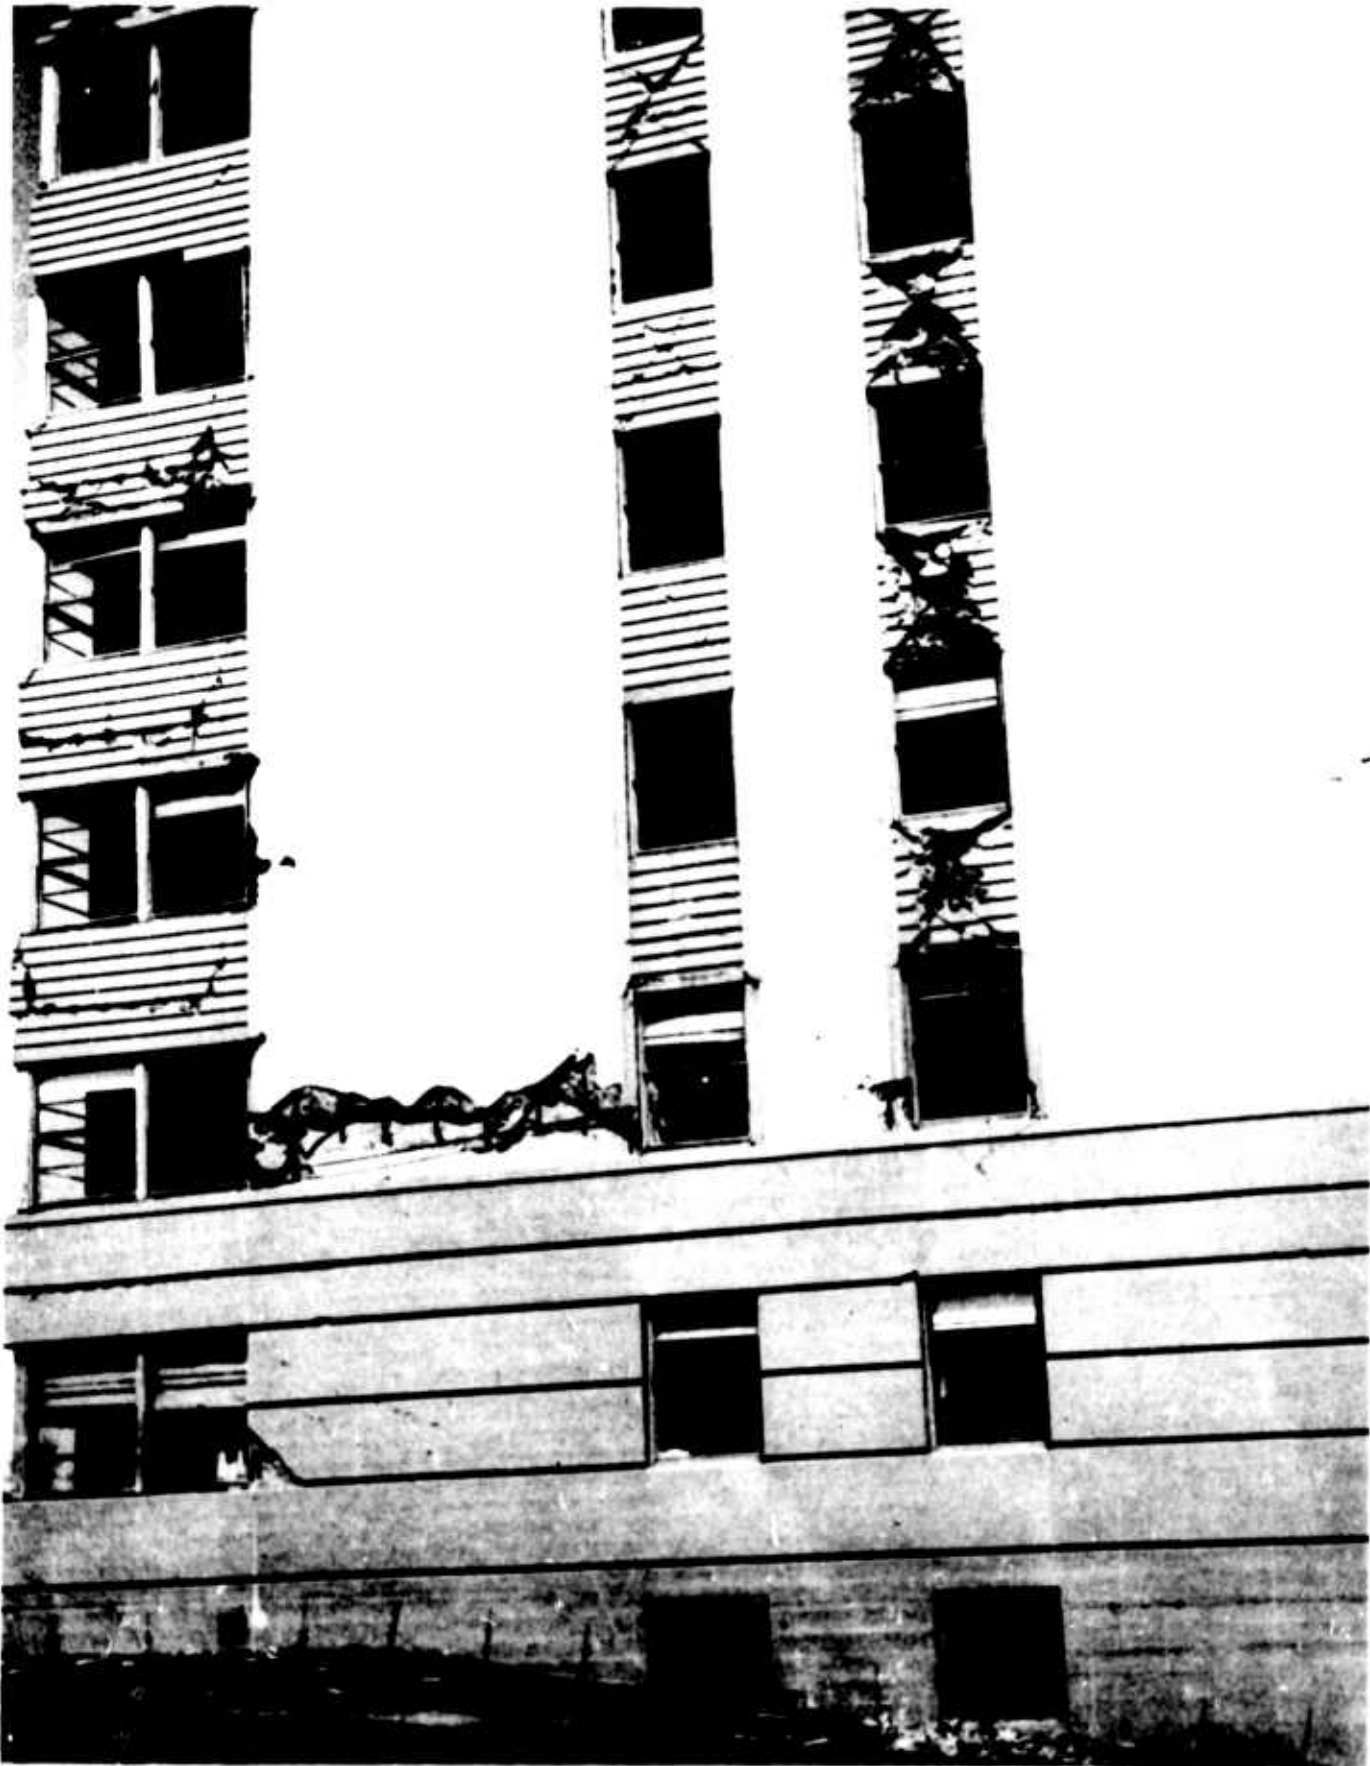
Figure 149. Twelve-Hundred L Street Apartments
(Exterior closeup of column wall fracture)

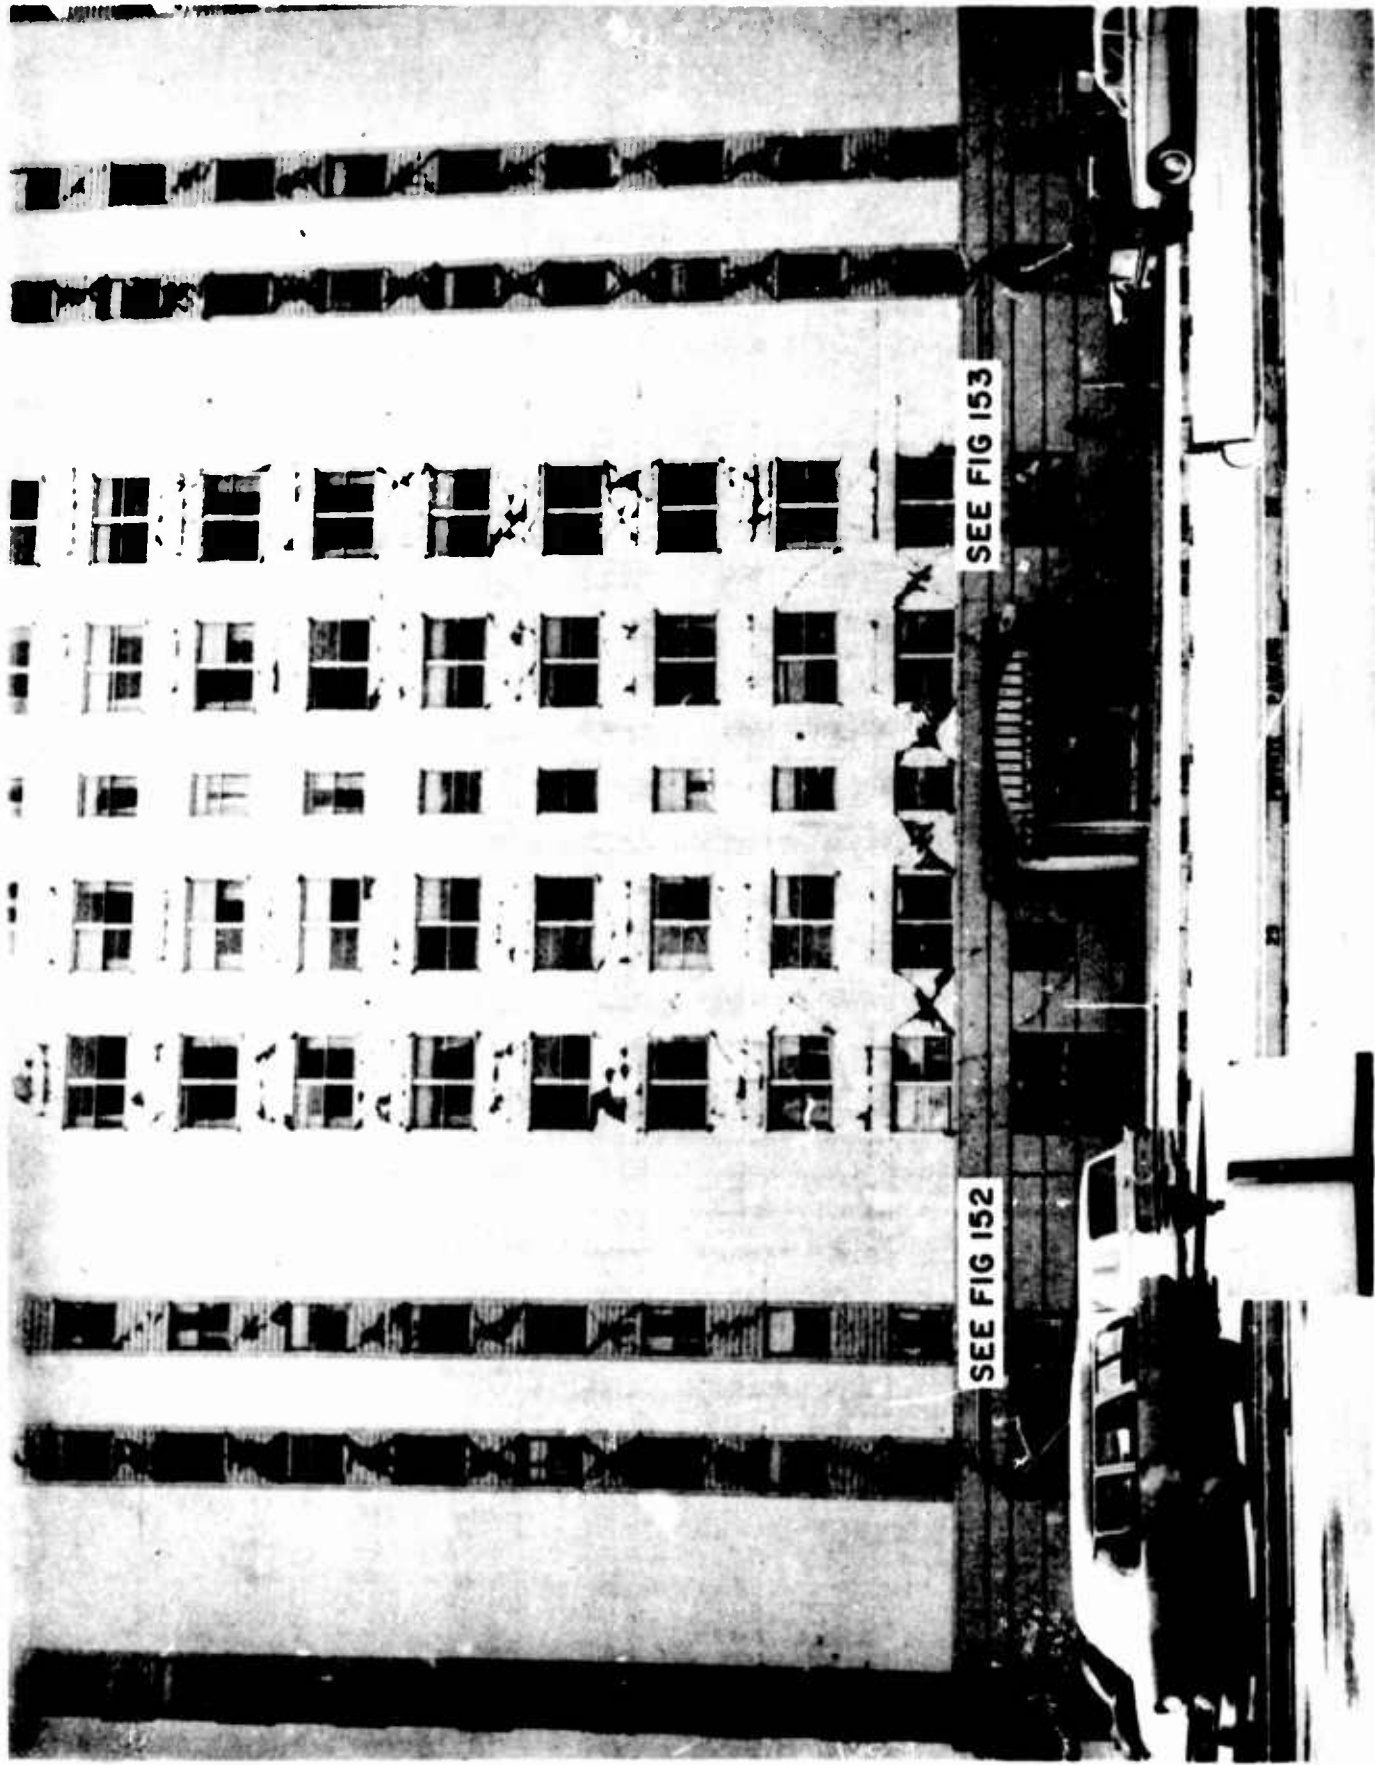
Figure 151. Mount McKinley Building
(East wall of structure showing major diagonal tension failures of second-floor level)

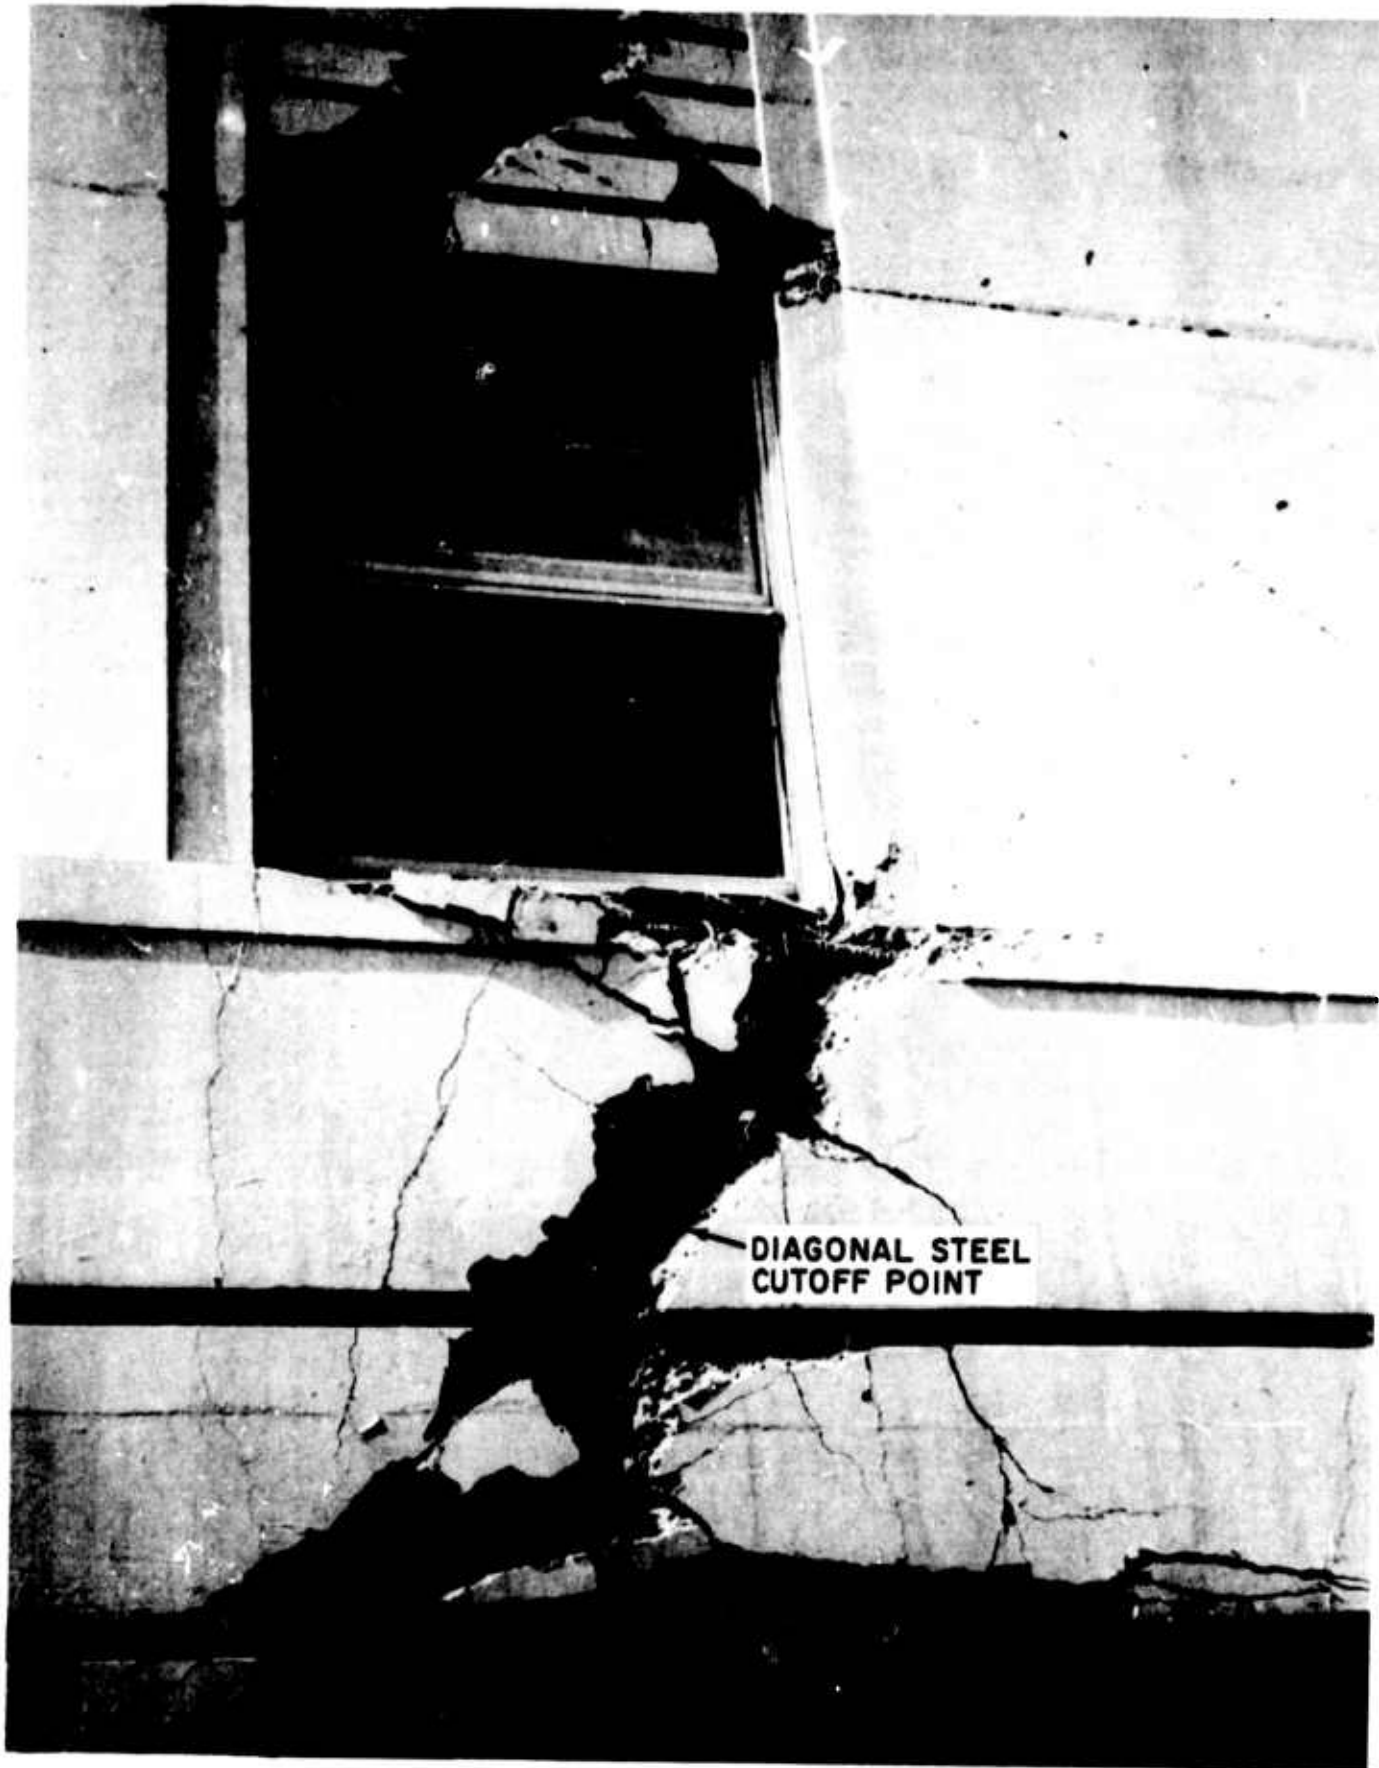
Figure 152. Mount McKinley Building
(Diagonal tension failure in east wall at second-floor level)

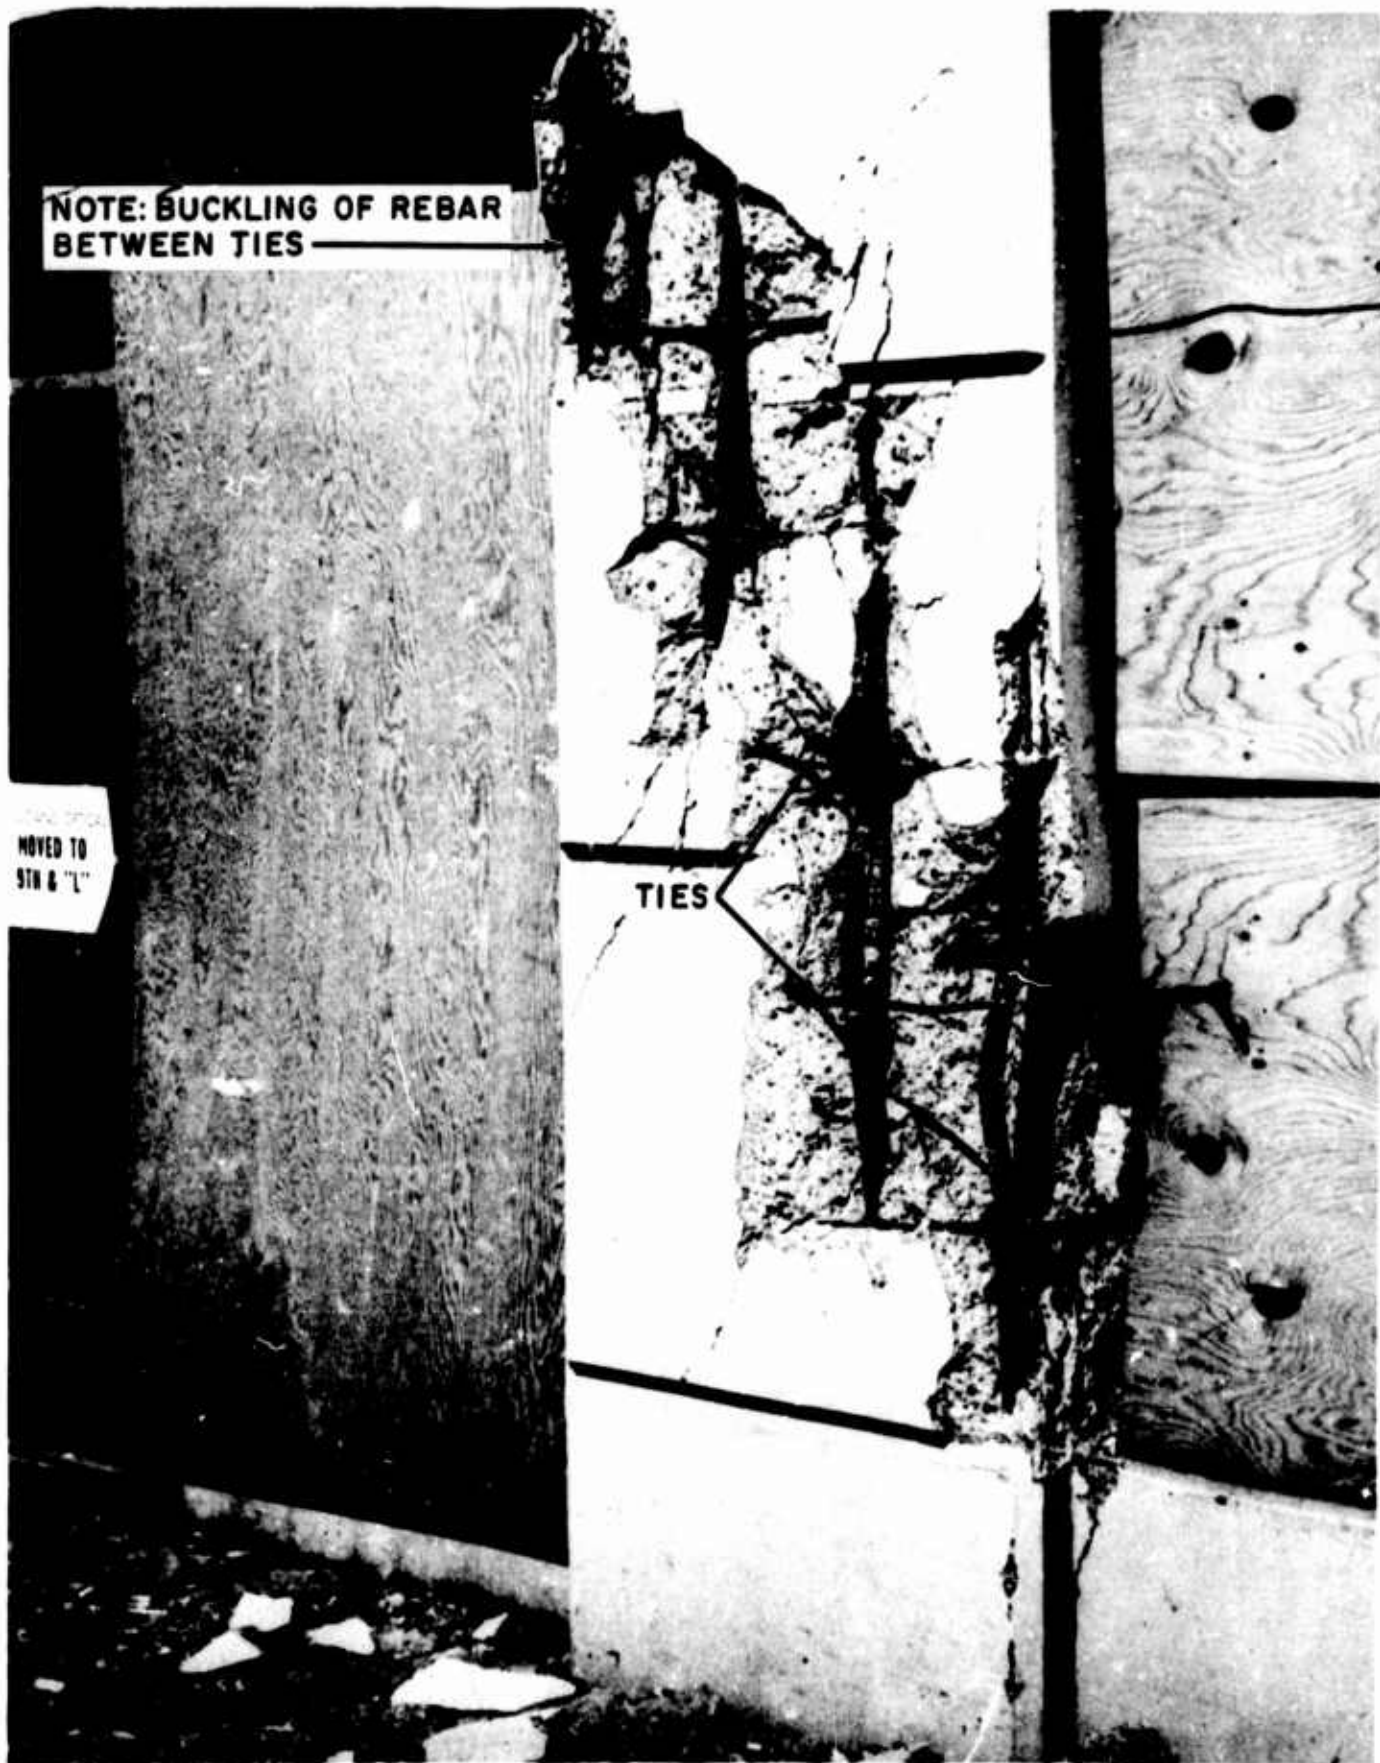
Figure 155. Mount McKinley Building (Shortened column in south wall near southeast corner of structure)

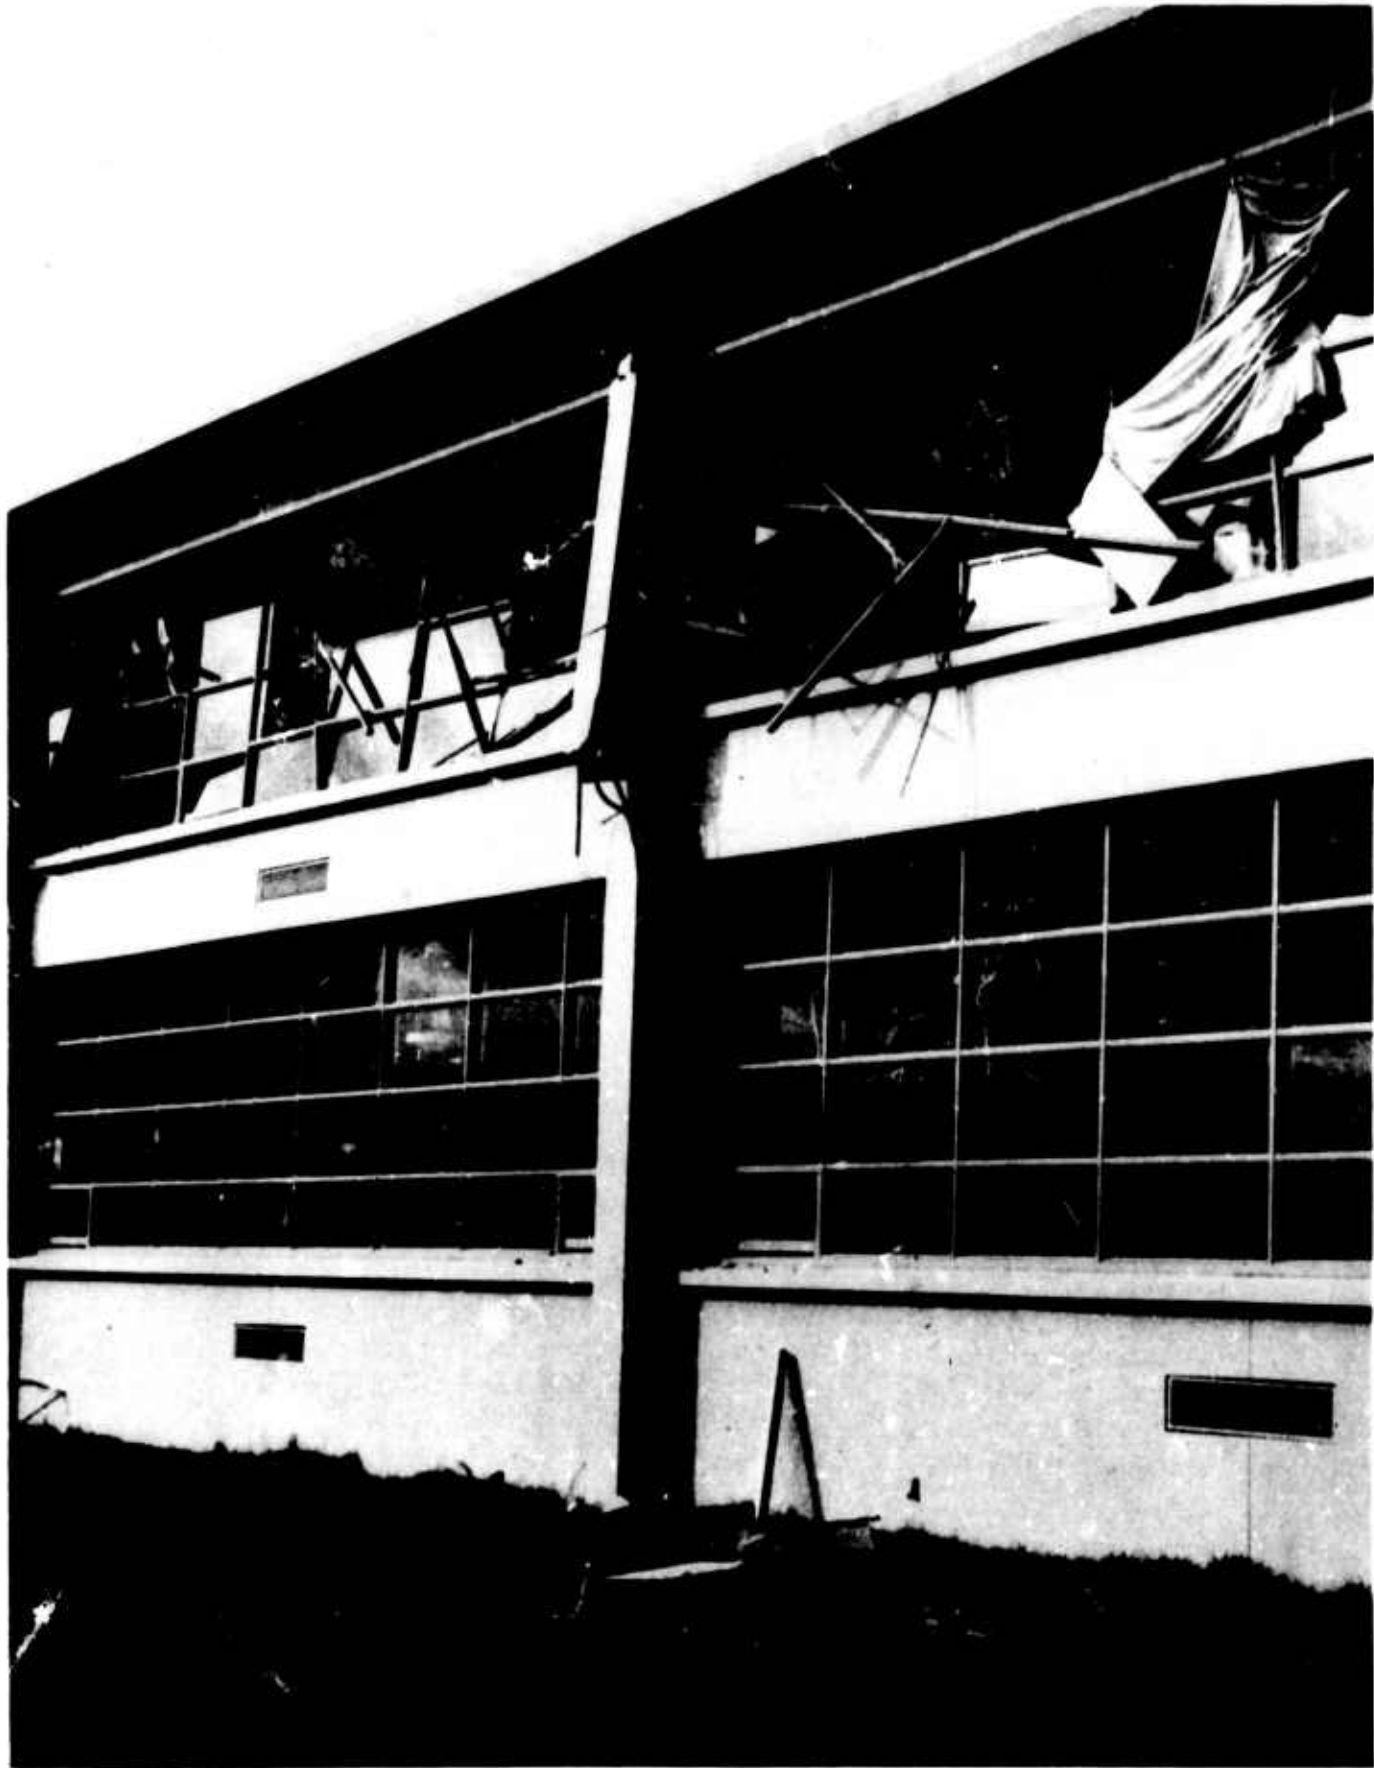
Figure 159. West Anchorage High School
(Damage to wing B and intersection of wings A and B)

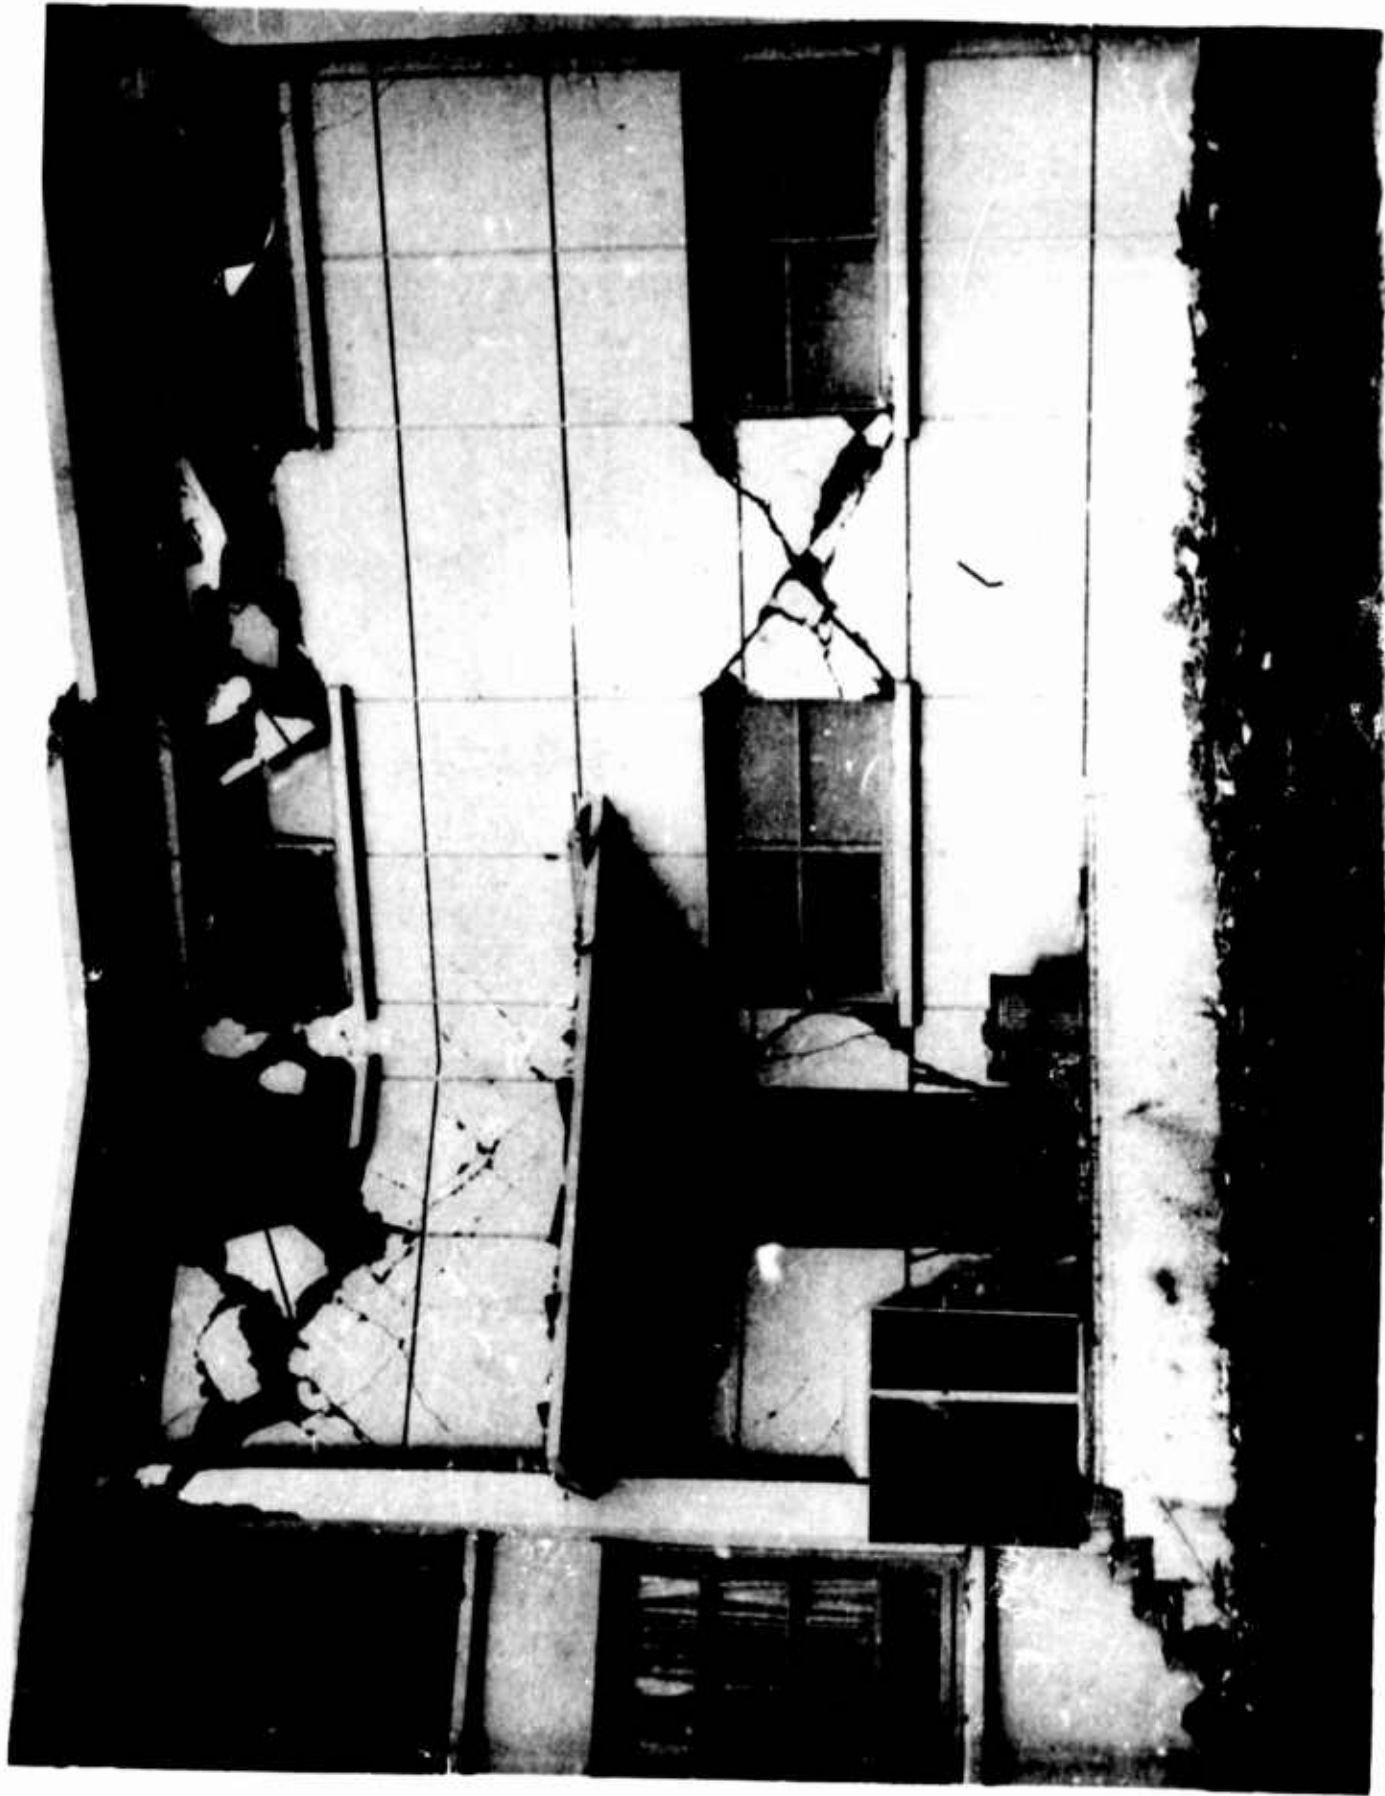
Figure 162. West Anchorage High School (Damage at intersection of wings A and B)

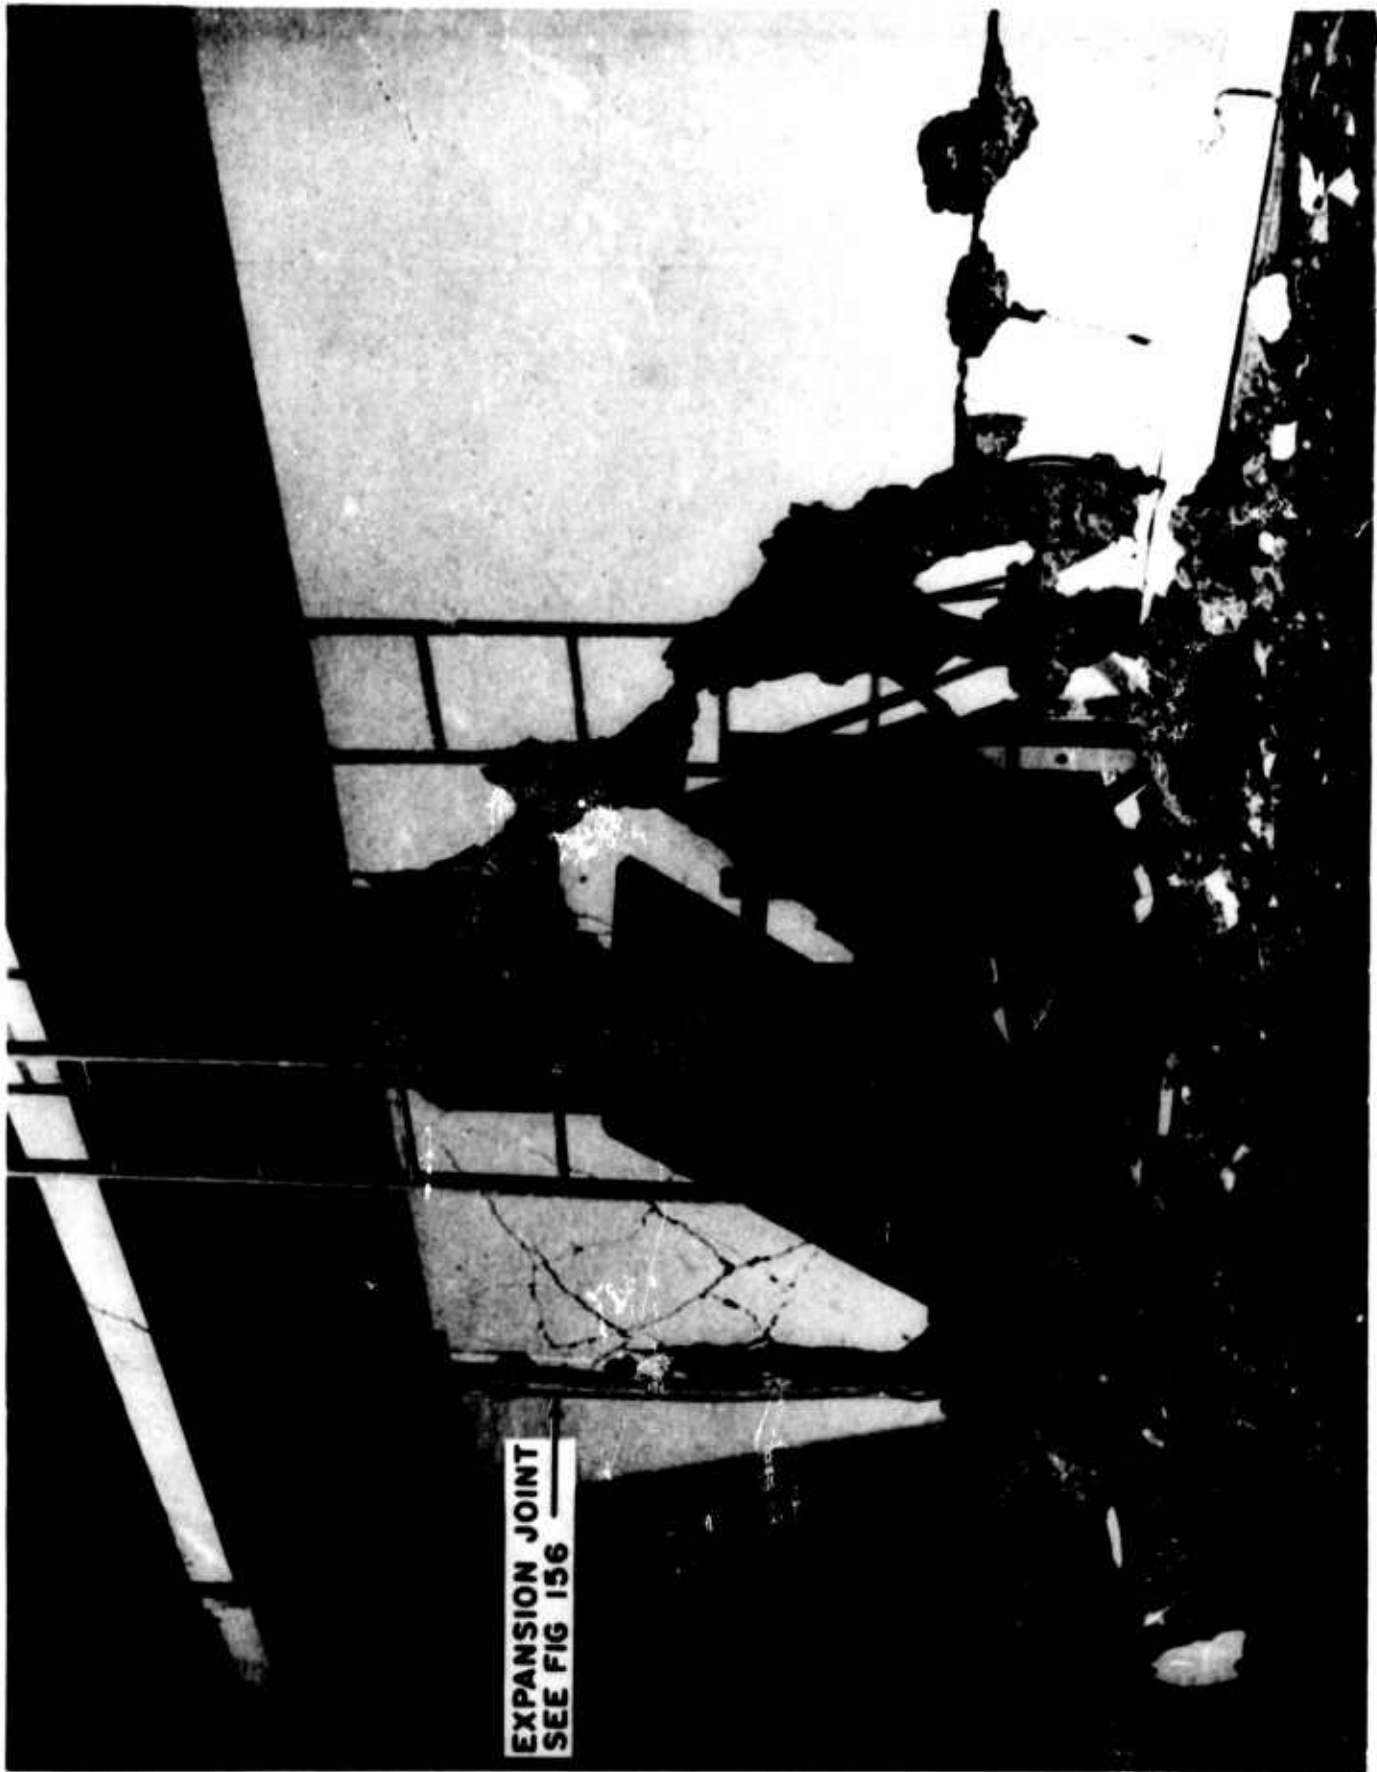
Figure 163. West Anchorage High School (Damage to wing B near expansion joint between wing B and auditorium/gymnasium structure)

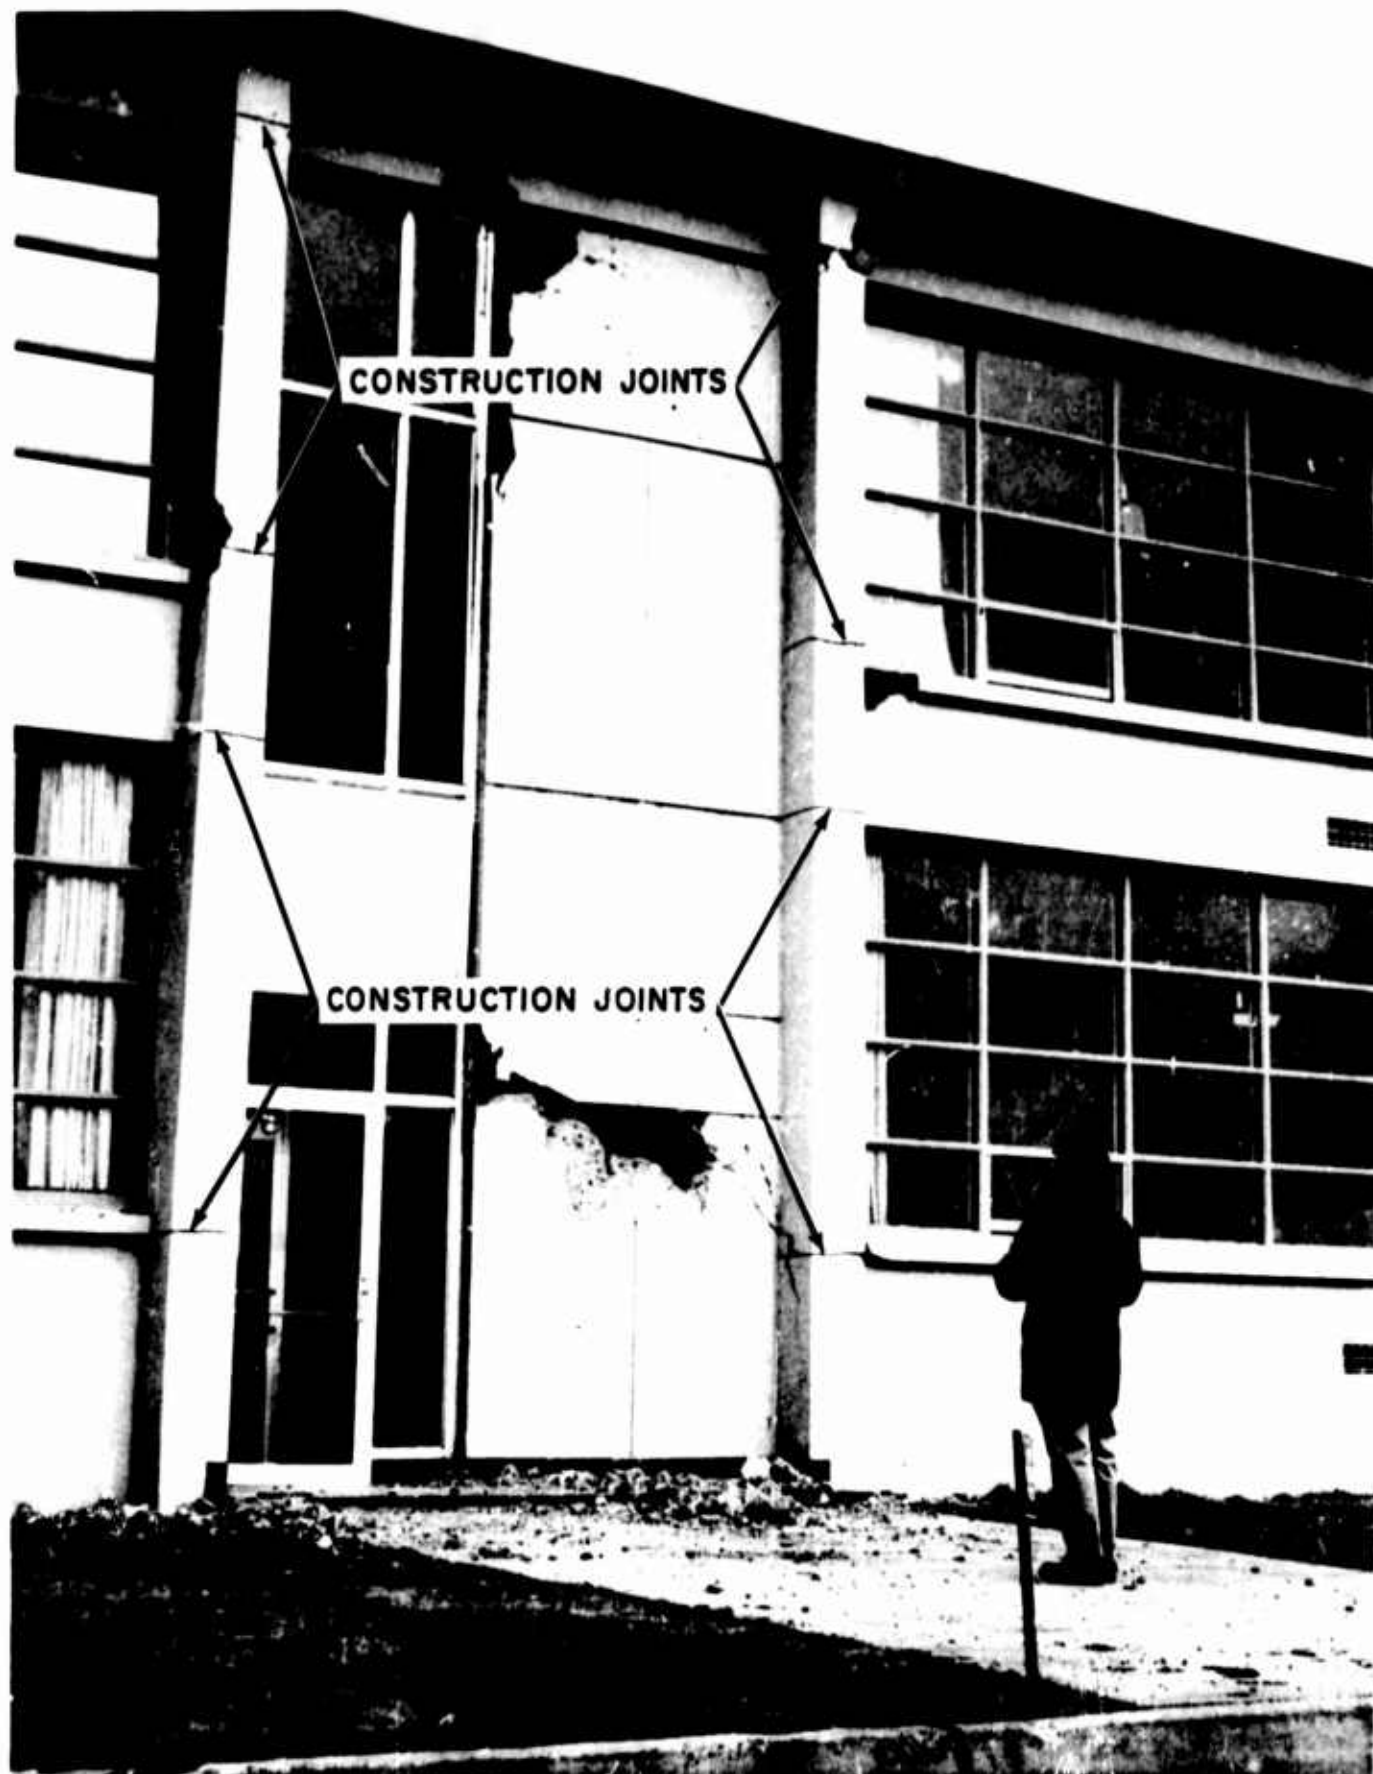
Figure 170. West Anchorage High School
(Damage to wing A addition near expansion joint
between addition and original wing A)
