THE GREAT ALASKA EARTHQUAKE

Volume II

Illustrations and Maps

TECHNICAL REPORT NO. AFWL-TR-65-92, Vol II

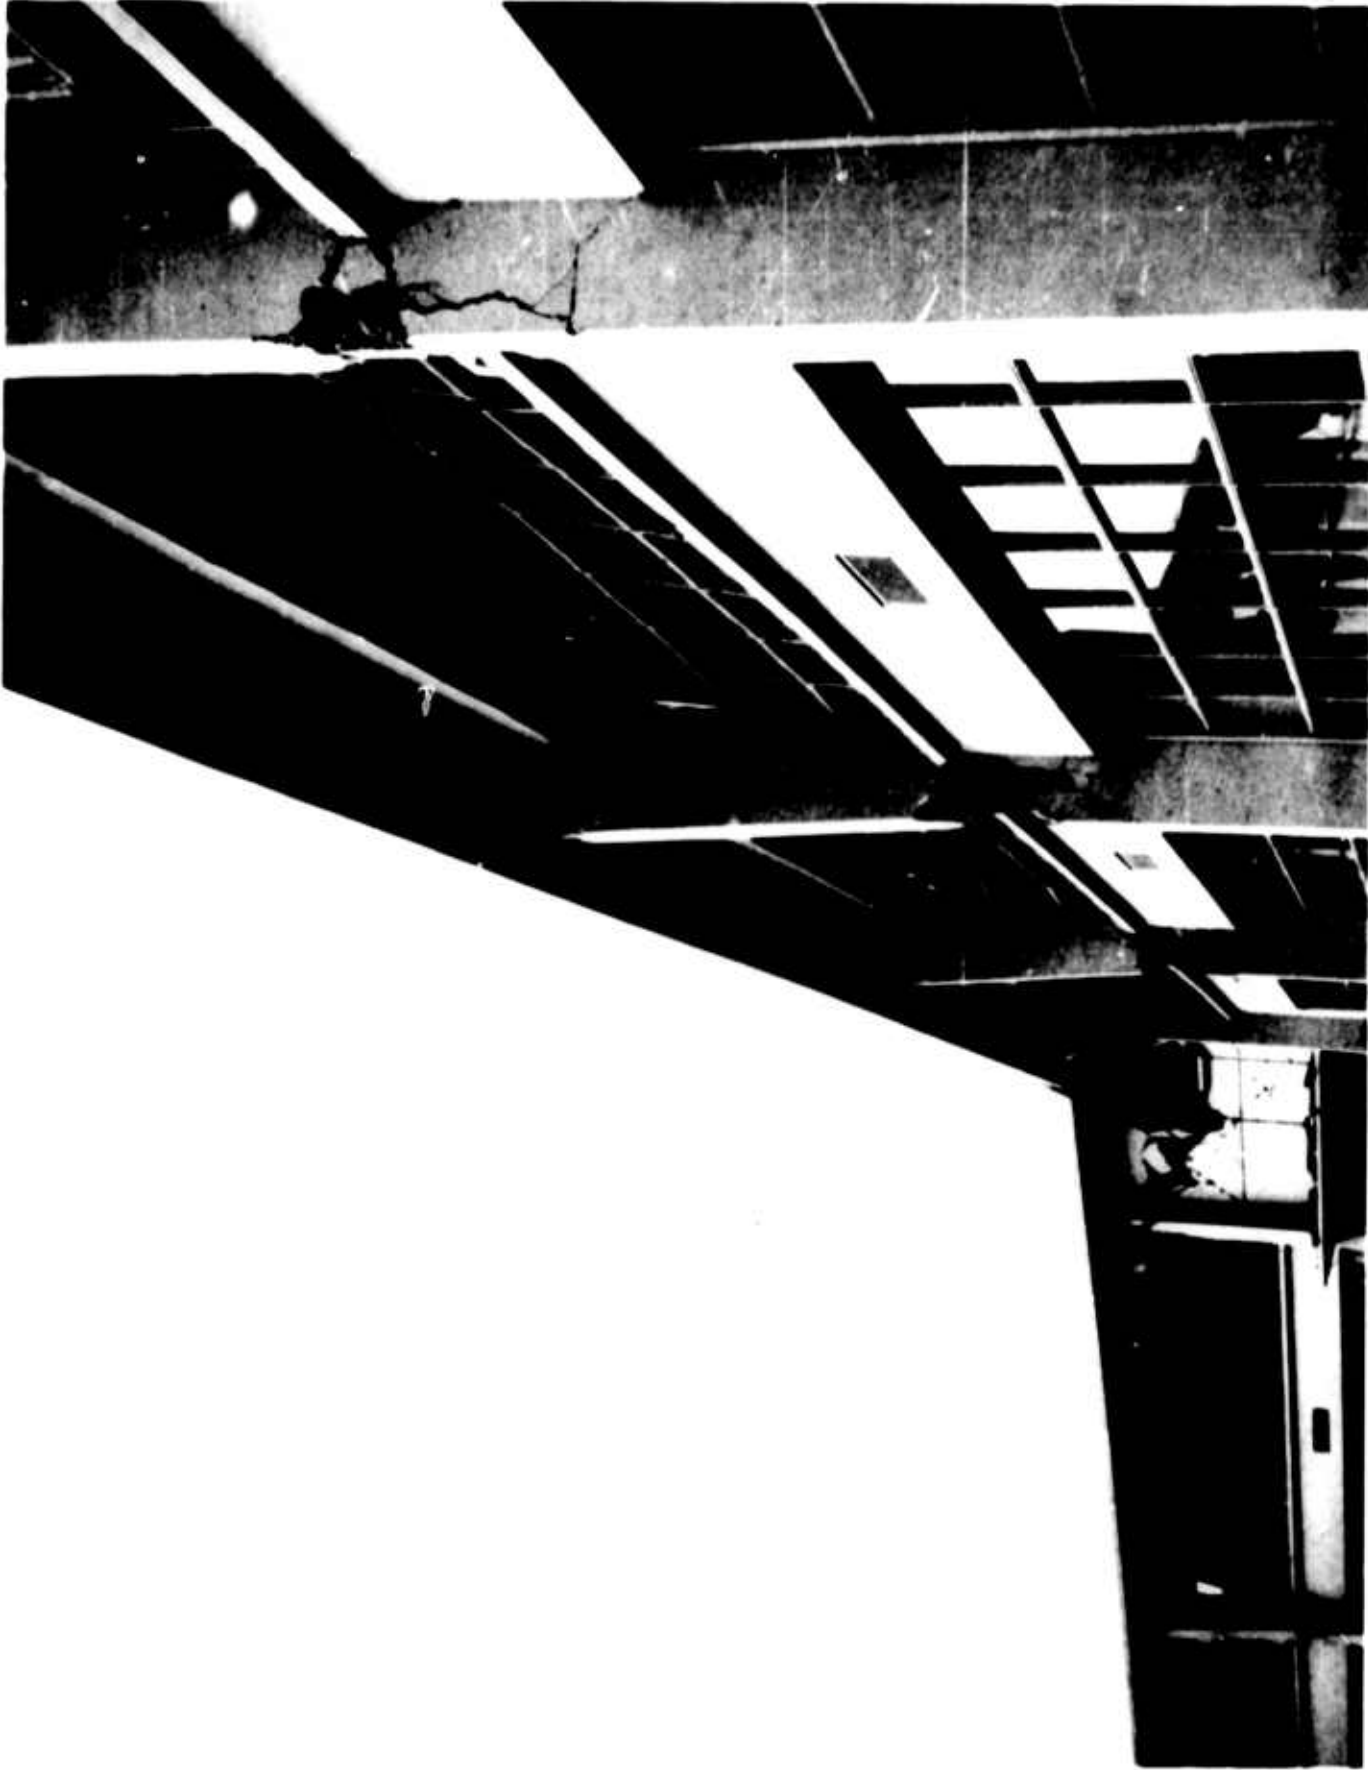
Figure 174. West Anchorage High School (Damage to second-story columns in west wall of wing A near intersection of wings A and B showing consistently poor column construction joints)

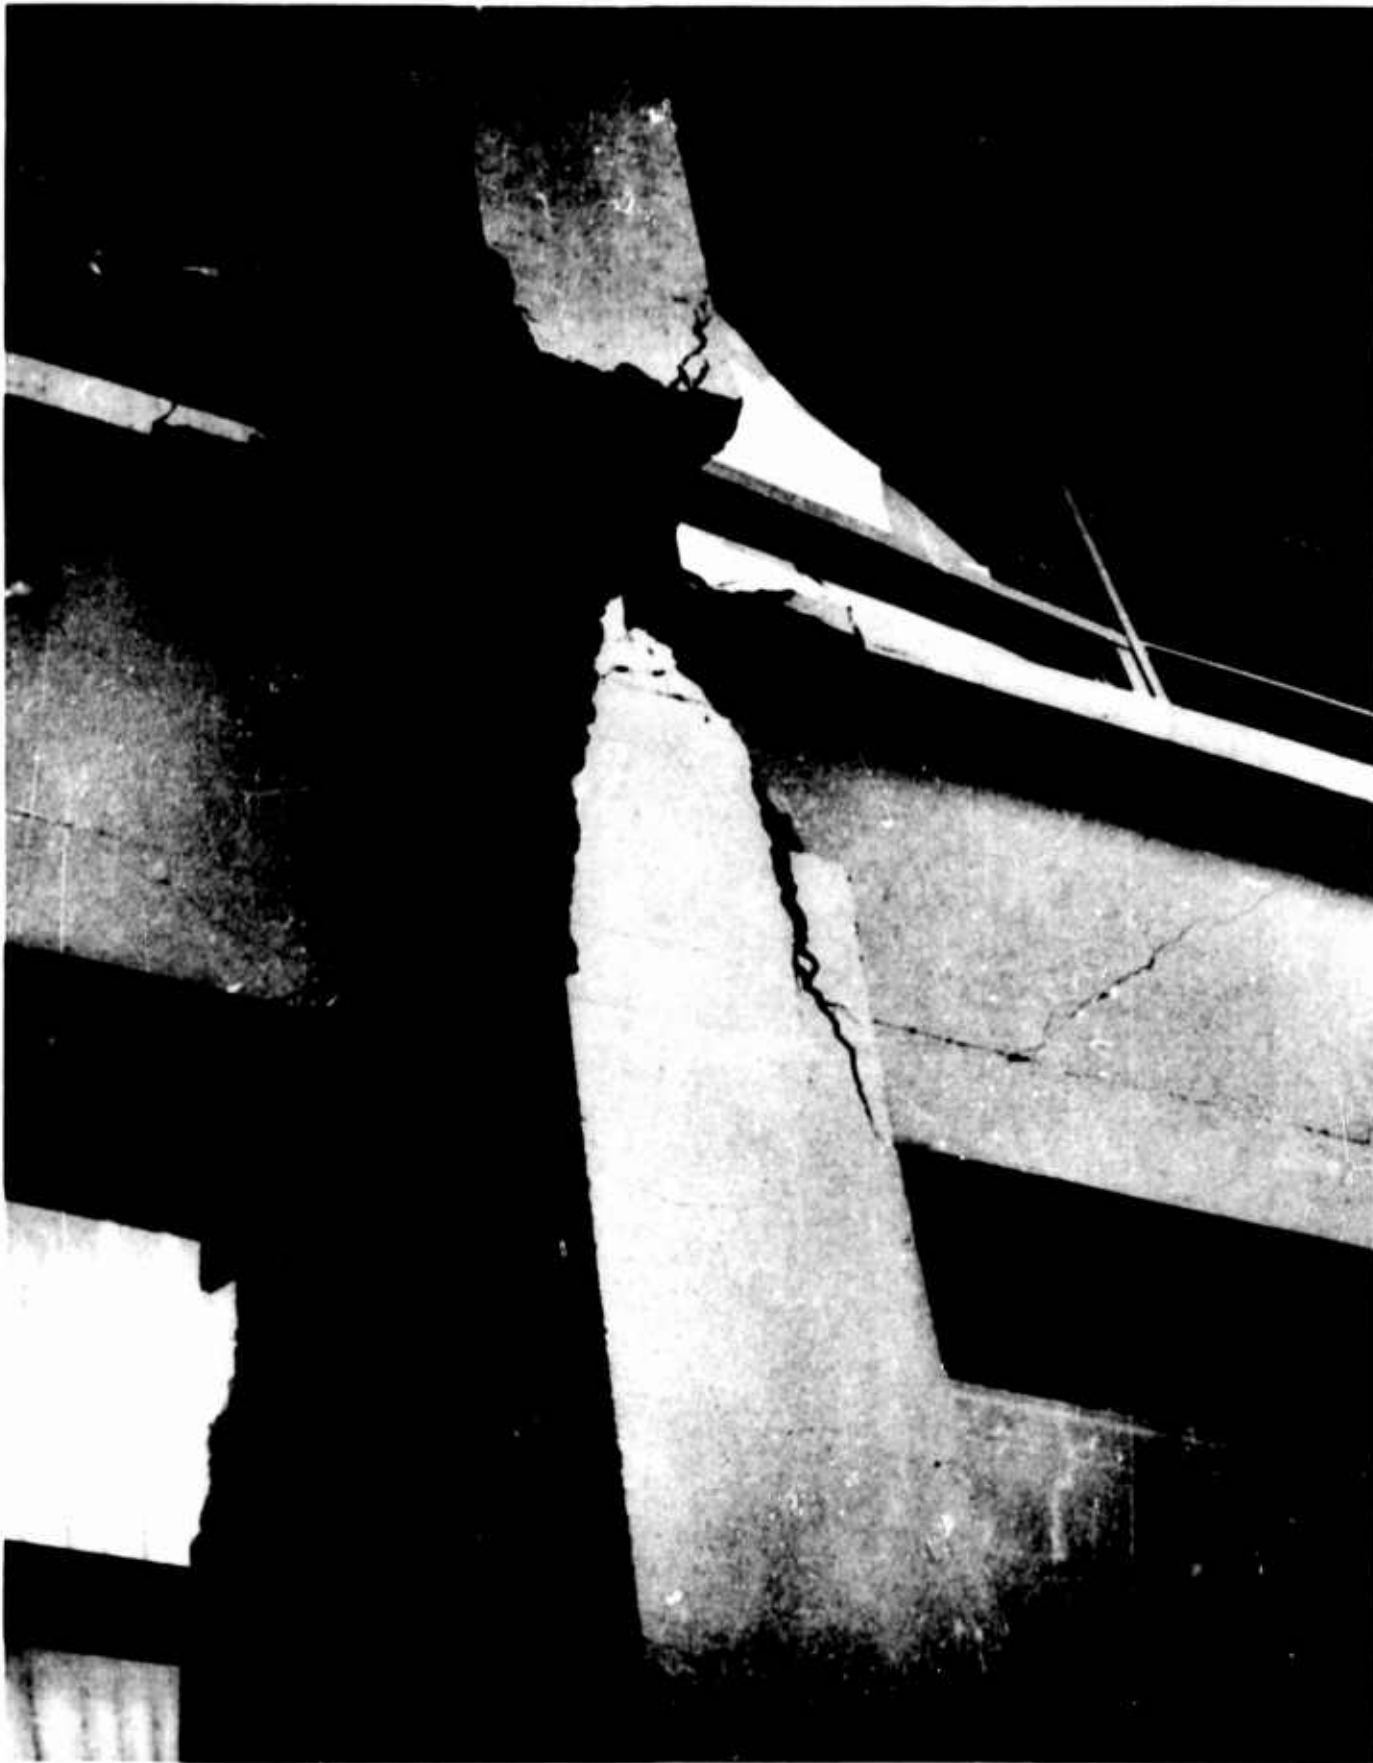
Figure 175. West Anchorage High School
(Closeup of damaged column shown in figure 174)

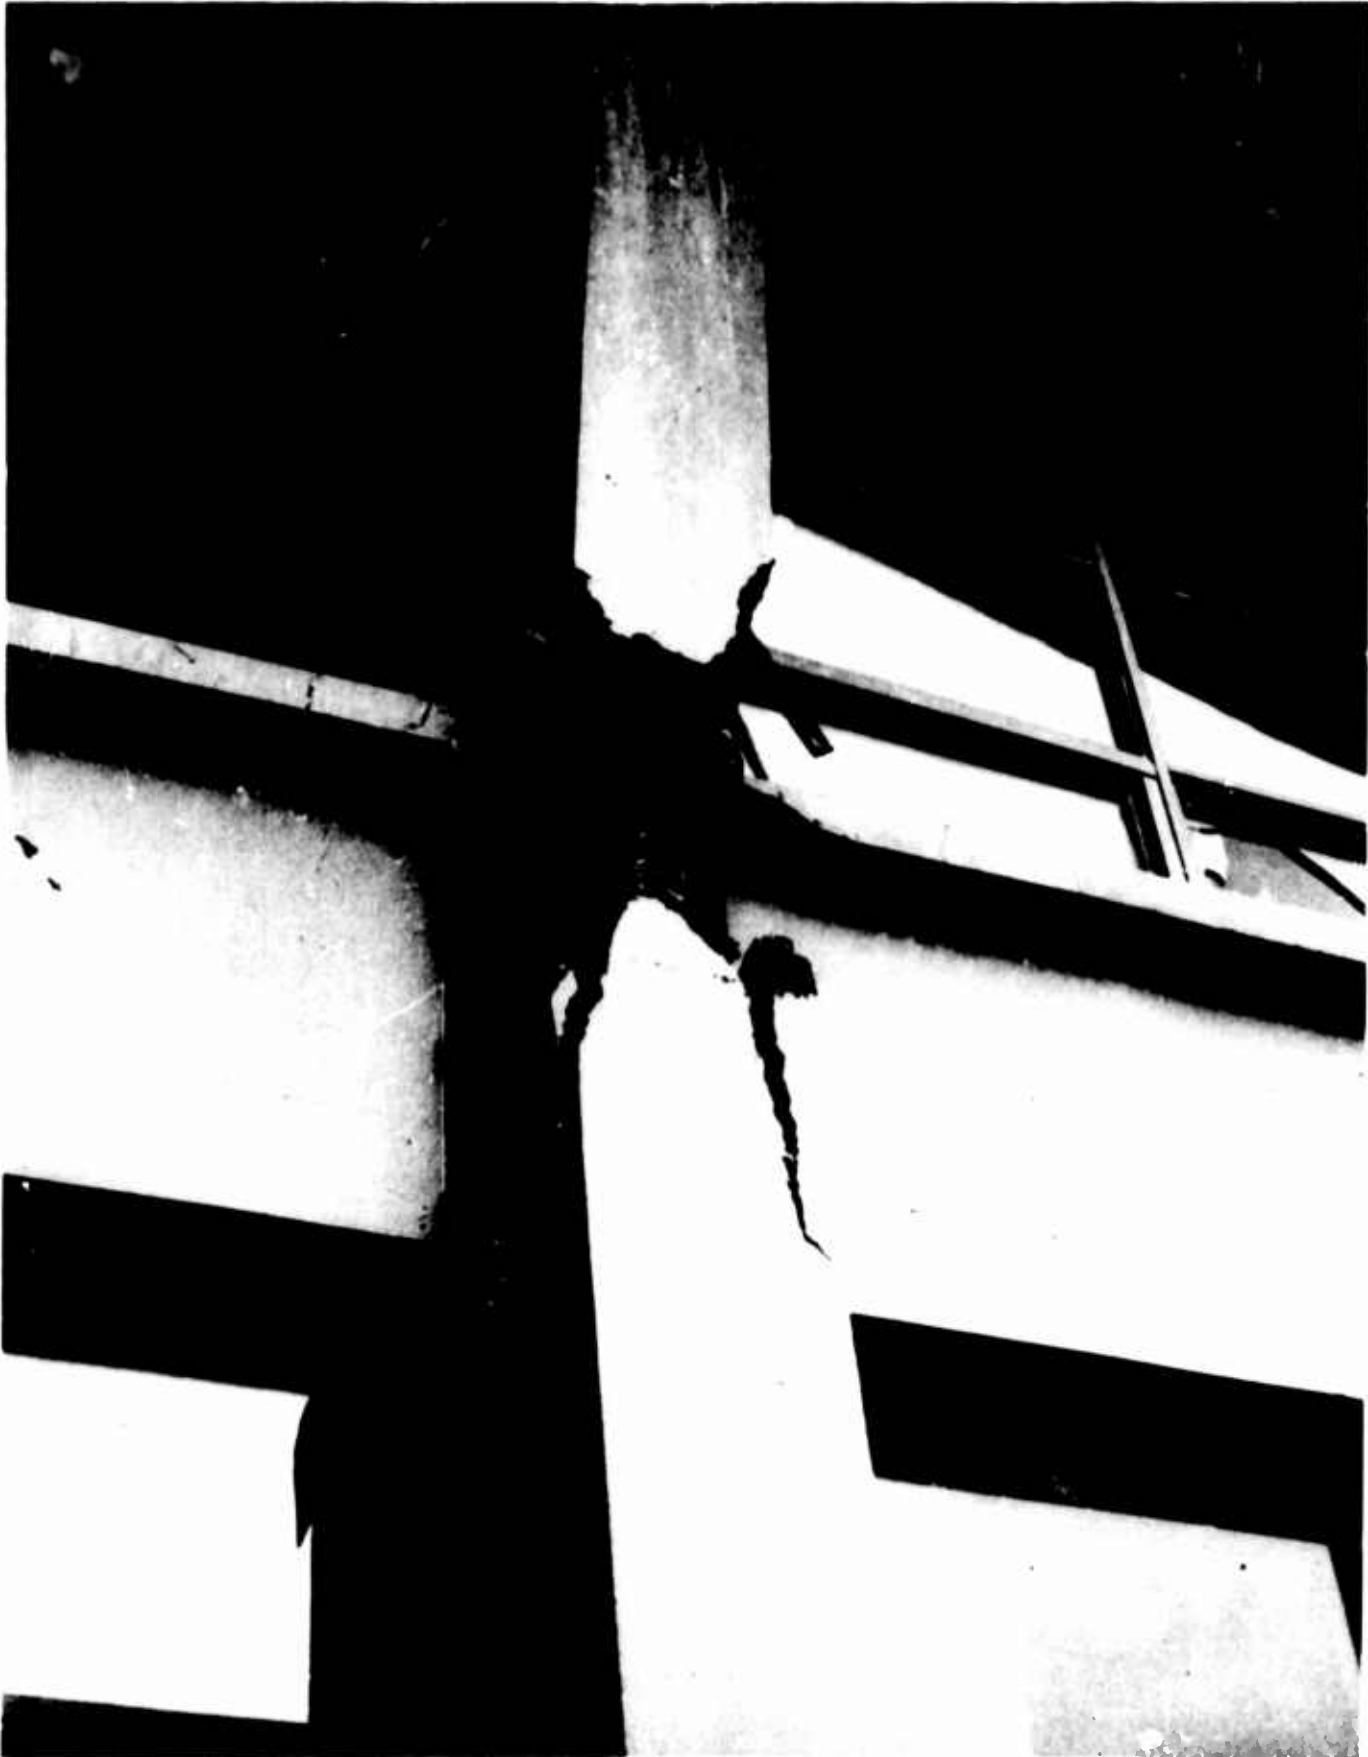
Figure 176. West Anchorage High School
(Closeup of damaged column shown in figure 174)

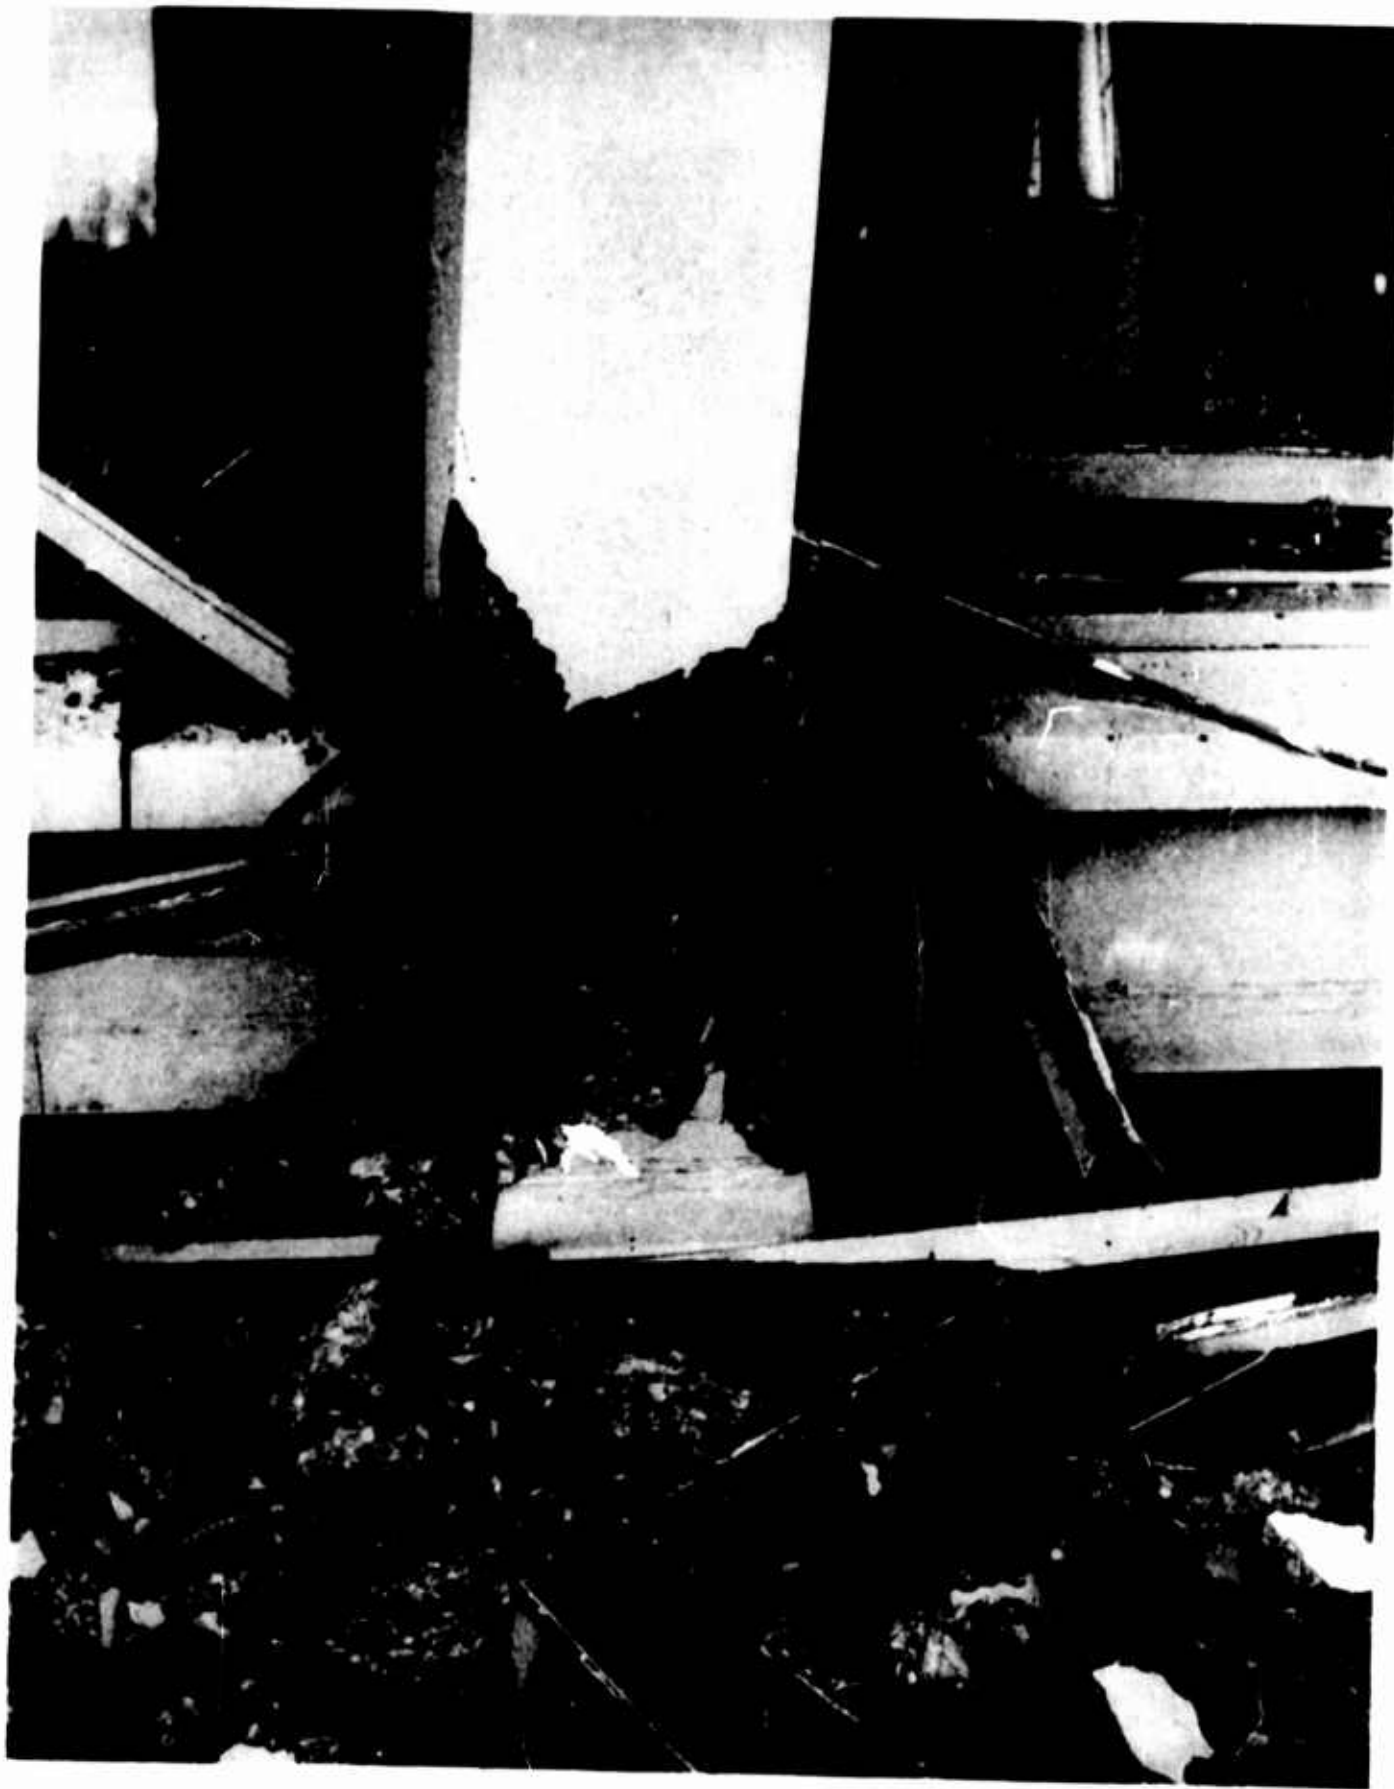
Figure 178. West Anchorage High School
(Closeup of the base of the column shown in figure 177)

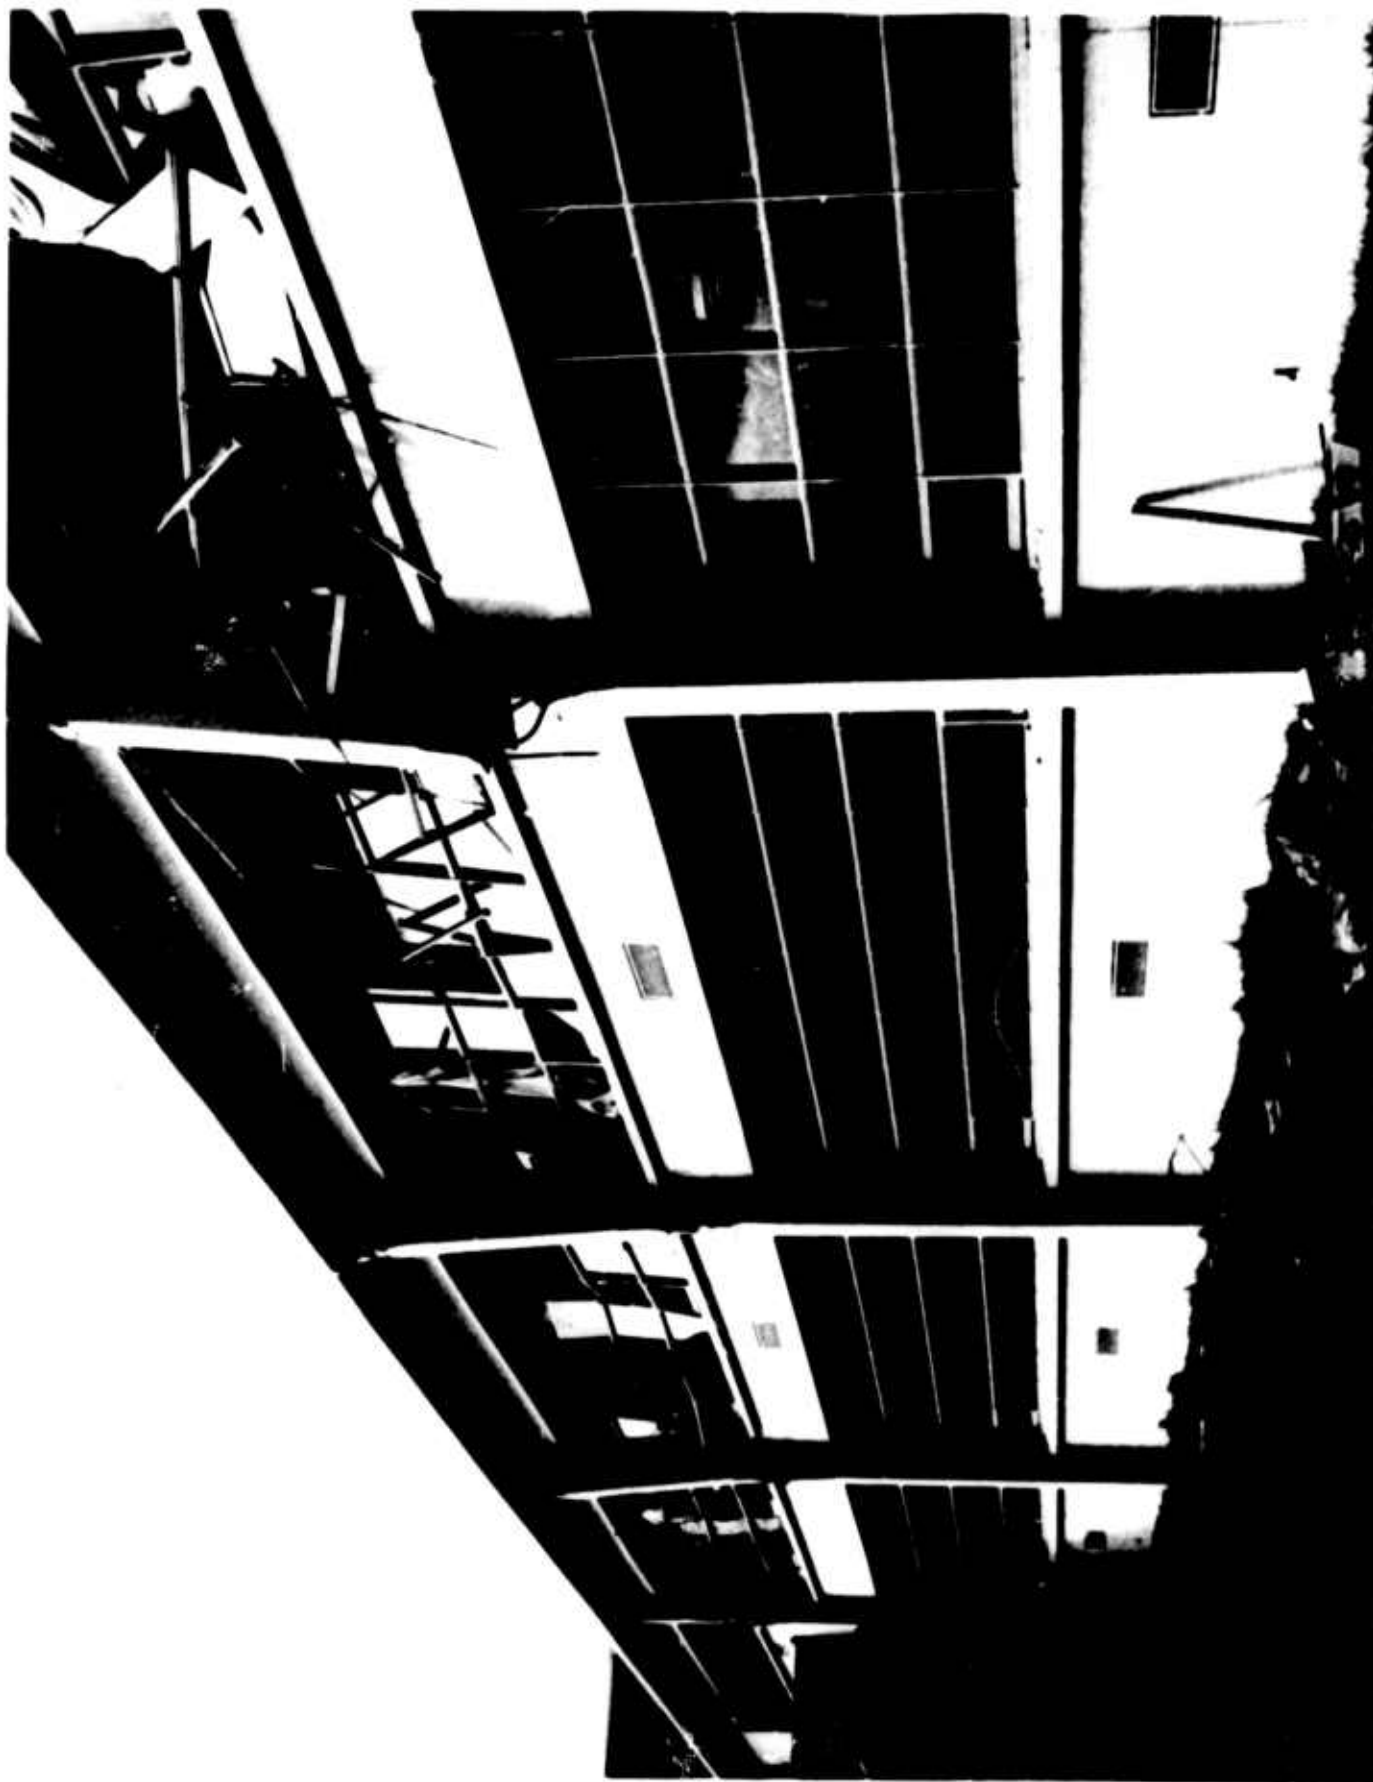
Figure 179. West Anchorage High School (Damage to second-story columns in south wall of wing B)

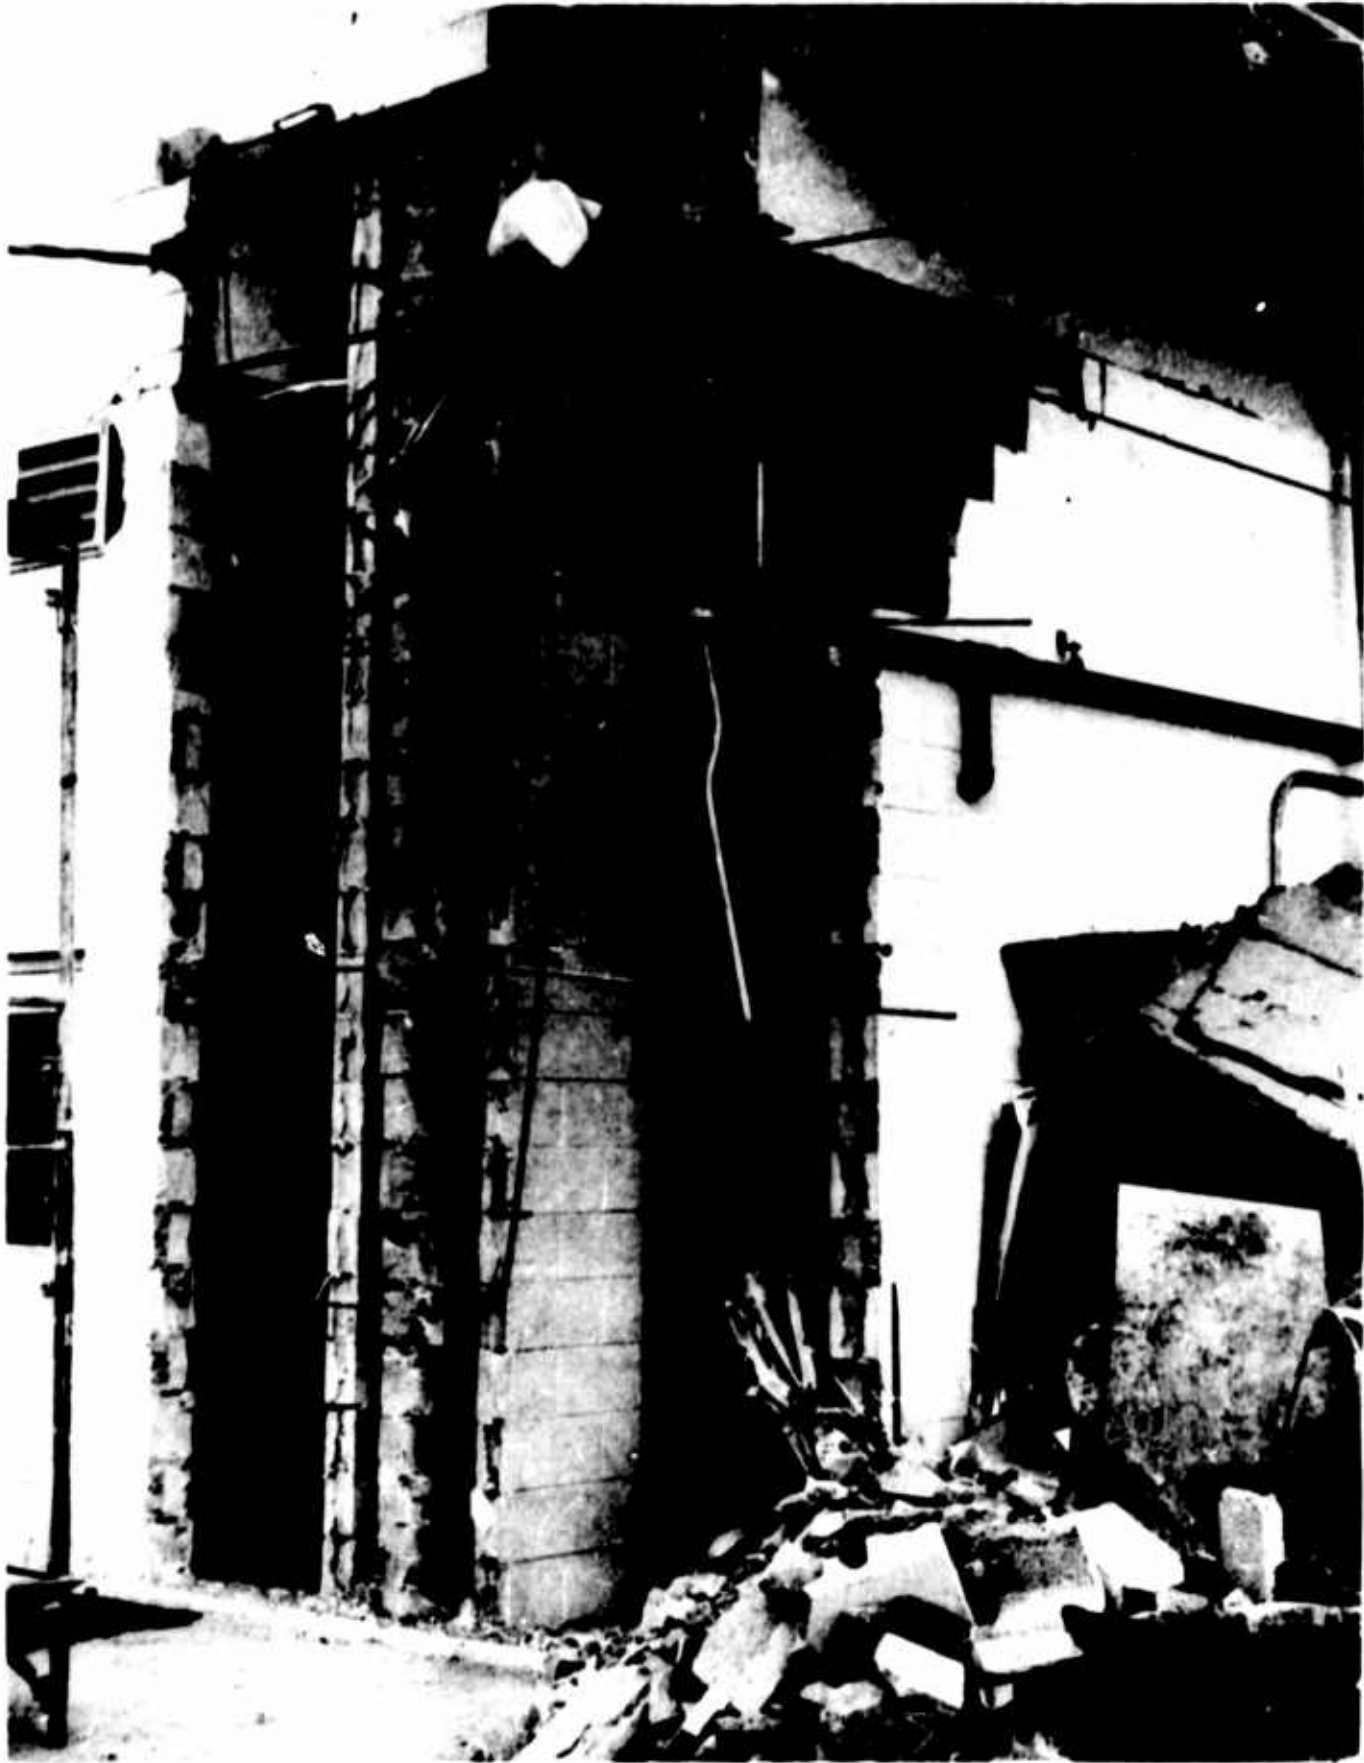
Figure 200. Fifth Avenue Chrysler Center (Damage to the structure progressed back to an interior masonry wall which provided sufficient rigidity to hold a roof beam in place and prevent further damage to those beyond)

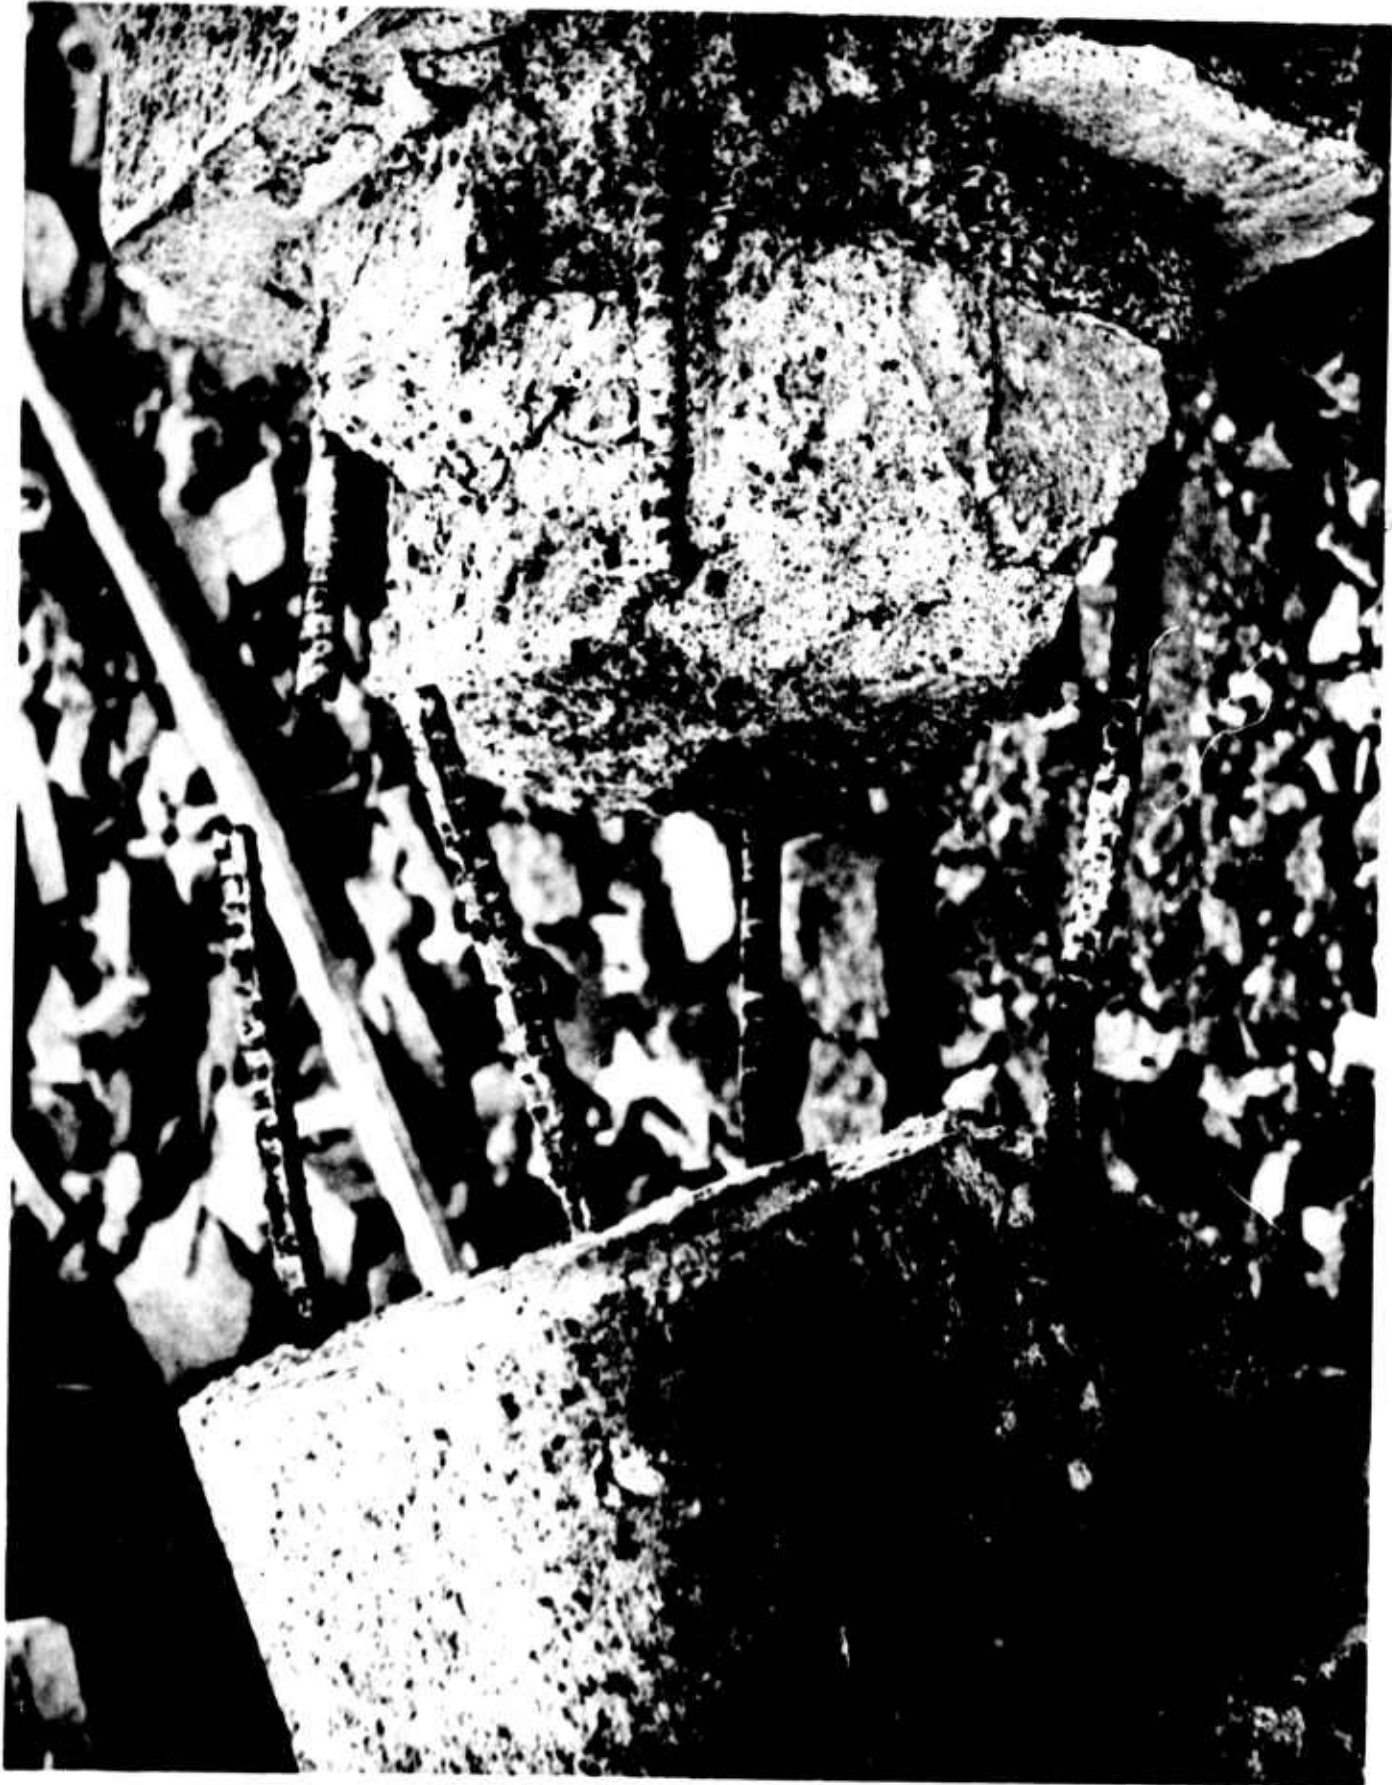
Figure 206. Gay Airways Hangar (Closeup of fractured pilaster rebar overlap)

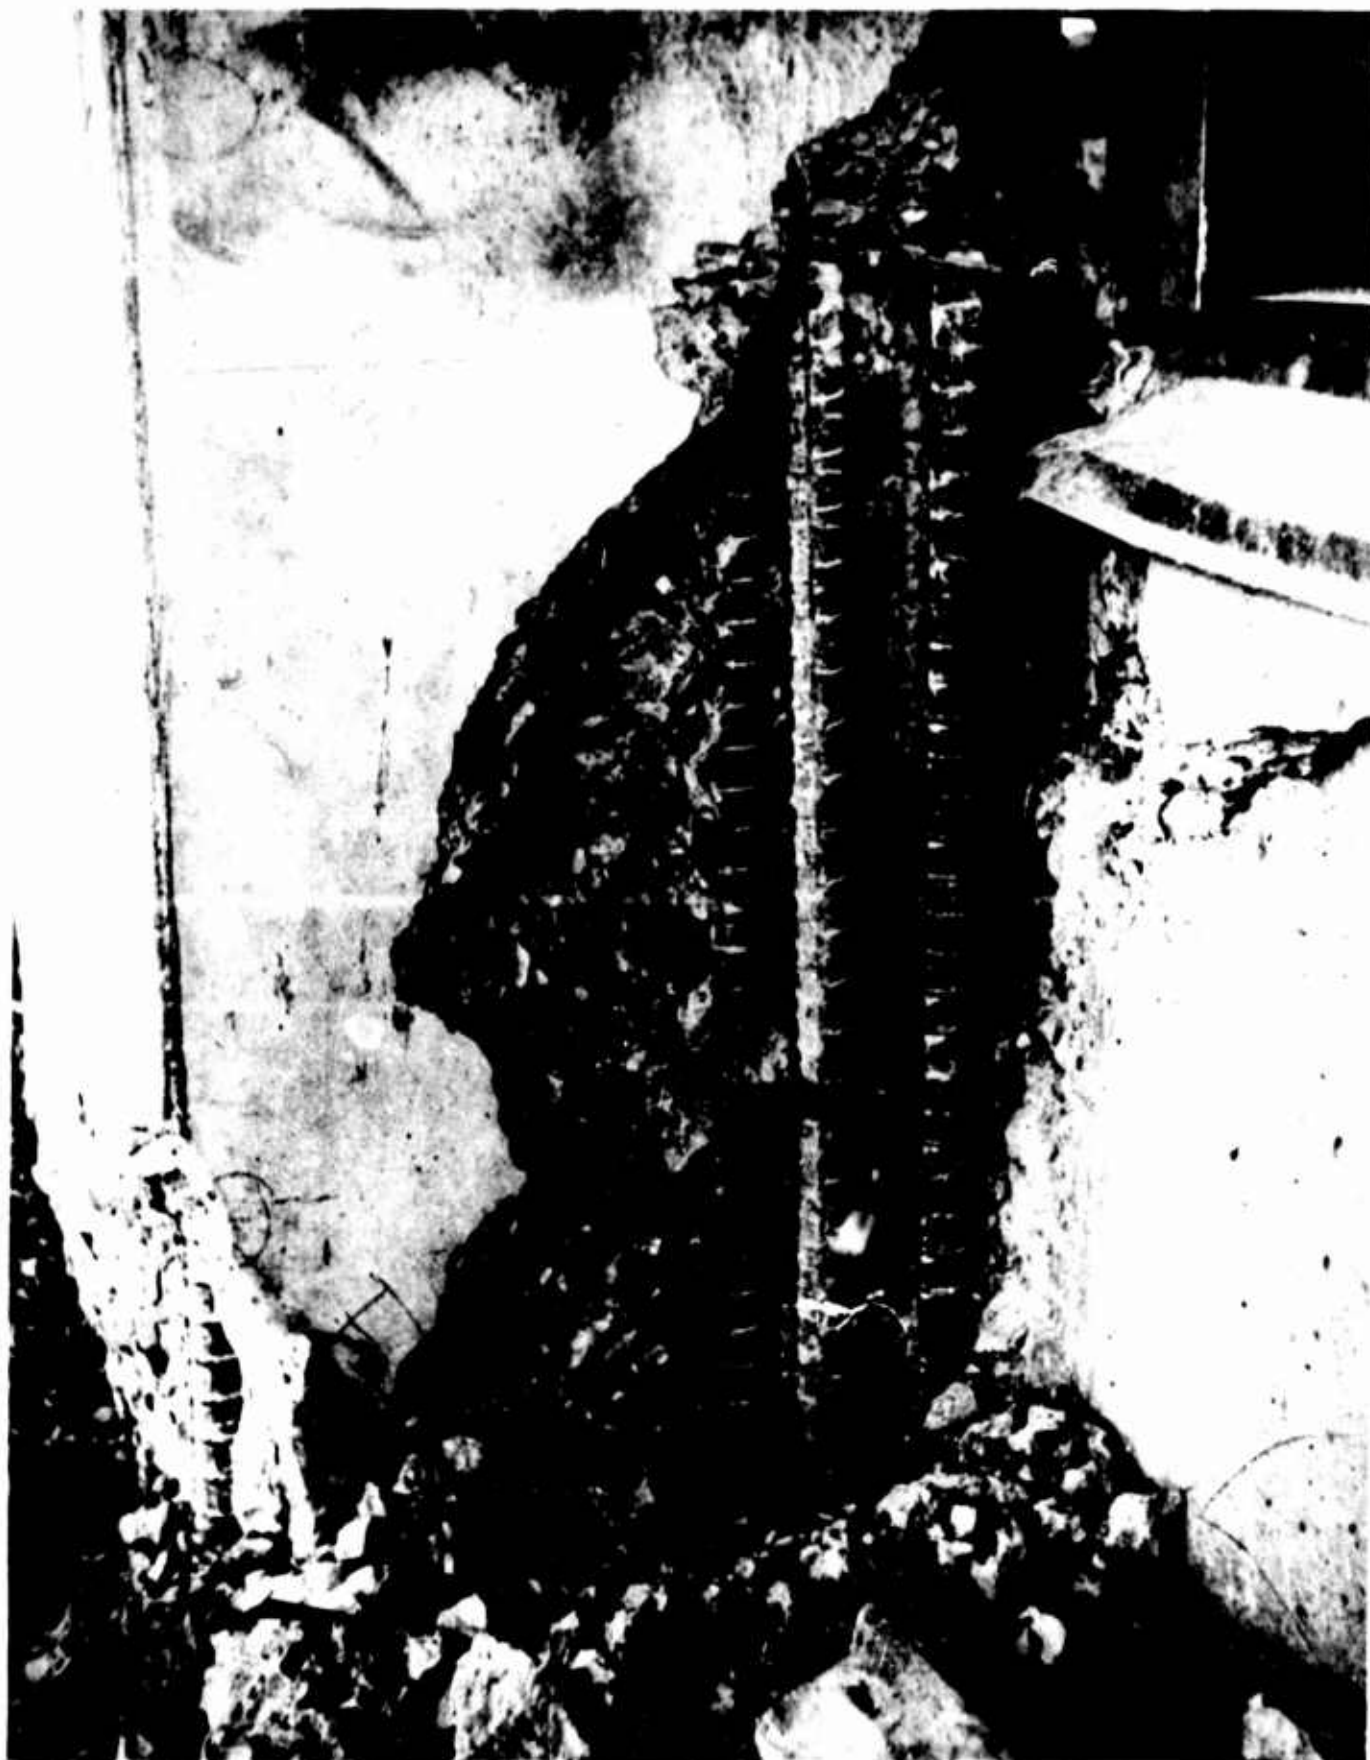
Figure 210. Alaska Sales and Service Building
(Spalling at the base of a heavy T-column along the north side of the structure)

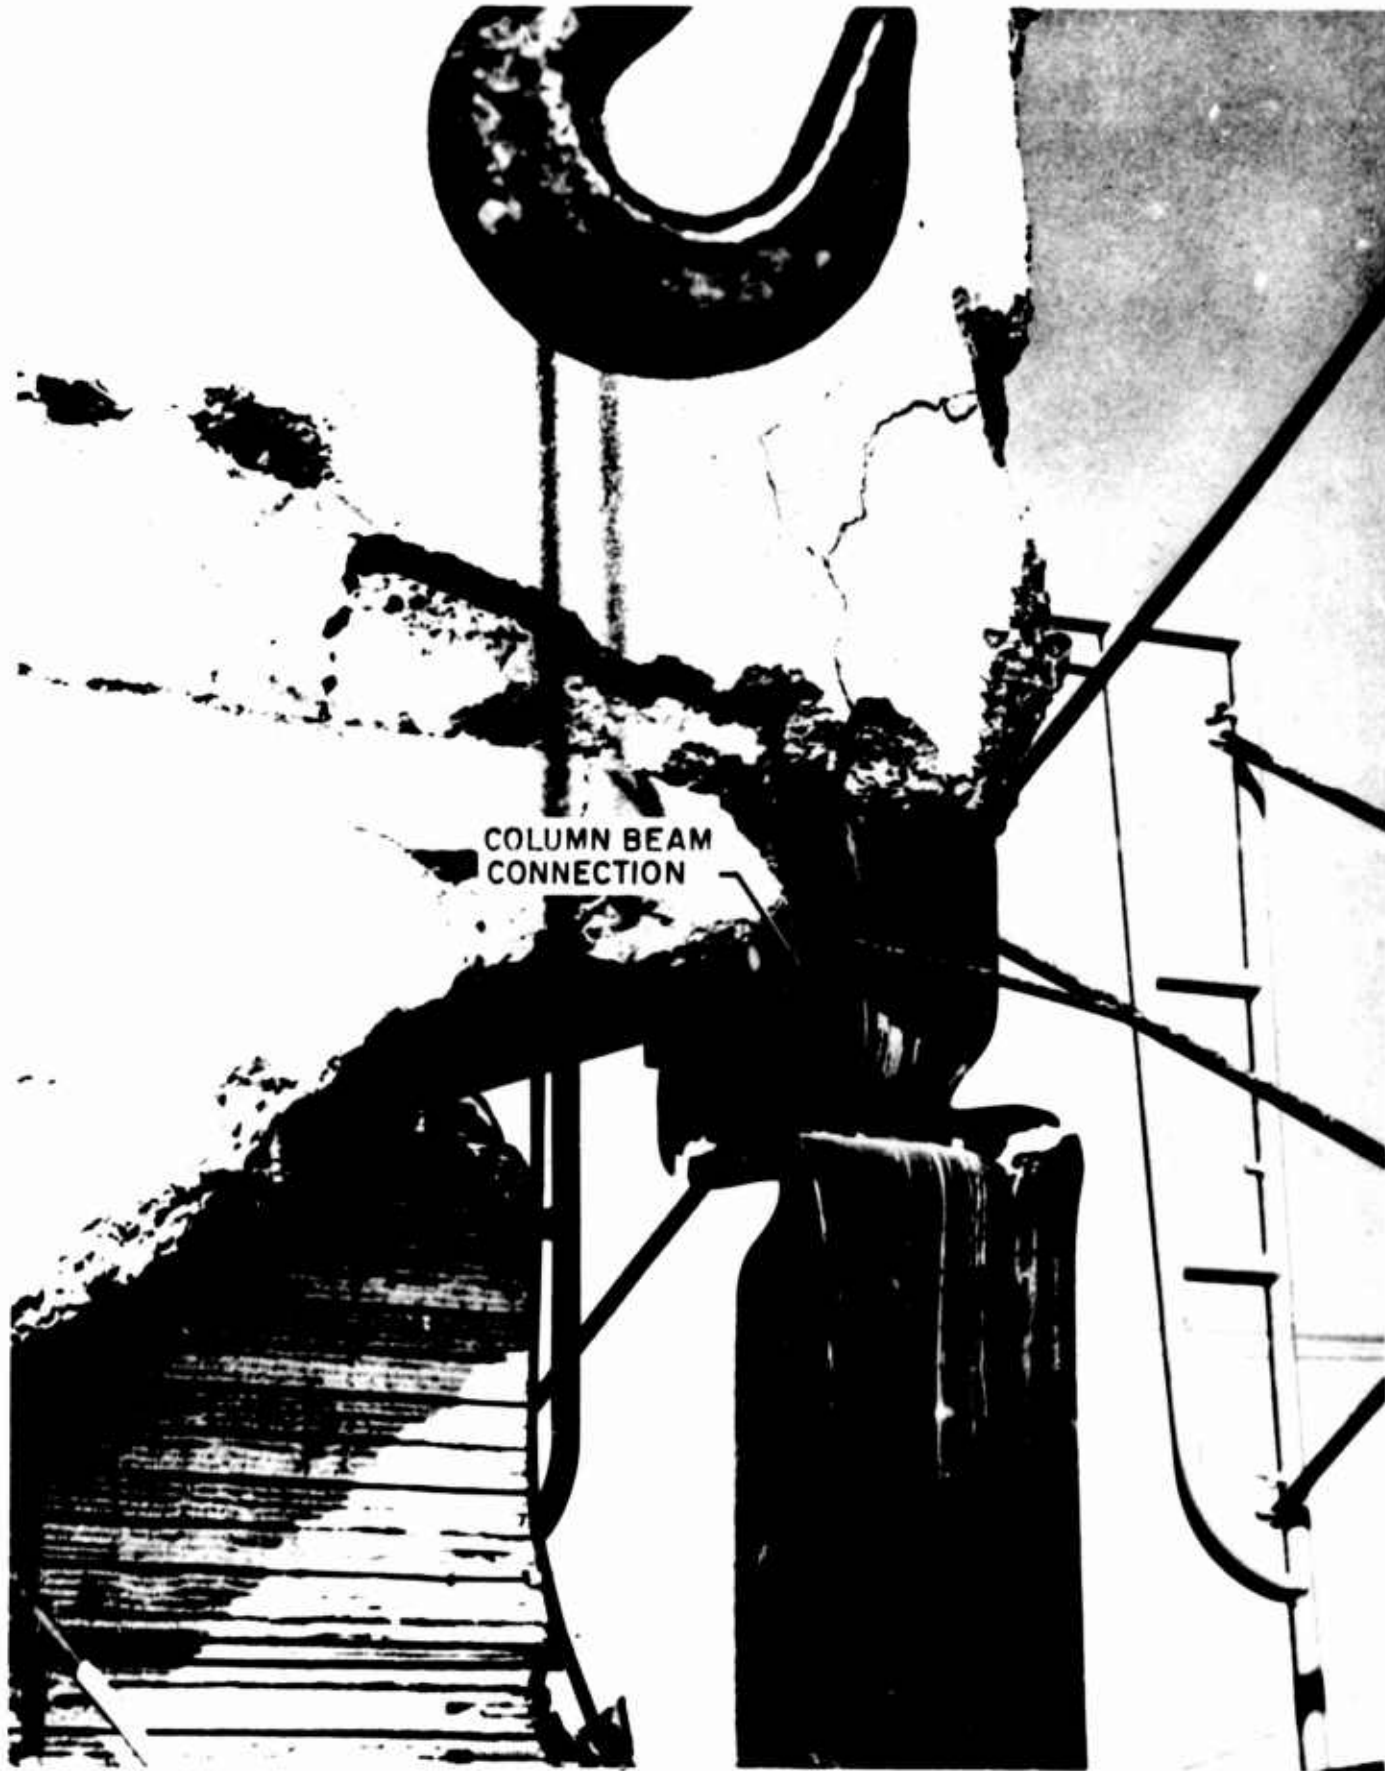
Figure 219. Cordova Building
(Shear buckle in southeast corner column of building)
