THE GREAT ALASKA EARTHQUAKE

Volume II

Illustrations and Maps

TECHNICAL REPORT NO. AFWL-TR-65-92, Vol II

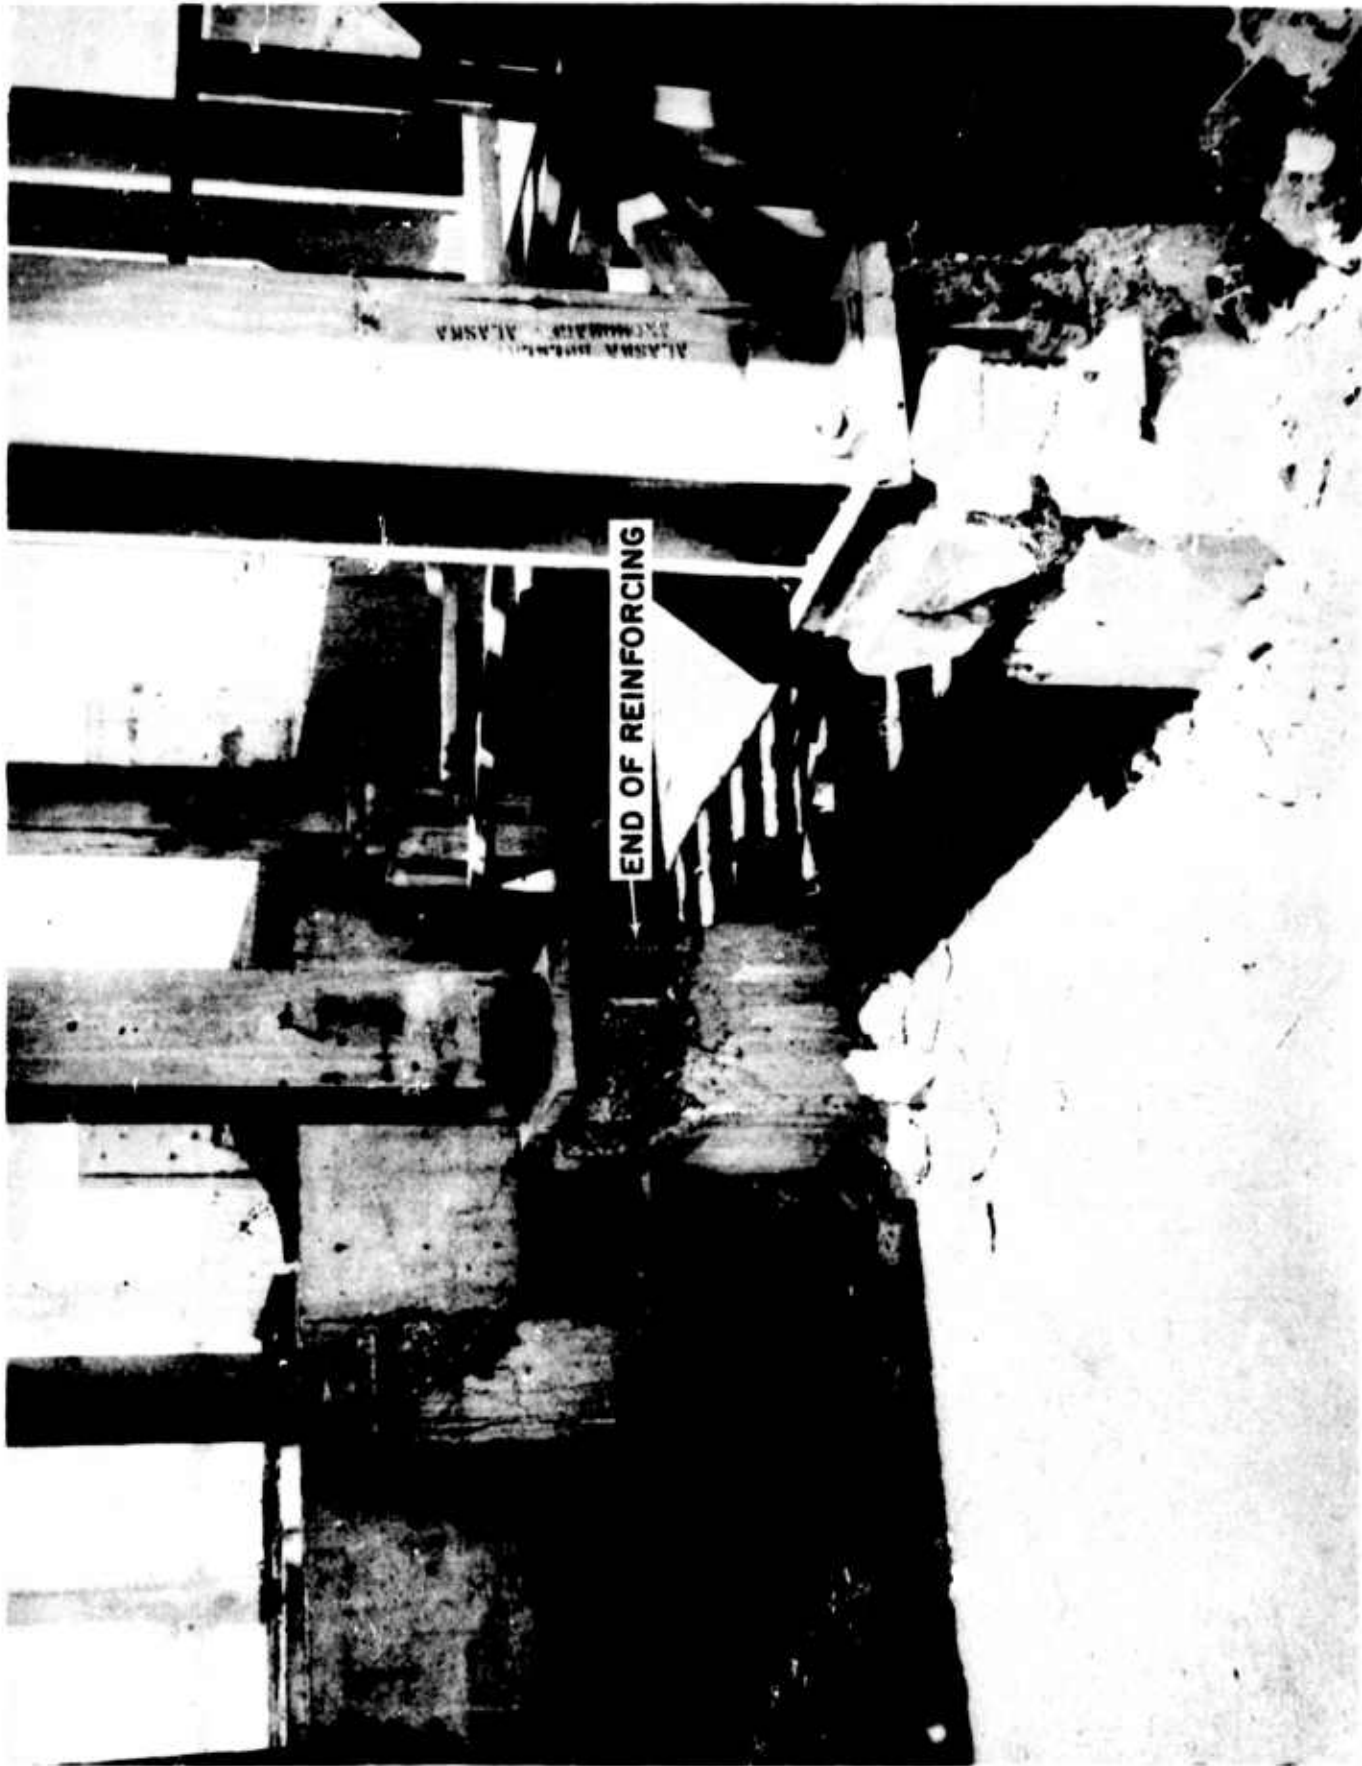
Figure 223. Alaska Brewery Company Structure
(Typical damage to interior footing due to pounding by steel columns)

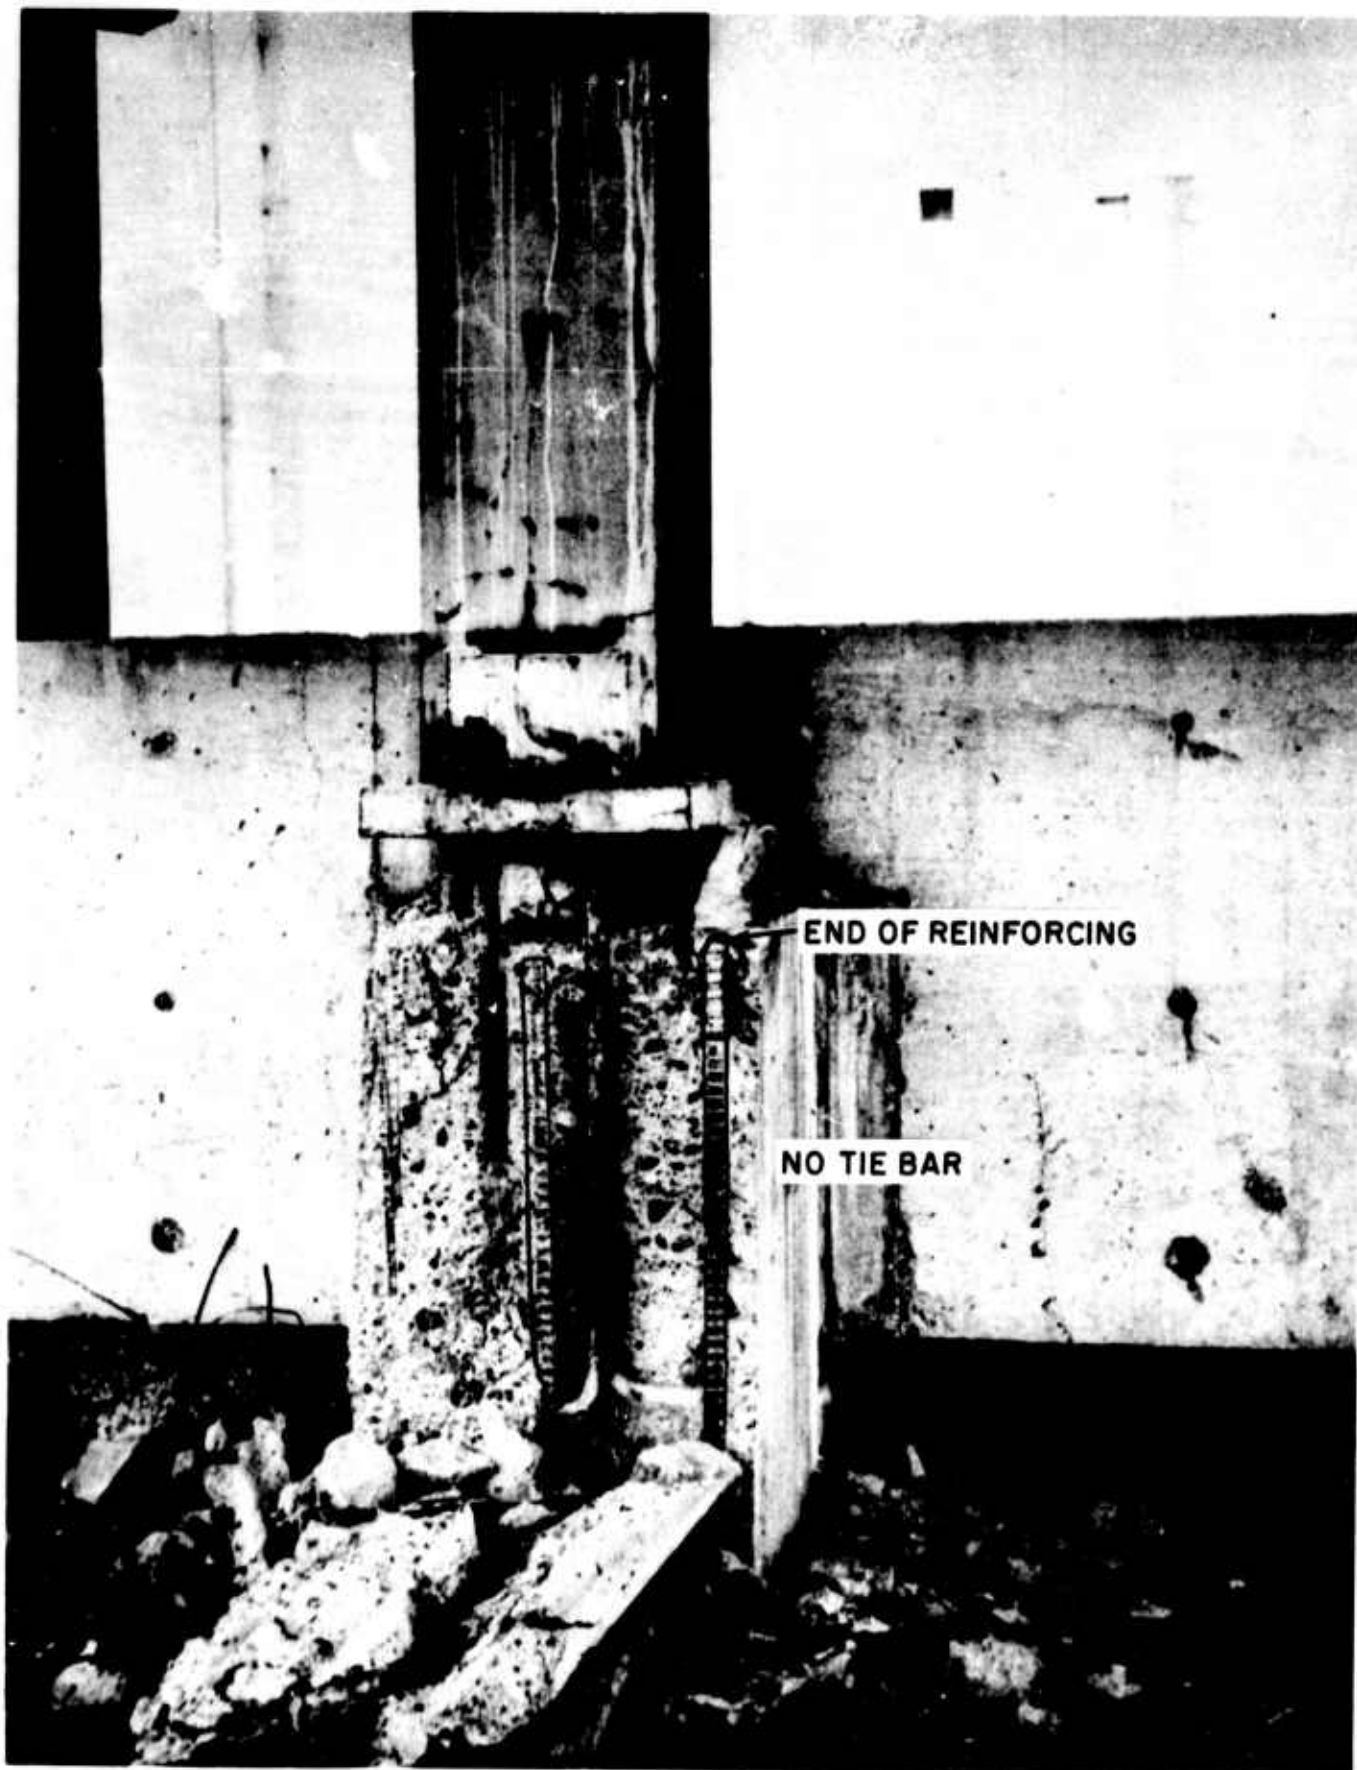
Figure 226. Alaska Brewery Company Structure
(Severe damage to an exterior footing without horizontal ties)

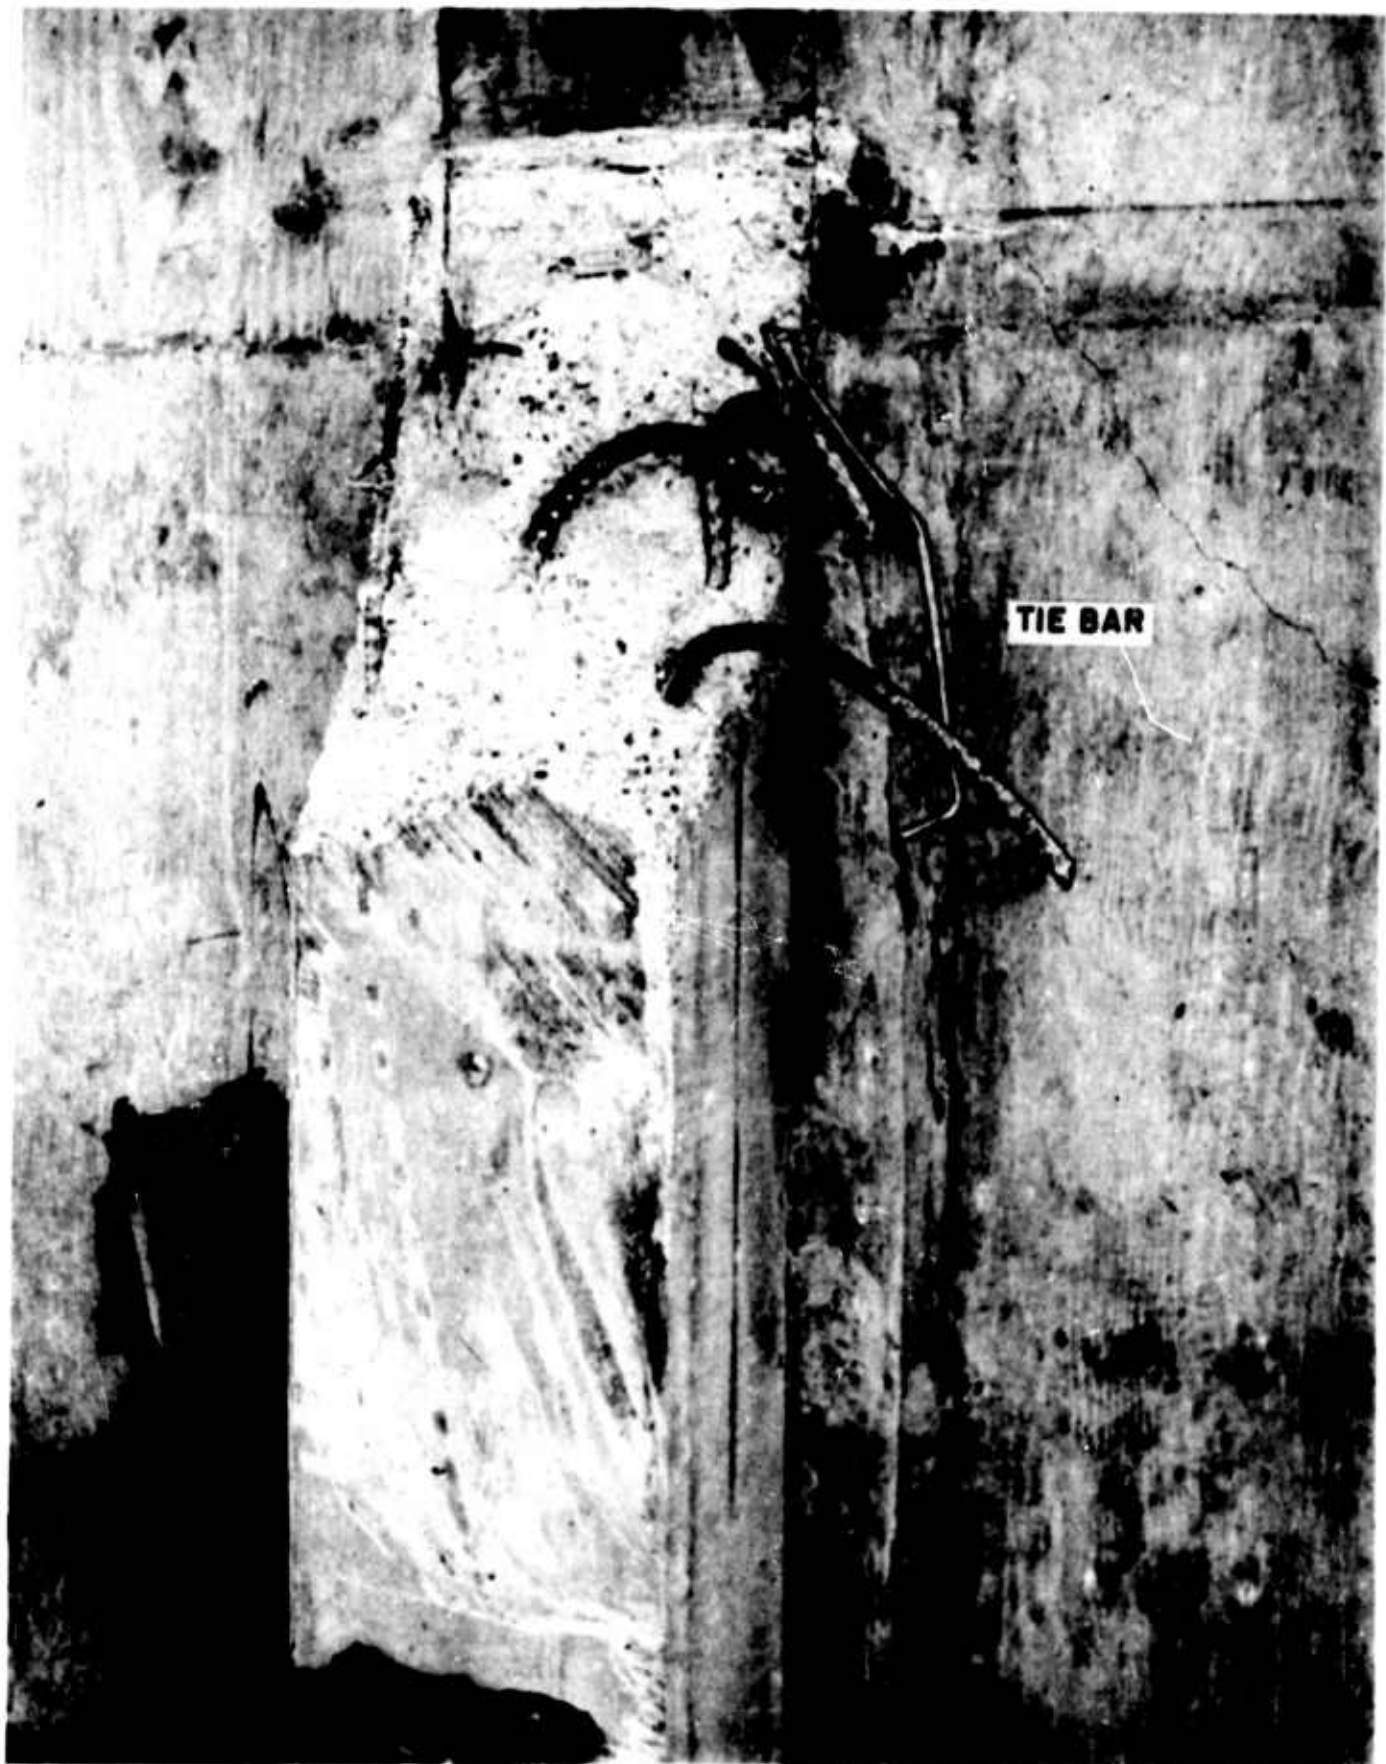
Figure 261. Elmendorf AFB Warehouse
(Closeup of column failure showing tie-rod failure)

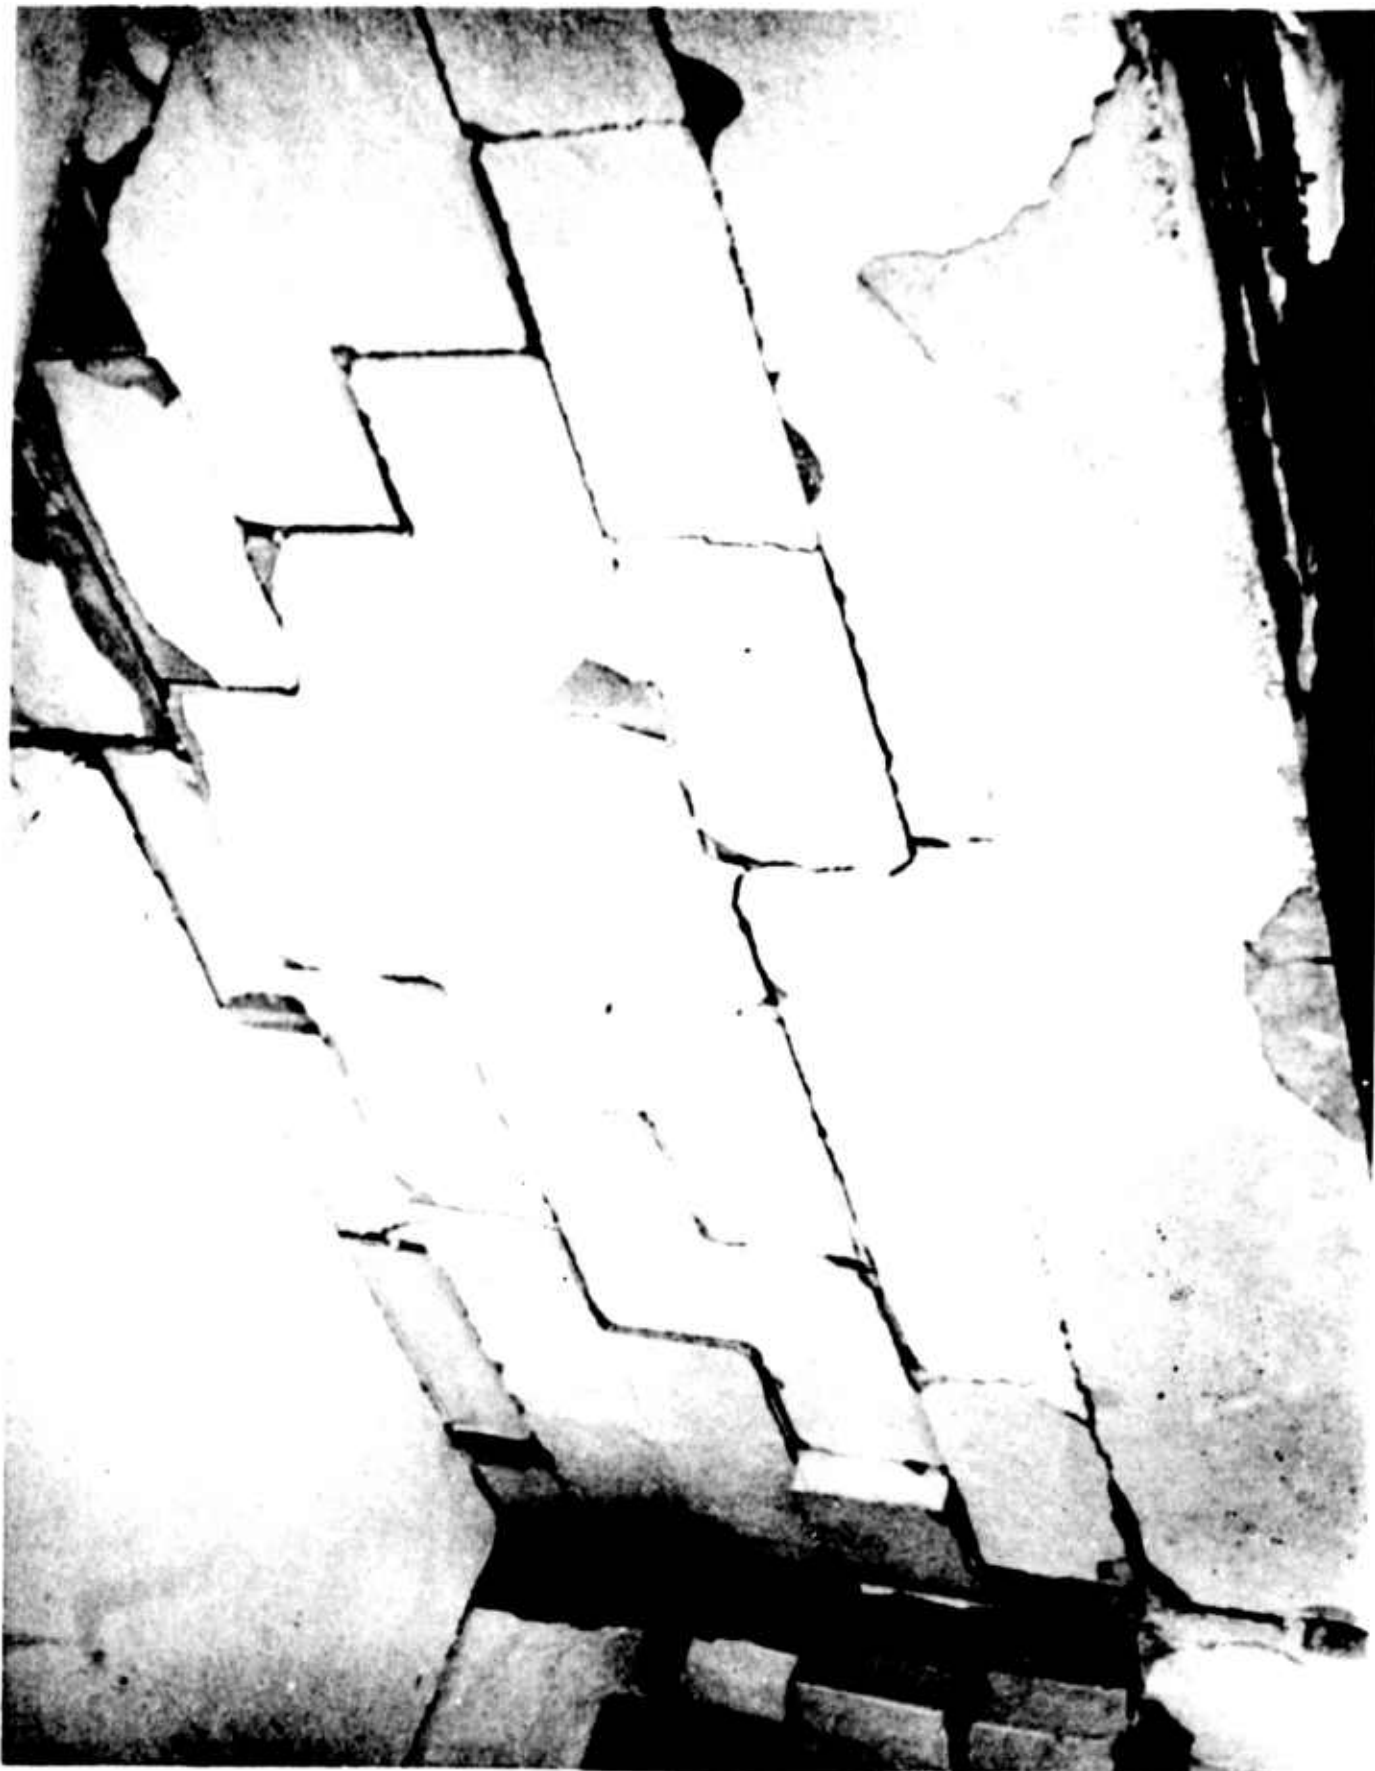
Figure 275. Hillside Apartments (Typical crack pattern of interior masonry-block walls)

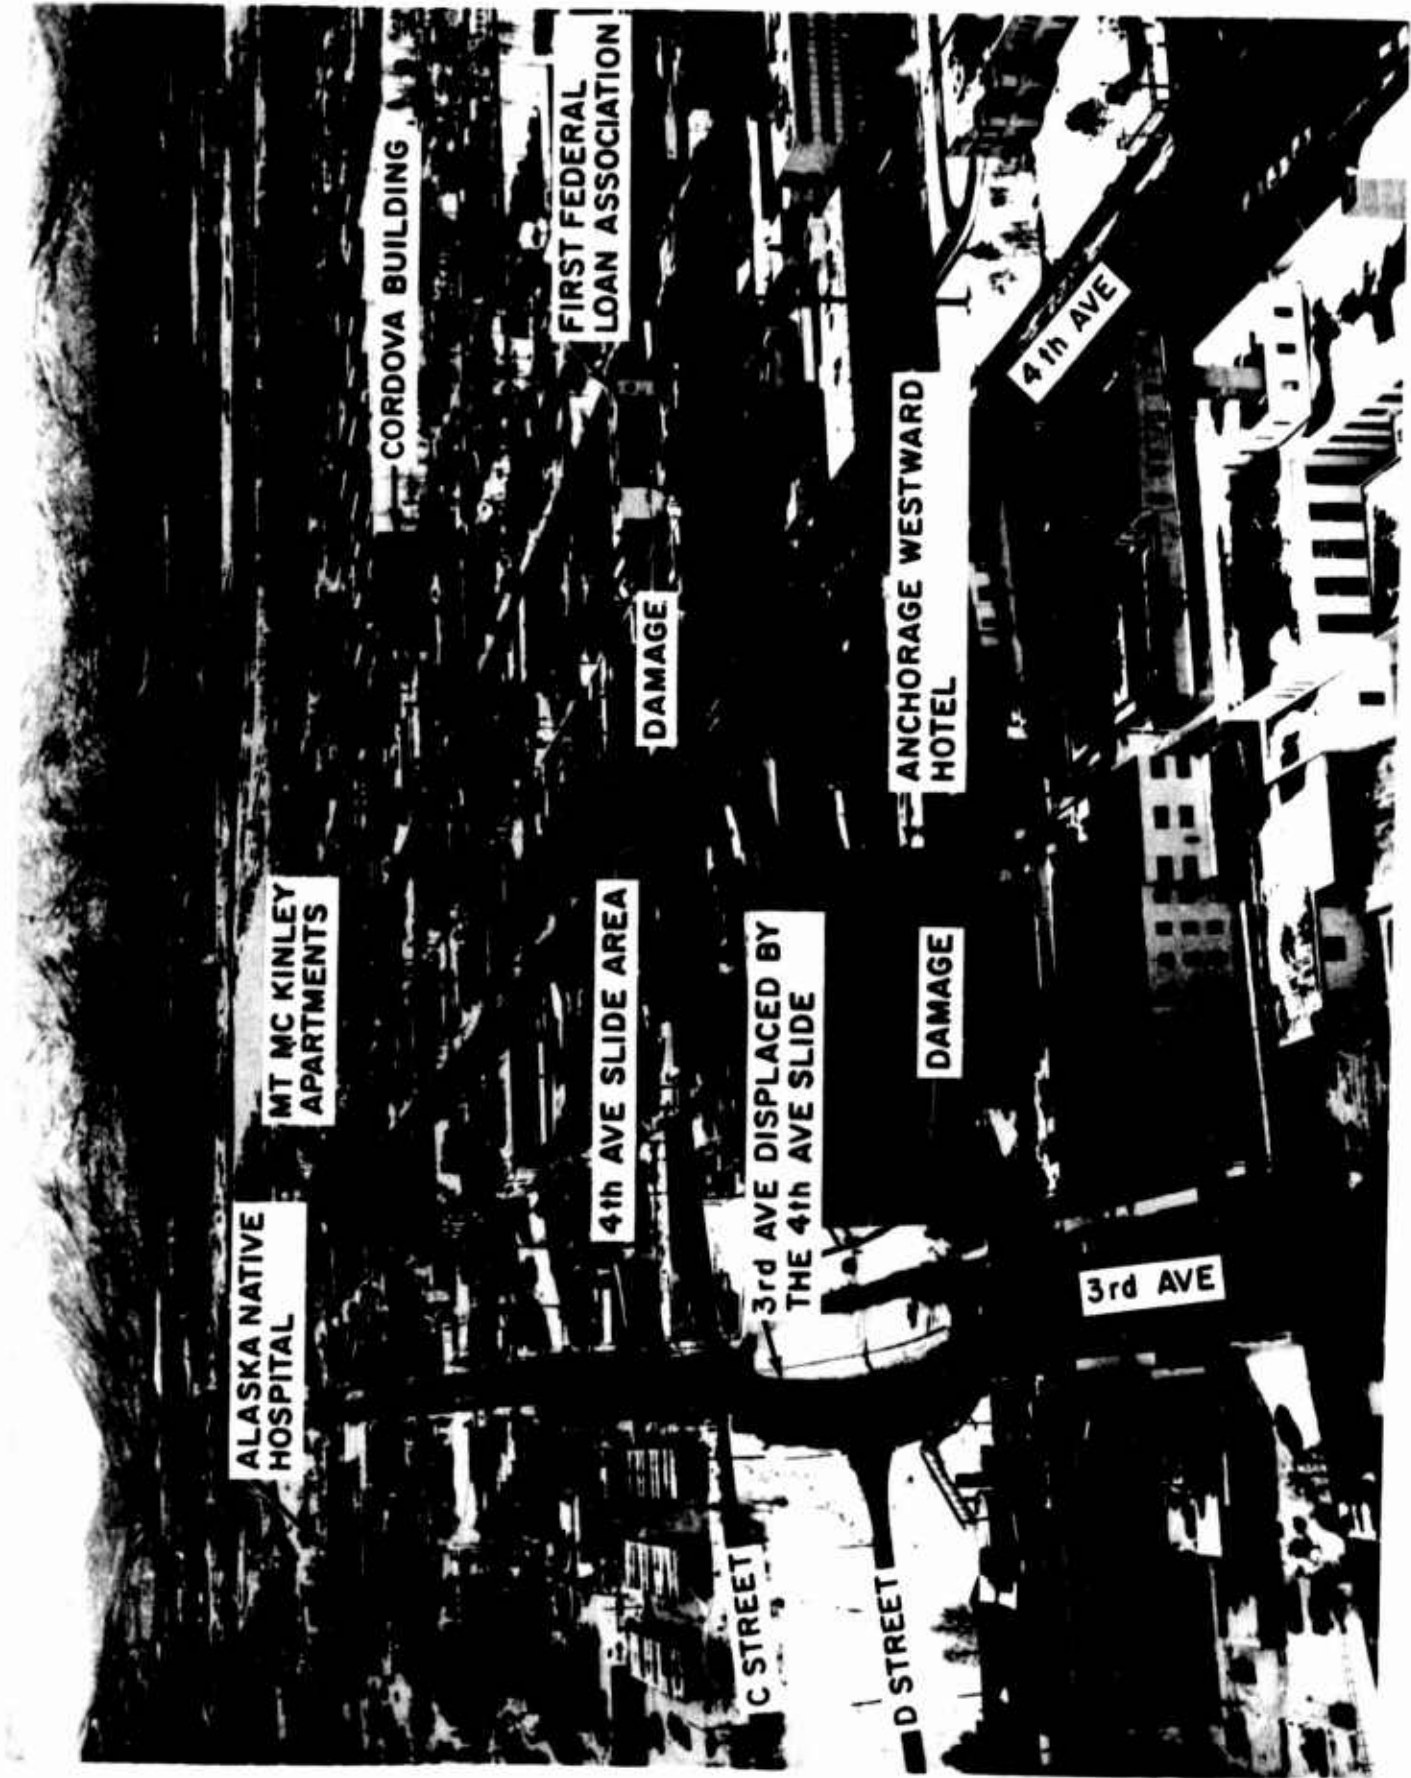
Figure 282. First Federal Savings and Loan Association Building (Aerial view of downtown Anchorage after the quake showing horizontal shear cracks in west wall of building)
