Technical Memorandum 8-60

HUMAN FACTORS ENGINEERING EVALUATION  
OF THE  
M60 MAIN BATTLE TANK

Kermit D. Foster

June 1960

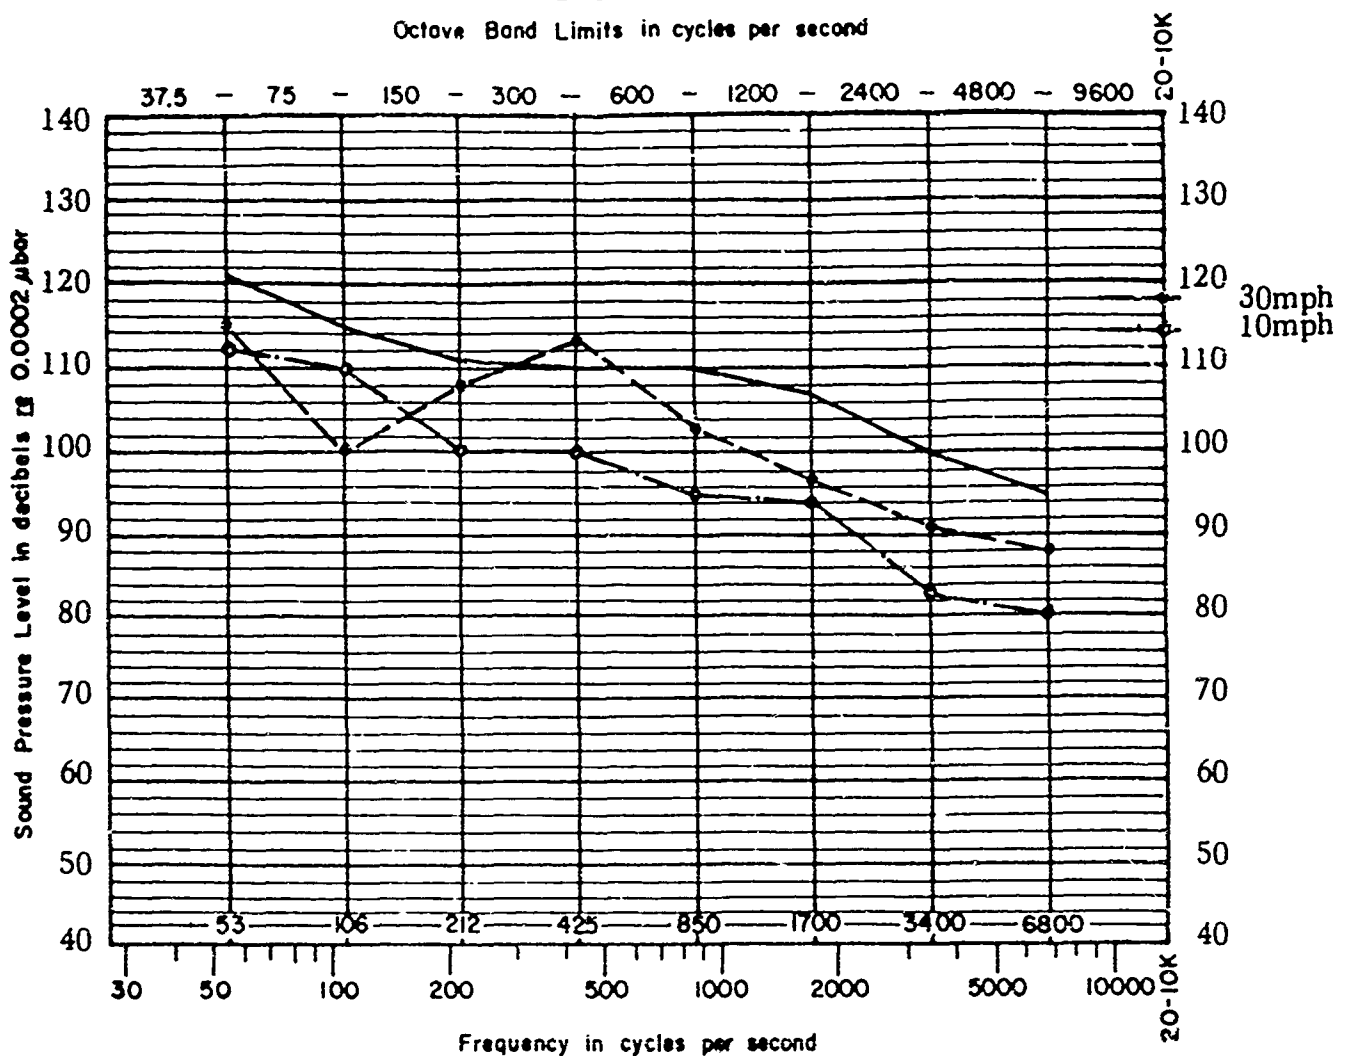
An octave band analysis of noise in the turret at speeds of 30 mph (high range) and 10 mph (low range) was also conducted. At 500 cycles per second, the sound pressure level exceeds the Human Engineering Laboratories' maximum sound pressure level standard for that octave band by 3 db. This deviation from the recommended limit is negligible and no action, in terms of additional sound attenuation, is recommended.

Fig. 1. Octave band measurements of the noise in the turret of the M60 Tank at 30 mph and 10 mph
