PROTECTION OF MOORING BUOYS
PART VIII. RESULTS OF SEVENTH
RATING INSPECTION

June 1966

U. S. NAVAL CIVIL ENGINEERING LABORATORY

Technical Report R-458

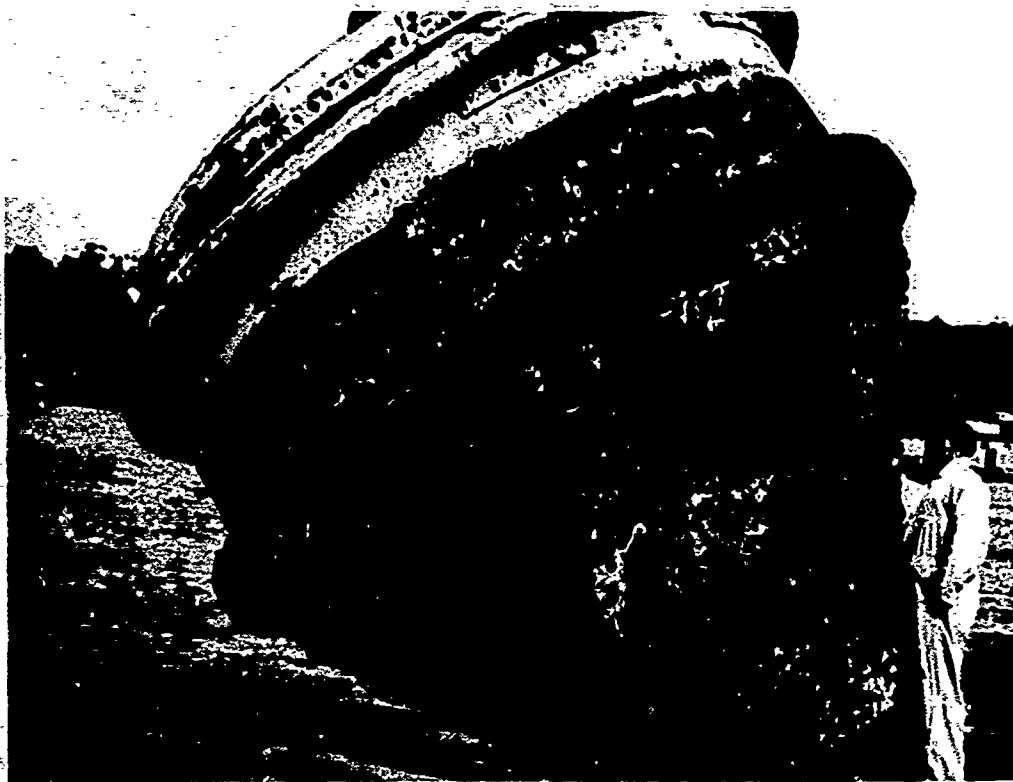
The condition of the System 1 buoy (Figure 1) had changed only slightly since the previous rating inspection. The small blisters in the splash zone noted in that inspection had slight rusting around their edges (Figure 2) and accounted for most of the rusting in this area.

Figure 1. System 1 buoy after removal of fouling.

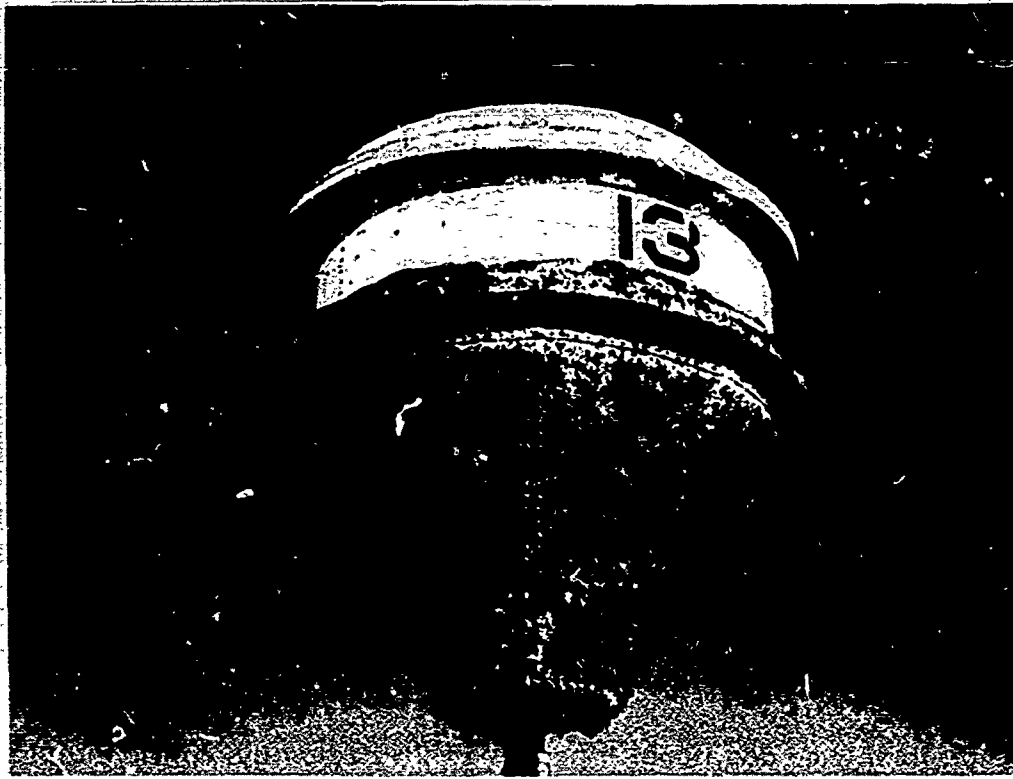
The condition of the System 3 (Figure 6) buoy was essentially unchanged from that noted at the last inspection. The epoxy primer exposed in the submerged zone where much of the polyester topcoats had delaminated was continuing to protect the underlying steel. The rusting in all three zones was related to abrasion damage.

Figure 6. System 3 buoy after removal of fouling.

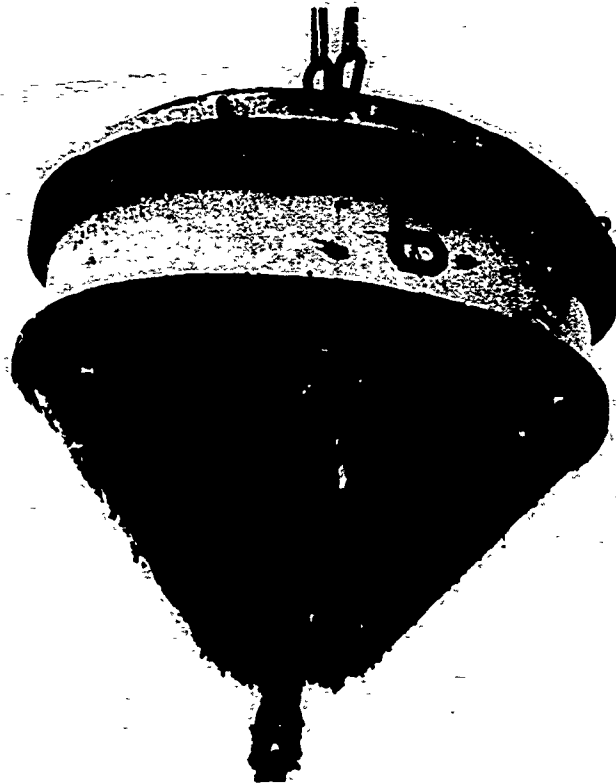
The condition of the System 4 buoy (Figure 7) was essentially unchanged since the last inspection. The previously noted delamination of the topcoat and seal coat in the submerged zone had not advanced significantly since the last inspection, and the underlying epoxy primer and coal tar epoxy were providing good protection to the steel. Elsewhere, the entire coating system was performing well.

Figure 7. System 4 buoy after removal of fouling.

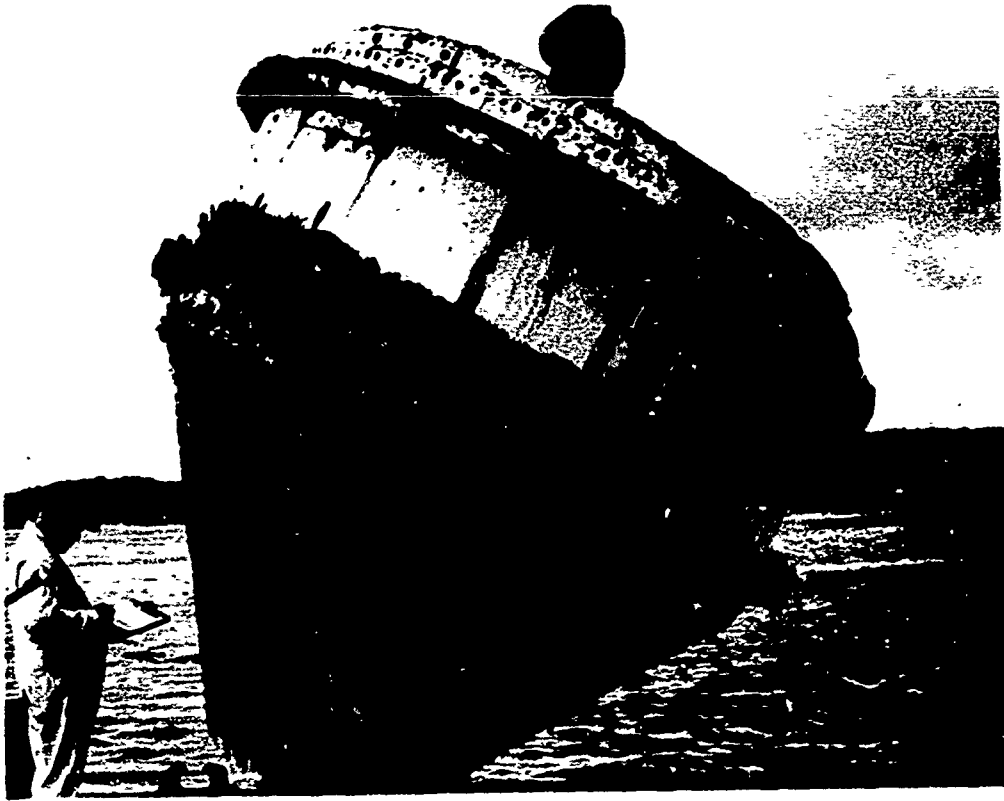
Aside from some additional top rusting initiated by the abrasive action of the securing assembly, the condition of the System 5 buoy (Figure 8) was essentially unchanged since the last inspection. Most of the coating damage in the atmospheric and splash zones was related to abrasion damage.

Figure 8. System 5 buoy after removal of fouling.

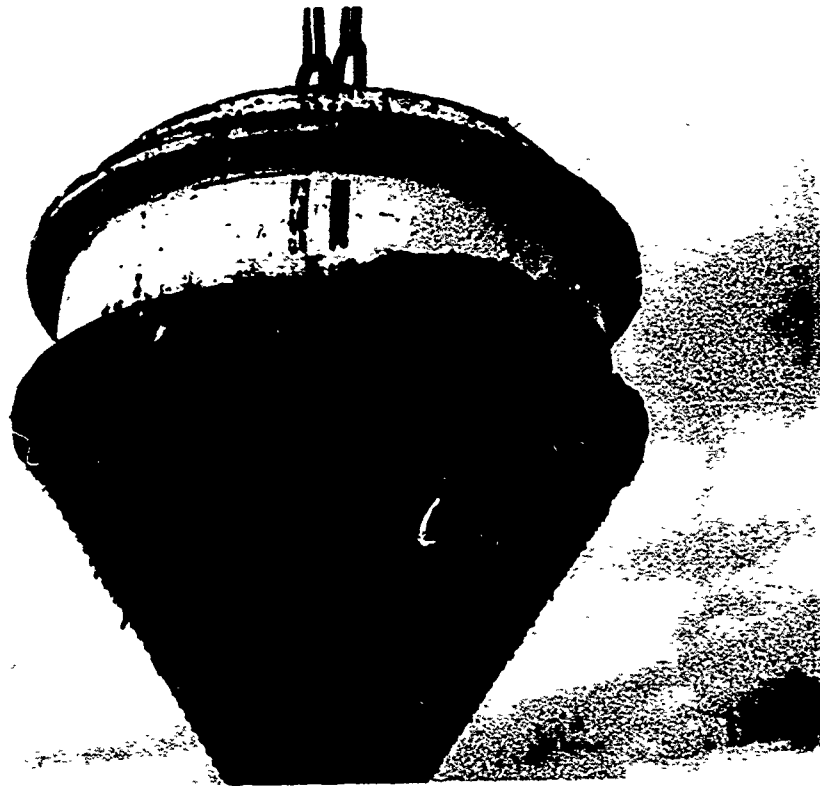
Systems 6 and 6C were identical but the 6C coating was applied to a cathodically protected buoy. Aside from some additional top rusting initiated by the abrasive action of the securing assembly, the condition of both buoys (Figure 9) was essentially unchanged since the last inspection. The System 6 buoy was in slightly poorer condition than the 6C buoy due in large part to its lighter fendering and lack of cathodic protection.

Figure 9. System 6 buoy after removal of fouling.

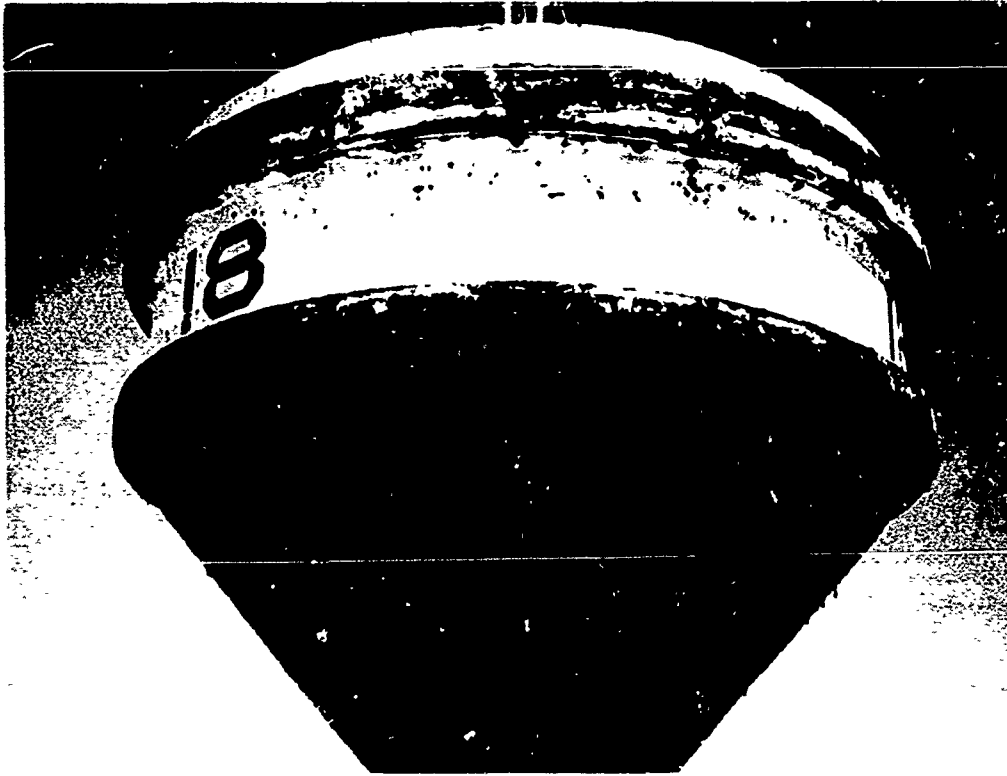
Figure 12. System 8 buoy after removal of fouling.

The condition of the System 8 buoy (Figure 12) had not changed greatly since the last inspection. The submerged portion of this buoy had the identical coating system used on the System 7C buoy, and the condition of the coating system in the submerged zone on both buoys was essentially the same. There was, however, more rusting of steel in this area of the System 8 buoy since it did not receive cathodic protection. Rusting on the side of the buoy was either of the pinpoint variety or had been caused by abrasion.

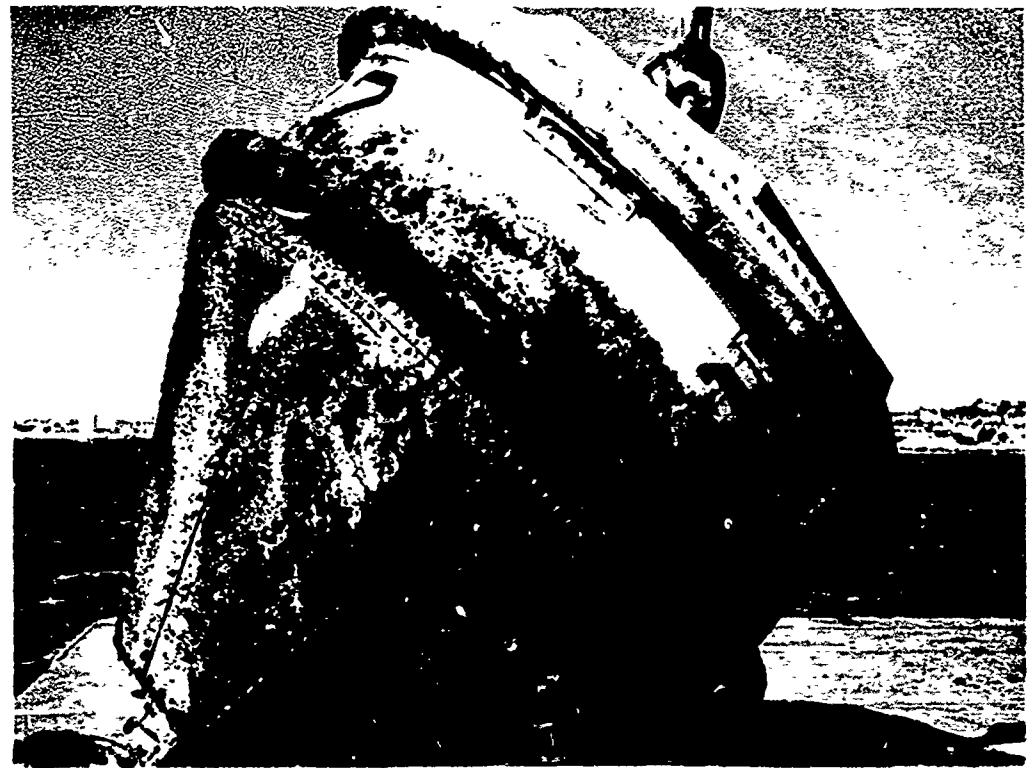
Figure 16. System 9 buoy after epoxy patching.

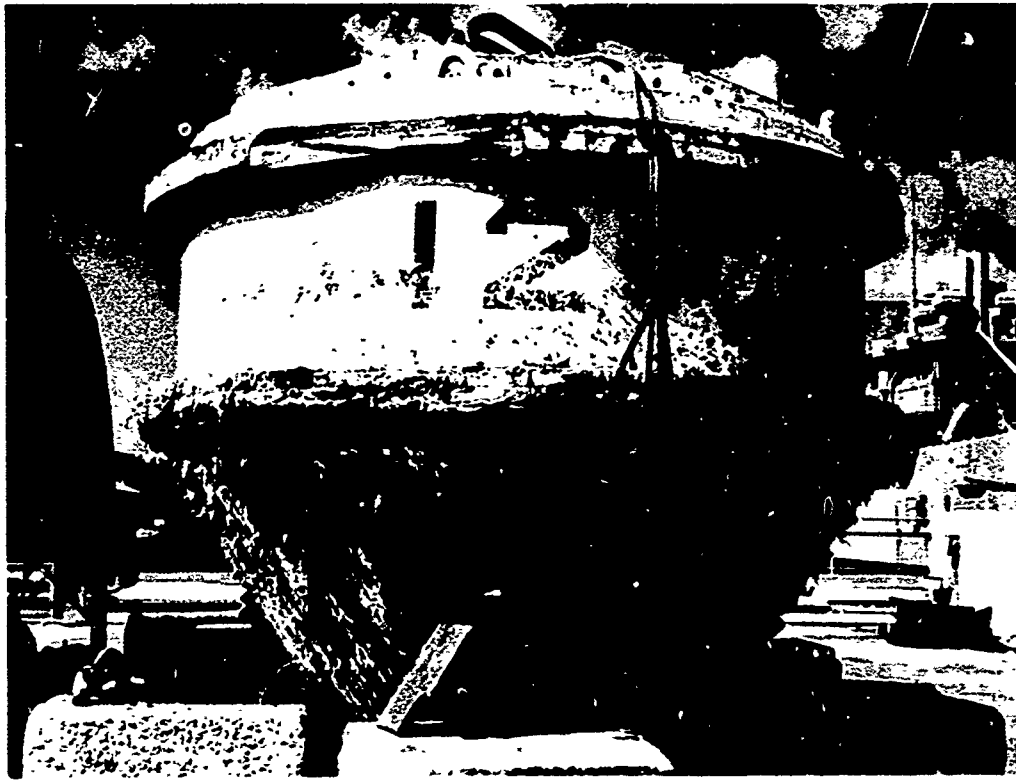
Systems 13 and 13C were identical, but System 13C was applied to a cathodically protected buoy. The former buoy was in the mooring yard (Figure 18) undergoing structural repair at the time of inspection. The condition of the coating on both buoys had not changed greatly since the last inspection. Most of the rusting was due to abrasion or was of the pinpoint variety. The cathodic protection on the System 13C buoy was mitigating corrosion in the submerged area (Figure 19). The square of bare steel (Figure 20) previously exposed on the cone of the System 13C buoy was covered with a thin film of loose rust and had no pitting.

Figure 18. System 13 buoy in mooring yard for structural repair.

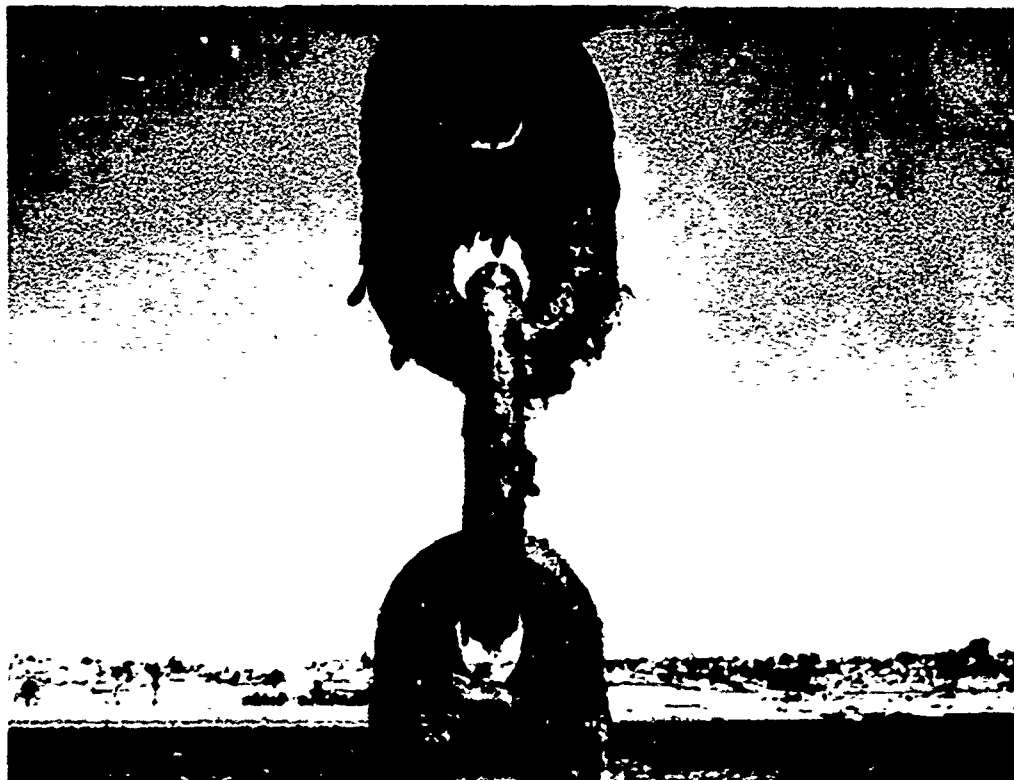
Figure 22. Riser chain linkages on System 8 buoy.
