# A RESEARCH STUDY ON INTERNAL CORROSION OF HIGH PRESSURE BOILERS

## SECOND PROGRESS REPORT

**P. GOLDSTEIN**

Steam and Water Division  
Kreisinger Development Laboratory  
Combustion Engineering, Inc.  
Windsor, Connecticut

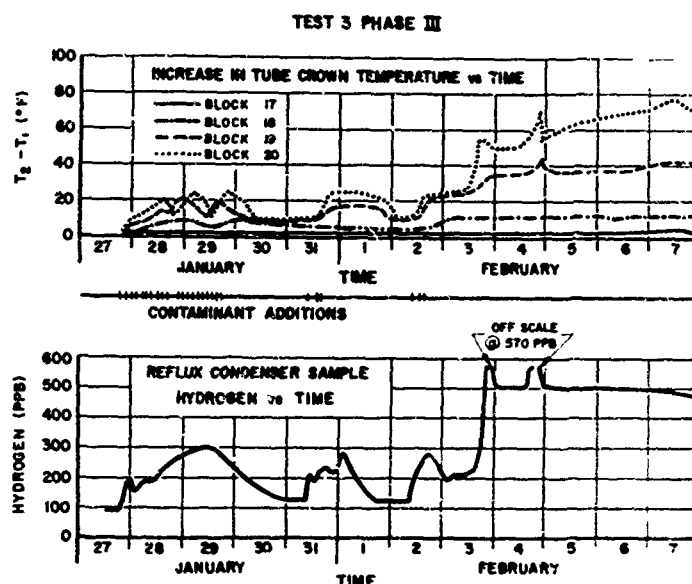
Fig. 7: Plot of tube-crown-temperature and hydrogen evolution data from the "dirty boiler" caustic test

Figure 7 shows the relationship between hydrogen evolution and the deposit effect upon tube crown temperature during the dirty-boiler caustic run. This plot reveals that the initial increases in temperature and hydrogen were triggered by contaminant additions, but that later in the test self-sustaining increases in both values occurred. Photographs of the ruptured tube and the damaged test loop are shown in Figs. 8 and 9.

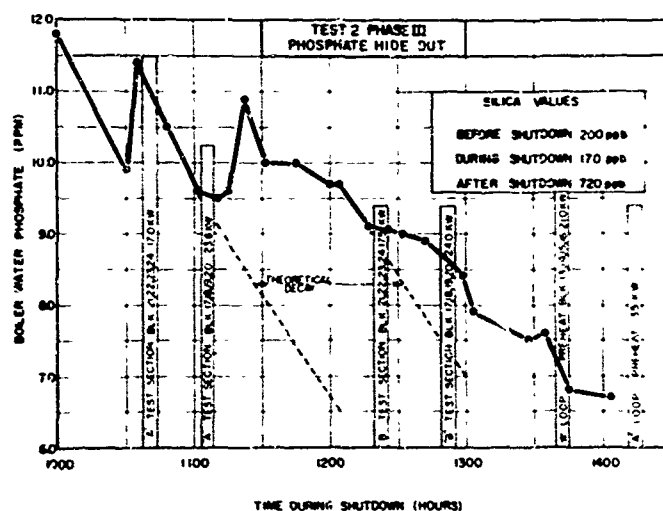
Data on phosphate hideout was gathered during shutdown at the conclusion of the phosphate tests. No hideout was observed in either the test sections or vertical-preheat areas following the clean-boiler run. However, a considerable increase in the phosphate concentration was noted after shut-down of the horizontal preheater. The results of a similar check at the end of the dirty-boiler test revealed hideout, primarily in the high-heat-flux portion of the A-loop, as shown by Fig. 12. No increase in suspended matter was noted in the boiler water during these tests.

**Fig. 12: Results of a check for phosphate hideout after the "dirty boiler" coordinated phosphate test**
