NAVY REPORT SERIAL NO. NT-003-010

"DEVELOPMENT OF SHORE PARTY EQUIPMENT"  
(STEEL WIRE PALLETS)

Purpose - The investigation and test of two designs of Steel Wire Pallets for possible acceptance as "Shore Party Equipment" to be used in amphibious Navy Combat supply.

Conclusions - Final results of all tests included in the Navy Standard Test Procedure For Pallets indicate only limited acceptability of the Steel Wire Pallet (Rolled Expanded Metal Deck) for Shore Party Equipment use in combat supply.

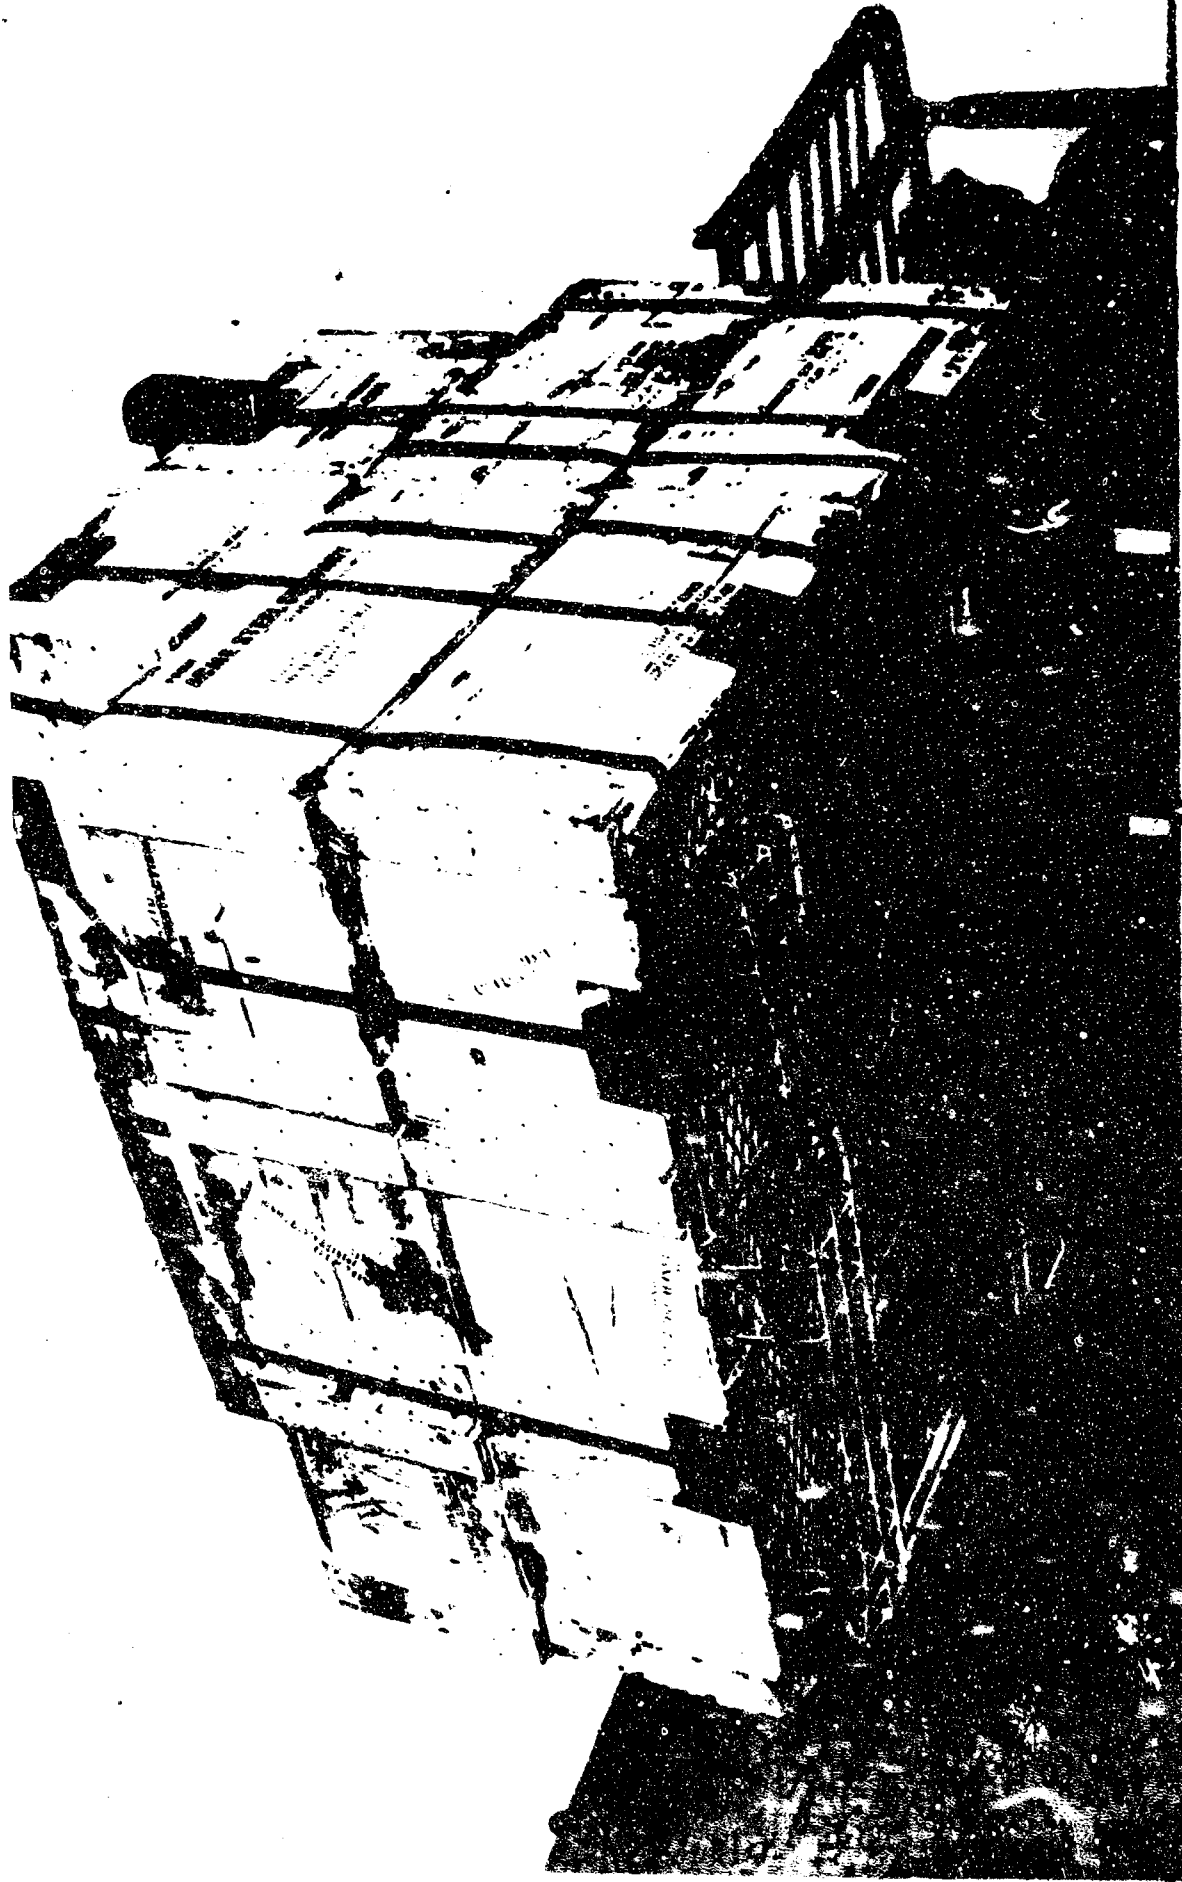
1) The bottom structure of both types of pallets showed considerable wear after being dragged over the 300 ft run of coarse gravel road. The .264" dia. pallet bottom wires, in contact with the road were found to have been ground down to .158" thickness where these wires crossed the vertical support wires. It is estimated that a continuation of this test for another 300 ft would have caused complete collapse of the bottom portions of the pallet. It was also found that the towing cable permanently bent the vertical .264" corner support wires where the cable was passed around the rear of the pallet. The welds bonding the vertical wires to the deck did not break apart. Photo #40-2, Page 47 indicates the position of the cable during dragging operation and damage resulting to corner wires.

PORTAGE OF TOWING CABLE AROUND STEEL WIRE  
FASTER DURING TOWING OPERATIONS.
