**STABILITY OF STRUCTURE FOLLOWING  
BIRD STRIKE**

**TECHNICAL REPORT  
ADS - 60**

**Robert H. Ahlers  
National Aviation Facilities Experimental Center**

**March 1966**

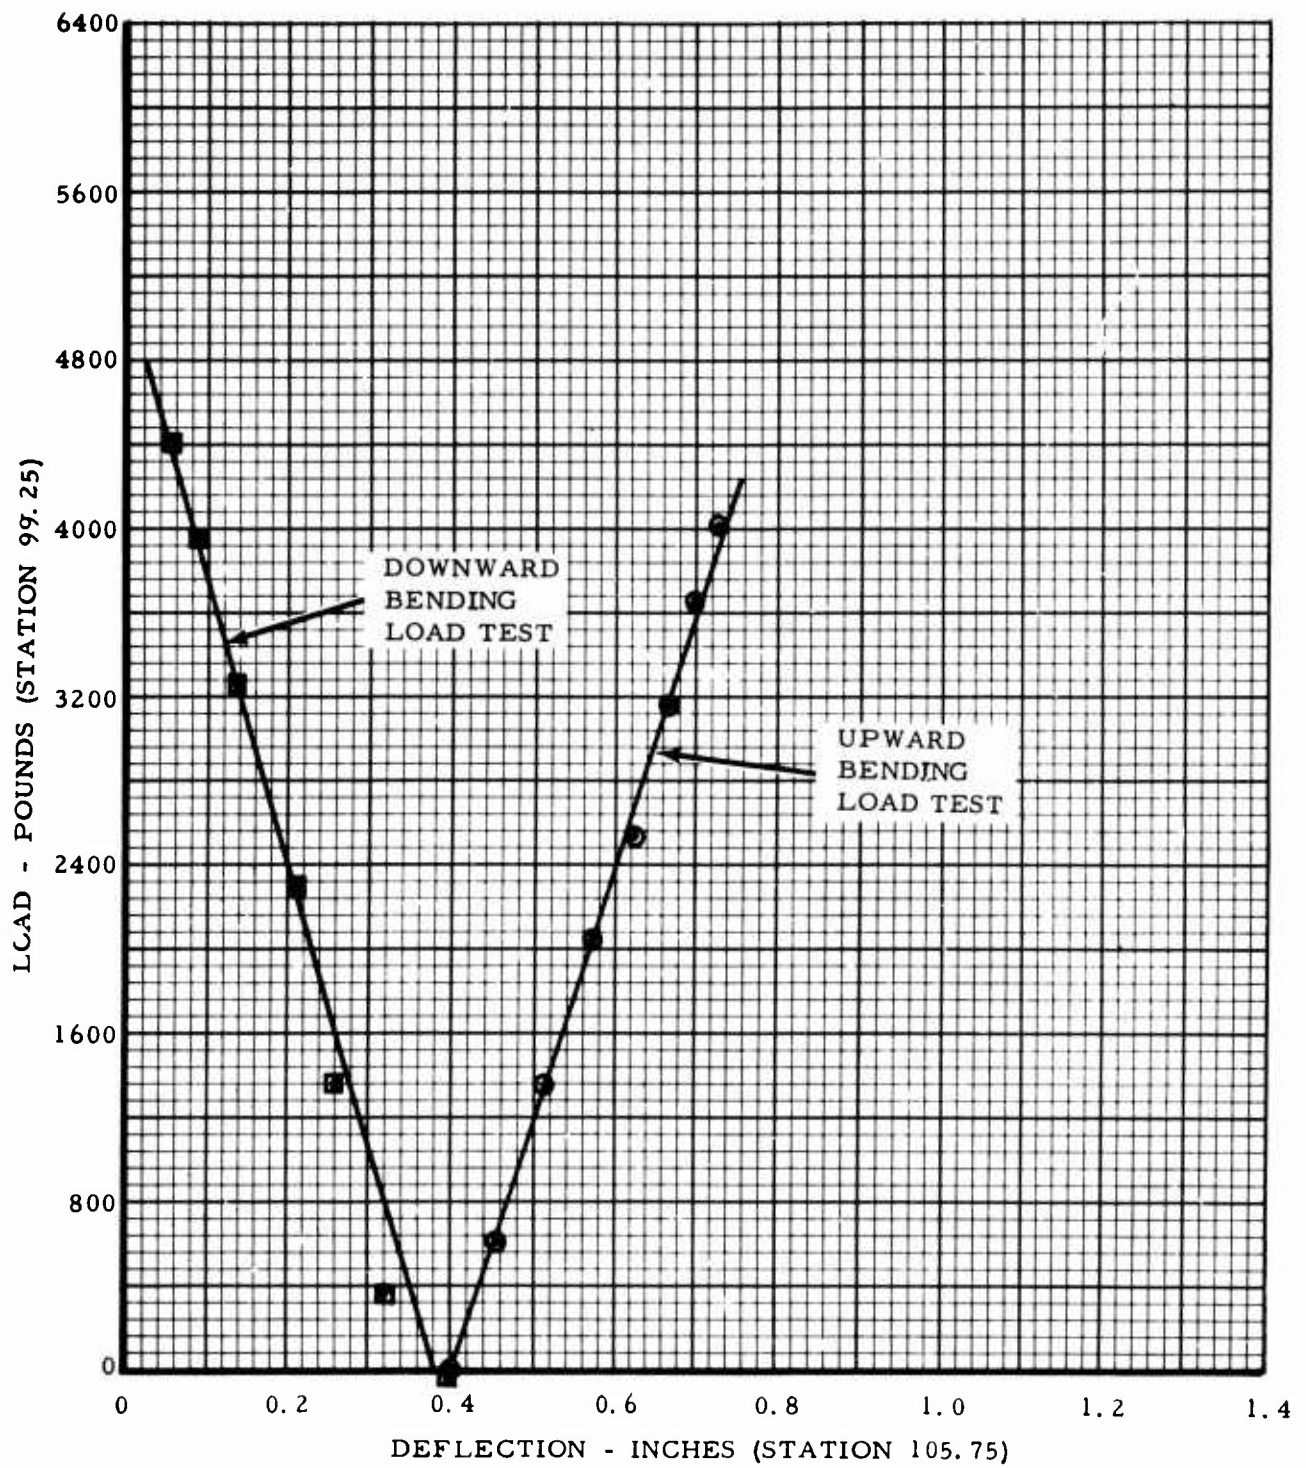
FIG. 1 TYPICAL LOAD-DEFLECTION TEST RESULTS ON A PISTON-ENGINE TRANSPORT AIRPLANE HORIZONTAL STABILIZER

The rigidity of the structure was tested in bending and the structure was vibrated to determine its natural frequency. Figure 1 is typical of the results obtained in the bending load tests made at the various station locations on the tail surface. The load plotted in Figure 1 was applied at Station 99.25 and the deflection was measured at Station 105.75. Since the only bird strike made on the tail surface inboard of Station 99.25, prior to the time this bending test was made, was Test No. 1, Figure 1 is an assessment of the structural damage caused by Test No. 1. The plots of the data result in a straight line, which would tend to indicate that the structure remained within the elastic limit. Also, from the vibration test it was determined that the natural frequency of the structure had not changed sufficiently, after Test No. 1 to indicate that any deterioration of structural strength had occurred.

All of the load-deflection data resulted in a straight line, indicating that the structure of the tail surface remained within the elastic limit as a result of sustaining nine bird strikes.

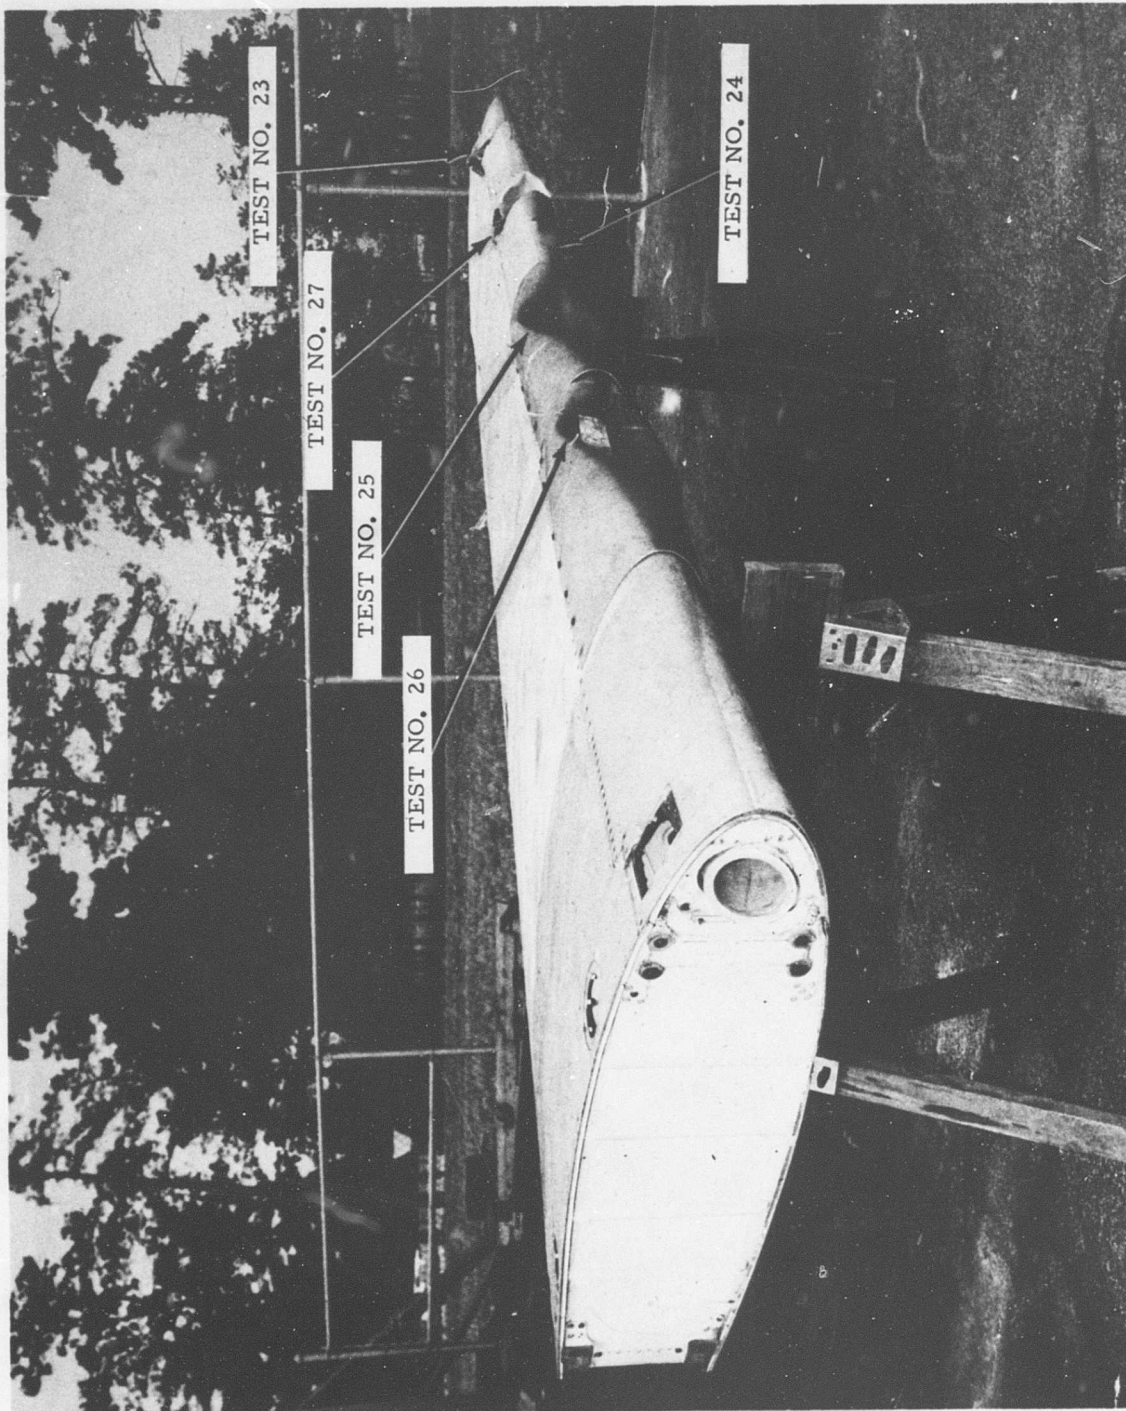
FIG. 5 BIRD STRIKE RESULTS ON A MODIFIED HORIZONTAL STABILIZER  
OF A PISTON-ENGINE TRANSPORT AIRPLANE

In an effort to decrease the vulnerability of the horizontal tail surface to bird strike damage, several modifications to the leading edge were incorporated. Table II contains a summary comparison of the results of the bird strikes made against the modified tail surface as well as the unmodified one, and Figure 5 shows the modified stabilizer after the bird strike tests had been completed on it.

An aluminum structural angle splitter was installed behind the leading edge of the tail surface where Test No. 23 was made. The impact load taken up by the structural angle was transmitted to the outboard support and then to the spar caps to which the support was attached. This load transfer to the spars caused them to be severely distorted and the failure of the weld, which connected the structural angle to the support, allowed the structural angle to sweep back in an arc and tear out more of the internal structure than was the case for the unmodified structure. It was judged that this modification actually increased, rather than decreased, the vulnerability of the structure to bird strike damage.

The leading edge section on which Test No. 25 was made had a stainless steel doubler 0.100 inch thick, and a plastic foam filler in the D section of the leading edge. The stainless steel doubler successfully stopped the bird from penetrating the leading edge. Since the stainless steel doubler was attached to the front spar caps by a row of bolts, the impact energy was transferred from the doubler to the rest of the structure through several points and there was no localized failure of the structure, as was the case on Test No. 23.

For Test No. 26 the section of the leading edge had an 0.100 inch stainless steel doubler backed up by an aluminum structural angle. The modification prevented the bird from penetrating the leading edge. The impact load was transferred from the stainless steel doubler to the front spar caps and there was some buckling of the external skin, but the structural strength of the surface was not seriously affected by this bird strike.

On Test No. 27 the section had the original standard aluminum leading edge backed with a plastic foam filler. The bird penetrated the leading edge, distorted the front spar caps, and passed completely through the rear spar web. This modification was completely ineffective and this bird strike caused structural failure just as it did on the unmodified tail surface.

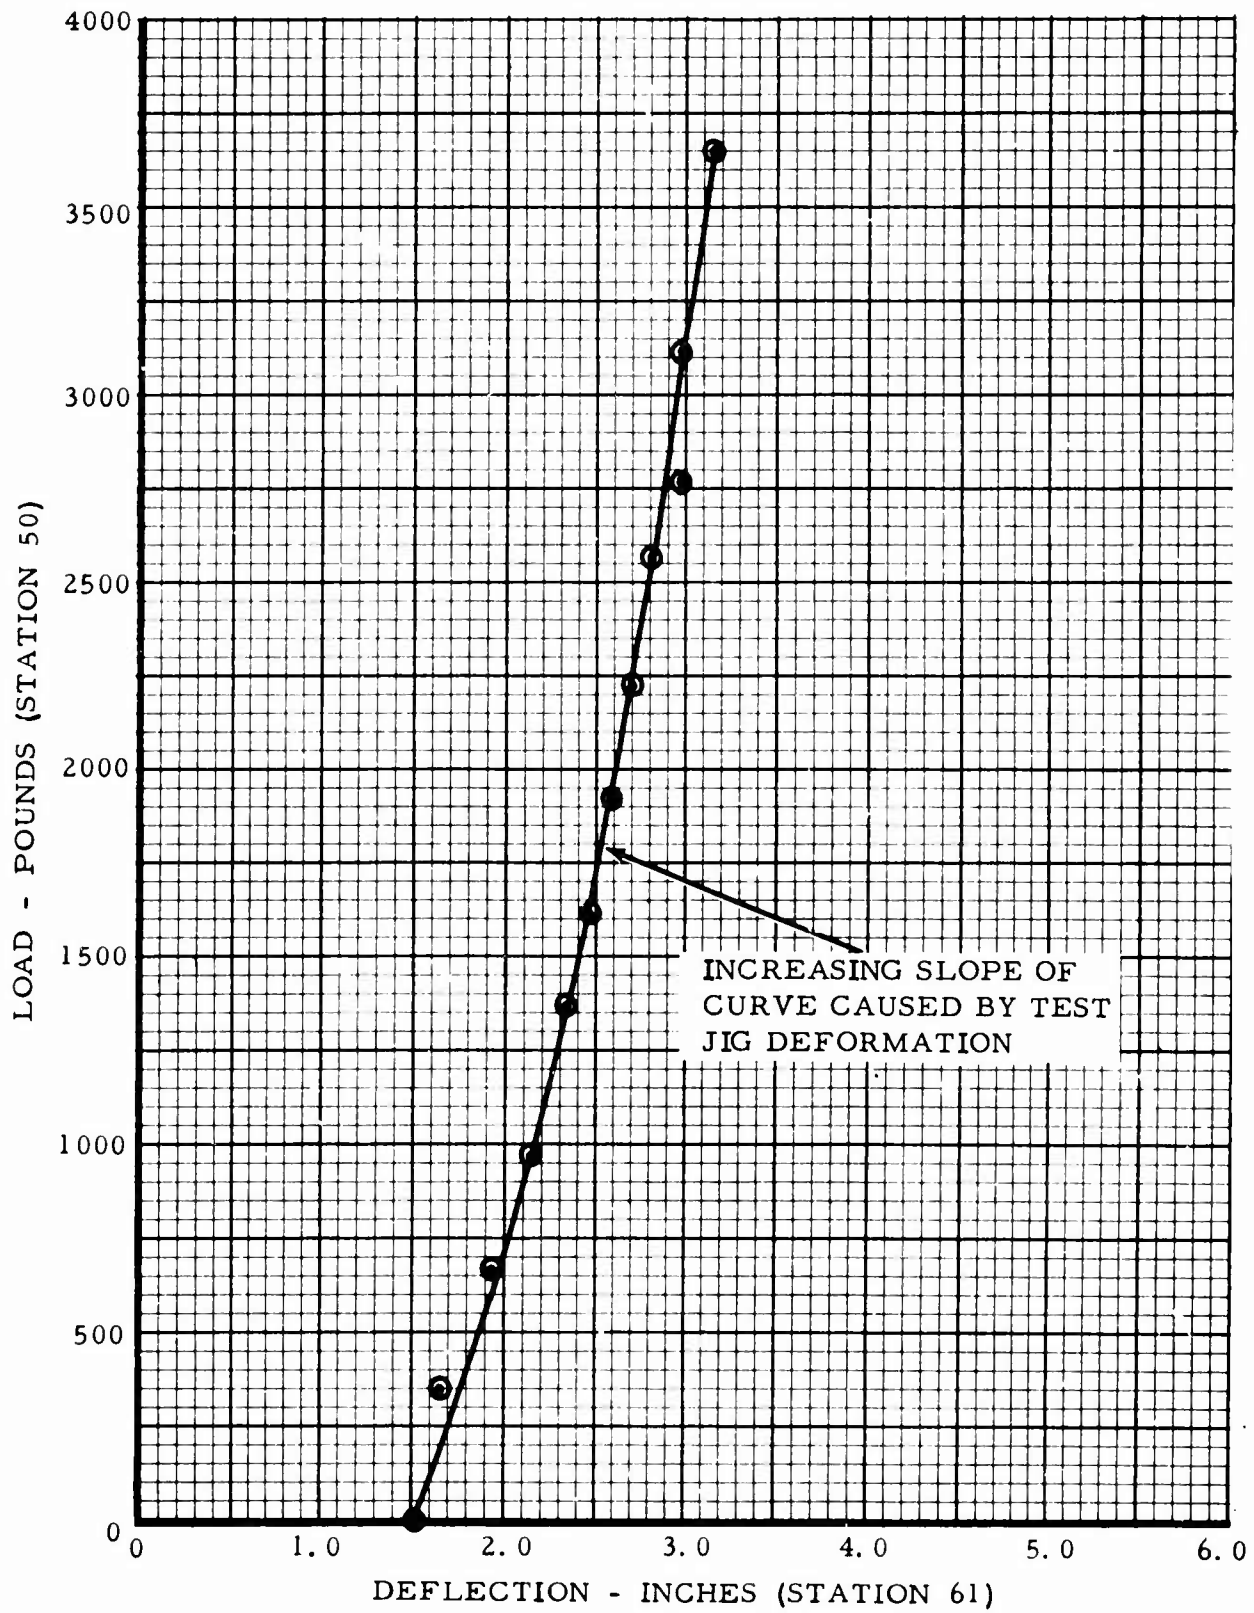
FIG. 6 RESULTS OF LOAD-DEFLECTION TEST MADE AFTER TEST NO. 31 ON A TURBOPROP TRANSPORT HORIZONTAL STABILIZER

The structural integrity of the tail surface was not impaired by any of these strikes except Test No. 32. On this last one the bird went completely through the stabilizer, cut the elevator in two and tore off the elevator trim tab. The spar was severely damaged and the tail surface lost all structural strength. Figure 6 is a load-deflection curve of Test No. 31 and is representative of the three previous strikes where structural failure did not occur. Figure 7 is a plot of the load-deflection data taken after Test No. 32 where the deflection increased with decreased load indicating structural failure of the stabilizer.

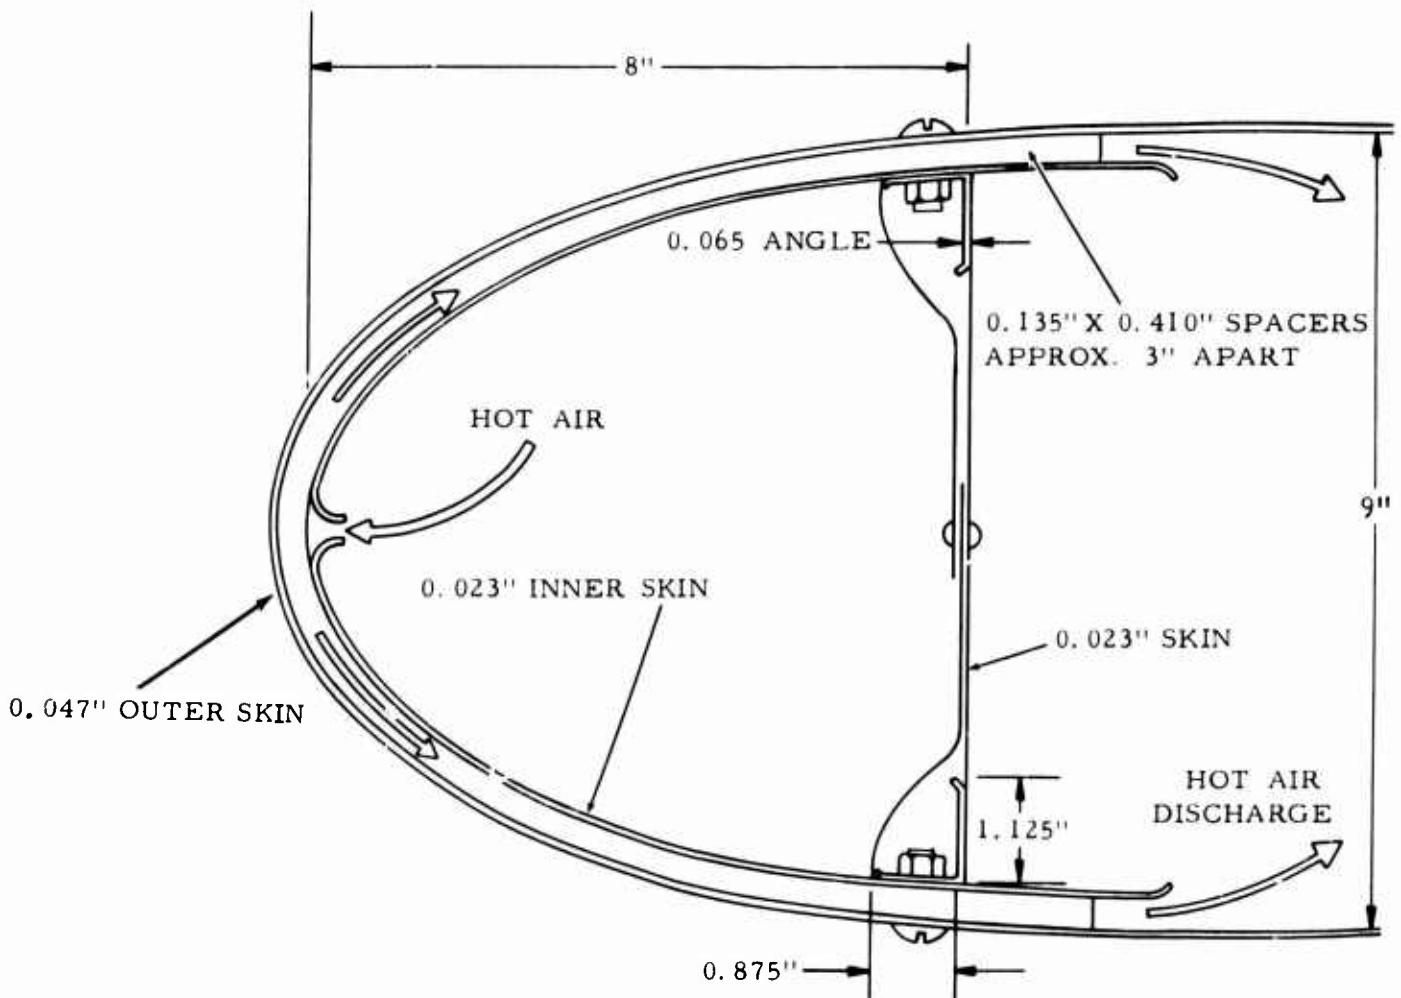
FIG. 8 ORIGINAL LEADING EDGE ON HORIZONTAL STABILIZER OF A TURBOPROP TRANSPORT AIRPLANE

Three modifications to the leading edge of the horizontal stabilizer were made to increase its resistance to bird strike damage. The original leading edge is made of two layers of aluminum skin separated by a distance of 0.135-inch by stringers to allow hot air to flow between them for de-icing the leading edge. A typical cross-section of the standard leading edge is shown in Figure 8. The three modifications to the leading edge consisted of a laminated stainless steel splitter plate behind the original leading edge, as shown in Figure 9; a stainless steel leading edge to replace the aluminum, with the addition of two stainless

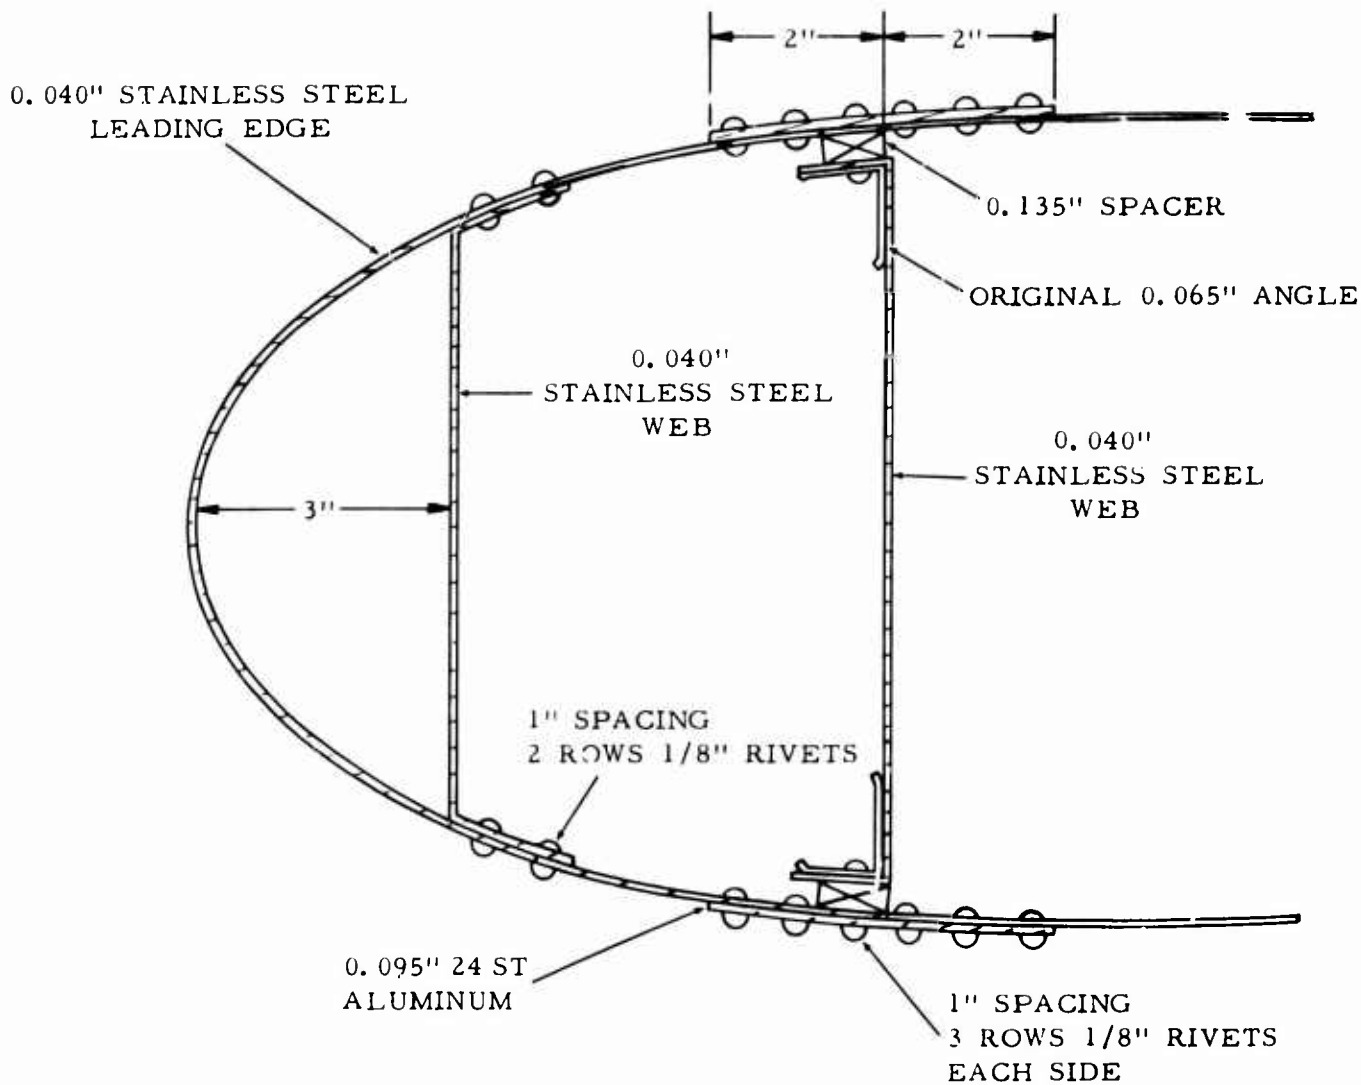
FIG. 10 STAINLESS STEEL LEADING EDGE WITH TWO STAINLESS STEEL WEBS ON A TURBOPROP TRANSPORT AIRPLANE

WEIGHT: 4.5 POUNDS PER FOOT  
 ORIGINAL LEADING EDGE WEIGHED 1.8 POUNDS PER FOOT  
 NET ADDED WEIGHT 2.7 POUNDS PER FOOT

steel webs, as shown in Figure 10; and a stainless steel doubler over the existing leading edge, as shown in Figure 11. Each modification was about four feet long and all were incorporated on one horizontal surface.

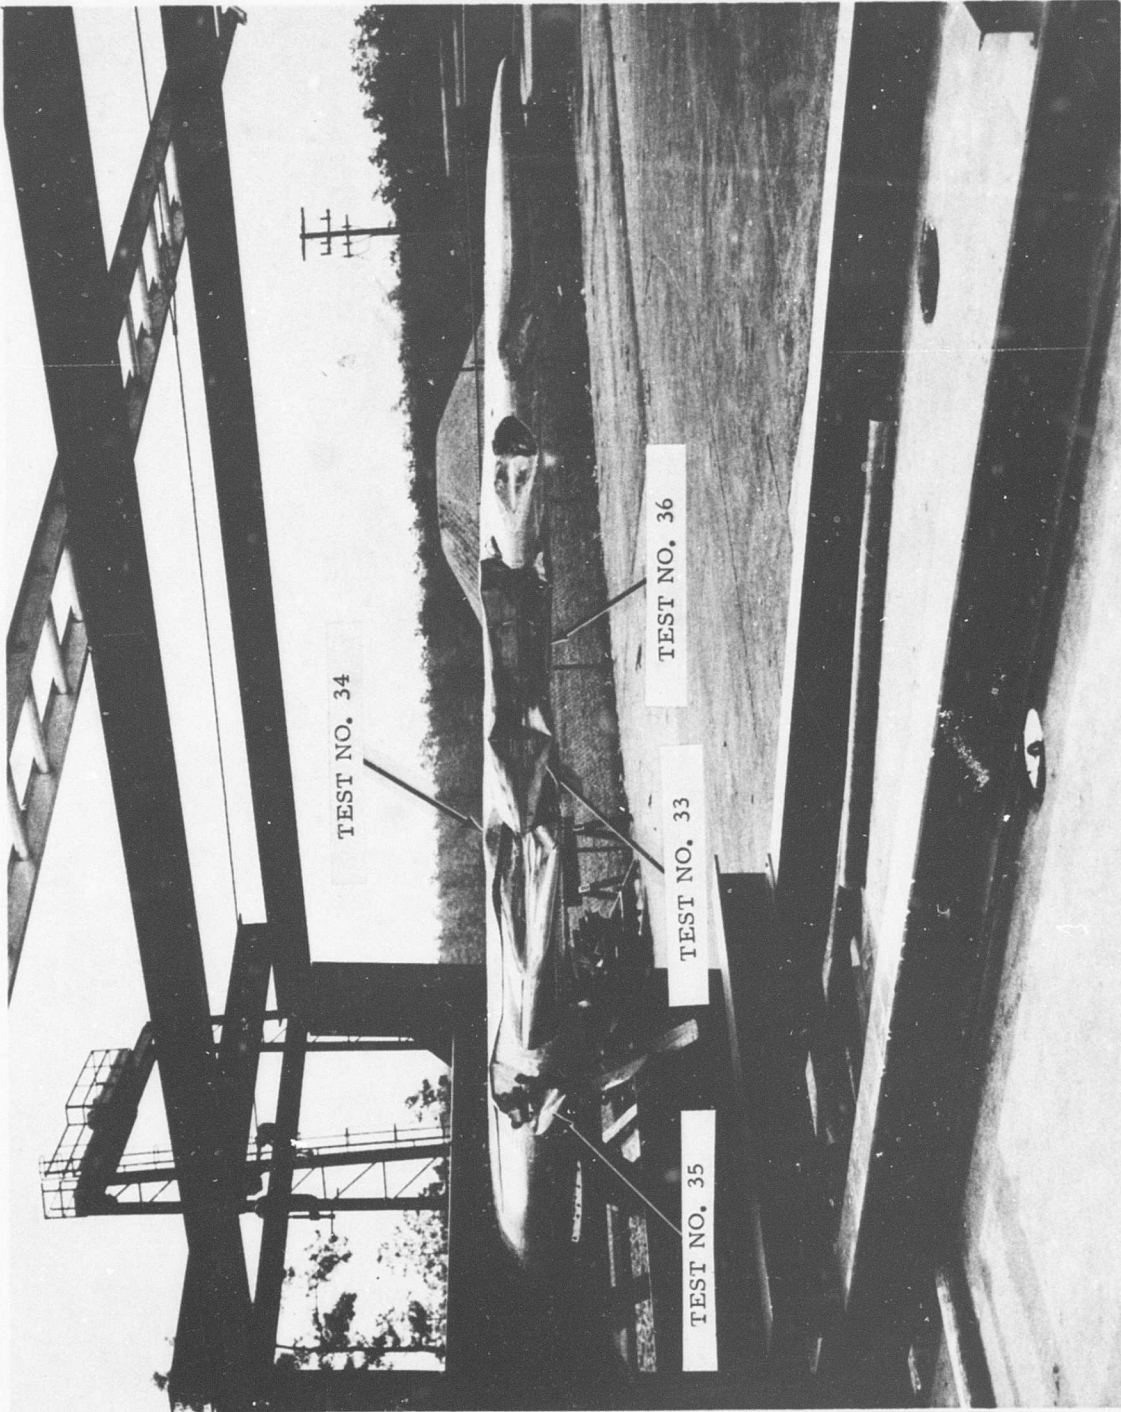
FIG. 12 HORIZONTAL STABILIZER OF A TURBOPROP TRANSPORT  
AIRPLANE AFTER BIRD STRIKES

Figure 12 is an overall view of the modified stabilizer after it had been struck by the four birds. The modifications were effective in preventing bird penetration but the energy of impact was transferred to the structure behind the leading edge, causing it to buckle. The modifications prevented bird penetration and therefore, protected the rear spar, which is the main structural member of this type of airfoil construction.

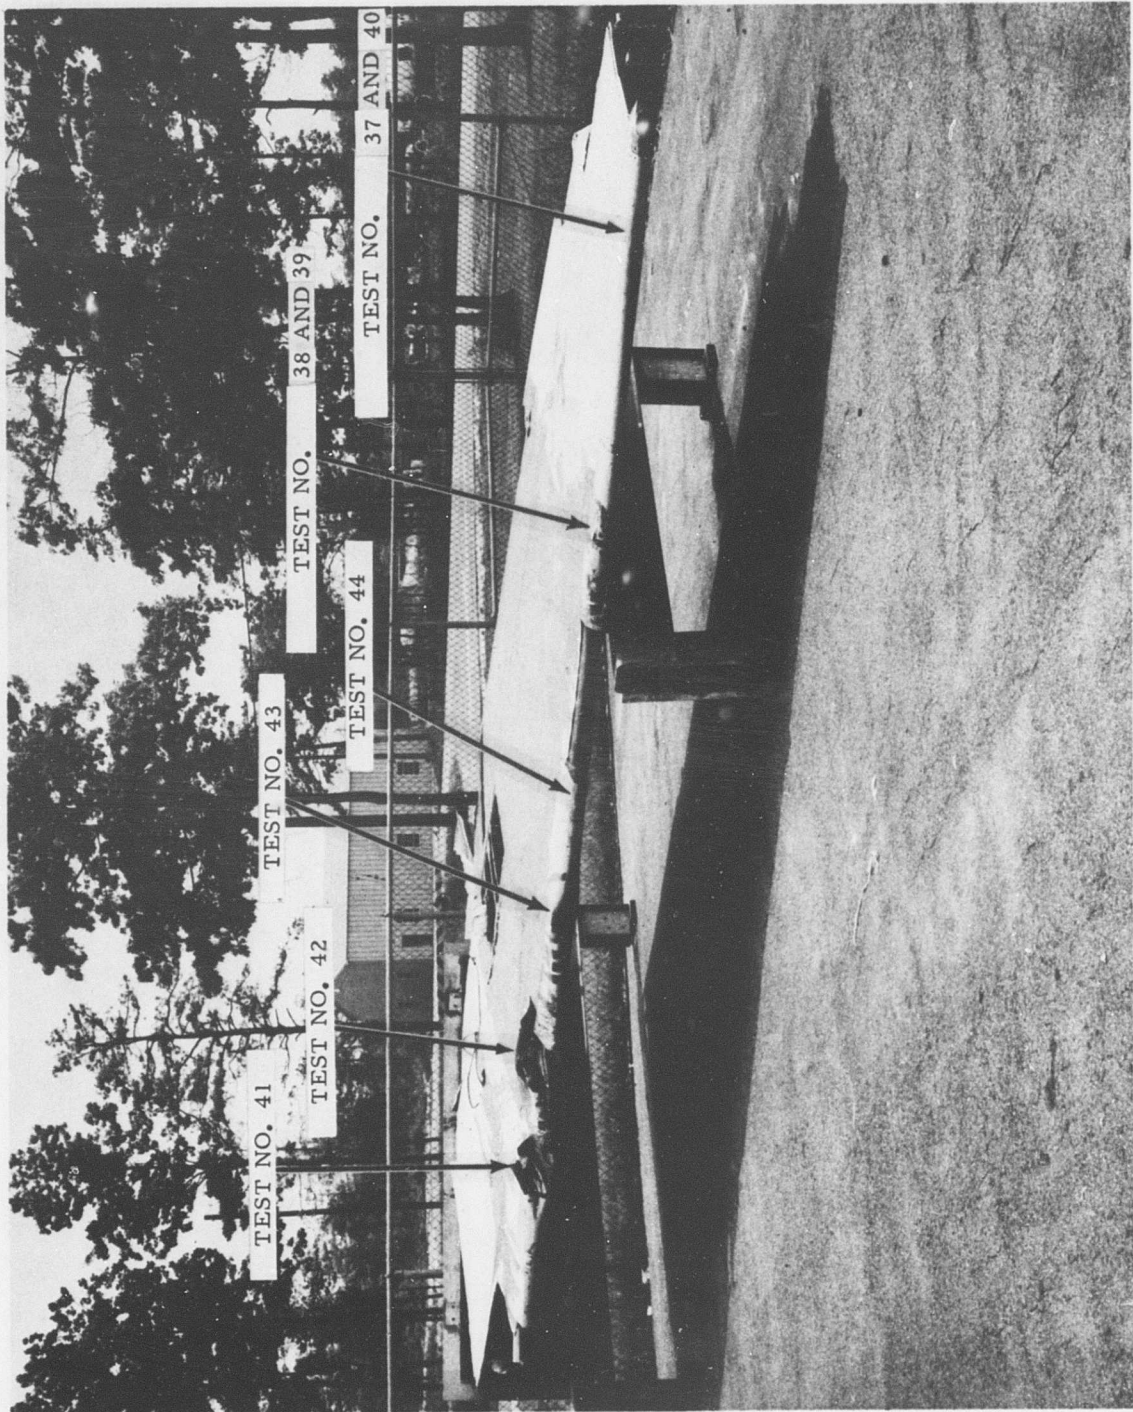
FIG. 13 VERTICAL STABILIZER OF A JET-TYPE TRANSPORT AIRPLANE  
AFTER BIRD STRIKES

Bird strikes were made against a vertical stabilizer and a horizontal stabilizer of a modern high-speed transport jet airplane. Eight bird strikes of various weights, ranging from 11 to 14 pounds, were made on the vertical stabilizer at impact speeds of about 300 mph. Table IV is a summary of these strikes. Figure 13 is an overall view of the surface after the eight bird strikes had been made.

Tests Nos. 41 to 44 were a series of strikes made where bird weight and impact speed were kept constant but the impact locations were changed. The first shot of this series was made at the furthestmost inboard location 216 inches from the surface tip. The bird penetrated the leading edge but did not damage primary structure, and therefore, this strike did not weaken the structure. The impact point of the next shot (Test No. 42) was outboard of the last strike and the bird did not penetrate the leading edge as much. The next two strikes were successively farther outboard and leading edge penetration became less as the impact moved farther outboard on the tail surface. On Test No. 44 the impact did no damage to the leading edge. A series of four bird strikes were made on the horizontal stabilizer of the jet-type carrier transport. A summary of these strikes is given in Table V. Figure 14 is an overall view of the horizontal stabilizer after the four bird strikes had been made. On all of these strikes, the bird penetrated the leading edge and tore out internal structure and ribs before becoming lodged inside the structure. Although the birds penetrated the structure, the spar caps were undamaged and therefore, the structural strength was not impaired. It appears from the above tests that the horizontal stabilizer was not as resistant to bird strike damage as the vertical stabilizer. A ten-pound bird at about 300 mph impact speed easily penetrated the leading edge of the horizontal stabilizer at any location along its length, whereas the vertical stabilizer withstood a 14-pound bird impacting at 300 mph penetration, if the strike was made toward the

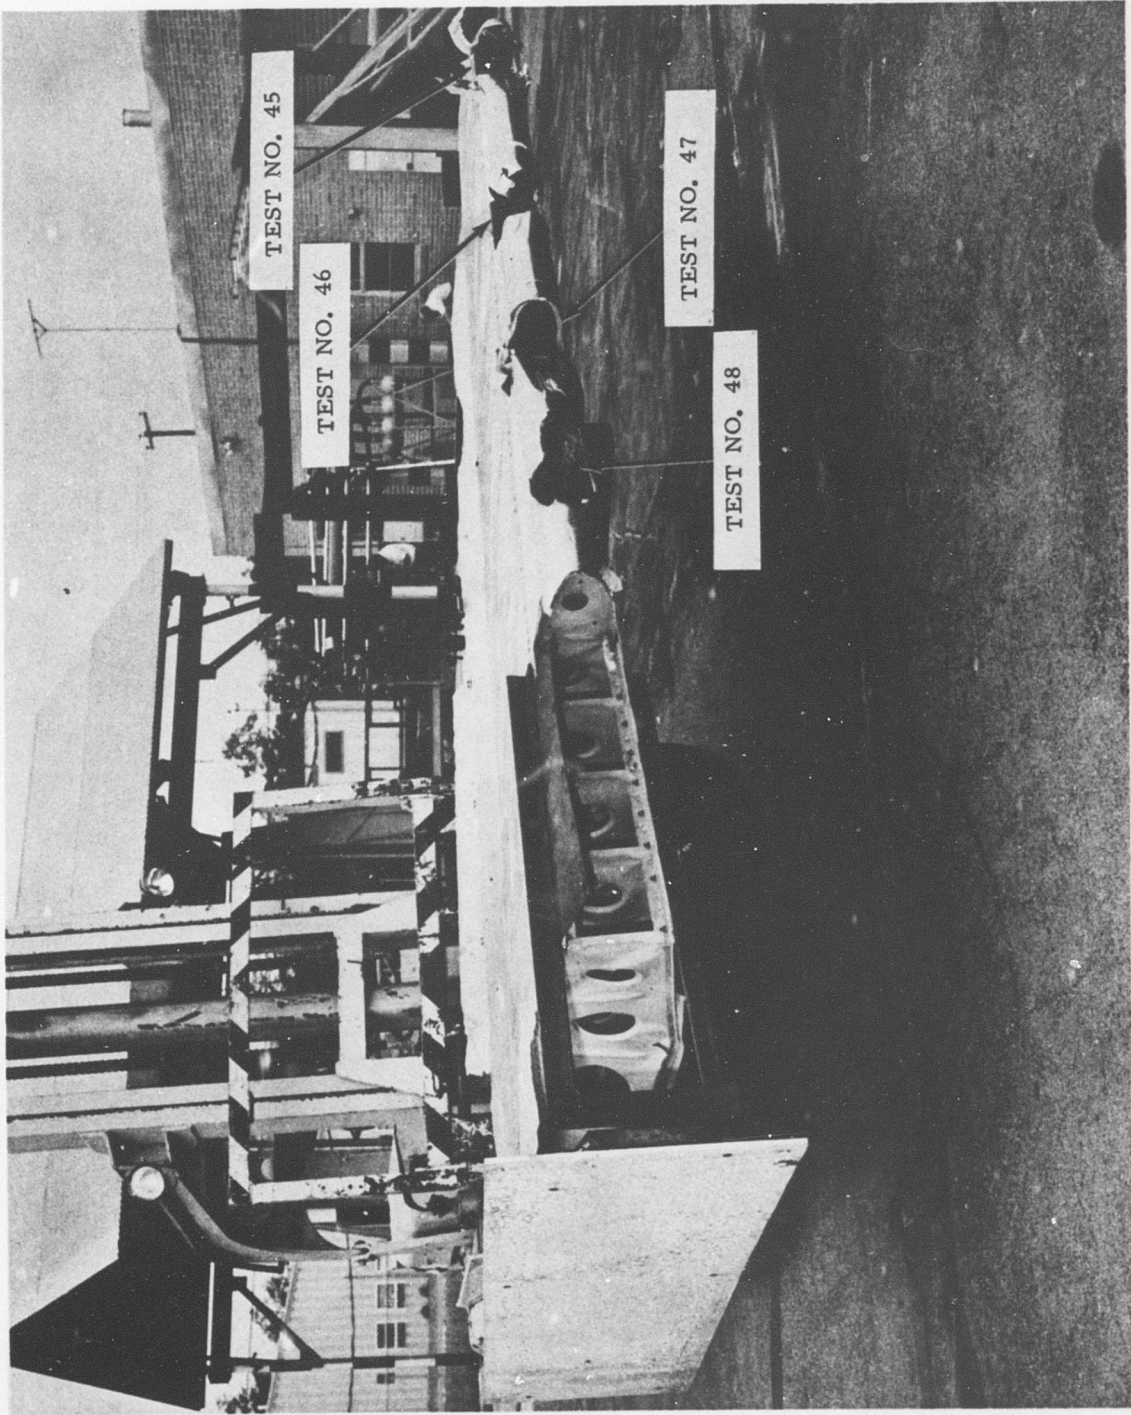
FIG. 14 HORIZONTAL STABILIZER OF A JET-TYPE TRANSPORT AIRPLANE  
AFTER BIRD STRIKES

outboard tip. If the horizontal stabilizer could be manufactured more along the lines of the vertical stabilizer, it appears that it might be less vulnerable to bird strike damage.

TEST No.	BIRD WEIGHT Pounds	IMPACT VELOCITY mph	DISTANCE OF IMPACT POINT FROM TIP in	REMARKS
45	9.25	294	12	On all of these shots the bird penetrated the leading edge, tore out internal ribs, and remained lodged inside the stabilizer. Spar caps were undamaged.
46	9	304	48	
47	10	305	80	
48	10.75	300	106
