**R 542**

PROTECTION OF MOORING BUOYS --  
PART X. RESULTS OF NINTH RATING  
INSPECTION

September 1967

NAVAL CIVIL ENGINEERING LABORATORY

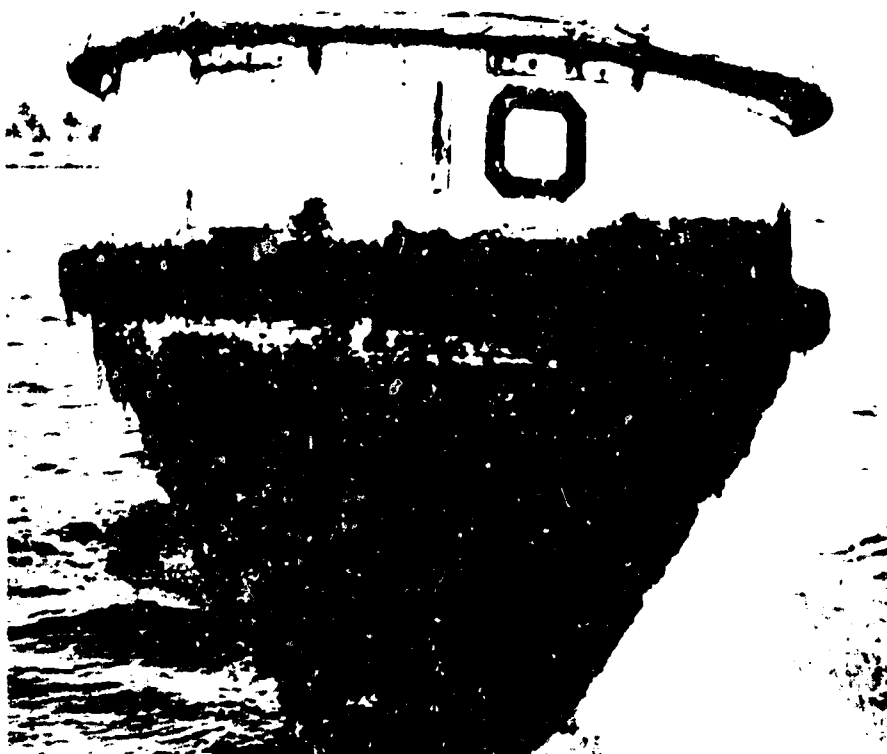
Figure 1. Typical fouling as seen on System 5 buoy.

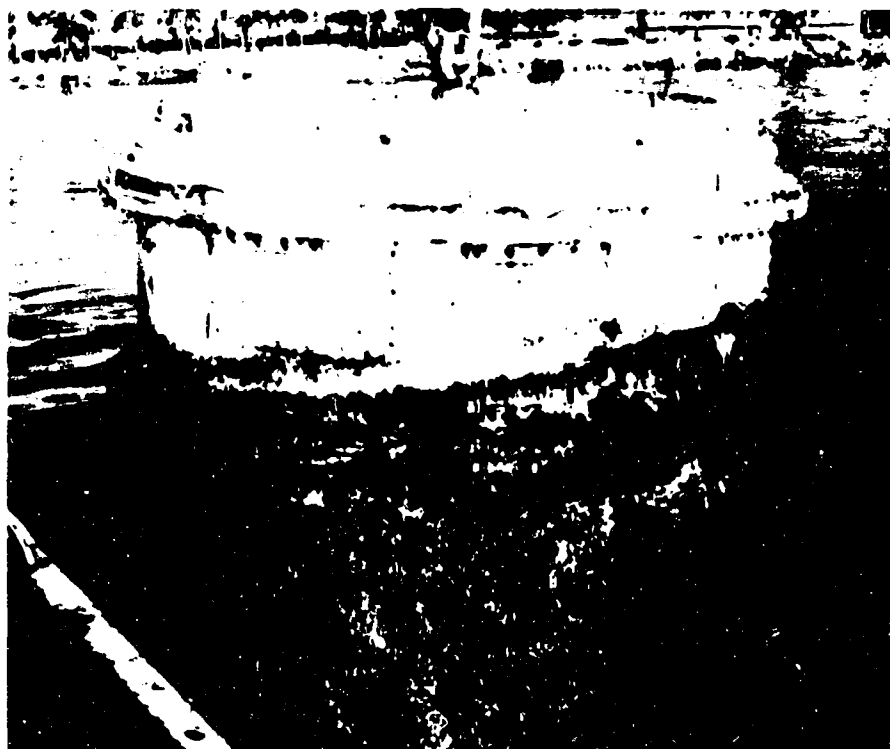
The condition of the System 1 buoy (Figure 3) had deteriorated slightly since the previous rating inspection, and there was somewhat greater rusting in the atmospheric and splash zones. Much of this, however, was either of the pinpoint type (Figure 4) or had been caused by impact or abrasion. The pinpoint rusting on the buoy side was initiated by small blisters previously noted there.

Figure 3. System 1 buoy before removal of fouling.

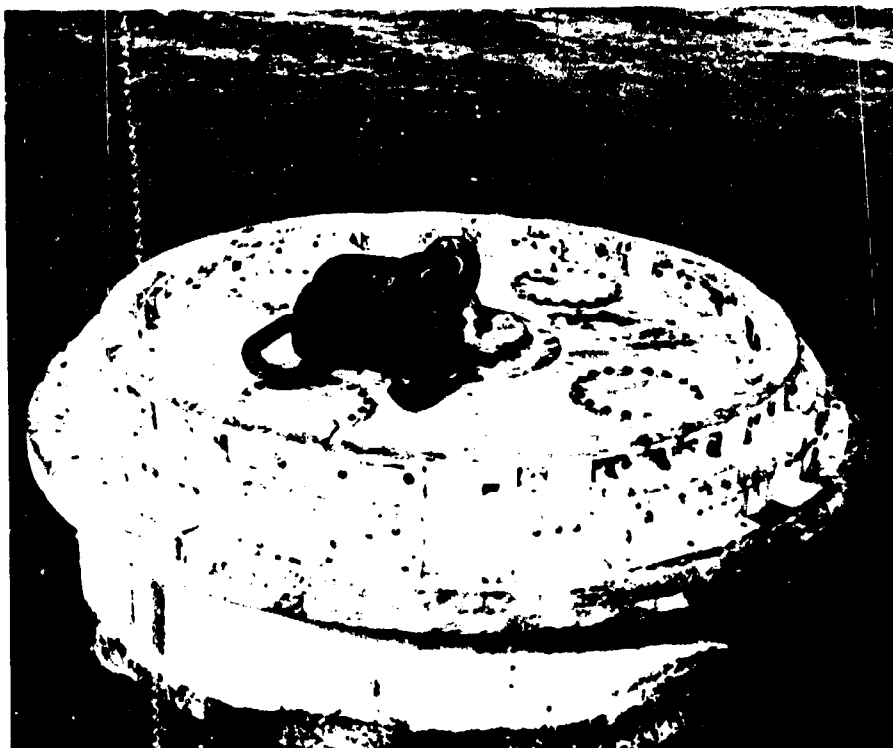
Figure 6. Abrasion damage on System 6 buoy.

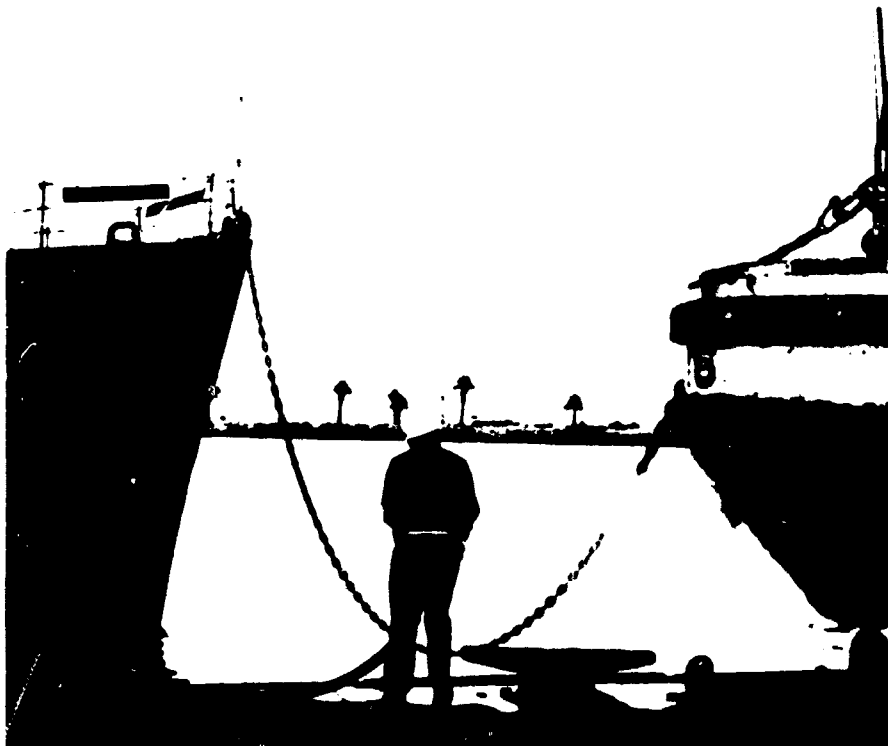
Figure 9. Hosing of System 13C buoy with destroyer secured to it.
