CRASH INJURY EVALUATION

AO-1BF MOHAWK MOCKUP

AO-1BF U. S. ARMY "MOHAWK" MOCKUP EVALUATION
Bethpage, Long Island, New York
31 March 1960

REPORT OF CRASH INJURY EVALUATION
AvCIR-12-PV-117
August 1960

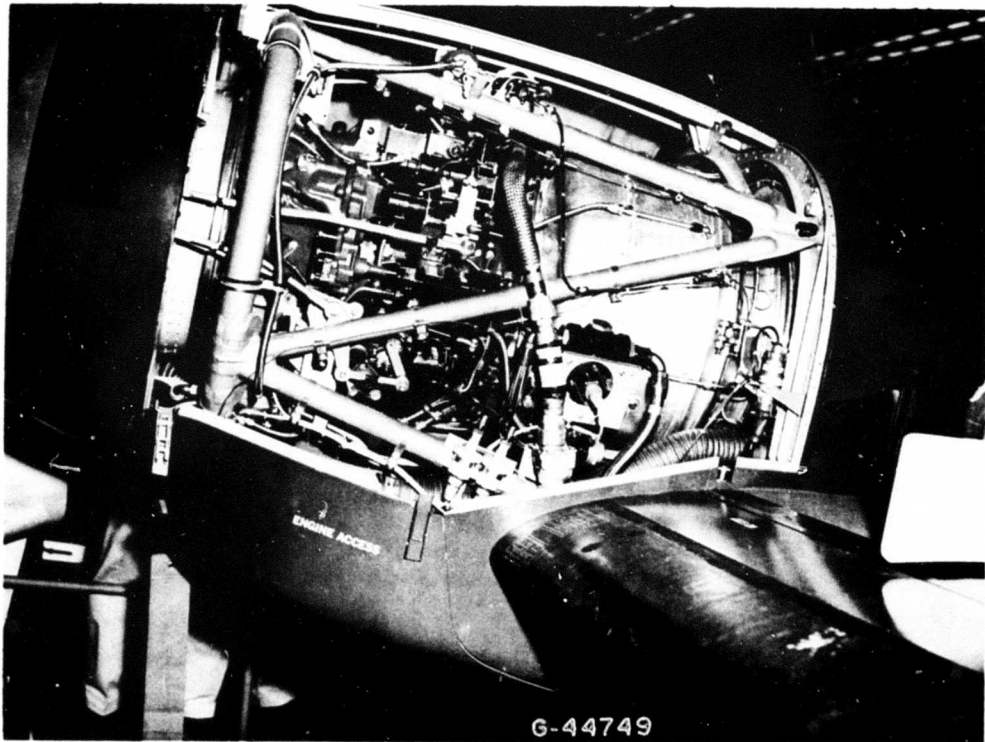
Figure 5 depicts an outboard view of the Lycoming T53-L-3 engine utilized on the Mohawk, which develops 1,005 ESHP at take-off. At the present time, it appears that the engines are adequately mounted; however, lack of time prevented detailed analysis which might predict the manner in which the engines would tear loose in the event of an accident.

Figure 5. Outboard view of the Lycoming T53-L-3 engine.

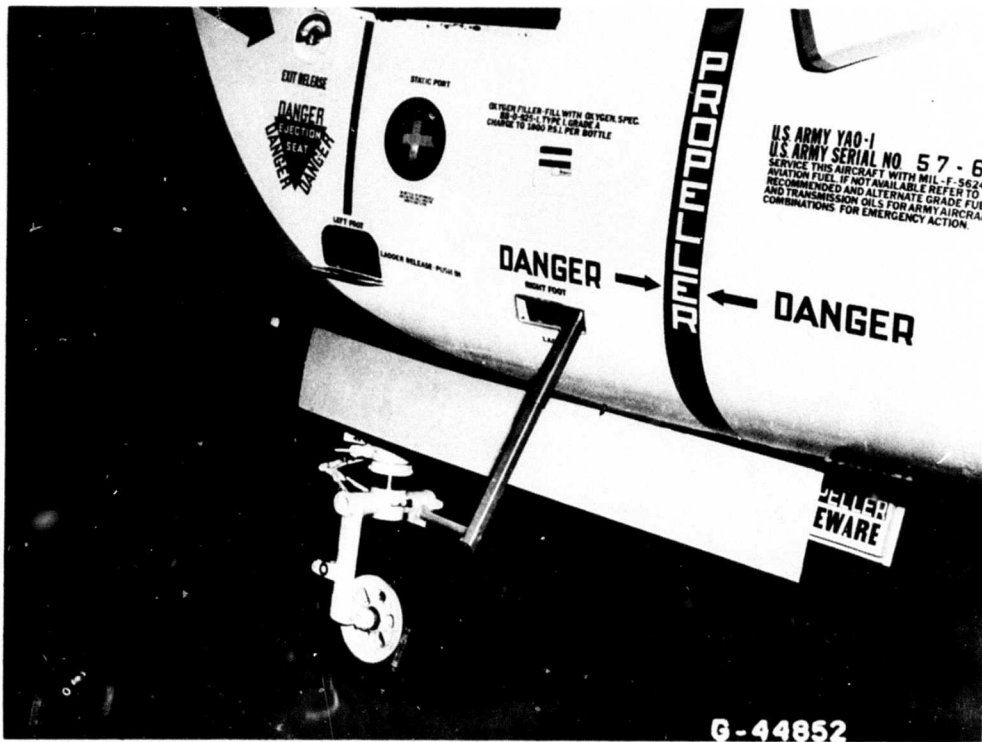
The exterior markings (Figure 1 and 6) in regard to the exit release, ejection seat, and the propeller danger area are well placed and legible from a considerable distance. The rescue arrow, upper left in this photo and also in Figure 1, pointing out the exit release, is deemed adequate for rescue personnel.

In addition to the markings mentioned above, one additional marking should be added to the aircraft which specifies the location of the hand fire extinguisher. Fire and crash trucks are not always readily available; therefore, the time spent trying to locate the fire extinguisher might prove costly in the event of a post-crash fire.

Figure 6. View of the exterior rescue and danger area markings.

1. One additional exterior marking be added which specifies the location of the fire extinguisher.
2. The in-flight fire extinguishing system be modified to permit activation by impact in addition to manual activation.

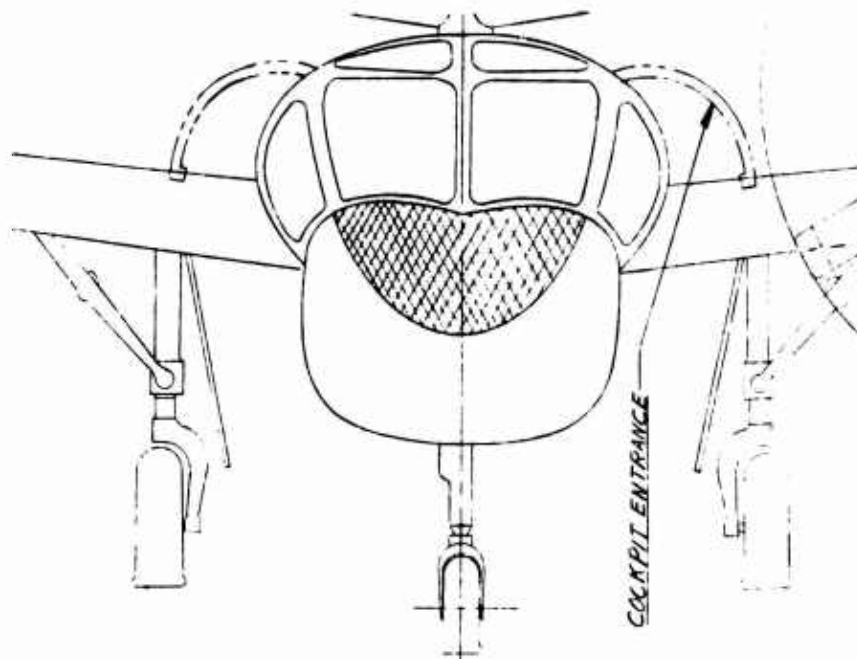
The open cockpit side entrances are depicted in Figure 9. These side panels are presently hinged at the top and swing outward to the position denoted by the arrow. Two steps are available on both sides to facilitate entrance and departure while the aircraft is parked. Departure while in flight is via the ejection seats. Normal entry and departure is very similar to a H-19 or H-34 helicopter. Care must be exercised, particularly by tall crew members, to avoid striking the open side panels while in the vicinity of the cockpit.

Figure 9. Front view showing cockpit side entrances. The arrow depicts the side entrances in the open position.

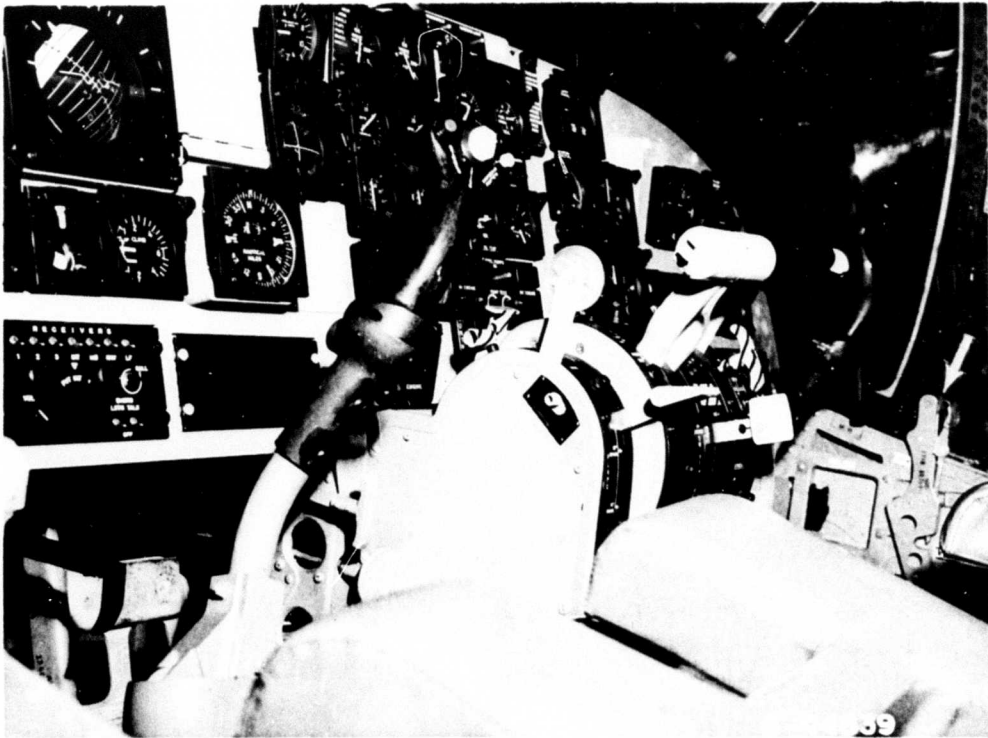
The arrow in Figure 11 denotes the side entrance opening and closing handle and is shown in the forward, or open, position. This lever, when in the locked or closed position, is directly to the left of the pilot's left arm and to the right of the other occupant's right arm and extends upward approximately three inches. This aircraft is normally flown from the left side, and it is conceivable that the pilot could catch his sleeve on this lever during violent evasive maneuvers.

Figure 11. Close-up of the instrument panel and the center pedestal. The arrow denotes the side entrance opening and closing handle.

It is suggested that a revised locking device be utilized to prevent interference by this device during flight and also while boarding the aircraft or deplaning.

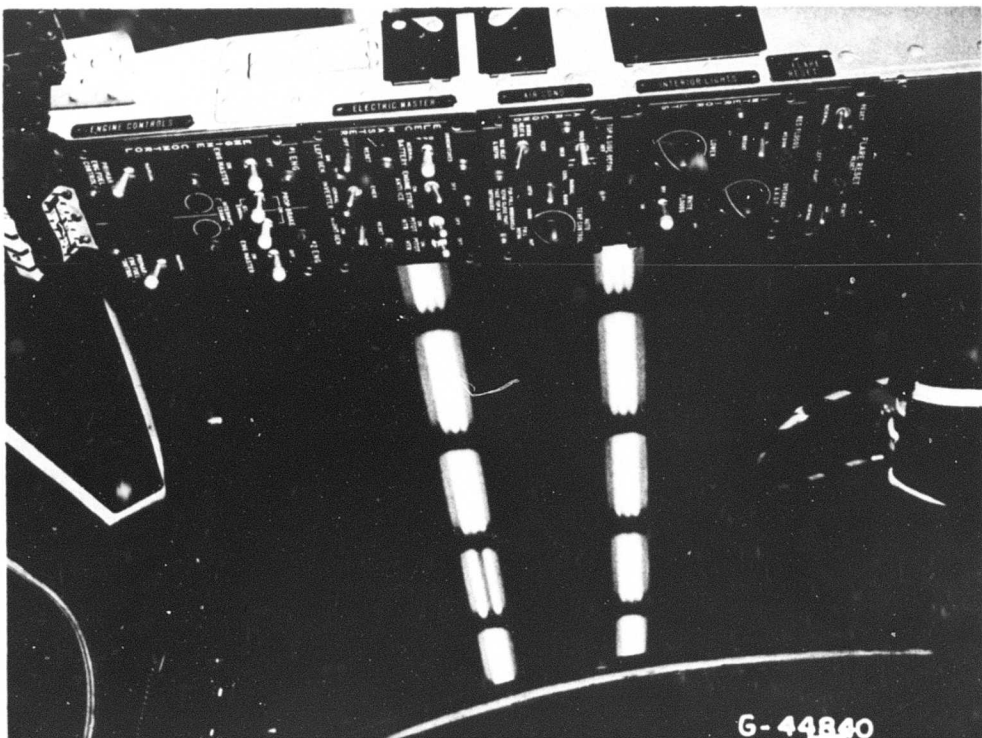
Figure 14 depicts the overhead console, which is located between the two occupants. When the heads of the occupants are improperly restrained, they are within striking range of the console. Again, the possibility of getting these knobs and switches recessed is remote; therefore, it must be re-emphasized that the safety belt, shoulder harness and helmet should be worn in the prescribed manner at all times.

It should also be noted that the edges of this overhead console are quite sharp and could also produce injuries to the head in the event they were struck. It is therefore suggested that these edges be padded with a high energy-absorbing material.

Figure 14. View of overhead console which is located between the two occupants.

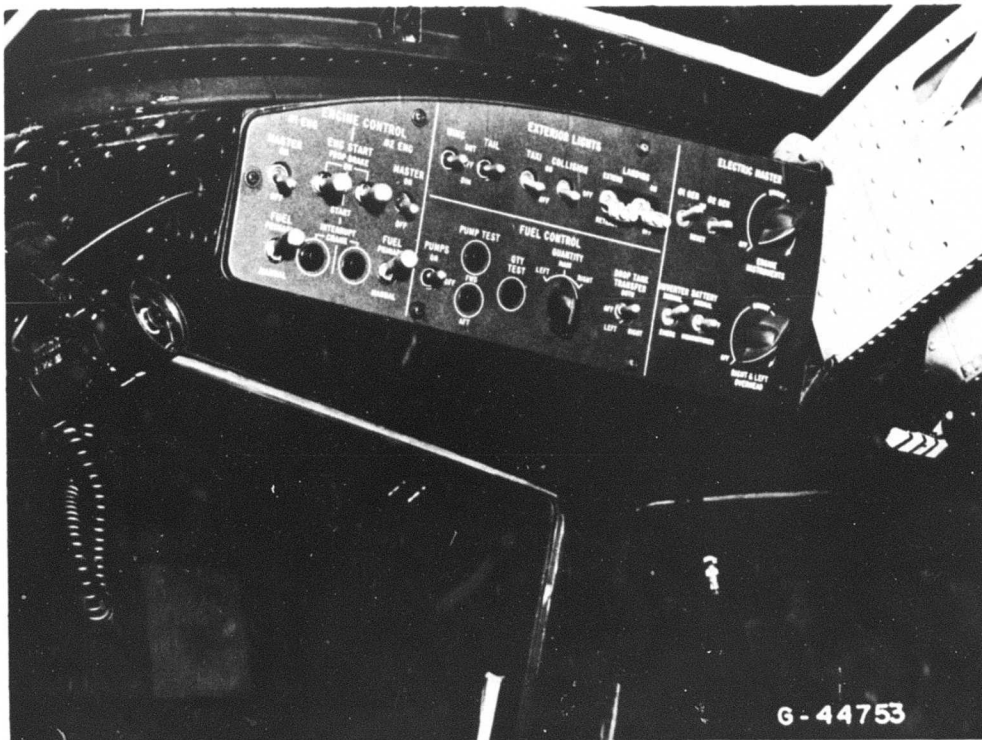
Because of the addition of the electronic equipment, it was necessary to relocate some of the switches and controls. To accommodate these controls, two eyebrow panels, Figures 15 and 16, were added. These panels cover the small eyebrow windows directly above the windshield, which are depicted in Figure 9. If the restraint system and helmet are utilized, it is not likely that the occupants will strike this panel during decelerative forces. However, the lower edge of this eyebrow panel should be padded with a high-energy-absorbing material to provide protection during an ejection. It appears possible for the ejected occupant to impact this lower edge with his knee area in the event that he was not properly positioned during ejection.

Figure 15. The left eyebrow panel is depicted.

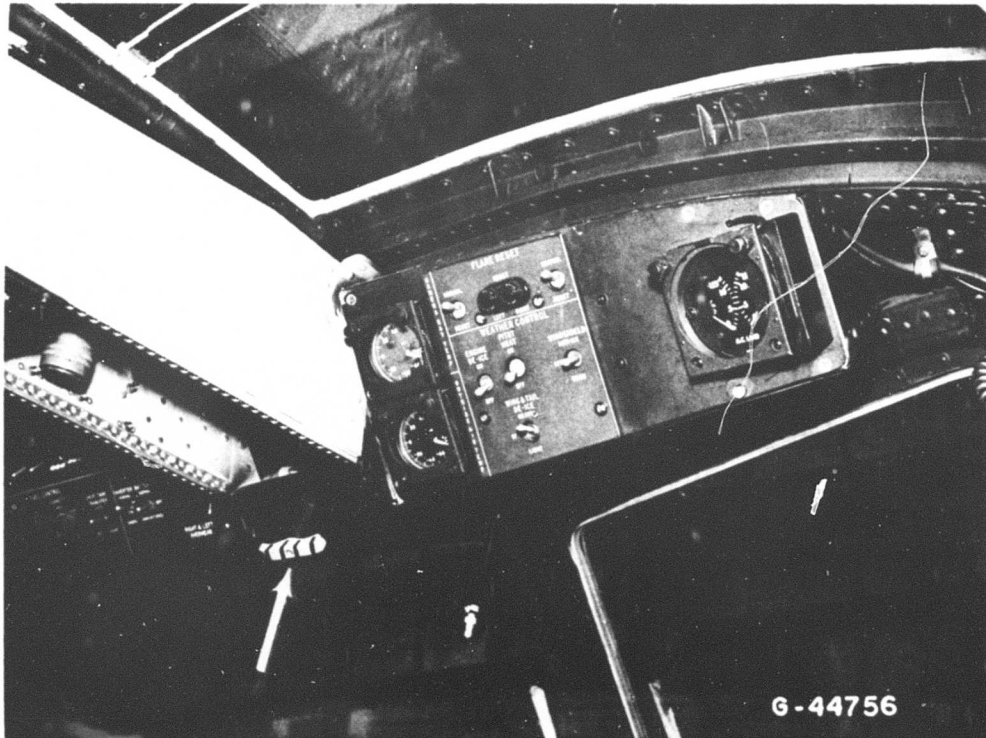
Figure 16. The arrow denotes the emergency hatch release. The right eyebrow panel is also depicted.

The overhead hatch in AO-1BF can be jettisoned from the interior only (arrow); however, this action is not a part of the firing sequence during an ejection. Normal ejection in the Mohawk is upward through the overhead canopy. Grumman advises that this method is safer than blowing off the canopy, because if the canopy jammed and was only partially blown off, the pilot's head might contact a structural bow on the canopy, which could cause fatal injury.

It is suggested that this overhead hatch be jettisonable from both the interior and the exterior to provide an additional entrance into the cockpit area for rescue personnel.

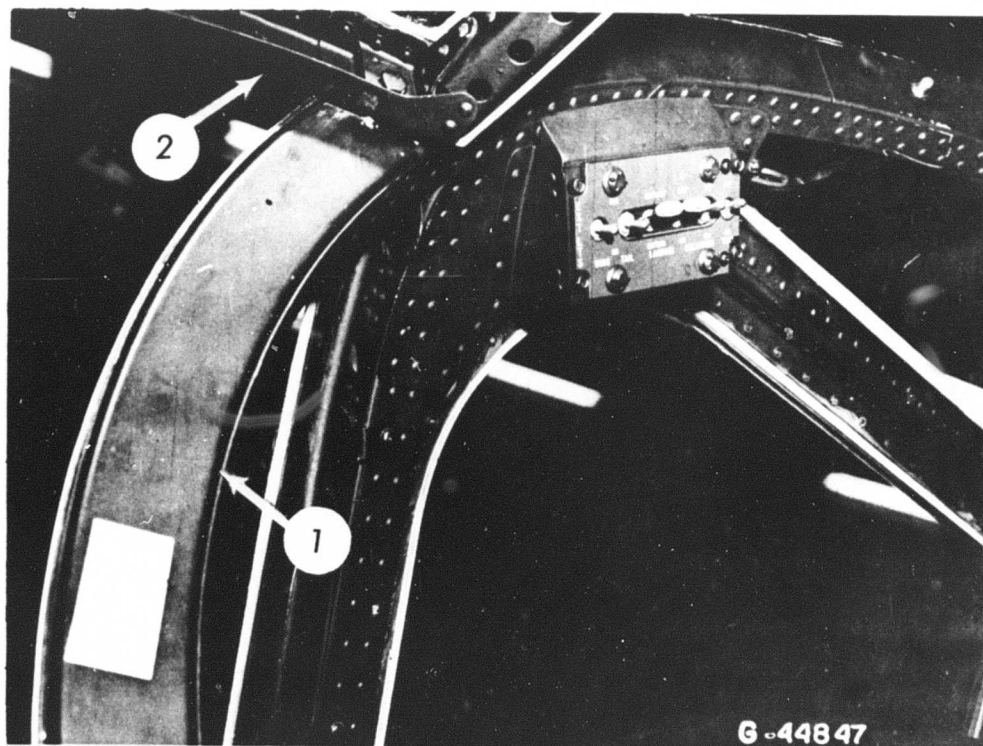
In order to build a cockpit to withstand 40 G, a rugged structure is necessary. Some of this ruggedness is depicted in Figure 17. The heavy structure surrounding the cockpit entrance is depicted by arrow 1, while arrow 2 denotes the entrance hatch in the open position. The sharp edges on the entrance hatch, arrow 2, could cause a very serious injury in the event they were struck.

Figure 17. The sharp injury-producing edges on the side panels are denoted by the arrows.

It is suggested that these two injury potential areas be padded with a high-energy-absorption material.
