CRASH INJURY BULLETIN

PART I ATTACHMENT OF SEAT BELTS IN THE HU-1A HELICOPTER

PART II STOWAGE OF EQUIPMENT UNDER TROOP SEATS

September 1960

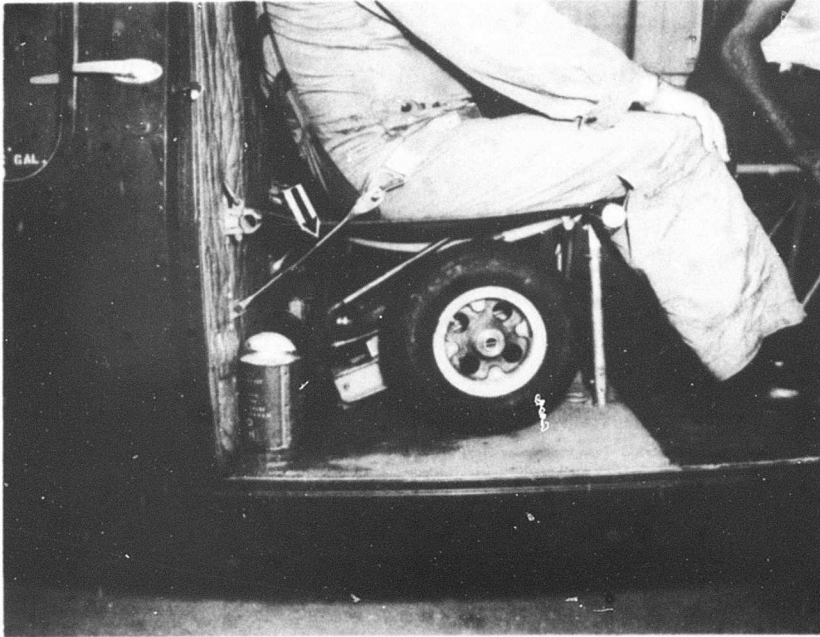
The photographs on page 2 (Figures 1 and 2) depict the correct and the incorrect manner of attaching the safety belts in the HU-1A helicopter. The most desirable installation is illustrated in Figure 1.

To fully utilize the skeletal strength of the human body, the seat belt should pass across the hips at approximately 45° to the longitudinal axis of the airplane as illustrated in Figure 1. When restrained by a seat belt only, which is common in the cabin area, the occupant's body will flex over the seat belt during a forward deceleration. If this flexing of the body occurs at the lumbo-sacral joint, the strain on the spine will be minimal.

Figure 1. The correct manner in which the safety belt should be installed in the HU-1A is depicted by the arrow. Note that the belt crosses the hips at approximately 45°.

Attachment of the safety belts to the cables as illustrated in Figure 1 reduces the possibility of spinal or internal injuries to the occupants involved; reduces the possibility of rear longitudinal seat support failures; and provides for greater restraint for the occupant since these cables are anchored to primary structure.

Based on the foregoing, it is recommended that a bulletin be issued, specifying that the proper attachment (cables) be used for the safety belts in the cabin of the HU-1A.

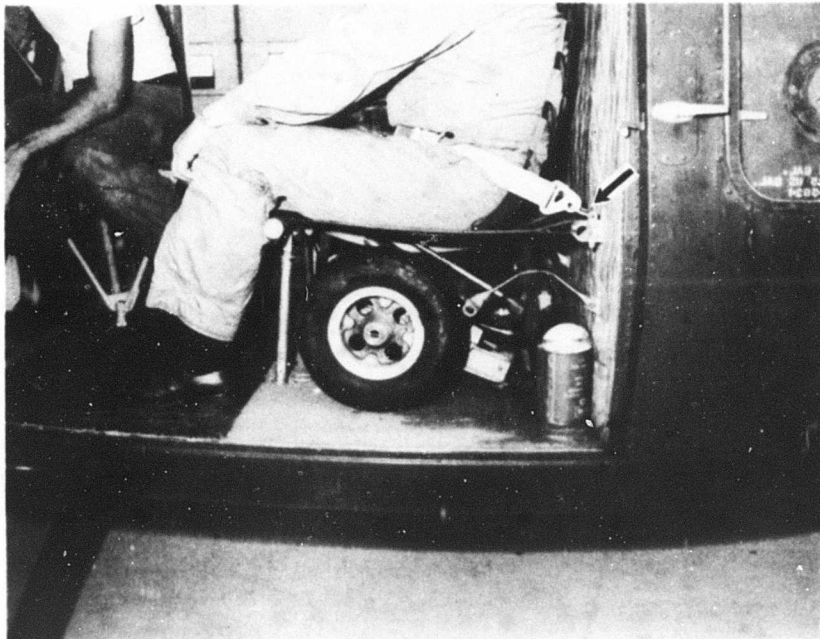
When the safety belt is attached to the "O" ring, (Figure 2) the spine is forced to bend or flex at a much higher level which often causes flexion fractures of the spine.

The incorrect belt installation permits the safety belt to "ride up" and could cause rib and/or chest injuries due to flexing over the belt buckle, in addition to possible spinal injuries.

Figure 2. The incorrect method of attaching the safety belt to the "O" ring is depicted by the arrow. Note that the belt crosses the occupant at approximately 90°.

"A red streak across the chest, tenderness to the lower rib cage, tenderness in the lumbar spine area, and contusion right buttock. Decreased breath sounds at right inferior - anterior chest. Microscopic hematuria. X-ray revealed hazy density lower left lung field with sharply defined borders - may be fluid or contusion. This cleared somewhat by two days post accident. "

The attending doctor stated that he felt the injuries to the chest, lower rib cage, and lumbar spine were due to the safety belt not being properly positioned over the hips. This statement was substantiated during an interview with the occupant, during which he stated the safety belt kept "sliding up".

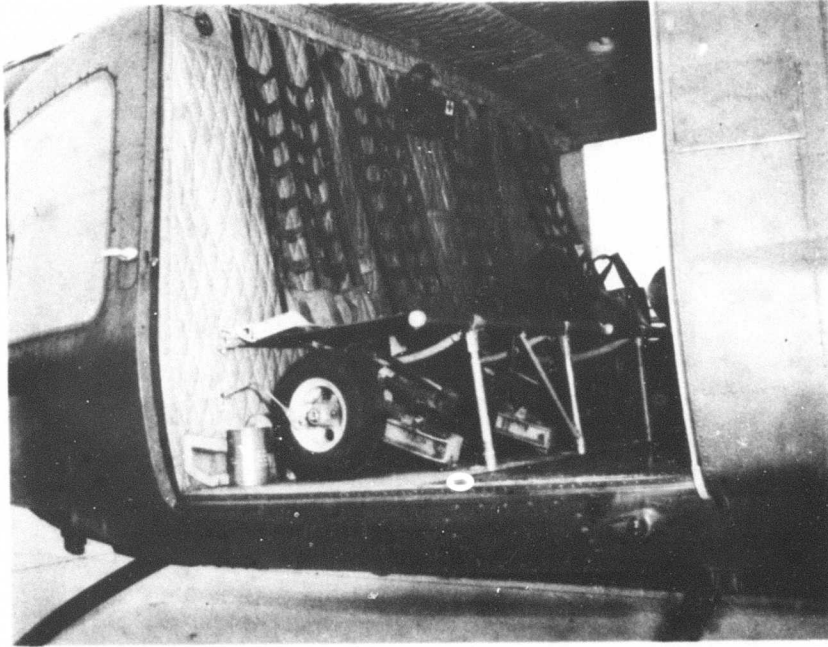
Figures 3 and 4 illustrate the area under the seat which is used as a "catch all" for the ground handling wheels, oil cans, tool boxes, main rotor tie-down, litter attachments, and other loose equipment carried in the aircraft. These photos were taken of an aircraft selected at random.

Accident experience with the type troop seat utilized in this aircraft indicates the seat will fail under even moderate crash load conditions. It is, therefore, important that the area directly beneath all occupied troop seats be kept free of loose equipment such as illustrated in Figures 3 and 4.

Figure 3. Over-all view depicting the large assortment of items placed beneath the seat.

Based on the foregoing, it is recommended that a bulletin be issued specifying that the area beneath all occupied troop seats be kept free of loose equipment. Further, if equipment has to be carried under unoccupied troop seats, it should be of a non-rigid type and securely anchored to prevent it from becoming a missile in the event of a forward deceleration.

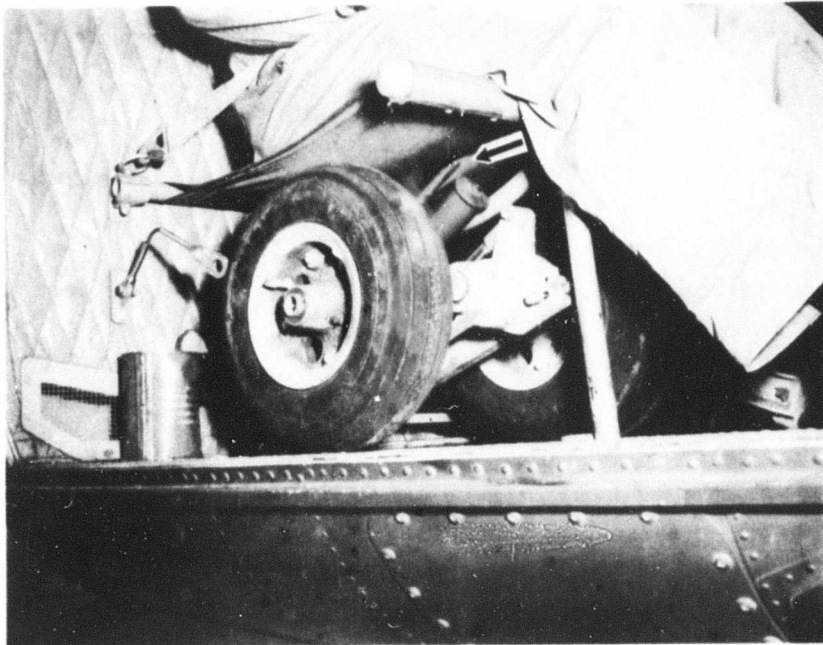
Figure 4. Close-up of the ground handling wheels stored beneath the seat. Note the position of the hand pump lever (arrow).

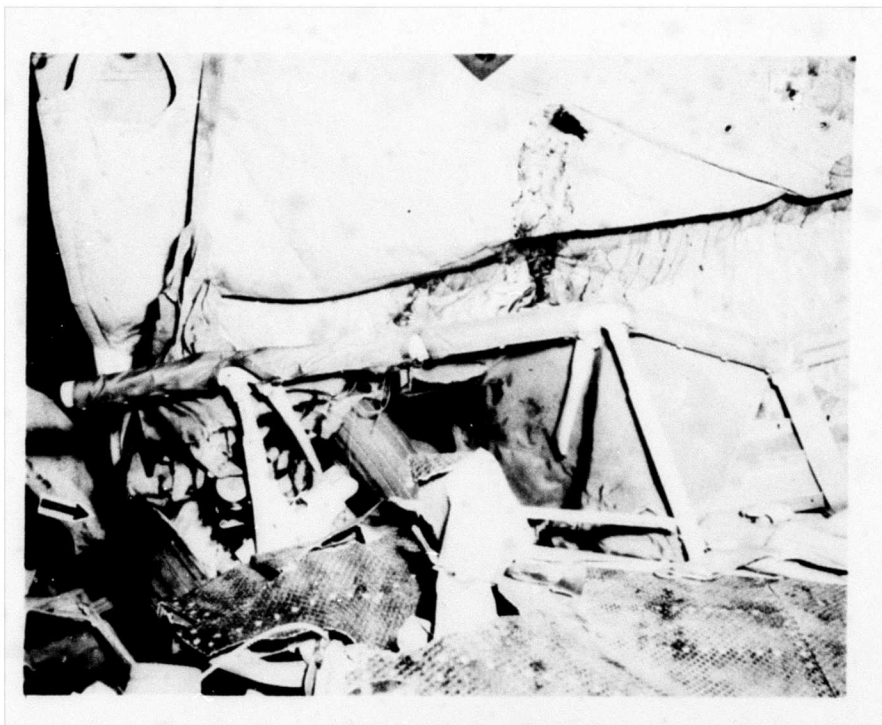
Figure 5 depicts an accident showing the wheels stowed beneath the seats. The occupant of this seat sustained painful buttock injuries and tenderness in the lumbar spine area as a result of bottoming out and striking the ground handling wheels with sufficient force to break the castings (arrow - Figure 6) at the top of the wheel assembly.

Figure 5. The wheels stowed beneath the seat (arrow) were a prime contributor of the injuries sustained by this occupant.
