WORLD WAR II GERMAN
FIRE DOCUMENT TRANSLATIONS

WORLD WAR II GERMAN FIRE DOCUMENT TRANSLATIONS

REPORT OF THE REGIMENTAL COMMANDER OF THE
FIRE-PROTECTION POLICE REGIMENT "SAXONY"
ABOUT THE COURSE AND RESULTS OF THE MASSIVE AERIAL ATTACKS
ON ROTTERDAM ON MAY 14, 1940, AND THE EXPERIENCES
DRAWN THEREFROM (by Hans Rumpf) A-1

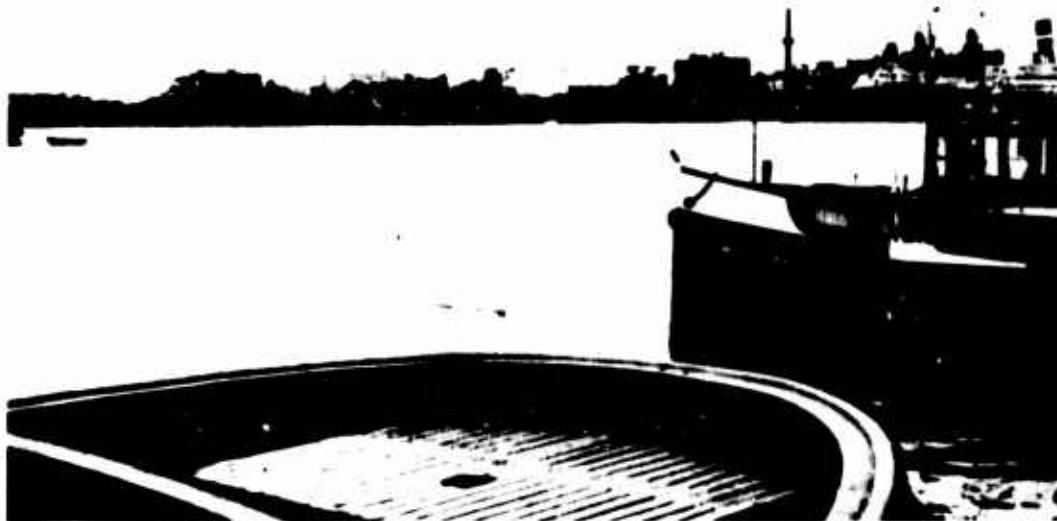
At the same time, great fires raged on the other side of the Maas River across from the island in the installations of the Holland-America Line (Picture 1). At that time, the fire on the 28,000-ton passenger liner "Staatendam" of the Holland-America Line took place, caused by shelling by Dutch artillery. This was the flagship of the Dutch merchant marine (Picture 2). Fire-fighting activities by the fire department were initiated, but no real success in putting out the fire was achieved. On Sunday, May 12, in the morning, an air attack by German stukas on the navy barracks took place, and the barracks were in flames a short time afterwards. Fire fighting was allegedly curtailed because of a shortage of water; the main waterline received a direct hit. Thermal radiation and flying sparks ignited a block of houses on Hoogstraat, and they burned to the ground. Nothing of the navy barracks was saved.

Picture 1 GUTTED WAREHOUSES AND STORAGE DEPOTS OF THE HOLLAND-AMERICA LINE

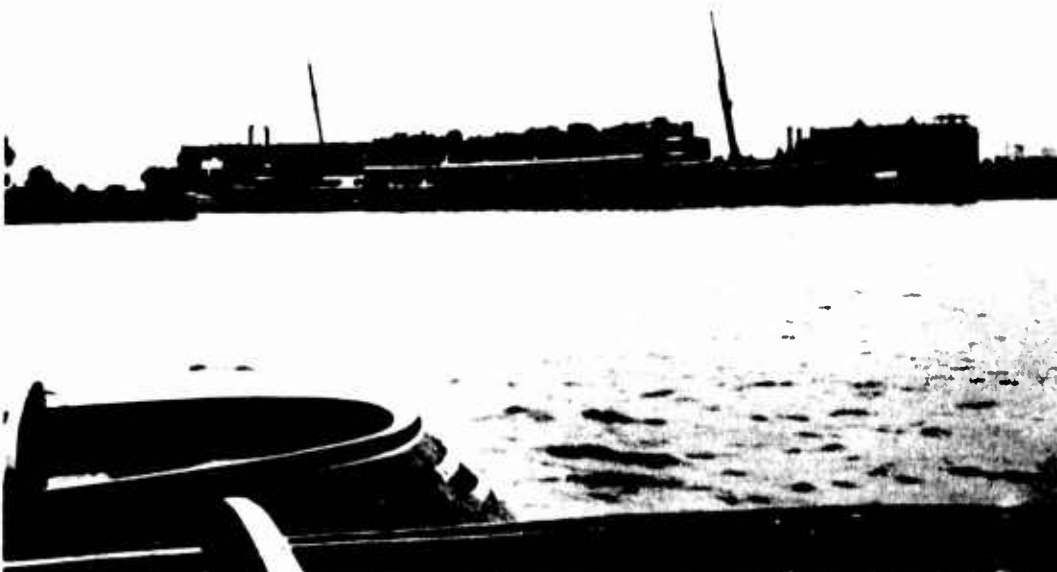
Picture 2 THE GUTTED 28,000-TON PASSENGER SHIP "STAATENDAM"

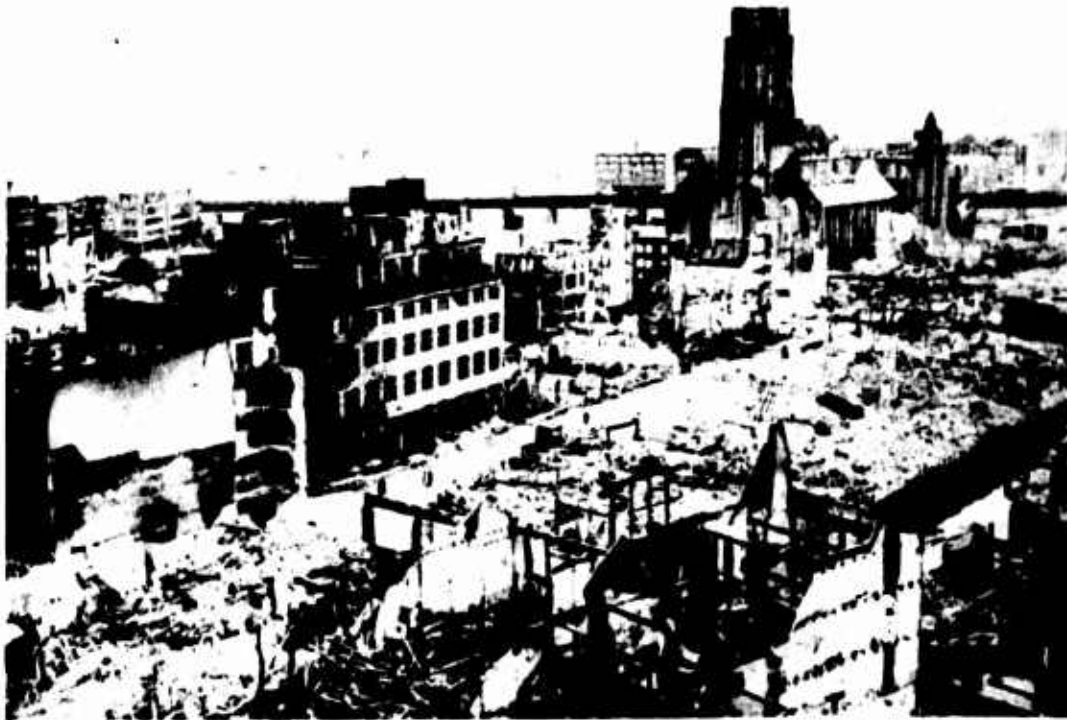
Picture 3 VIEW FROM THE SKYSCRAPER SHOWING THE FIELD OF RUINS OF THE DESTROYED INNER CITY (SEE CITY MAP, FIGURE 1). Because the skyscraper is not located in the center, but on the southeast corner of the field of ruins, the borders of the latter to the east and north cannot be seen on the picture.

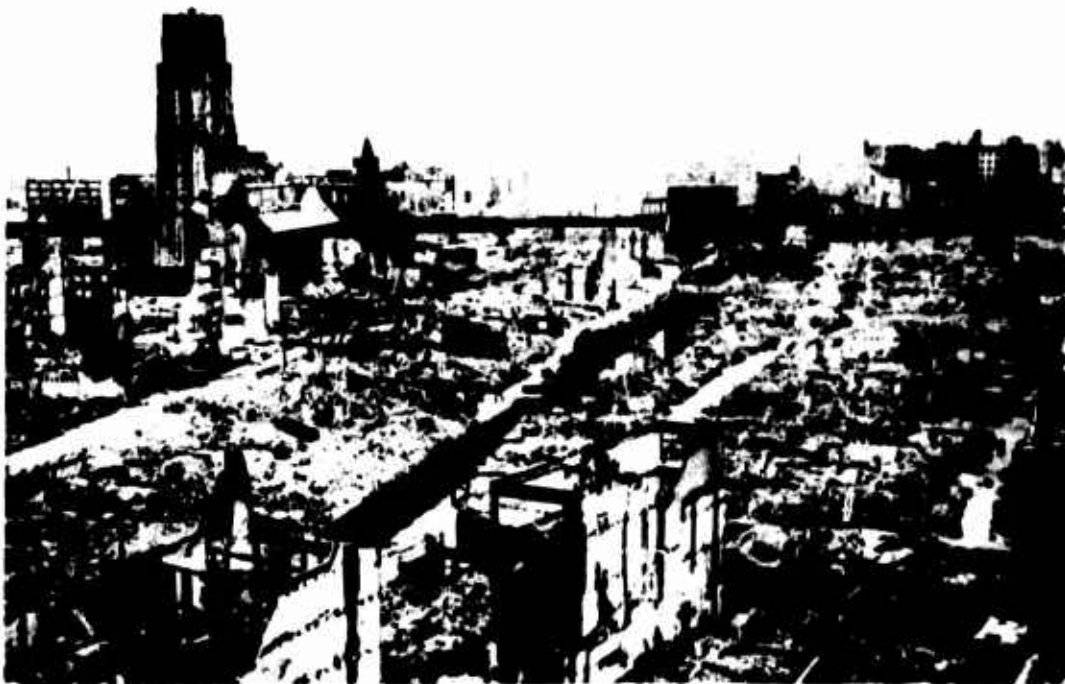
Picture 8 OVERHEAD RAILWAY AND DAMAGED AREAS OF THE INNER CITY NEAR THE HARBOR

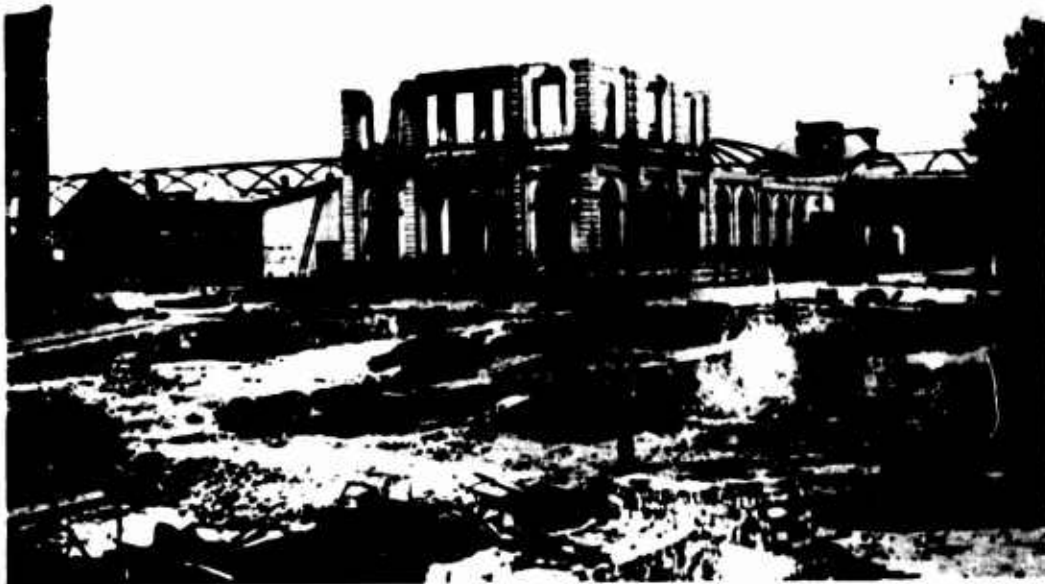
Picture 19, 20 THE DELFTER POORT RAILROAD STATION, WHICH DID NOT CATCH ON FIRE UNTIL MAY 15, 1-1/2 DAYS AFTER THE BOMBING ATTACK

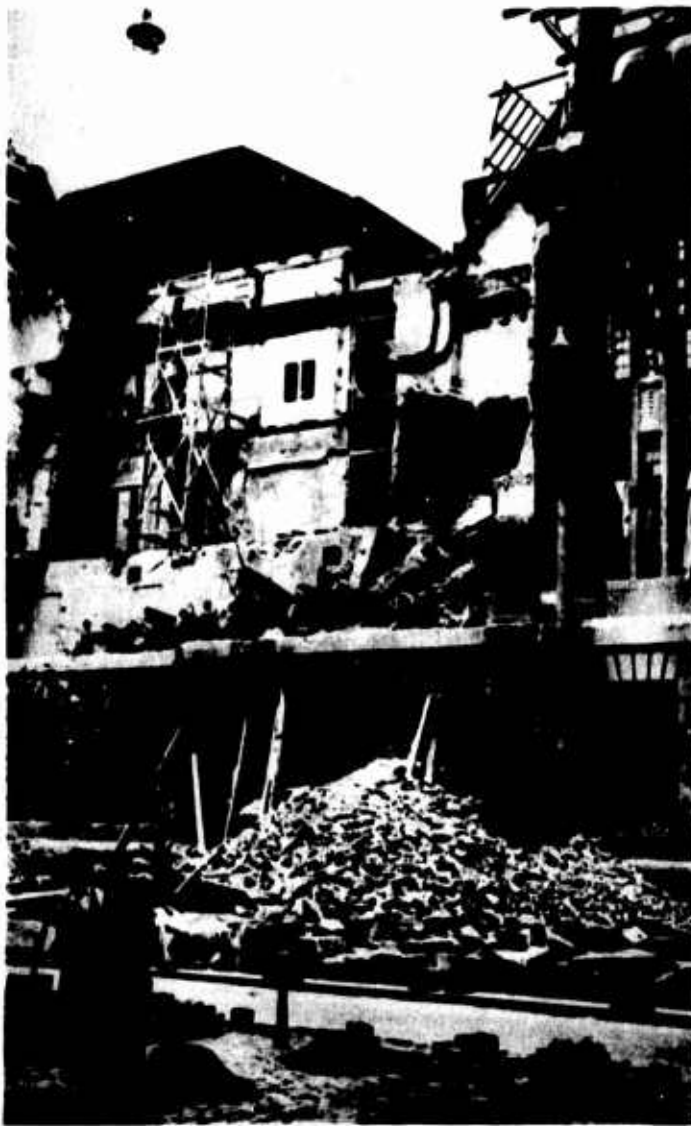
Picture 25 DIRECT HIT ON POST OFFICE BUILDING (NEXT TO THE CITY HALL; SEE CITY MAP, FIGURE 1). An example of pure high explosive bomb effects, i.e., hits from high explosive bombs that did not ignite.

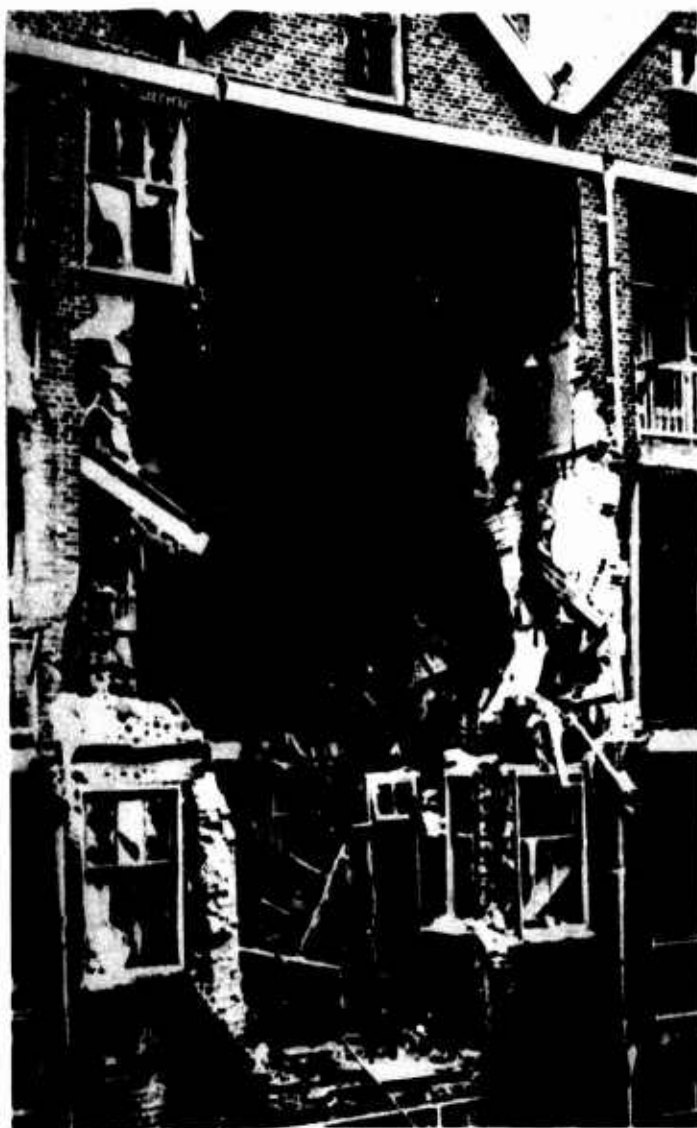
Picture 26 DIRECT HIT ON A RESIDENTIAL HOUSE. The bomb did not drop vertically through the roof but at an angle from above into the front wall of the house.

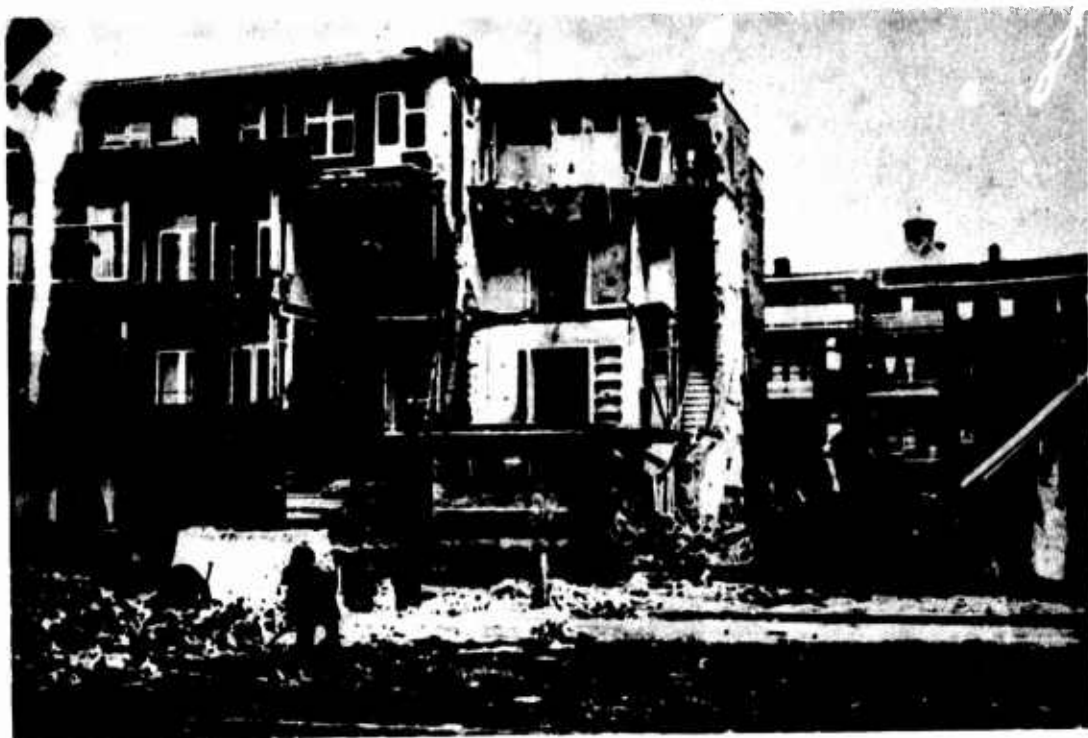
Pictures 27, 28 HOUSES DAMAGED BY BLAST ONLY

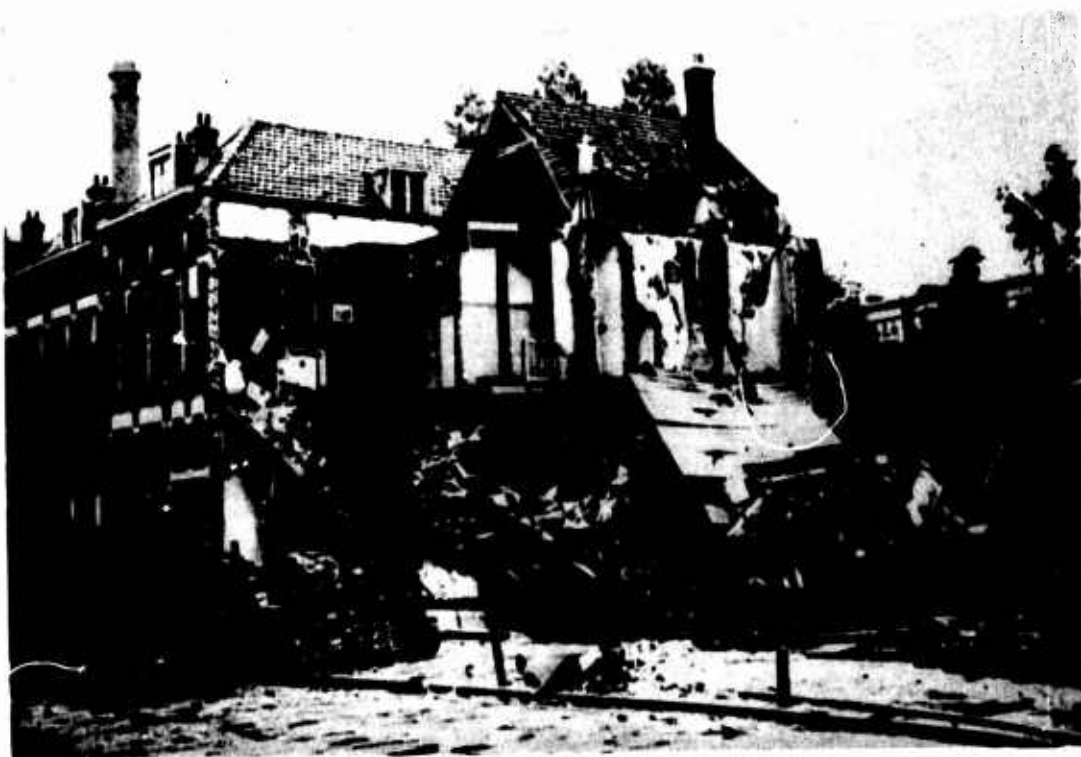
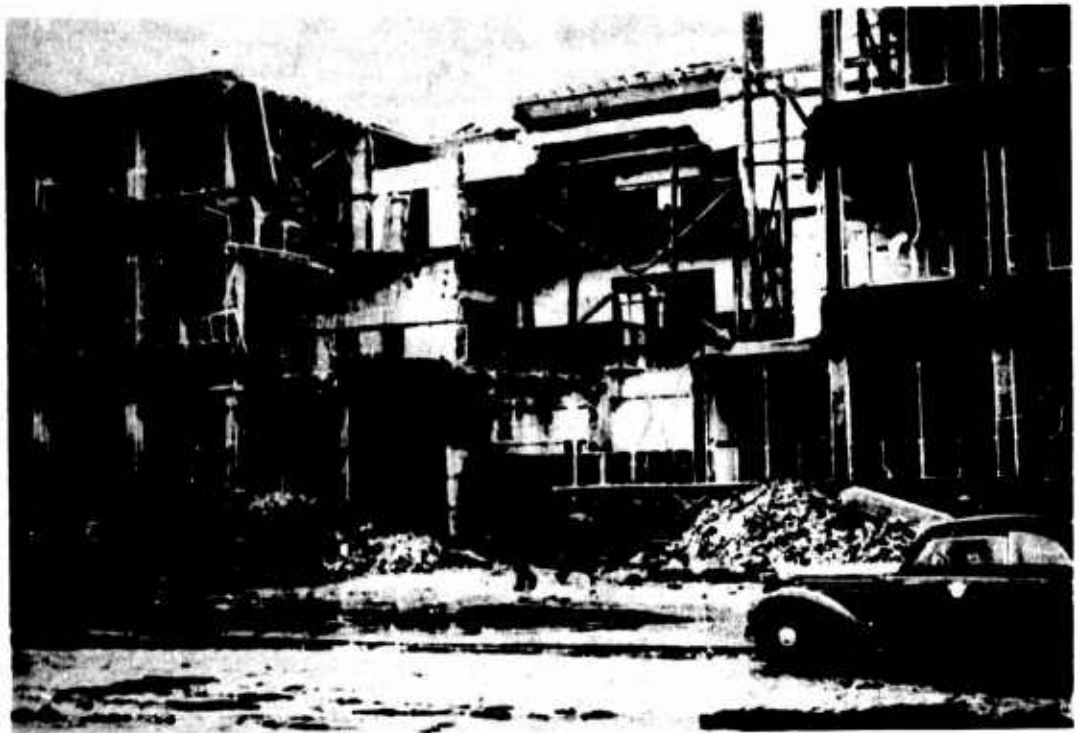
Pictures 29, 30 BOMB HITS ON BUSINESS BUILDINGS THAT CAUSED PARTIAL DESTRUCTION BUT DID NOT DESTROY THE BUILDING COMPLETELY

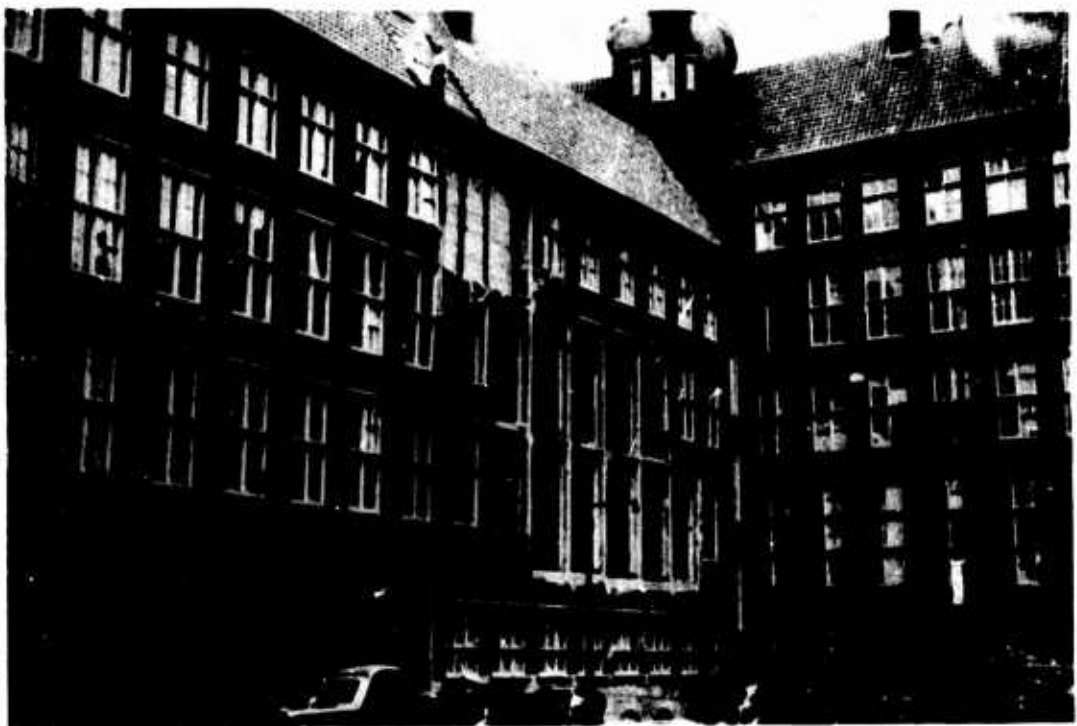
Practically nowhere did the debris clearing crews find any beams, girders, posts, planks, doors, or window frames made of wood among the debris. Also, the fire sites of former purely residential districts were free of wood. The Dutch use wood as a building material, though not to the extent as in Germany. All this wood was burned. If the ruins had resulted from high explosive bombs, the wood would have been found among the debris (see Pictures 31 and 32).

Pictures 31, 32 FIRE-DESTROYED STRUCTURES. All wooden parts, like beams, floors, doors, window frames, and shafts are completely burned. The fire sites are completely free of wood.

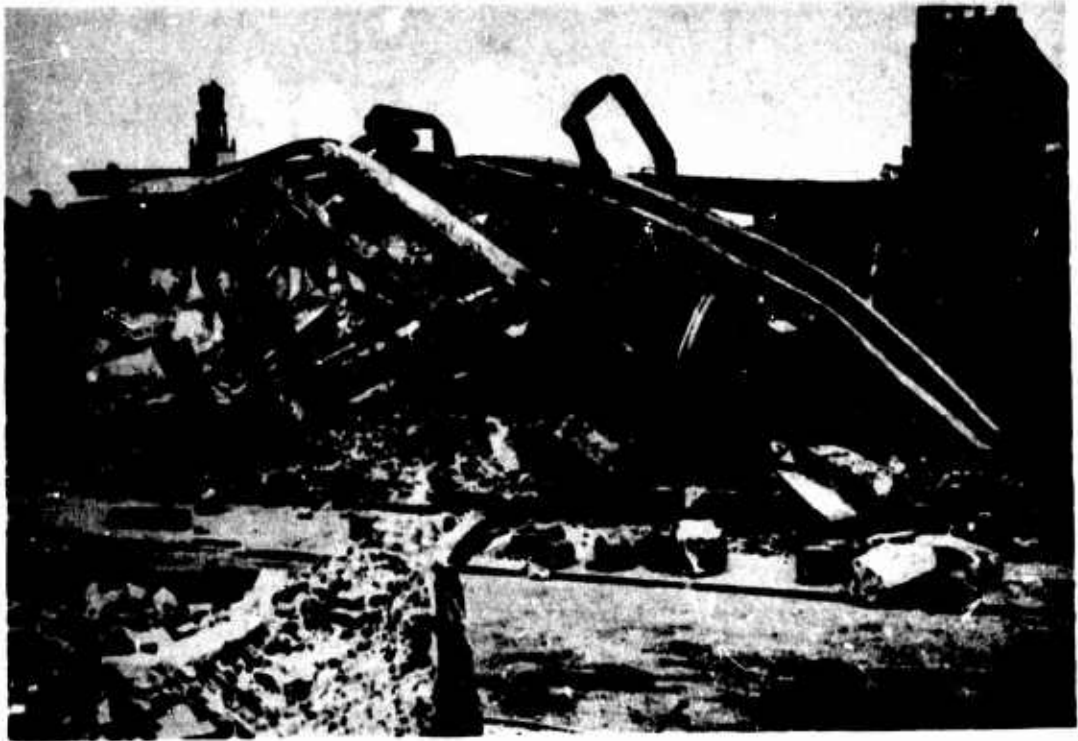
A characteristic of fire ruins is the tangle of twisted metal. With the exception of a few buildings which received a direct hit by a high explosive bomb and were left standing without burning (see Pictures 25 to 30), all parts of the field of ruins show the typical destruction by fire, with the metal supports twisted by heat and fire (see Pictures 33 to 42).

Pictures 33, 34 TWISTED STRUCTURAL STEEL, CHARACTERISTIC OF STRUCTURES DESTROYED BY FIRE

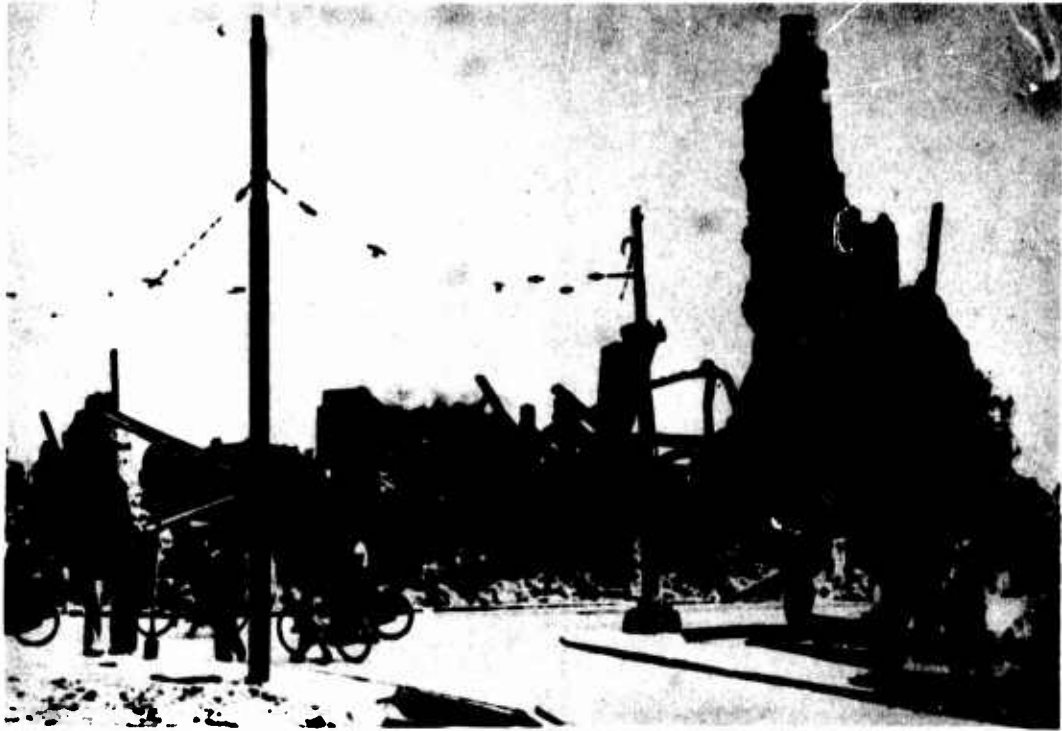
Figures 39, 40 TWISTED STRUCTURAL STEEL, CHARACTERISTIC OF STRUCTURES DESTROYED BY FIRE

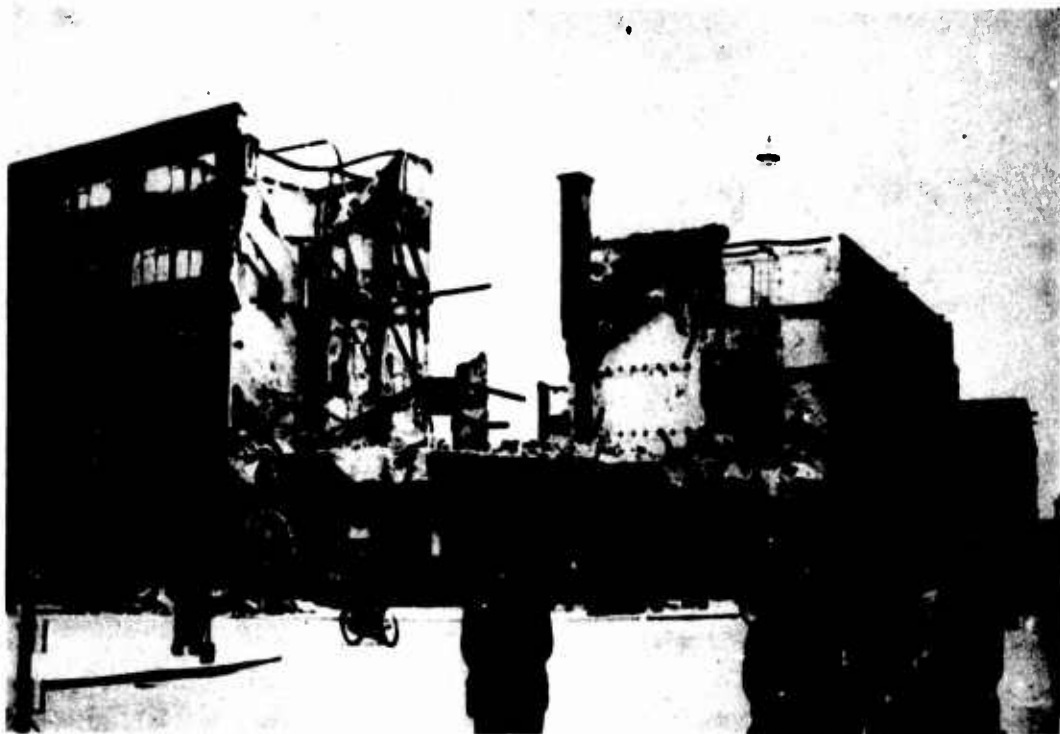
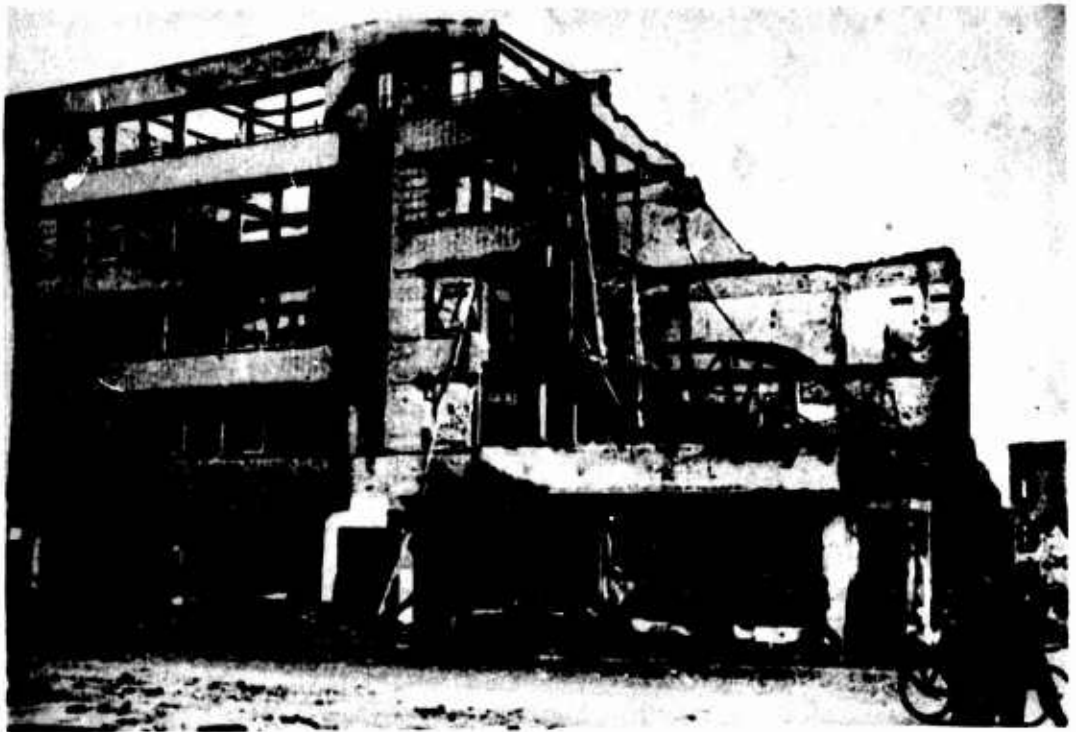
Pictures 41, 42 TWISTED STRUCTURAL STEEL, CHARACTERISTIC OF STRUCTURES DESTROYED BY FIRE

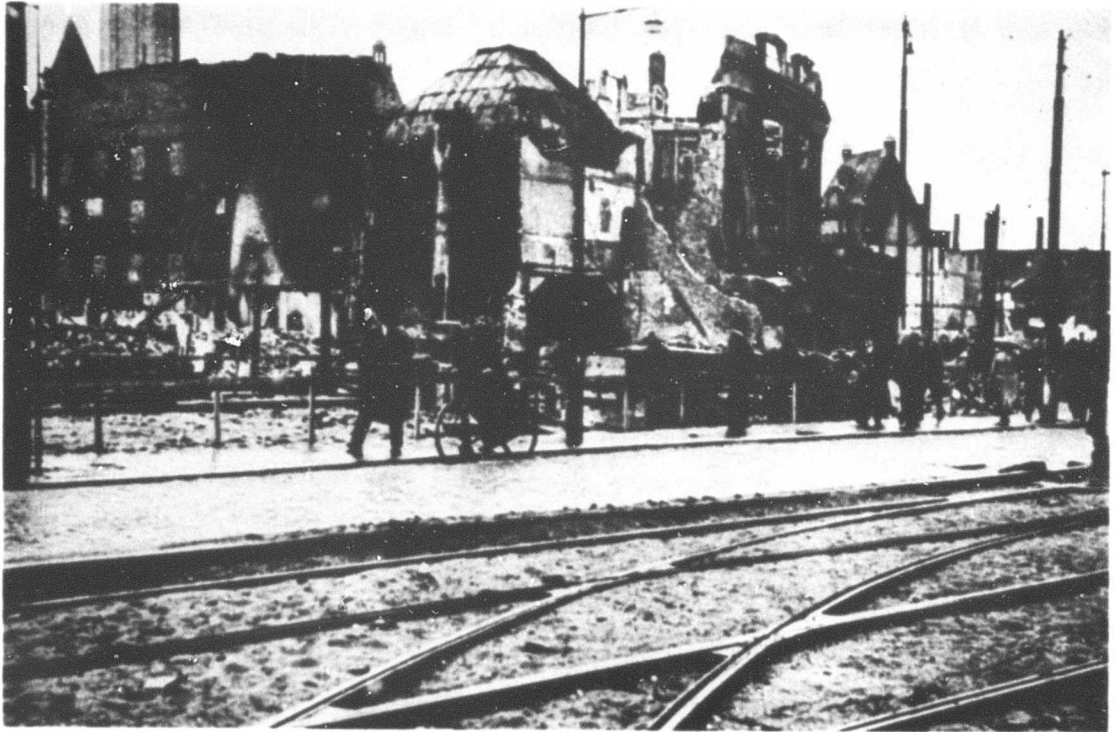
Also, from the outside the countless blackened facades of remaining buildings show plainly that the destruction was accomplished by fire and not through the force of high explosive bombs (Pictures 43 to 55).

Pictures 43, 44 PICTURES OF SOOT-BLACKENED HOUSE FRONTS WHICH CLEARLY SHOW THAT DESTRUCTION WAS CAUSED BY FIRE AND NOT BY DETONATION OF HIGH EXPLOSIVE BOMBS

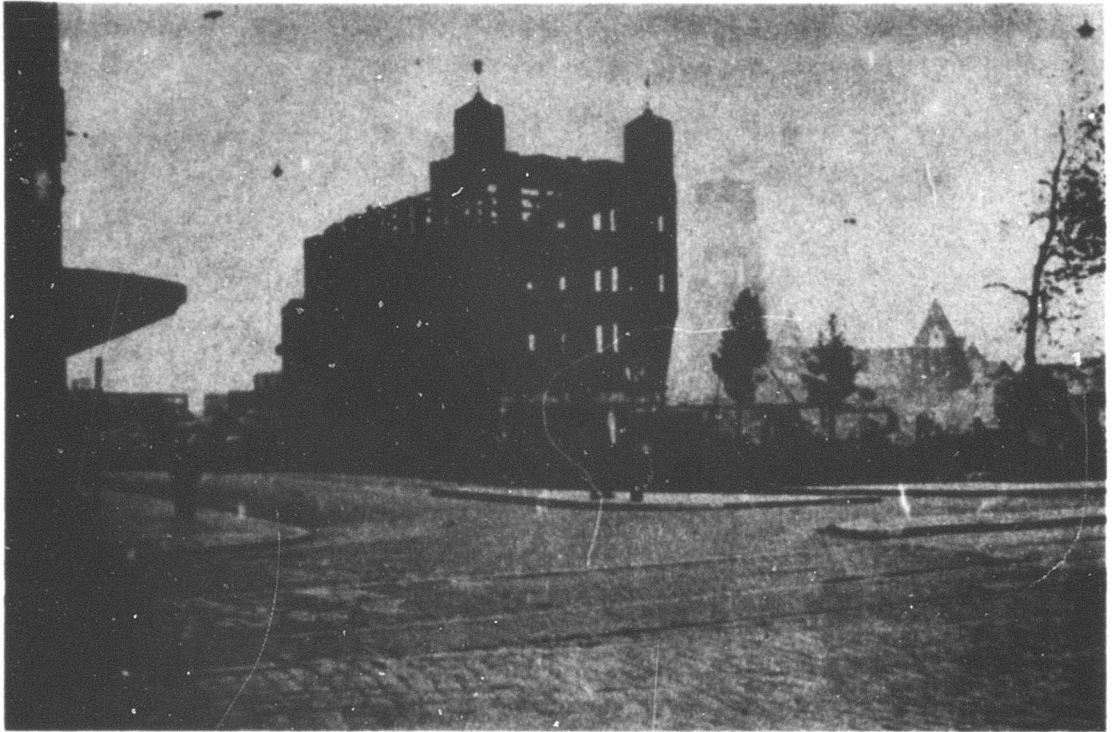
Pictures 46, 47 SOOT-BLACKENED STRUCTURES

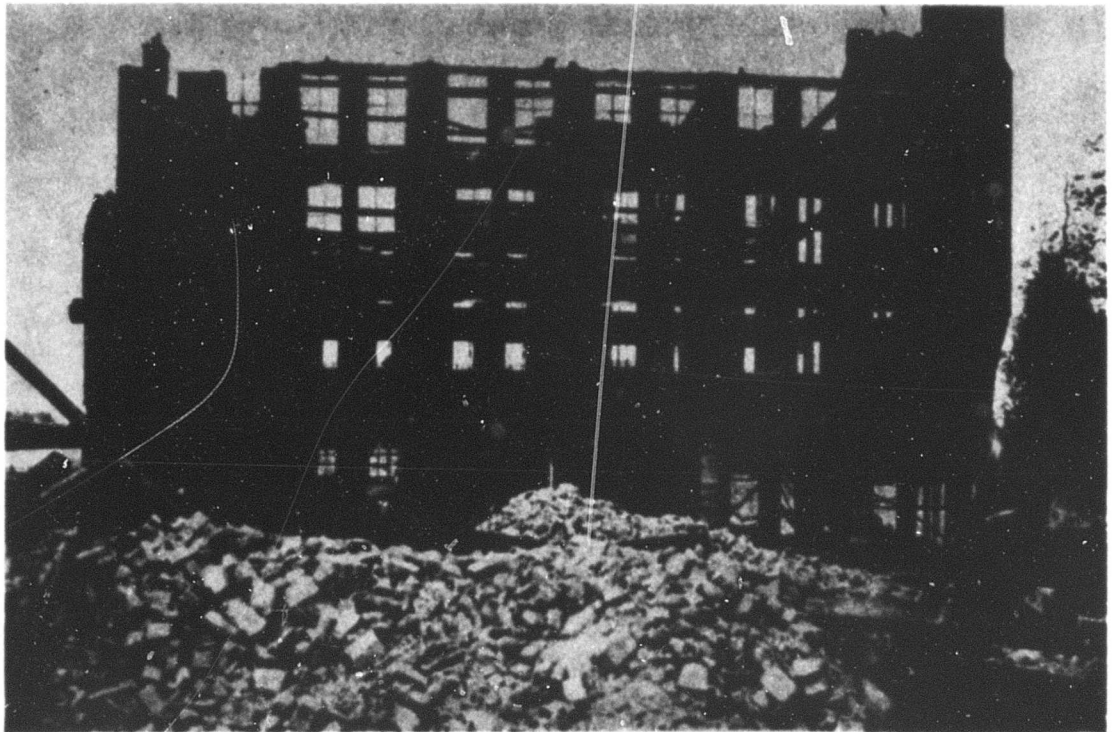
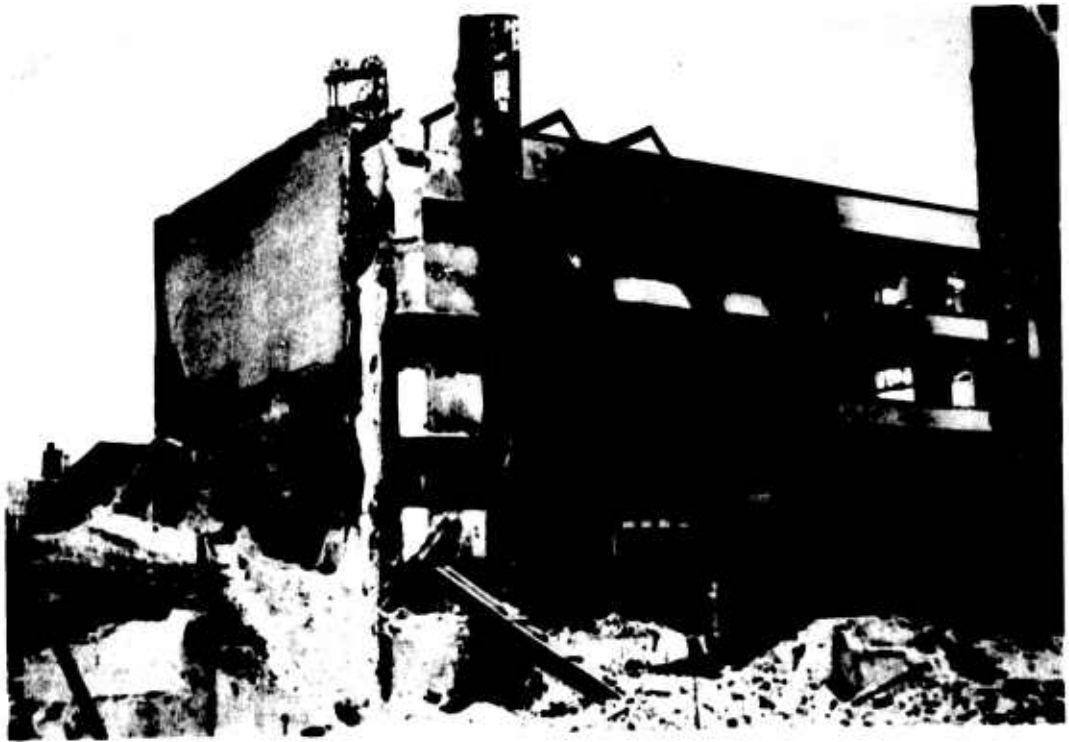
Pictures 48, 49 SOOT-BLACKENED STRUCTURES

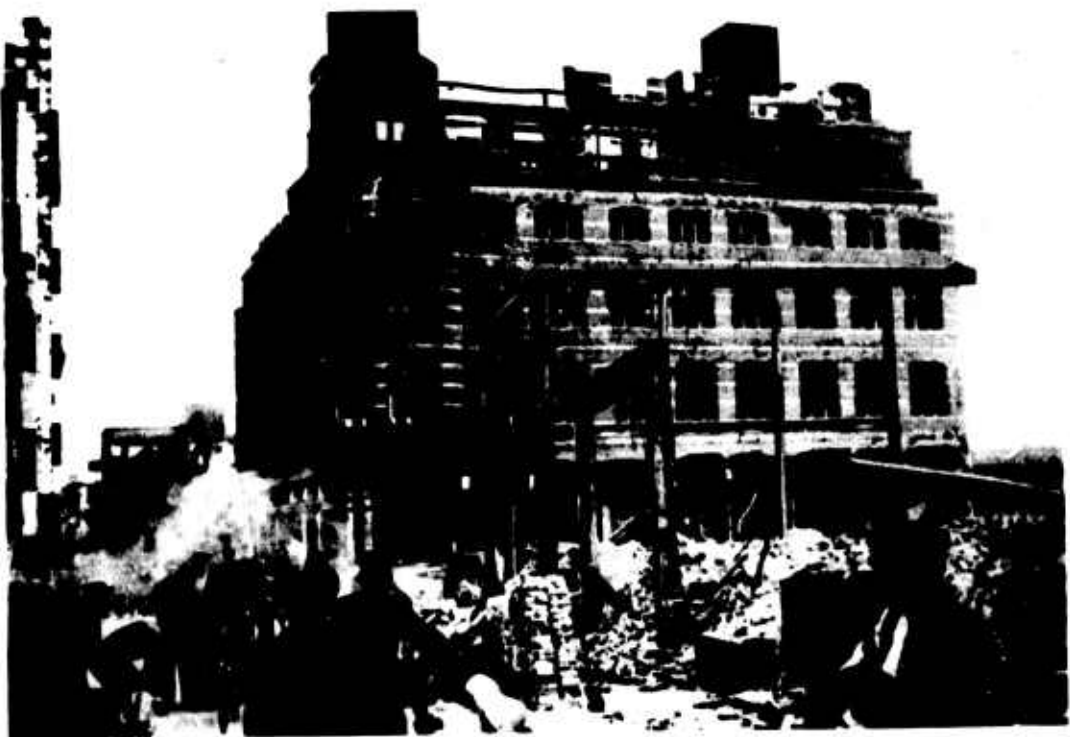
Pictures 50, 51 SOOT-BLACKENED STRUCTURES

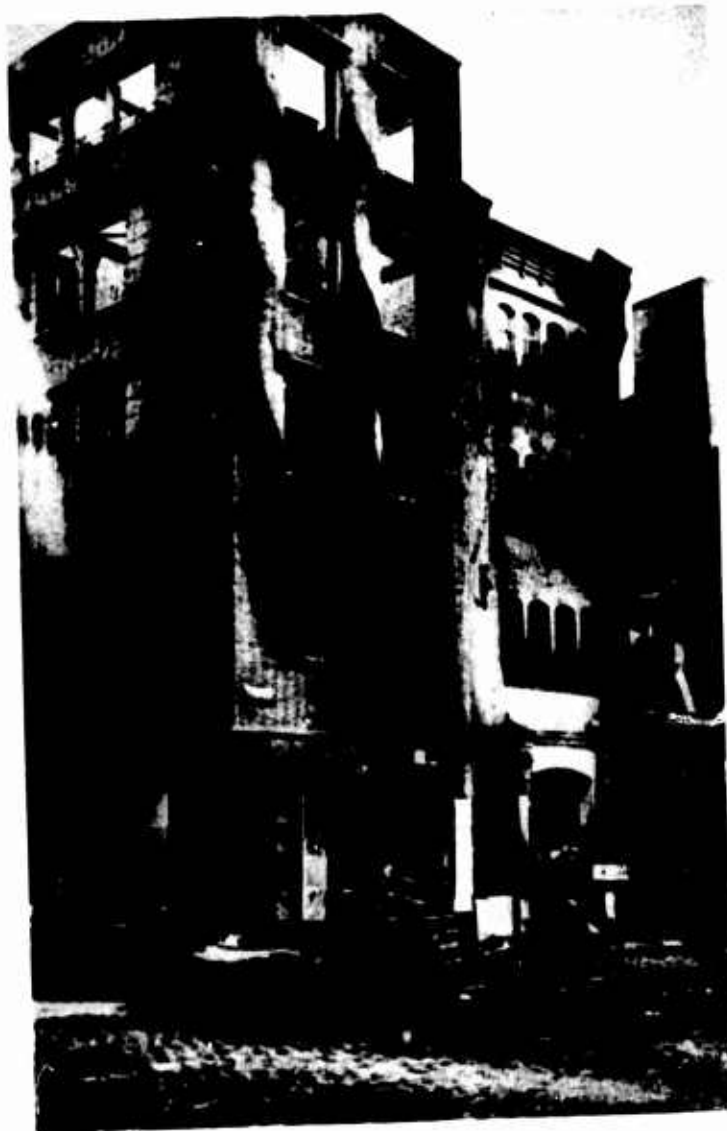
Picture 54 SOOT-BLACKENED STRUCTURE

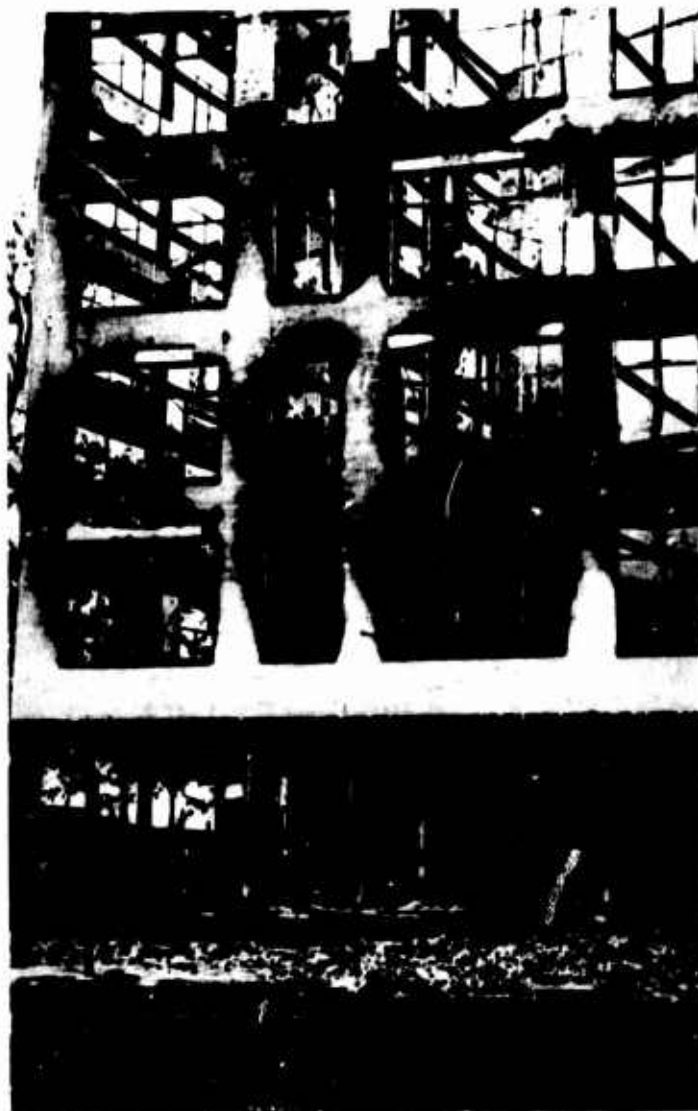
Picture 55 SOOT-BLACKENED STRUCTURE

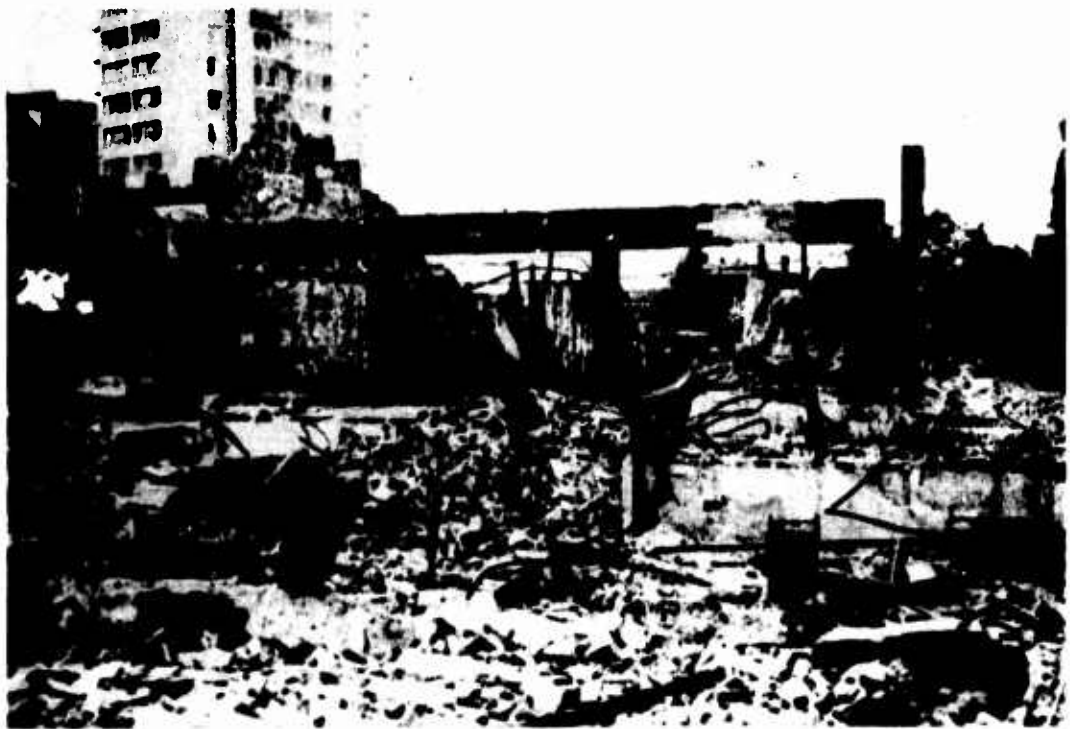
Another outstanding example of the fact that the destruction was caused by fire and not through high explosive bombs is presented by the skyscraper which the whim of the fire left standing intact (see city map, location b, Figure 1). Here all windows facing away from the wind were left undamaged. If the destruction of the neighboring houses had been effected by high explosive bombs, then all the window panes would have been broken due to the force of the detonation (see Picture 56).

Picture 54 UNDAMAGED SKYSCRAPER SURROUNDED BY DEBRIS FROM FIRE-DAMAGED STRUCTURES

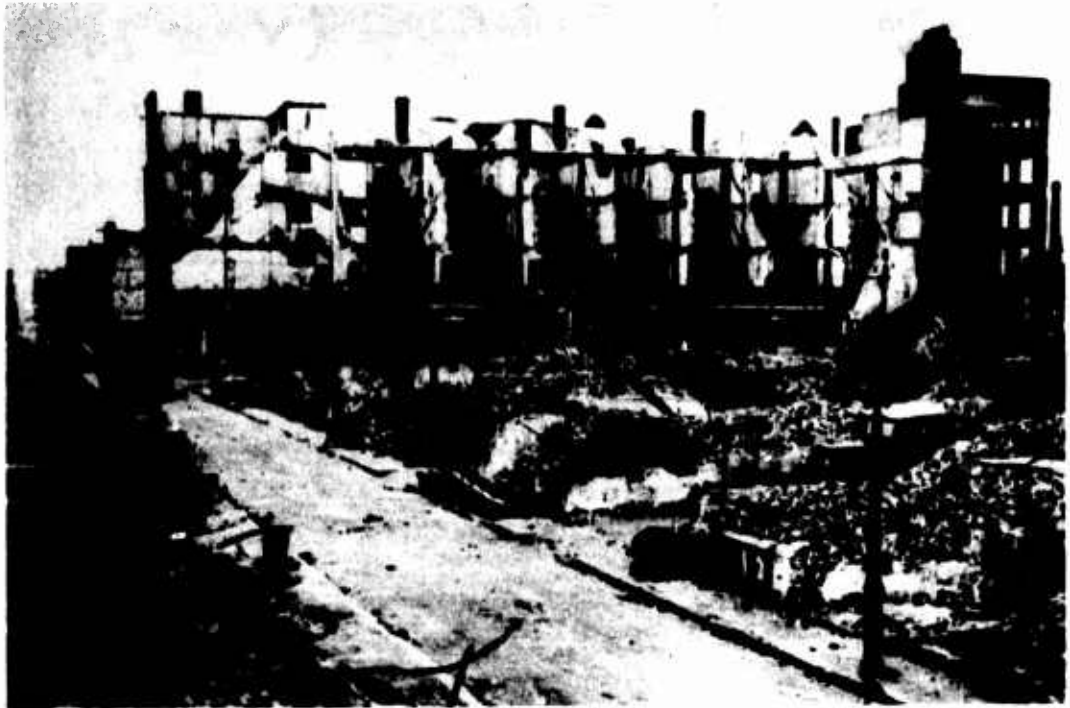
high explosive bomb, which destroys a city mansion in one hit (see Pictures 57 and 58).

Pictures 57,58 BLAST-DAMAGED MANSIONS AND APARTMENTS

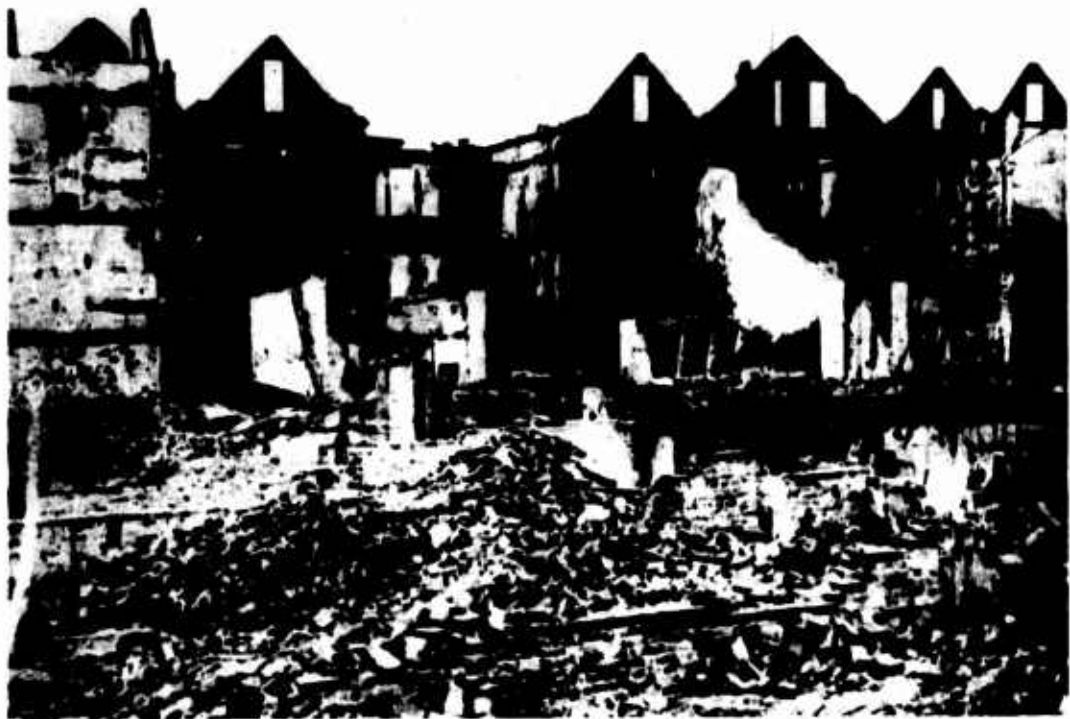
Pictures 59,60 MELTED AND TWISTED BEAMS

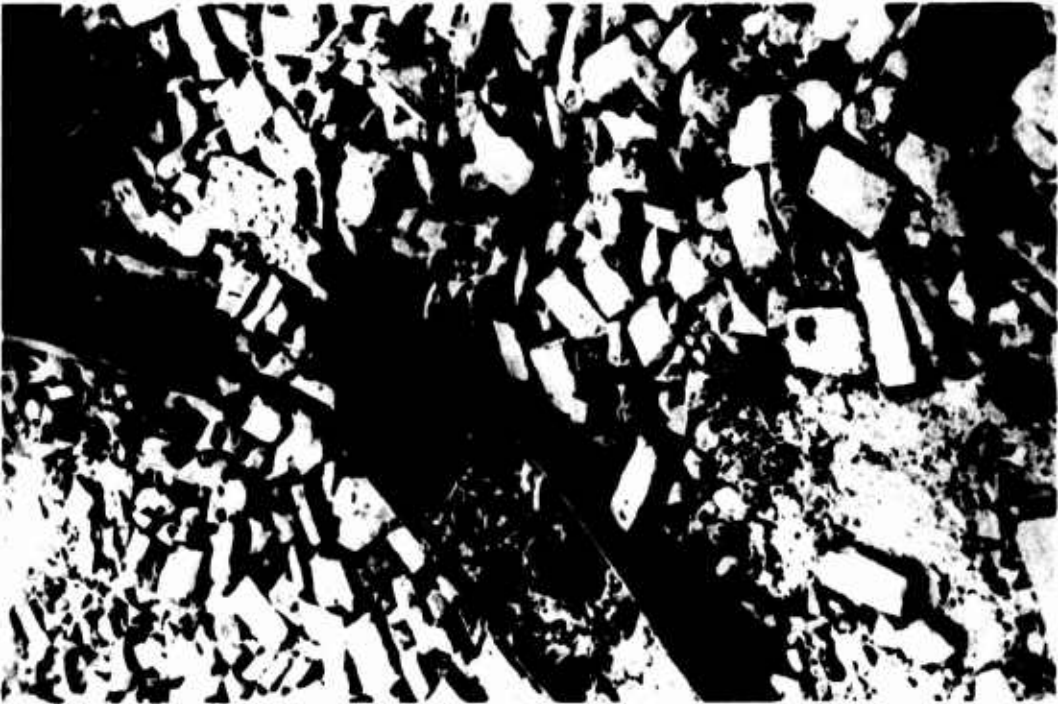
Picture 61 BRICK DAMAGE FROM EXTREME HEAT

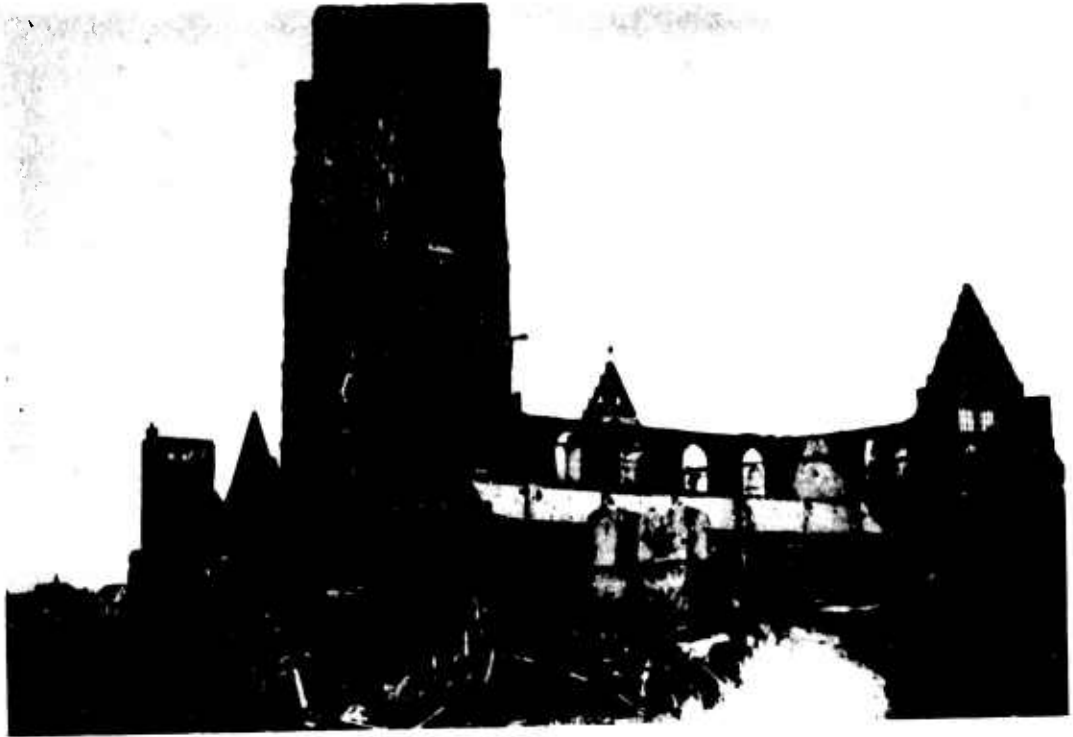
Picture 62 STEEL VAULT IN CENTER OF DESTROYED BUILDING

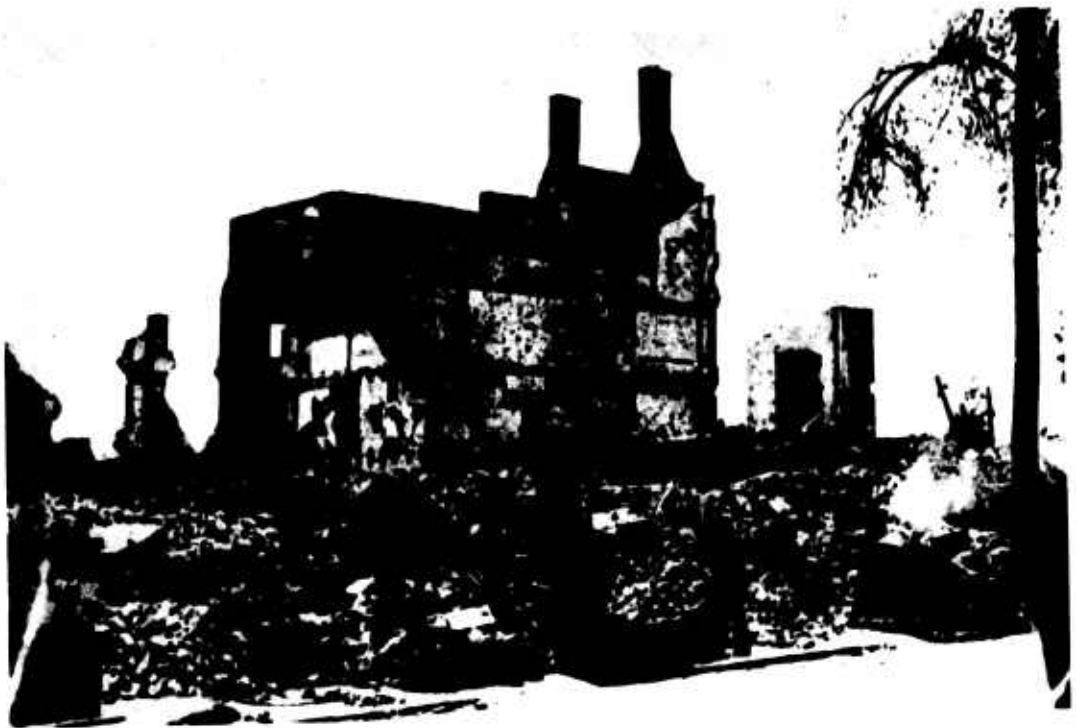
Picture 63 STEEL VAULT IN MIDST OF BURNED-OUT STRUCTURAL DEBRIS
