WORLD WAR II GERMAN
FIRE DOCUMENT TRANSLATIONS

WORLD WAR II GERMAN FIRE DOCUMENT TRANSLATIONS

REPORT OF THE REGIMENTAL COMMANDER OF THE
FIRE-PROTECTION POLICE REGIMENT "SAXONY"
ABOUT THE COURSE AND RESULTS OF THE MASSIVE AERIAL ATTACKS
ON ROTTERDAM ON MAY 14, 1940, AND THE EXPERIENCES
DRAWN THEREFROM (by Hans Rumpf) A-1

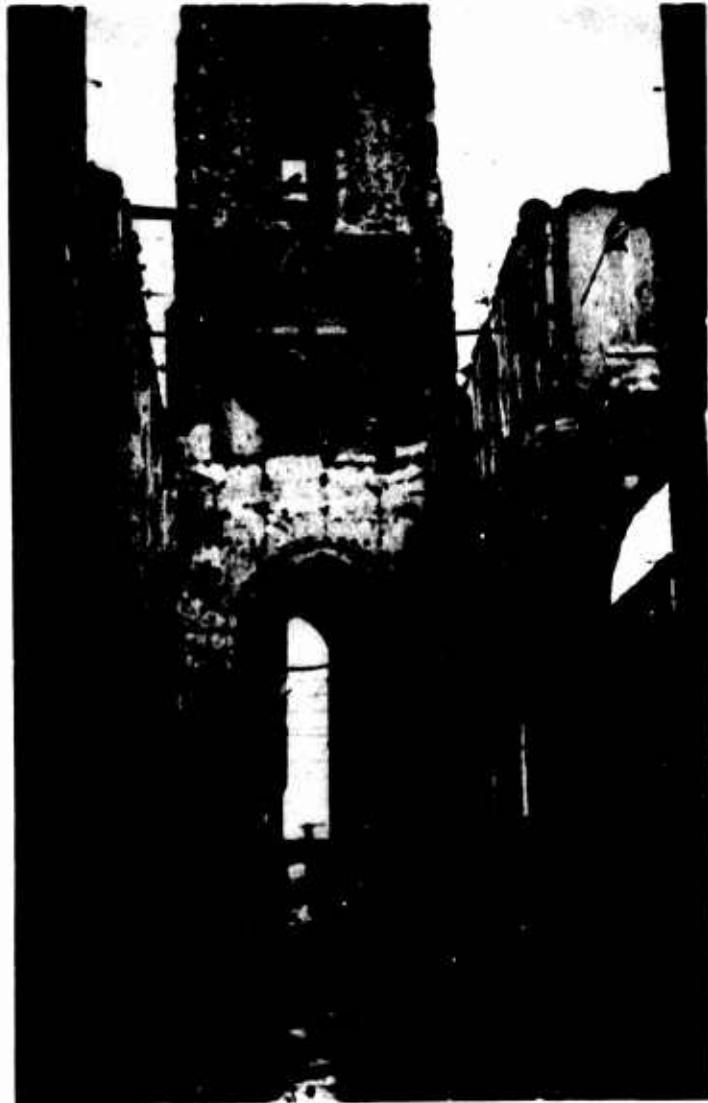
Comparing the effect of fire on sandstone with the effect on brick, it must be reported that sandstone proved to be much more fire resistant than the Dutch brick. Picture 67 shows the completely gutted St. Laurens Church, which was a pure gothic building of sandstone. The spire and the columns show strong splintering and peeling. Picture 68 shows a sandstone support in the old stock exchange building, which, despite considerable weakening, still has enough strength to support construction. Picture 69 shows strong peeling manifestations on a sandstone niche of the railroad viaduct at Railroad Station Hofplein.

**Picture 67 ST. LAURENS CHURCH SHOWING EVIDENCE OF
FIRE-CAUSED SPLINTERING AND PEELING OF
SANDSTONE**

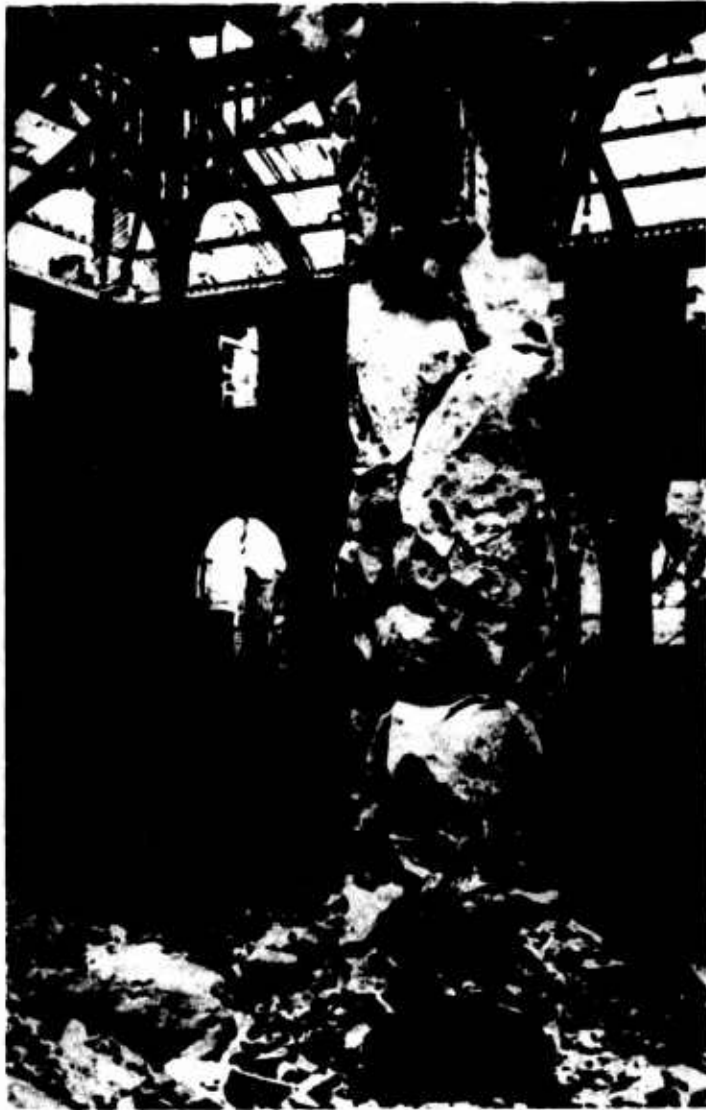
**Picture 68 DAMAGED SANDSTONE COLUMN IN FIRE-GUTTED
OLD STOCK-EXCHANGE BUILDING**

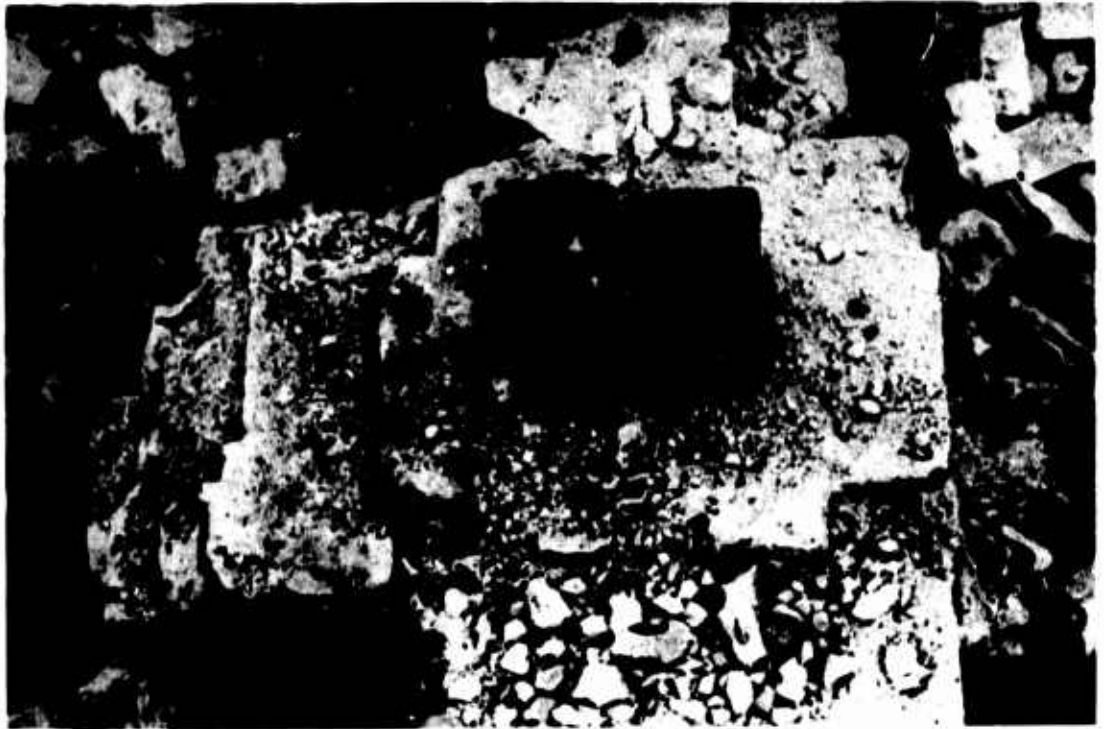
Picture 70 FIRE-DAMAGED YELLOW AND RED BRICKS

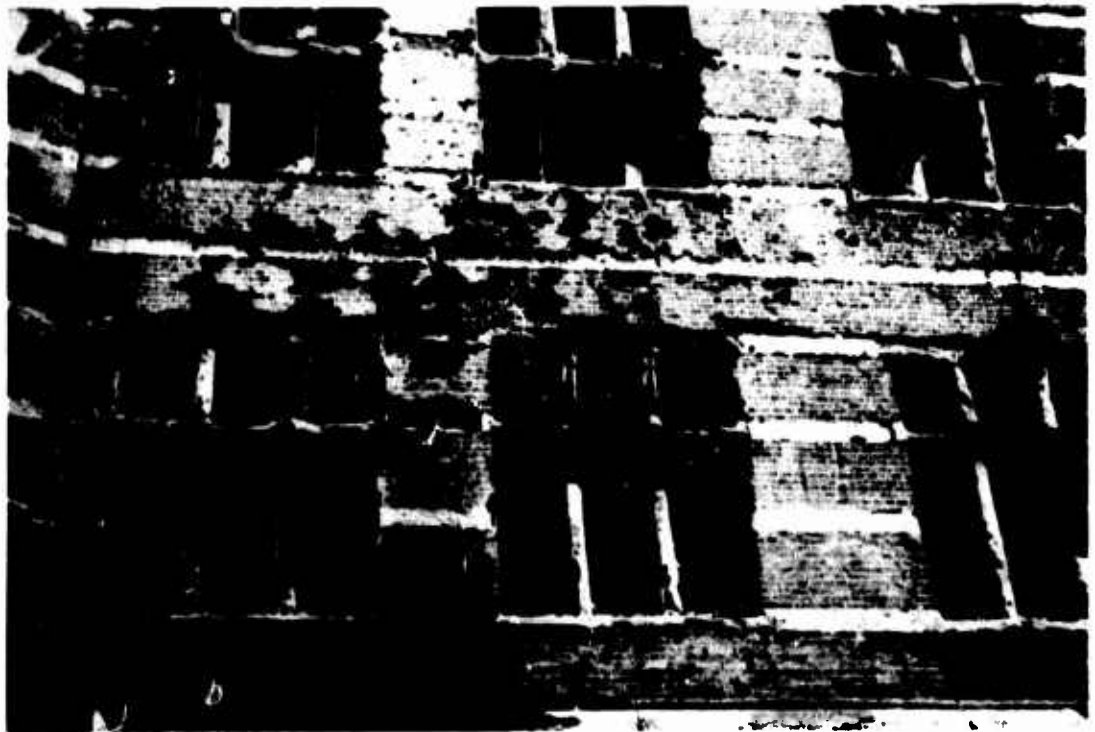
Picture 71 FIRE-DAMAGED BRICK AND SANDSTONE

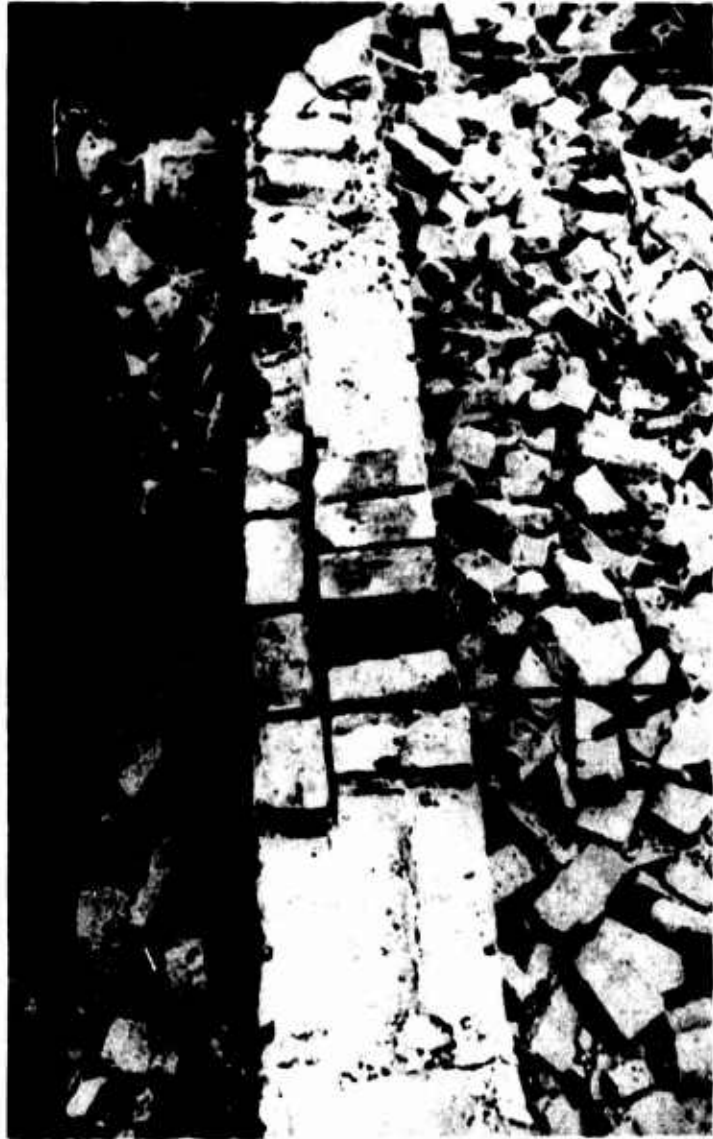
Picture 73 FIRE-DAMAGED BRICK FIRE WALLS
(Note contiguous mortar layer between inner and outer wall)

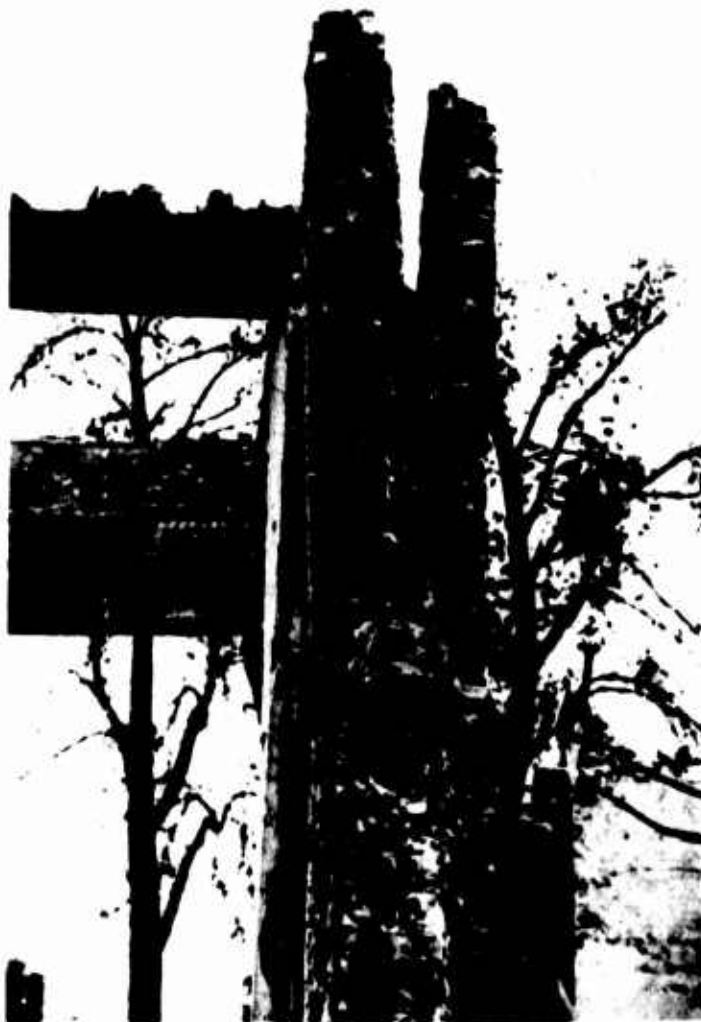
This loose joining permitted the embedded girders, after heating up, to crush the walls they were supporting (Picture 74).

Picture 74 FIRE-DAMAGED BRICK WALLS

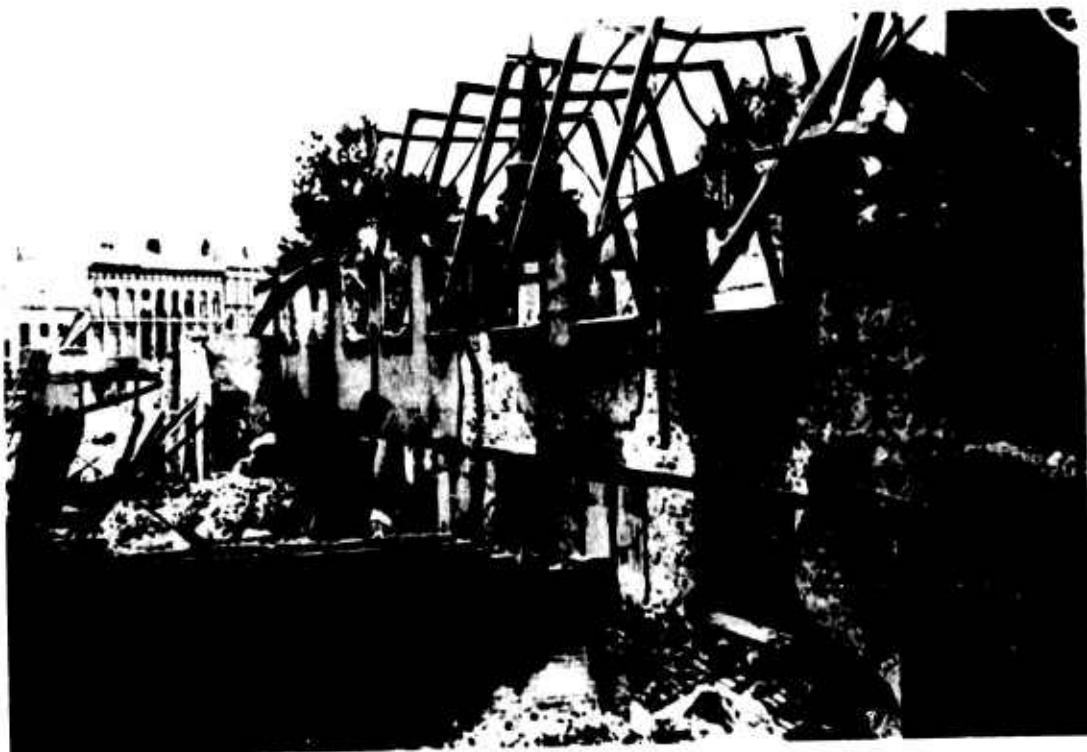
Picture 76 shows the peculiar construction of the roof of a nightclub in the amusement district of Coolsingel. Eyewitnesses to the fire report that as soon as this kind of roof construction is set afire, jet flames will crawl behind the casings and spread the fire to the whole roof.

Picture 76 FIRE-DESTROYED ROOF OF NIGHTCLUB IN COOLSINGEL DISTRICT

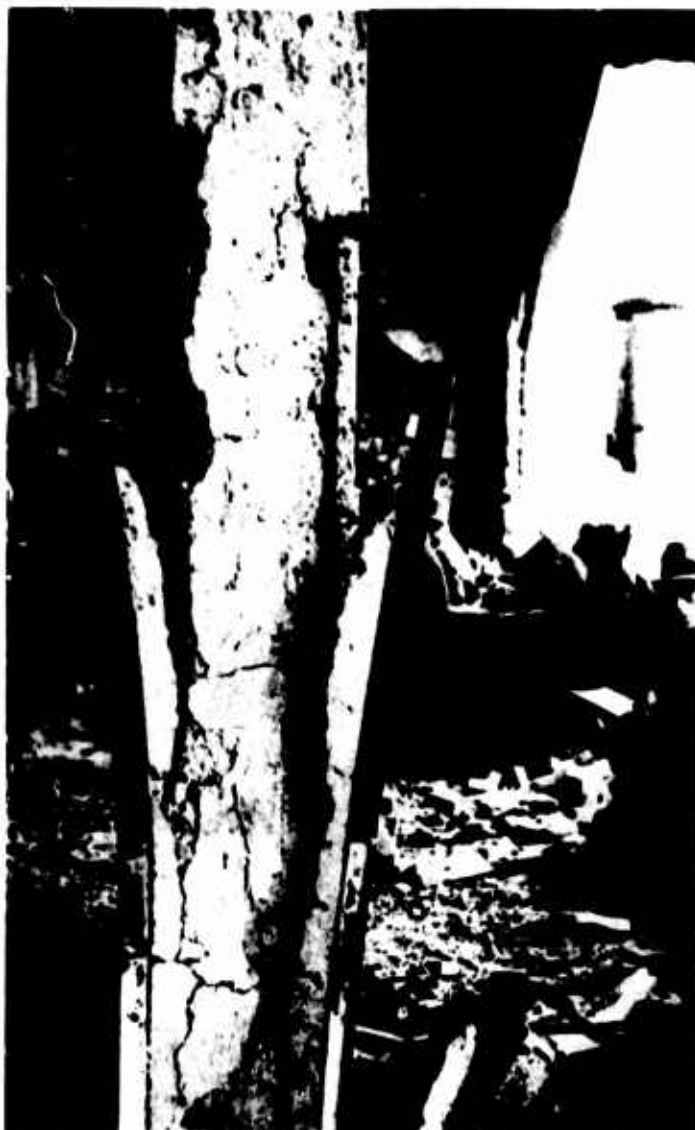
The effect of fire on reinforced concrete buildings is shown in Picture 77. In picture 77, the angle irons are torn out of the supports

Picture 77 FIRE-DAMAGED CONCRETE PILLAR WITH BENT ANGLE-IRONS

through the effects of the fire. In other instances, the stone masonry lost firmness to such an extent that the reinforced concrete ceiling collapsed of its own weight.

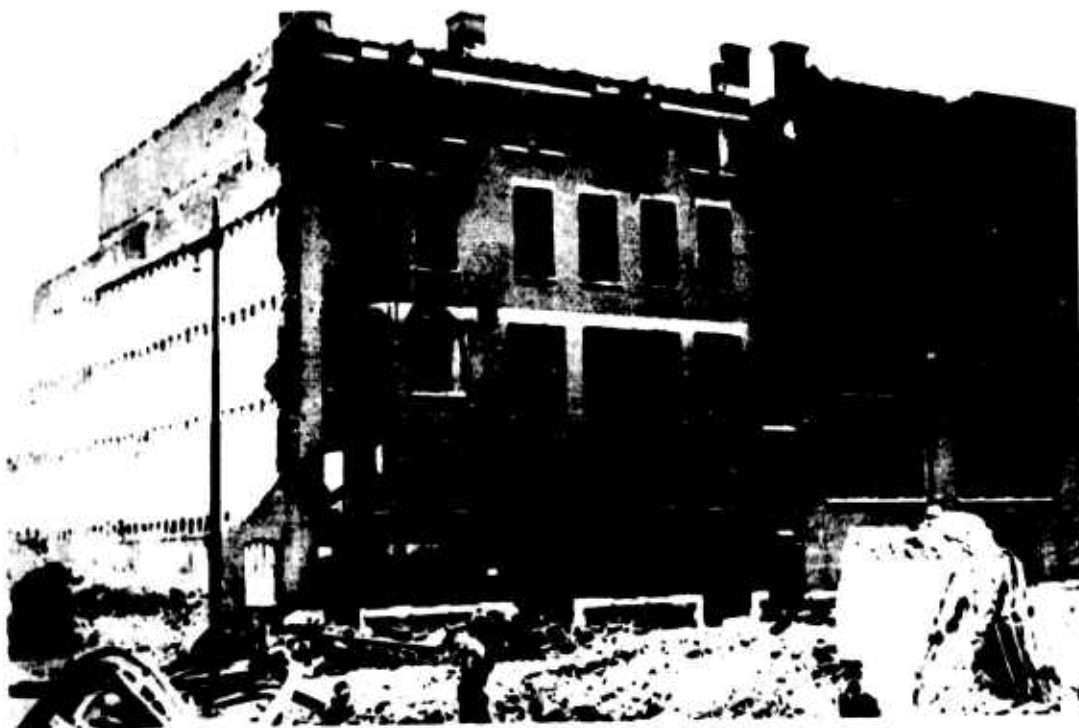
Pictures 78,79 RELATIVE FIRE-RESISTANCE OF GERMAN BRICK

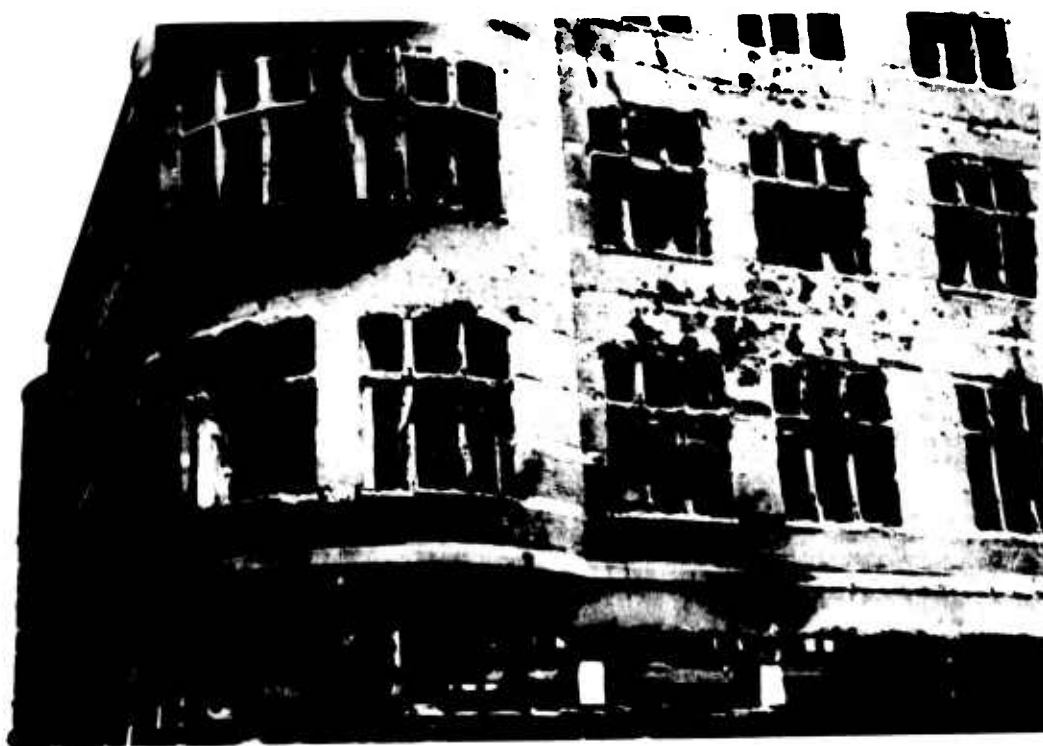
Picture 80 RELATIVE FIRE-RESISTANCE OF GERMAN AND DUTCH BRICK CONSTRUCTION

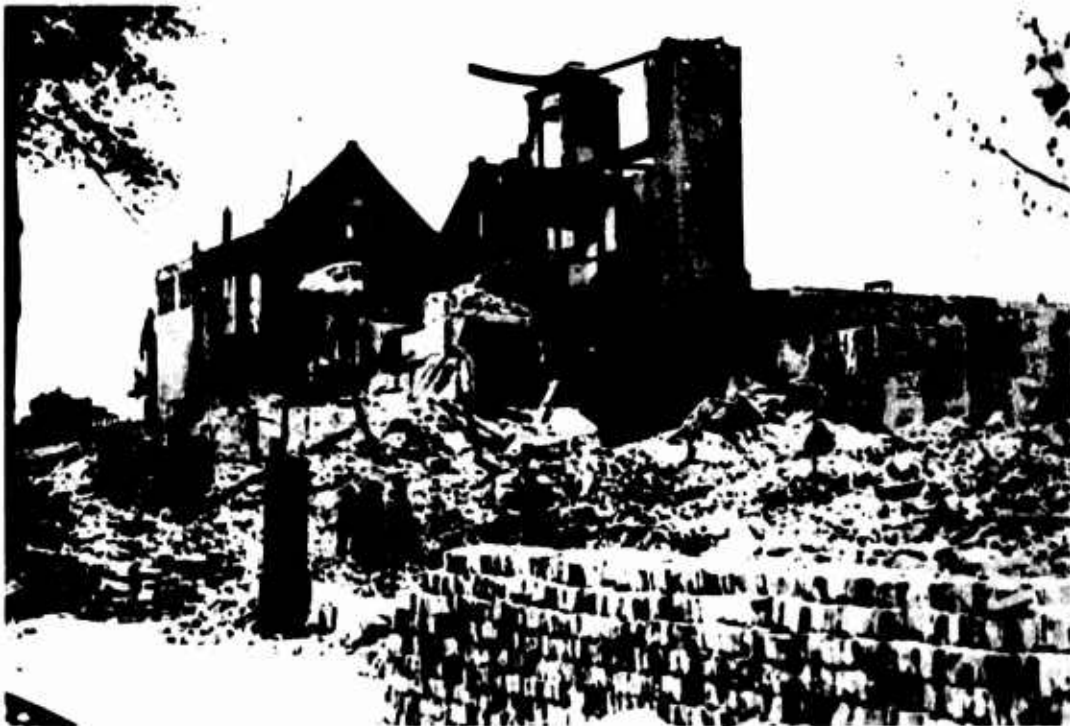
Picture 81 BRICK DEBRIS AFTER THE FIRE

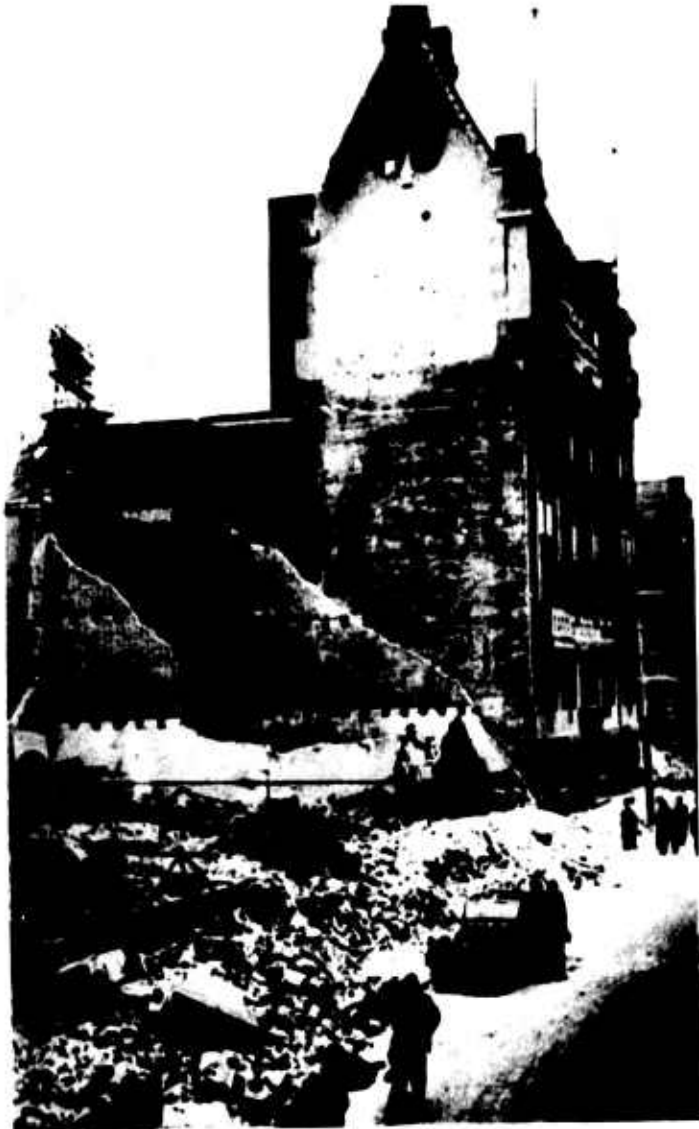
**Picture 82 RELATIVE FIRE-RESISTANCE OF DUTCH AND
GERMAN BRICK WALL CONSTRUCTION**
