**USAAVLABS TECHNICAL REPORT 67-74**

**FEASIBILITY OF BURNING EMULSIFIED FUEL  
IN A 7LM100 ENGINE**

February 1968

**CONTRACT DAAJ02-67-C-0038  
FLIGHT PROPULSION DIVISION  
GENERAL ELECTRIC COMPANY  
CINCINNATI, OHIO**

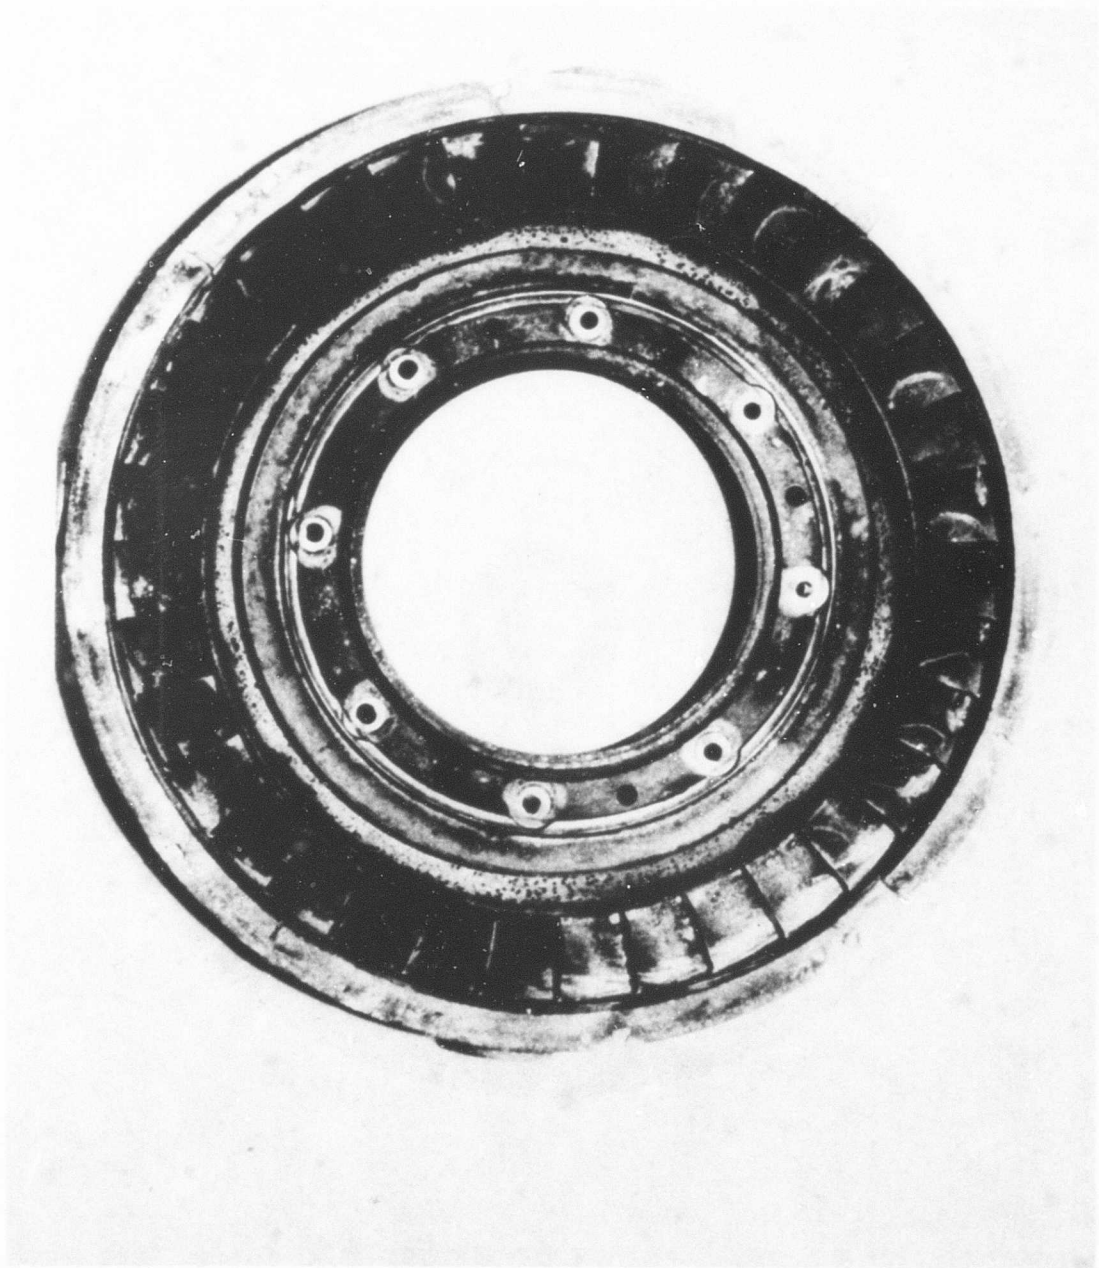
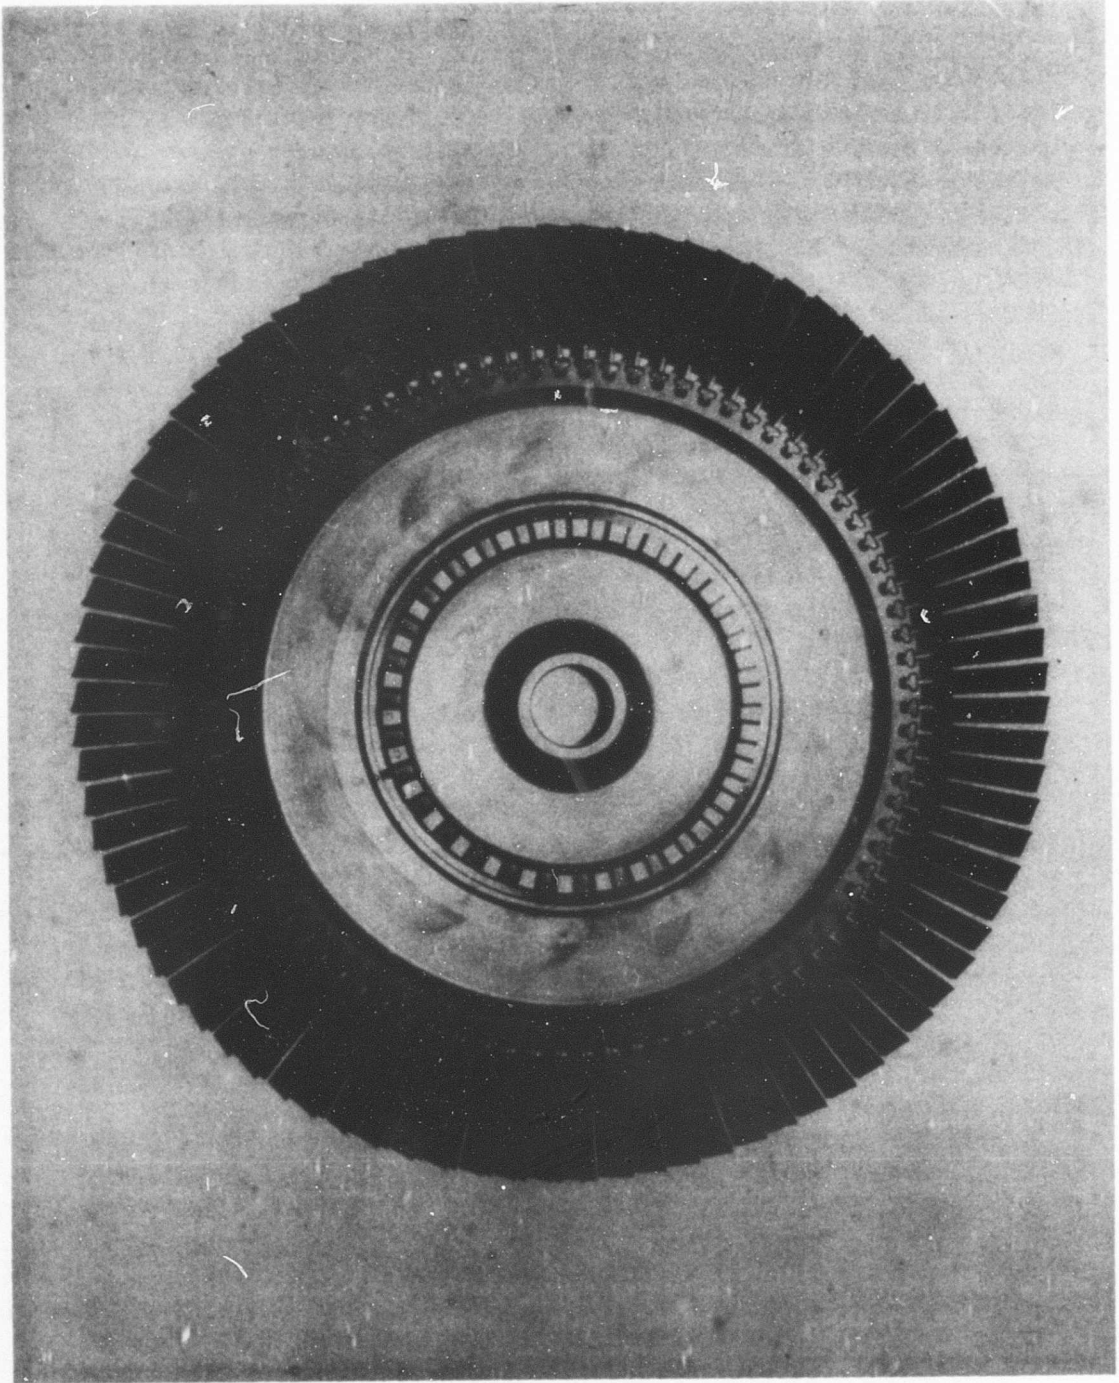
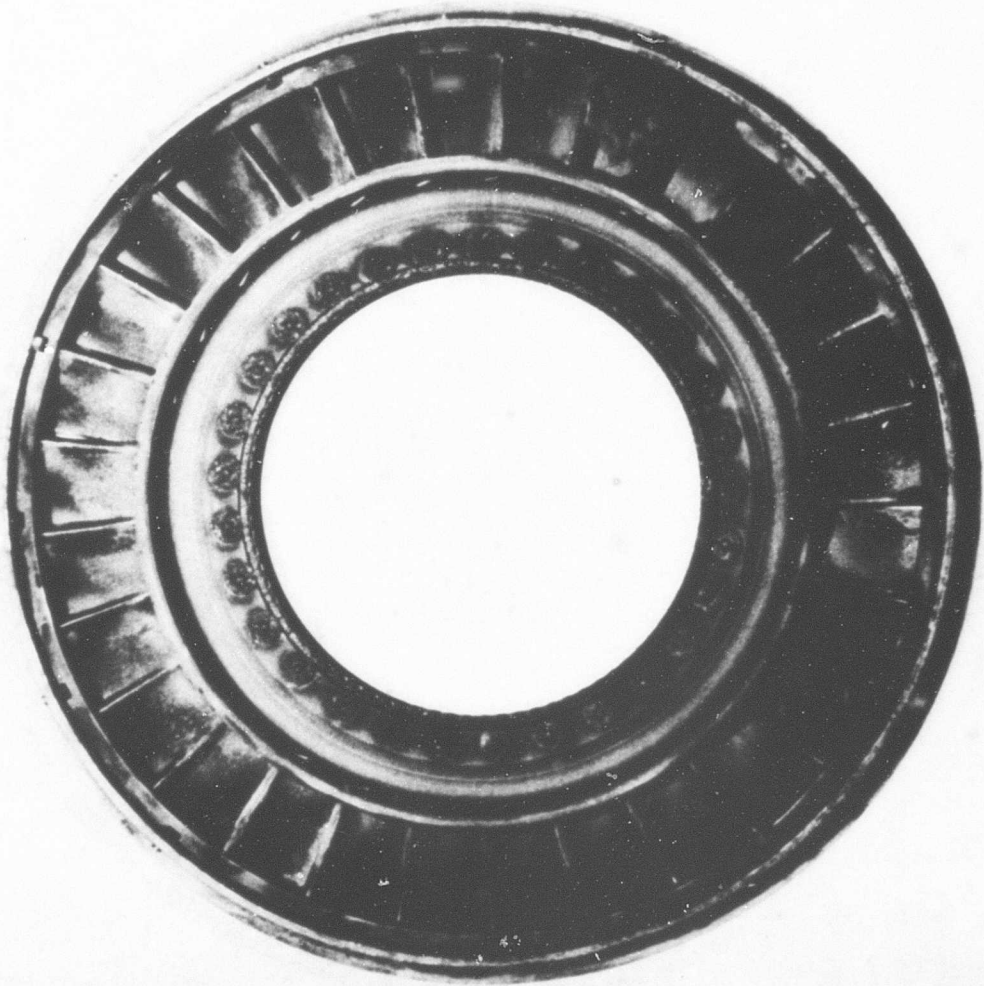
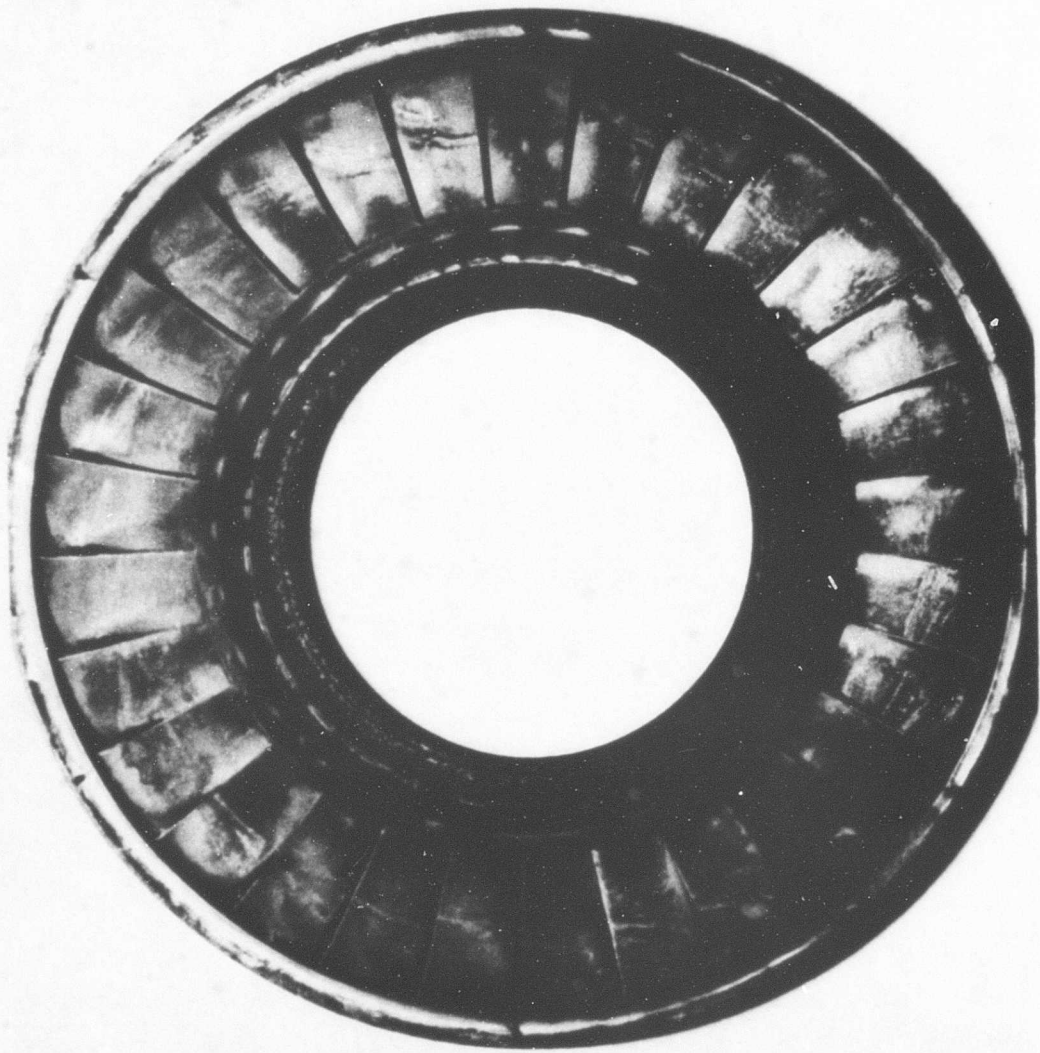
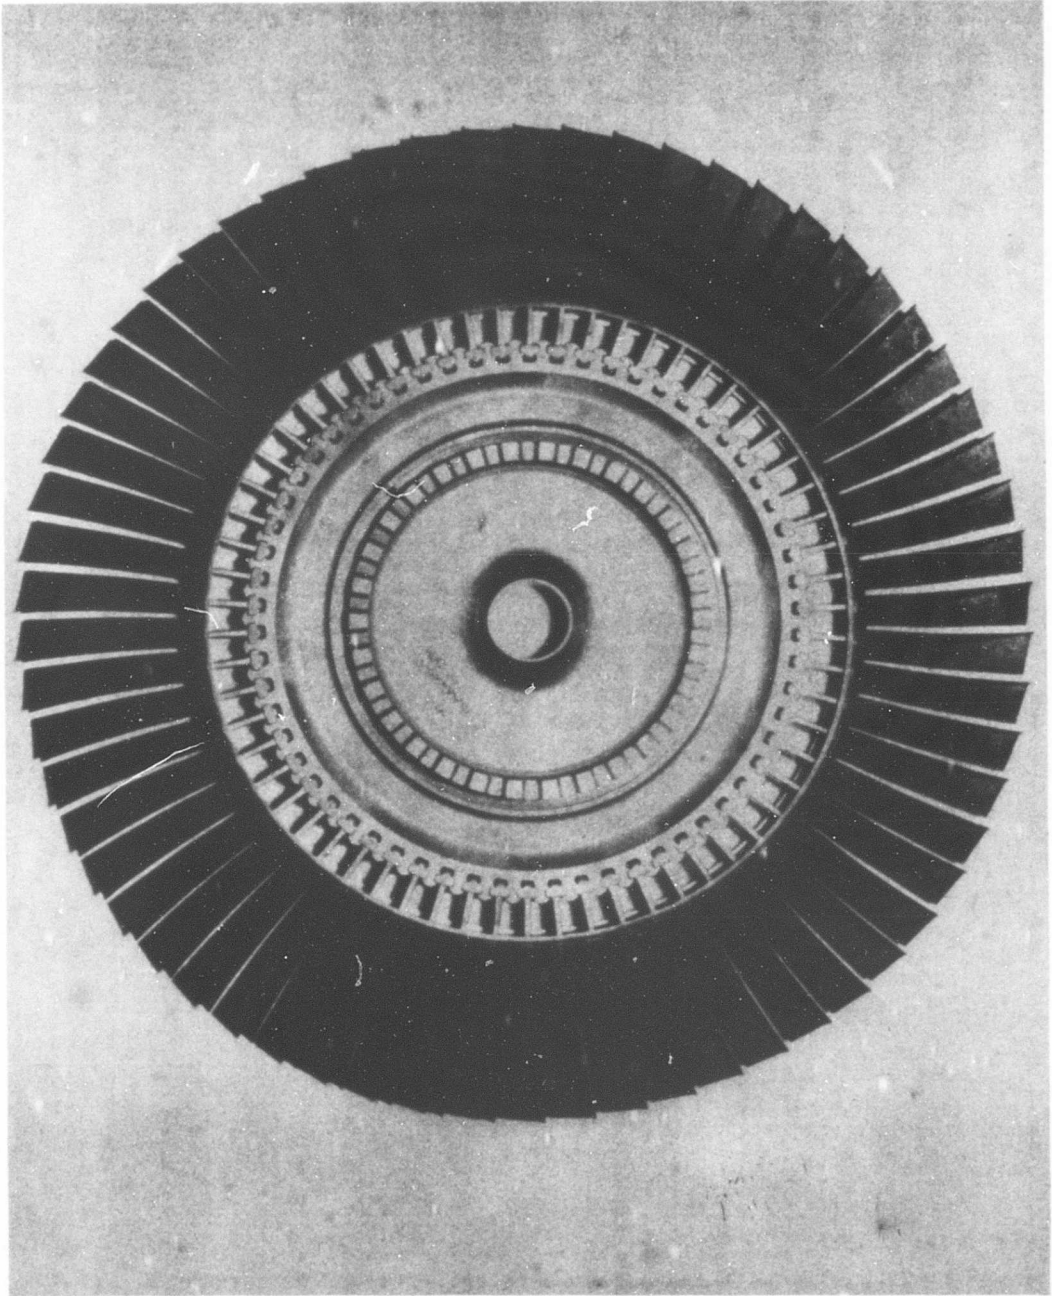
Prior to the testing, a hot-section inspection of the engine was performed. Figures 2 through 6 show the results of this inspection. New fuel manifold assemblies and two new first-stage turbine blades were installed. An overhauled fuel metering valve was installed so that corrosion could be monitored. Otherwise, only those parts necessary to run the engine safely were replaced at this time.

1. First-stage nozzle - All partitions corroded; 14 cracked on trailing edge.
2. Second-stage nozzle - Five partitions cracked on leading edge (3 o'clock position); badly discolored; shows signs of hot corrosion.
3. Third-stage nozzle - Coking on aft face; visually good.
4. First-stage casing - One dump tube pad has a bolt seized and broken off; internal cooling tubes plugged; otherwise, visually good.
5. Second-stage casing - Visually good.

1. Forward shaft - Visually good; normal discoloration.
2. Cooling plates - Some corrosion; extensive discoloration; not visually warped or otherwise damaged.
3. First-stage wheel - Some evidence of hot corrosion on buckets.
4. Second-stage wheel assembly - Some evidence of hot corrosion.
5. Coupling shaft - Visually good.
6. Tie bolt - Good.

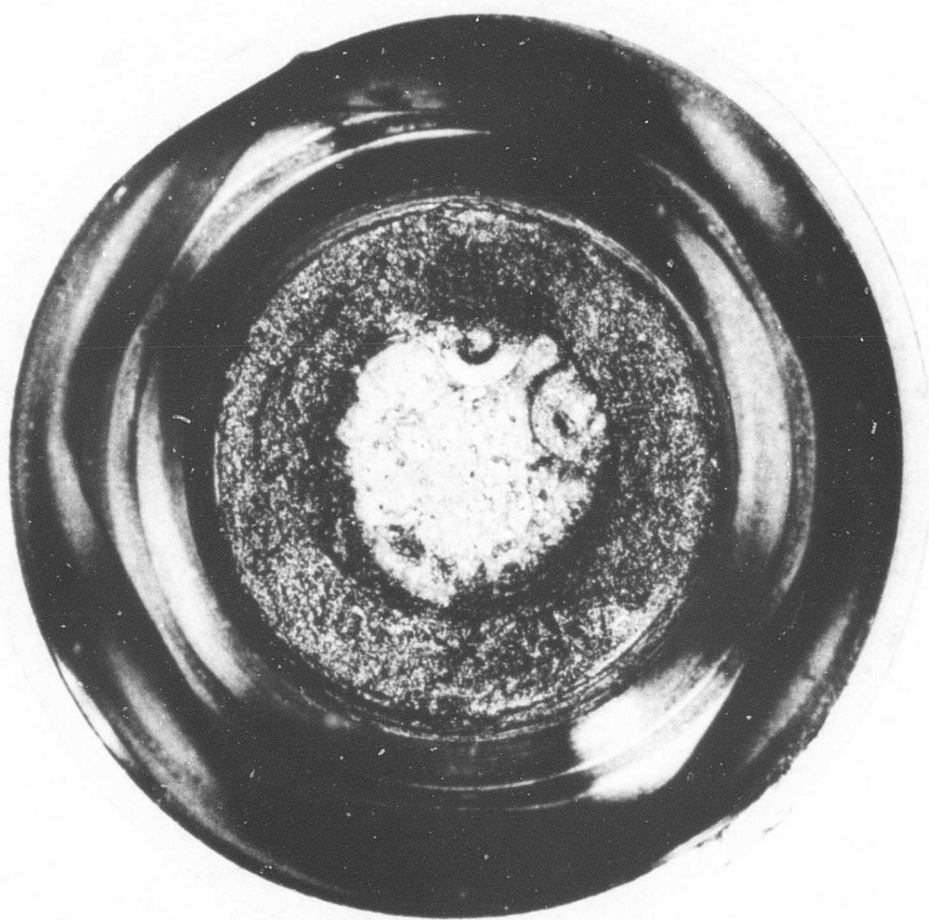
After 4 hours 18 minutes (3 hours 17 minutes on emulsified fuel), the fuel manifolds were changed because of high fuel manifold pressure. This was caused by the fuel nozzles' clogging on dirty fuel (see Figures 7, 8, and 9). Bench checks showed five secondary fuel nozzles not flowing at inlet pressures up to 500 psig. All nozzles were dirty and clogged to some extent. Two secondary nozzles had collapsed nozzle filter screens. This is shown in Figures 10 and 11. Also, globs of emulsified fuel were dribbling out of these nozzles, as shown in Figures 13 and 14. A white crystal-like residue was also found (see Figures 15 and 16) on the nozzles. Figures 17, 18, and 19 are typical of the condition of the other fuel nozzles in the first set.

Laboratory analysis revealed that the fuel contained sand, a large amount of fiber, and large pieces of material that appeared to be gray paint. The contamination level was 17.8 mg/gal. MIL-T-5624G allows 8 mg/gal for liquid JP-4.

Figure 7. Clogged Secondary Fuel Nozzle (Upstream View).

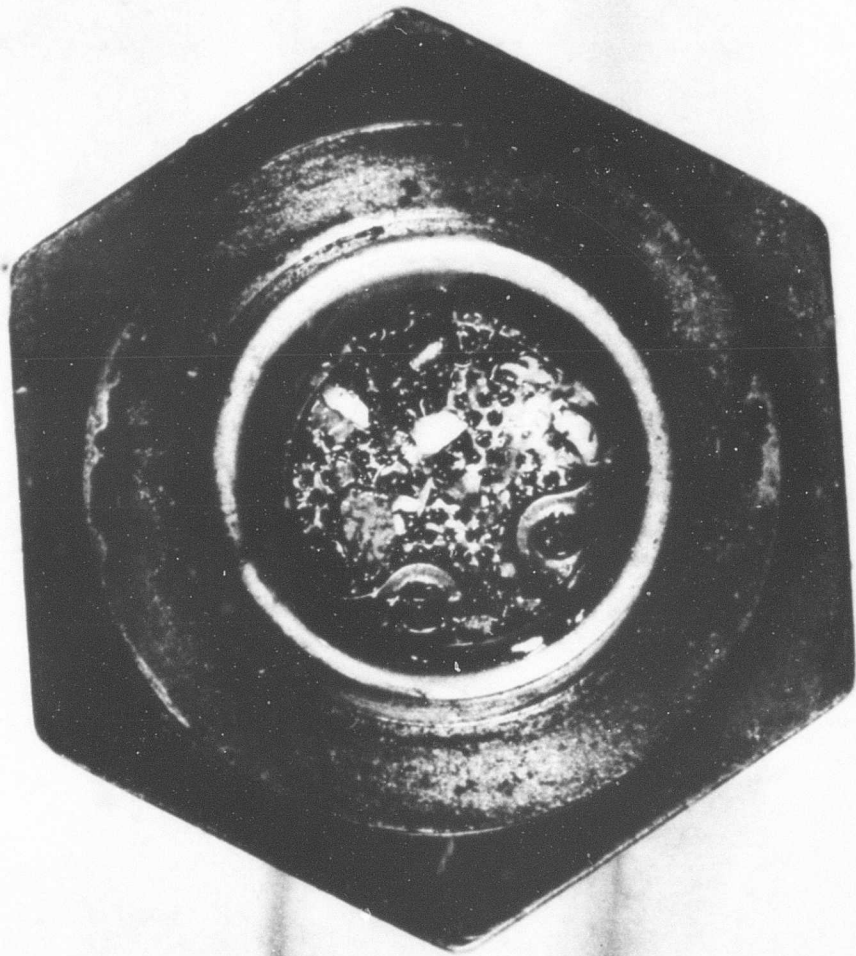
Figure 8. Clogged Primary Fuel Nozzle (Upstream View).

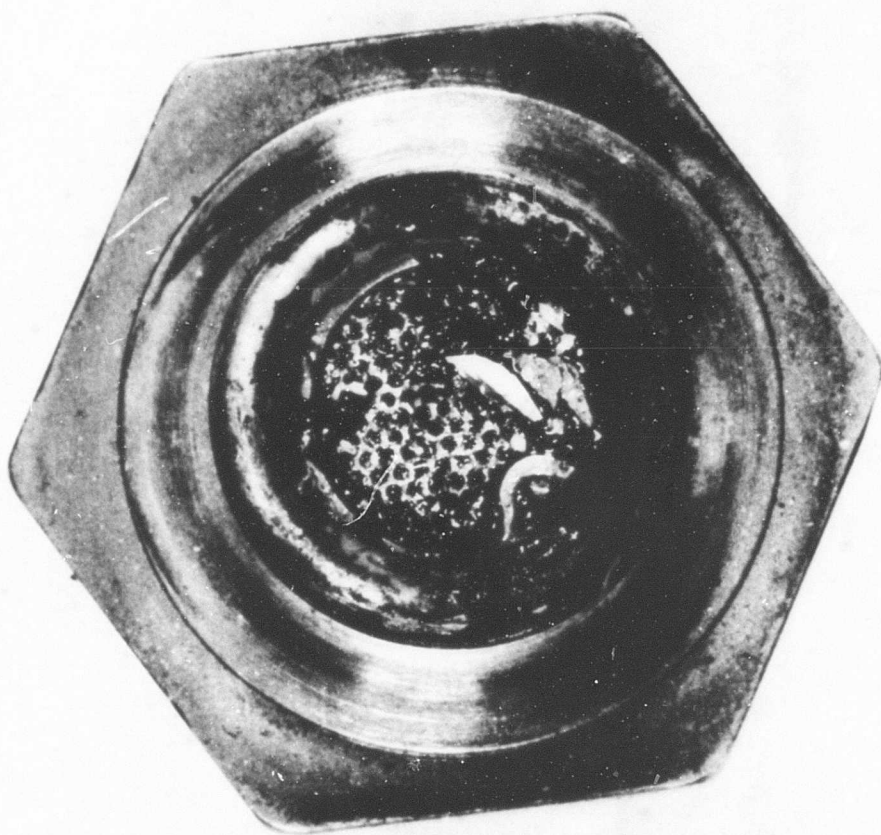
Figure 9. Clogged Primary Fuel Nozzle (Upstream View).

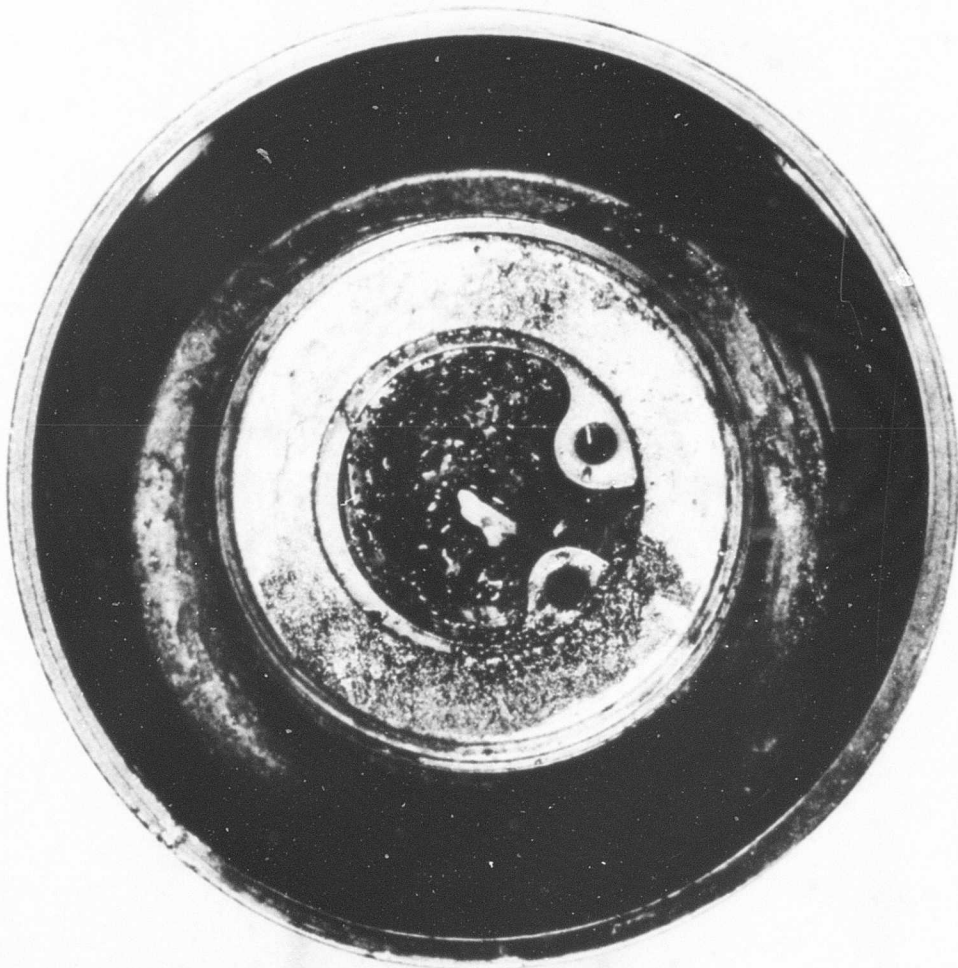
Figure 10. Clogged Secondary Fuel Nozzle With Collapsed Filter Screen (Upstream View).

The nozzle strainer completely clogged in two secondary nozzles. All strainers were dirty. Contamination appeared to be chips of paint, sand, and wood (same type of contamination found in fuel filter).

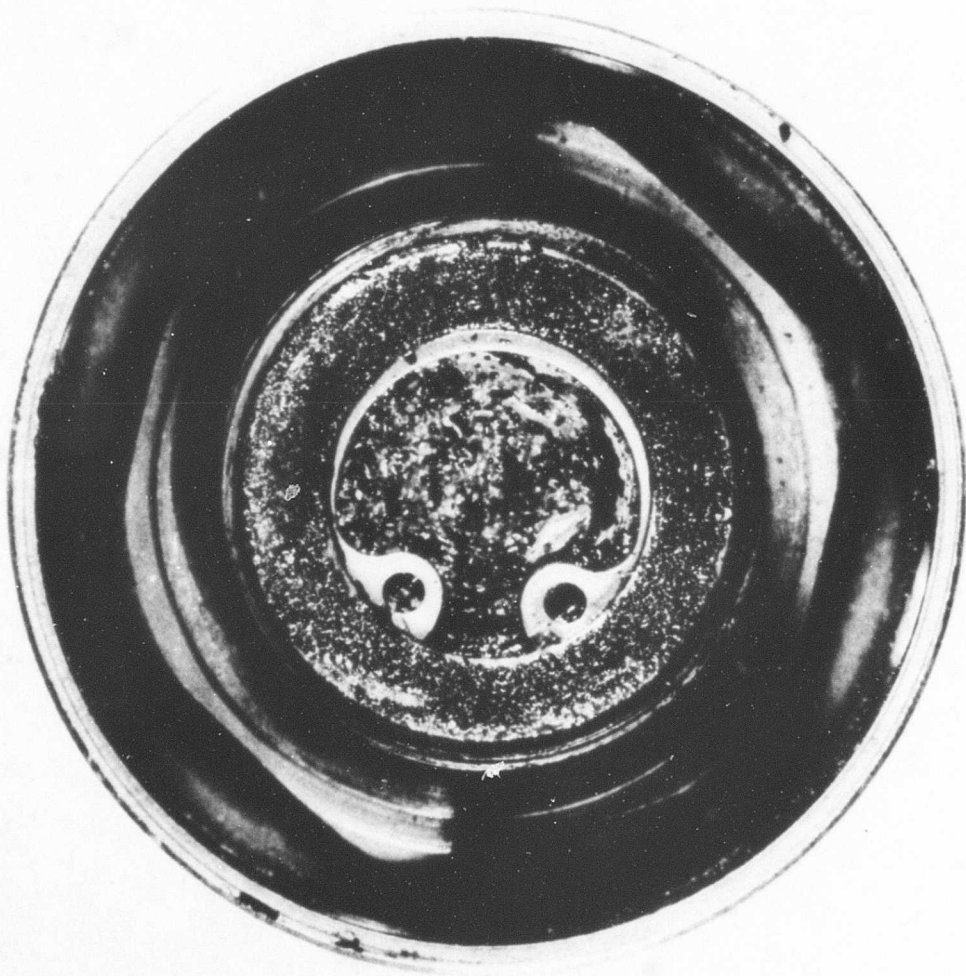
Figure 11. Clogged Secondary Fuel Nozzle With Collapsed Filter Screen (Upstream View).

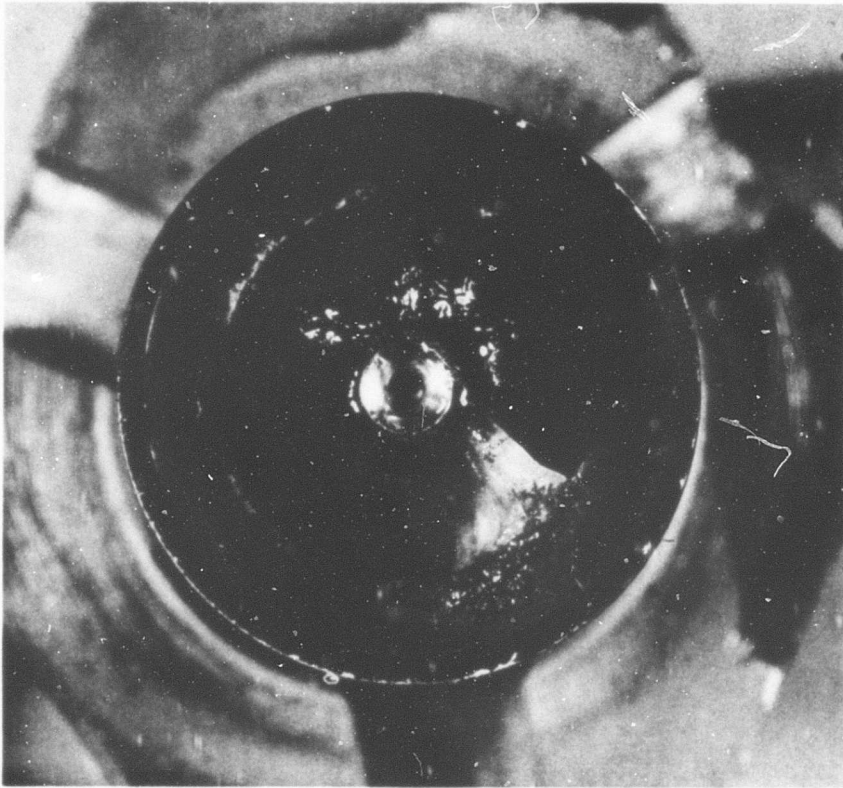
Figure 13. Emulsified Fuel Clinging to Primary Fuel Nozzle.

White crystal-like deposits were found on four primary nozzles. Coking was evident on primary and secondary nozzles. The coking was apparently caused by dribbling. The primary nozzles were coked the heaviest. Globes of fuel were hanging on two primary nozzles.

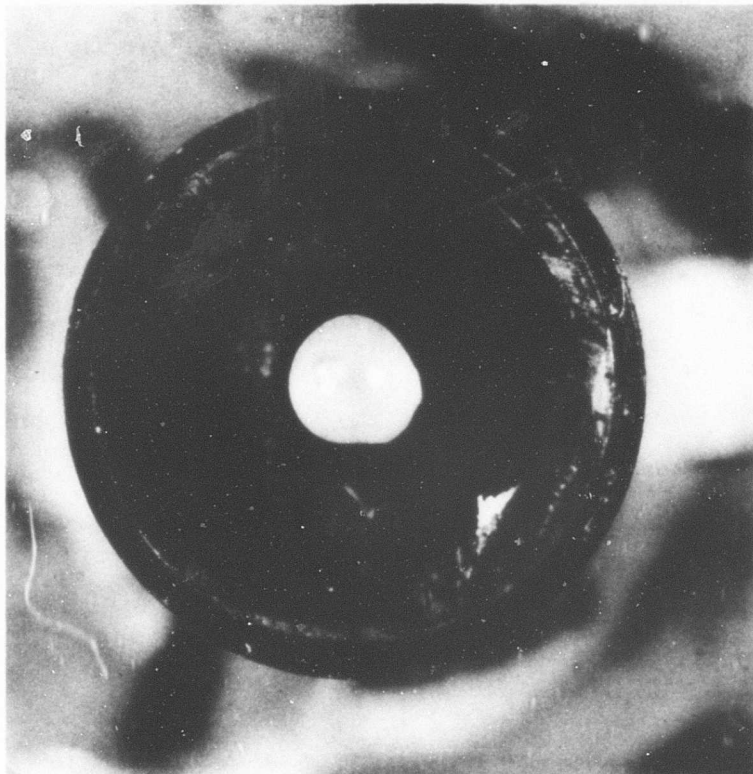
Since emulsified fuel must be pumped to move, it will not drain after shutdown but will stay in the nozzle and coke. Secondary fuel nozzles showed signs of this, since they do not flow below 185-psi manifold pressure. Figures 18 and 19 show coking on the secondary nozzles which can be attributed to high-temperature no-flow conditions.

Figure 14. Emulsified Fuel on Primary Fuel Nozzle After Shutdown.

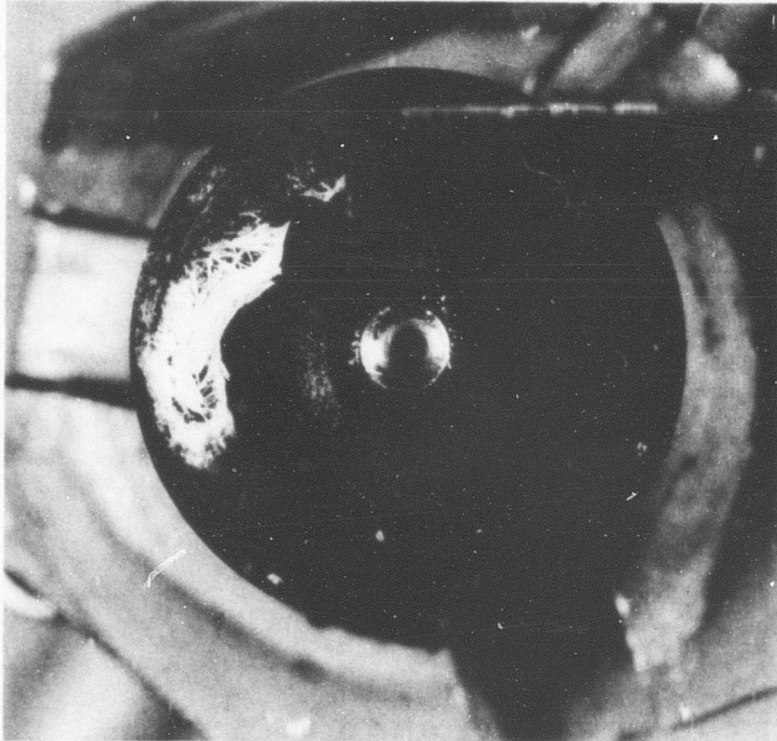
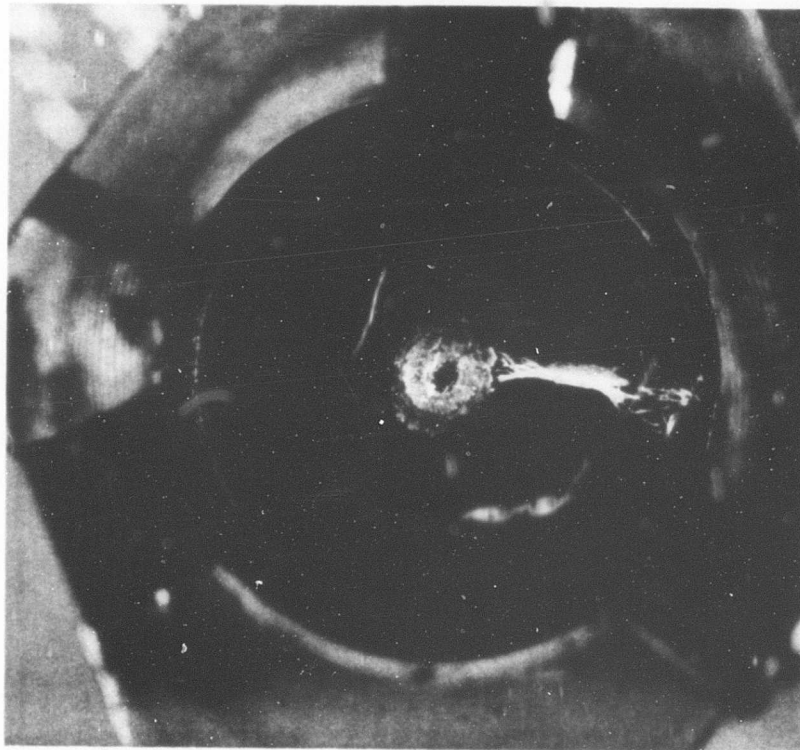
Figure 15. White Residue Found on Fuel Nozzles.

Figure 16. White Residue Found on Fuel Nozzles.

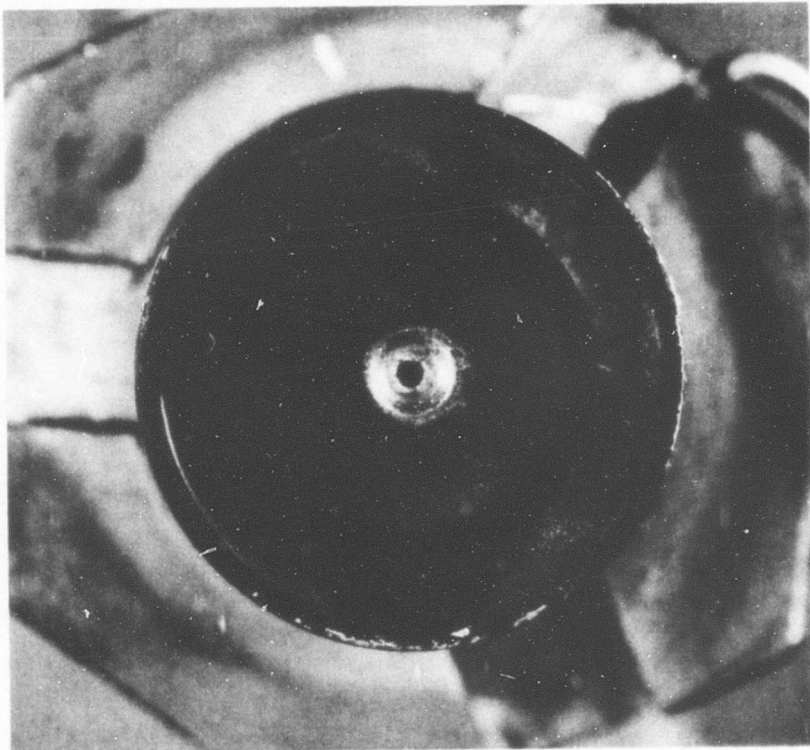
Fuel nozzle coking may be a problem in achieving required nozzle life if emulsified fuel is supplied to the fuel nozzles. The primary fuel nozzles were coked the heaviest. This suggests that spray characteristics with emulsified fuel are much poorer at lower pressure drops across the fuel nozzles. The secondary nozzles, which operate only above 185-psi fuel manifold pressure, showed much less coking. Coking was aggravated by dirty fuel's clogging the nozzles.

Figure 17. Primary Fuel Nozzle Coking.

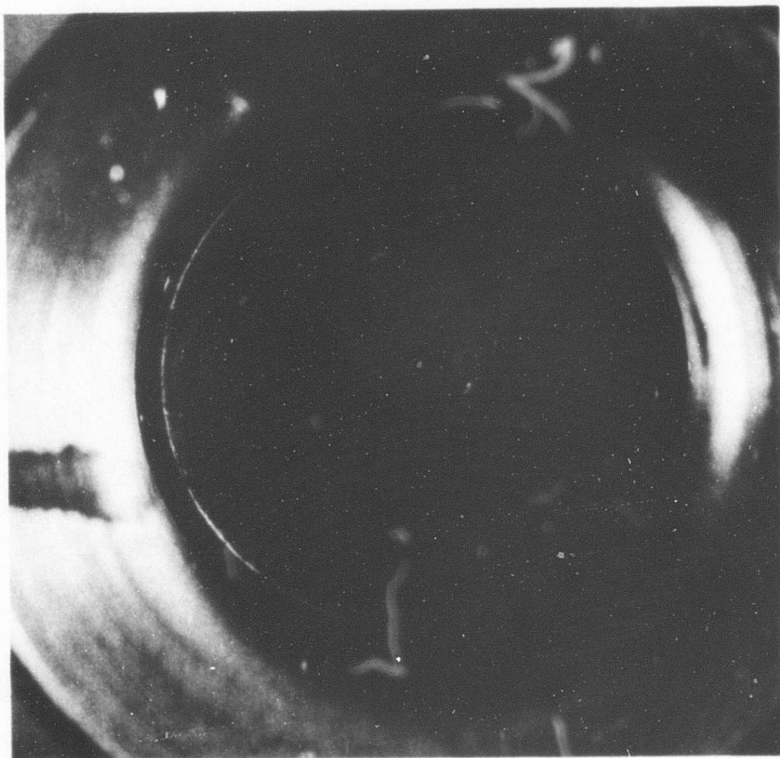
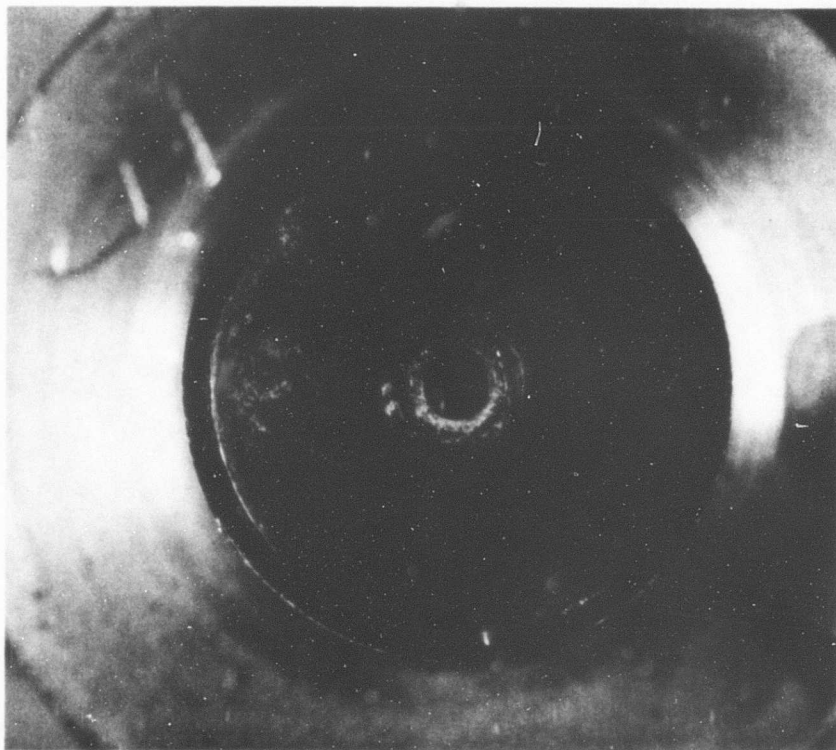
Figure 18. Secondary Fuel Nozzle Coking.

Figure 19. Secondary Fuel Nozzle Coking.

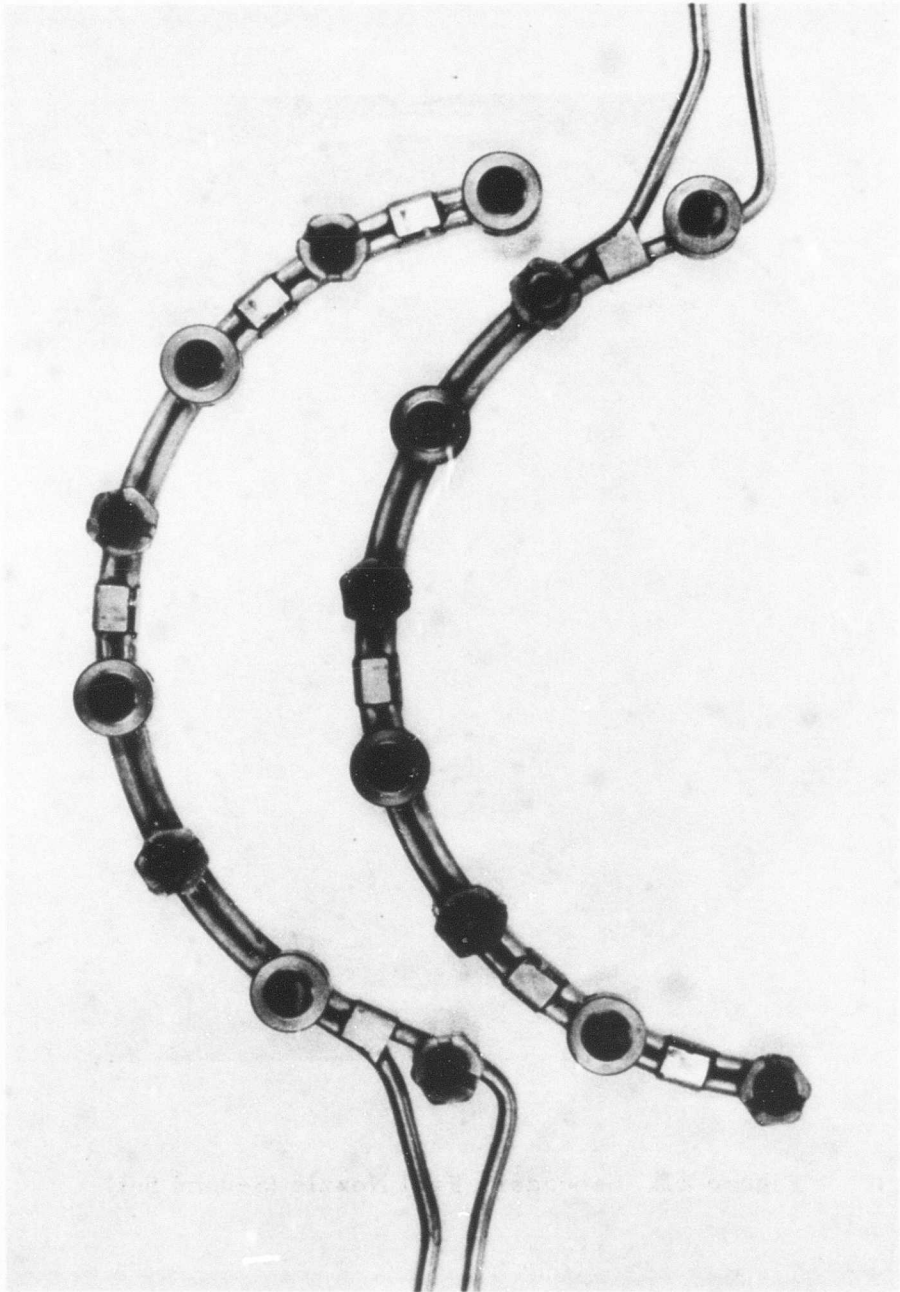
Figure 20. Secondary Set of Fuel Nozzles After Test.

The second set of manifolds was in much better condition at the end of the test. A slave filter had been added to the fuel supply system when the manifolds were changed. These nozzles were about 35 percent clogged at the end of the test. There was some white residue around the nozzle orifices, but there were no blobs of fuel. The nozzles had been operated on JP-4, whereas the first set had been operating on emulsified fuel prior to shutdown. Clogging of the first set of fuel nozzles was caused by contaminated fuel. Figures 21 through 28 show typical fuel nozzles from the second set.

- 9. Fuel manifolds - Coking on all nozzles; primaries coked the most; much better than first set; no globs of emulsified fuel seen.**
- 10. Fuel control valve S/N 704043 - Some small globs of emulsified fuel still present; no signs of corrosion or scale.**
