**USAAVLABS TECHNICAL REPORT 67-74**

**FEASIBILITY OF BURNING EMULSIFIED FUEL  
IN A 7LM100 ENGINE**

February 1968

**CONTRACT DAAJ02-67-C-0038  
FLIGHT PROPULSION DIVISION  
GENERAL ELECTRIC COMPANY  
CINCINNATI, OHIO**

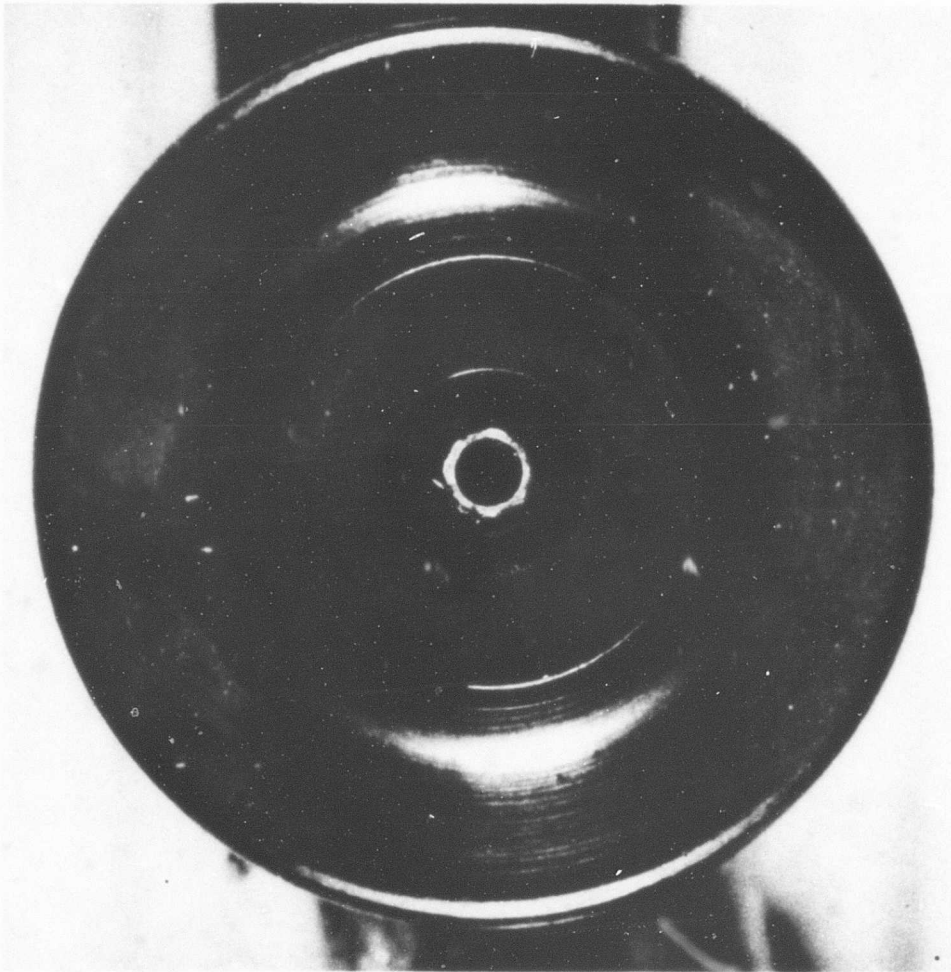
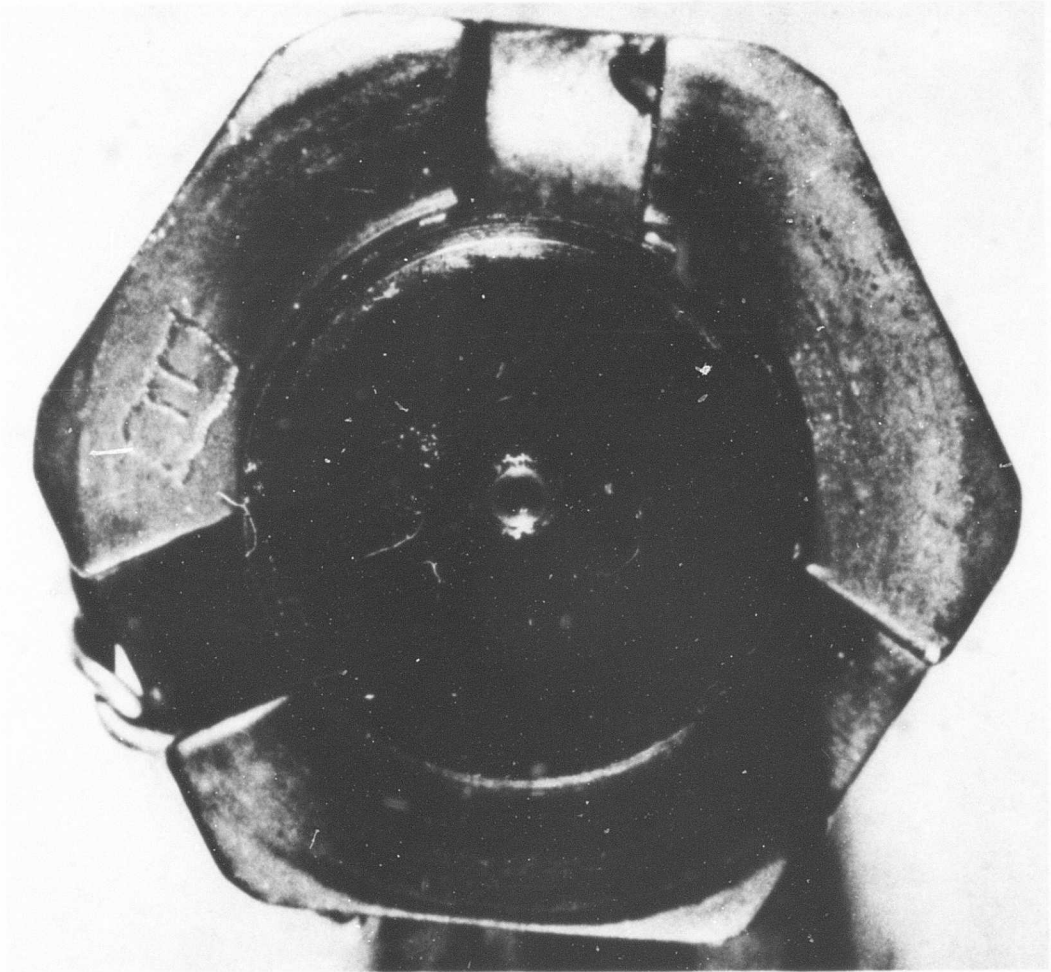
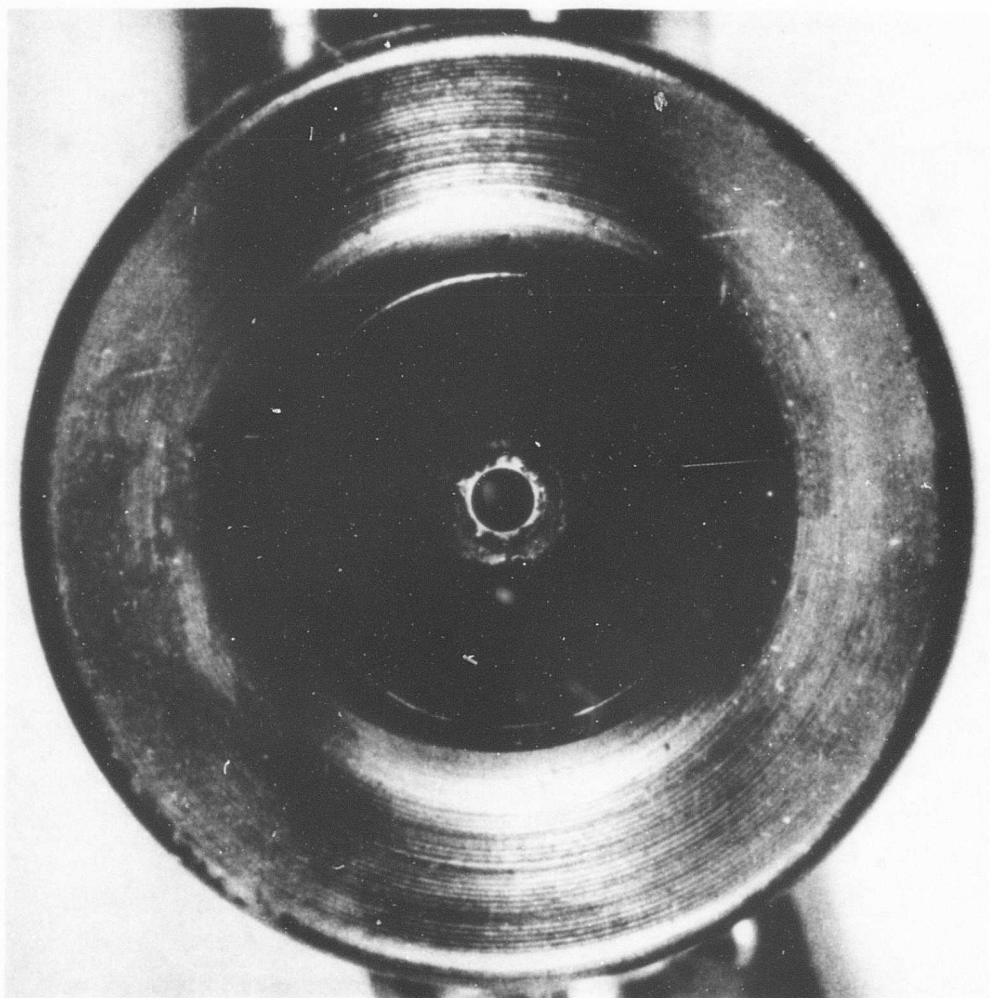
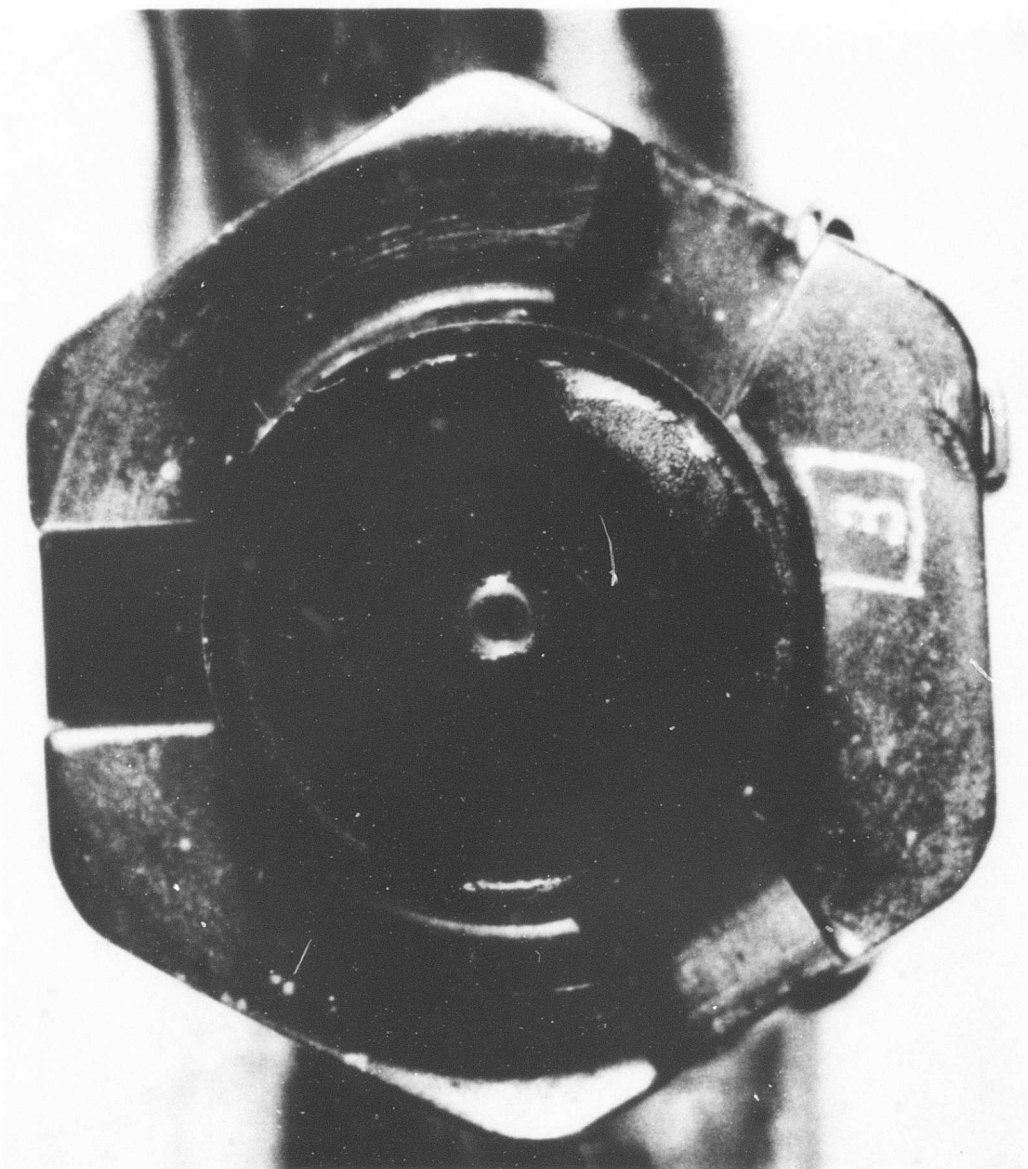
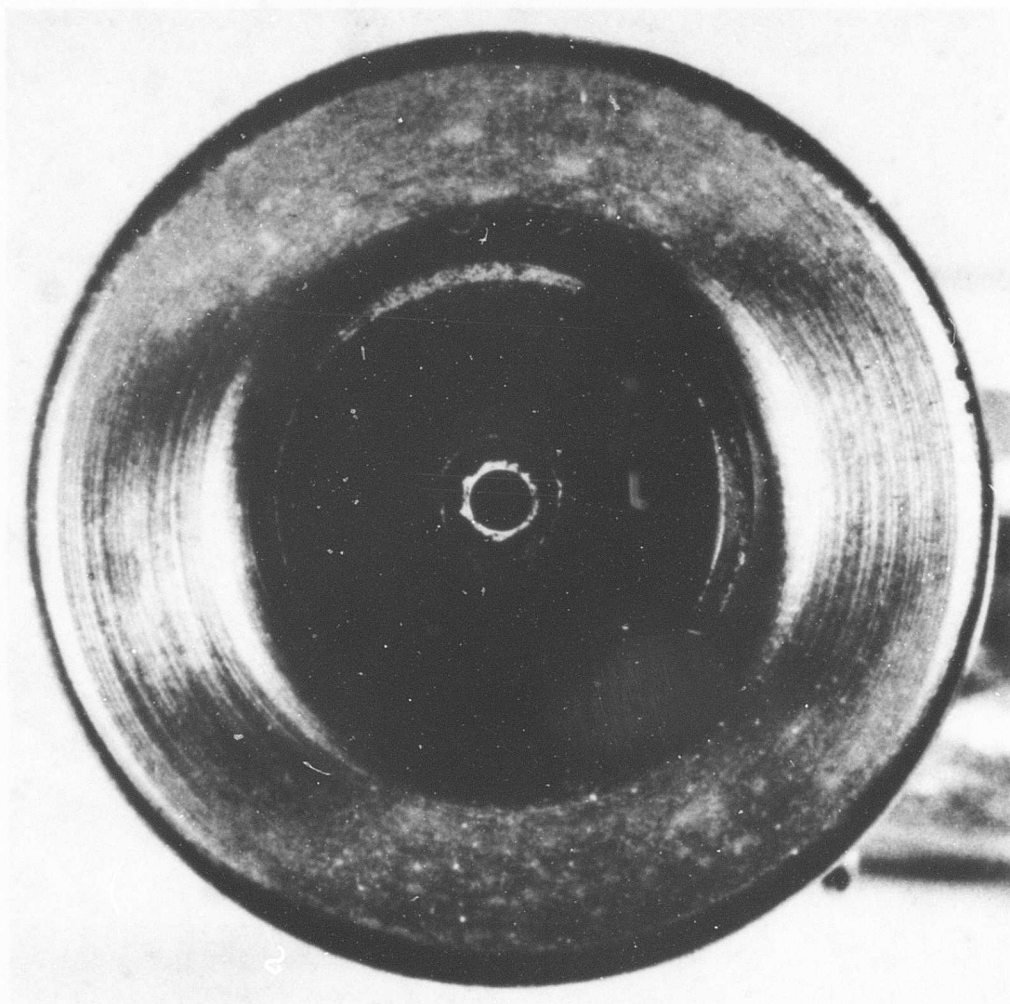
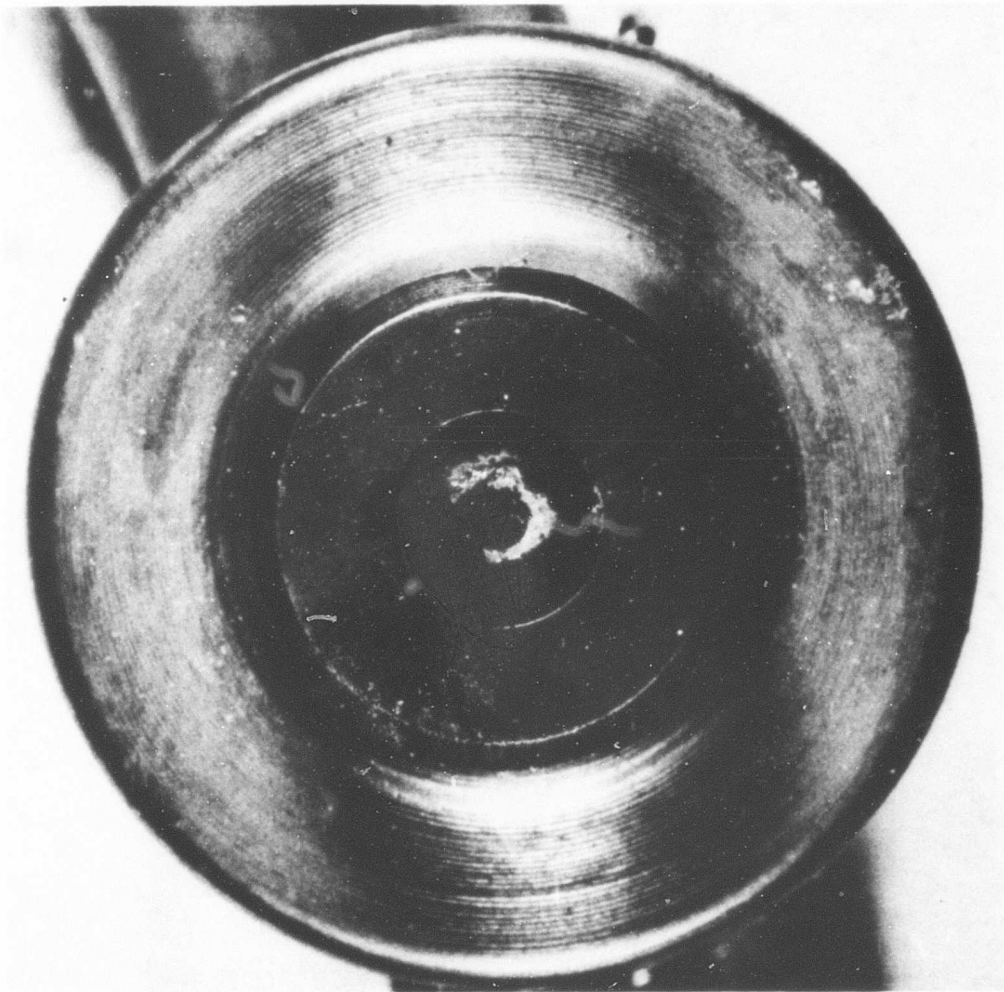
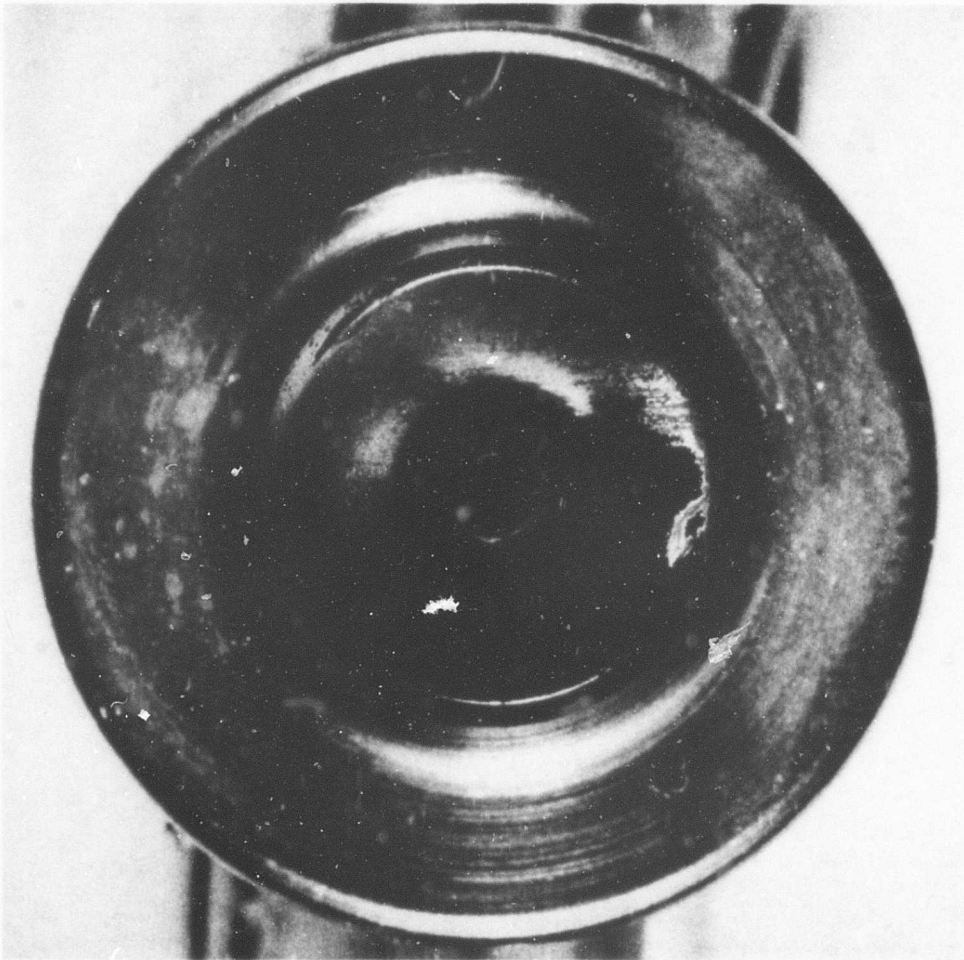
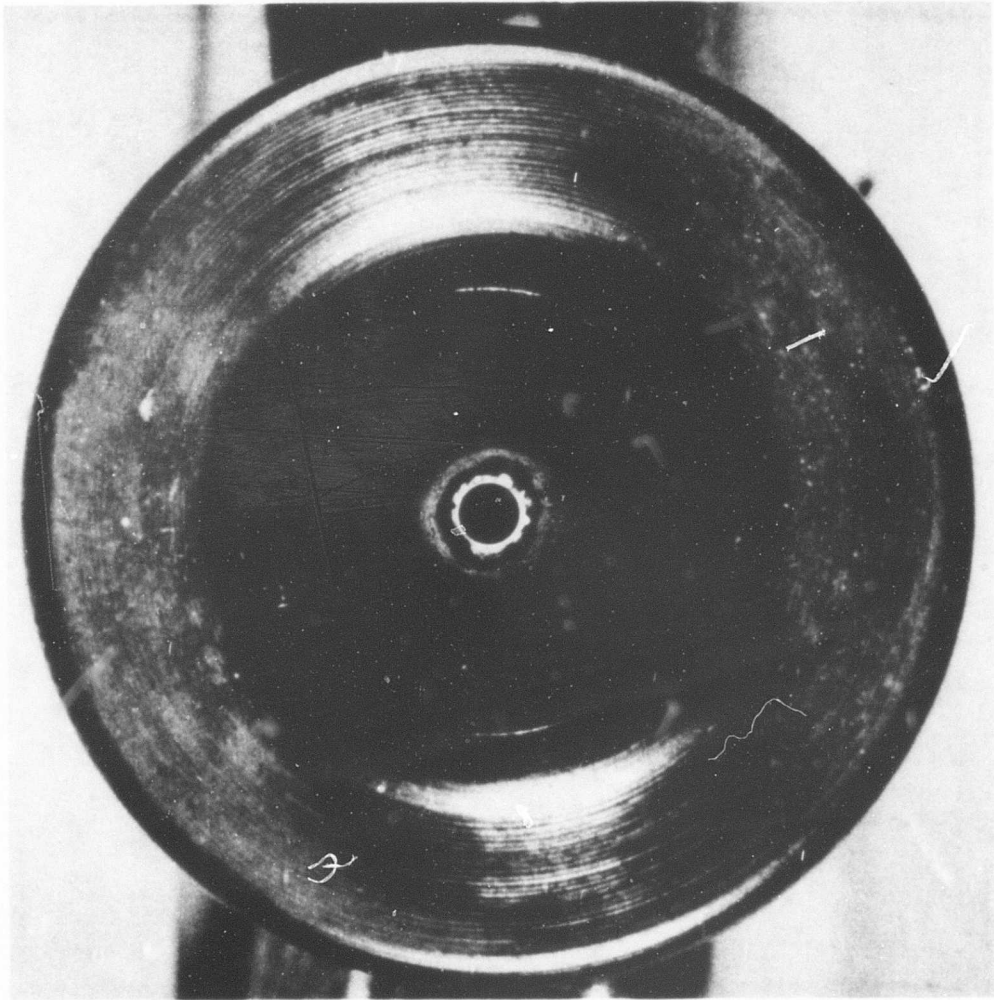
The second set of manifolds was in much better condition at the end of the test. A slave filter had been added to the fuel supply system when the manifolds were changed. These nozzles were about 35 percent clogged at the end of the test. There was some white residue around the nozzle orifices, but there were no blobs of fuel. The nozzles had been operated on JP-4, whereas the first set had been operating on emulsified fuel prior to shutdown. Clogging of the first set of fuel nozzles was caused by contaminated fuel. Figures 21 through 28 show typical fuel nozzles from the second set.

Fuel nozzles from the second set were disassembled, and a reddish deposit was found on the screens and in the nozzle areas. This deposit was inadvertently cleaned from the second set of nozzles prior to obtaining a sample for chemical analysis. However, there was a similar coating in the first set of nozzles in addition to all the other contaminant.

A sample of this reddish deposit was analyzed and found to be primarily iron, with traces of aluminum, calcium, chromium, copper, magnesium, manganese, nickel, lead, silicon, and titanium. Flow check of the second set of nozzles after ultrasonic cleaning restored them to pre-test condition

3. Experiments and tests are recommended to determine the feasibility of developing a cleaning fluid that might be injected periodically into the fuel system to clean fuel nozzles of the deposits that cause clogging with extended operation on WSX-7165 emulsified fuel.

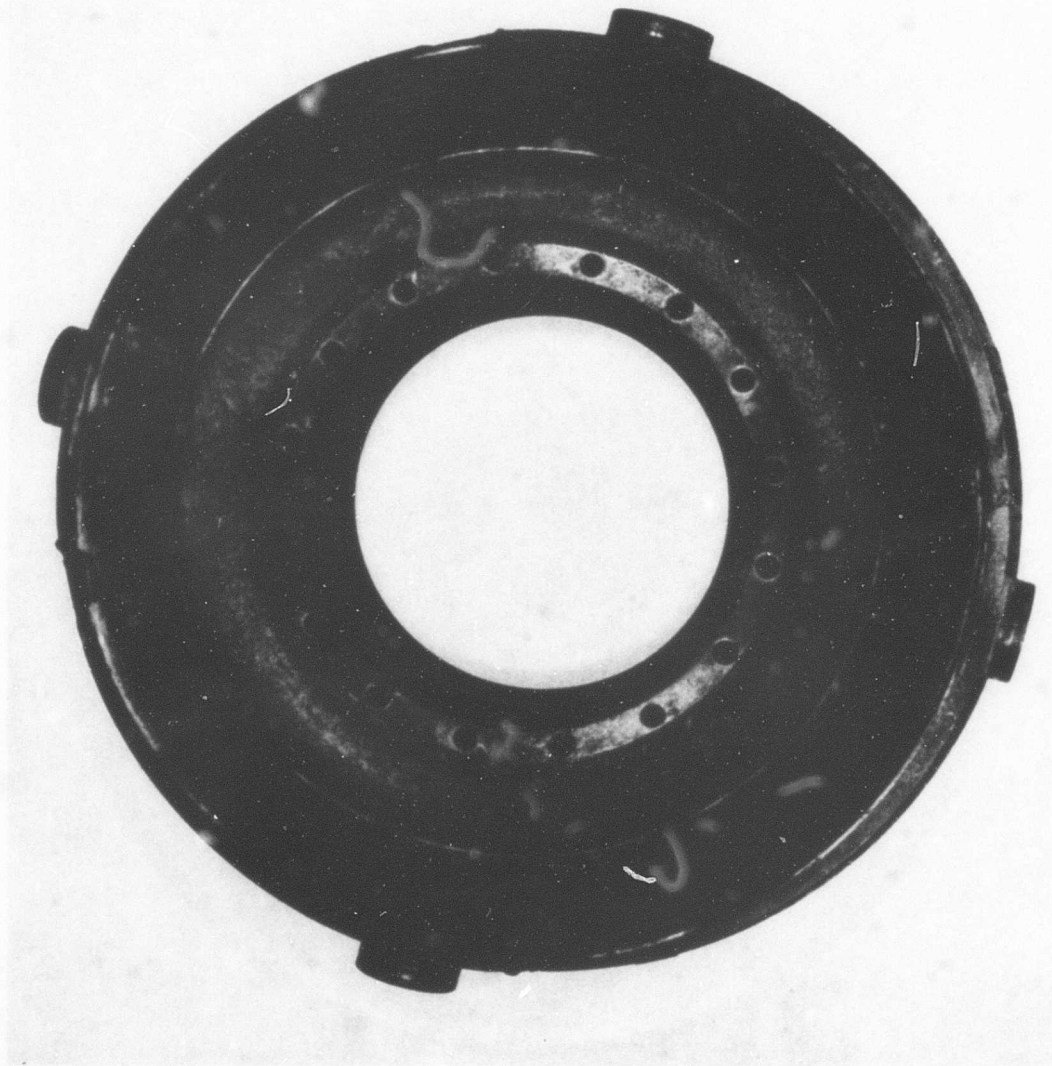
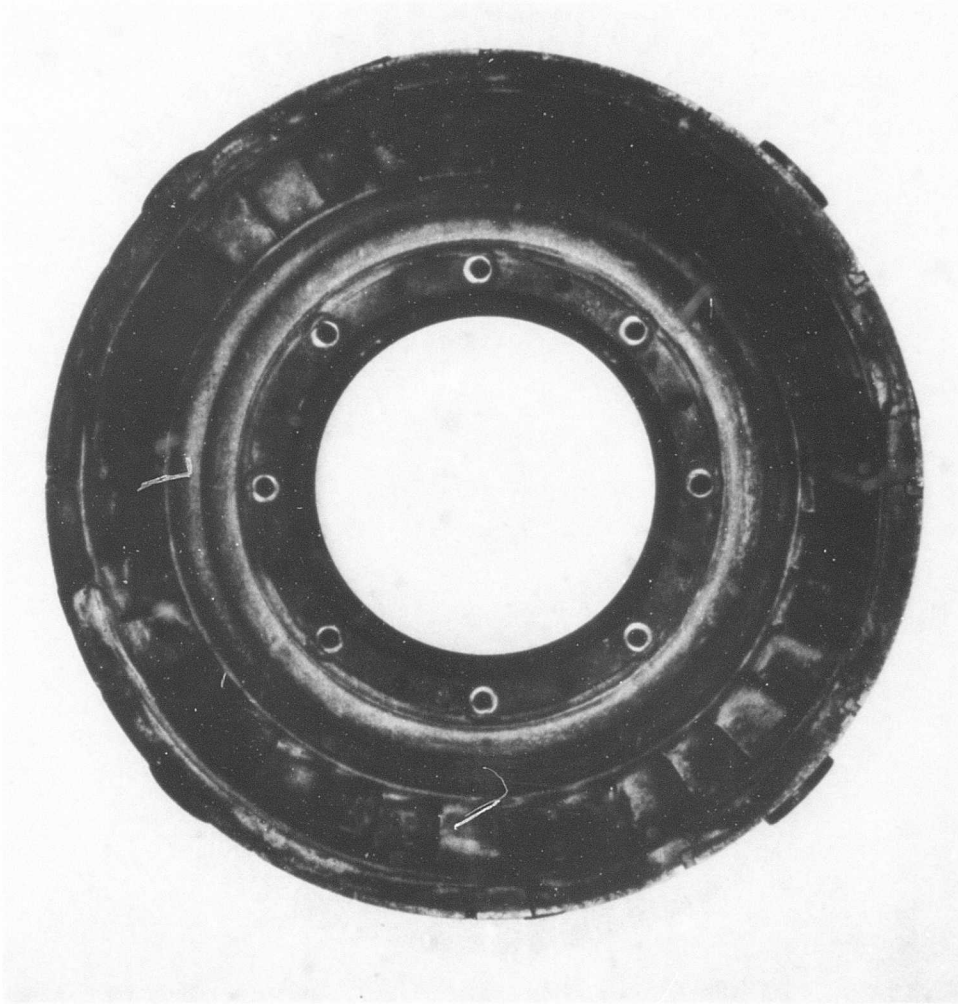
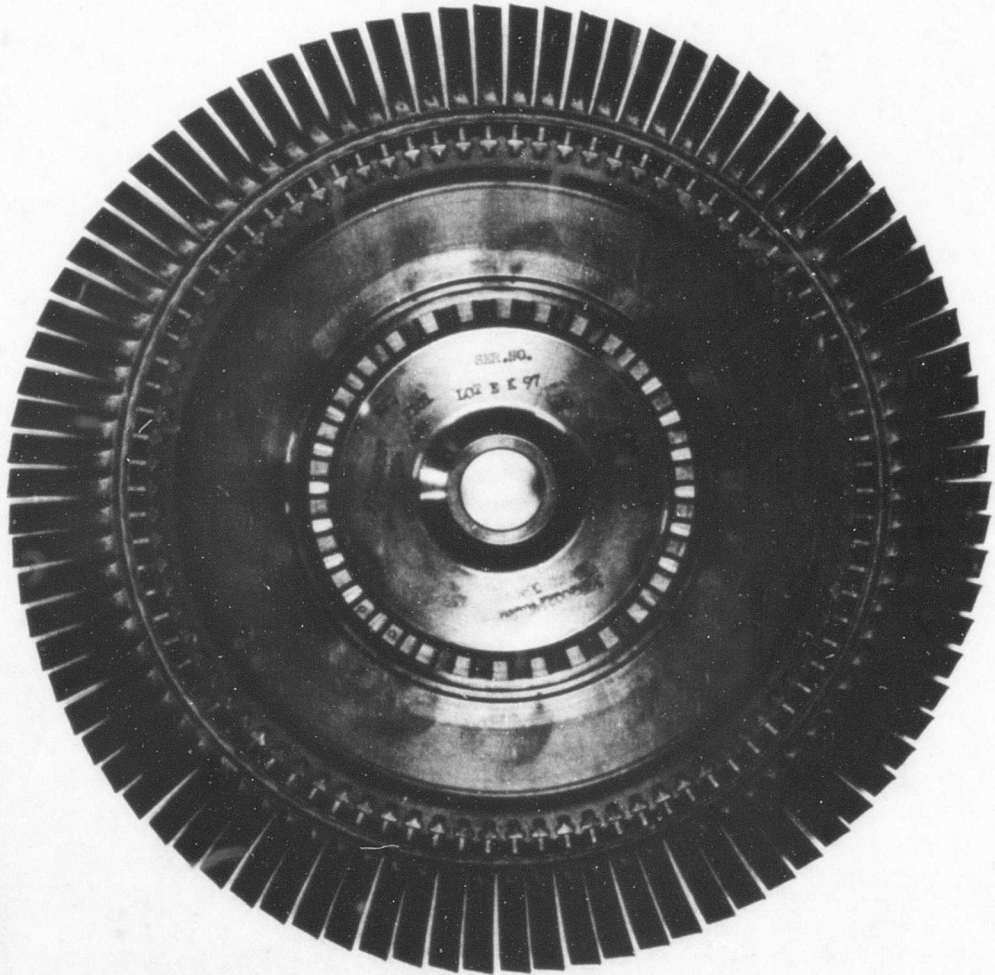
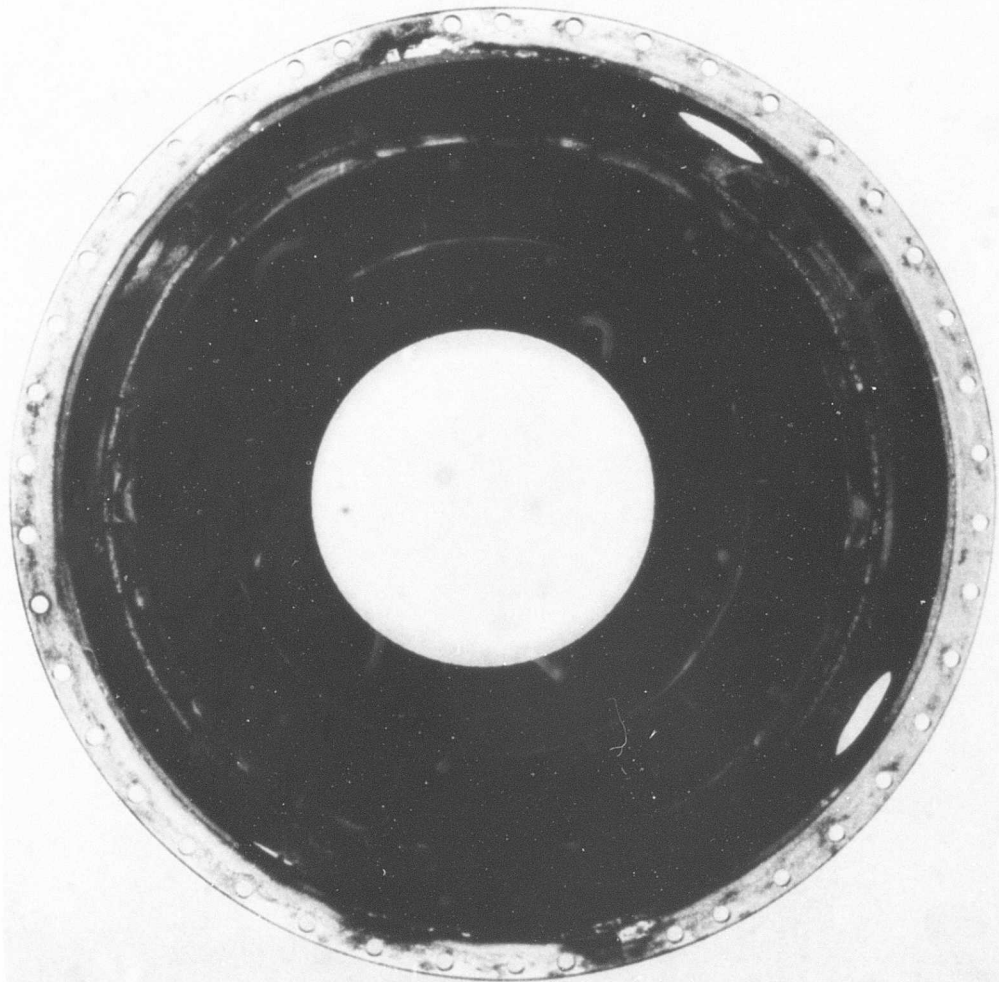
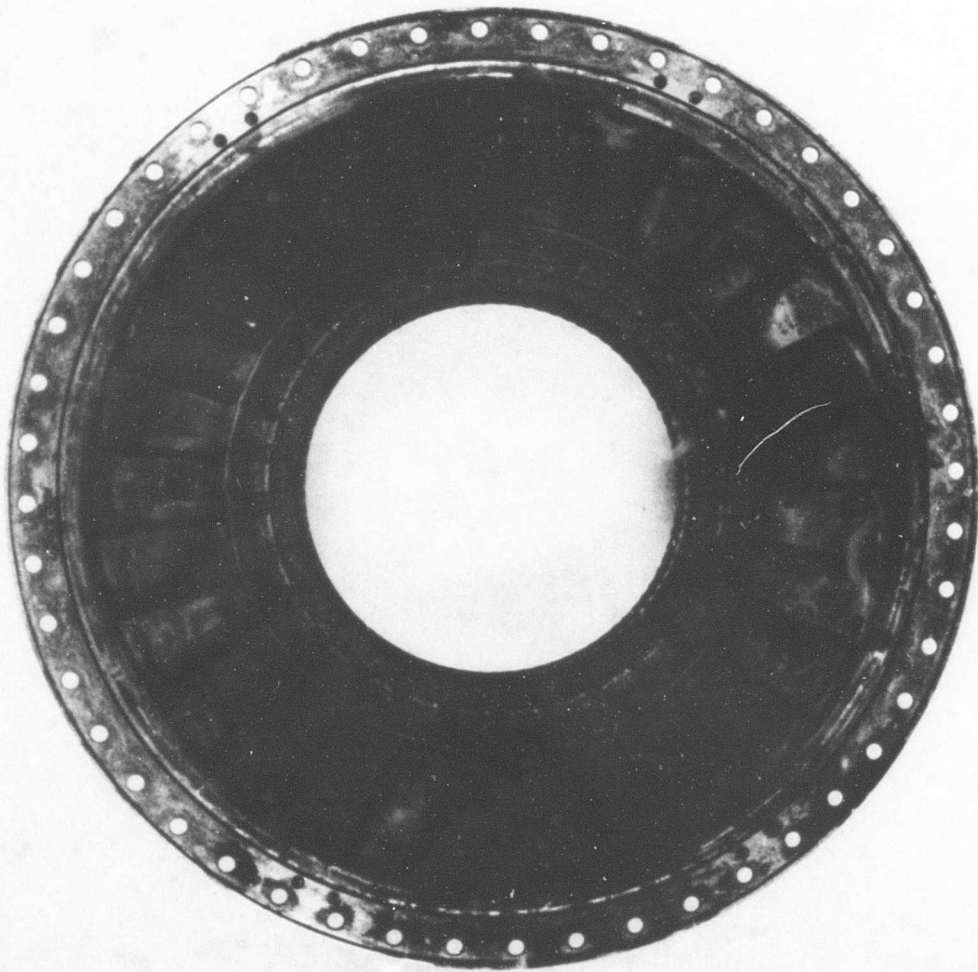
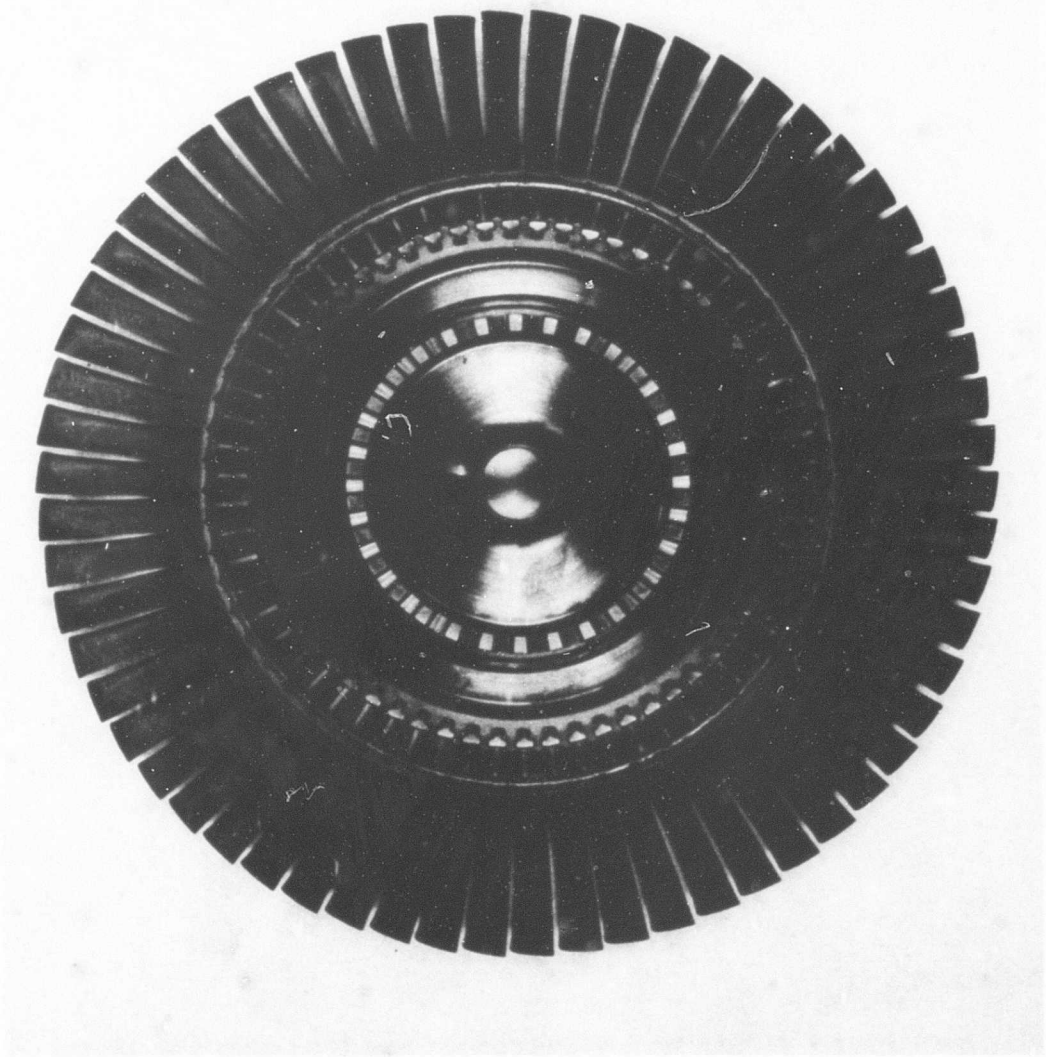
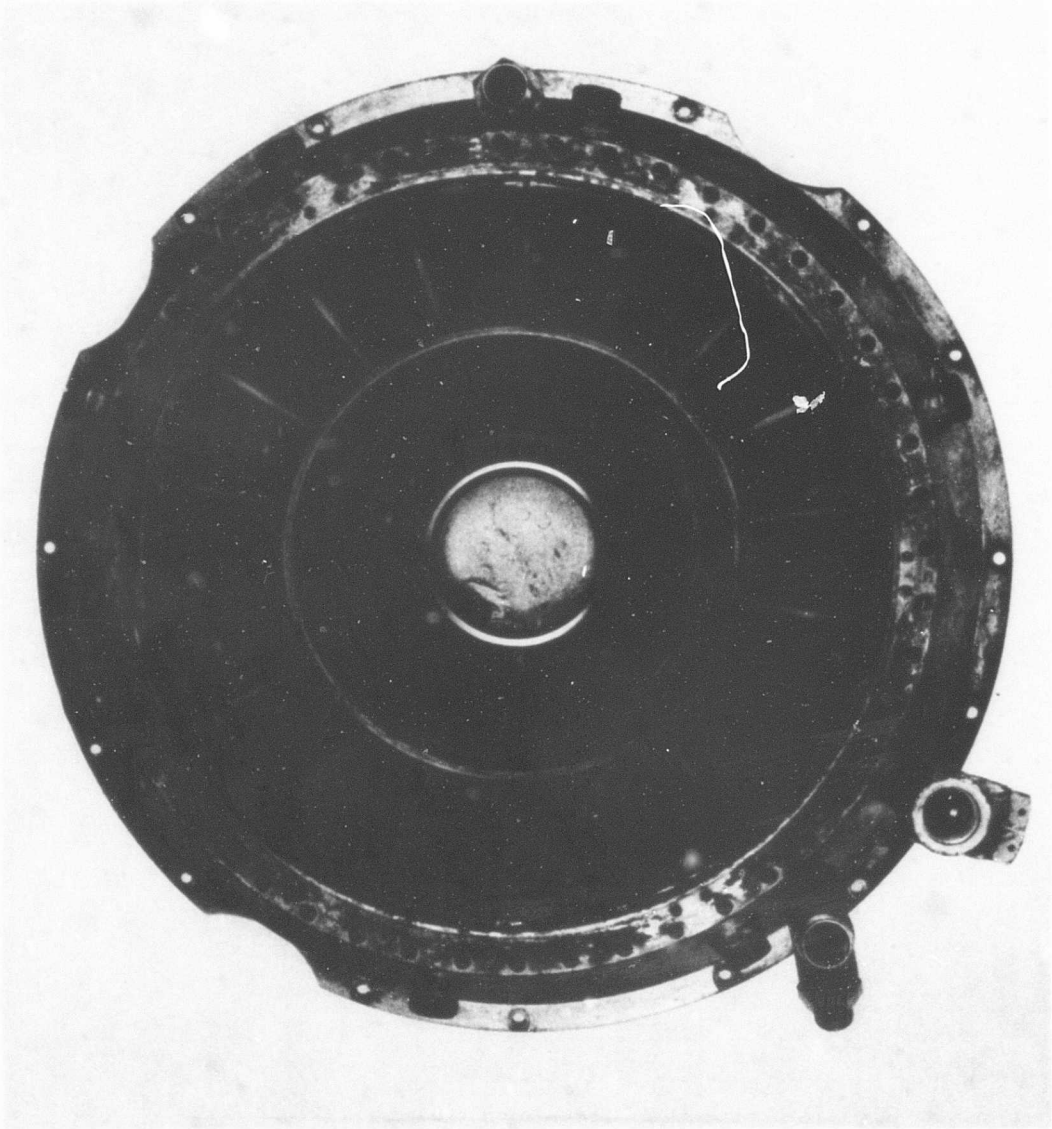
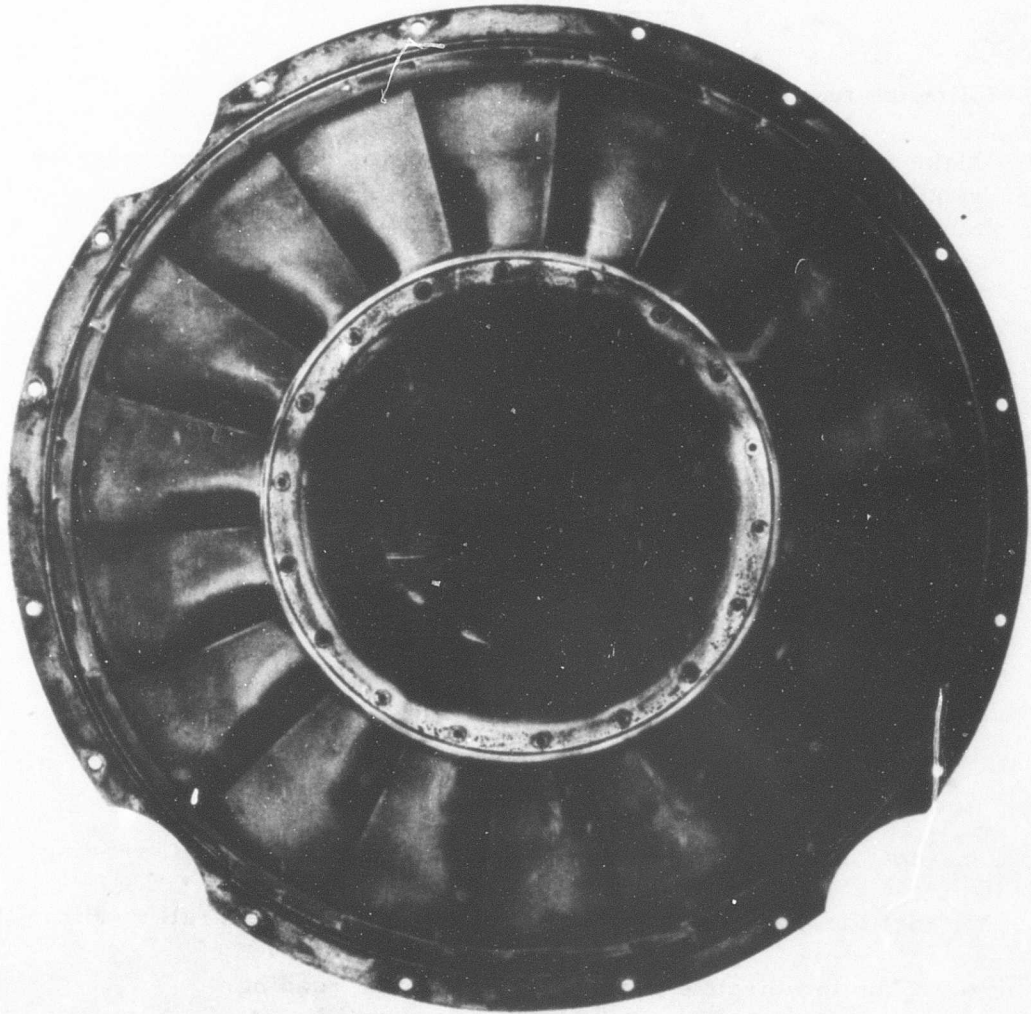
Figures 29 through 36 are pictures of the hot-section parts after test. A blue coloring on most of the hot-section parts was analyzed and found to be a cobalt-based material. It is surmised that the cobalt came from hot-section materials, as each component that was coated incorporated a high percentage of cobalt. The coloring did not show on the second-stage

nozzle or on the power turbine buckets. The second-stage nozzle material is 713 (B50T1239), and the power turbine buckets are A286. The blue-colored coating did not adhere to these two metals. See Appendix VIII.

- 1. First-stage nozzle - Leading edge oxidized; blue deposit on part exposed to primary air; some white salt-like deposits; does not appear to have deteriorated during test.**

6. It is recommended that hot-section materials be tested to determine what deleterious effects (i. e. , alloy depletion, oxidation, etc.) result from burning emulsified fuel.
