**USAAVLABS TECHNICAL REPORT 68-88**

**T63 REGENERATIVE ENGINE PROGRAM  
(EXTENDED ENDURANCE AND ENVIRONMENTAL TESTING)**

Edward J. Privoznik

December 1968

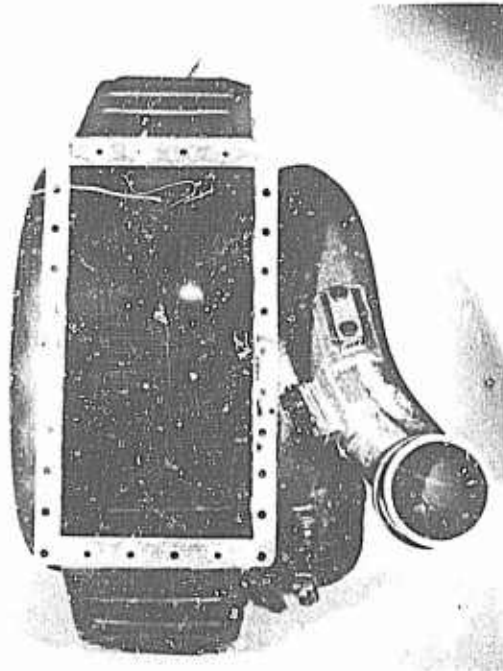
Figure 5. P/N 6858369 Regenerator After 150-Hour Endurance Test.

The regenerators were pressure checked prior to and following the endurance test. At 20 psig, both the left- and right-hand regenerators had a leakage rate well below 0.0045 pound per minute on both checks, indicating that all tubes and braze joints were intact.

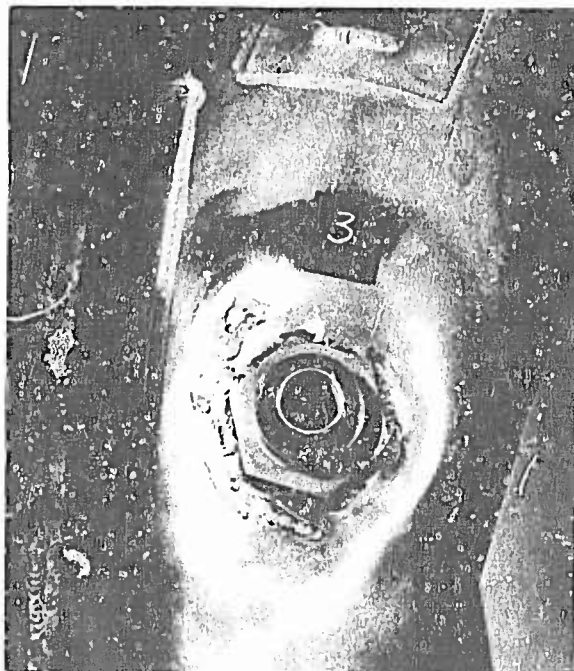
Figure 6. Weld-Repaired Air Inlet Duct.

The regenerator on the right side was removed twice during the endurance test for weld repair of cracks that developed in the inlet air duct at the auxiliary turbine cooling air fitting; a loss of power of 9 to 13% at 1380°F TOT resulted. The weld beads show the location of these cracks in Figure 6.

The regenerators successfully completed a 150-hour endurance test with no evidence of serious deterioration. The sheet metal cracks in the air inlet duct could be eliminated by use of a doubler between the duct and the fitting. The exhaust ducting cracks were a result of wrinkles in the sheet metal which would be eliminated by production tooling.

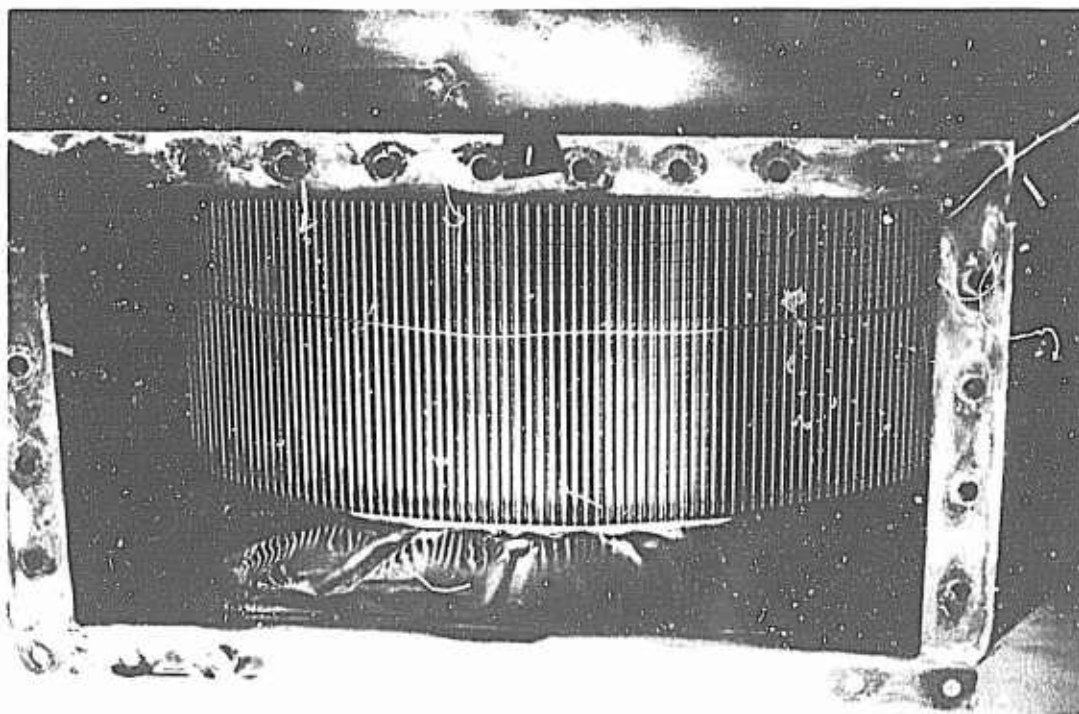
Figure 10. P/N 6858502 Regenerator After Carbon Fouling Test.

As mentioned previously, approximately five quarts of oil went through the regenerators after the postendurance calibration. This oil passed through the regenerator in a liquid state as shown in Figure 10. The liquid oil removed all carbon deposits from the outside of the tubes. There was also some evidence of coked oil on the tubes at the junction of the tubes to the header. However, the high oil consumption occurred after the completion of the postendurance calibration. Therefore, the performance evaluation before and after the 3-hour idle run was valid.

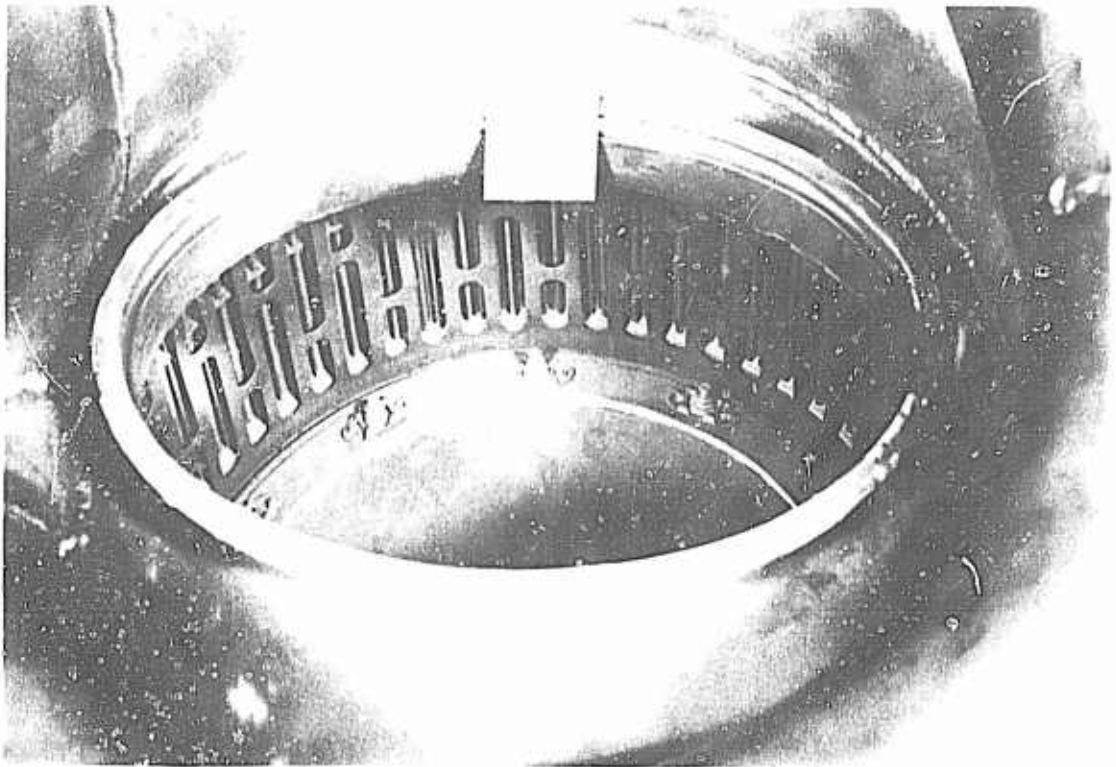
Figure 15. P/N 6858501 Regenerator (Left Side) After Dust Ingestion.

One of the potential problem areas in the regenerator is dust collection in the air inlet and outlet ducts. To determine the amount of dust collected in the regenerators, the regenerators were weighed before and after the dust ingestion test. The increase in weight was 0.04 pound on the left-hand regenerator and 0.07 pound on the right-hand regenerator. This increase in weight is not considered to be significant. Figures 15 and 16 show the left-hand regenerator after the dust ingestion test. There was some indication of a scale formation on the first row of tubes (gas inlet)

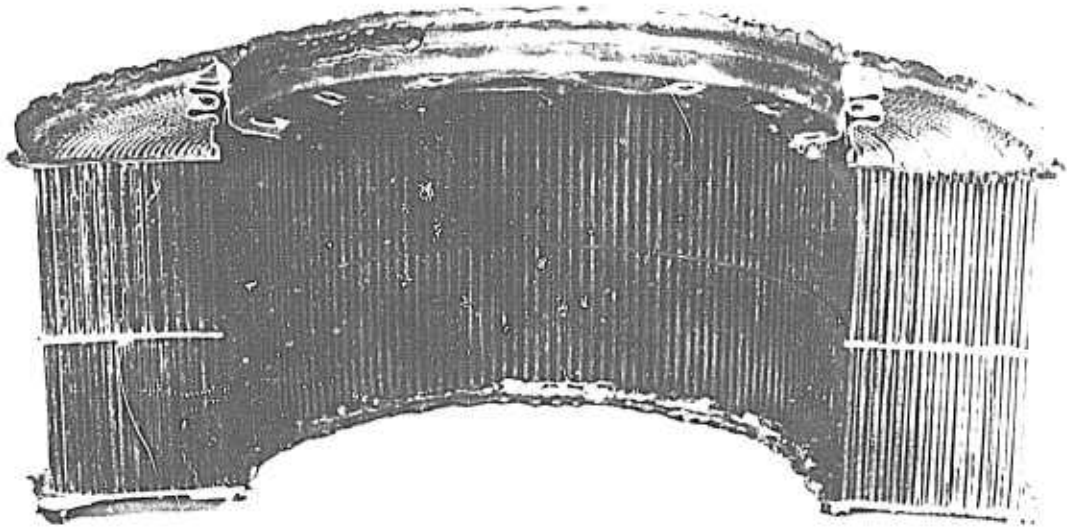
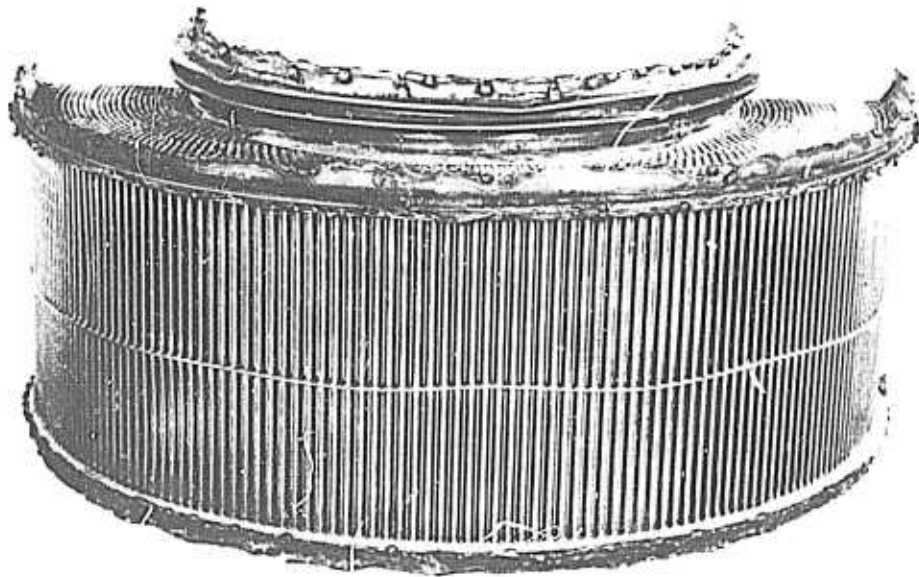
Figure 20. Gas Side of Regenerator Core—Second Pass.

Figures 20 and 21 show the condition of the second pass of the regenerator core. Again, there was no visual indication of erosion or damage to the tubes as a result of the dust ingestion. There was no evidence that the scale on the gas inlet side was more pronounced than the scale on the first pass.

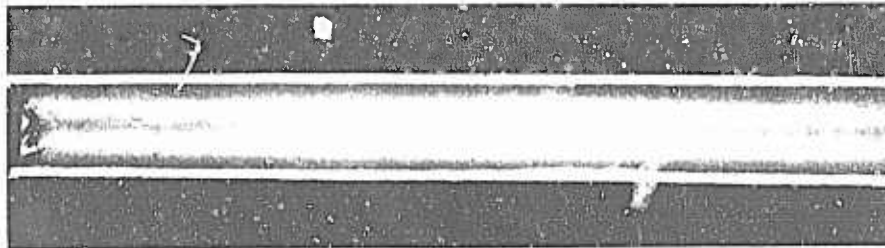
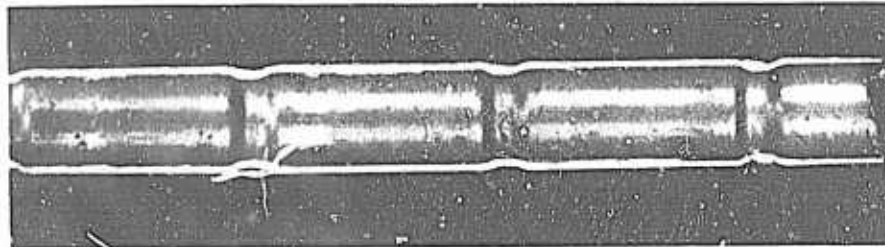
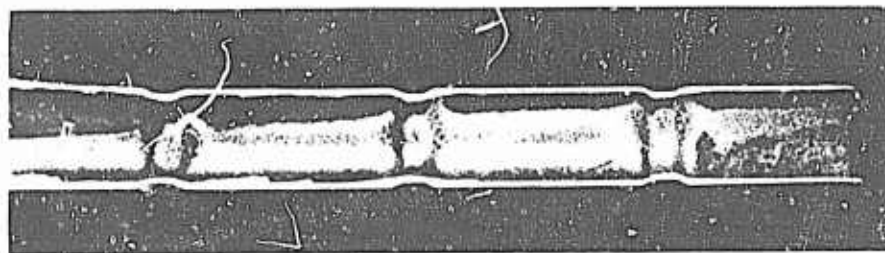
Figure 23. Inside Diameter of Gas Inlet Tubes—6X View.

Figure 23 shows the typical condition of the inside diameter of the tubes. All tubes in both the first and the second pass were very clean, with the exception of braze on the ID of some tubes in the vicinity of the tube-to-header braze joint.
