MISCELLANEOUS PAPER S-69-27

LANDING MAT OVERLAY ON DETERIORATED PAVEMENT

BARE BASE SUPPORT

U. S. Army Engineer Waterways Experiment Station
CORPS OF ENGINEERS
Vicksburg, Mississippi

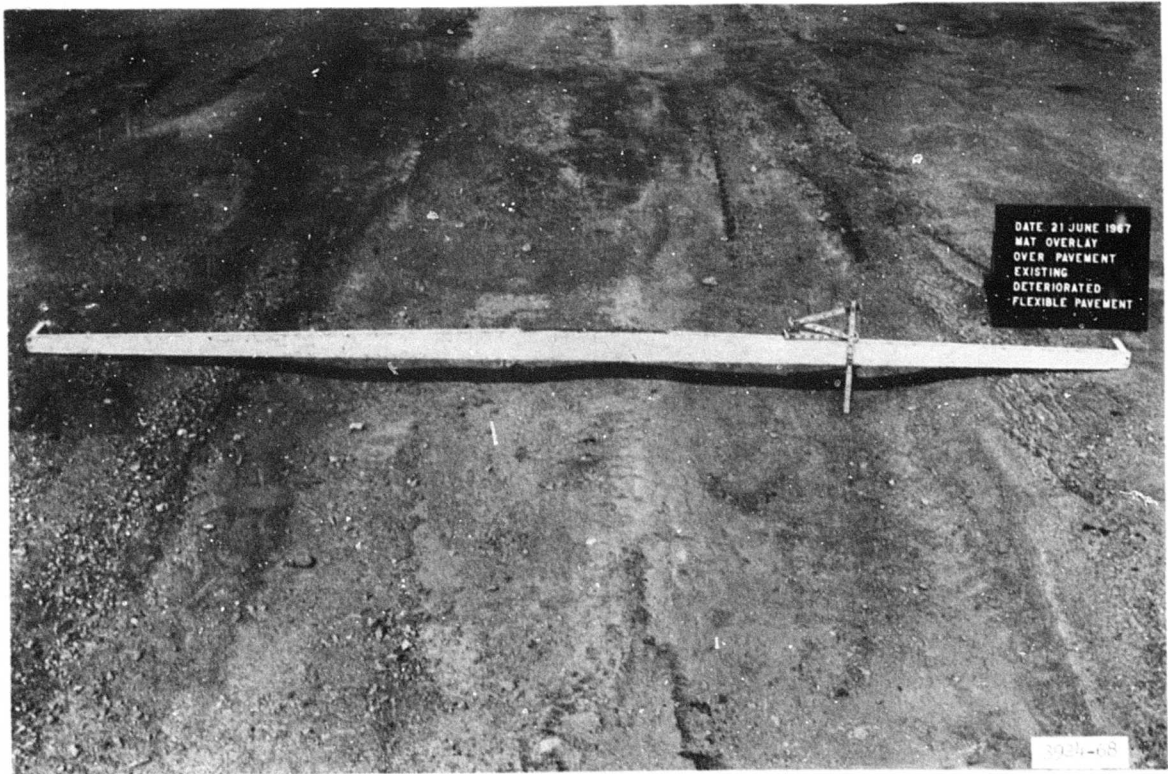
Photograph 3. Deteriorated asphaltic concrete pavement used for test section

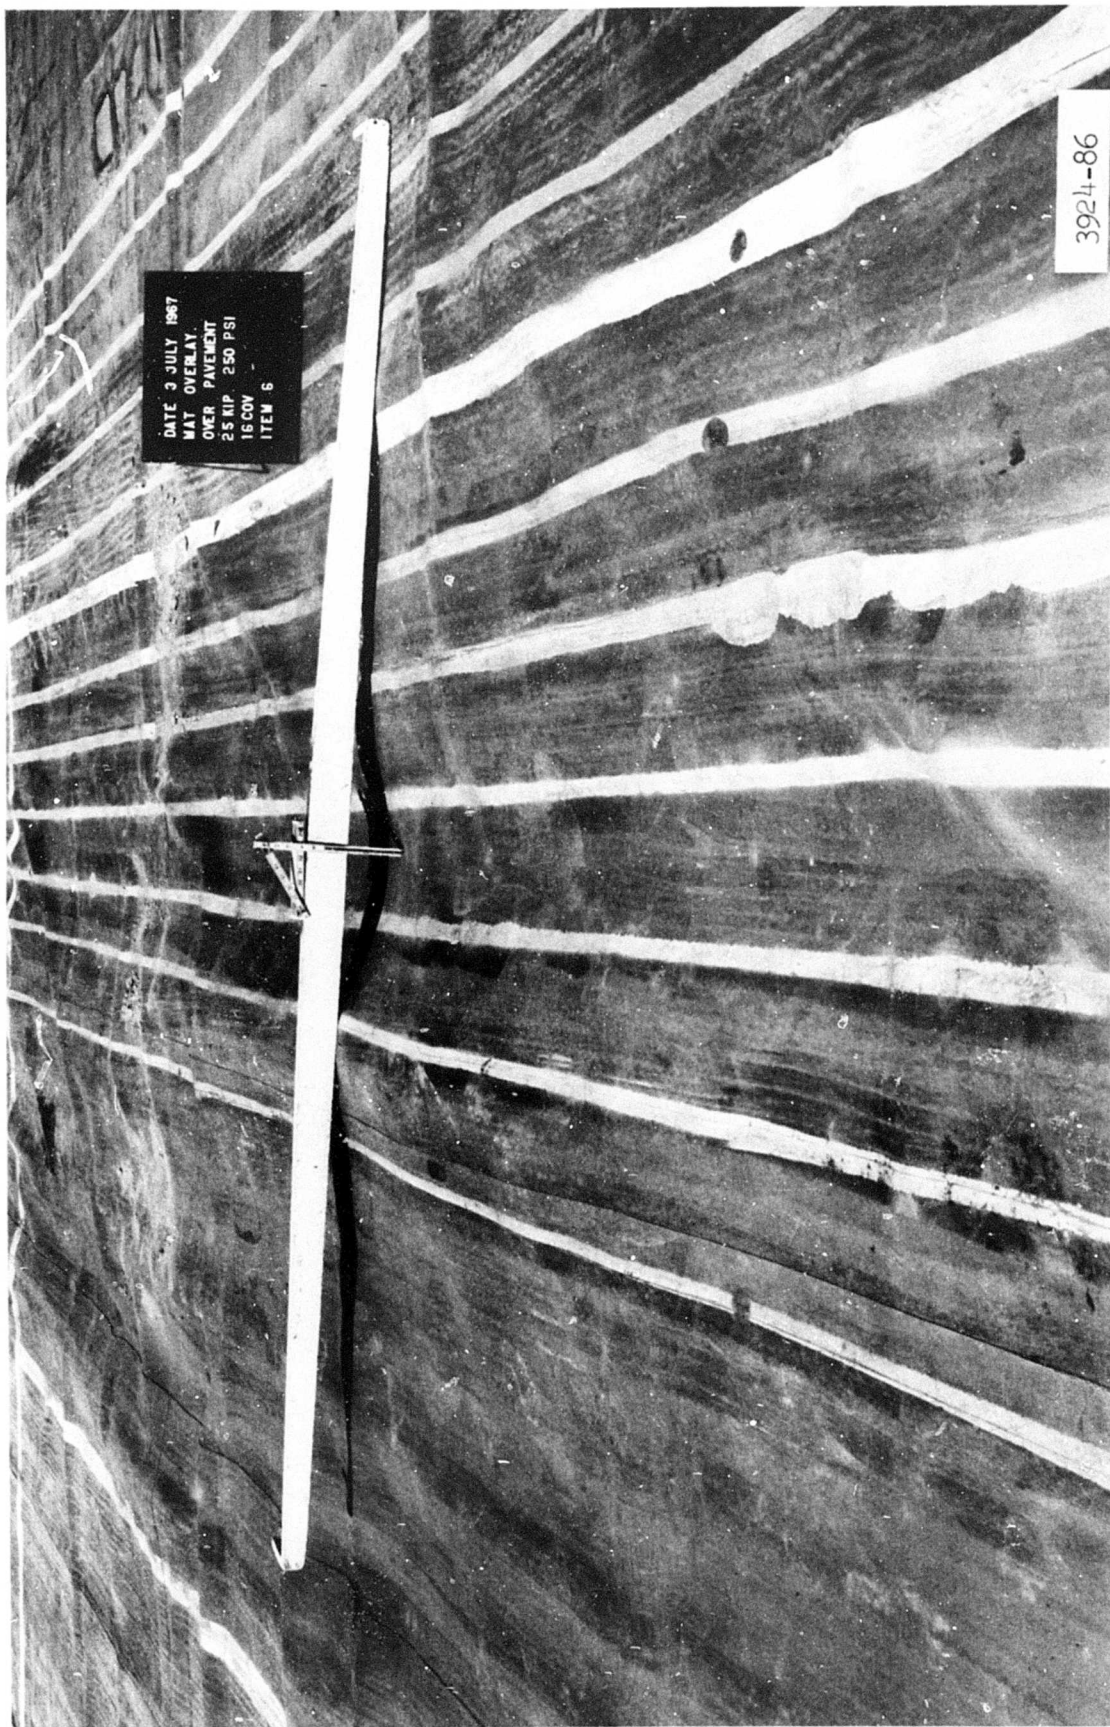
31. Test traffic was begun on 30 June 1967. General views of items 1 through 6 prior to traffic are shown in photographs 10 through 15. Rutting began to develop in item 6 at about 10 coverages. By 16 coverages there was an average rut depth of approximately 2.5 in. as shown in photograph 16. Investigation of the lean clay leveling material revealed that the in-place moisture content was approximately 16.5 percent, which was too high for the compaction effort being exerted by the simulated F-4C test

load. The high soil moisture resulted in the development of pore pressure in the soil under the high-pressure tire traffic with a resultant loss in strength. Therefore, at this stage of the test, it was necessary to remove the WX18 membrane from item 6 and to dry the lean clay soil to a lower water content. The soil was dried back to about 11.5 percent moisture and compacted with 16 coverages of the 50,000-lb roller described in paragraph 23. The compacted clay overlay was then proofrolled with four coverages of the test load vehicle, after which an average surface CBR of 44 was indicated. The compacted clay was then fine bladed with a road grader, the WX18 membrane was replaced on the item and anchored, and the traffic test was resumed.

Photograph 16. Item 6 after failure at 16 coverages

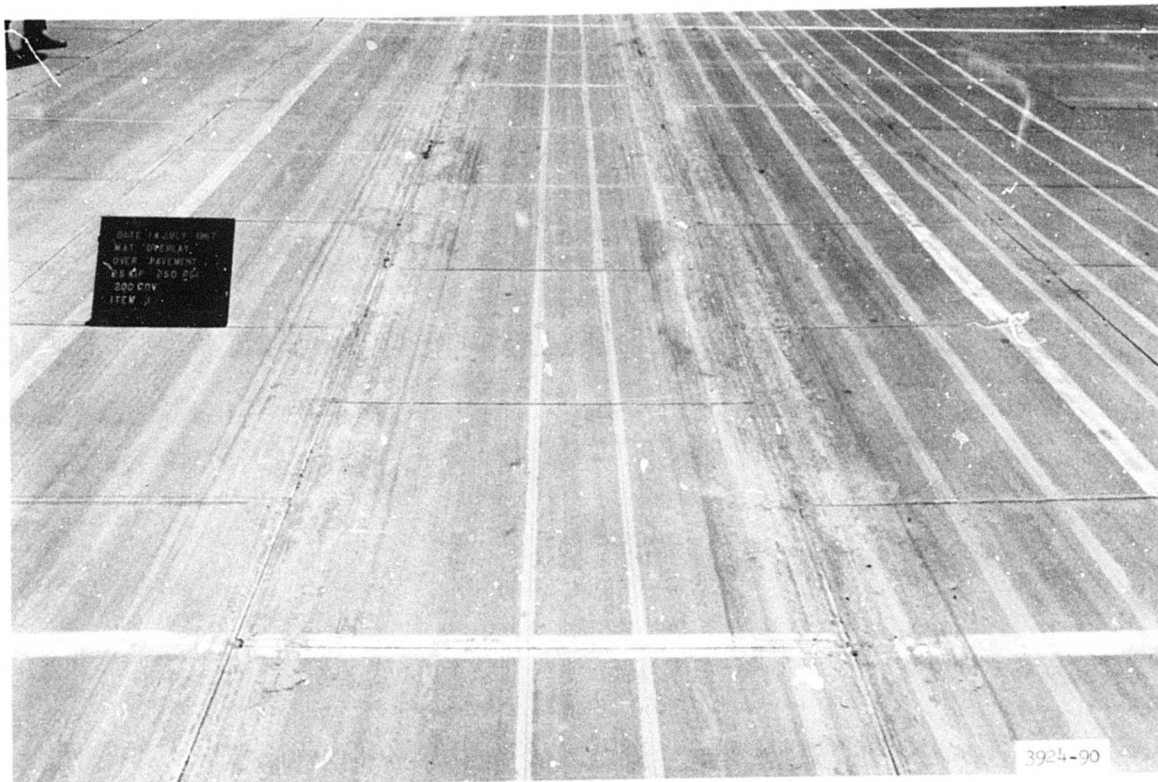
32. On 12 July, 64 coverages of traffic were applied to the test section for a total of 80 coverages. During these 64 coverages, there was a light rainfall in the test area, and it was observed that a slight amount of soil (i.e. the fines in the clay gravel) was pumping up through the mat joints in item 3. The pumping was minor, however, and did not affect the serviceability of the item. The remainder of the test section indicated no signs of soil pumping and was quite serviceable at this time.

Photograph 19. Item 3 after 120 coverages applied during light rainfall (200 coverages total). Note soil pumped onto mat surface

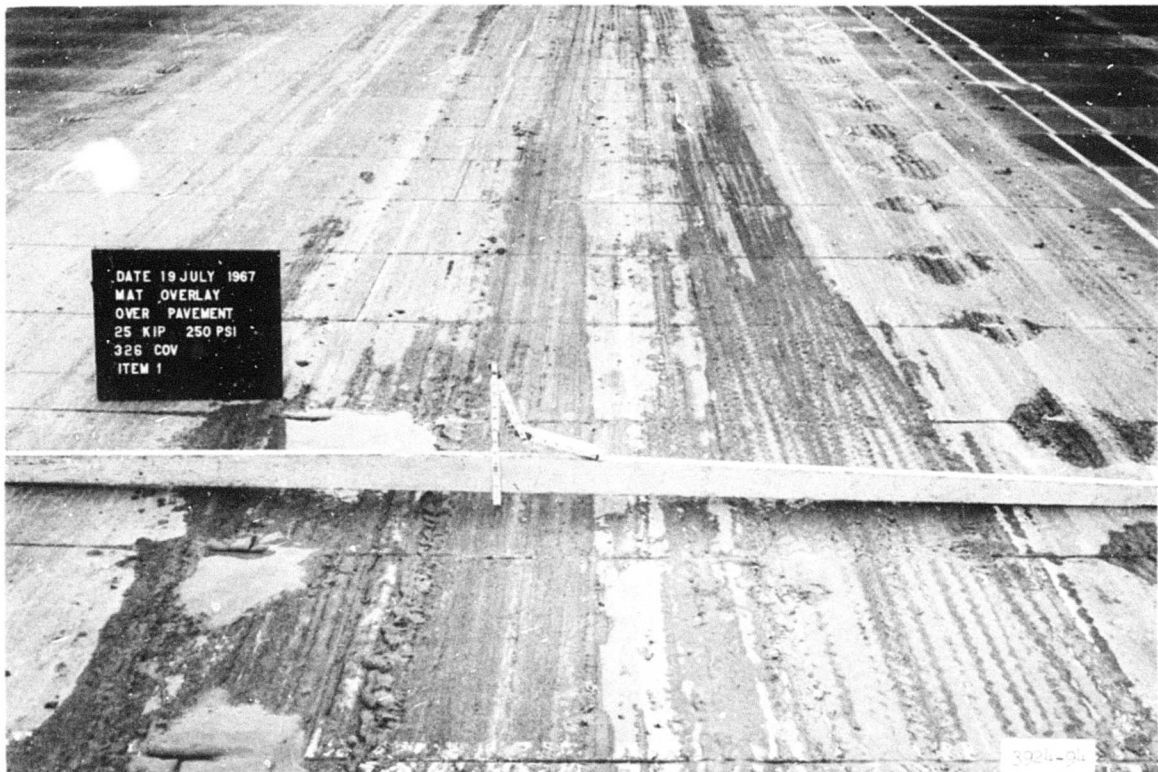
34. From 14 to 18 July, the test section received 100 coverages (total 300) and no difficulties were experienced. On 19 July, 26 coverages were applied during a heavy rainstorm. Severe pumping of the sand in items 1 and 2 and of the clay gravel fines in items 3 and 4 occurred. No soil pumping was observed in items 5 and 6. Views of items 1 through 6 at 326 coverages are shown in photographs 23 to 28, respectively. A close-up of sand pumped through the mat joints between items 1 and 2 is shown in

Photograph 23. Item 1 after 26 coverages applied during heavy rainfall caused severe pumping (326 coverages total)

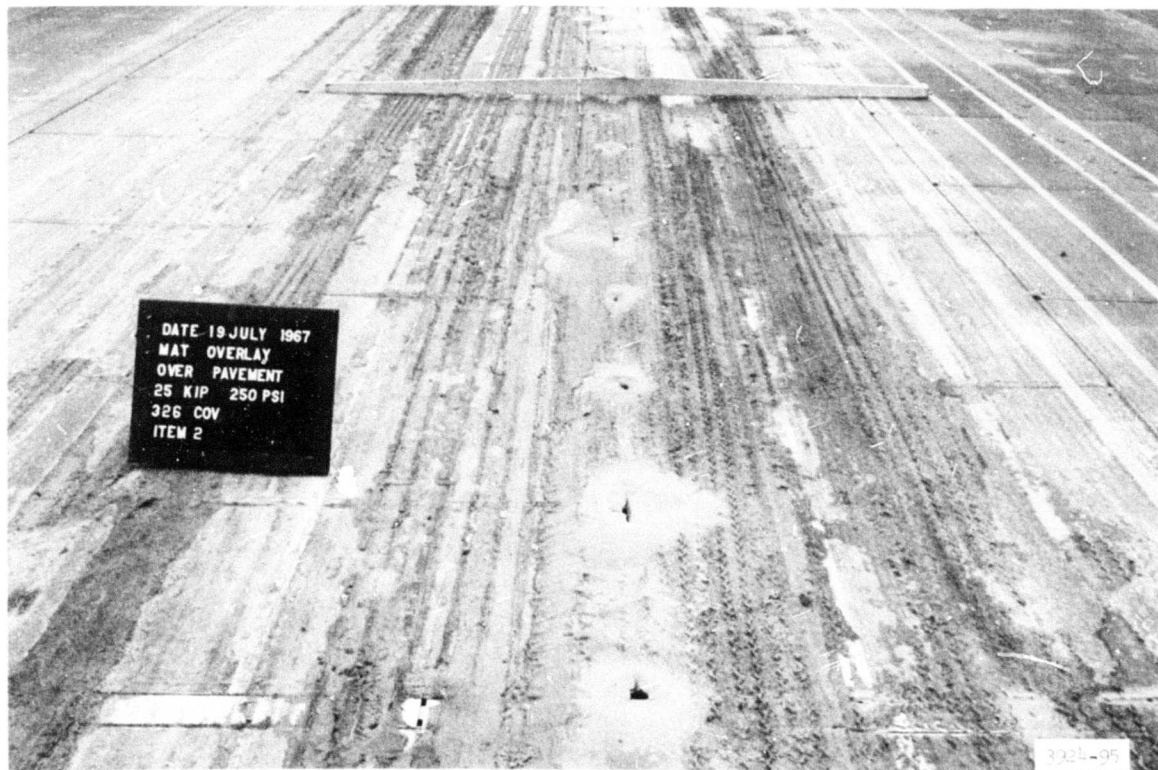
Photograph 24. Item 2 after 26 coverages applied during heavy rainfall caused severe pumping (326 coverages total)

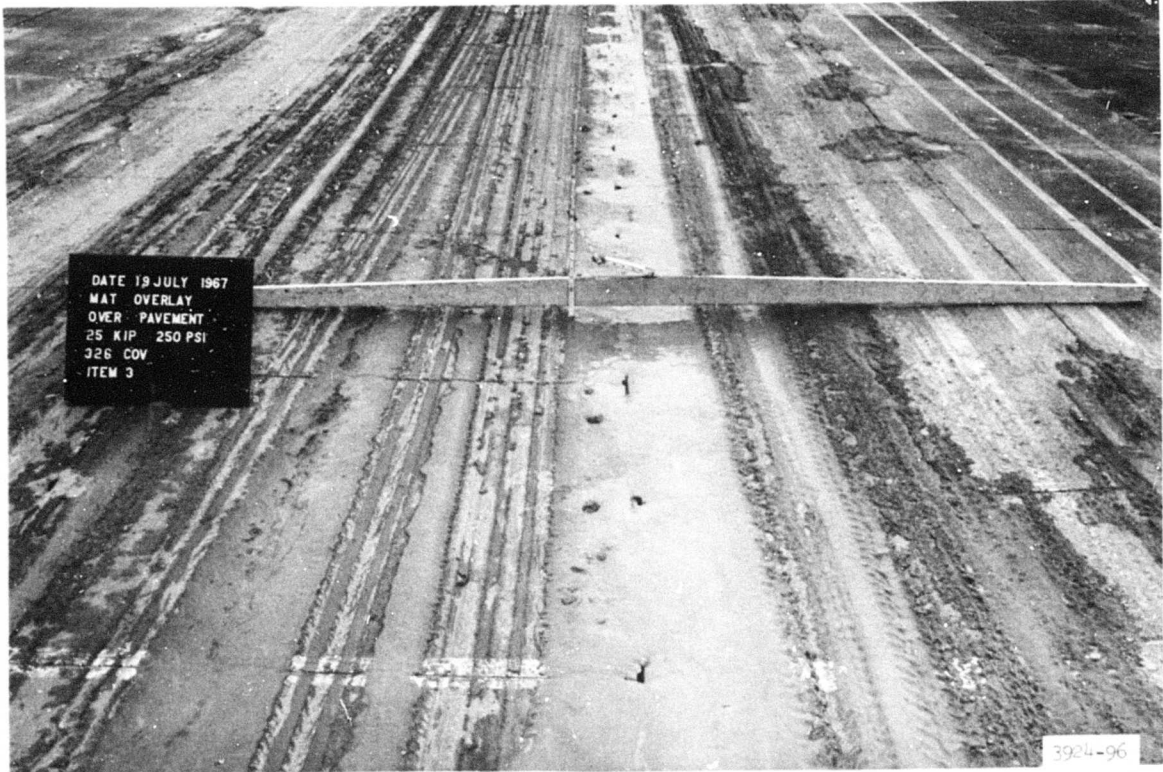
Photograph 25. Item 3 after 26 coverages applied during heavy rainfall caused severe pumping (326 coverages total)

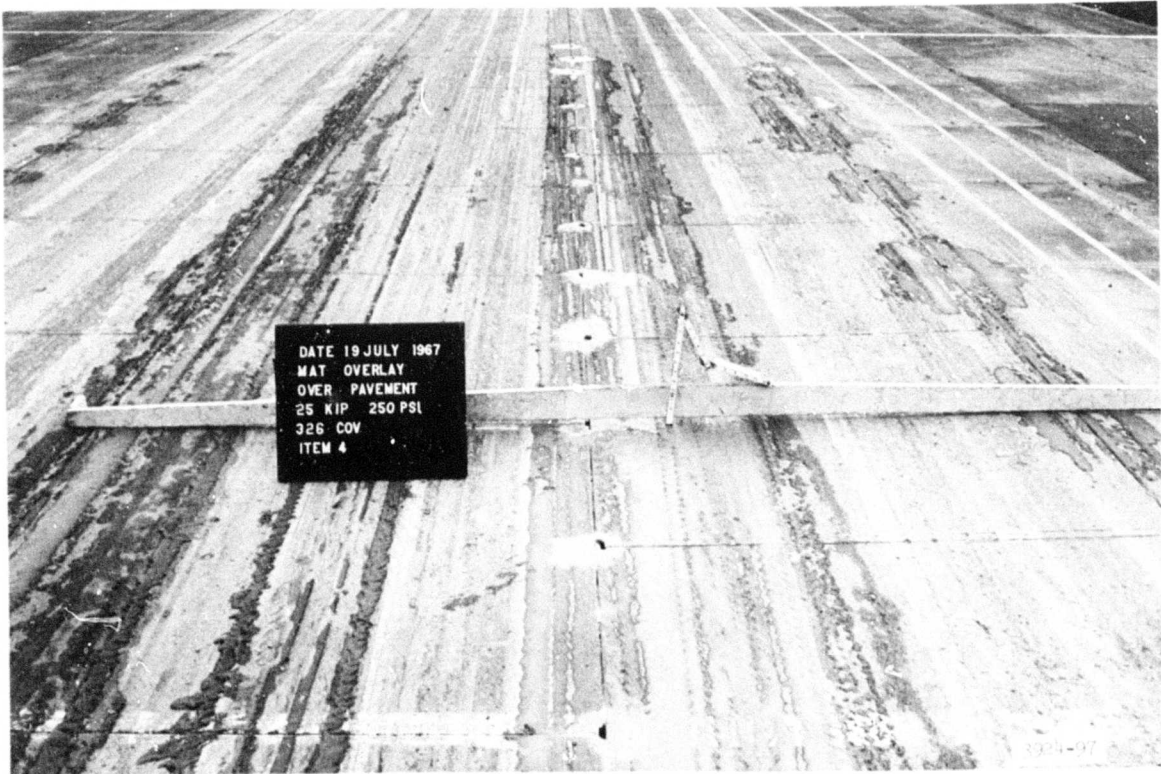
Photograph 26. Item 4 after 26 coverages applied during heavy rainfall caused severe pumping (326 coverages total)

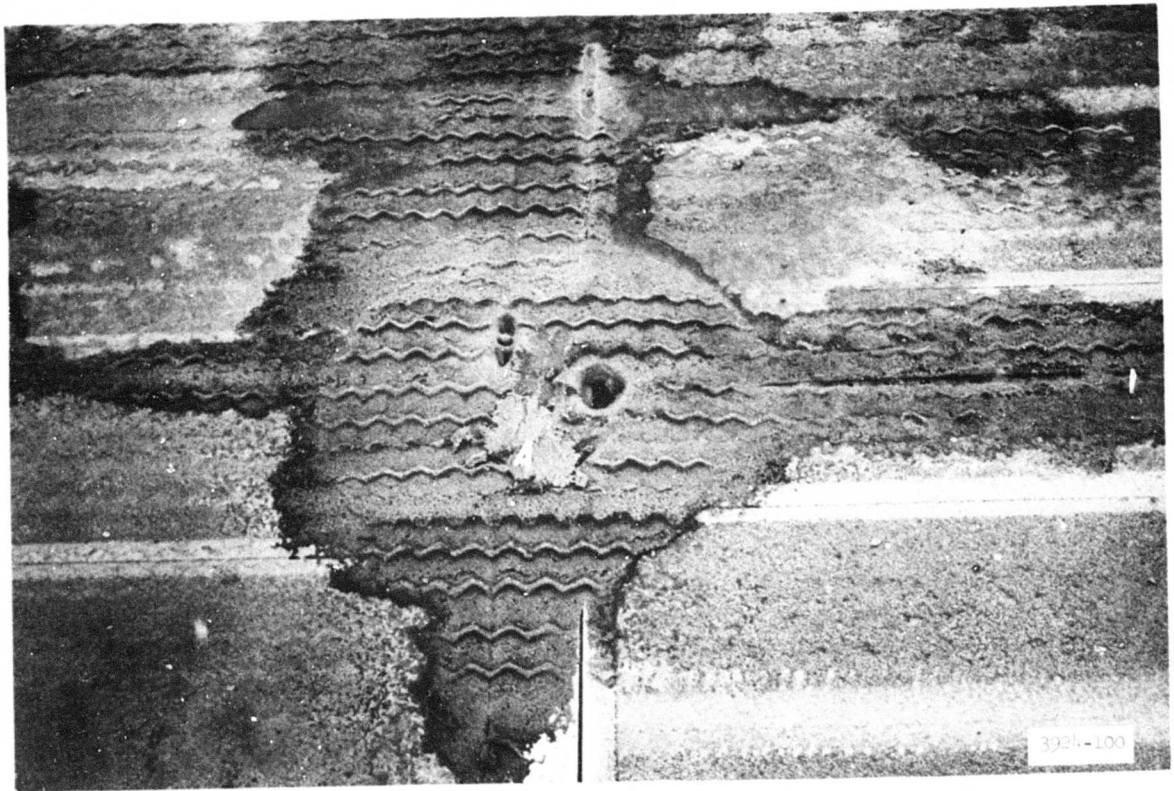
photograph 29. After 330 coverages, it was decided that major maintenance would be required to prevent further deterioration of items 1 through 4; therefore, test traffic was suspended.

Photograph 29. Sand that pumped through the mat joints between items 1 and 2 when section was trafficked during heavy rainfall

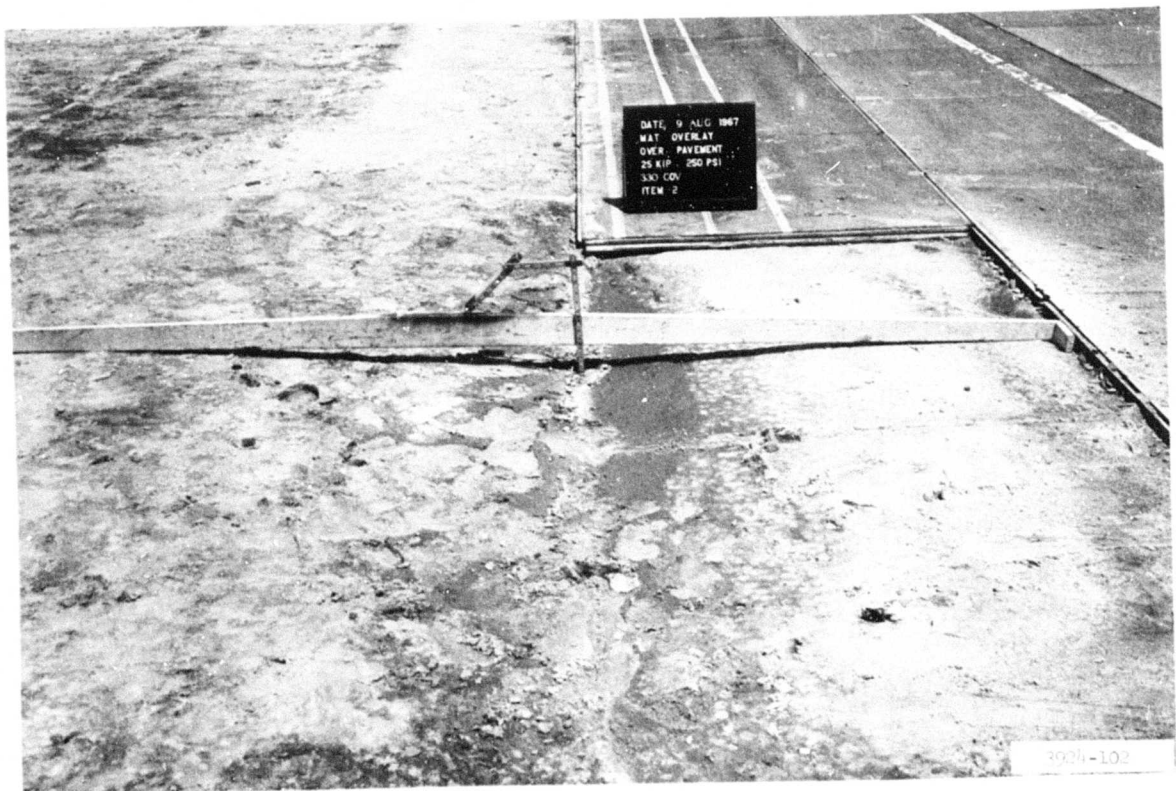
Photograph 30. Condition of sand overlay after 330 coverages

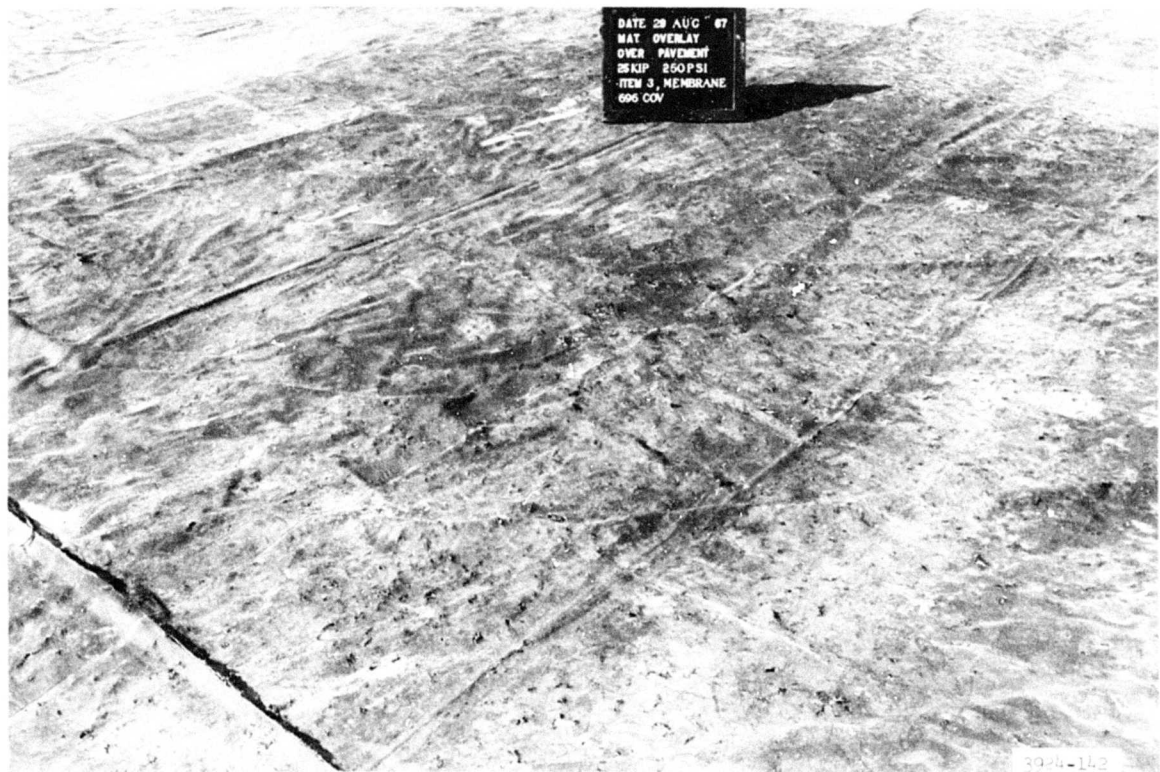
Photograph 44. Numerous holes worn in T16 membrane on item 3 during 366 coverages (696 total coverages on section)

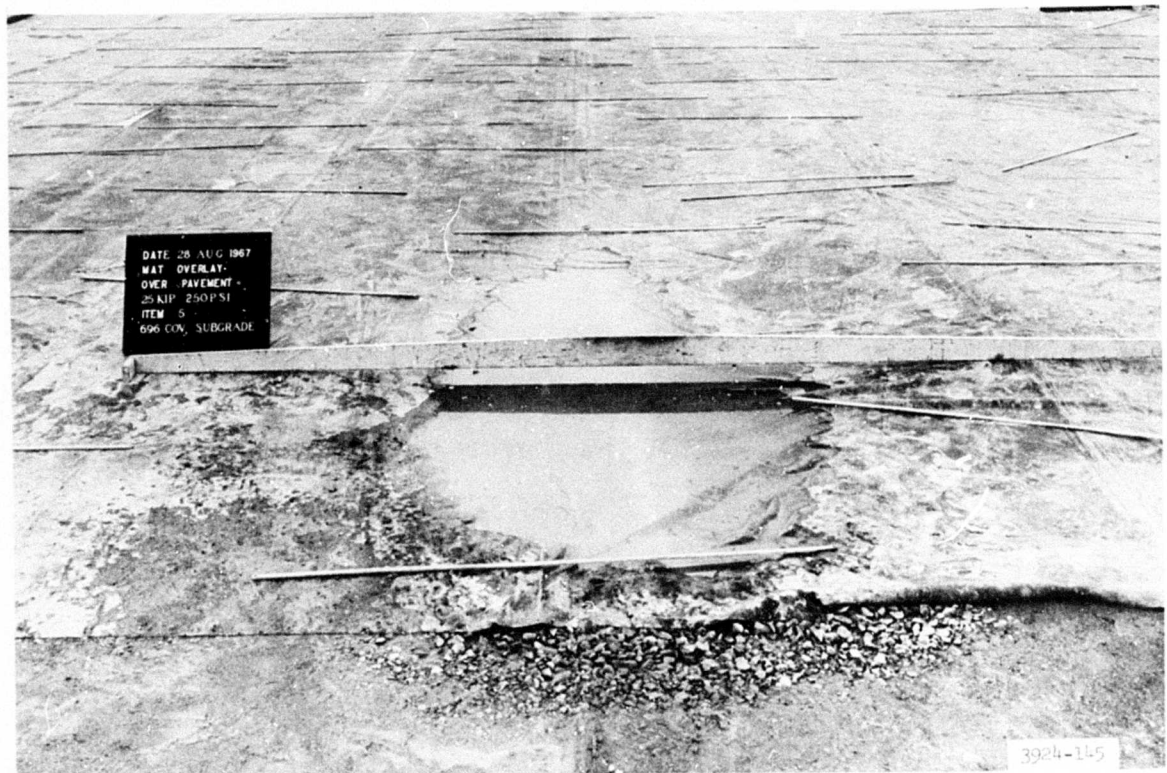
Photograph 46. Washed clay gravel between items 4 and 5 (rods are XM19 connector bars)

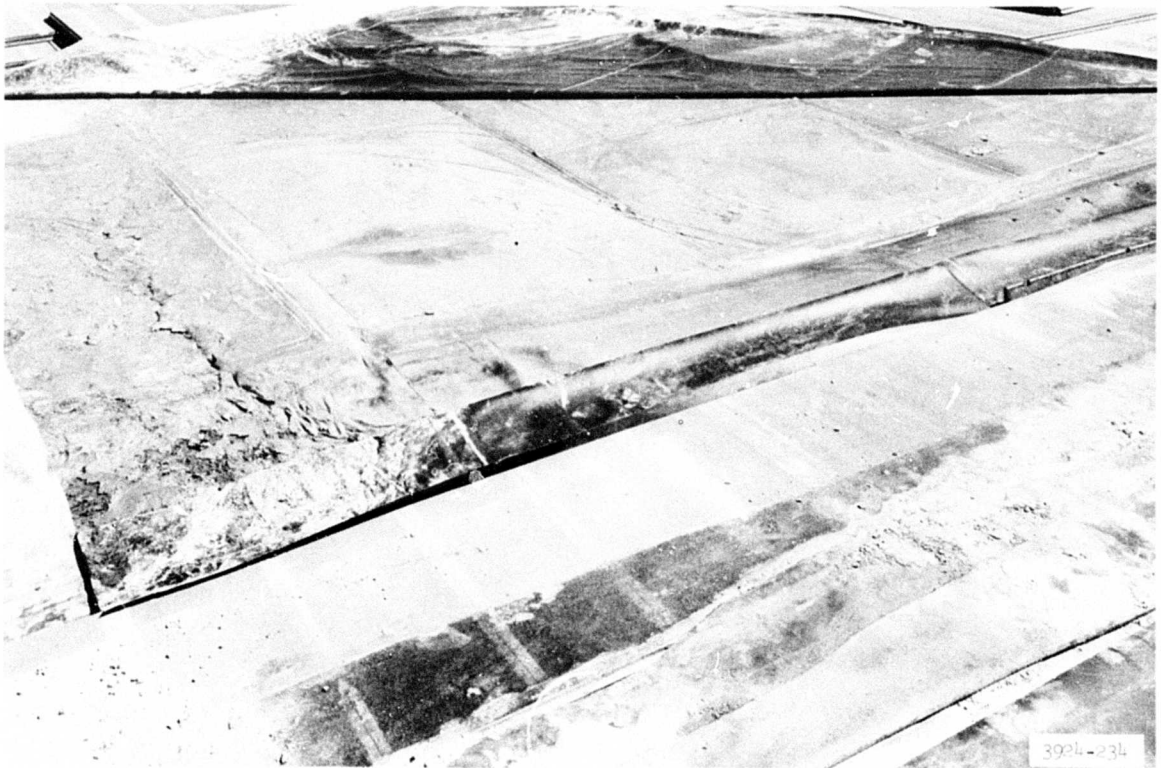
46. From 28 September to 11 October, an additional 502 coverages were applied for a total of 1790. During this period, several panels of XML9 mat appeared to be developing core damage; however, no difficulties were experienced with the overlay soil courses. On 12 October, 60 coverages were applied for a total of 1850. At this time, it was observed that a panel of XML9 located at the northwest corner of item 5 had developed core failure. The failed panel and several adjacent panels were removed. An inspection of the underlying membrane revealed that several holes had been abraded in the T16 membrane, which during previous showers had resulted in leakage to the soil immediately under the failed panel (photograph 51). The wet soil was removed and replaced with soil cement, the membrane was replaced, the holes were patched with waterproof tape, and the landing mat was relaid. The failed panel was replaced with a new XML9 panel. Test traffic was resumed on 18 October. By 24 October, 2149 coverages (total) had been applied to the test section. No damage to or pumping of the overlay soils was observed; however, several panels of XML9 began to indicate signs of fatigue.

Photograph 51. Condition of soil under failed panel of XM19 (1850 coverages)

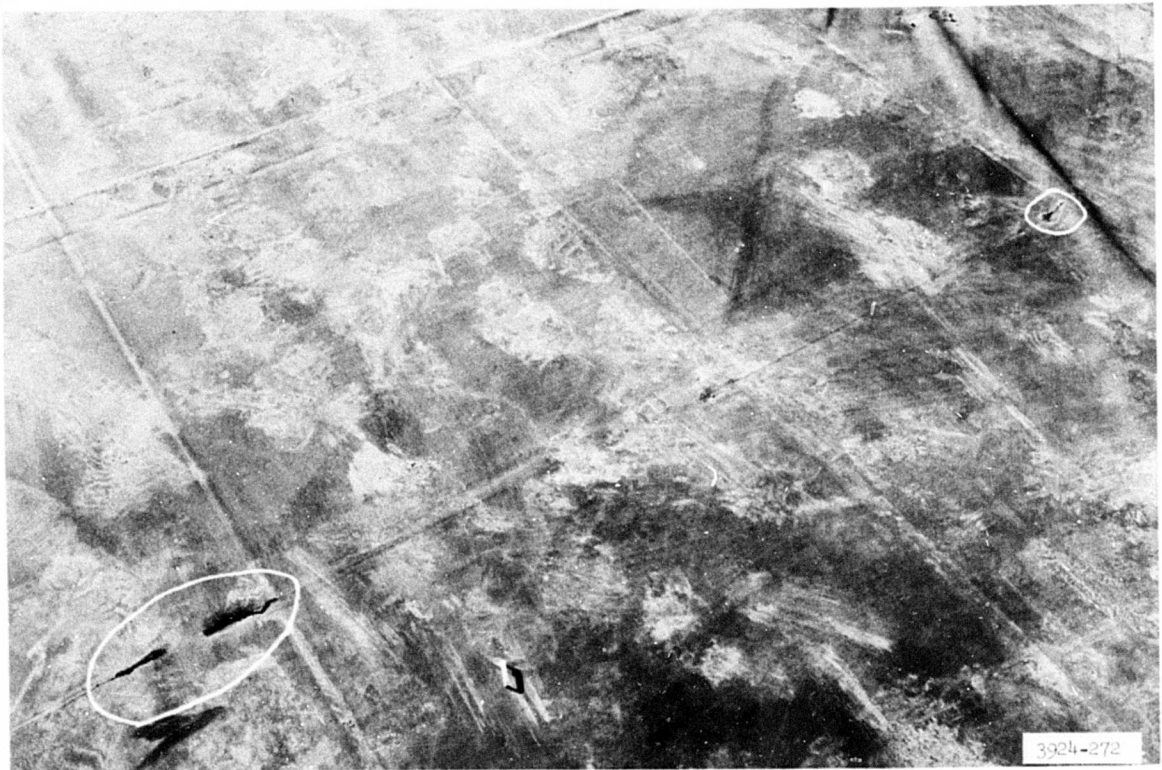
48. All mat was removed from the test section. Inspection of the test section revealed that the continual movement of the individual mat planks during trafficking had caused a pinching action on the T16 membrane directly below the mat joints in items 1 and 2. The pinching had cut the membrane in several locations, which allowed water to enter the sand and cause subsequent pumping. Closeup views of the result of the pinching action of the mat in items 1 and 2 are shown in photographs 57 and 58, respectively. The soil pumping had not been particularly severe, and as shown in photographs 59 and 60, the underlying sand was still relatively smooth and stable. An examination of the WX18 membrane in item 3 revealed that the WX18 fared little better than the T16 membrane when exposed to the abrasive action of the mat and clay gravel. Photograph 61 shows that numerous holes were worn in the WX18 membrane.

58. The service life of the T16 membrane when used between a sand overlay and landing mat appears to be about 2000 coverages. When traffic was stopped at 2170 coverages, it was found that several holes had been worn in the T16 by the pinching action of the mat joint flexure during traffic. Since no evidence of pumping of either dry powdery material during dry weather or wet sand during wet weather was found prior to this

Photograph 57. Membrane cut by pinching action of mat in item 1

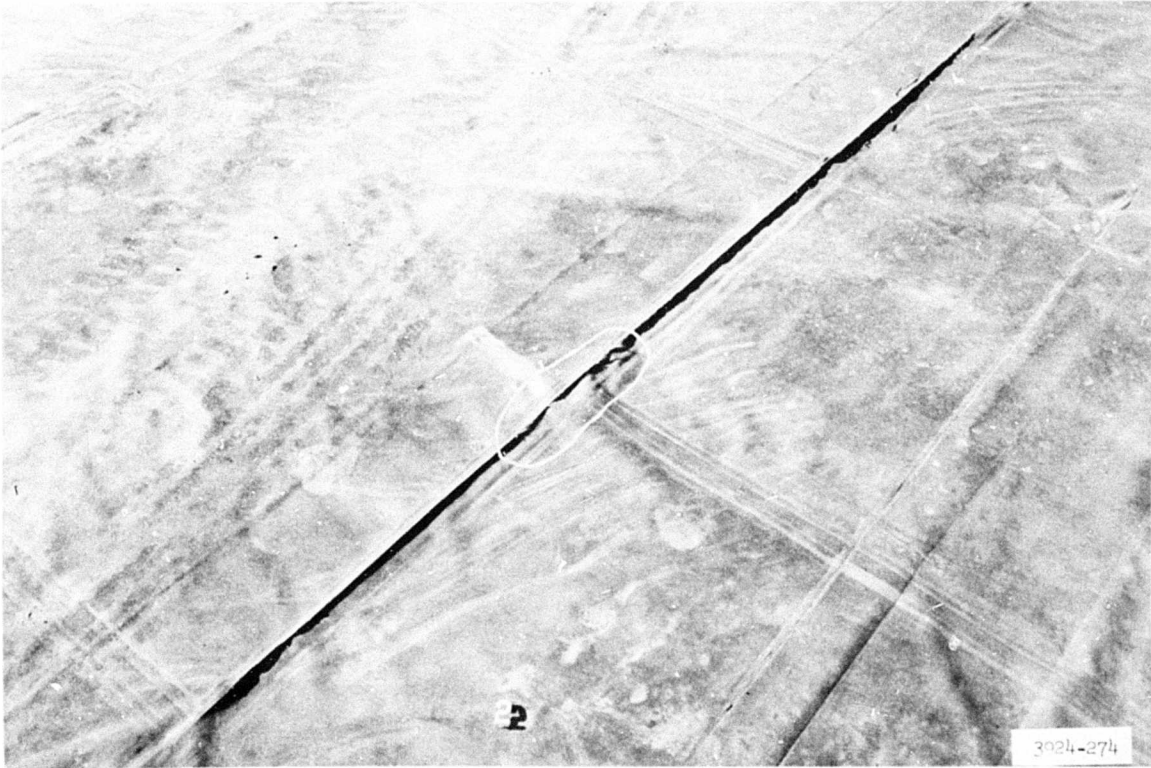
Photograph 58. Membrane cut by pinching action of mat in item 2

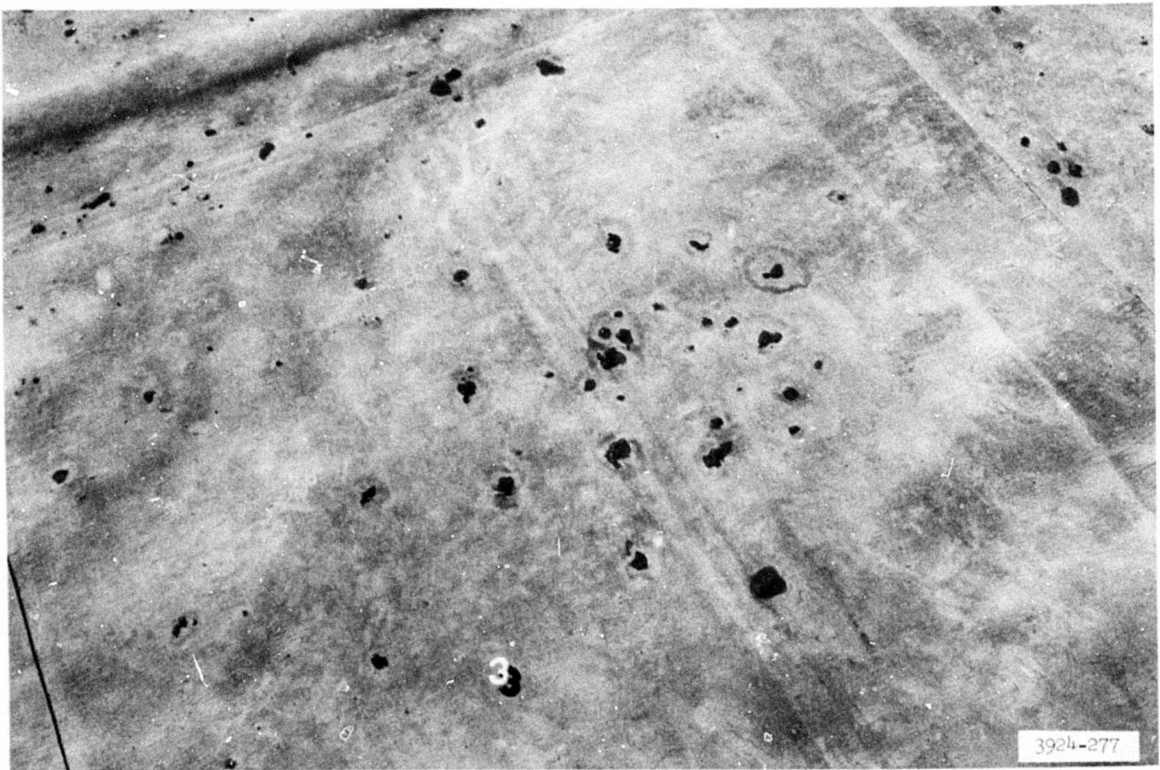
59. The first 15 ft of item 3 was utilized to determine the capability of T16 and WX18 membranes to withstand the abrasions under traffic when situated between landing mat and a clay gravel overlay. The results of this test indicated that both membranes were severely damaged as evidenced by the numerous holes found in the membranes when the mat was removed. Even the heavy WX18 membrane cannot withstand the extreme point loading of sharp angular objects in the soil as traffic is applied to the overlying mat.

Photograph 61. Holes worn in WX18 by abrasive action of mat and clay gravel

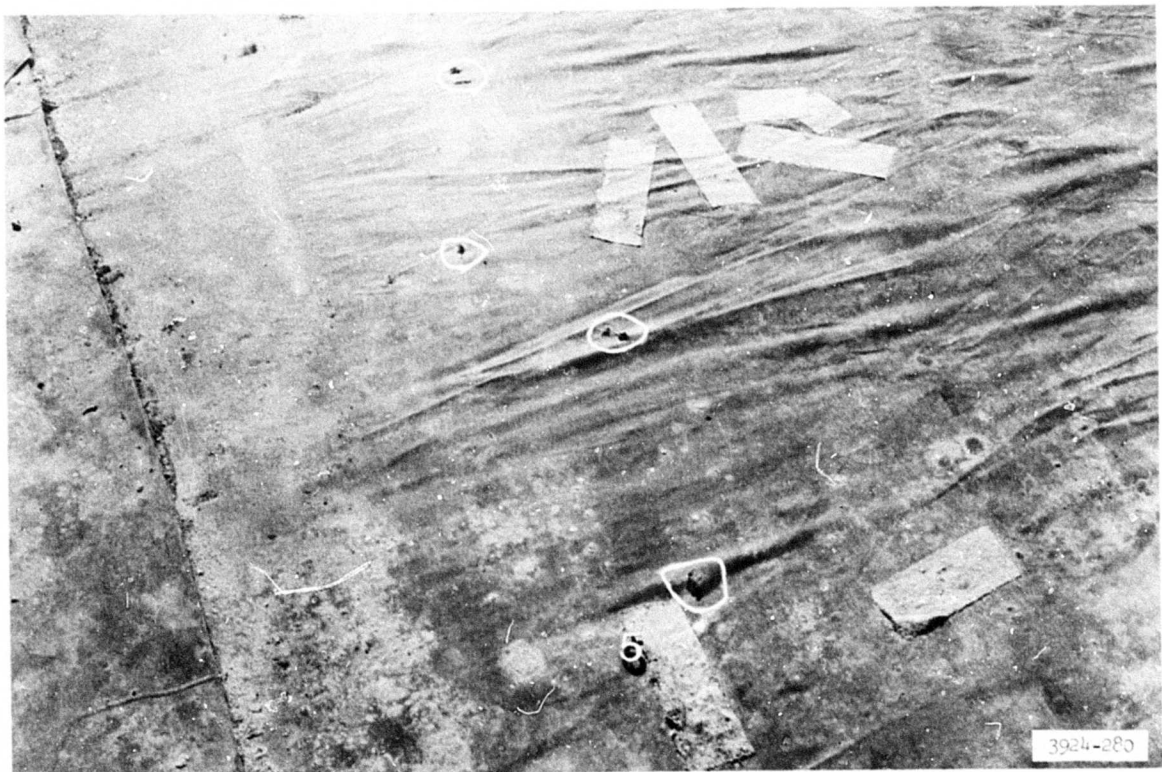
50. Examination of the T16 in item 5 after removal of the mat revealed that, generally, the membrane had remained intact throughout the test. In a small area near the transition to item 4, it was found that several small holes had been cut in the membrane due to point abrasion of the membrane on pebbles and small rocks between the membrane and hard soil surface during traffic (see photograph 63). The exposed lean clay in the area directly below the location of the holes in the T16 is shown in photograph 64. It can be seen from the heel prints on the soil that the lean clay had become wet in this particular area. Soil tests in this area indicated an average surface strength of about 3.2 CBR.

Photograph 63. Small holes cut in T16 membrane in item 5

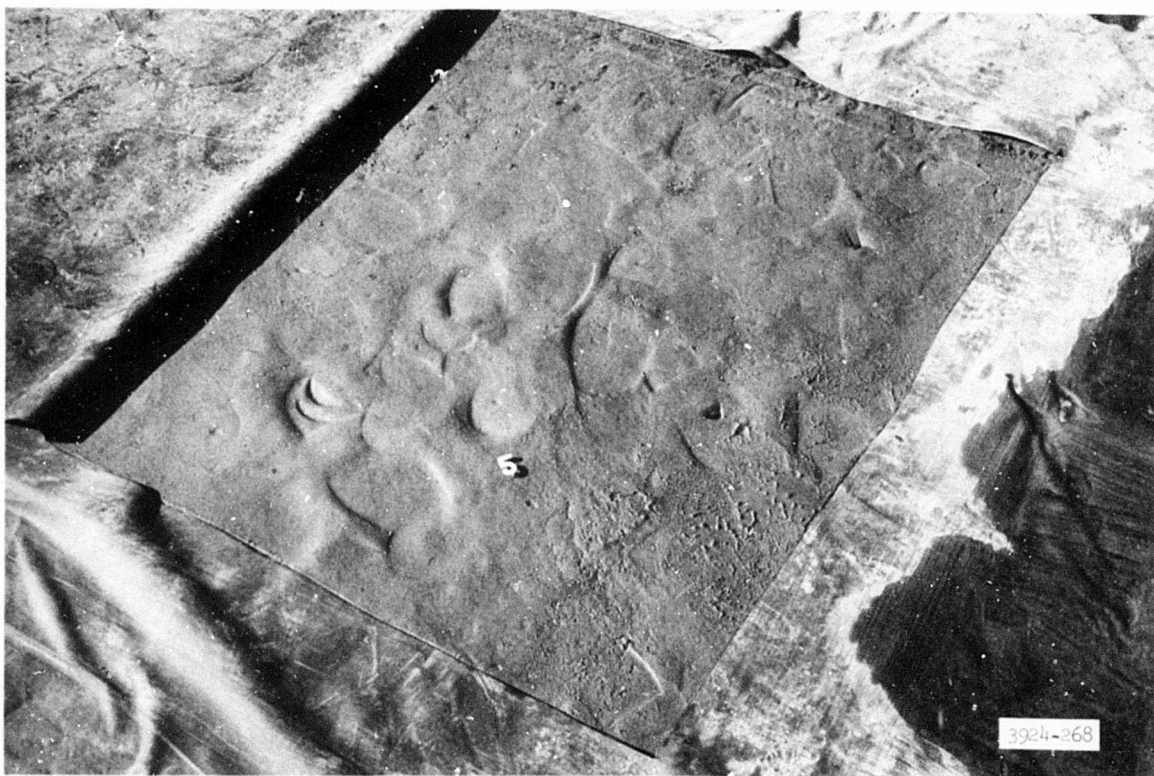
Photograph 64. Lean clay directly under holes shown in photograph 63

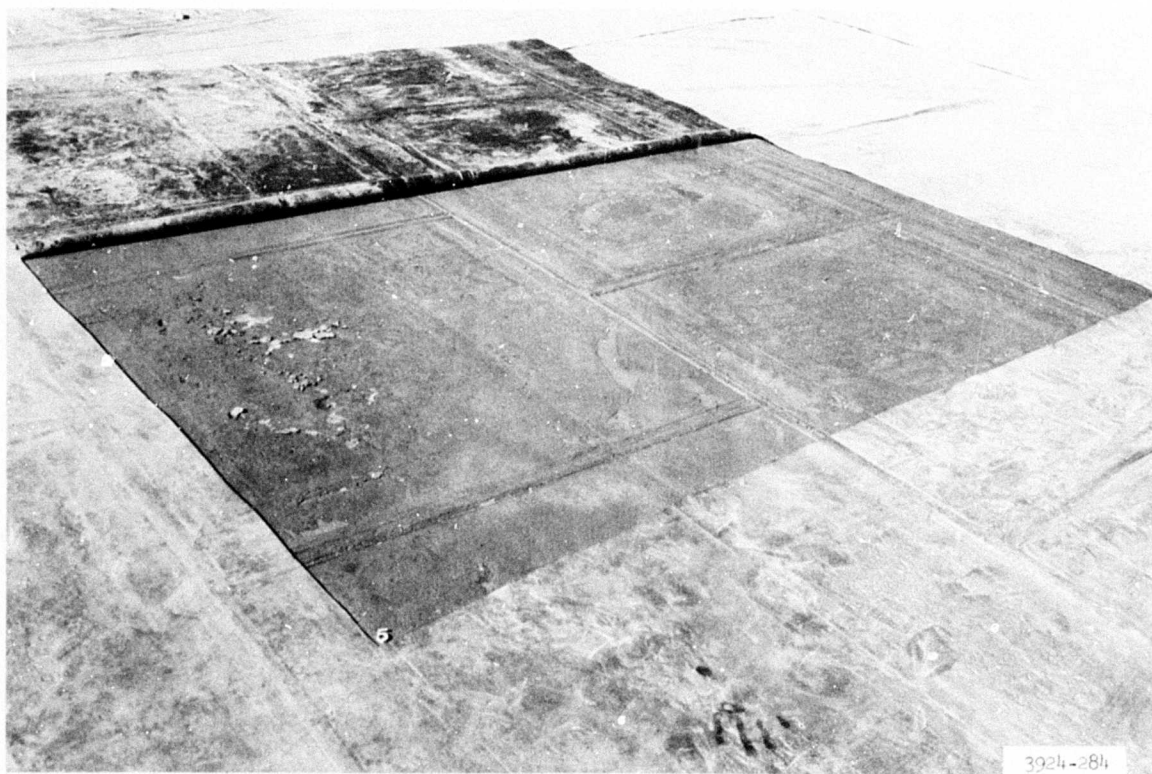
exposed area of the lean clay considered to be typical of the item is shown in photograph 65. The top 1/8 to 1/4 in. of soil was moist due to condensation under the membrane; however, the underlying material was quite dry and hard. Soil tests in this area indicated soil strength below the moist zone to be about 49 CBR.

Photograph 65. Stable condition of lean clay considered typical of item 5

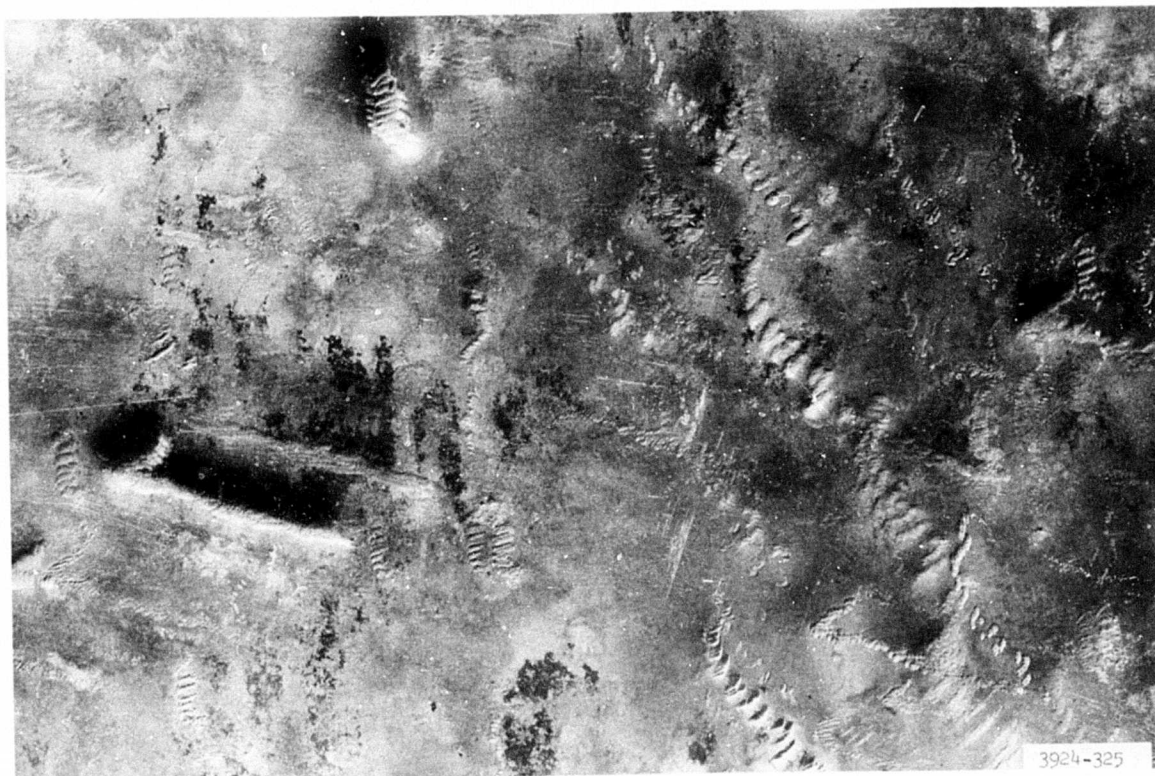
61. One point that should be emphasized at this time is the performance of the XM19 mat on the clay gravel. During the latter part of the test, it was observed that a number of panels in items 3 and 4 had developed shallow depressions 4 to 8 in. in diameter in the upper surface, which indicated that core failure was developing in these areas. Upon removal of the mat after testing was completed, it was found that the panels had been subjected to point loading in areas of contact between the mat and the larger aggregate in the clay gravel. This was evident from the numerous indentations found on the underside of the panels after their removal from the clay gravel items (see photograph 67). The results of this point loading were localized failures of the mat core that progressed to form large depressed areas. Photograph 68 shows a cut section of mat in an area where a surface depression had

Photograph 67. Indentations on underside of mat that had been placed on clay gravel

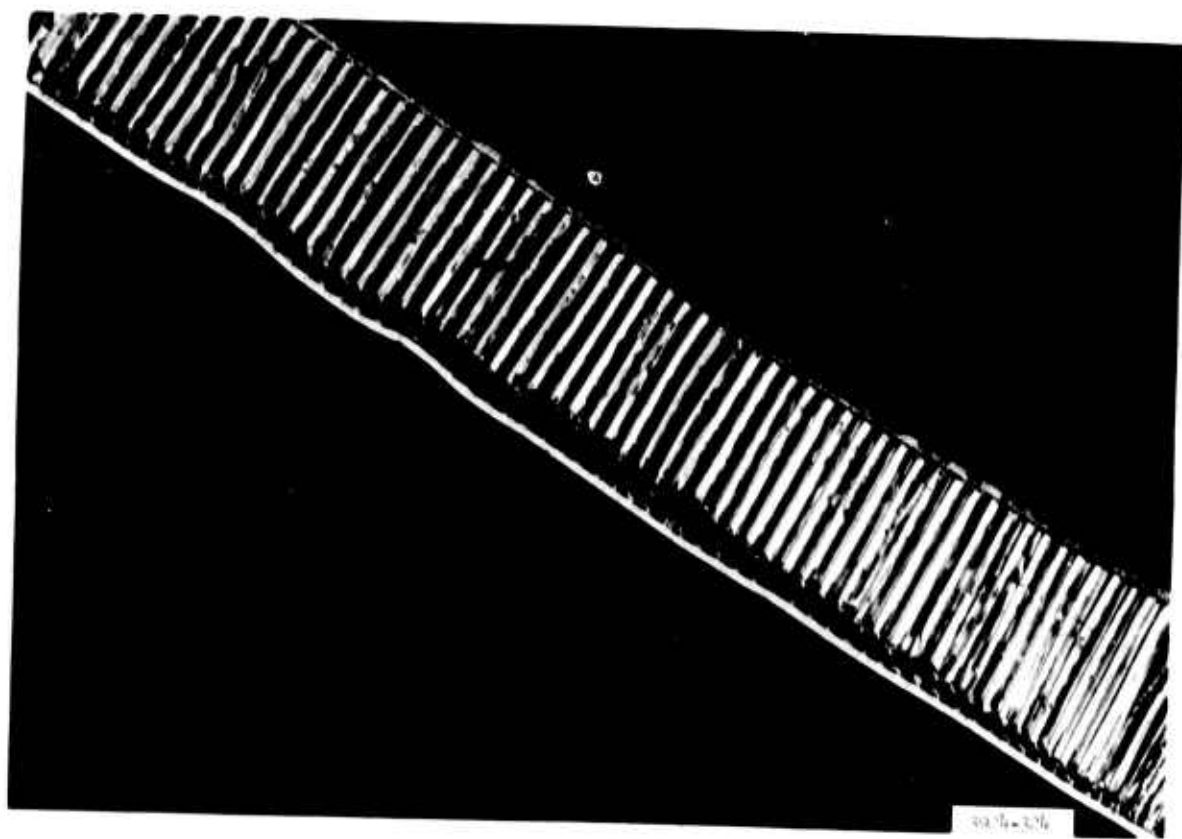
developed. It can be seen that the lower part of the internal core had failed and separated from the panel skin.

Photograph 68. Internal failure of XM19 mat
