Technical Note N- 1045

CATHODIC PROTECTION OF MOORING BUOYS AND CHAIN --  
PART V. CONTINUED STUDIES WITH CABLES PROVIDING  
CONTINUITY

R. W. Drisko

August 1969

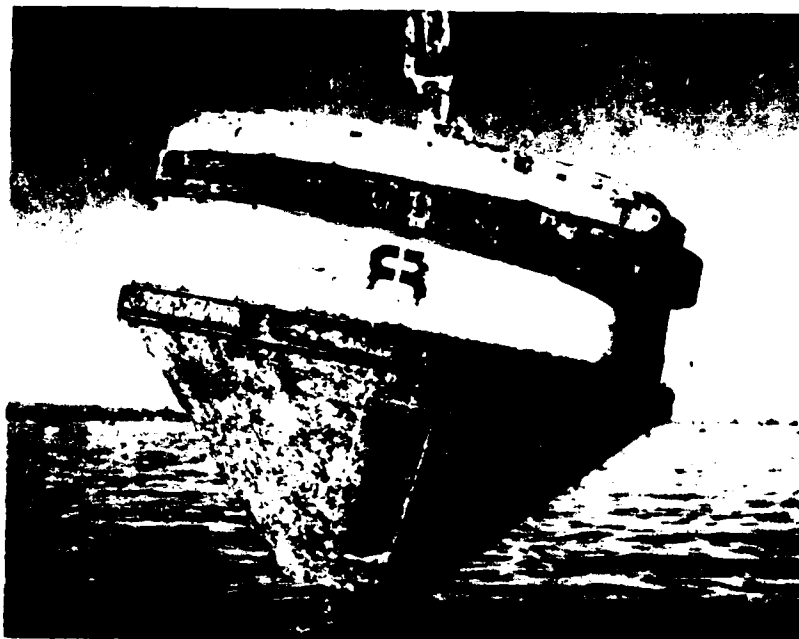
Eleven months after relocation of the cathodically protected mooring, the buoy was lifted from the water for the annual inspection specified in BUDOCKS Instruction 11153.4B. At that time the buoy was in excellent condition except for extensive marine borer damage to the lower wooden fender (Figure 4). There was very little corrosion above water (a few pinpoint rust spots) and none below. The riser chain showed no deterioration and the paint was still intact. A routine thickness measurement with a pair of calipers (Figure 5) revealed no reduction in chain thickness but a slight increase due to the thick paint. Both the buoy and the riser chain had medium to heavy marine fouling typical of other moorings in the area. Tunicates, barnacles, and green algae were the most typical organisms present. These were removed by high pressure hosing with seawater before the inspection.

Figure 4. Cathodically protected buoy after removal of fouling.
