**Corrosion Analysis of 304 Stainless Steel Wire Rope  
and Fittings From a NOMAD Buoy Mooring System  
After 34-Months Continuous Service  
in the Gulf of Mexico**

T. J. LENNOX, JR.

*Physical Metallurgy Branch  
Metallurgy Division*

September 1969

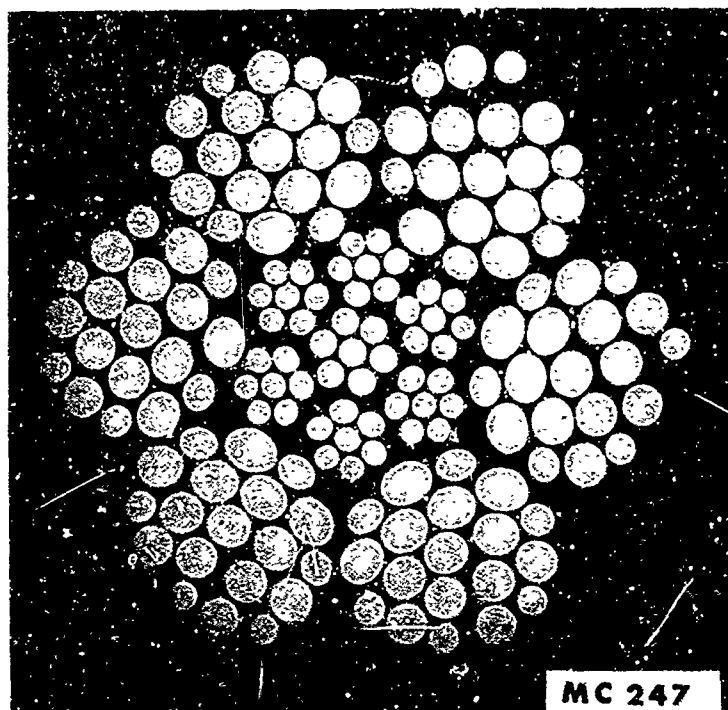
| Species Locations<br>Distance from<br>Top of Wire Rope | Initial Visual<br>Appearance of<br>Wire Rope<br>After Exposure | Corrosion Observations<br>on Cross Sections<br>(30x Magnification) | IMC | X-ray Diffraction<br>Identification of Products<br>on Wire Rope Surface | | Overall Corrosion Observations on 3 in. Lengths of Individual Wires<br>(20x Magnification) | | | | | | | Qualitative<br>Summary | |
|---|---|---|---|---|---|---|---|---|---|---|---|---|---|---|
| 11'-13' | white deposits<br>(fibrous and<br>crystalline), but<br>smaller<br>fibers) | essentially no<br>corrosion | essentially no<br>corrosion | NaCl | γFeO(OH),<br>calcite* | etched | etched | etched | etched | etched | etched | etched | etched | etch to<br>slight<br>corrosion |

Fig. 1 - 304 stainless steel wire rope after 34-months continuous immersion as part of a Nomad buoy mooring system, showing the essential absence of corrosion at a distance of 11-13 ft from the top of the wire rope.

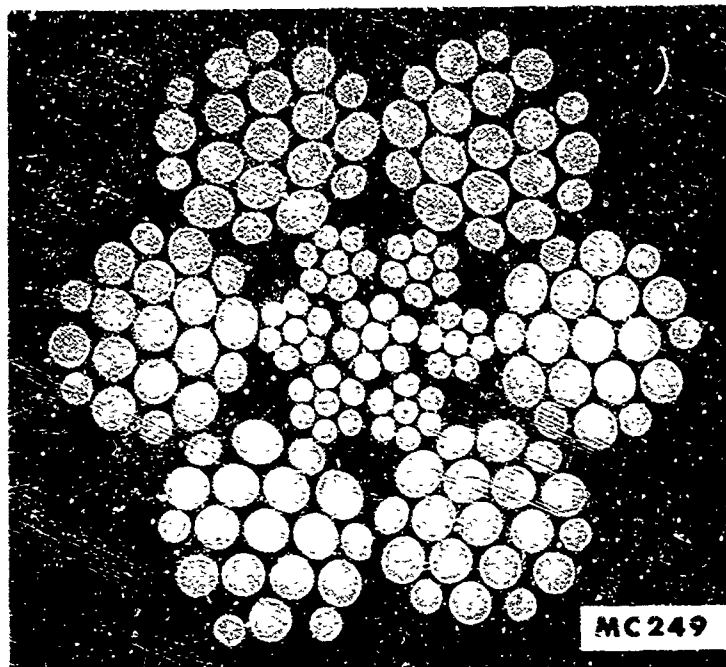
A definite transition was visually apparent between 1005 ft and 1009 ft. This transition was a change from a dark surface film to a heavily rusted condition beneath the neoprene jacket which covered the bottom 250 ft (approximately) of the wire rope. Only slight corrosion was observed just above and 4 in. outside the neoprene jacket. The condition of the wire rope at the rusted end of the transition area has been shown in Fig. 2.

Fig. 2 - 304 stainless steel wire rope after 34-months continuous immersion as part of a Nomad buoy mooring system, showing the moderate-to-severe corrosion at a distance of 1006 ft-7 in. to 1008 ft-7 in. from the top of the wire rope (rusted end of transition - under neoprene jacket).

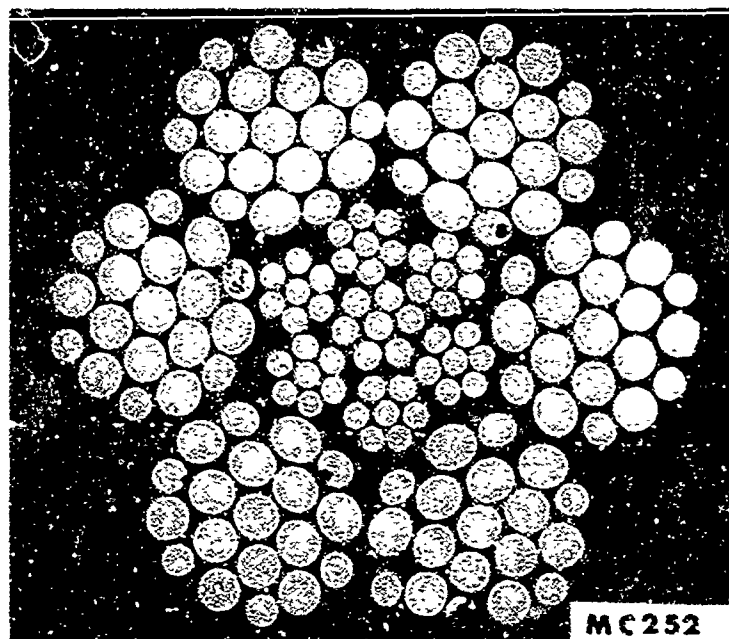
As would be expected when 304 stainless steel was shielded and not effectively cathodically protected, the corrosion under the neoprene jacket was quite severe. The tunnelling (black areas in cross-section photographs), deep pitting, and crevice corrosion that occurred on individual wires located between 1009 ft and 1233 ft from the top have been shown in Figs 3, 4, and 5. This tunnelling, deep pitting, and crevice corrosion was typical for 304 stainless steel corrosion in quiescent seawater.

Fig. 3 - 304 stainless steel wire rope after 34-months continuous immersion as part of a Nomad buoy mooring system, showing (a) tunnelling and (b) and (c) severe corrosion at a distance of 1008 ft-7 in. to 1010 ft-7 in. from the top of the wire rope (under neoprene jacket).

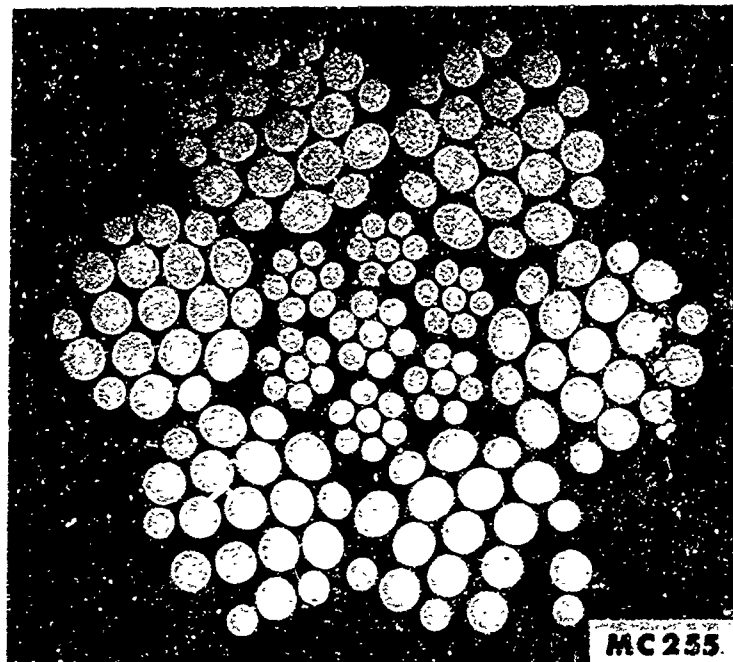
Fig. 4 - 304 stainless steel wire rope after 34-months continuous immersion as part of a Nomad buoy mooring system, showing (a) limited tunnelling, but (b) and (c) deep pitting on individual wires at a distance of 1088 ft-8 in. to 1090 ft-8 in. from the top of the wire rope (bright appearance under jacket).

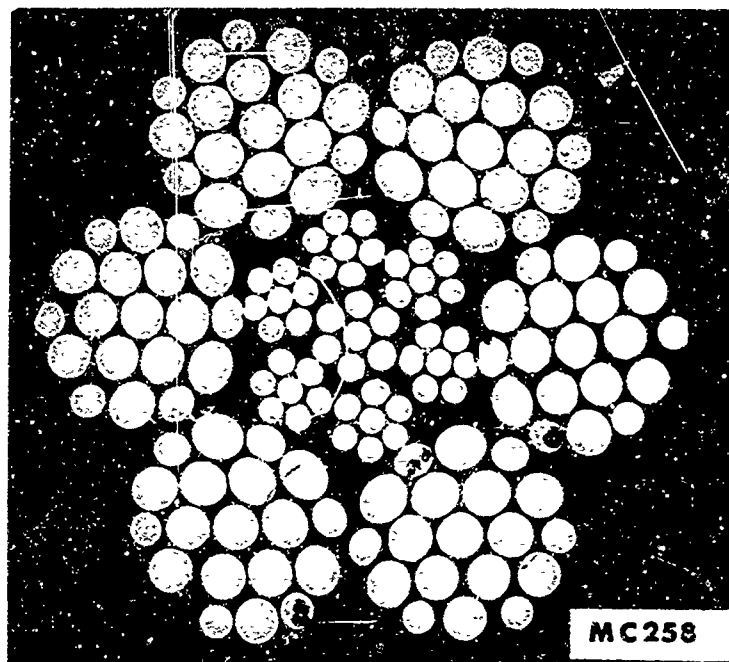
| Species Locations<br>Distance from<br>Top of Wire Rope | Initial Visual<br>Appearance of<br>Wire Rope<br>After Exposure | Corrosion Observations<br>on Cross Sections<br>(30x Magnification) | IMC | X-ray Diffraction<br>Identification of Products<br>on Wire Rope Surface | | Overall Corrosion Observations on 3 in. Lengths of Individual Wires<br>(20x Magnification) | | | | | | | Qualitative<br>Summary | |
|---|---|---|---|---|---|---|---|---|---|---|---|---|---|---|
| 1231'5"-1233'5"<br>(91" above<br>uppermost<br>lower cable<br>clamp, under<br>neoprene<br>jacket) | corroded | 3 small outer<br>wires tunnelled,<br>exterior corrosion<br>on small wires | some irregular<br>corrosion | γFeO(OH) | Fe <sub>2</sub> O <sub>3</sub> (OH),<br>NaCl | etched<br>striated<br>corrosion | etched<br>striated<br>corrosion | etched<br>striated<br>corrosion | etched<br>striated<br>corrosion | etched<br>striated<br>corrosion | crevice<br>corrosion<br>micro-etched<br>micro pitted | crevice<br>corrosion<br>etched<br>micro pitted | severe crevice<br>corrosion<br>etched and<br>pitted | moderate to<br>severe<br>corrosion |

Fig. 5 - 304 stainless steel wire rope after 34-months continuous immersion as part of a Nomad buoy mooring system, showing (a) severe tunnelling, (b) pitting and crevice corrosion, and (c) cracked area of a wire at a distance of 1231 ft-5 in. to 1233 ft-5 in. from the top of the wire rope.

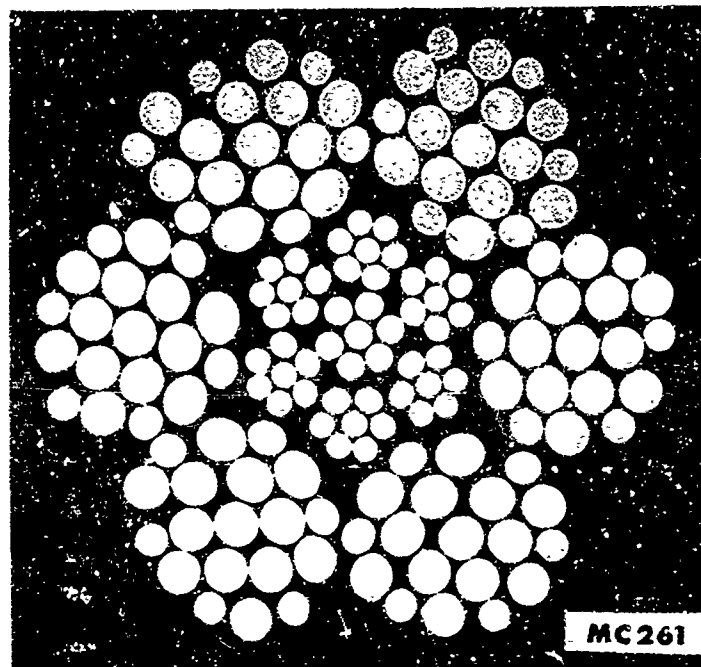
Fig. 6 - 304 stainless steel wire rope after 34-months continuous immersion as part of a Nomad buoy mooring system, showing the good condition of the wire rope under a cable clamp at the top of the wire rope (5X magnification).

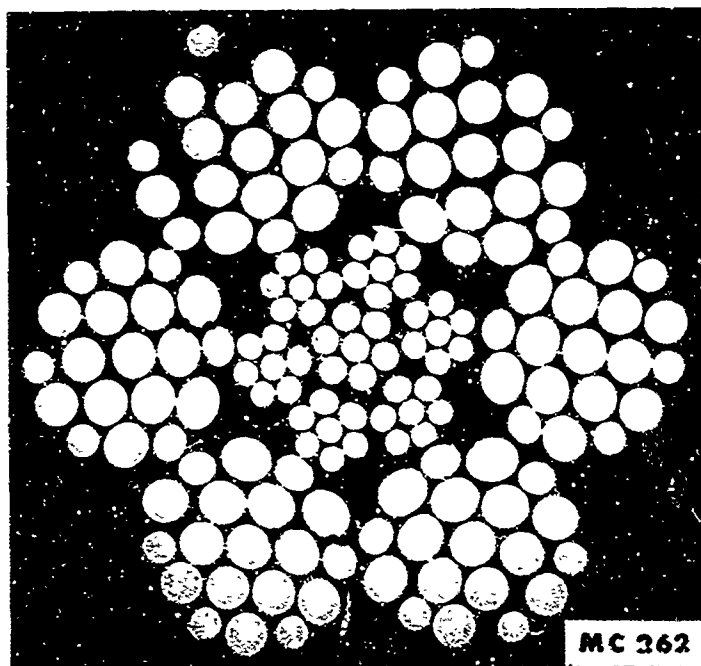
Fitting Areas of Wire Rope and Fittings -- The corrosion observed on the wire rope under the 304 stainless steel cable clamps has been described in Table 1. The corrosion was much more severe on the shielded (with tape) areas at the lower end of the wire rope compared to the areas near the top of the mooring which were unshielded and received cathodic protection. A comparison of the extent of corrosion that occurred at these areas is indicated in Figs. 6 and 7. The severe pitting and crevice corrosion observed on the wire rope under one of the lower cable clamps are indicated in Fig. 8.

Fig. 7 - 304 stainless steel wire rope after 34-months continuous immersion as part of a Nomad buoy mooring system, showing corrosion at periphery of some wires under a cable clamp near the bottom of the wire rope (clamp and wire rope shielded with tape) (5 magnification).

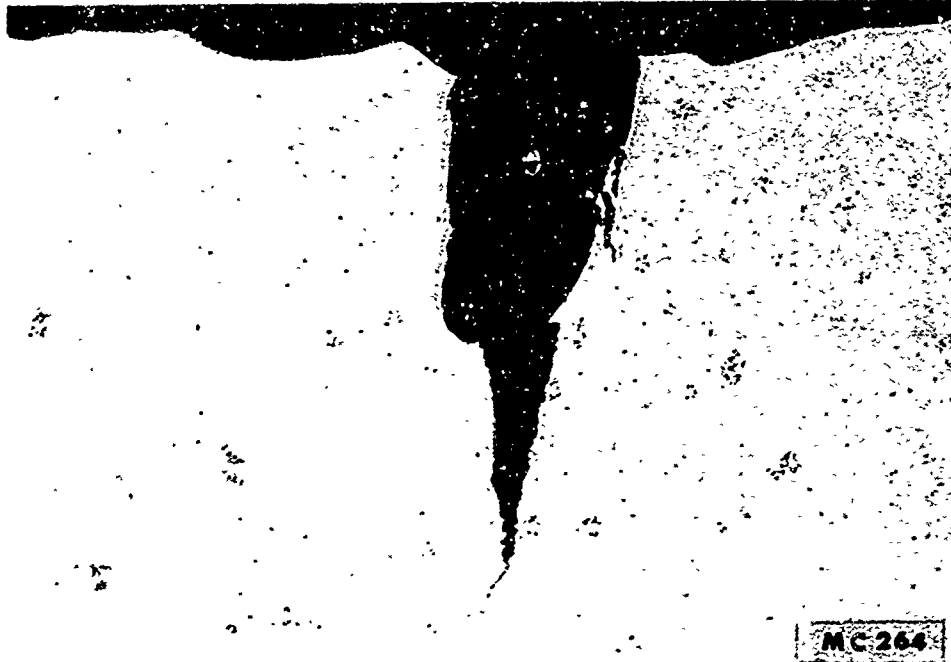
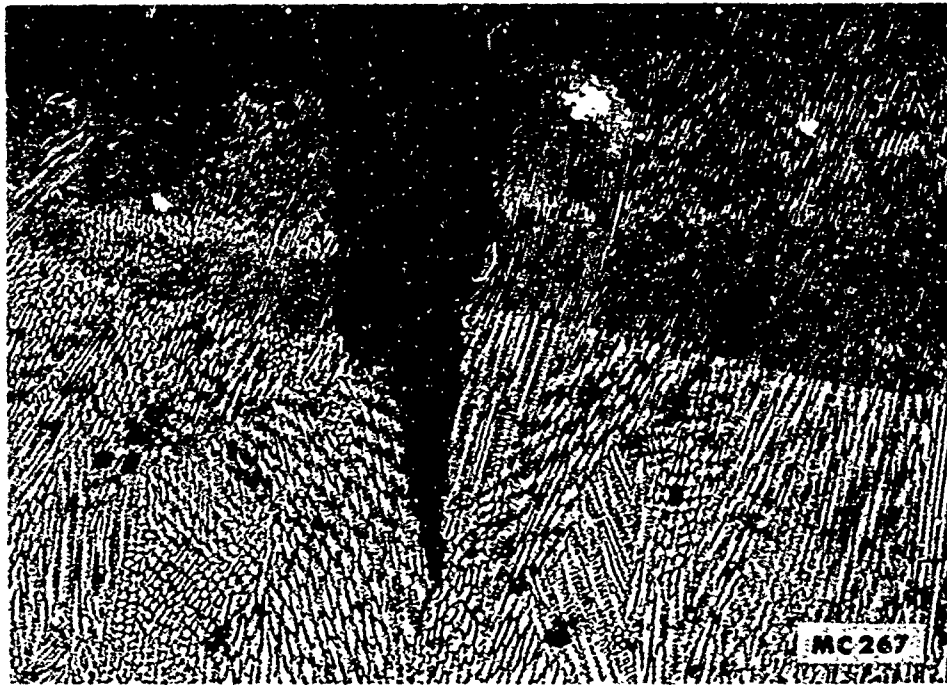
The overall condition of the upper and lower 304 stainless steel fittings, i.e., cable clamps, clamp nuts, and tube thimbles was generally excellent. Some shallow pitting had occurred, however, on the base metal of the tube thimble in the heat-affected zone caused by the welding of a wear plate to the tube thimble. A crack was also evident at the junction of the weld and the tube thimble located at the top of the stainless steel wire rope. This crack may have been caused by a cold weld or by undercutting during welding. The cracked area before and after electrolytic etching in 10 percent oxalic acid is shown in Fig. 9.

| Fittings and Locations | Observations |
|---|---|
| Upper | Surface roughening inside and outside and local pitting in heat-affected zone. One section cracked at weld of doubler. May have been caused by undercutting or a cold weld. |

Fig. 9 - Section of 304 stainless steel wire rope tube thimble showing crack which may have been caused by a cold weld or by undercutting during welding.
