EXPERIMENTAL STEEL PILE GROINS, PALM BEACH,  
FLORIDA

Corps of Engineers  
Washington, D. C.

BEACH EROSION BOARD  
OFFICE OF THE CHIEF OF ENGINEERS

TECHNICAL MEMORANDUM NO. 10

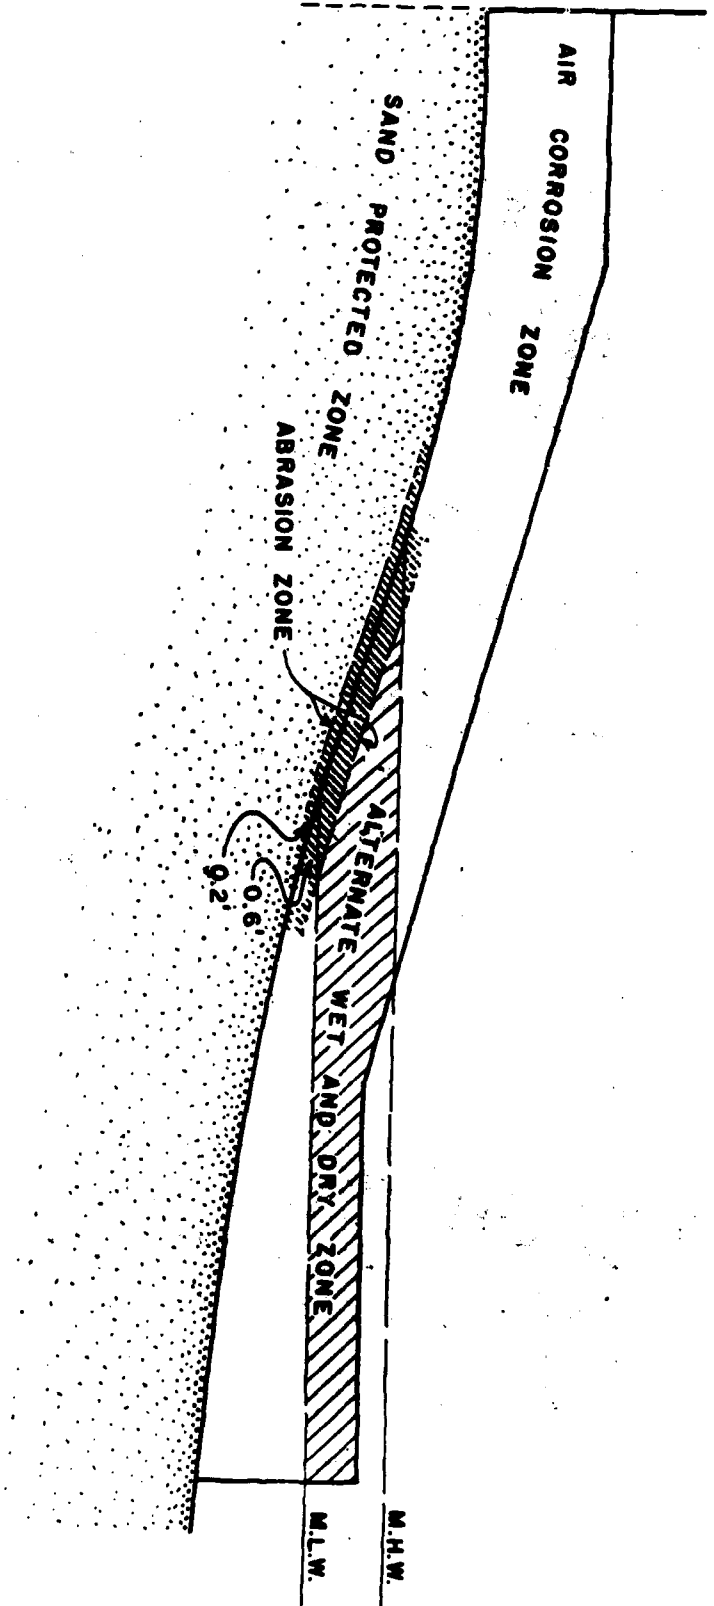
CONDITIONS OF GROIN EXPOSURE  
 FIG. 9

32. The location of the naturally perforated holes in the piling, the thinness of rust and frequent appearance of bright polished metal at the sand line shows that the beach material moving under wave action is the primary factor in the rapid deterioration of steel piling at Palm Beach. The principal wear on the piles occurs in a zone a few inches above and below the sand line. Abrasion by the sand continually removes the rust covering and re-exposes the bare steel to oxidation, thereby accelerating corrosion. The moving sand may also abrade the steel. Based on visual observation at the site of the experimental groins, the zone of rapid abrasion appears to be usually an inch or so wide and extends from near the upper limit of wave uprush seaward to depths greater than one foot below mean low water. Its position changes frequently as the sand line adjacent to the groin fluctuates. In order to take into account these fluctuations, the abrasion zone was arbitrarily taken as extending from 0.2 foot below the sand line to 0.6 foot above as shown in Figure 9.

34. The results of the field test show, rather conclusively, that the loss of steel from those pile surfaces in the other three zones shown in Figure 9 is much less than in the abrasion zone. The degree is indicated by the computed average annual rate of 0.011 inch for the air corrosion zone, 0.005 inch for the wetting and drying zone, and 0.001 inch for the sand protected zone.

35. The rate of reduction in thickness of 0.001 inch for the sand protected zone suggests that an abundant supply of sand which would practically cover the groins would prolong their life for a considerable period. It is recognized, of course, that groins are seldom built except at locations where more sand is desired and that a groin in performing its function of holding or accumulating sand will be exposed, at least in part, to waves and sand erosion.
