Technical Report

January 1970 "

PLASTIC MOORING BUOYS—COST AND ADDITIONAL PERFORMANCE DATA

Technical Report R-655

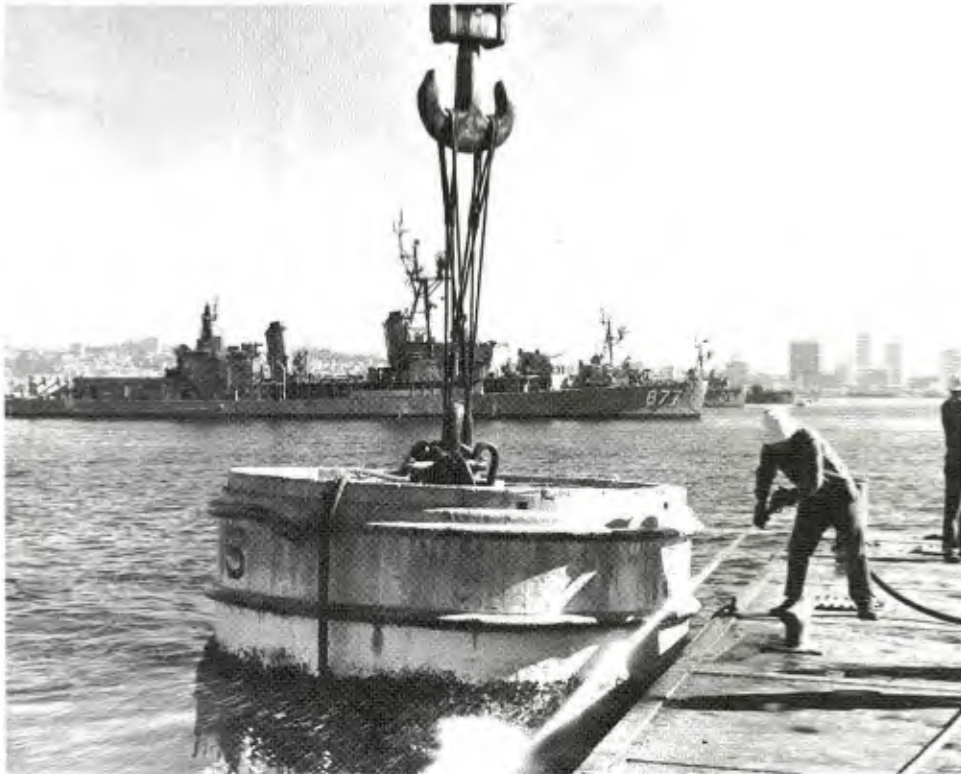
Figure 1. Hosing of marine fouling from hand lay-up buoy in San Diego Bay.

similar to that on steel buoys exposed in the Bay for the same length of time. Fouling organisms included green algae (heaviest in the splash-zone), barnacles, tunicates, bryozoa, tube worms, and hydroids. The barnacles were comparatively few in number but large in size. The organisms were rather easily removed (as they are from steel buoys) by high-pressure hosing with seawater.

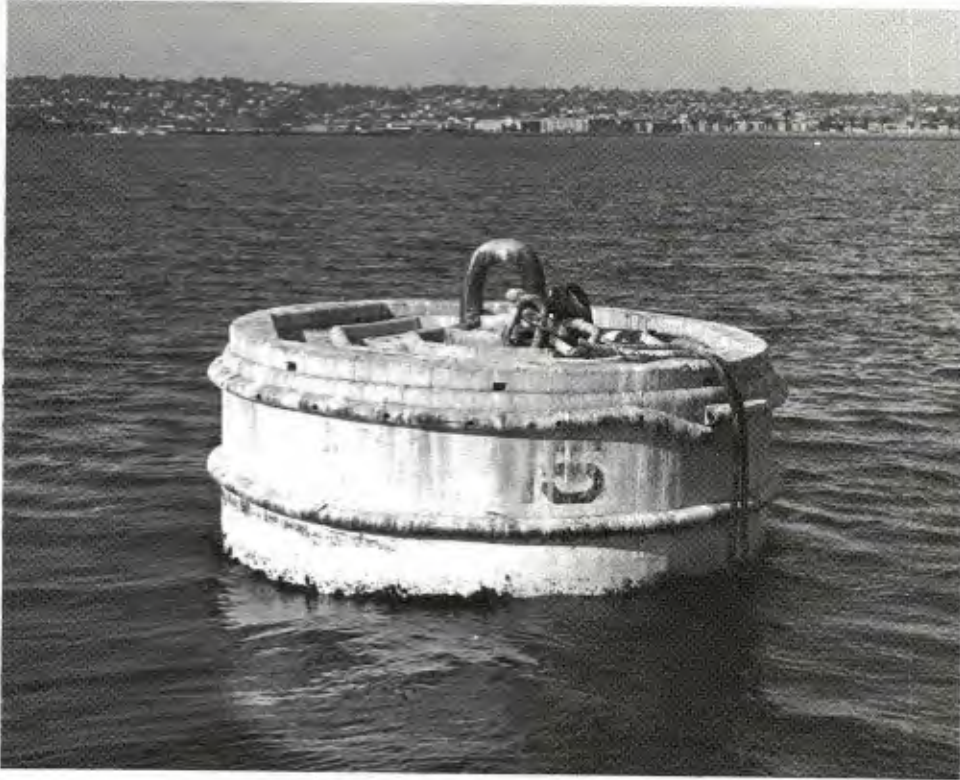
Hand Lay-Up Buoy. The hand lay-up buoy was still in very good condition after about 4 years of service to the Fleet. There was considerable superficial white staining by guano on the top and side (Figure 2). There was also rust streaking from the steel mooring eyes and hardware used to secure the fenders in place. The upper lateral fender, which had previously been torn loose by impact and later wired back in place, was still providing good protection. The two test patches* made on the buoy side after one-half year of service were also in good condition. Most of the reflective glass beads embedded in the buoy coating had been lost above water, but many remained below water.

Figure 2. Hand lay-up buoy in San Diego Bay after 4 years of service. Note guano staining on side and slight displacement of upper lateral fender.

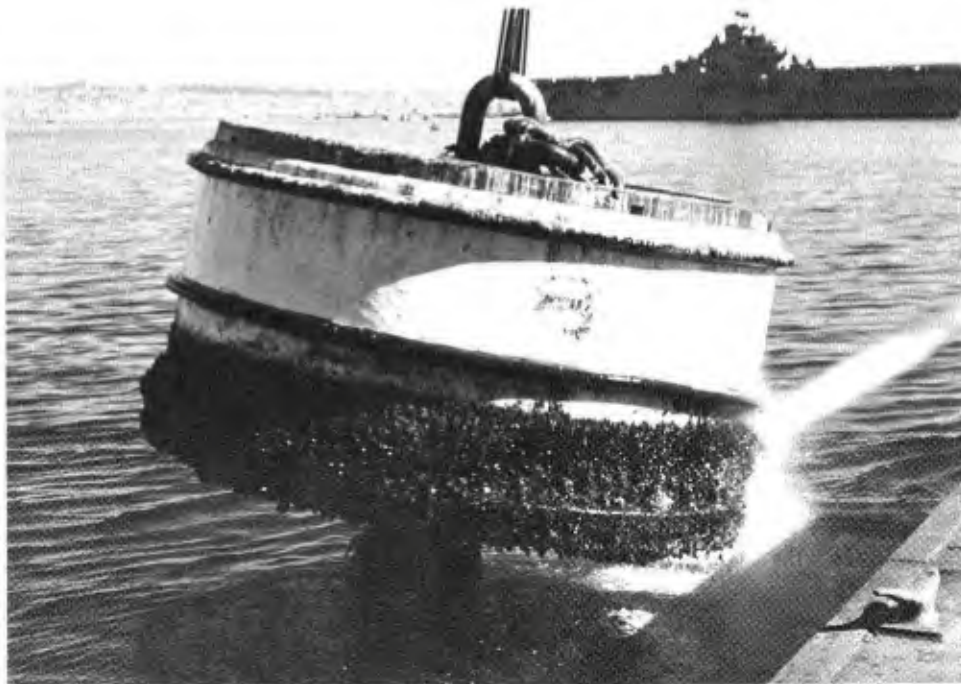
Spray-Up Buoy. The spray-up buoy (Figure 3) had continued to deteriorate slightly during the last year. The upper shoulder had numerous cracks in the outer skin from which rust was streaking (Figure 4). Guano buildup and staining were not so great as on the hand lay-up buoy. The exterior shell was cracked through to the polyurethane-foamed core in three places—one normally above the water (Figure 5) and two below (Figure 6). These cracks were over 1 foot in length, but did not permit sufficient passage of water to affect the flotation of the buoy or its service to the Fleet. The middle lateral fender, held in place by a steel cable, had also been displaced (Figure 5) by the impact of a ship. The two test patches in the side (Figure 4) were in good condition. The above superficial damage did not seem to have any effect on the utilization of the buoy.

Figure 3. Hosing of marine fouling from spray-up buoy in San Diego Bay.

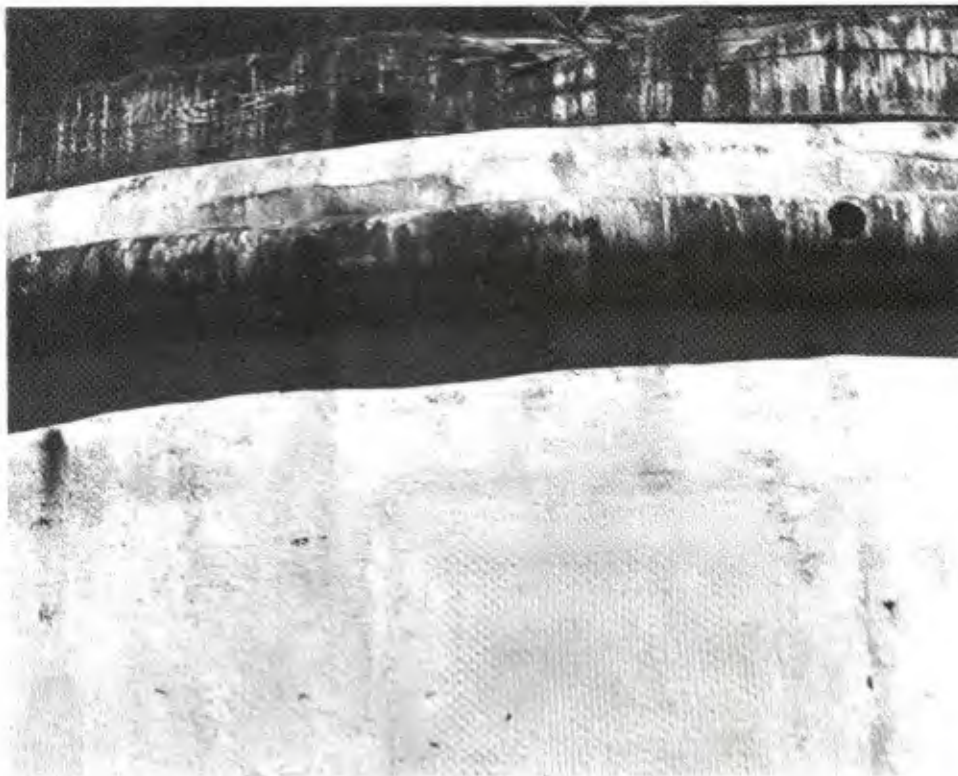
Figure 4. Upper portion of spray-up buoy in San Diego Bay after 4 years of service. Note worn upper wooden fender, deteriorated shoulder, and square at bottom center.

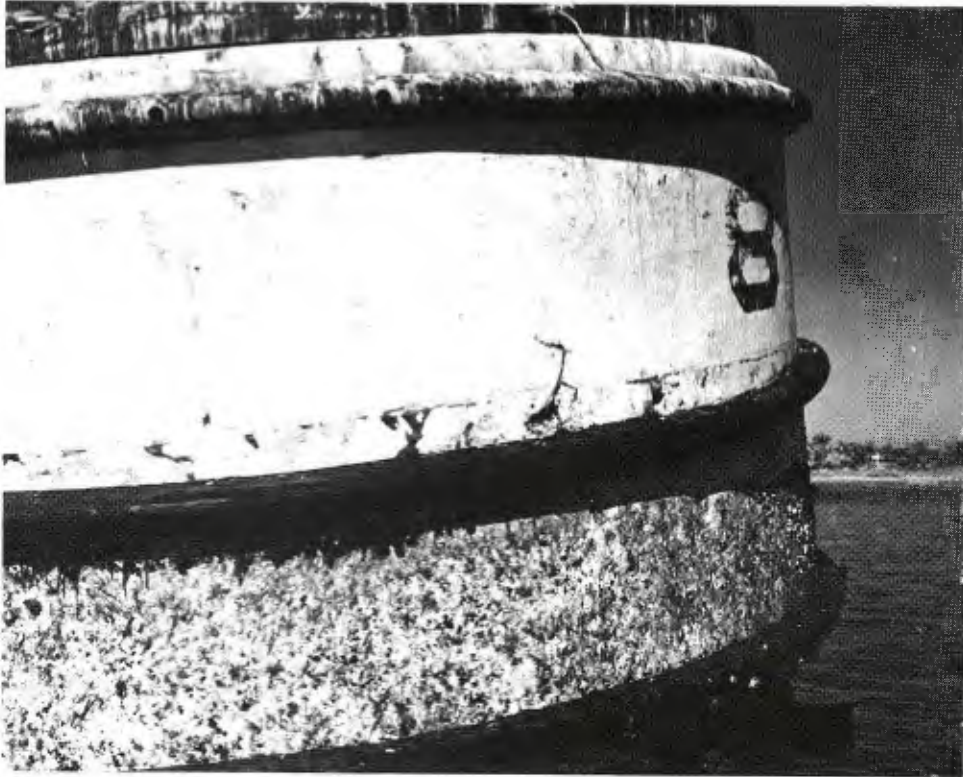
Figure 5. Side of spray-up buoy in San Diego Bay. Note displaced middle fender and crack in shell above it.

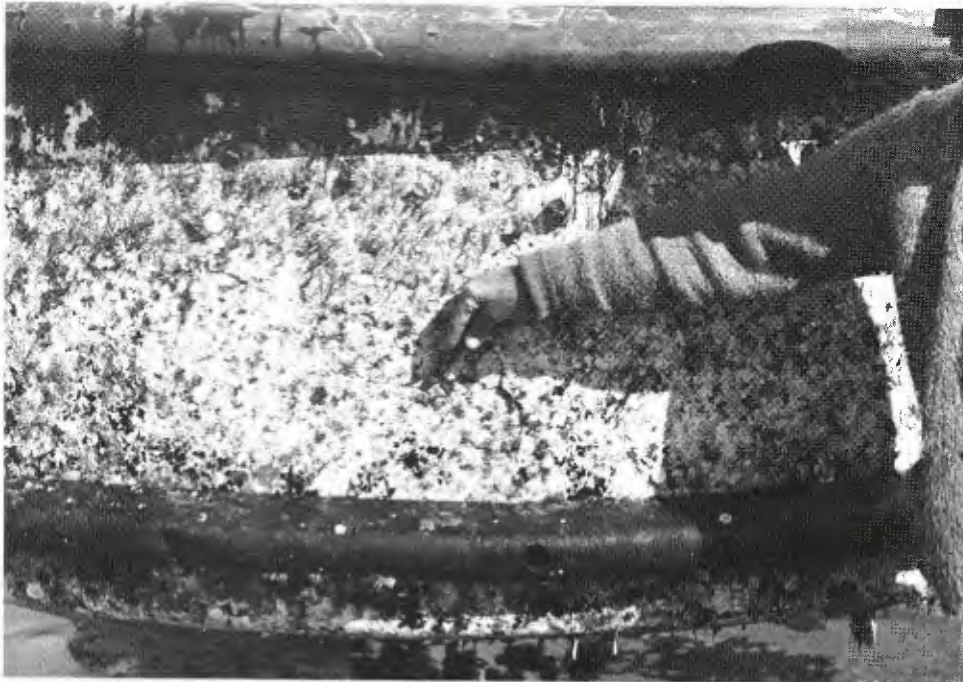
Figure 6. Crack in shell of spray-up buoy located below water line.

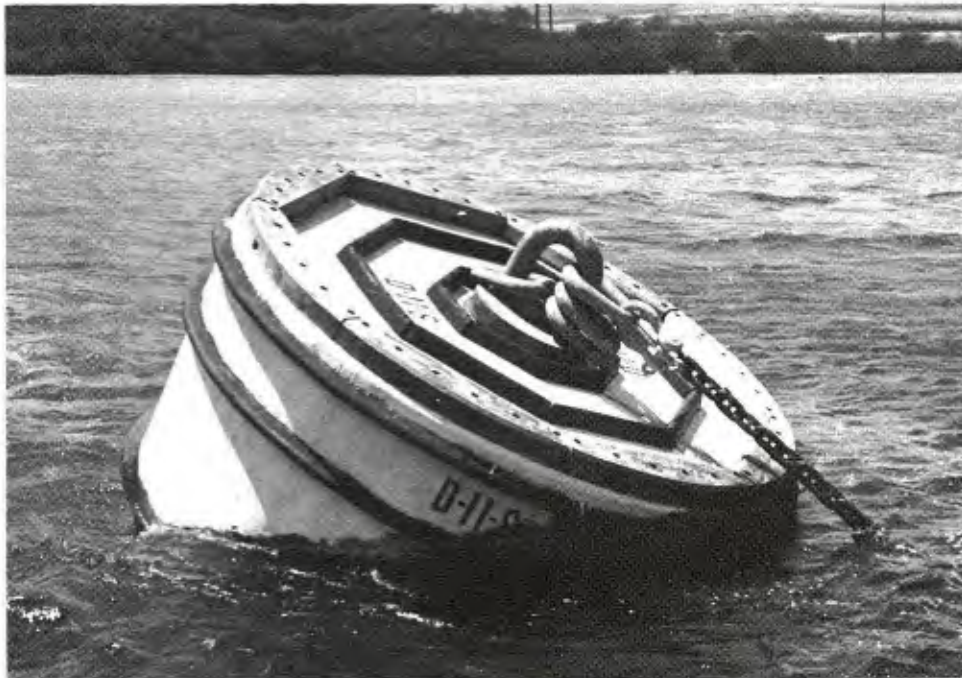
The plastic mooring buoy with the improved design was installed by Public Works Center, Pearl Harbor as part of a bow and stern mooring for a barge in a reserve area. As such, it receives much less abuse than do the two buoys in San Diego Bay. The buoy is examined quarterly by Public Works Center personnel; it was examined by the NCEL project scientist about 1 year after installation. The buoy at that time had heavy marine fouling, but very little corrosion or other deterioration. Rust streaking from the steel mooring eye and the hardware used to secure the fenders in place was very slight. The outer skin was also relatively free of dirt and yellowing. All in all, the buoy was in excellent condition (Figure 7).

Figure 7. Plastic buoy after 1 year of service at Pearl Harbor.

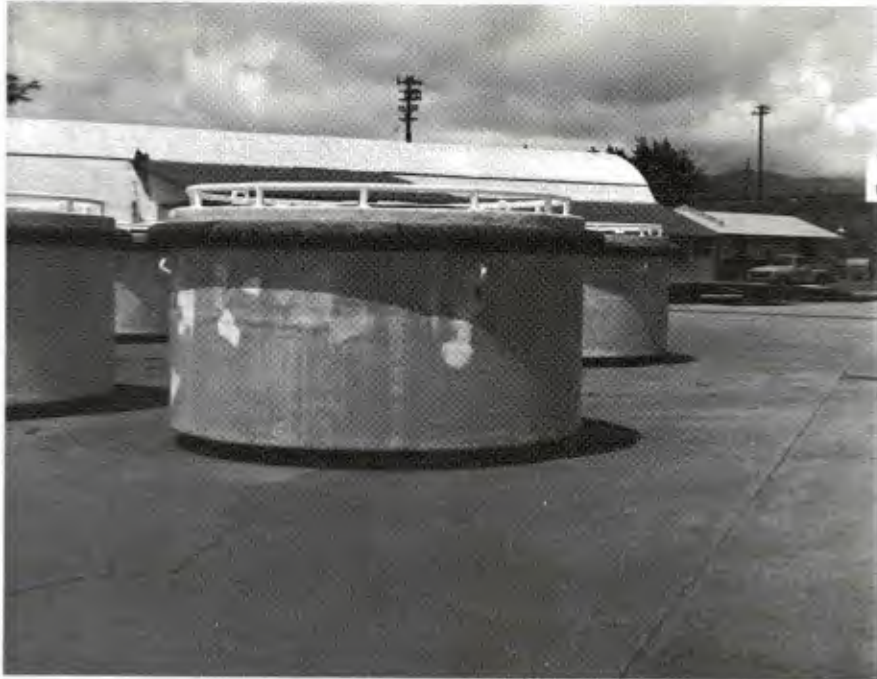
During inspection of the buoy it was brought to the author's attention that several steel mooring buoys at Pearl Harbor had been coated with alternate layers of fiberglass cloth and mat impregnated with polyester resin similar to the construction of the plastic buoy exposed at this location. Many of these buoys have had extensive yellowing of the white finish coat (Figure 8). A similar yellowing was observed on the exterior of the San Diego spray-up buoy at the time of initial installation. This yellowing appears to be related to degradation of the resin by ultraviolet light and suggests that an ultraviolet light absorber incorporated into the finish coat may be desirable.

Figure 8. Steel mooring buoys at Pearl Harbor with yellowed fiberglass-reinforced polyester coating.
