EXPERIMENTS TO DETERMINE DEBRIS FORMATION  
FROM CORRUGATED STEEL AND BRICK WALLS

Final Report

January 1970

URS RESEARCH COMPANY

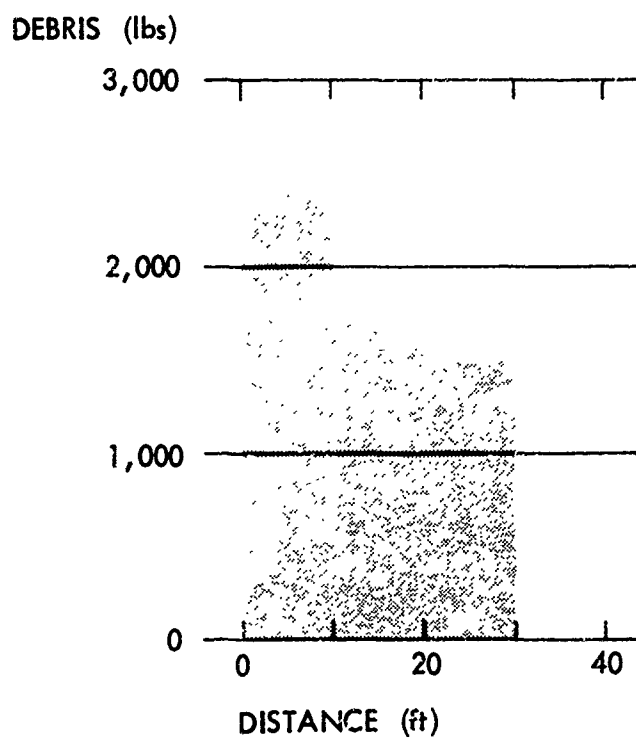
Debris Distribution, Wall Number 5

Results: The wall collapsed and debris scattered to 24 ft (See debris distribution chart below).

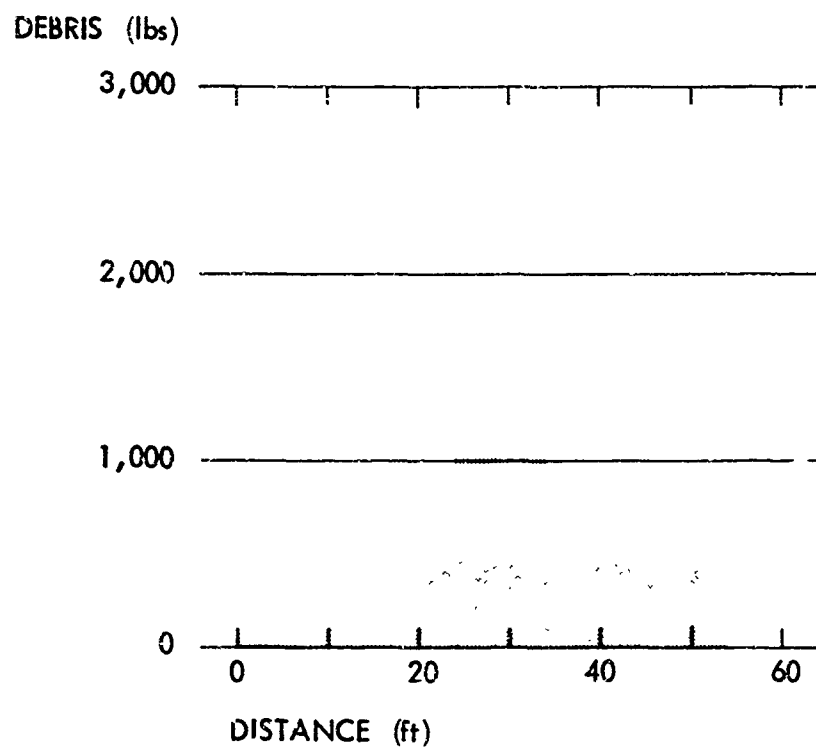
Debris Distribution, Wall Number 6

Results: First cracks appeared as horizontal lines at heights of ~ 4 and ~ 6 ft. The wall failed and debris scattered to 54 ft. (See debris distribution chart below).

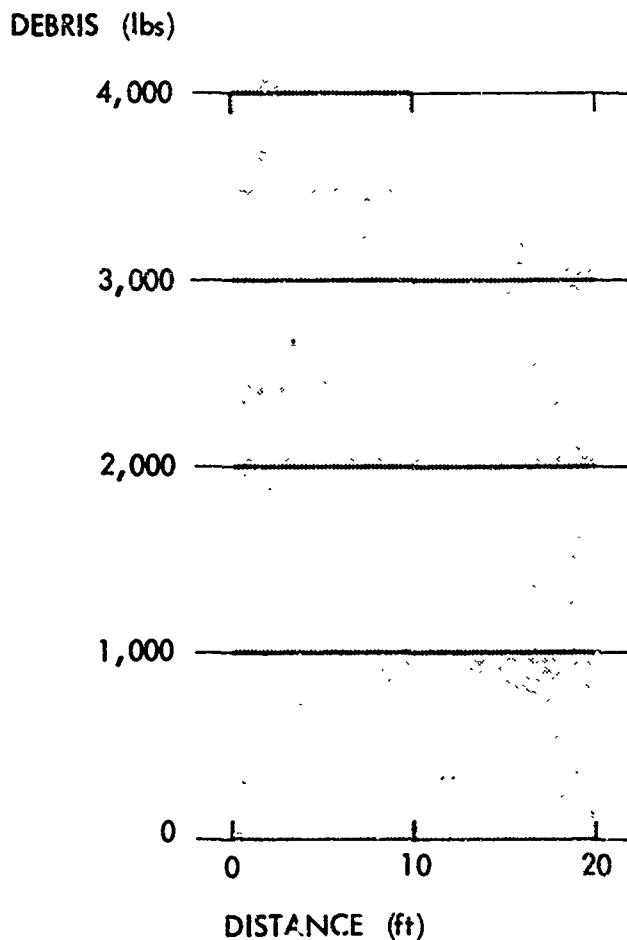
Debris Distribution, Wall Number 7

Results: The initial crack appeared horizontally at a height of ~ 4 ft. The wall failed and debris scattered to 19 ft. (See debris distribution chart below).

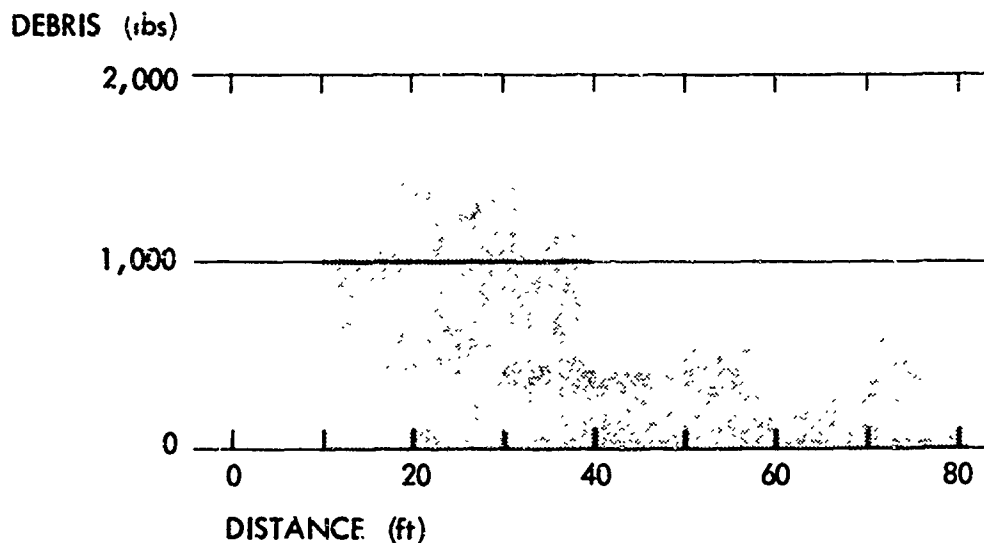
Debris Distribution, Wall Number 20

Results: Two essentially horizontal cracks occurred initially at heights of ~ 3 and ~ 5 ft. The wall failed, scattering debris to ~ 80 ft. (See debris distribution chart below).

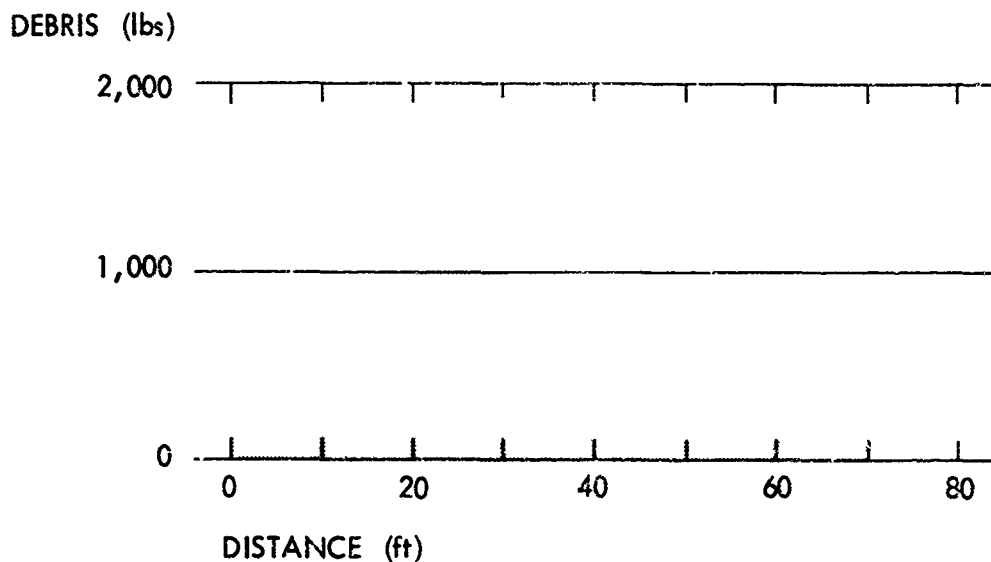
Debris Distribution, Wall Number 22

Results: Two initial horizontal cracks were noted at heights of ~3 ft and 6.5 ft. The wall failed and scattered debris to 70 ft. (See debris distribution chart below).

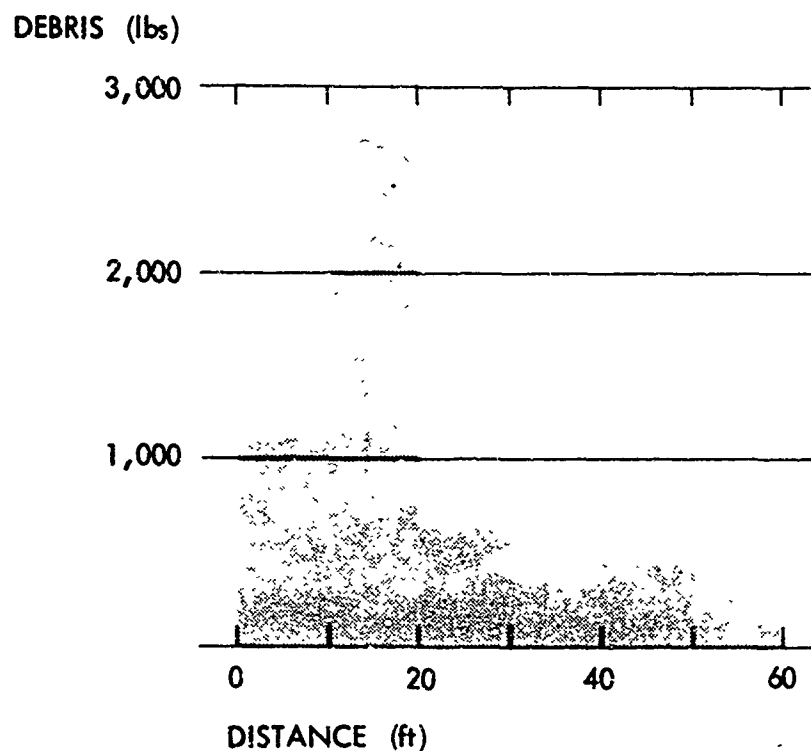
Debris Distribution, Wall Number 23

Results: Initial cracks formed as shown in sketch below. The wall failed, and debris was scattered to 57 ft. (See debris distribution chart).

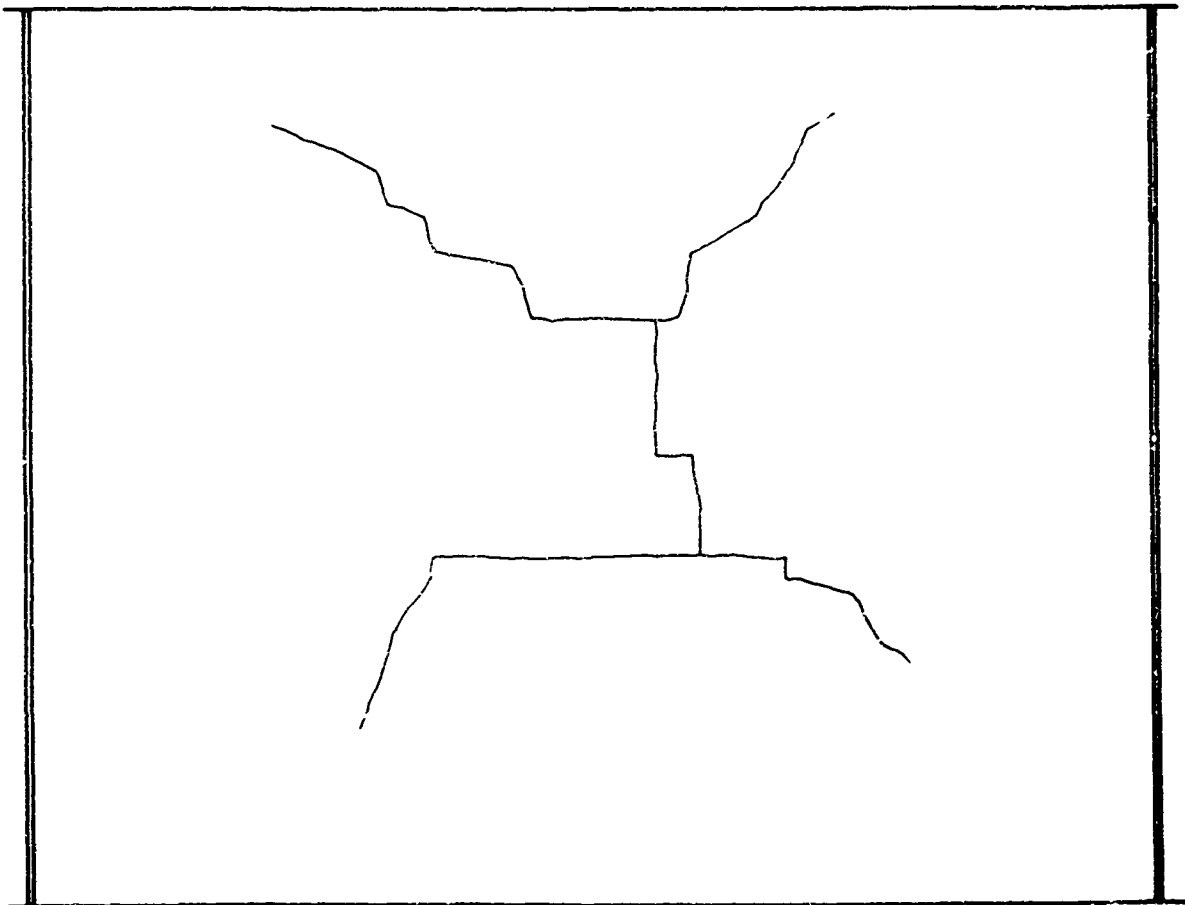
Results: The wall cracked as shown in the sketch below but did not collapse. (The wall failed on second test at 3.0 psi peak reflected overpressure).

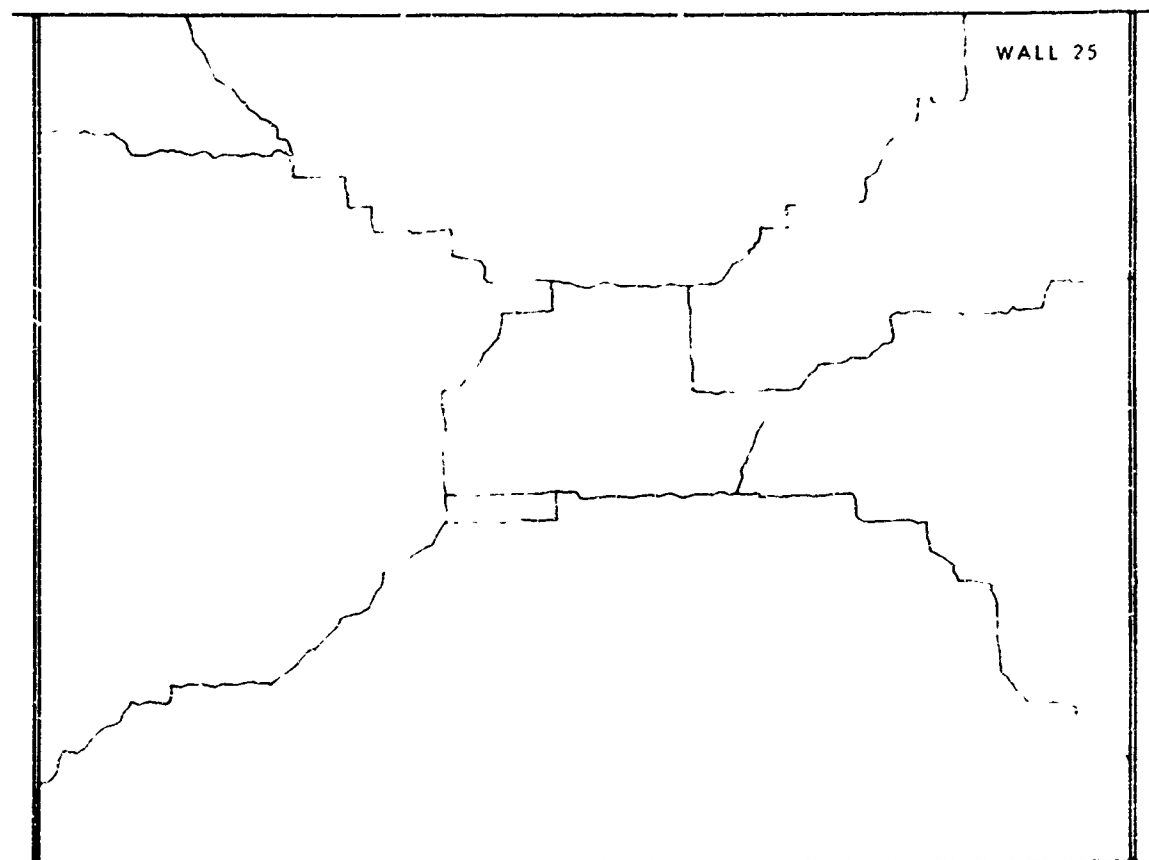
Results: Wall cracked as shown in sketch below but did not collapse.

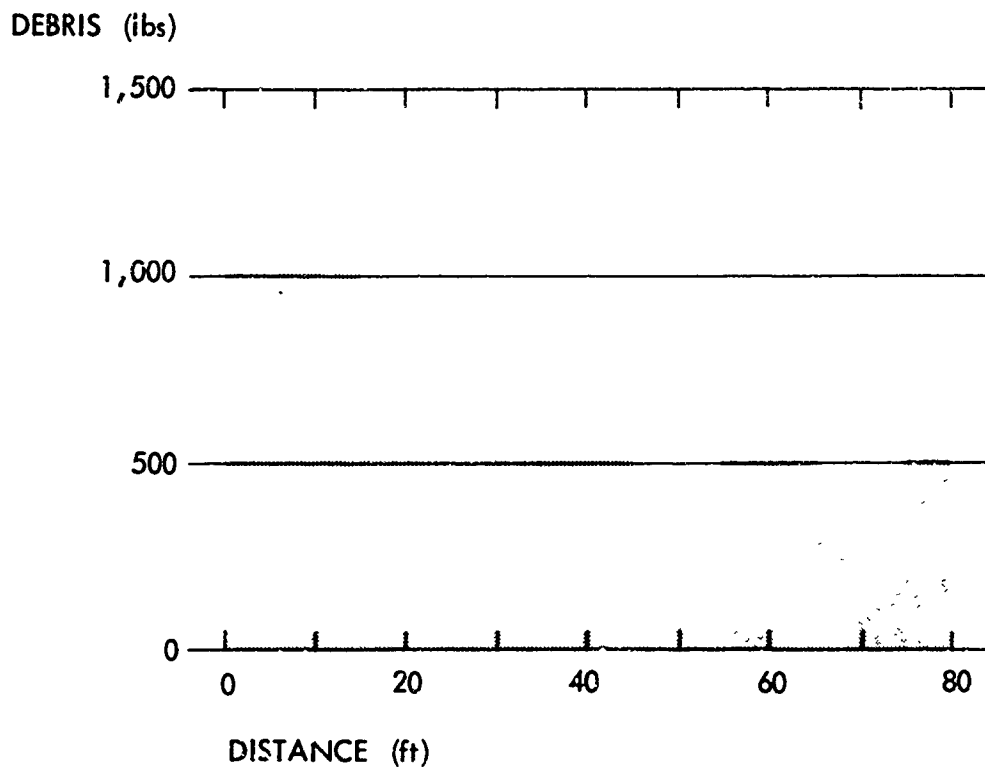
Debris Distribution, Wall Number 26

Results: The wall failed, and debris scattered to 80 ft. (See debris distribution chart below).

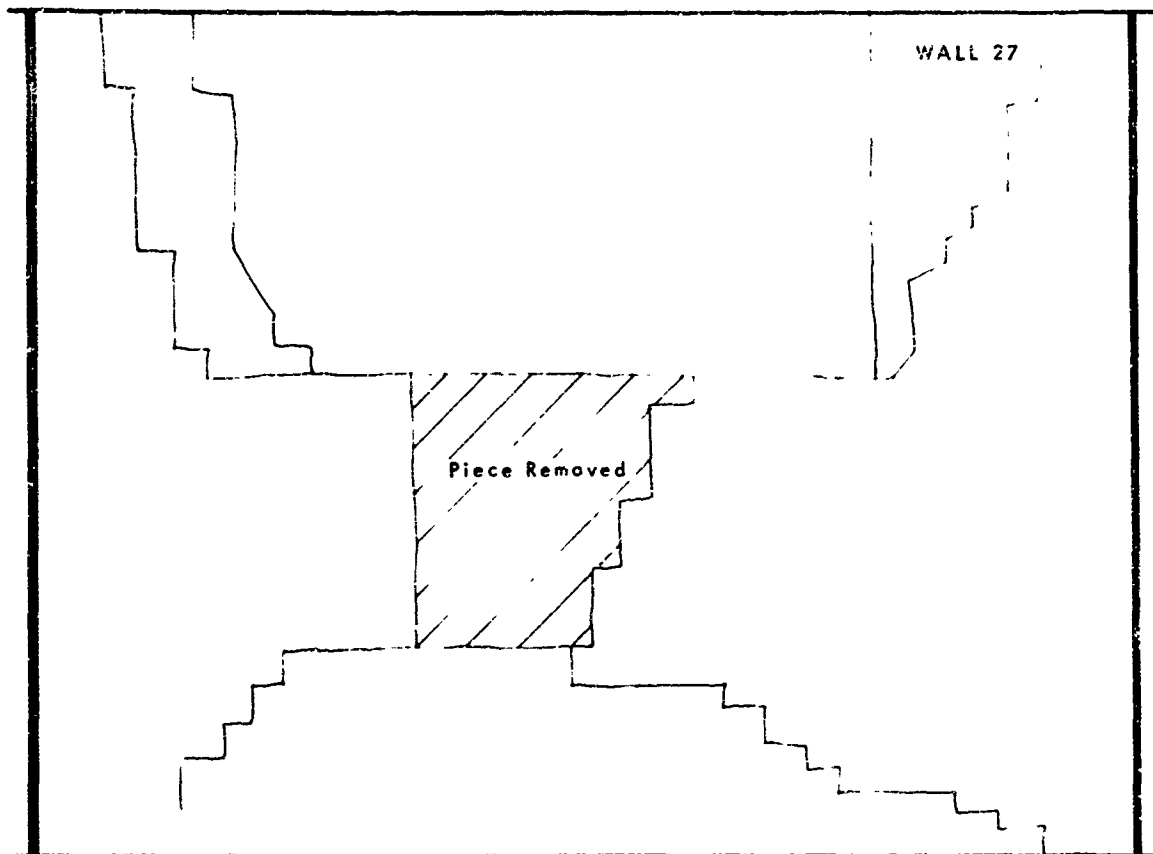
Results: The wall cracked, and a section weighing ~ 500 lb fell out of the center. The remainder of the wall stayed in place. (See crack pattern sketch below).

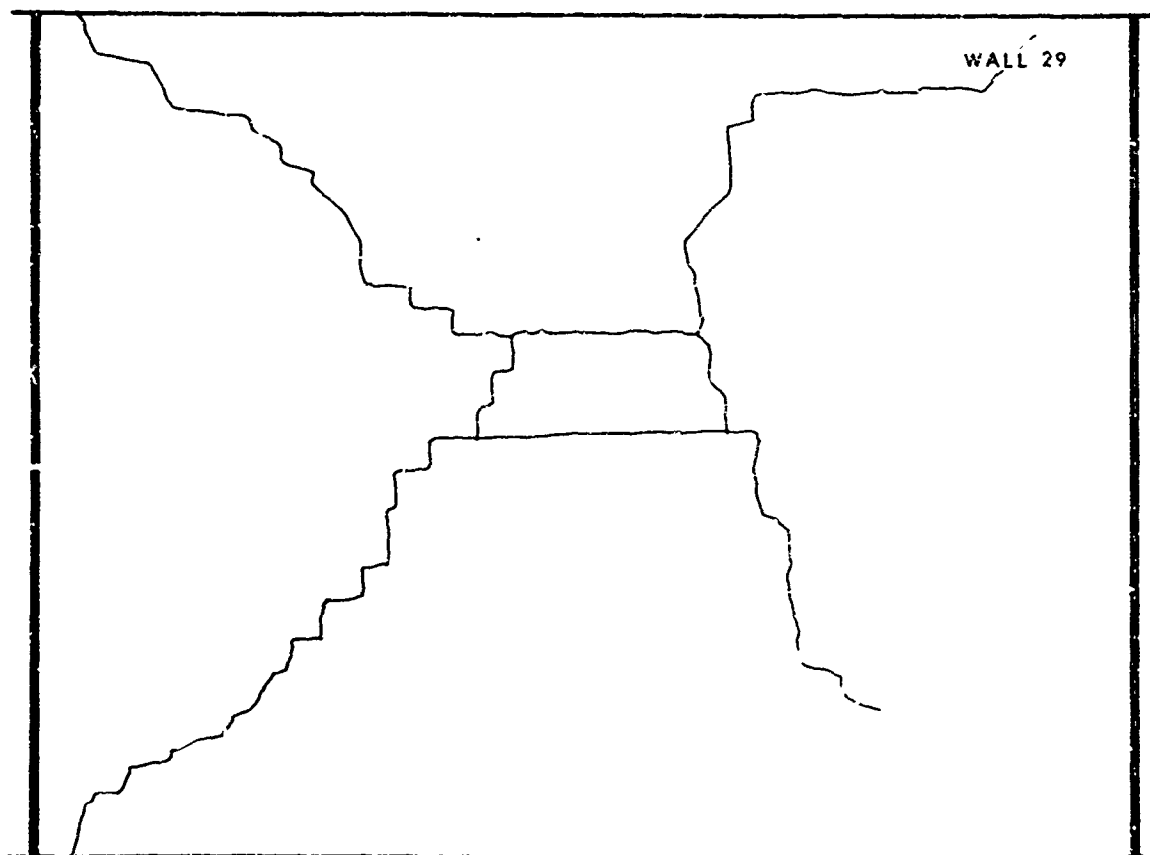
Results: The wall cracked but did not collapse. (See crack pattern sketch below). A second test on this same wall at a peak reflected overpressure of 4.2 psi caused about 350 bricks to fall out of the wall, all landing within 10 ft.

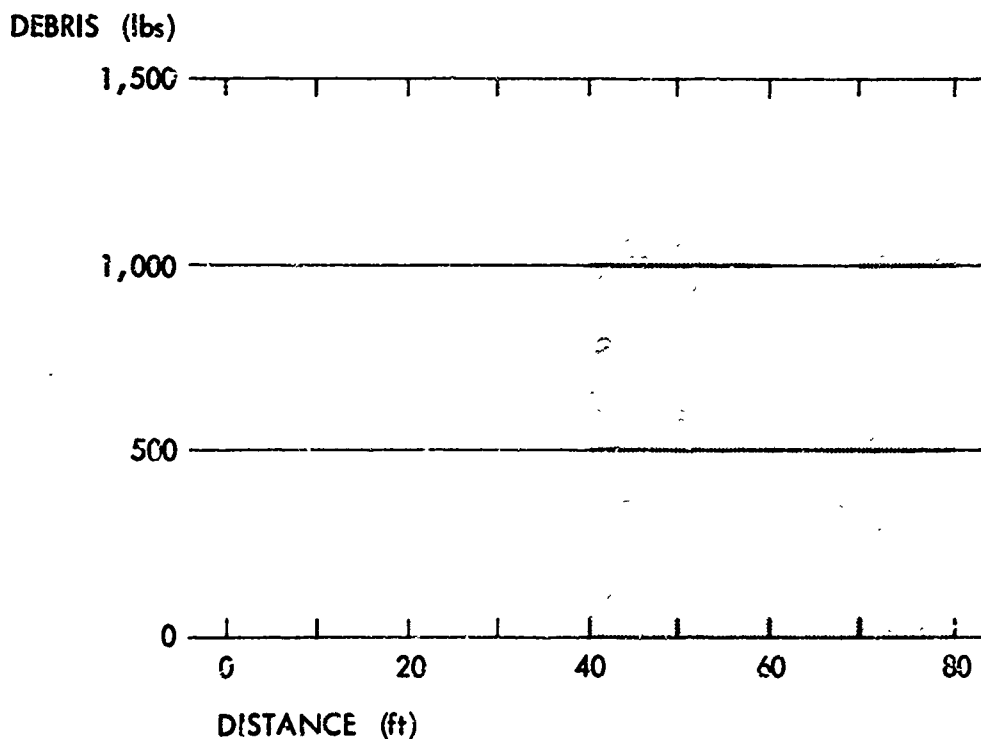
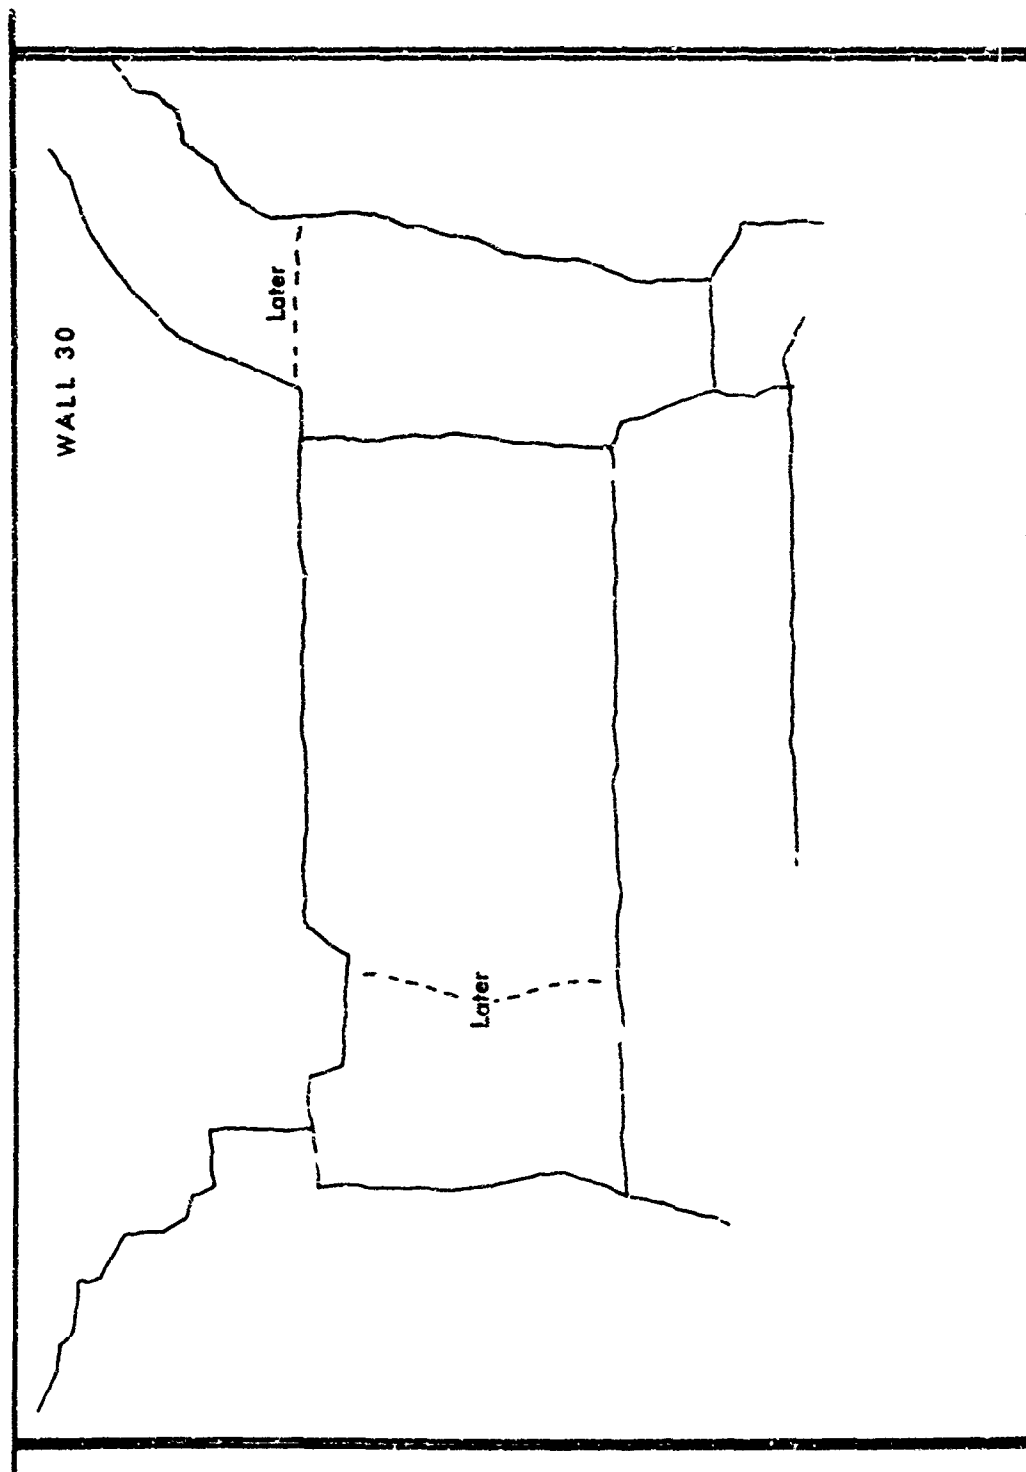
Debris Distribution, Wall Number 30

Results: The wall failed and debris scattered more than 70 ft. (See distribution chart and initial crack pattern sketch below).

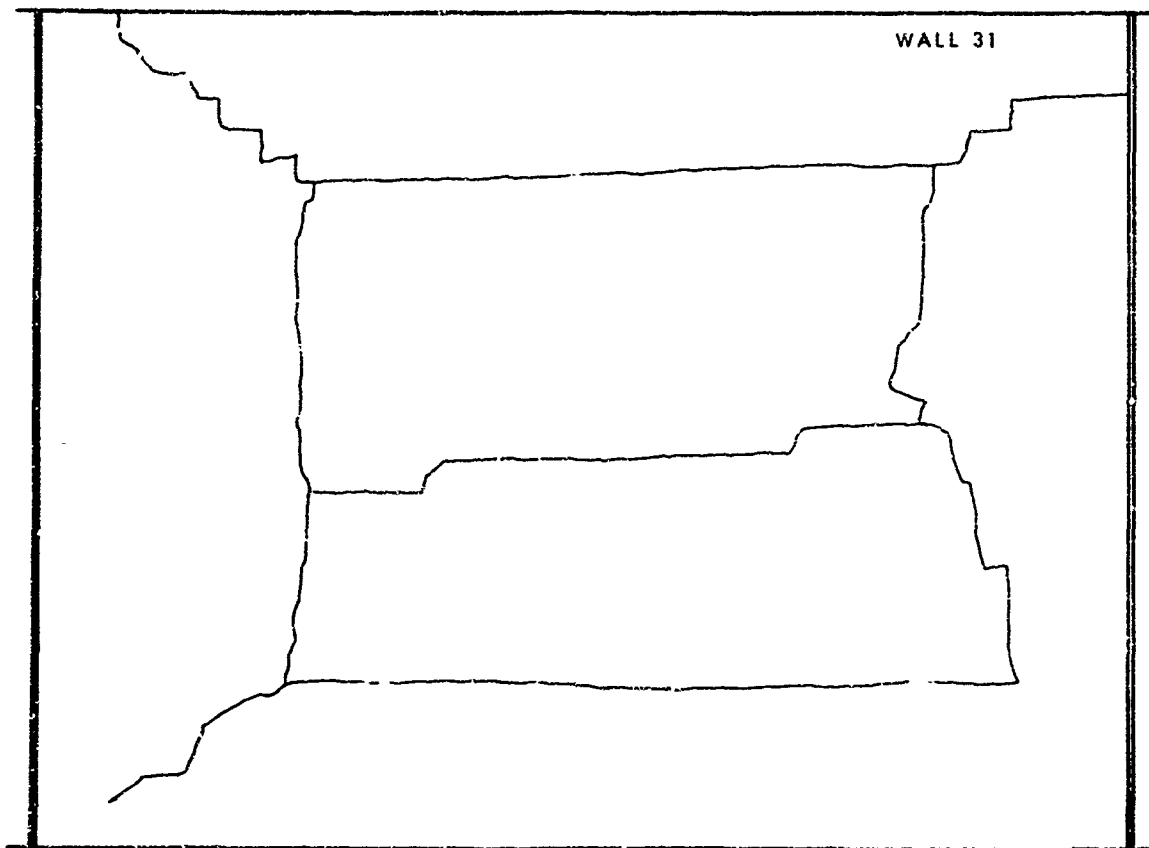
Results: The wall failed. (See initial crack pattern sketch.)
