TECHNICAL REPORT N-70-10

**SURVEY OF GULF COAST
STRUCTURAL DAMAGE RESULTING FROM
HURRICANE CAMILLE, AUGUST 1969**

Final Report

By U. S. Army Engineer Waterways Experiment Station, Vicksburg, Mississippi

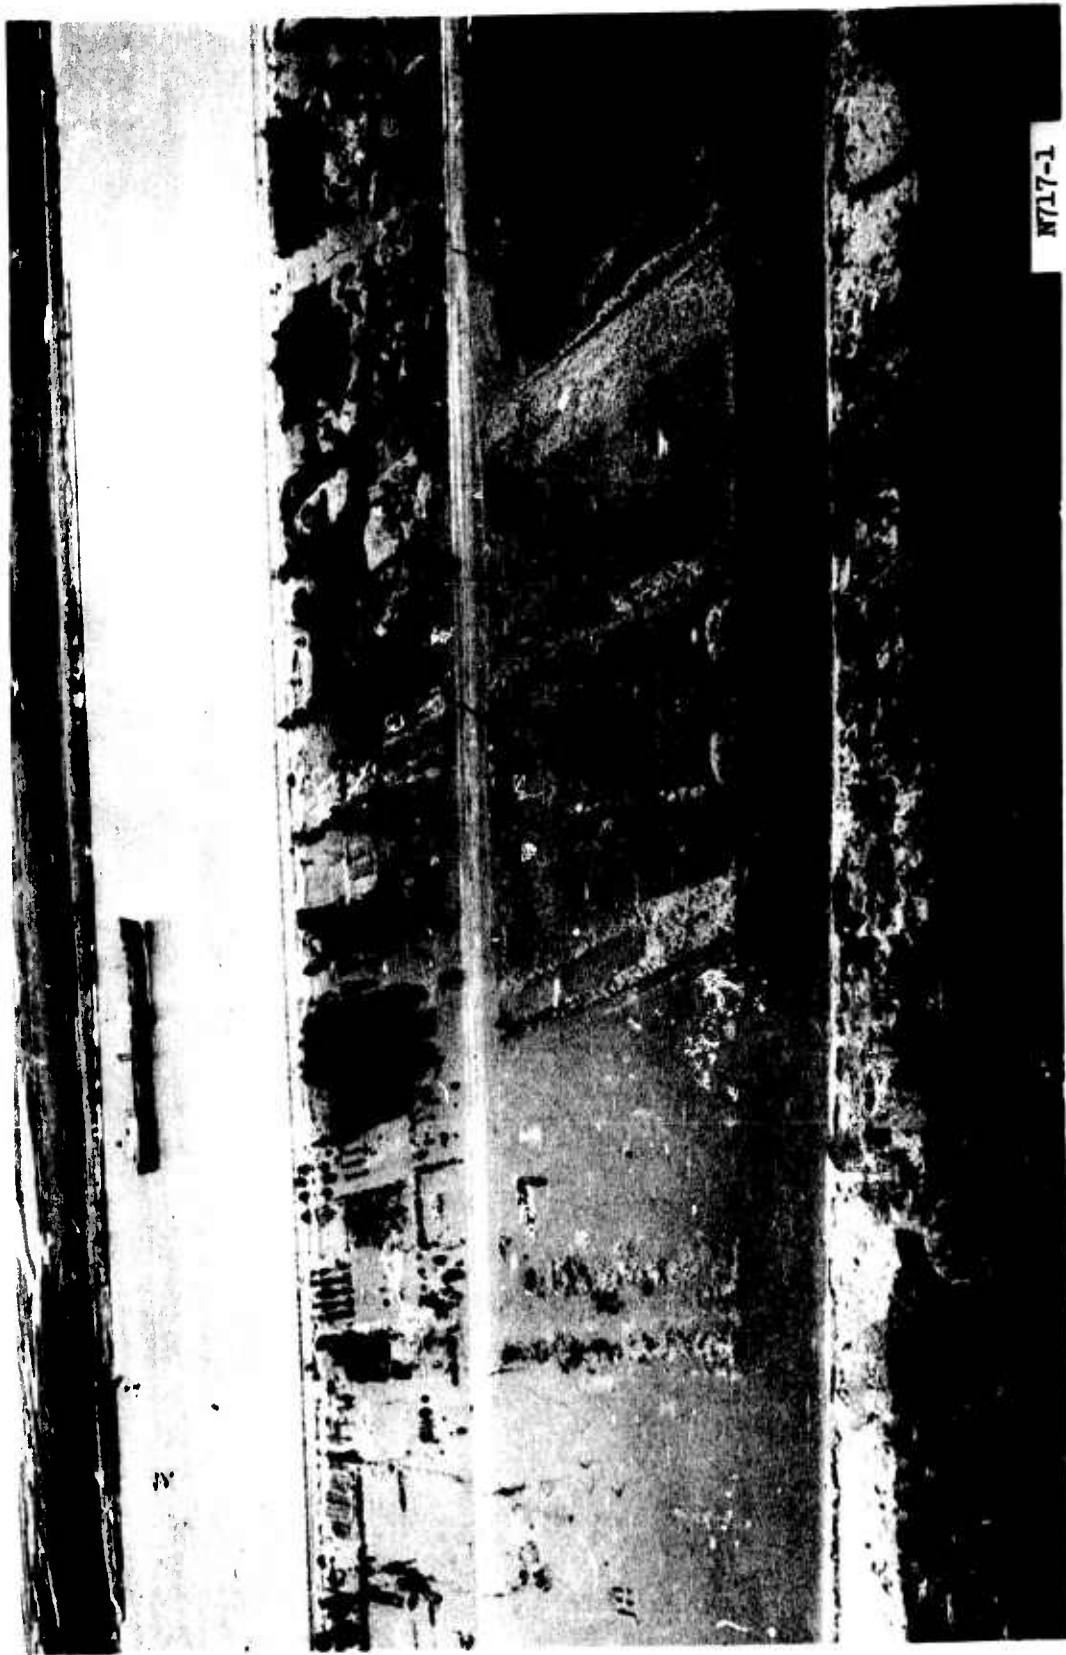
Figure 2.5 Damage near Buras, Louisiana.

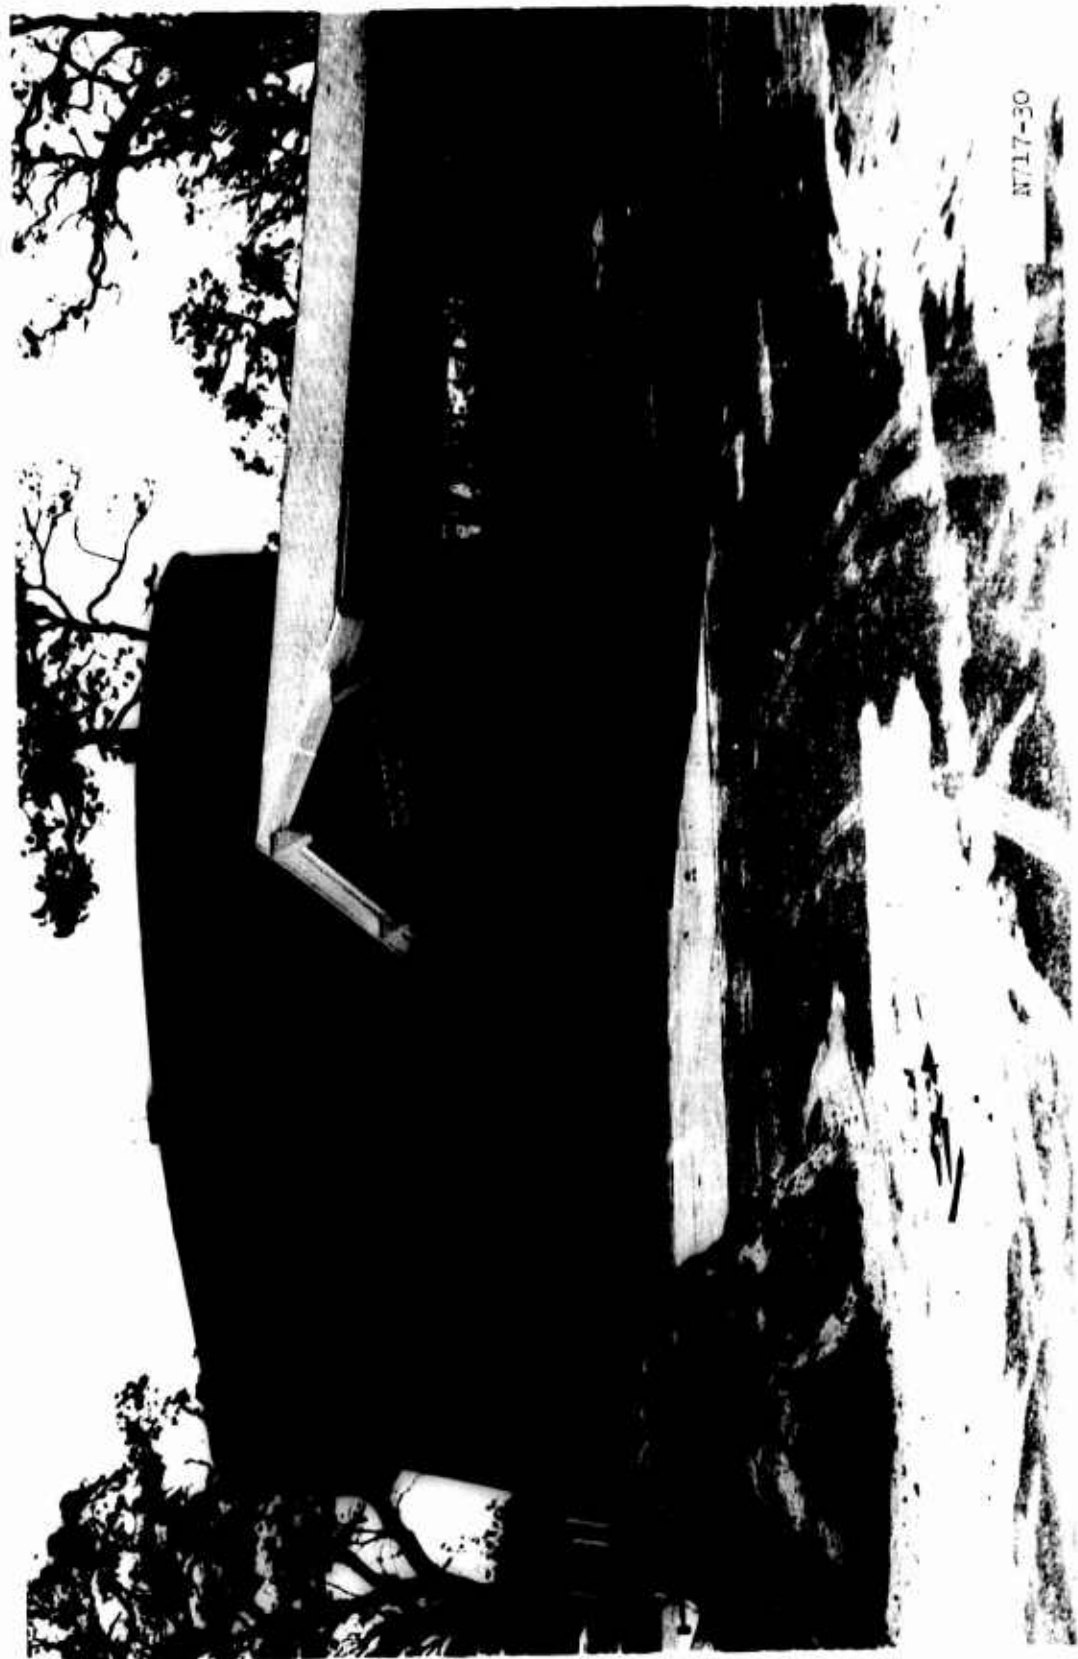
NT17-30

Figure 2.30 Tank floated in from harbor, west Gulfport, Mississippi.

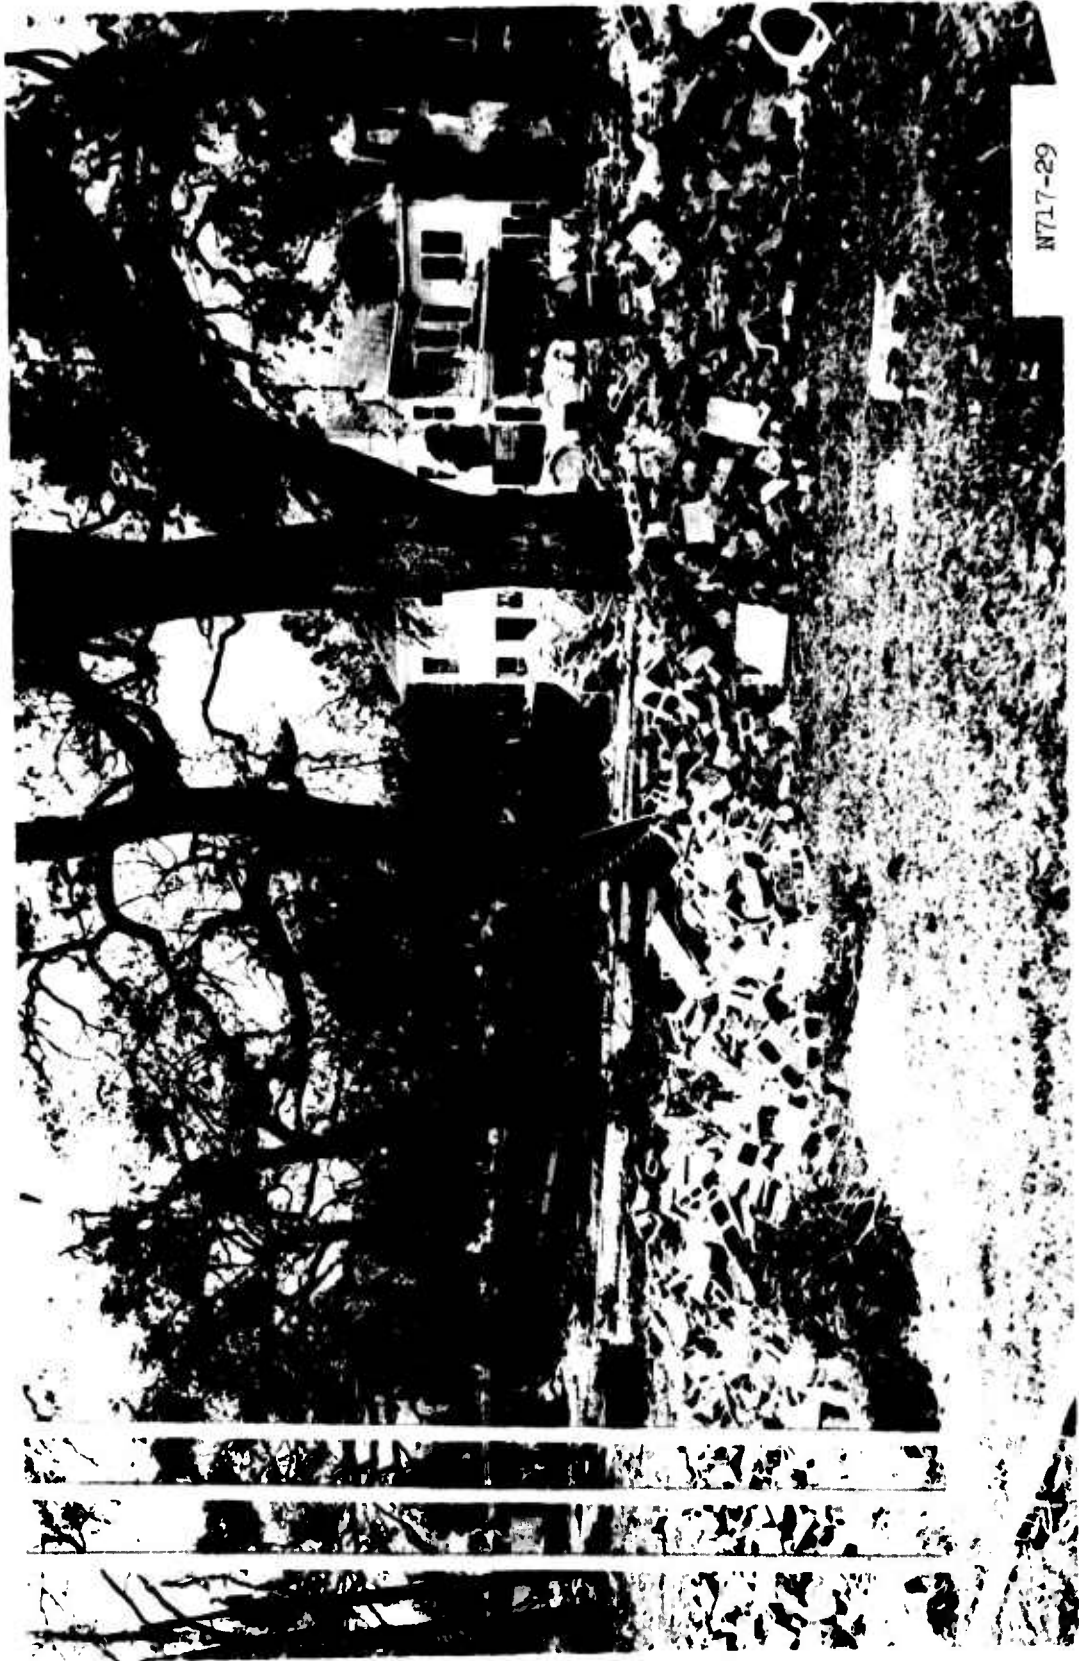
Figure 2.32 Barge, debris, and damaged residence, west Gulfport, Mississippi.

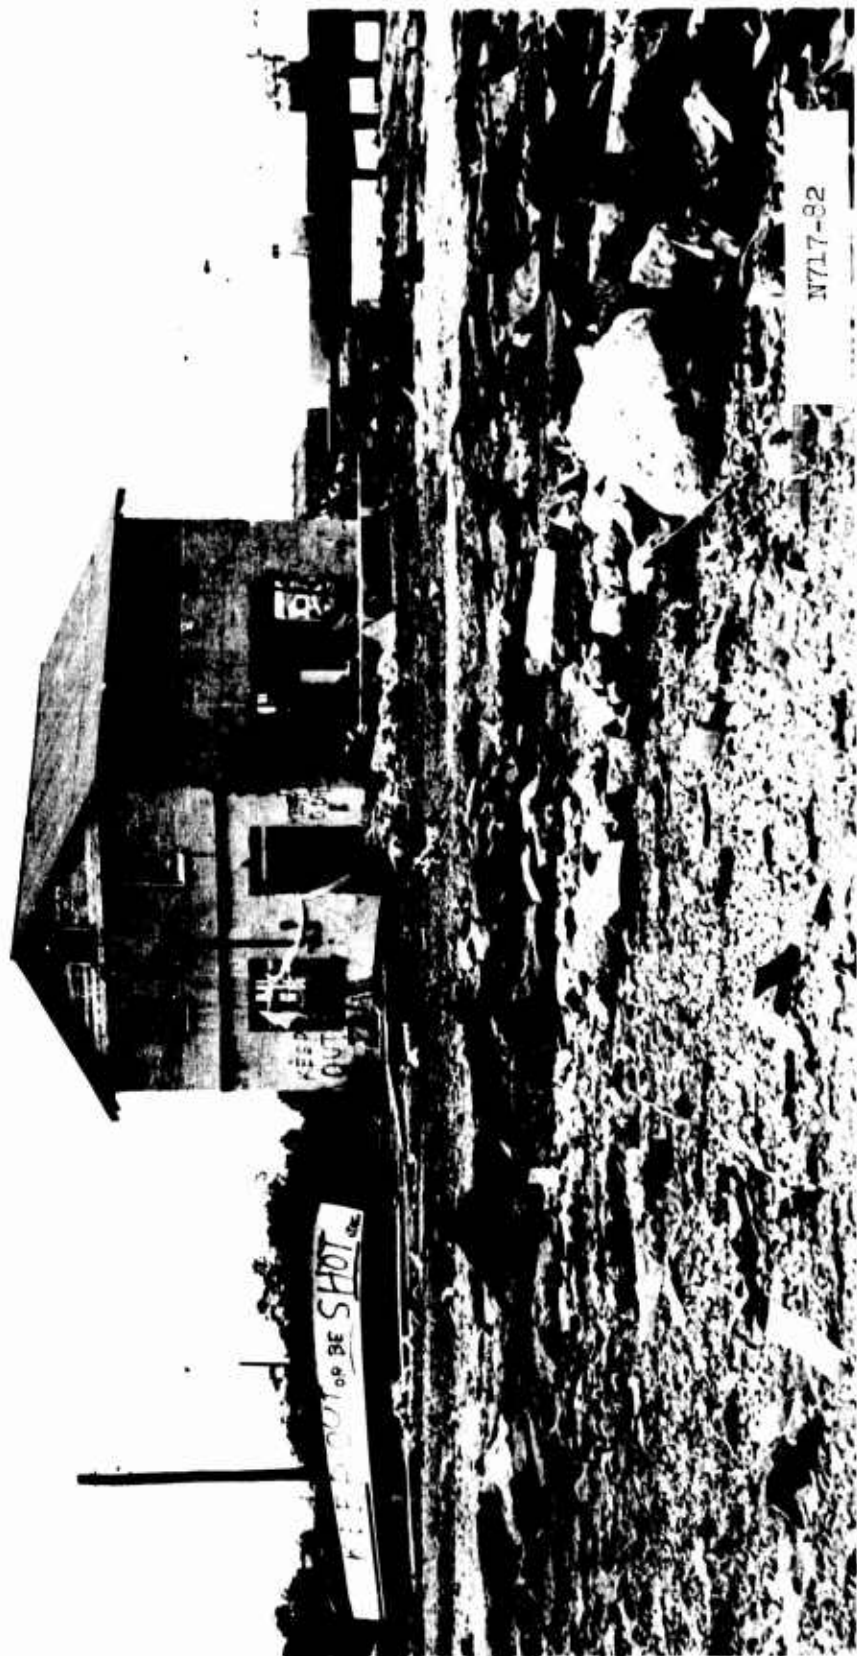
Figure 2.38 Water-damaged building, Back Bay of Biloxi.

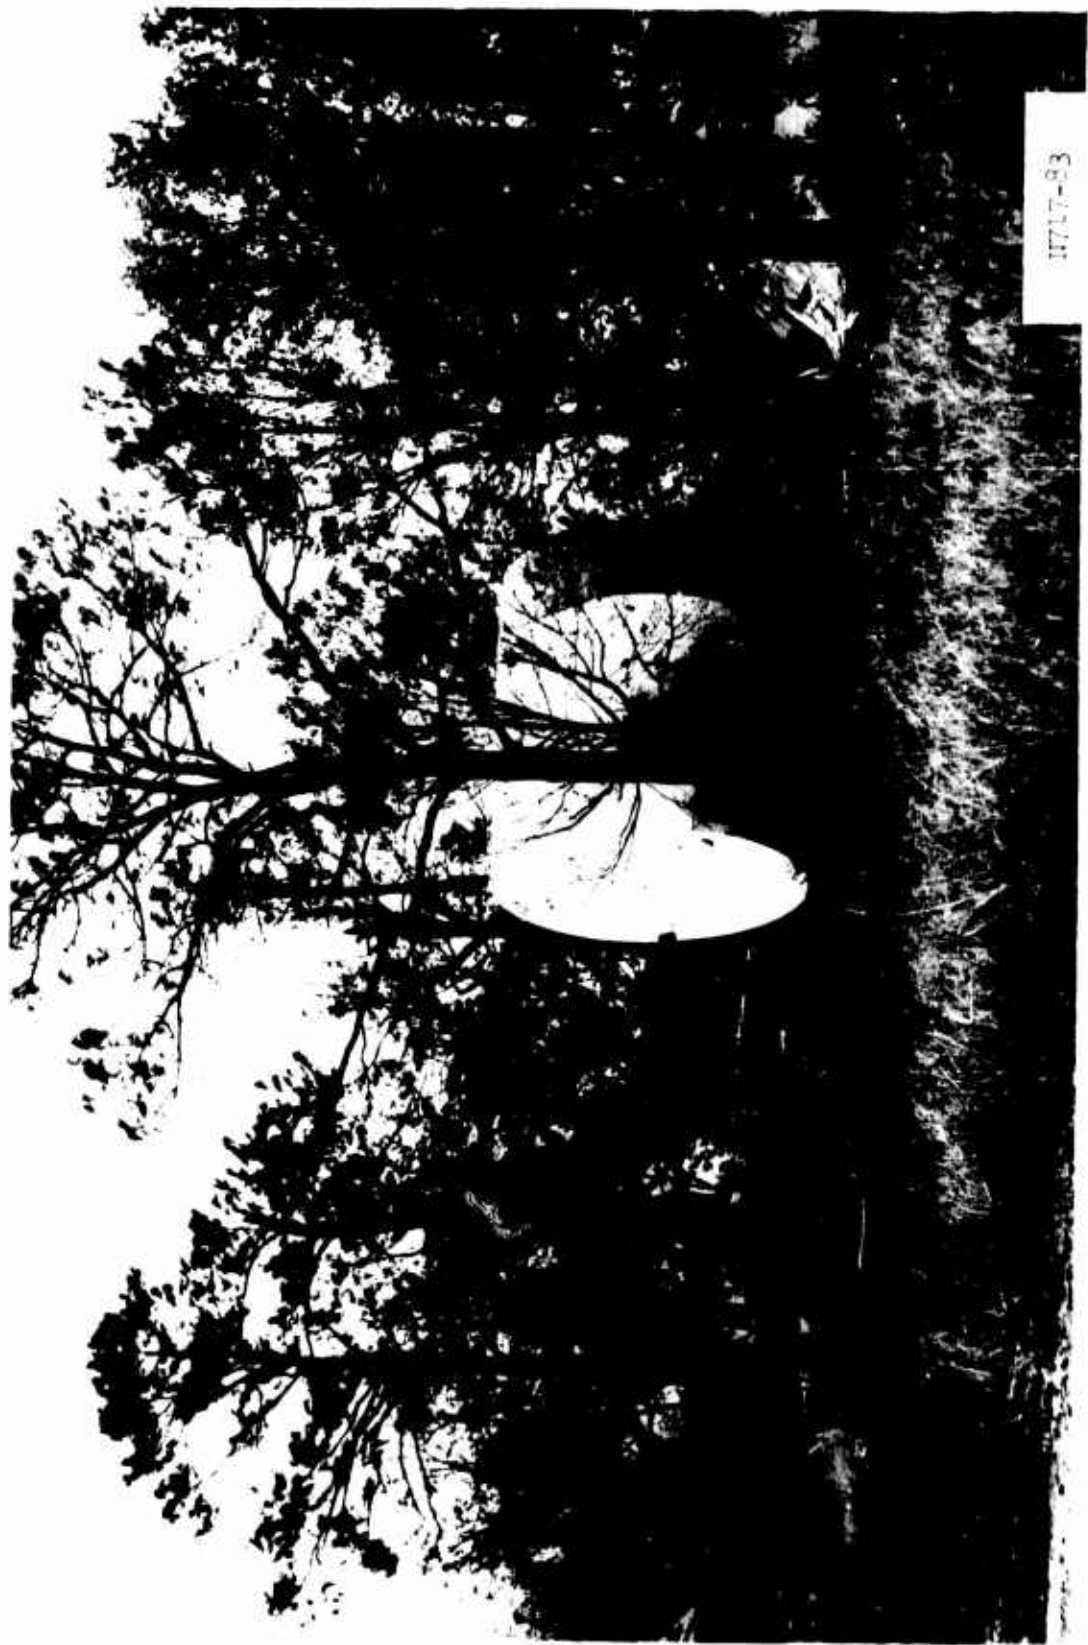
Figure 2.39 Oil storage tank floated inland, Back Bay of Biloxi.

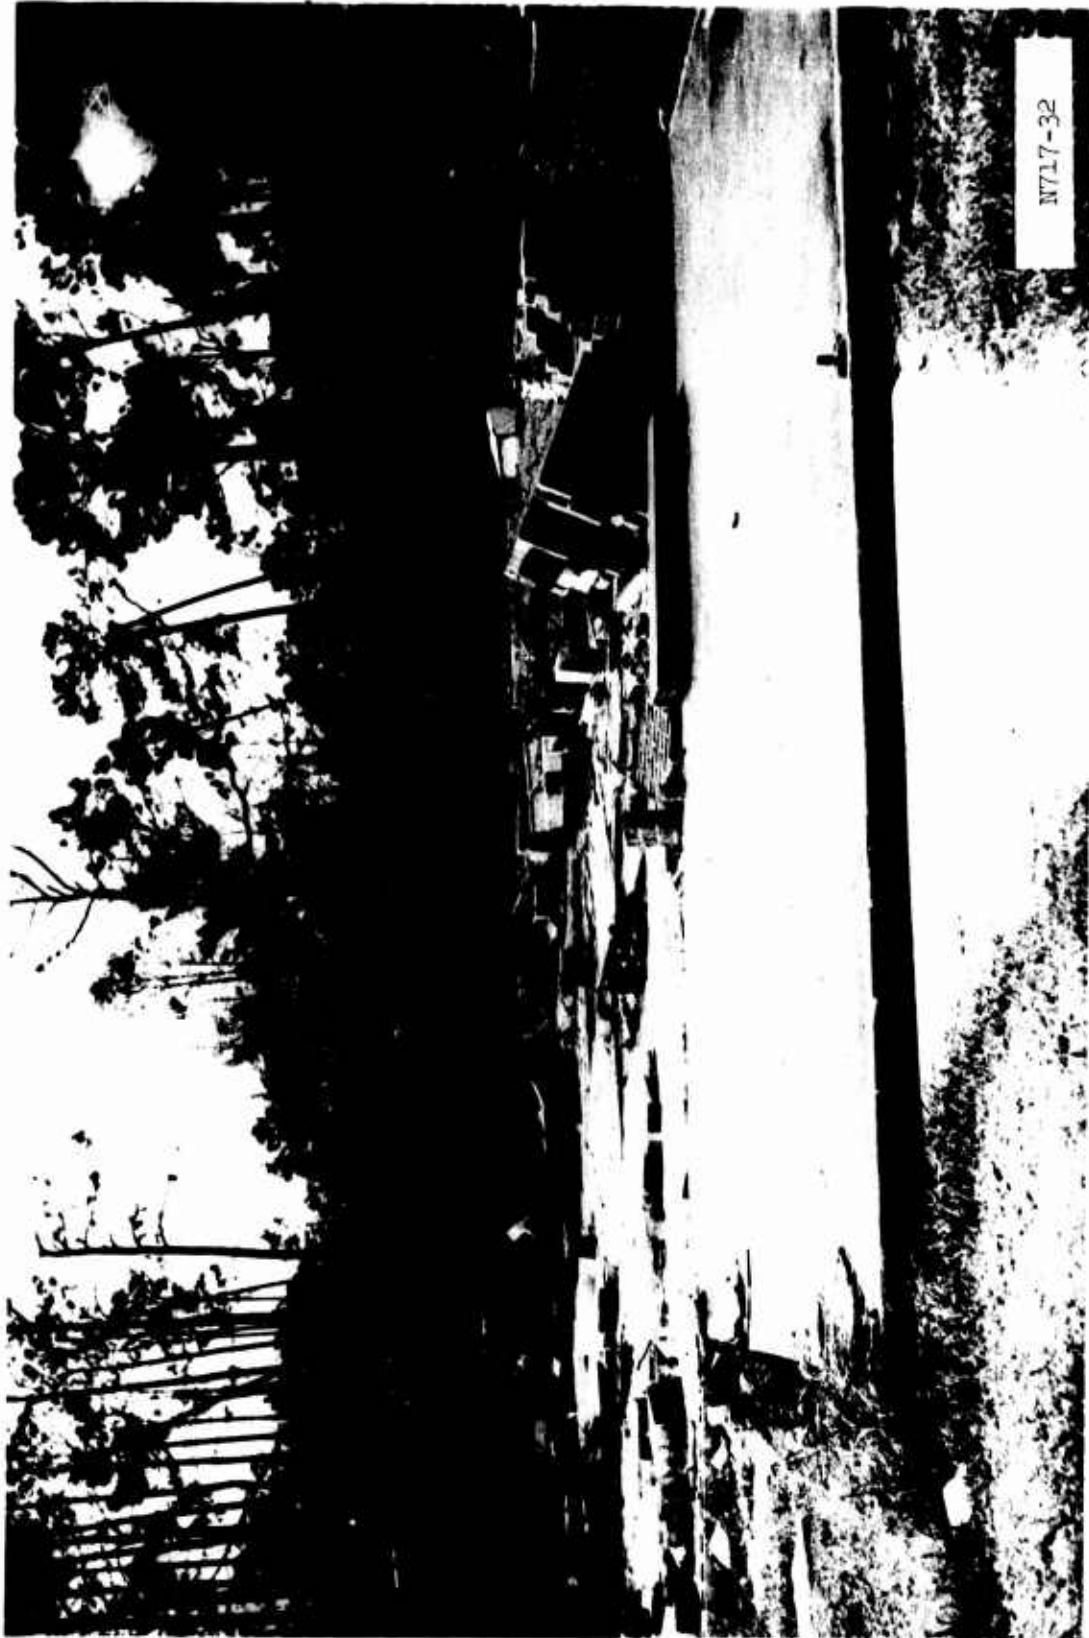
Figure 2.40 Remains of brick and block residence, Long Beach area.

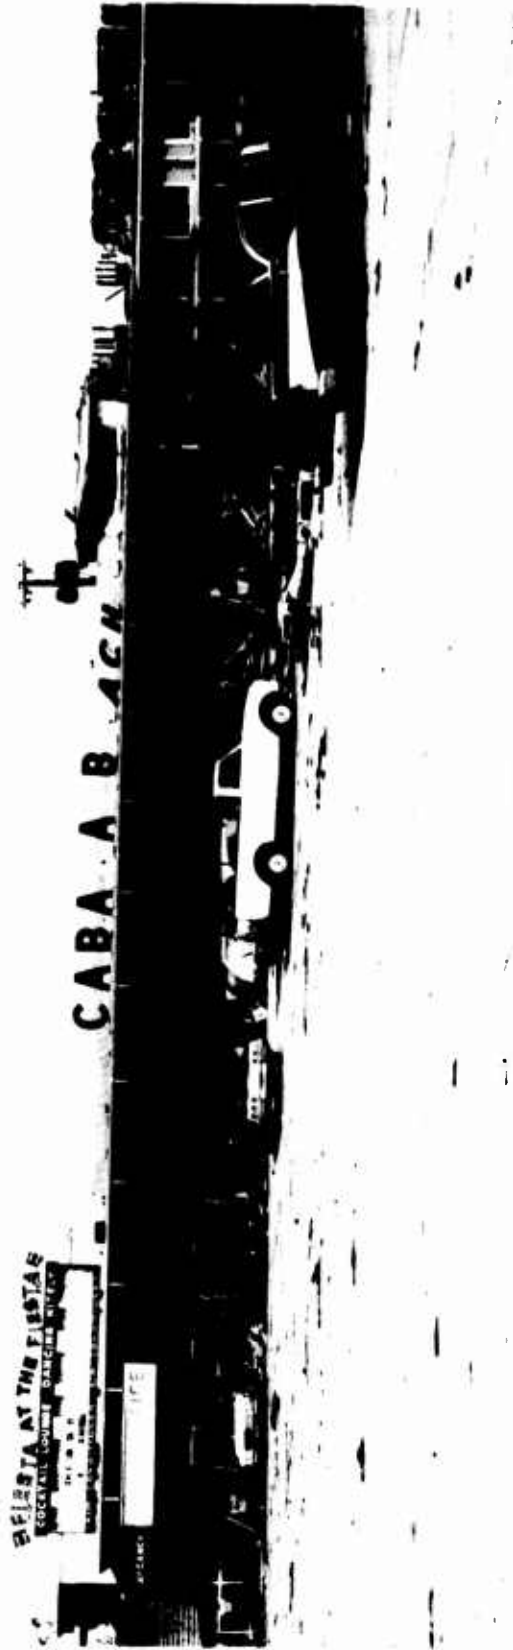
W717-79

Figure 2.52 Frame motel structure, Biloxi, Mississippi. There had been fire damage before the storm to the building shown at the right.

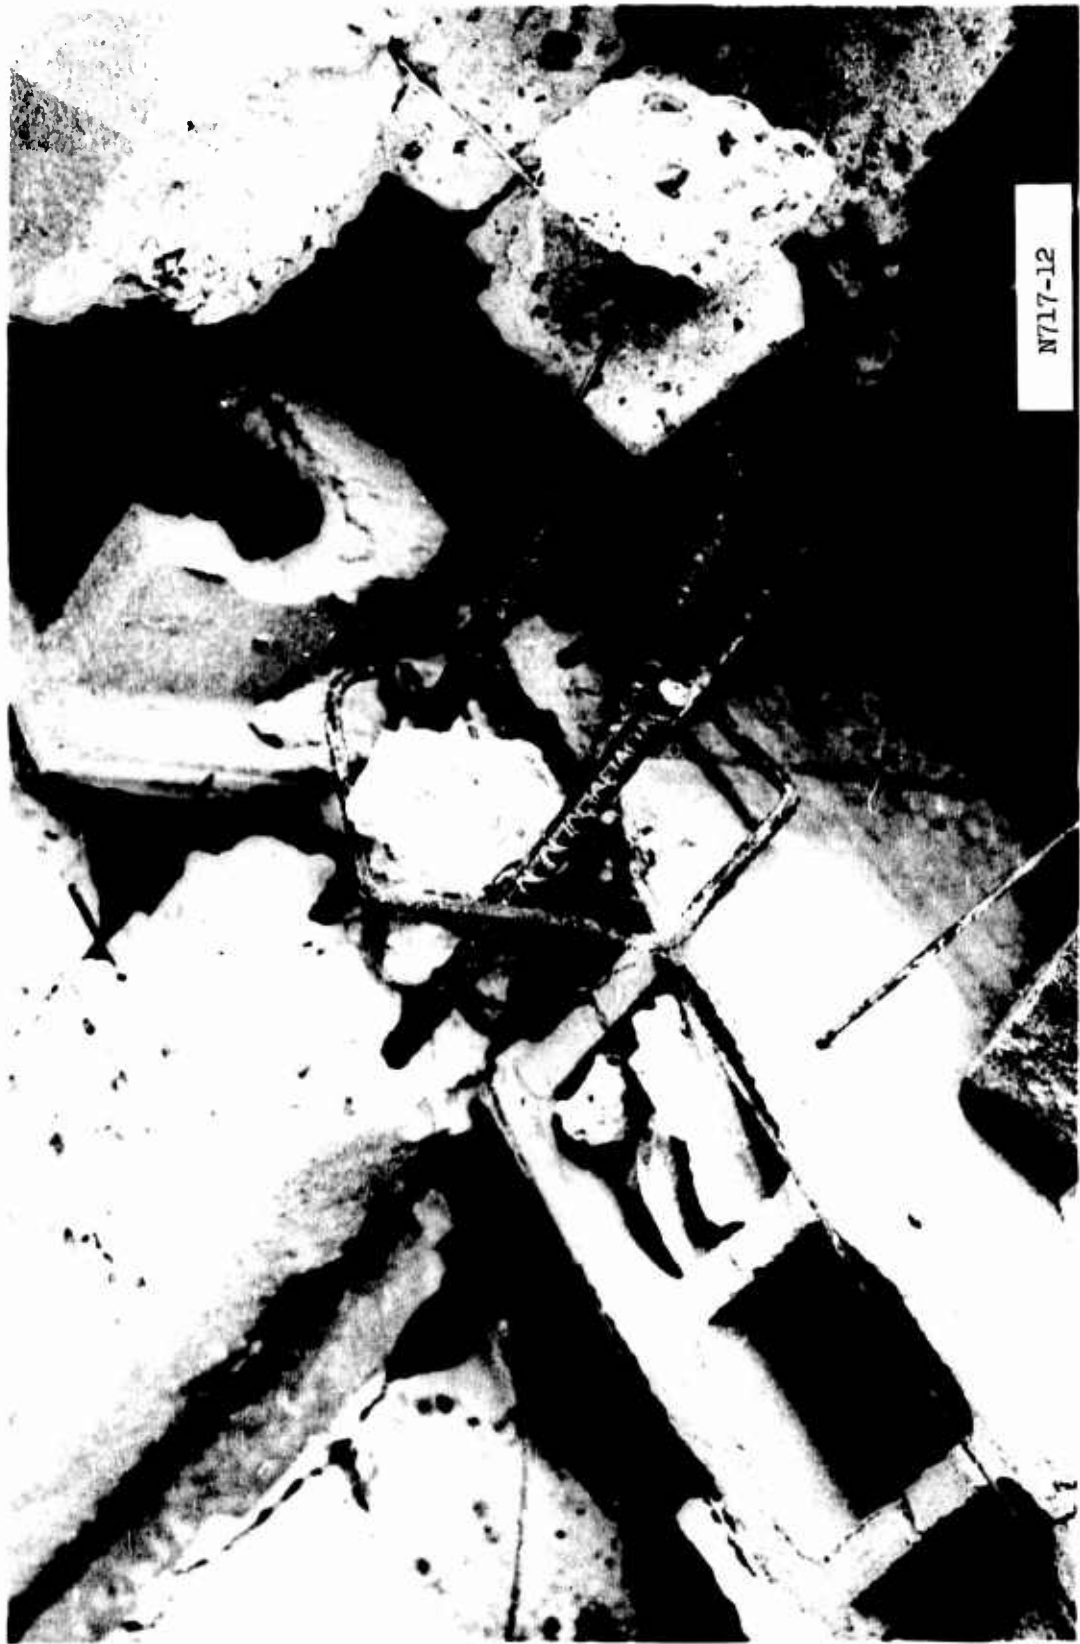
Figure 3.21 Overhead view of beam failure over block wall, Marine Life.

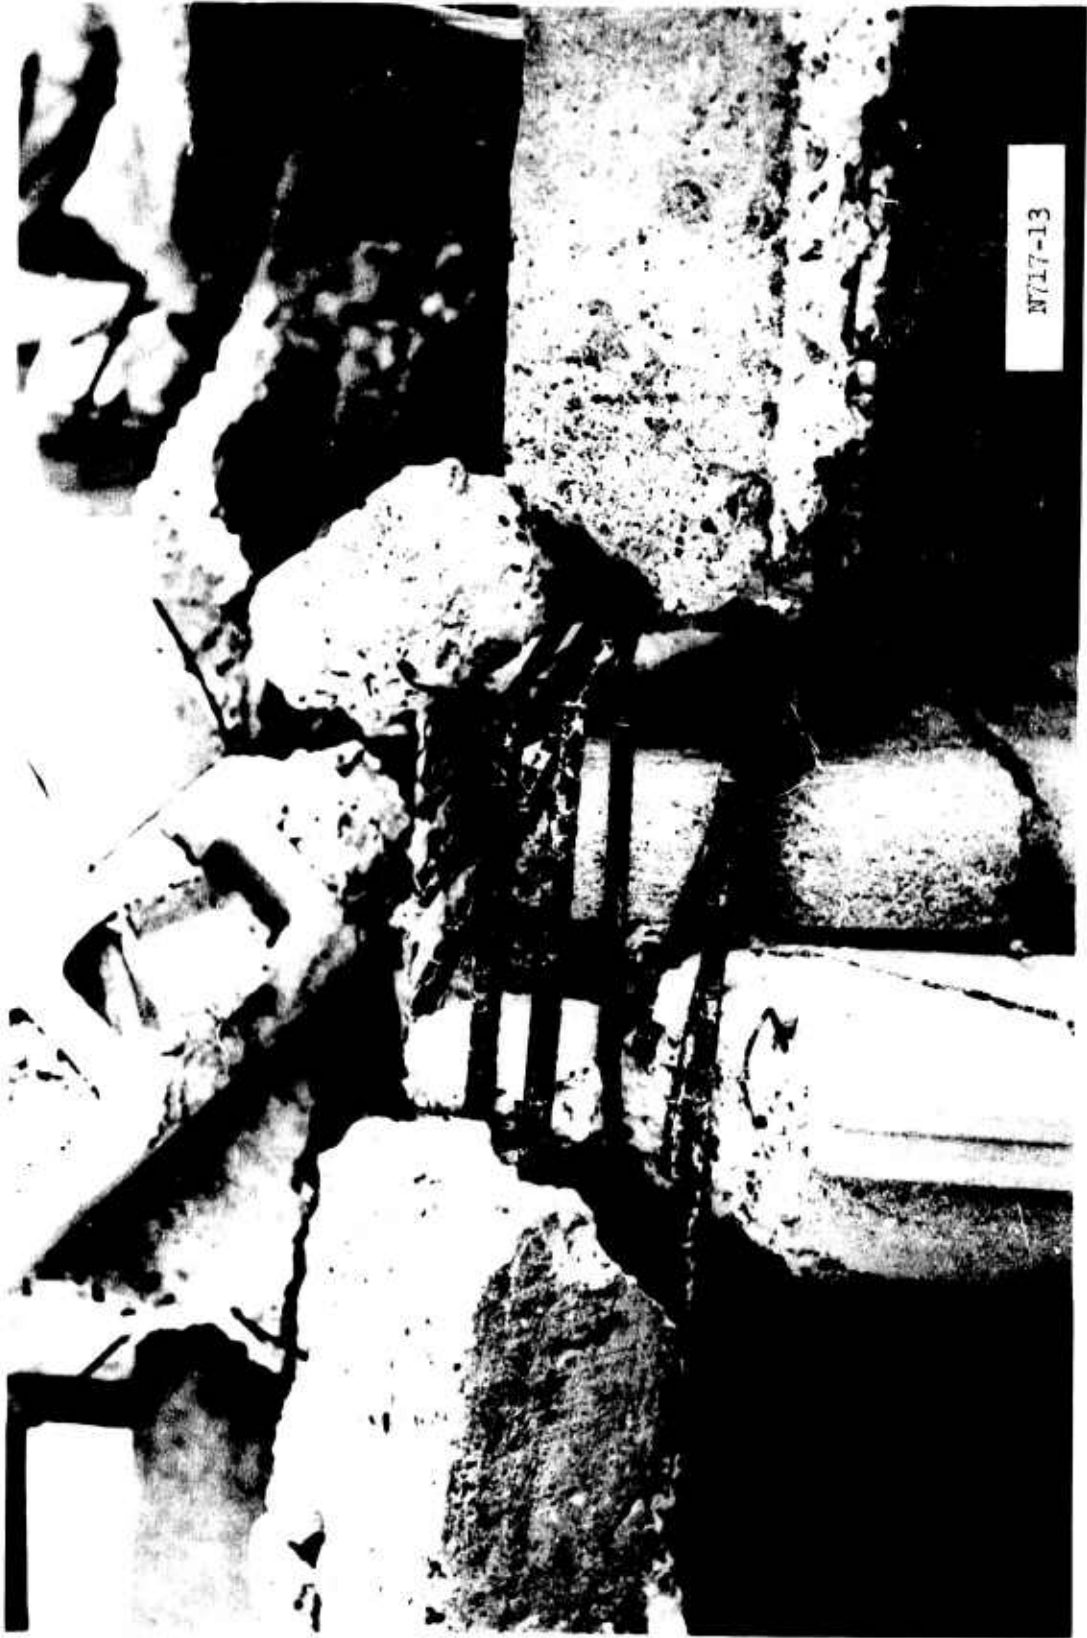
Figure 3.22 Side view of beam failure over block wall, Marine Life.

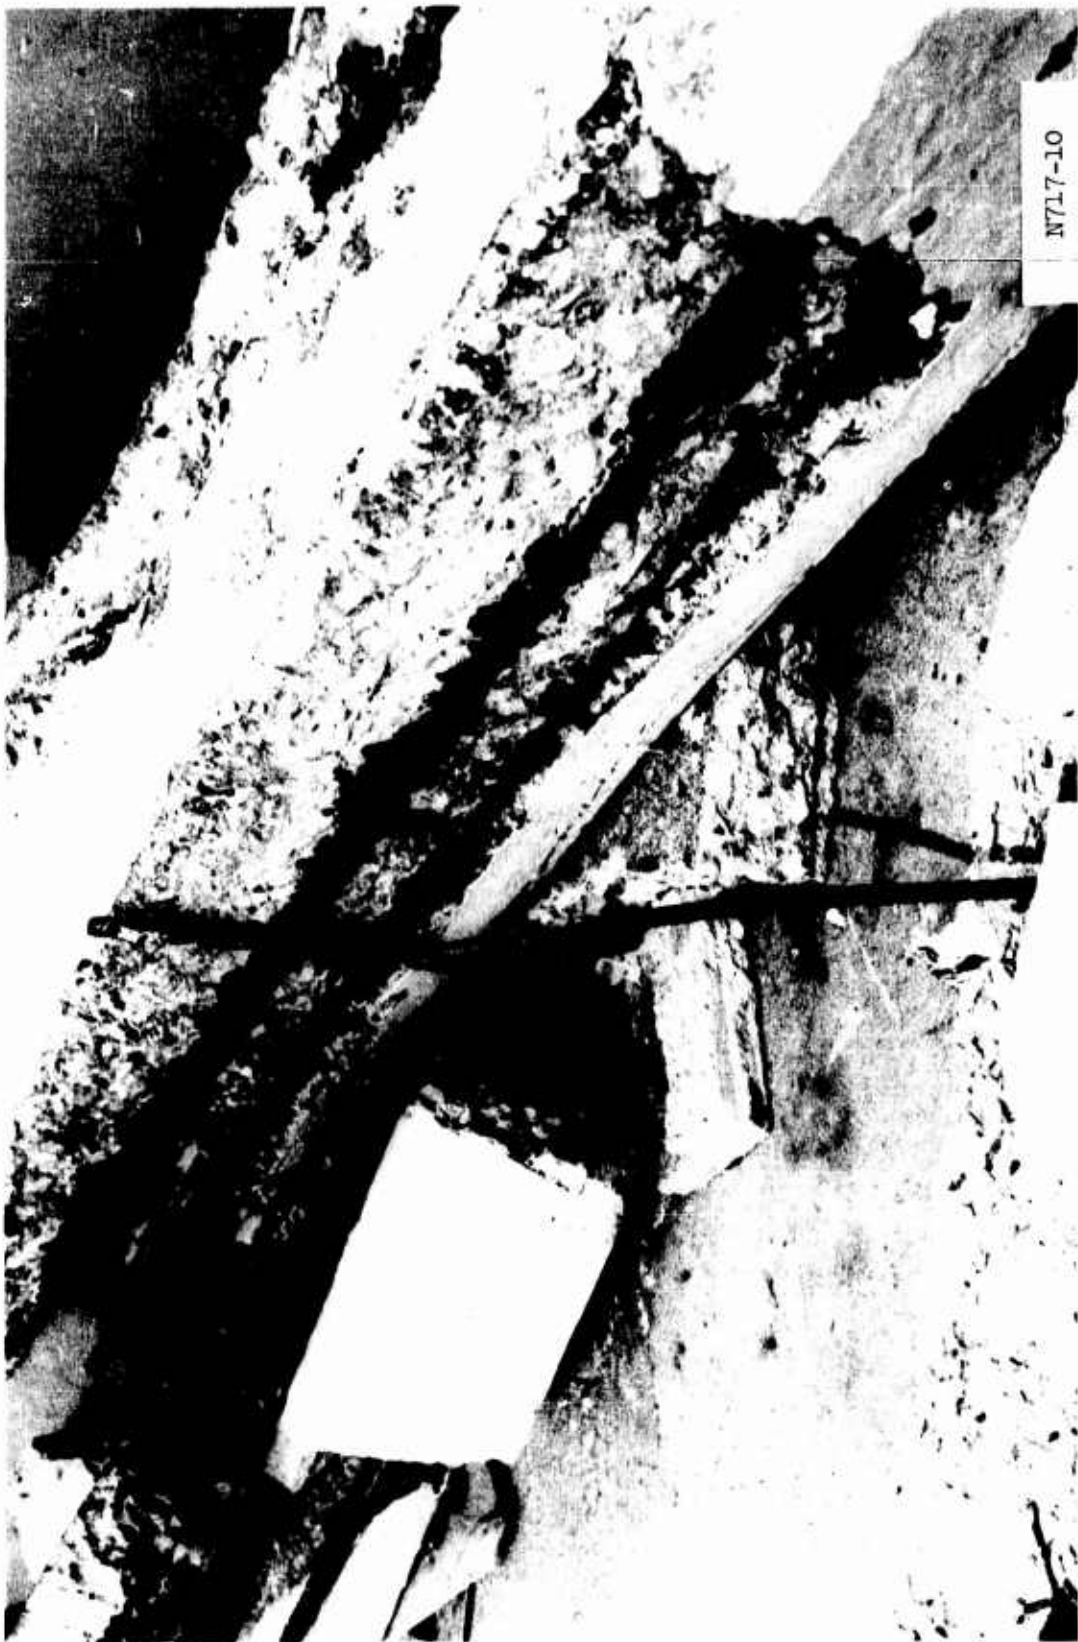
Figure 3.25 Reinforcement corrosion in a beam, Marine Life.

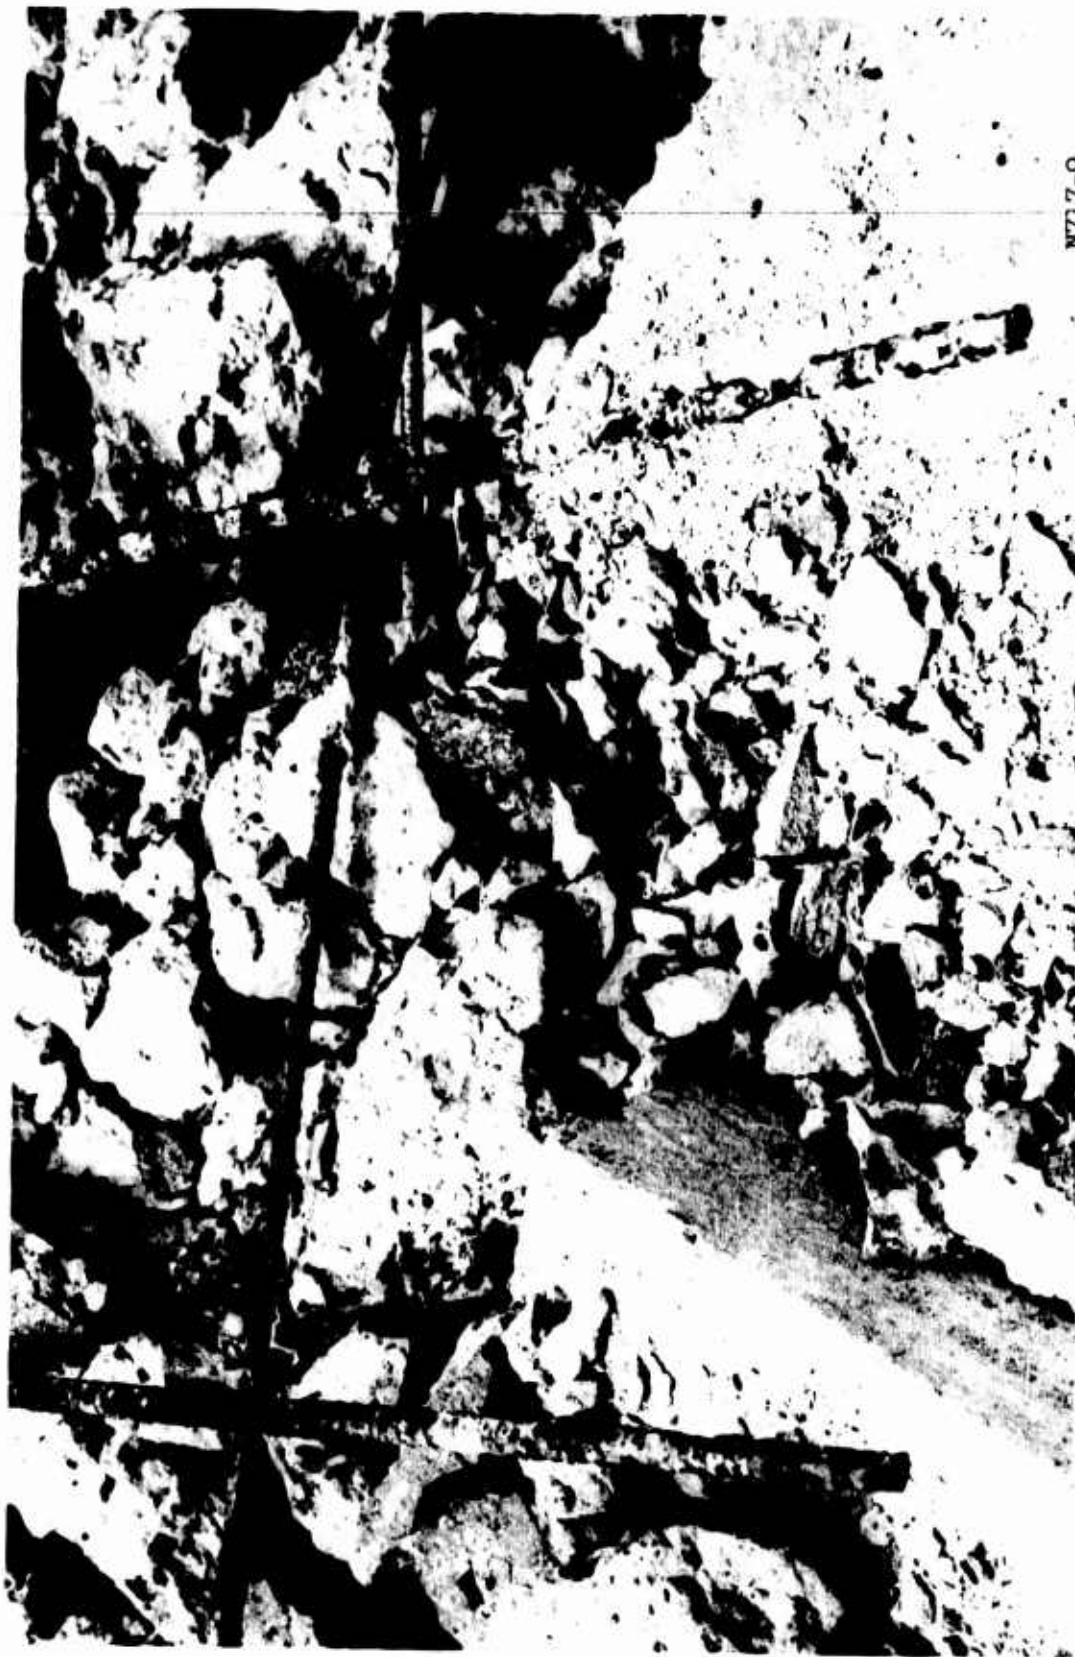
W717-9

Figure 3.26 Reinforcement corrosion in a slab, Marine Life.

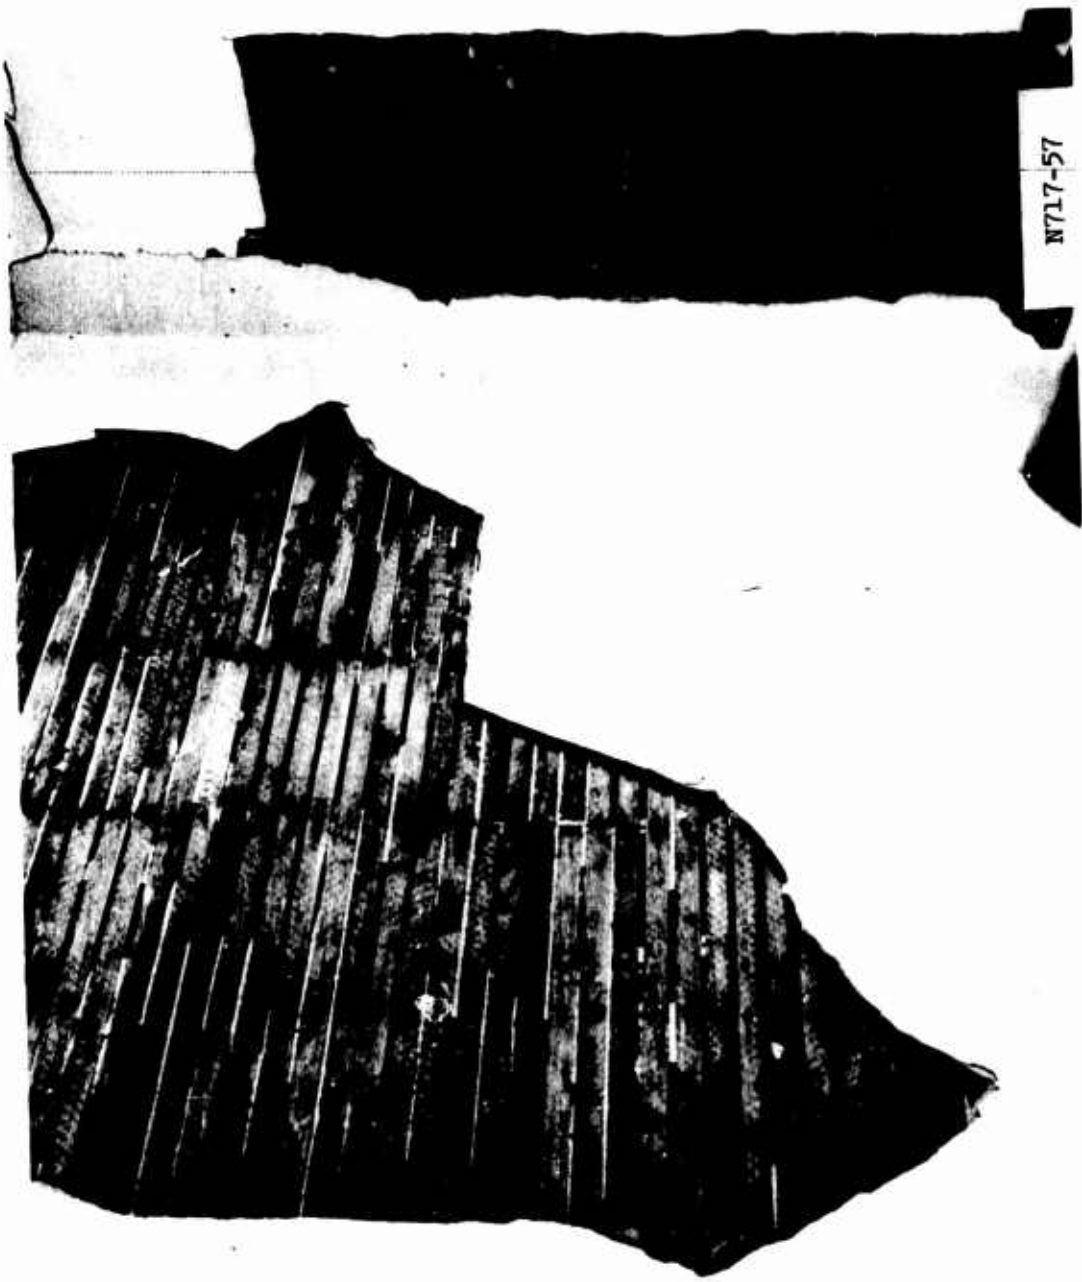
Figure 3.36 Wall damage, Pass Christian City Hall.

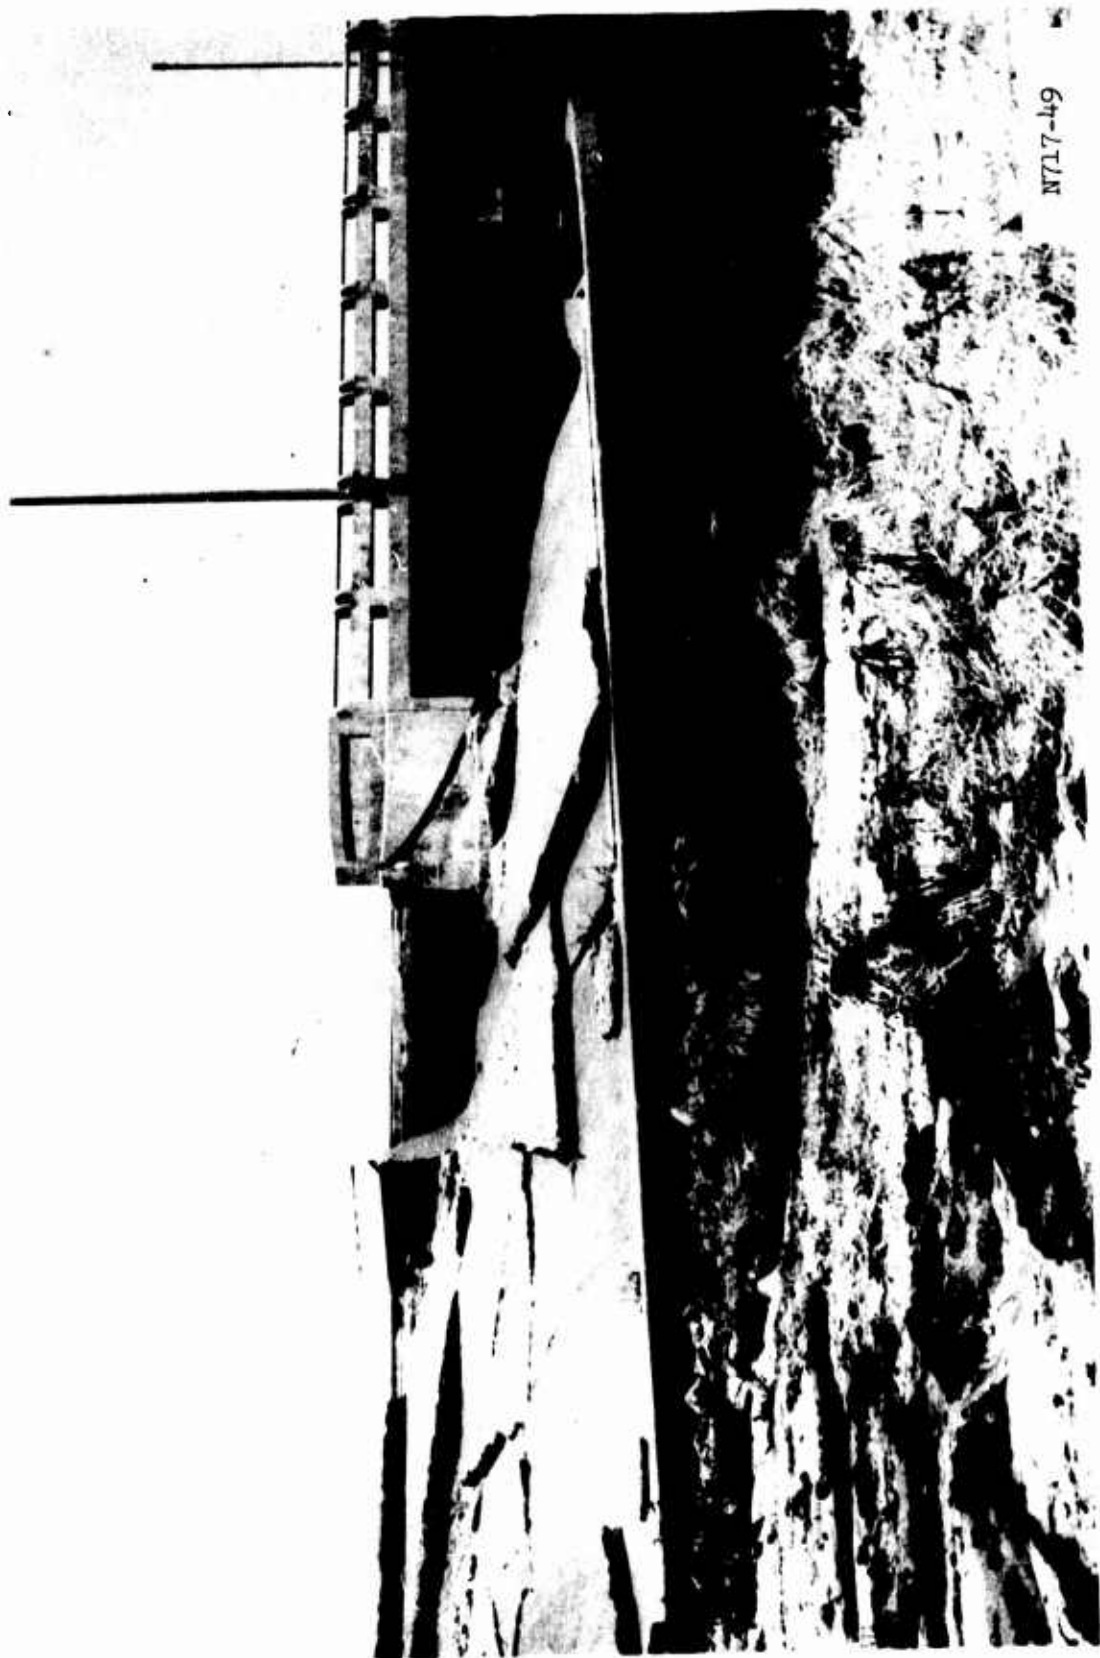
N717-49

The water appeared to have lifted the seaward deck slabs up enough for the rocker bearings on the east end of each span to fall out, resulting in a sawtooth appearance along the south side of the bridge (Figures 3.52 and 3.53). Some of the railing sections were tilted inland, and all but one lamp was torn from its pole. One span was moved about 4 feet laterally (Figure 3.54). Considerable concrete was spalled along the bridge centerline where the two deck slabs joined. The west abutment was heavily damaged by wave action (Figure 3.55).

Figure 3.55 West abutment of Bay Saint Louis Bridge.
