# TARGET RESPONSE TO EXPLOSIVE BLAST

Final Report  
By  
George H. Custard  
John R. Thayer  
Falcon Research and Development Company  
Denver, Colorado

September 1970

ARMED SERVICES EXPLOSIVE SAFETY BOARD  
FORRESTAL BUILDING  
WASHINGTON, D. C.  
Contract No. DAHC04-69-C-0095

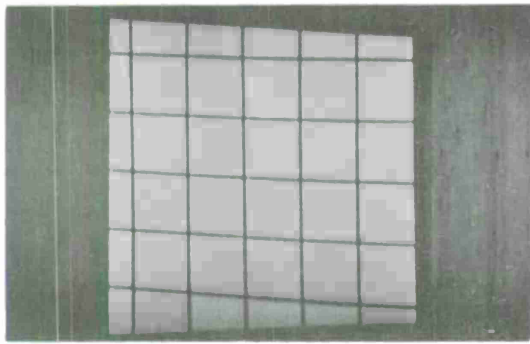
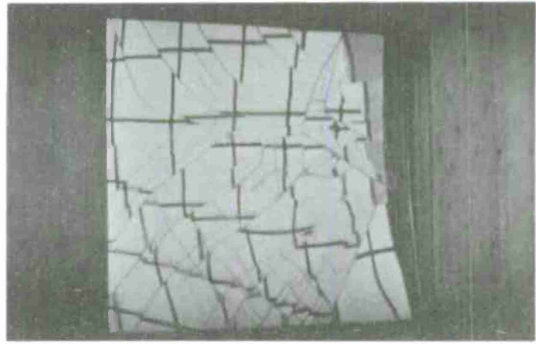
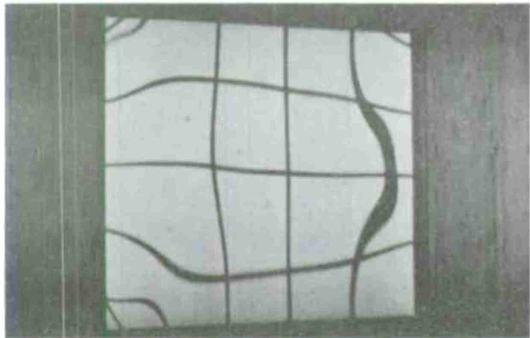
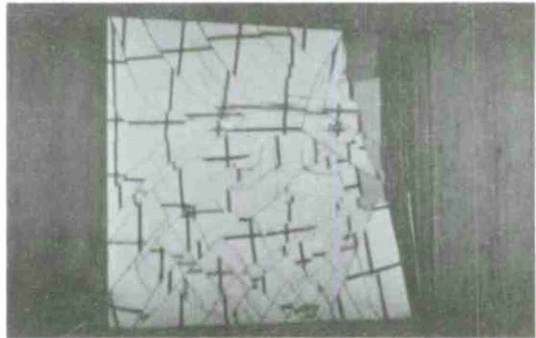
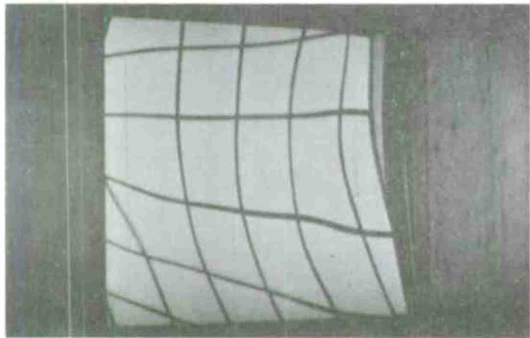
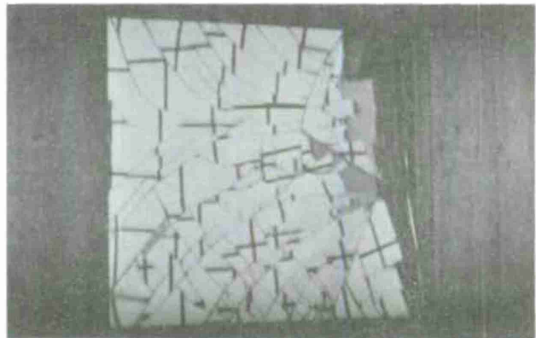
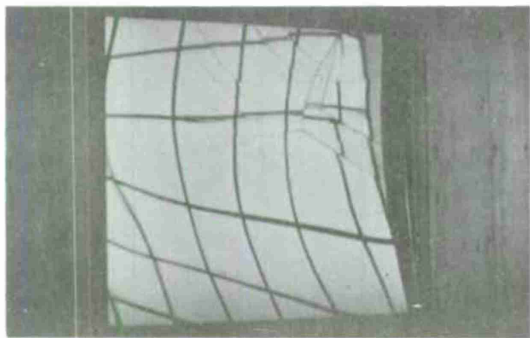
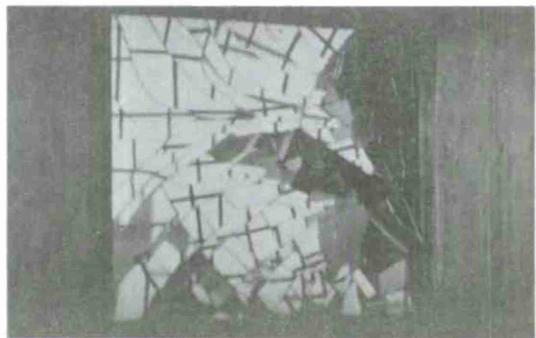
All cameras operated properly on this test and good quality 16-mm photographs of the loading and breakage process were secured. Figures 11 and 12 show series of frames taken from the two film records of the 530-foot window test. These photographs were taken at 1000 and 400 frames per second for Figures 11 and 12 respectively. An analysis of the film records shows that the first cracking of the window took place 35 milliseconds after shock arrival and that the breaking process continued for an additional 10 milliseconds.

The deflection of this window was somewhat more complex than a simple oscillation prior to breakage. The center portion of the window appears to complete a full cycle at about 12 milliseconds after shock arrival; however, the surrounding glass has, at times, moved in different directions than the center of the window. At about +23 milliseconds the left side of the window appears to be well forward of its original position and starting to move in a rearward direction while the right side of the window is beginning to move back from the original position. The total deflection at this point in time is sufficient to allow the right side of the window to escape from the supporting moulding. This would have required a radial deflection of about 3 inches if simple window curvature were assumed. The window continues to be held at the top, bottom and left edges even after the right side escapes from its support. It is interesting that breakage did not occur until twelve more milliseconds elapsed and substantially more window motion had taken place. At breakage, or at least soon thereafter the left side of the window can be seen to be moving forward while the right side is moving backward or into the building.

Figure 11. Selected Frames from the Film Record of Window Breakage Taken at 1,000 Frames/Second.

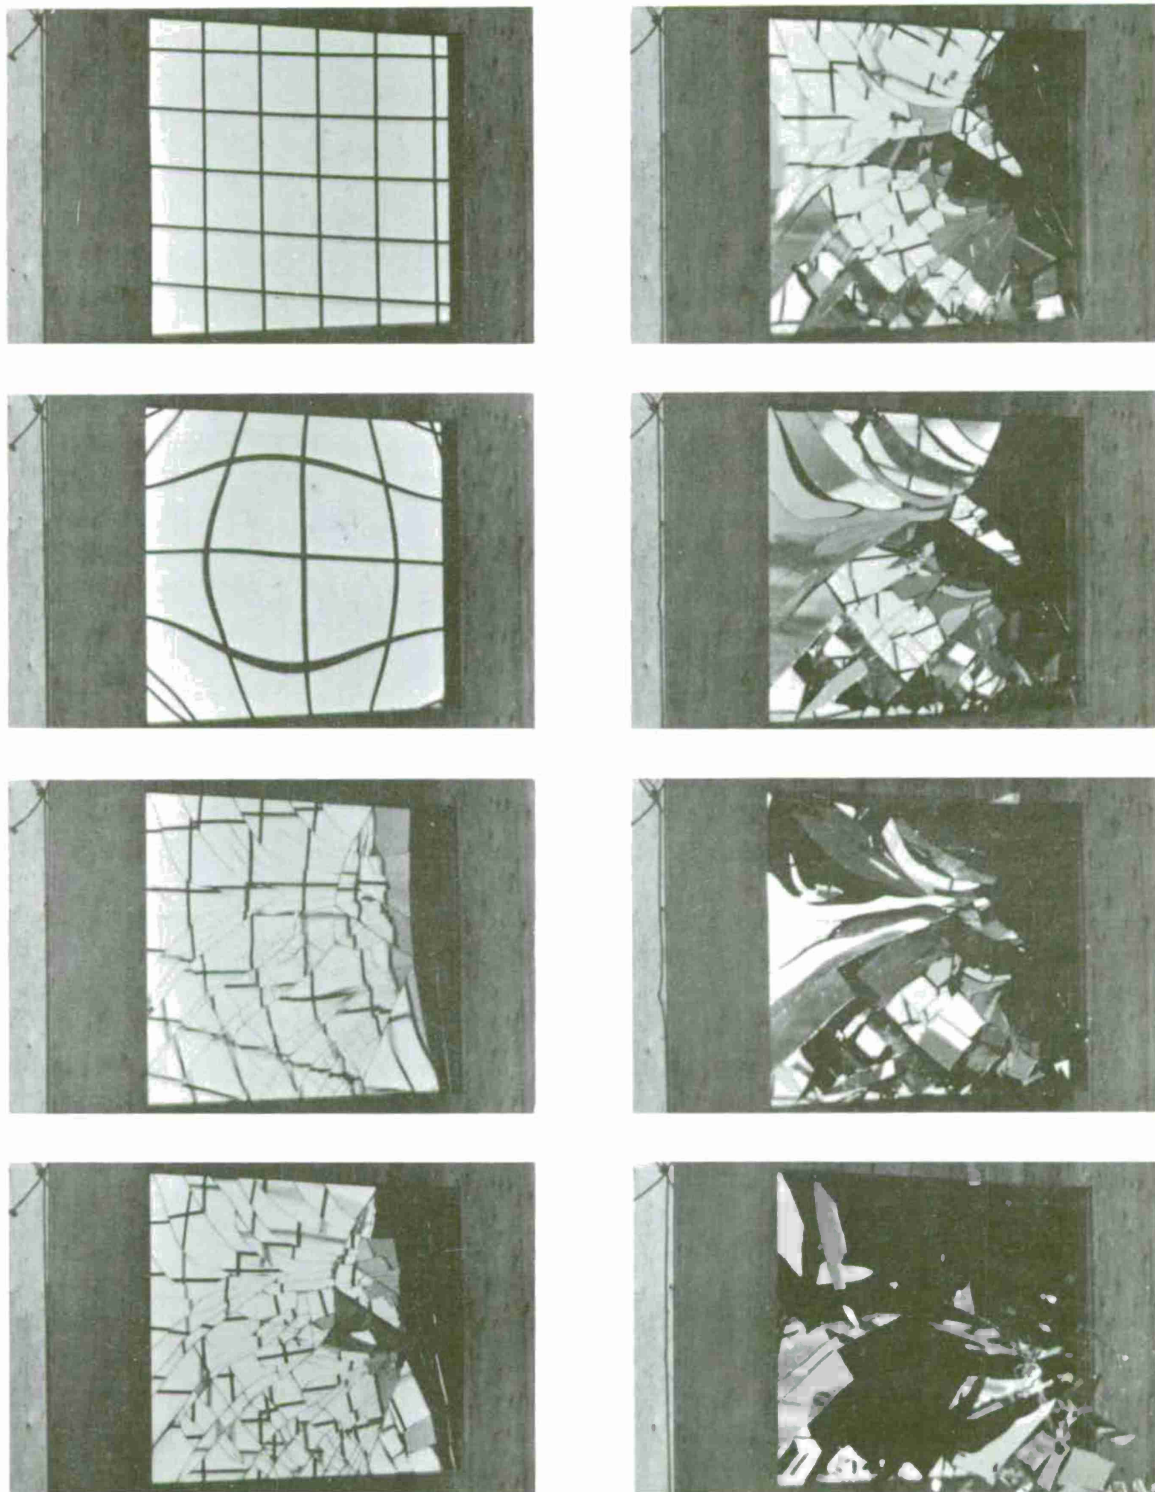
Figure 12. Selected Frames from the Film Record of Window Breakage Taken at 400 Frames/Second.

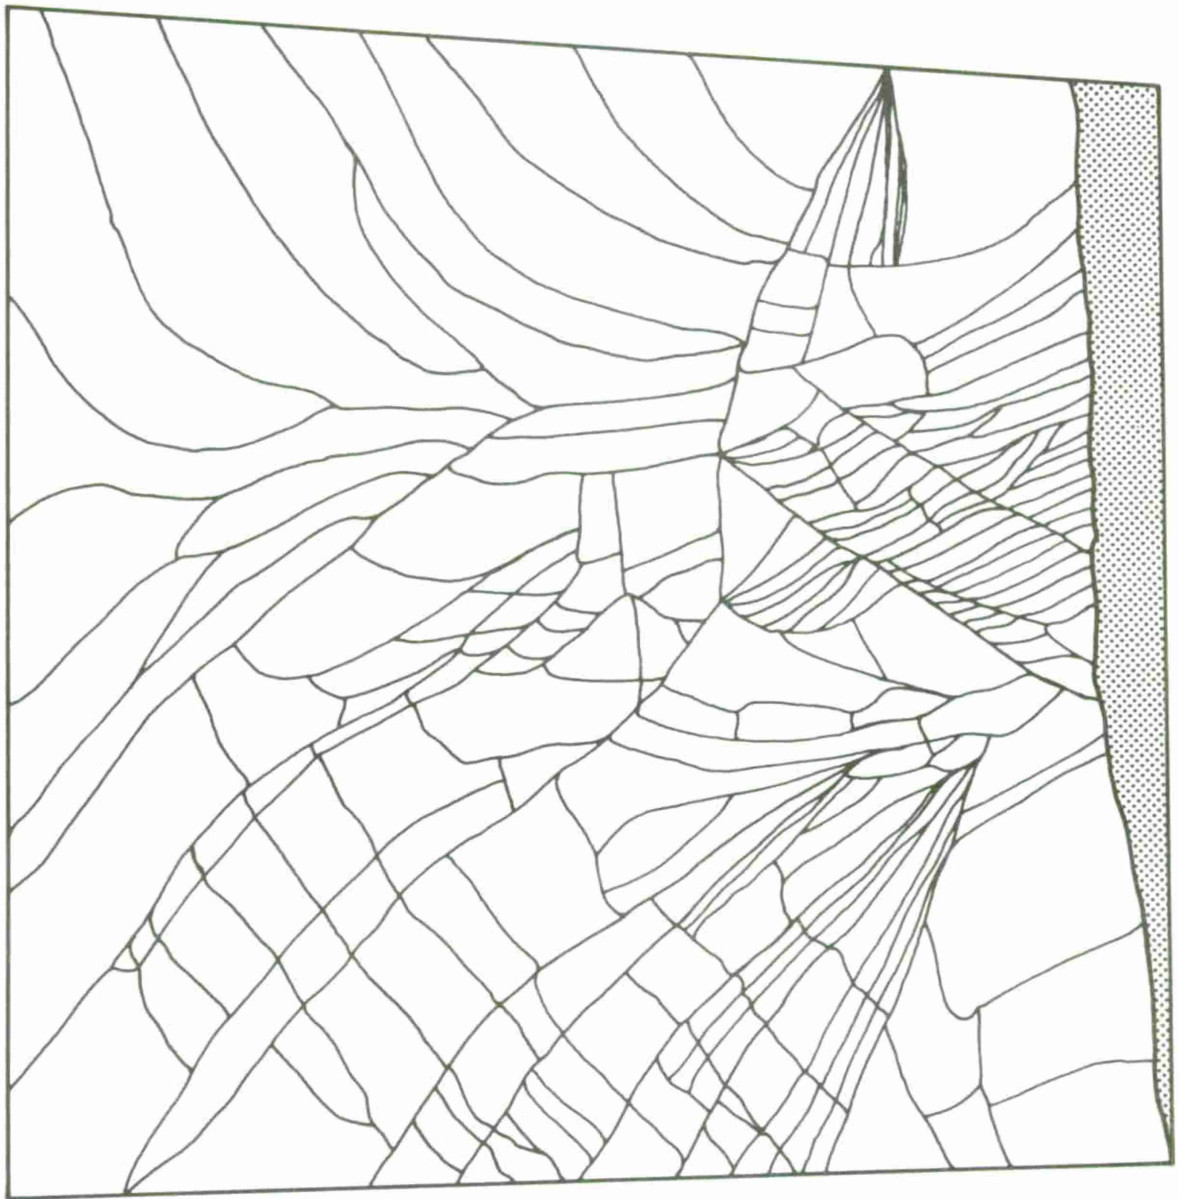
in this test of blast interaction with the window. Figure 13 provides a diagram of these fragments. At least for the larger fragments the shape and size of the fragments is clear and can be accurately drawn. The smaller fragments cannot be defined with as much accuracy since they cannot be seen as clearly and since each crack did not always produce a separate fragment. A number of fragments were found on the ground which had cracks within them but which had not been sufficiently fractured to separate. Figure 13 thus represents a best estimate of the discrete fragments into which the window was broken.

Figure 13. Fragments Produced by the Blast Loading of 4 Ft. by 6 Ft. Plate Glass Window.

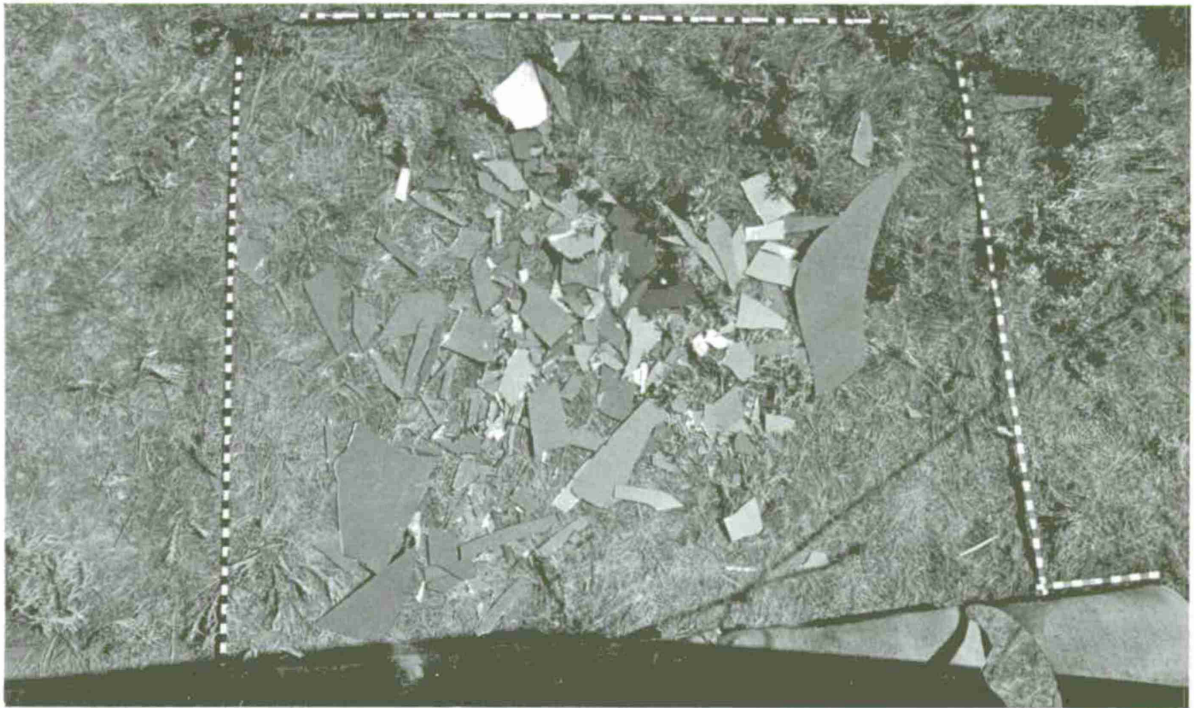
The larger fragments which were found on the ground following the test were also examined. Figure 14 shows the pile of fragments which landed outside the building and Figure 15 shows the fragments which went into the building. Very few fragments moved more than six feet forward of the building as they fell outside. Inside the building most fragments were within three feet of the front wall and none reached the back wall, only eight feet away. Approximately 60 percent of the fragment weight fell outside the building and 35 percent inside with 5 percent remaining in or on the window frame.

Figure 14. Glass Fragment Distribution Outside the Structure.

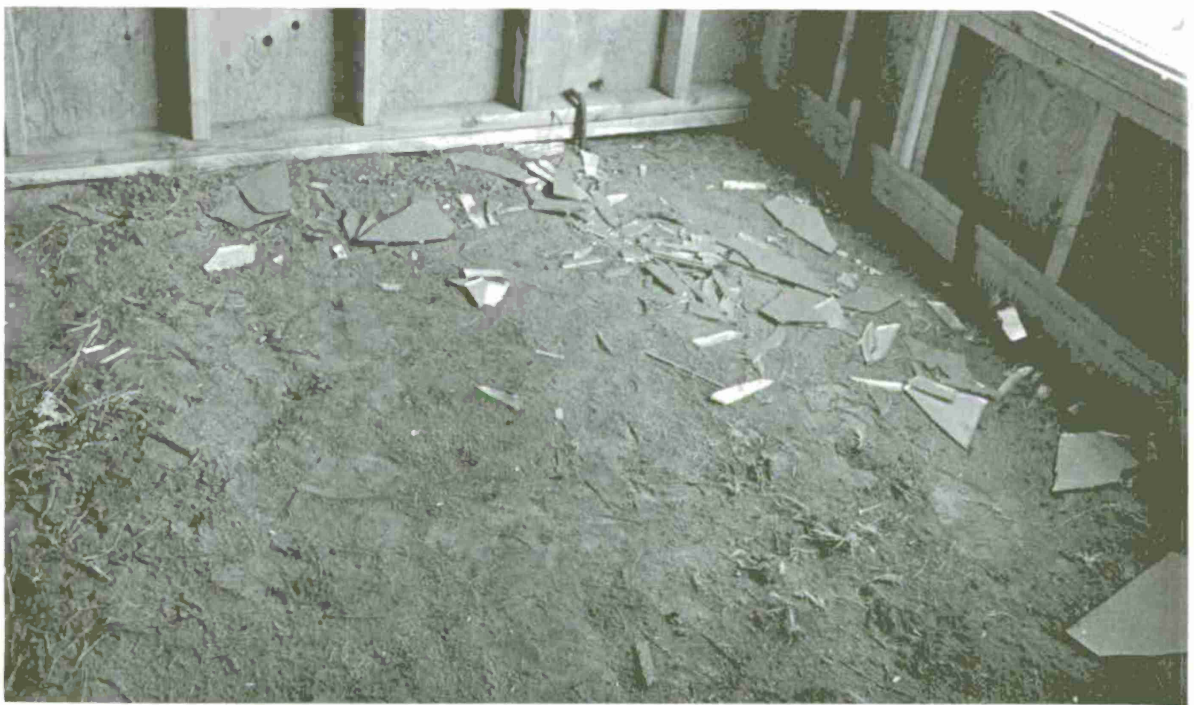
Figure 15. Glass Fragment Distribution Inside the Structure.

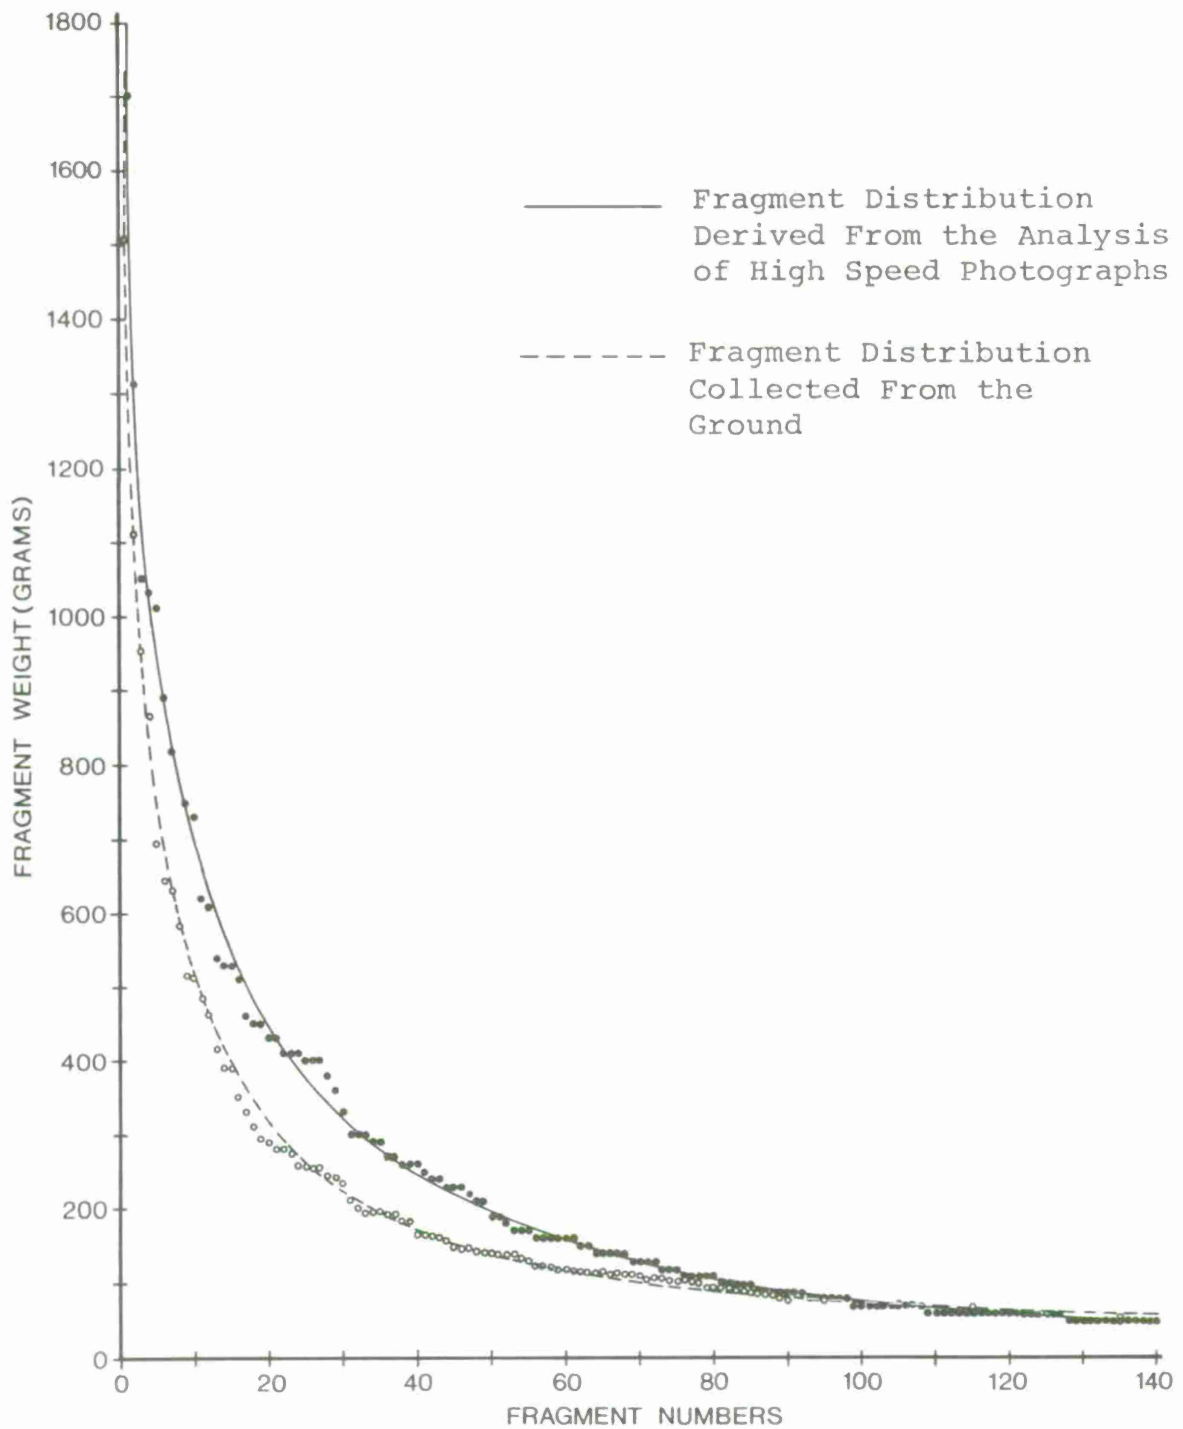
Figure 16 provides a plot of the data in Tables III and IV. The separation between the two curves must be attributed to secondary breakup of fragments caused by striking the ground or striking other fragments.

Figure 16. Cumulative Fragment Weight Distributions Produced by Threshold Blast Loading of a 4 Ft. by 6 Ft. Plate Glass Window 1/4 inch Thick.

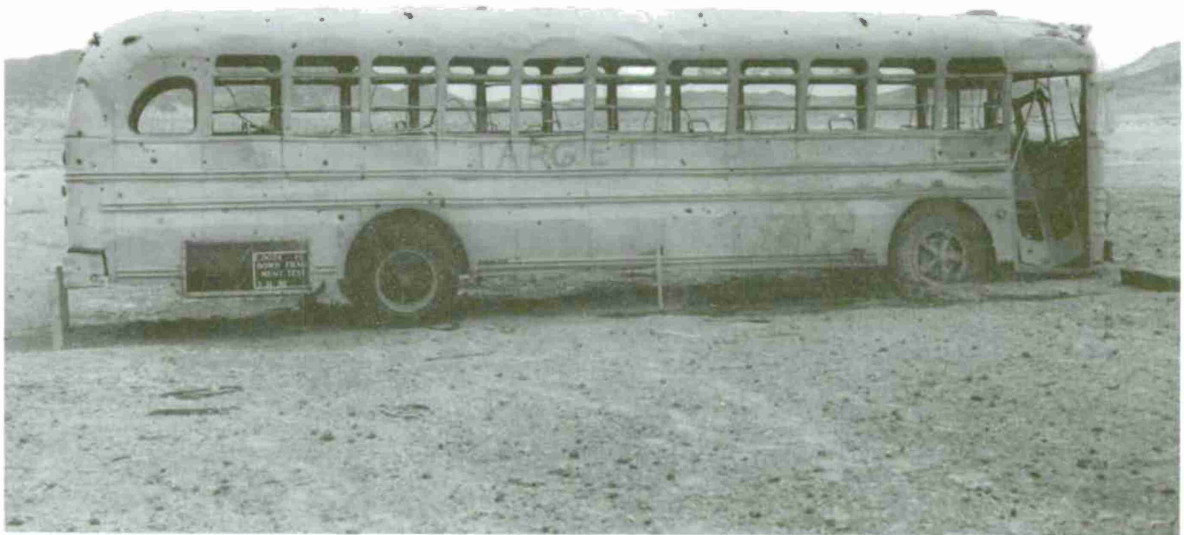
Both the bus and the pickup were moved laterally by the blast wave. The bus was moved 3 to 4 inches at the front and 7 to 8 inches at the rear. The pickup was moved 5 inches at the front and 4 inches at the rear.

Figure 17. Damaged Bus Following the Test at China Lake.

The sheet metal of the bus was steel, about 0.030 inch thick. Surface bending of this steel is evident in Figure 17. The sheet metal of the truck was heavier, except for the homemade cab, and was damaged less extensively. Maximum deformation of the bus sidewall was 7 to 8 inches on the near side. The far side of the bus was bulged outward only slightly between the vertical stiffeners. The sheet metal below the floor line was bent outward as much as 3 to 4 inches in some locations on the far side of the bus. The bus door was torn loose at the hinge attachment.

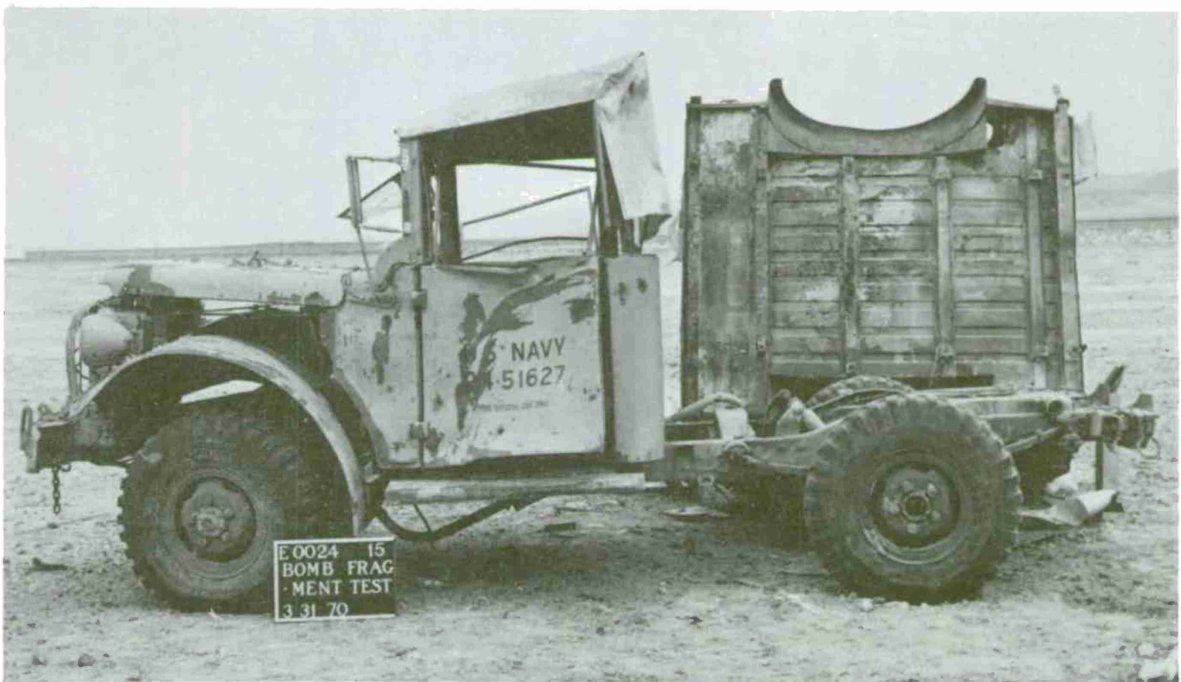
Post test examination indicated that the truck bed had not been securely bolted to the truck frame. An analysis of the potential for overturning the camper body as a separate unit indicates that the observed action would have been predicted. The weight of this unit has been estimated at 700 pounds with a center of gravity 17.3 inches above the frame members and 30 inches laterally from the overturning axis. The computed net impulse required to overturn such a unit is 50 psi-ms, while the actual impulse, from this test at 180 feet, on the camper body was approximately 150 psi-ms. The observed overturning action for this unit would have been much more severe had it not been for the binding, bending, and general restraint provided by the attachment bolts even though they were without nuts. A number of these bolts were seriously bent following the test. Other factors tending to reduce the overturning action for the camper included a 5- to 10-knot wind and poor blast coupling due to deformation and destruction of the near side of the camper by the blast wave.

Figure 18. Damaged Pickup-Camper Following the Test at China Lake.

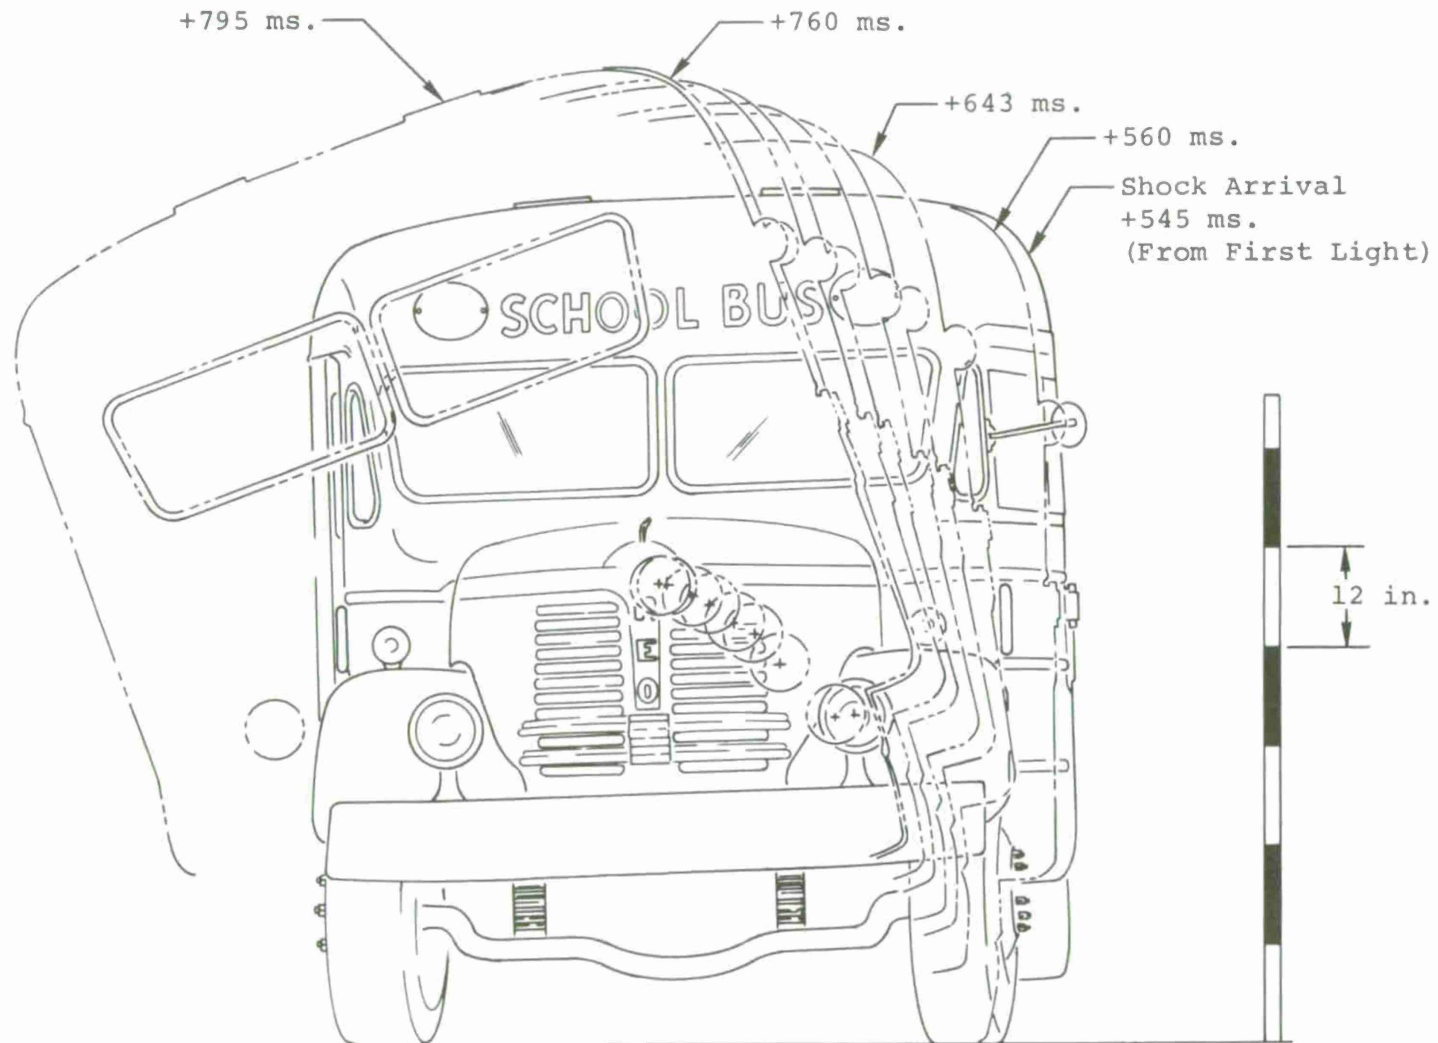
Figure 19. Bus Overturning Motion as Derived From the Analysis of High Speed Photographs.

An examination of the rotation of the bus as shown in the high speed films (summarized in Figure 19) indicates that 60 to 30 percent of the work needed to overturn the bus was completed. The center of gravity was lifted approximately two thirds of the total rise needed for overturning. Thus one conclusion which might be drawn from these data would be that the suspension system of this bus absorbed about one third of the impulse delivered to it and consequently the estimate of impulse needed for overturning should have been proportionately higher. While these data may not be sufficient to accurately determine such a factor, they do clearly indicate that more impulse was needed to complete the overturning. The needed additional impulse must have been at least an additional 80 psi-ms since no more than 80 percent of the required work has been done at a time near the end of the loading curve when the maximum delivered impulse was 315 psi-ms. Similarly the additional impulse needed must be no more than 200 psi-ms since at least 60 percent of the required work was accomplished. The total required impulse for this vehicle is thus bracketed between approximately 400 and 500 psi-ms.

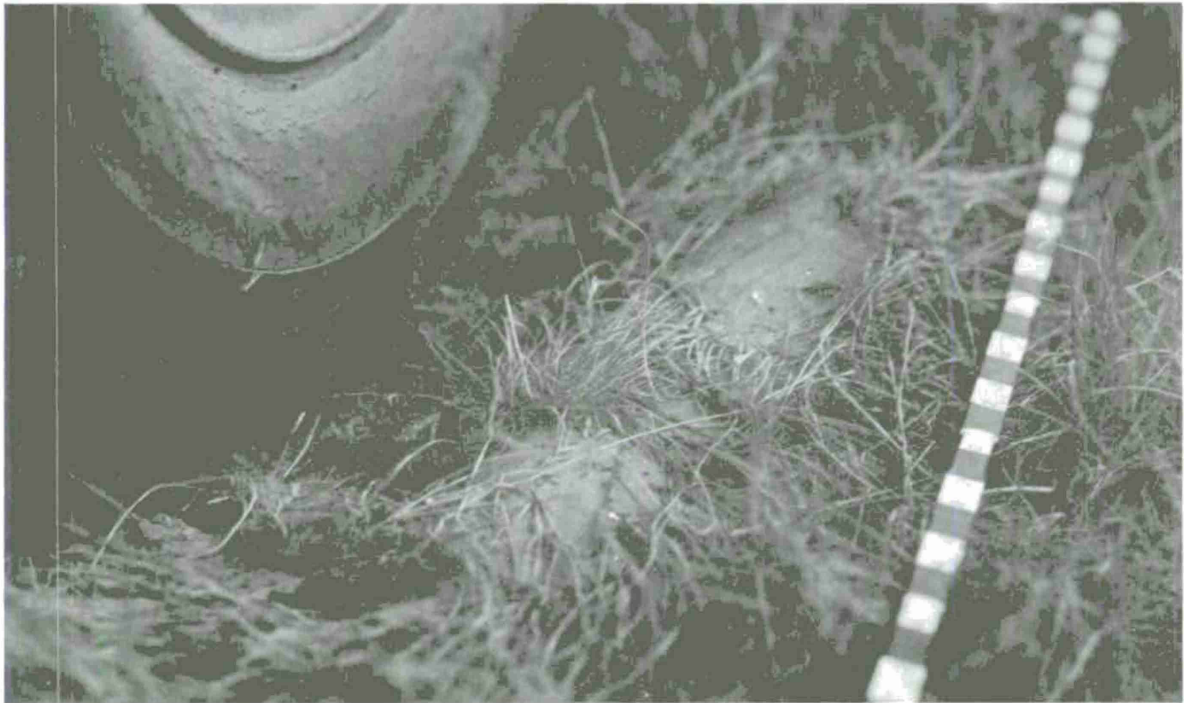
An examination of the earth surface in the vicinity of the tires showed that the tires which were on the far side of the blast had slid along the surface and had dug into the soil at the far edge to a significant extent. Tires on the near side of the vehicle left no marks at all and may have actually been above the surface as the lateral motion took place. This would indicate that the vehicles may have approached an overturning condition but then fell back to their original posi-

Figure 20. Tire Print in the Soil Following Bus Rotation.

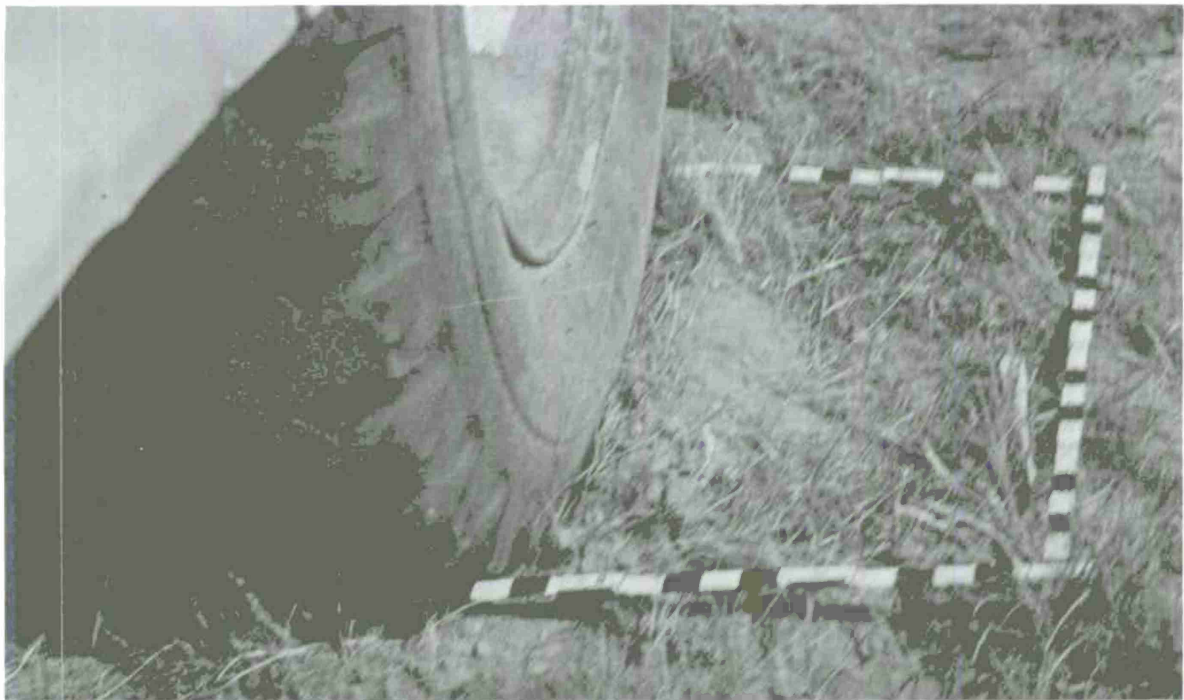
Figure 21. Up-Stream Tire and Soil Following Bus Rotation.

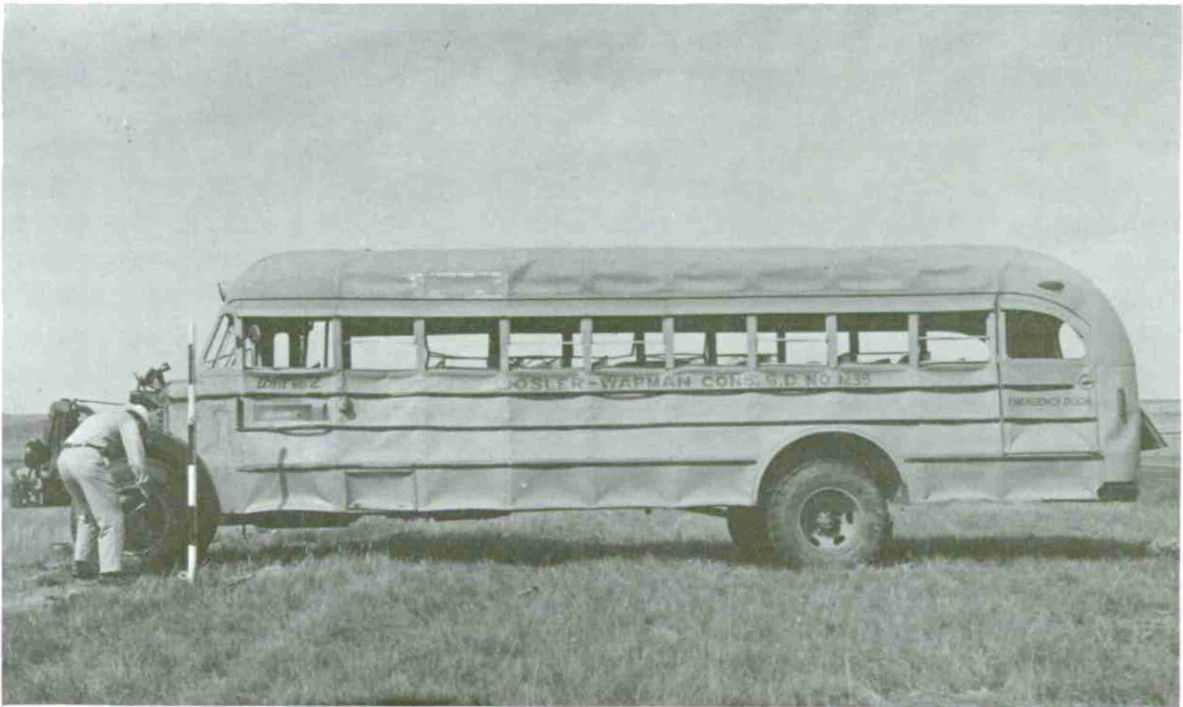
The bus at this location received substantial damage and was severely rocked by the blast but did not overturn. The tire

The rear wheels of the bus were displaced sideways 11 inches; all windows were broken out of the vehicle except for one small one on the right front by the door which was not even cracked. The three small windows in the door itself were only cracked and not removed. The fourth window in the door was blown out.

Figure 22. Damage to the Large Bus Following the Dial Pack Test - Side View.

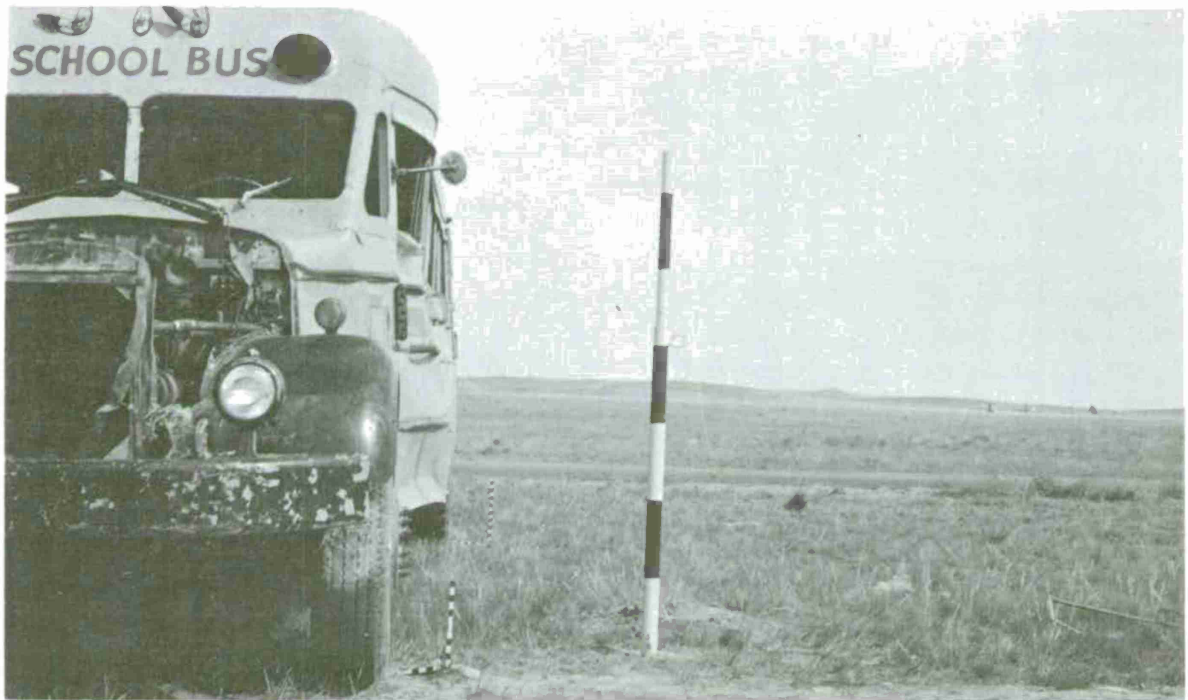
Figure 23. Damage to the Large Bus Following the Dial Pack Test - Front View.
