Technical Note N-1130

IMPROVED TECHNIQUES FOR THE NON-DESTRUCTIVE TESTING  
OF DIESEL ENGINE PISTONS

NAVAL CIVIL ENGINEERING LABORATORY  
Port Hueneme, California 93041

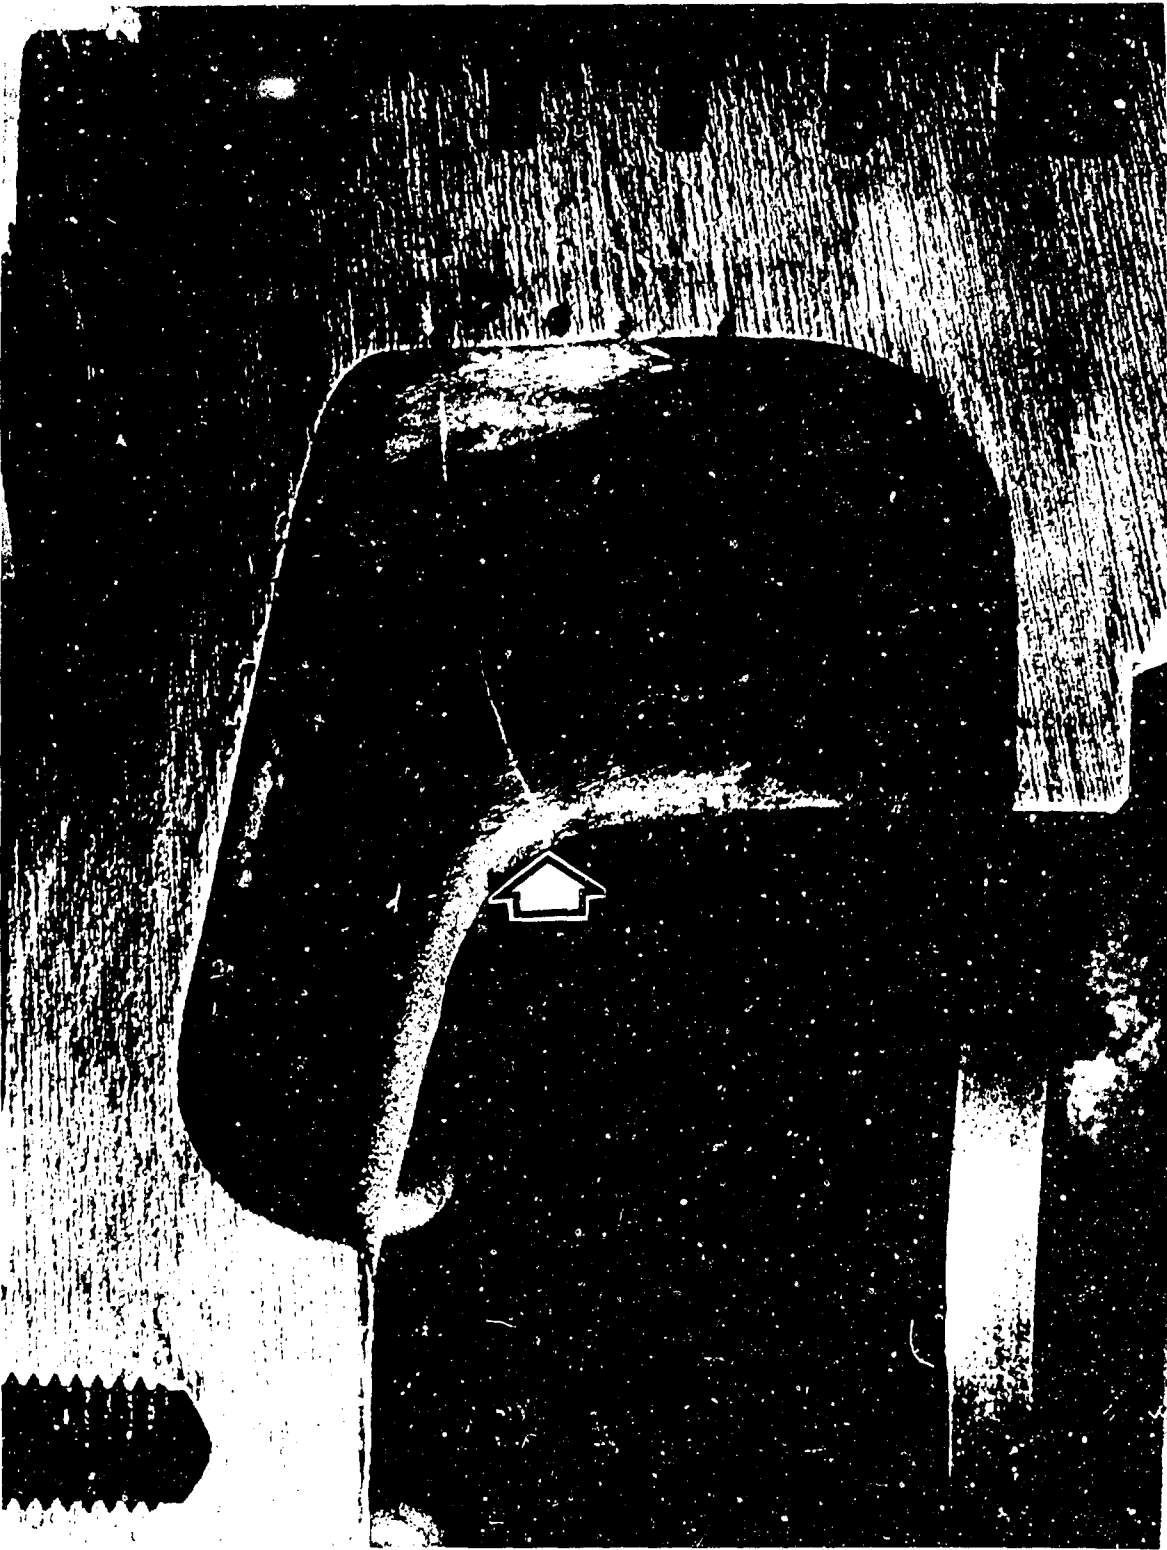
Initially two new, unused pistons were supplied for examination, and for use as a basis of comparison. Subsequent examination of all available defective and suspected pistons indicated that the cracking, and ultimate failure, originated along the inner major radius profile of any of the four major webs inside the piston, and propagated radially outward toward either of the two upper ring grooves (as illustrated in Figure 2). As the engine continues to operate, this cracking continues to develop circumferentially around the piston, until finally the top portion, or crown, separates from the piston body with disastrous results to the engine.

Figure 3. Fatigue crack in Enterprise piston. (1.5X)

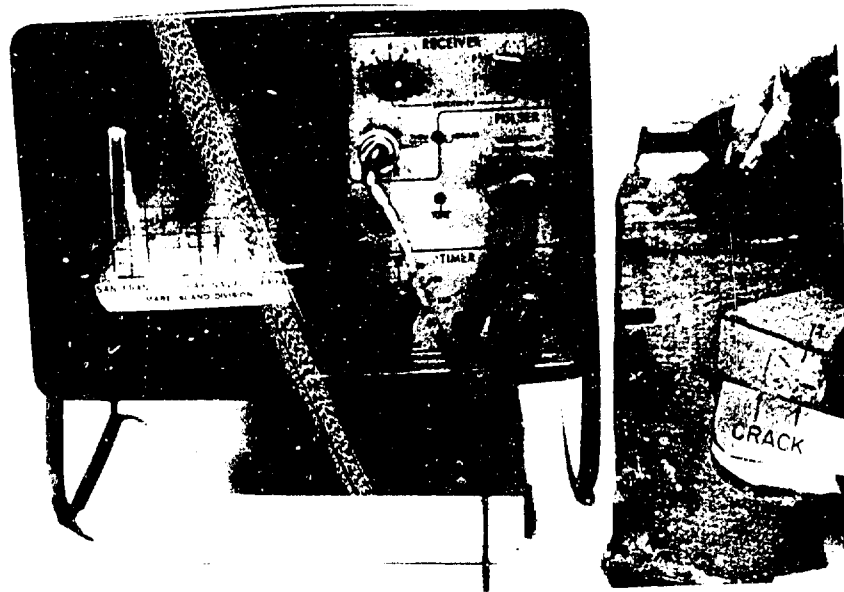
As the scan progresses, the 1-7/8 inch depth signal will gradually diminish to zero level. This results from the sound waves being directed at the internal radius of the major web and reflected away from, rather than back to, the transducer. (Note position "1" of Figure 7.) This area of the piston has been found to be a very vulnerable point with regard to crack susceptibility. It is therefore essential that the inspector be especially alert in this area for any signal indication in the 1 to 2 inch depth range, which may be indicative of an incipient failure in the piston structure. (See Figure 10 for typical oscilloscope response to a cracked web.)

Figure 10. Oscilloscope display of cracked web.

The entire search procedure, as outlined above, is now repeated over each of the remaining three major webs of the piston. Any piston which displays indications of a discontinuity in any portion of a major web, must be considered as defective, and that piston should be scheduled for immediate removal from the engine.

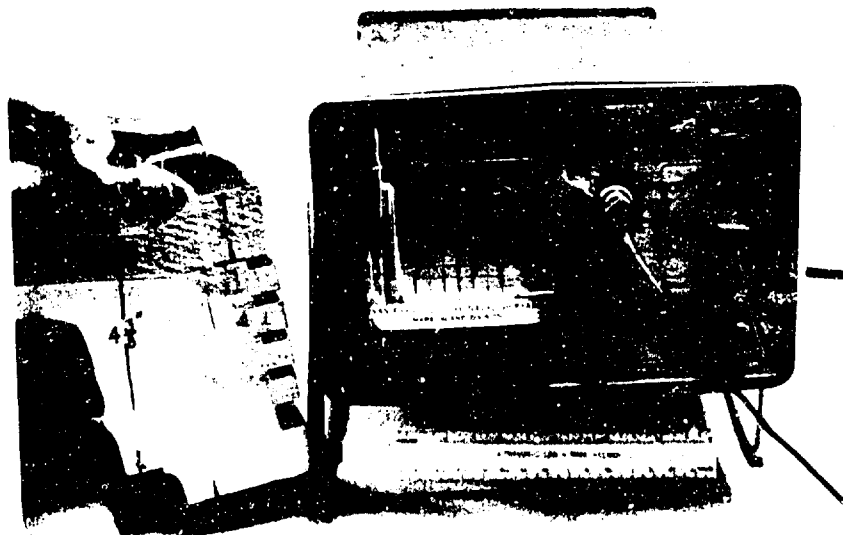
In continuing the scan outward from this point, if the web is sound, an indication will soon appear on the viewing screen at an approximate depth of 4-3/8 inches. (See position "2" in Figure 7 and Figure 11.) This is a reflection from the inner flange of the piston, and is evidence of satisfactory sound wave penetration through the major web profile. It should be noted that a continuation of the scanning from here on into the concave portion of the piston top surface will require a liberal "puddling" of couplant in order to adequately conduct the sound waves into the piston.

Figure 11. Acceptable major web at  $4 \frac{3}{8}$ " thickness.
