A FRACTOGRAPHIC STUDY OF THE FATIGUE FAILURE
OF AIRCRAFT WHEELS

BY
W. WIERE

NATIONAL AERONAUTICAL ESTABLISHMENT

REPORT
NOVEMBER 1954

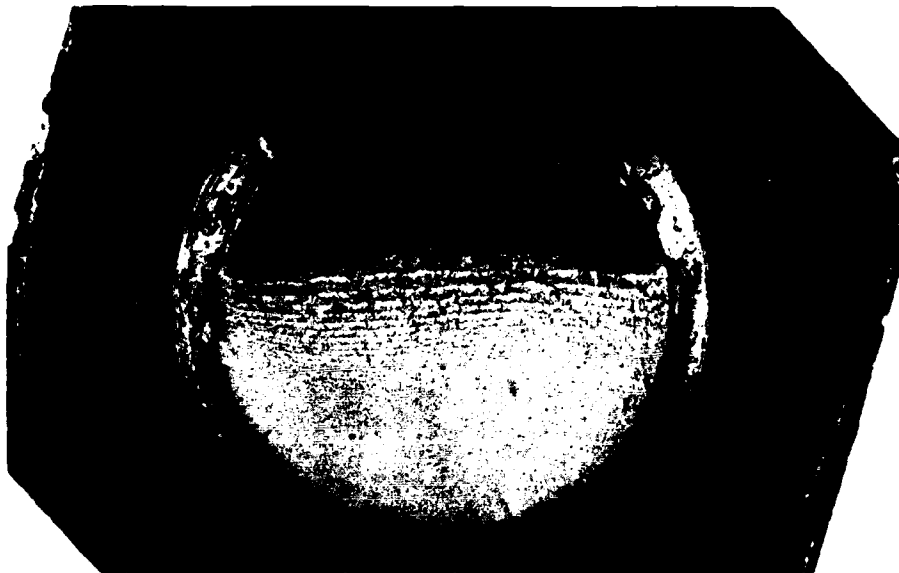
An example of this type of crack growth band on the fracture surface of a steel bolt is illustrated in Figure 3(a), and the repetitive loading sequence is sketched in Figure 3(b). The programme was such that the peak to peak tensile load amplitude remained constant at 15,000 lb. throughout the test, while the minimum and maximum loads shifted from 10,000 to 25,000 lb. to 20,000 and 35,000 lb. respectively. The 1,012 cycles per load block were divided approximately equally between the two load levels.

FIG. 3 (a) FRACTURE SURFACE OF A STEEL BOLT
SUBJECTED TO REPETITIVE SEQUENTIAL LOADING

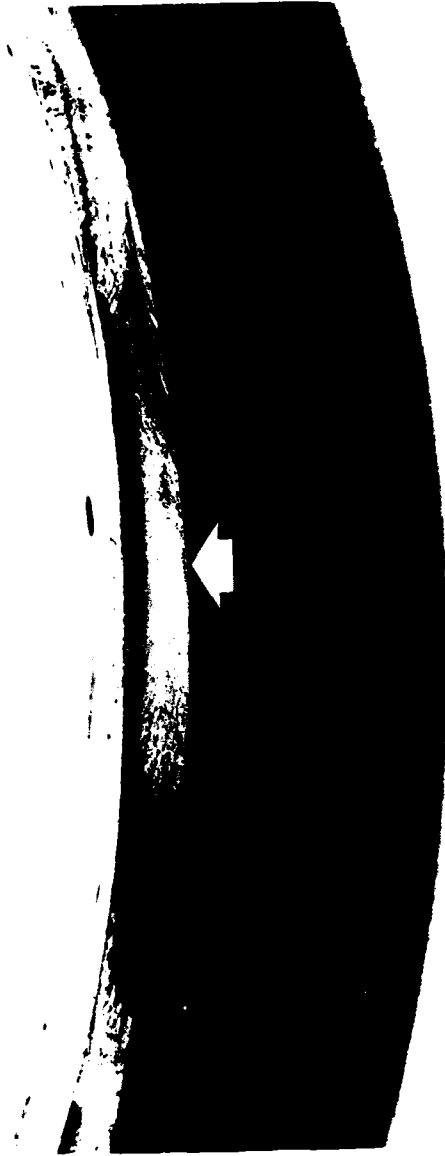
FIG.10 FATIGUE FRACTURE SURFACE - WHEEL TYPE "B"
(ARROW INDICATES CORROSION PIT)

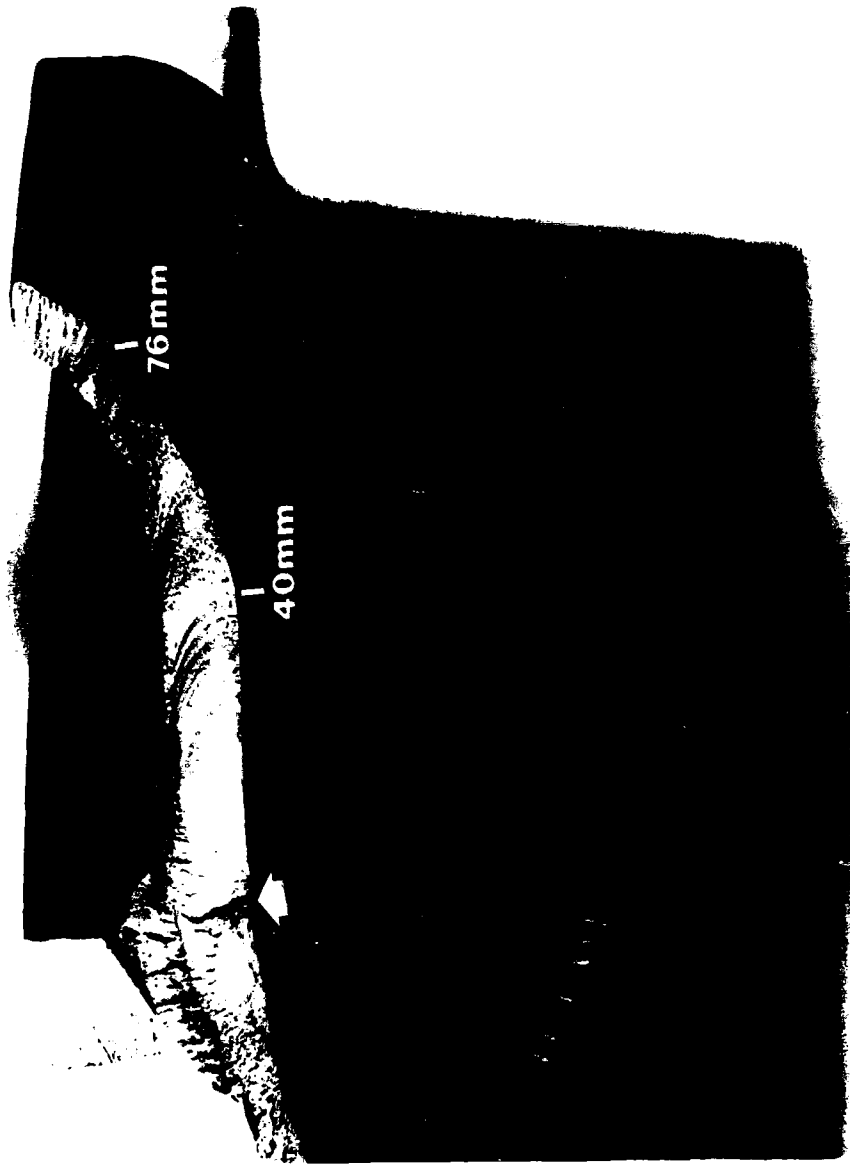
Curved macroscopic fatigue crack progression lines or "bands" emanating from the point of crack nucleation can readily be resolved on the wheel fracture surface illustrated in Figure 15. Since the validity of the following quantitative crack propagation analyses rests upon the proper interpretation of the nature of these bands in terms of the micro-mechanisms of fracture, a closer examination of the microscopic topographical features is warranted, and an attempt will be made to correlate them with certain aspects of the "landing, take-off" sequence, or "landing cycle" of the aircraft.

Fatigue crack growth information for this wheel was determined over the 76 mm. crack interval identified in Figure 15. Although the crack was initiated at a point adjacent to the bead-seat radius, crack growth occurred primarily at an angle of some 60° to the wheel radius, through the wheel flange.

FIG. 15 FATIGUE FRACTURE SURFACE - WHEEL TYPE "C"
(ARROW INDICATES REGION OF CRACK NUCLEATION)

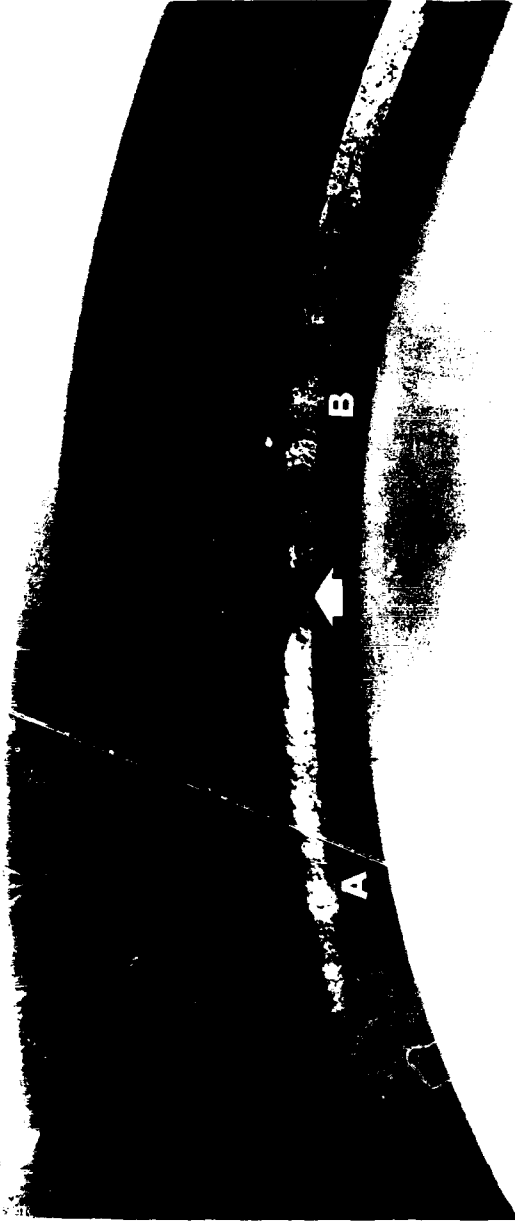
The point of fatigue crack initiation in this wheel hub, illustrated in Figure 26, appeared to be a corrosion pit on the outer surface of the rim. The circumferential crack penetrated the hub at a distance of approximately 40 mm. from the bead seat radius. As illustrated by the corresponding pairs of macroscopic growth lines (A,B, Figure 26), the rates of fatigue crack growth differed on either side of the crack origin. The final fatigue crack length on side A was 72 mm., and 58 mm. on side B, when catastrophic failure of the wheel occurred. A total of some 552 landings were accounted for over the half-crack length interval 2 mm. to 72 mm. It is of interest to note that notwithstanding the fact that this fatigue crack developed some 40 mm. in from the bead-seat radius, the change in the rate of fatigue crack growth as illustrated in Figure 27, is essentially identical to that determined for the previous type "B" wheel hub, Figure 25 which failed in the bead-seat radius.

FIG 26 FATIGUE FRACTURE SURFACE - WHEEL TYPE "B", No. 2
(ARROW INDICATES POINT OF CRACK NUCLEATION)

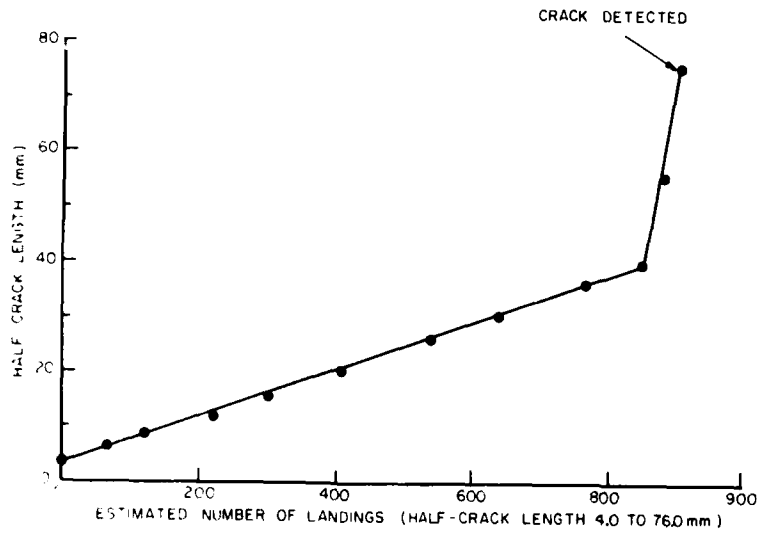
The graph, illustrated in Figure 28, accounts for some 903 landings over the fatigue crack interval 4 to 76 mm. The curve exhibited an approximately constant growth rate of 47 microns

per landing, over the range 4 to 40 mm. Over the crack interval 40 to 76 mm. the crack growth rate exhibited an abrupt increase to some 650 microns per landing. This latter interval corresponded to a clearly defined change in fracture surface topography (Figure 15) that exhibited a considerably coarser texture than the initial 40 mm. of fatigue crack length.

FIG. 28 CRACK GROWTH HISTORY - WHEEL TYPE "C"
