**MICROSTRUCTURAL ALTERATIONS IN ALUMINA  
CERAMICS ASSOCIATED WITH BALLISTIC IMPACT EVENTS**

**C. H. Kim and H. Palmour III**

**Technical Report 70-8**

**December 1970**

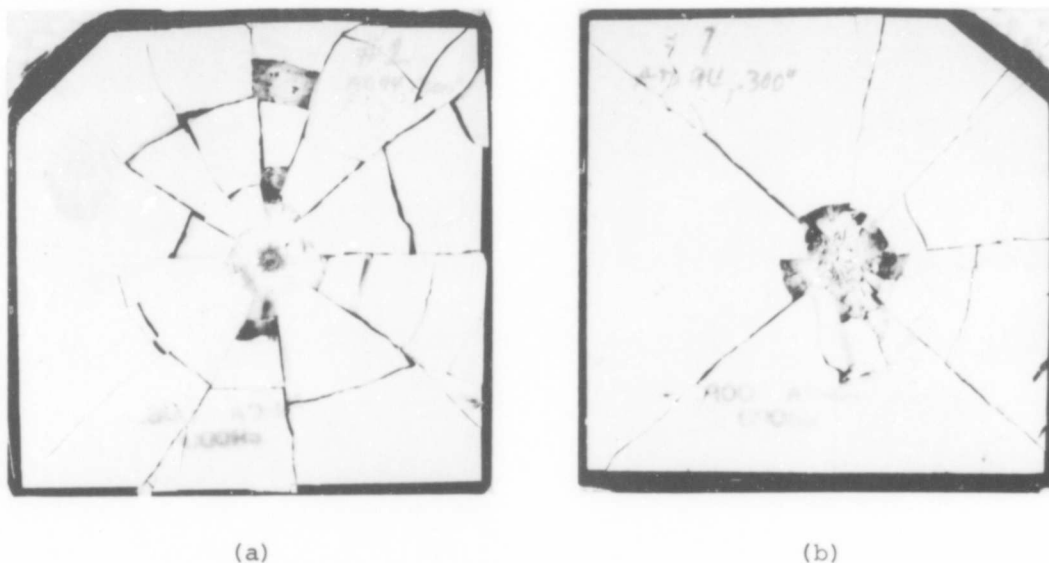
Figure 2. Macroscopic damage in alumina armor tiles caused by ballistic impact with different projectiles at 2240 feet per second: (a) 0.30 caliber ball (lead alloy); (b) 0.30 caliber APM-2 armor piercing (reassembled front faces of 6 inch  $\times$  6 inch  $\times$  0.30 inch alumina ceramic tile 1 (a) and tile 7 (b); corner had been removed from each tile prior to impact to serve as unshocked control)

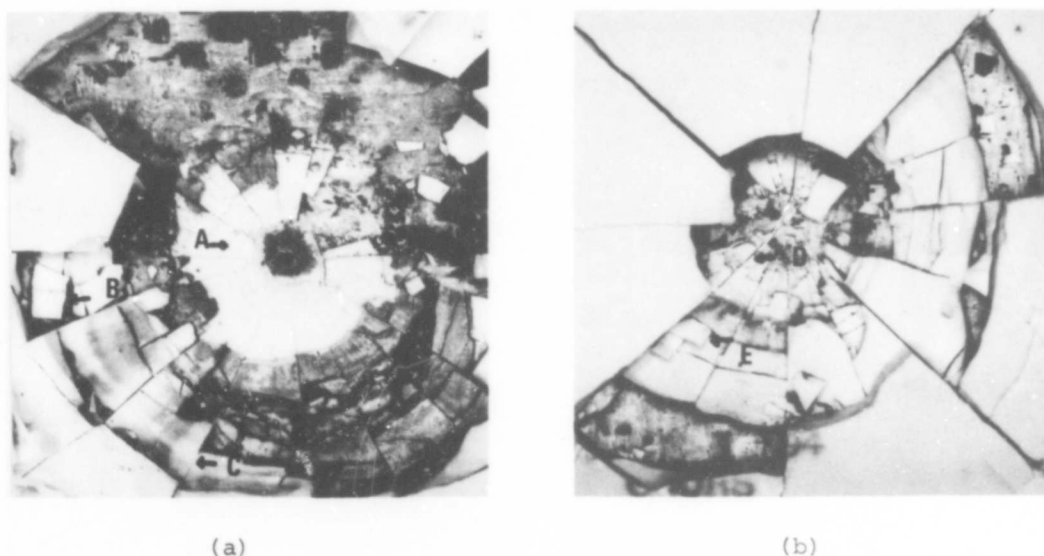
Figure 3. Interior views of 6 inch  $\times$  6 inch  $\times$  0.30 inch alumina ceramic tile 1 (a) and tile 7 (b) after removal of frontal spall fragments (arrows and letters indicate chips sampled for transmission electron microscopy studies)

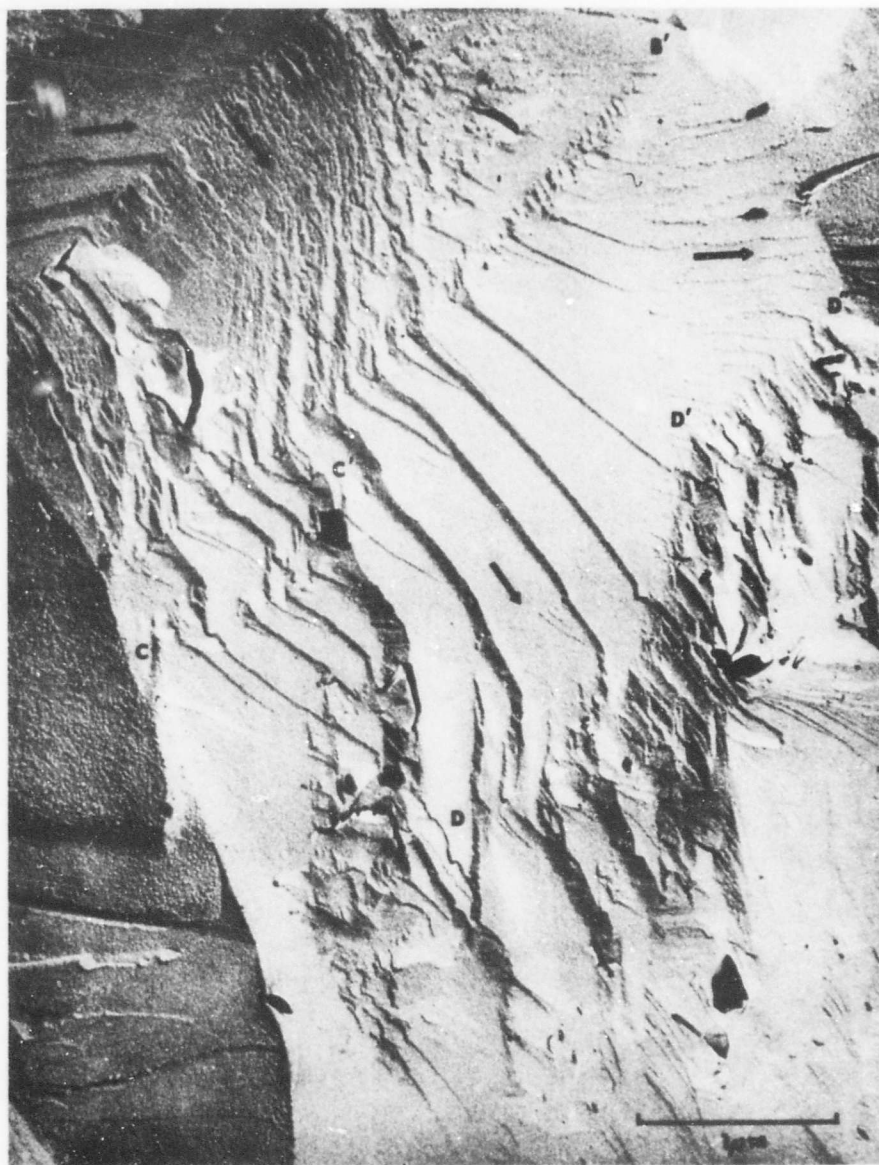
Figure 4. River pattern cleavage steps on a transverse secondary crack in ballistically damaged polycrystalline alumina tile; two-stage plastic-carbon replica, Pt-shadowed at  $30^\circ$  (after Kim, 1969)

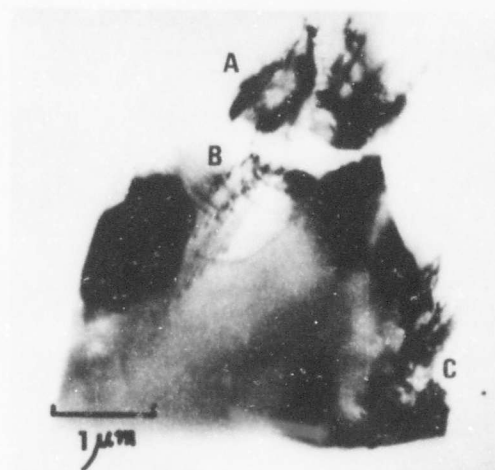
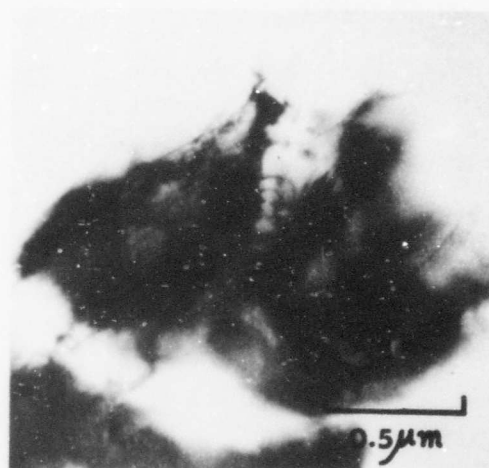
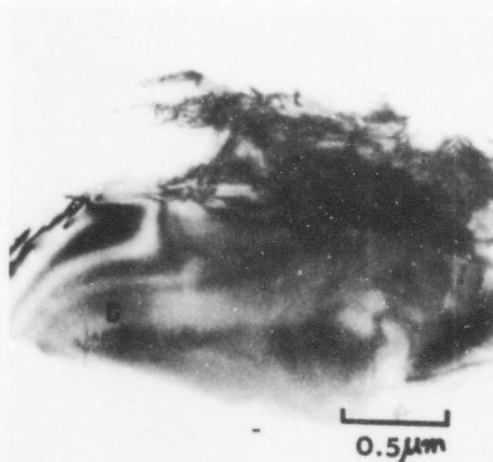
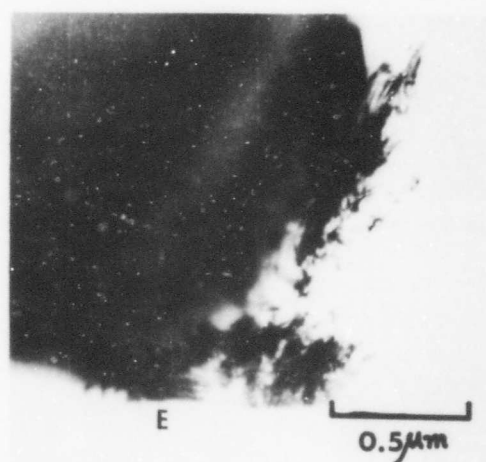
Figure 5. Structural defects in extracted fracture fragments from smooth radial surface in ballistically damaged polycrystalline alumina tile (letters locate dislocations and other features described in text): (a) diffraction contrast micrograph associated with defects in the regions marked A, B, and C; (b) higher magnification micrograph of the region marked A in Figure 5a; (c) dislocation arrays in the region marked D; (d) dislocation arrays and interactions in the region marked E

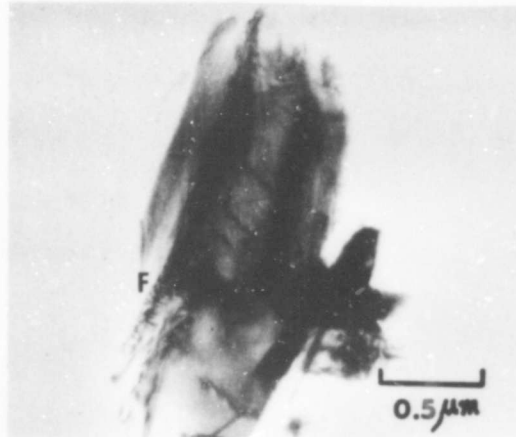
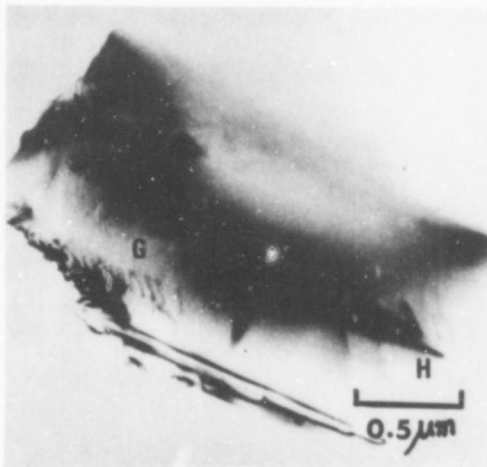
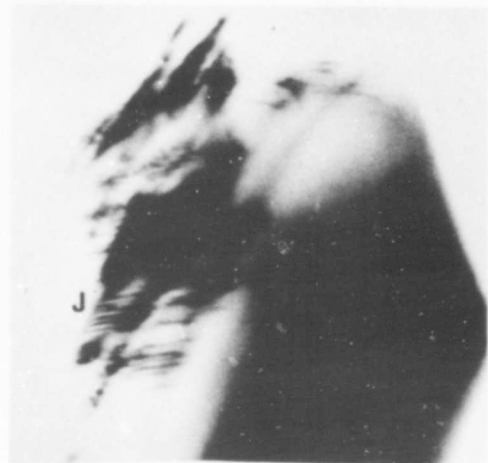
The later portions of the primary radial cracks are composed of very rough surfaces with complex textures. Figure 6 shows diffraction contrast micrographs of an extracted transparent fragment on a replica from such a rough surface.

Figure 6. Structural defects in extracted fracture fragments from a rough radial crack surface in ballistically damaged polycrystalline alumina tile (letters locate dislocations and other features): (a) high density dislocation arrays and other features in the region marked F; (b) dislocation arrays and interactions in the regions marked G and H; (c) heavy concentration of dislocations in the region marked J

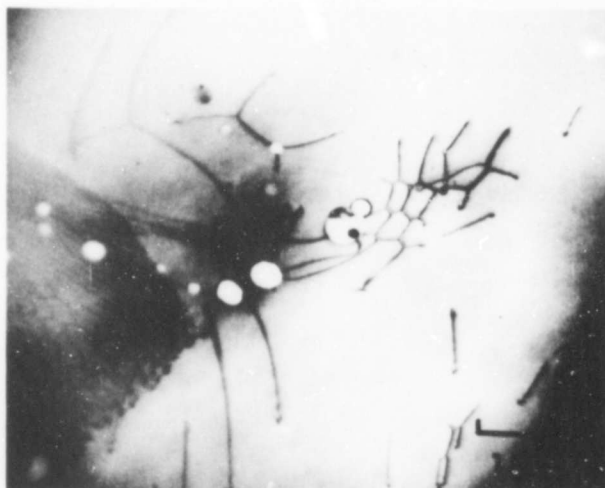
Figure 7. Dislocation configurations of unshocked control (corner, tile 1, Figure 2a)

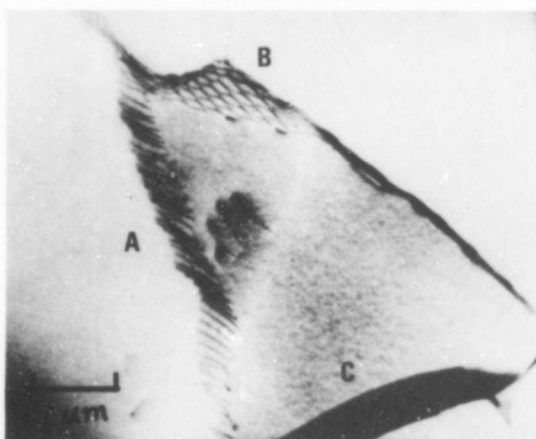
Dislocation arrays in the form of small-angle boundaries or sub-boundaries (most of tilt character, some with twist character) were often seen. However, such boundaries composed of dislocations occasionally revealed complex fringe patterns. The dislocations forming the sub-boundaries can be revealed after tilting the specimen with respect to the electron beam to obtain different diffraction conditions. Grain boundaries with high angle misfit can be imaged as a set of equal thickness fringes or as lines, depending on the orientation of the boundary with respect to the electron beam and on the operating reflection plane. One good example of an extensive dislocation network forming sub-boundaries is illustrated in Figure 8.

Figure 8. Typical microstructural features in ballistically damaged polycrystalline alumina showing tilt and twist boundaries, and high angle boundary fringe contrast (tile 1, chip A, Figure 3a)

The boundary marked A is a tilt wall, with the dislocations inclined to the foil. The interaction of a single dislocation with this tilt wall making an array of nodes is also seen. A dislocation network forming a simple twist boundary is shown at B. A grain boundary fringe contrast resulting from an interface inclined to the electron beam is noted at C. Figure 9 illustrates an inclined boundary of nearly pure tilt character which interacted with several single dislocations (left) and shows a moire fringe pattern resulting from complex fringe diffraction effects (right).

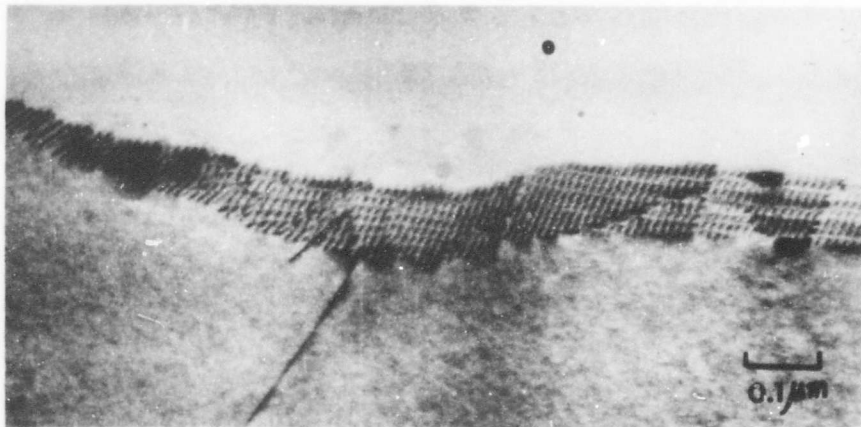
Figure 9. Typical microstructural features in ballistically damaged polycrystalline alumina showing inclined tilt boundary with foreign dislocations and a moire fringe pattern (tile 1, chip A, Figure 3a)

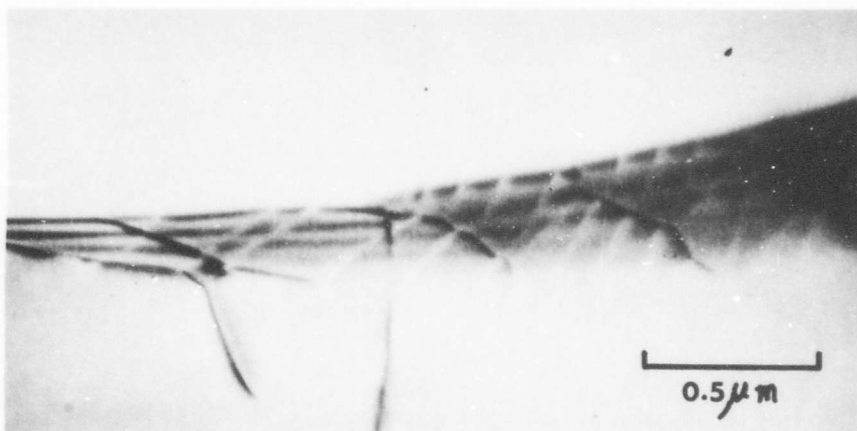
Figure 10. Typical microstructural features in ballistically damaged polycrystalline alumina: a bright field micrograph where both dark and light dislocation images are visible within the grain boundary (tile 1, chip C, Figure 3a)

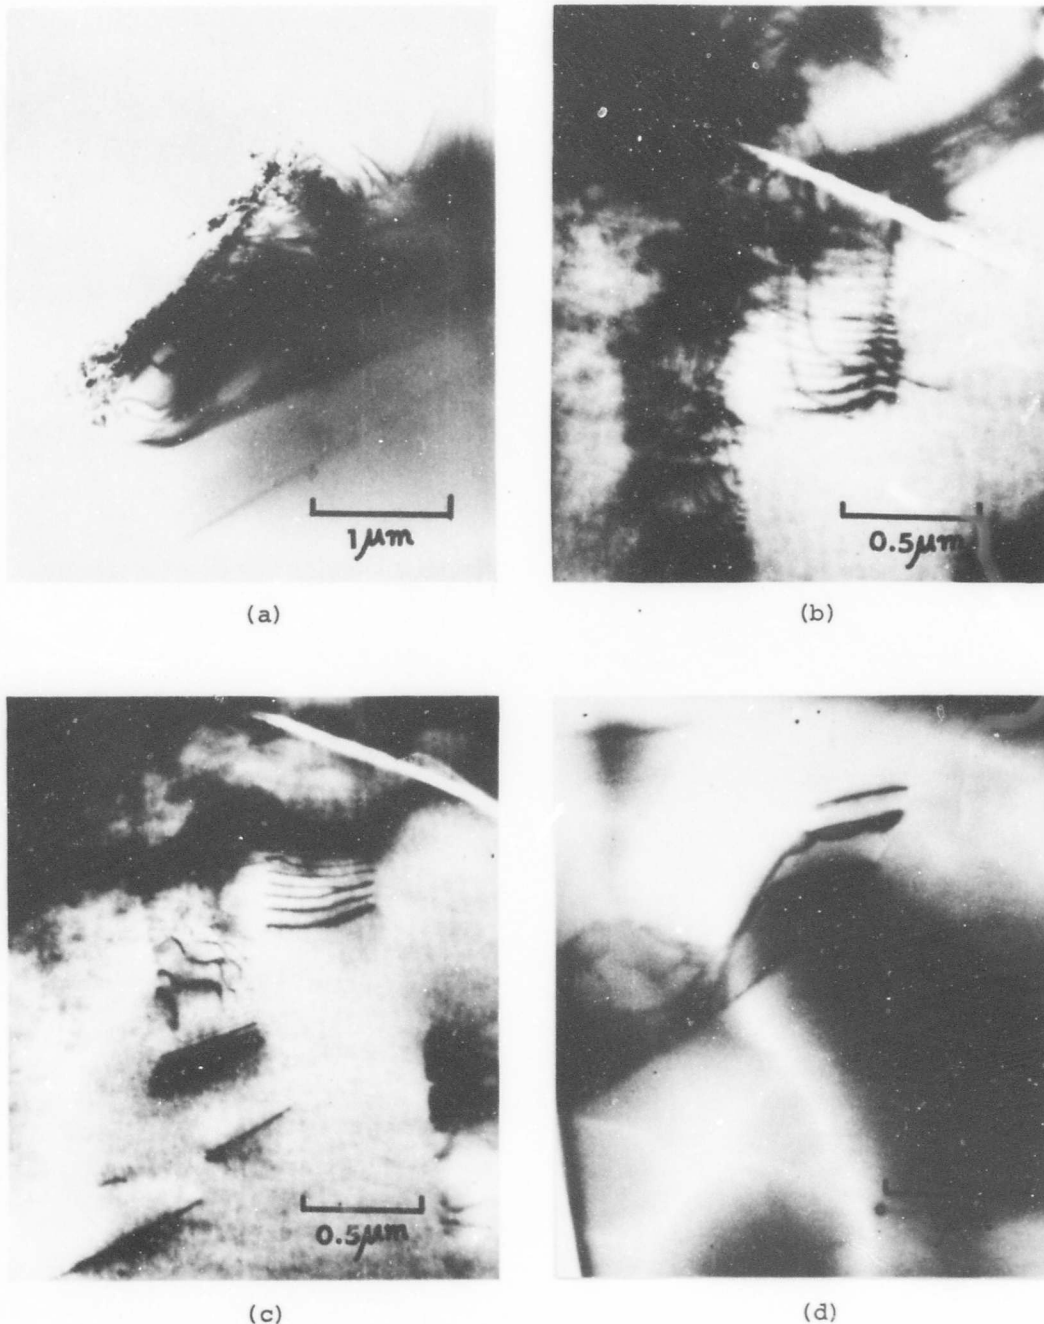
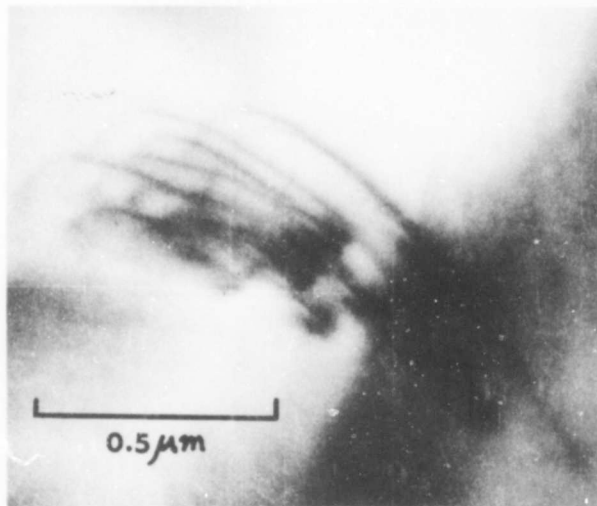
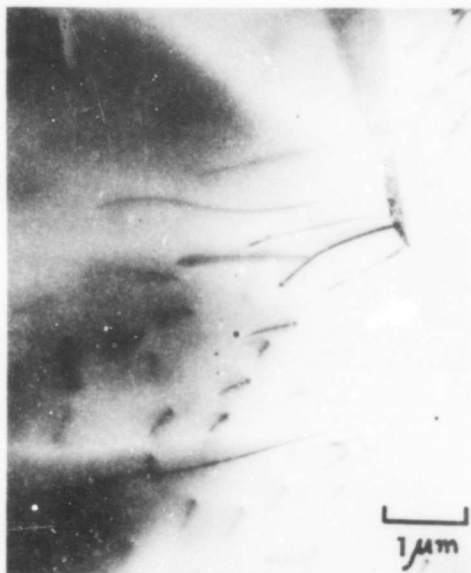
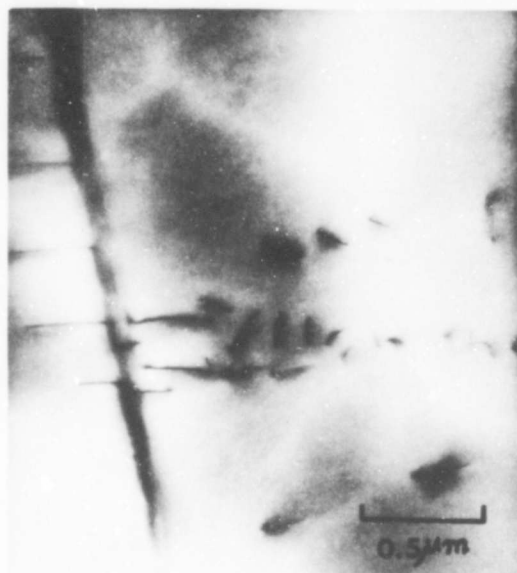
The interaction of a group of dislocations adjacent to a transverse crack are shown in Figures 11b and 11c which have slightly different orientations with respect to each other. Extension of slip bands was halted in the interior of the grain possibly because of unseen barriers which lay above or below this very thin foil.

Loop-like or bowed-out dislocations between locking points were infrequently observed. An obstacle in the path of a glide dislocation, or a jog, resulting for example from the intersection of a gliding screw with another dislocation, can locally retard dislocation motion. Examples are shown in Figures 11d and 11e. The dislocations being held back and consequently being formed into loops by unseen point defects or jogs consisting of short segments of edge dislocations are visible in Figure 11d. Figure 11e demonstrates multiplication of dislocations by gliding dislocations at the unseen obstacle.

Figure 11. Dislocation structures associated with ballistic impact in polycrystalline alumina (tile 1, chip C, Figure 3a): (a) heavily interacted dislocation structures at the edge of an isolated thinned grain; (b) the extension of slip bands adjacent to a crack; (c) the same area as (b), tilted to slightly different orientation; (d) dislocation loops formed during glide; (e) bowed-out dislocations; (f) individual dislocations; (g) dislocation is segmented by an obstacle

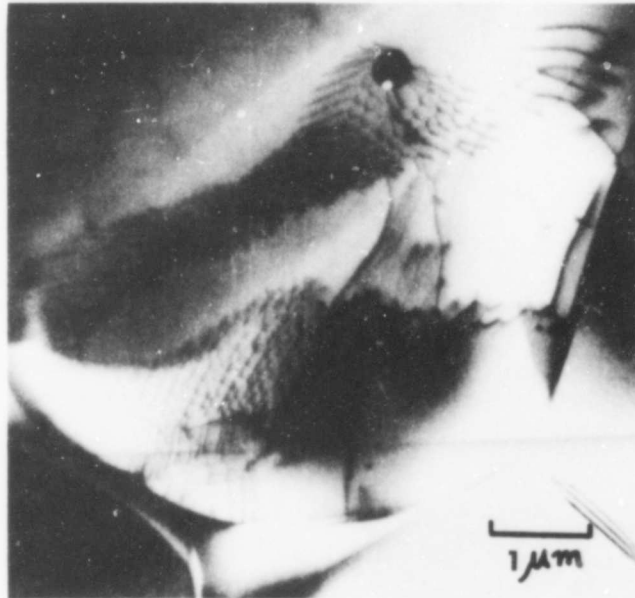
Figure 12. Transmission electron micrograph of foil thinned from bulk showing dislocation structures attributed to impact damage generated by plastic shock waves (tile 1, chip A, Figure 3a)

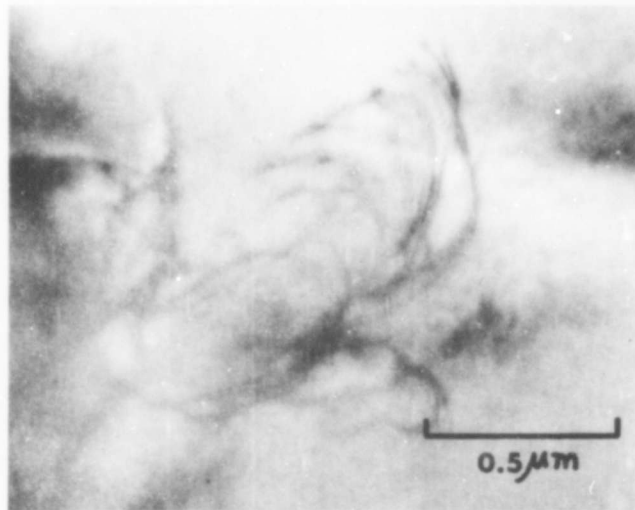
Figure 13. Bowed-out dislocations in ballistically damaged polycrystalline alumina (tile 7, chip E, Figure 3b)

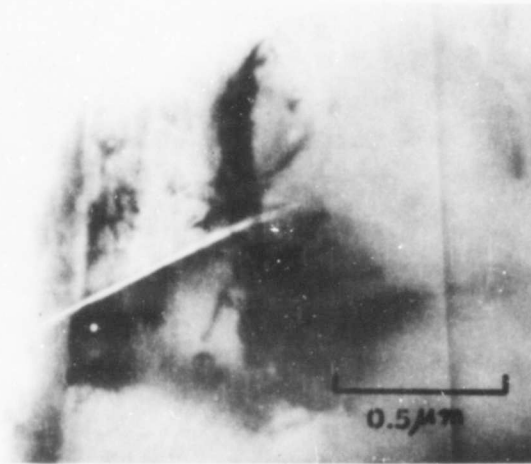
Figure 14. Defect structures associated with crack in ballistically damaged polycrystalline alumina (tile 7, chip E, Figure 3b)

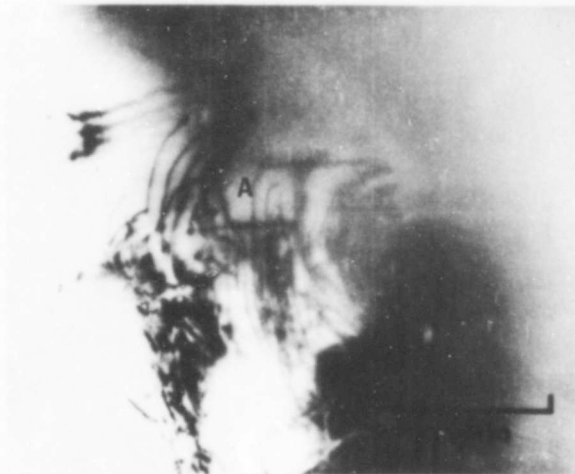
Several sets of dislocations are involved in Figure 15. It is likely that two, perhaps three, different slip systems have been involved in producing the dislocation tangles. Tilting experiments on this foil using the invisibility criterion  $g \cdot b = 0$  showed one set of dislocations (marked A) to have the Burgers vector  $\langle 11\bar{2}0 \rangle$  type. Others could not be positively identified.

Figure 15. Tangled mass of dislocations in ballistically damaged polycrystalline alumina (tile 7, chip E, Figure 3b)

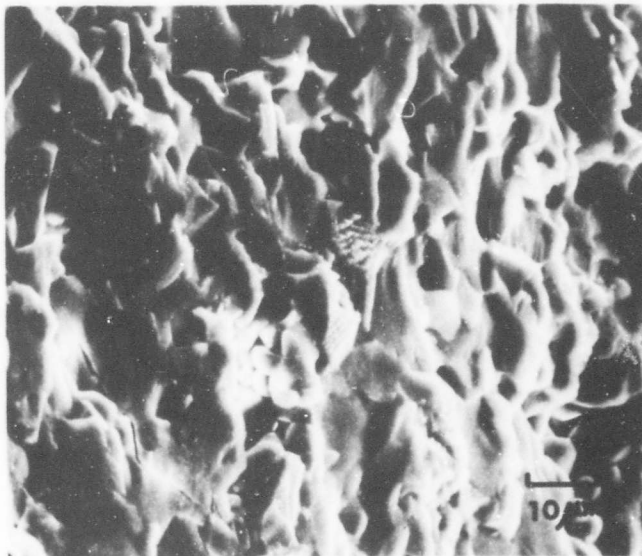
A low magnification micrograph of the fracture surface is shown in Figure 16. Several pores between grains, internal cracks, cleavage fracture facets, and river marks are visible in this micrograph.

Figure 16. Scanning electron micrograph taken from a fracture surface of ballistically damaged alumina (tile 1, central impact region, Figure 3a); intergranular and transgranular fracture facets with internal crack path are visible

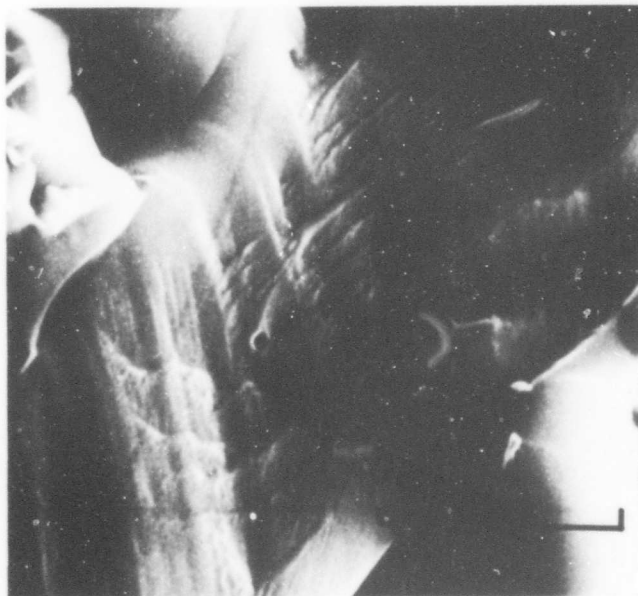
Figure 17. Scanning electron micrograph taken from a fracture surface of ballistically damaged alumina (tile 1, adjacent to chip B, Figure 3a); irregular steps formed by redirection of the fracture path; trapped pore is visible in the center of the micrograph

The intersecting straight lines in Figure 17 are artifacts associated with electron beam damage to the pure Au conductive thin film during line profile scans. This sort of artifact is relatively rare in scanning microscopy and can be almost totally precluded by using the more stable Au-Pd alloy as the evaporant.

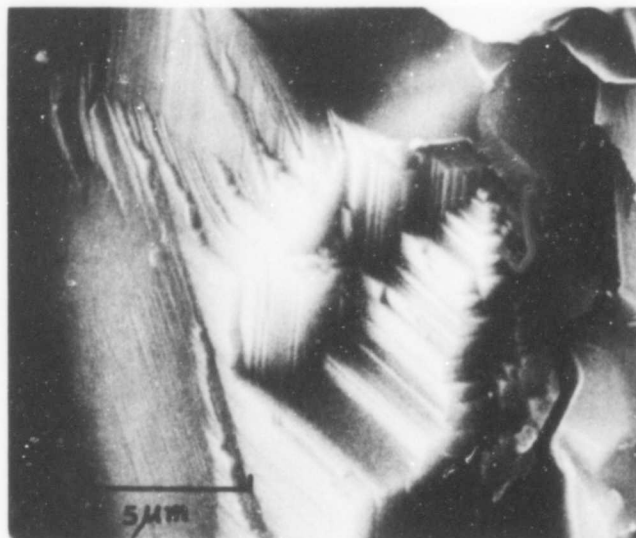
Figure 18. Scanning electron micrograph taken from a fracture surface of ballistically damaged alumina (tile 1, adjacent to chip B, Figure 3a); fine cleavage facets with internal crack path are visible

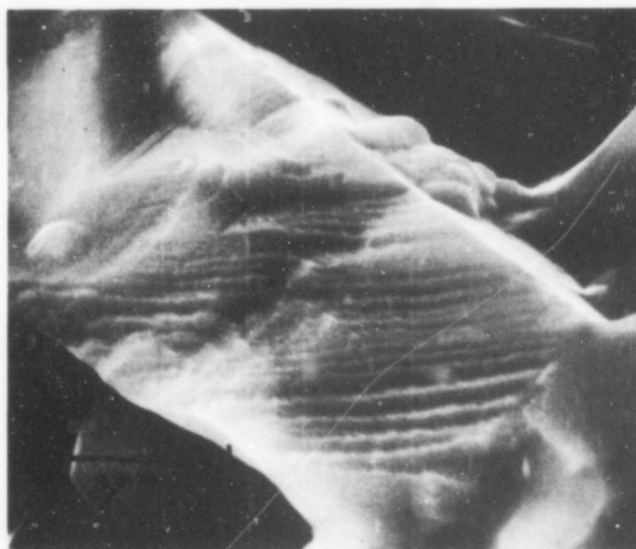
Figure 19. Scanning electron micrograph taken from a fracture surface of ballistically damaged alumina (tile 7, chip F, Figure 3b); adjacent cleavage planes are separated by regions of plastic tearing
