FINAL REPORT  
ON  
SCANNING ELECTRON MICROSCOPY STUDY OF  
6309 SIZE BEARINGS

JANUARY 31, 1971

U.S. Navy Contract: N00014-70-C-0229

SKF Report: AL71C002

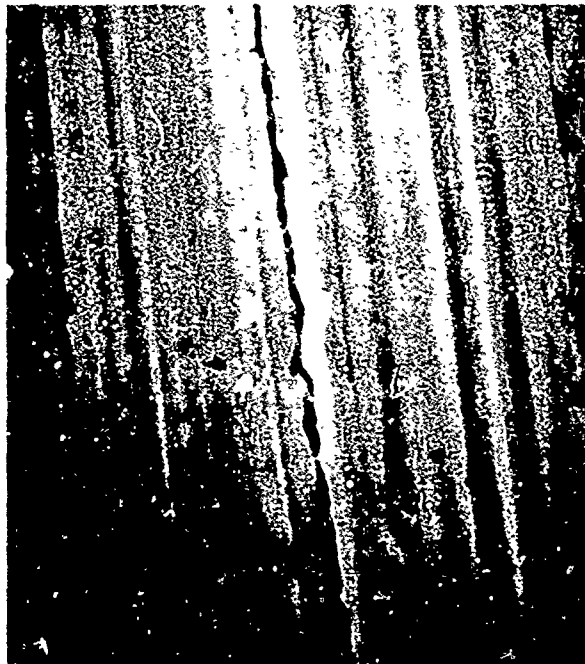
B. Finishing line partially  
smeared over in honing operation.

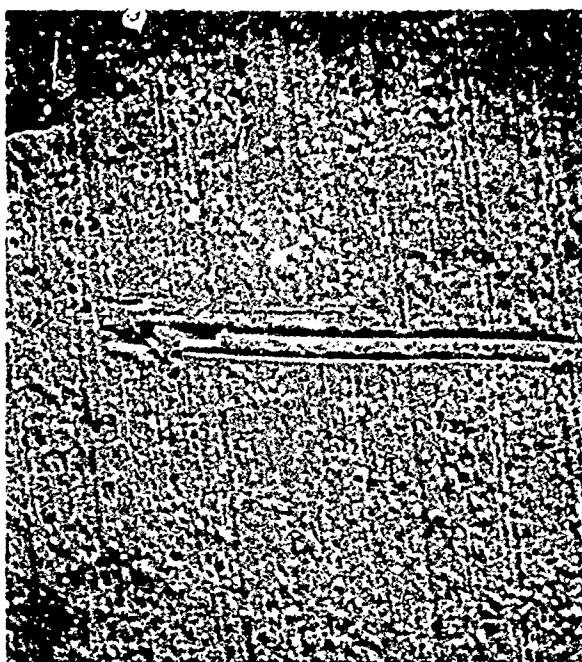
A. Bottom of the ball groove. The defect probably resulted from handling and was not typical of the surface in general.

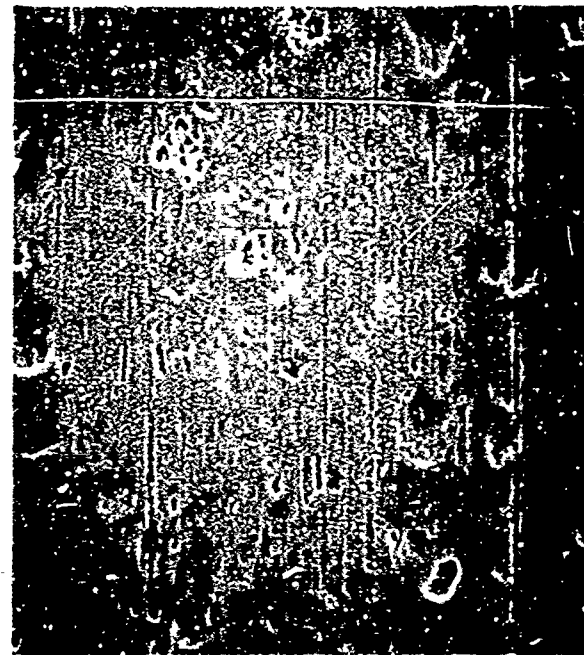
- E. Region 1 mm away from D, approximately at the bottom of the groove. Note the finger nail marks and heavy denting.

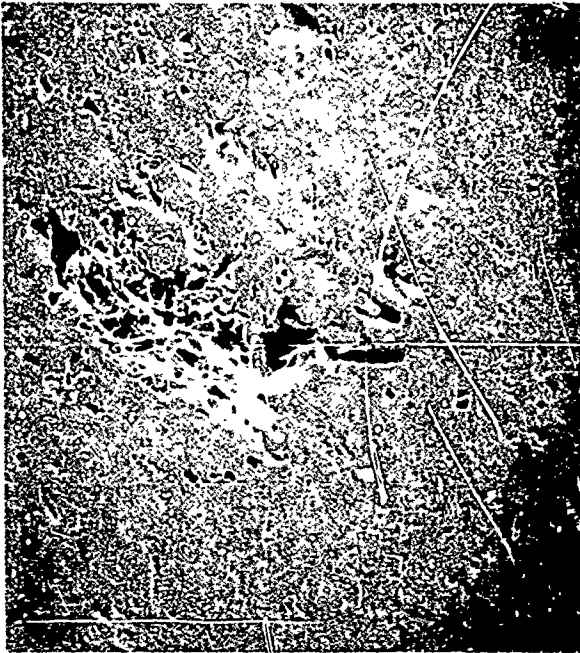
Defect between Heathcote band and edge of contact in  
T. U. (49.9 M.R.) carburized steel - low speed - grease.

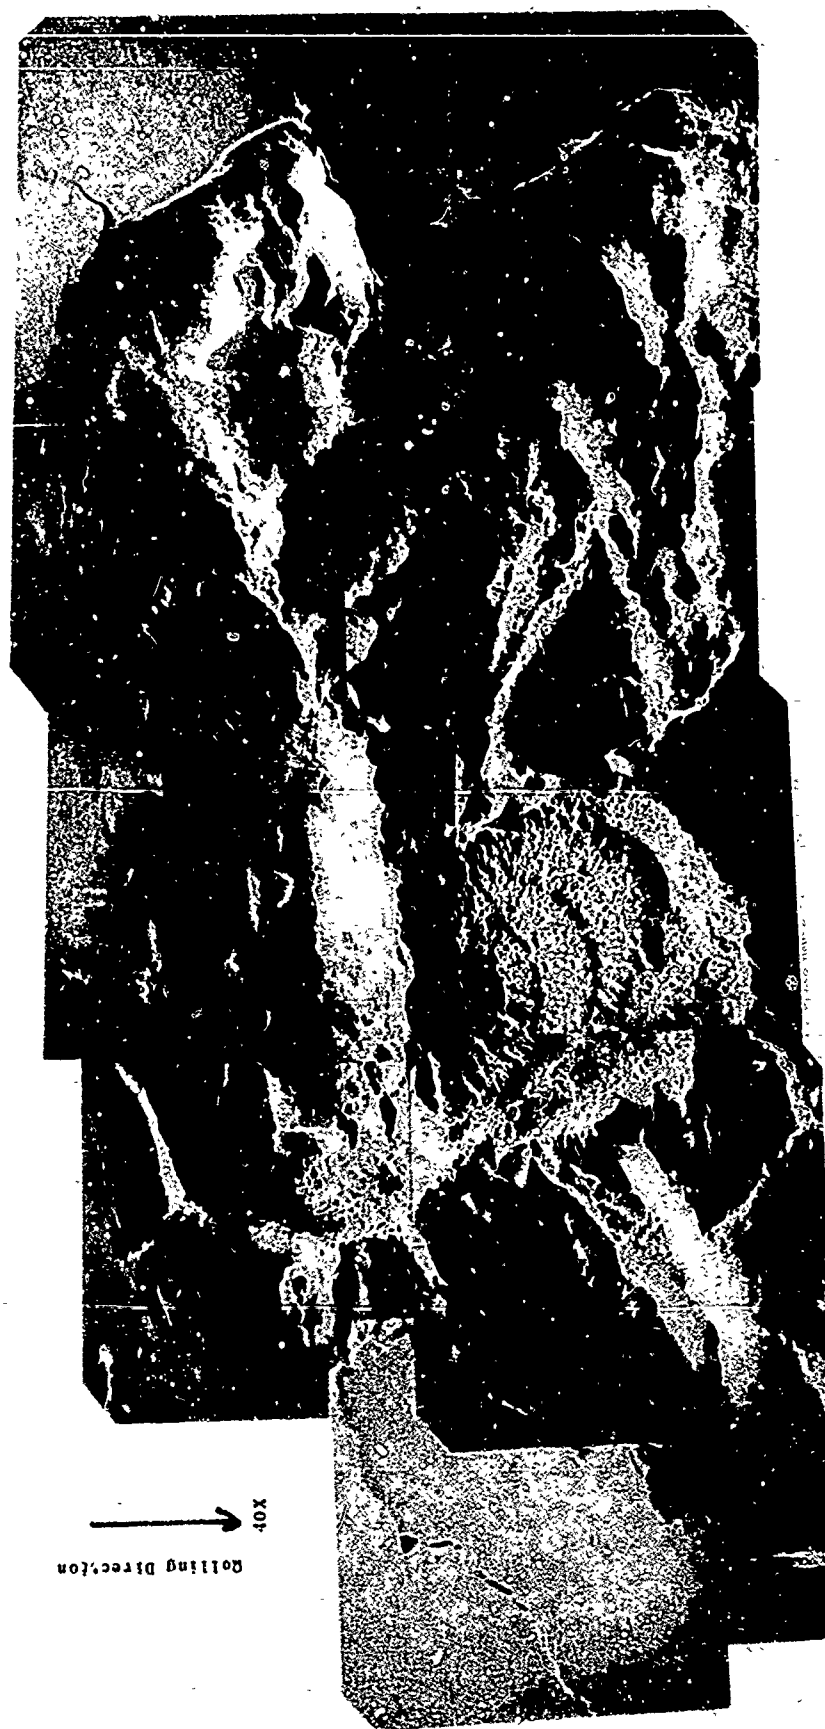
PORTION OF A SPALL ON THE CONTACT SURFACE OF 52100 STEEL (12.4 M.R.) - HIGH SPEED - HEAVY OIL

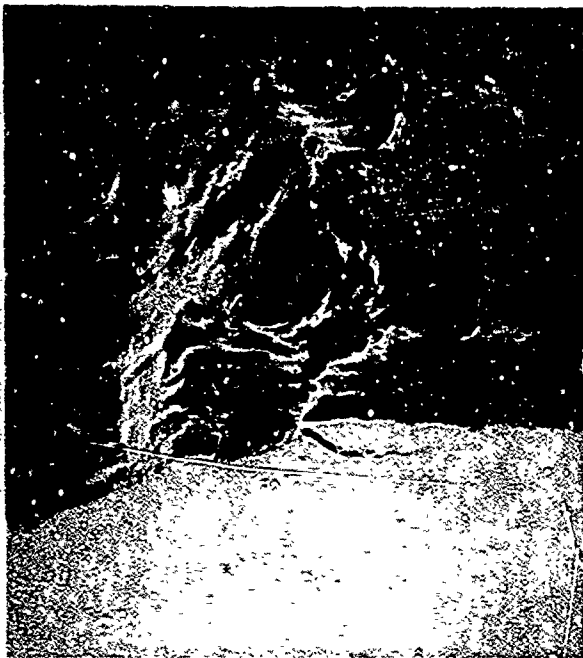
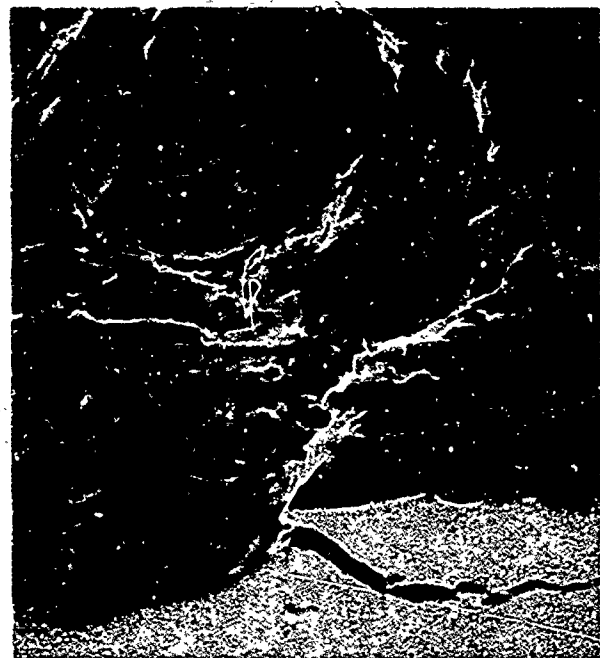
B. Cracking at entrance end of spall. Crack is growing opposite to the direction of rolling.

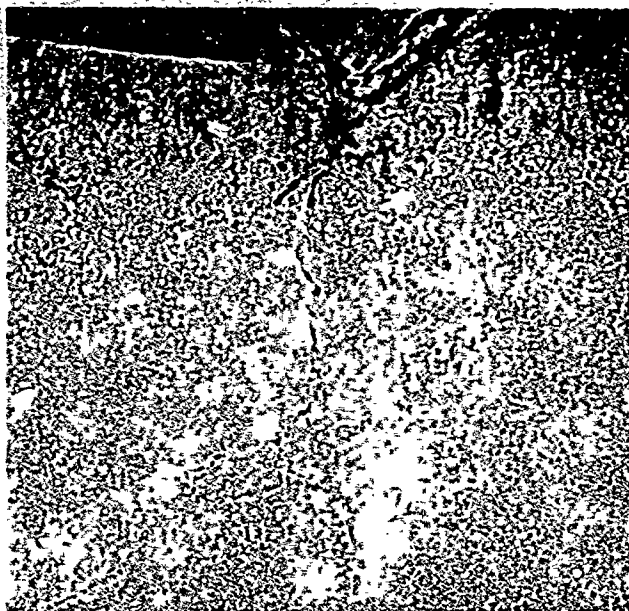
C. Cracking extending from the bottom of the spall. Extensive branching is evident.
