RE-70-196

**EROSION IN 7.62MM MACHINE GUN BARRELS**

**TECHNICAL REPORT**

December 1970

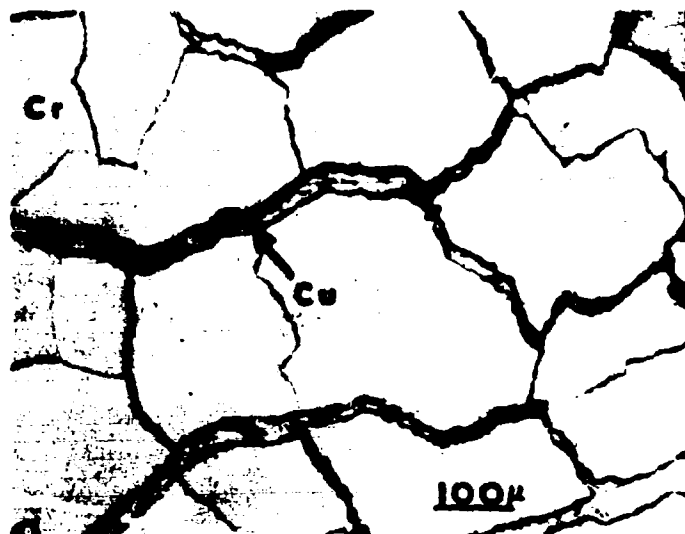
barrel. The extent of copper extrusion into the cracks is better observed in the polished section of Figure 4. The cracks observed on the bore surface extended through the chromium and well into the underlying steel, as shown in Figure 5. Not all of the cracks in the steel exhibited copper, but the microprobe analysis revealed copper in some of the most minute cracks (Figure 6). The cracks became larger primarily in the radial direction, with some bifurcation noted. An altered zone was observed to be associated with the cracks in the steel. Examples representative of the appearance of the altered zone are shown in Figures 7 and 8. The zone appears to consist of more than one phase and to have resisted chemical attack by common etchants (nital and picral) as depicted in Figure 9. Identification of this zone or of the phases present is not yet complete. However, it is generally described as being considerably harder than the unaffected steel. Microprobe analysis revealed that this zone is of a different chemical composition than that of the unaltered steel as evidenced by the scan shown in Figure 10.

FIGURE 4 COPPER FILLED CRACK NETWORK IN  
CHROMIUM PLATING  
(unetched)
