AFML-TR-71-104

**AN INVESTIGATION OF  
VERY-HIGH-SPEED-DROP-IMPINGEMENT  
EROSION OF 1100 ALUMINUM**

**Olive G. Engel  
University of Dayton Research Institute**

**May 1971**

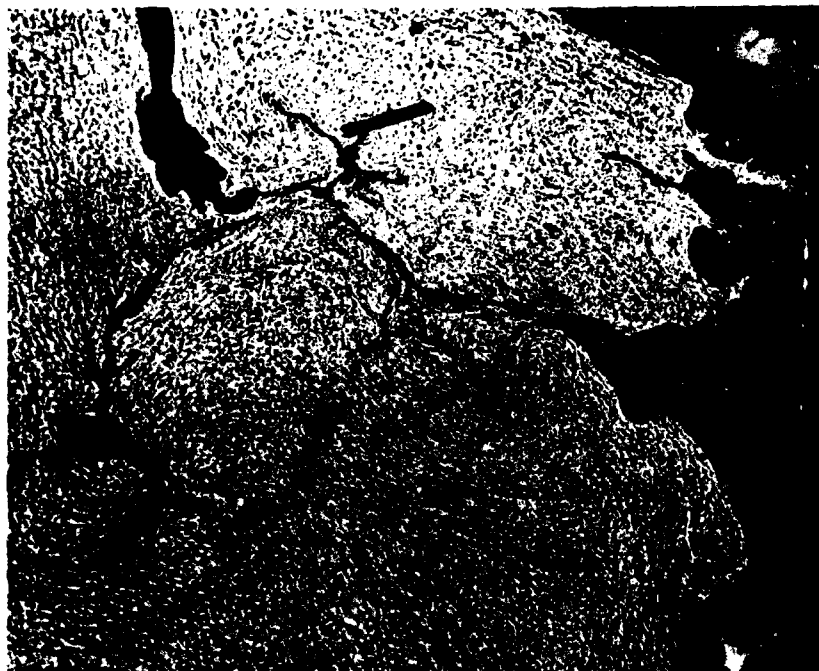
Inspection of the specimen tested at 3229 ft/sec at a magnification of 50X revealed several structures that suggested crack formation. These are shown in view A of Figures 20, 21, and 22. However, when the magnification was increased to 250X the lines of plastic flow in the metal clearly indicated that the meandering black lines are not cracks but are simply surfaces of separation between masses of plastically flowed metal.

Figure 21. Plastic Flow. Test Velocity 3229 ft/sec.
