TECHNICAL REPORT NO. 6-570

# DURABILITY AND BEHAVIOR OF PRESTRESSED CONCRETE BEAMS

## LABORATORY TESTS OF WEATHERED PRETENSIONED BEAMS

October 1971

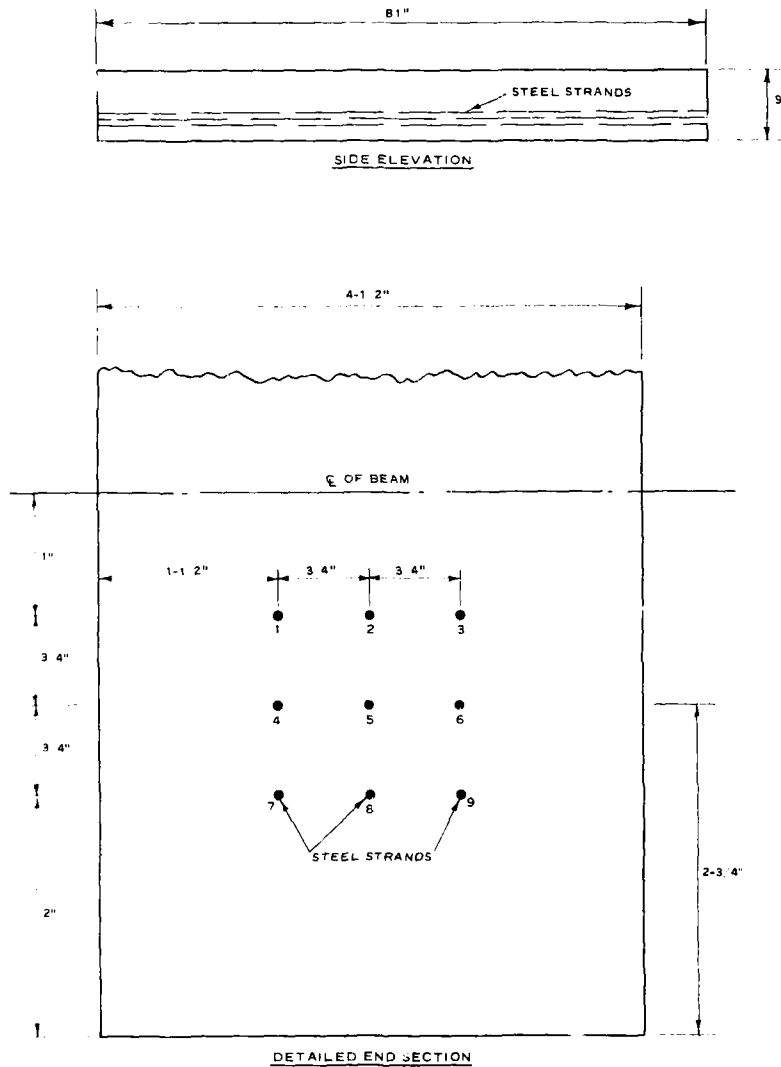
Fig. 1. Detailed section of pretensioned concrete beam

4. The pretensioned concrete beams in this study were of rectangular cross section (4-1/2 by 9 in.\*) and were 81 in. long. Each beam contained nine 1/4-in. (1 by 7) prestressing strands located as shown in fig. 1. The beams were made of good quality air-entrained concrete using

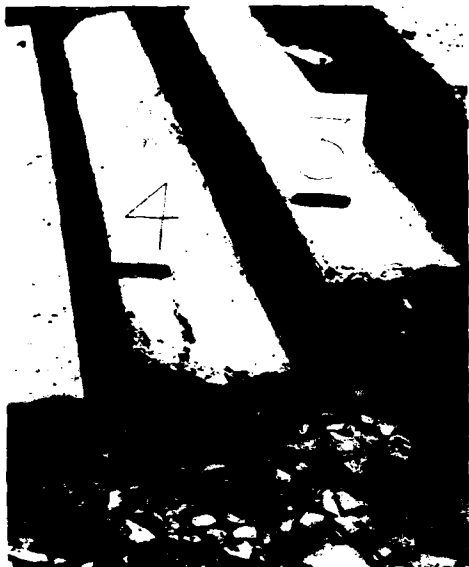
7. Photograph 1*a* and *b* shows beam 4 on the beach at Treat Island, as viewed from its landward and seaward ends, respectively, while it was under exposure. The protective epoxy pads had come off of both ends of the beam and there was considerable spalling (photograph 2*a* and *b*).

*a.* Beam 4, landward end

*b.* Beam 4, seaward end

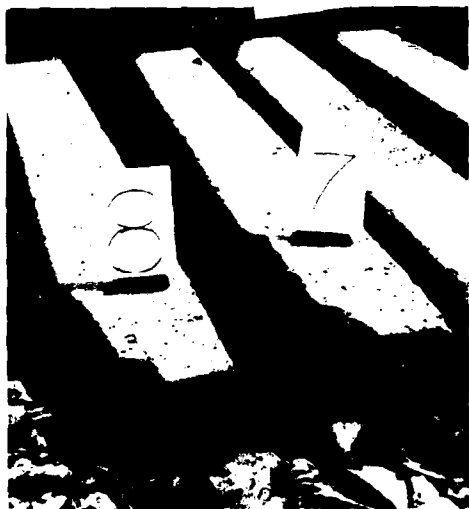
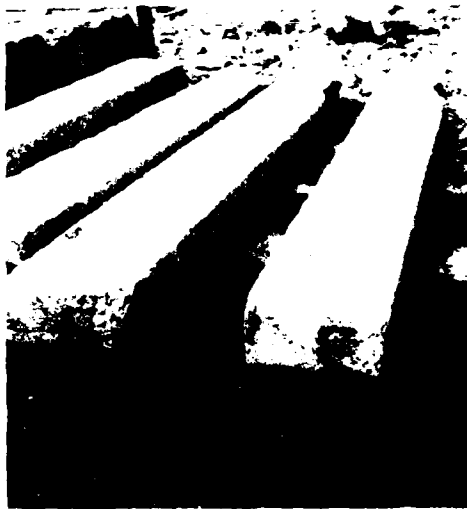
8. Photograph 1*c* and *d* gives the landward and seaward views of beam 8 under exposure. (Beam 8 is on the left in photograph 1*c* and on the right in photograph 1*d*.) The protective epoxy pads had come off of both ends and there was considerable spalling, especially on the landward end (photograph 2*c* and *d*).

*c.* Beam 8, landward end

*d.* Beam 8, seaward end

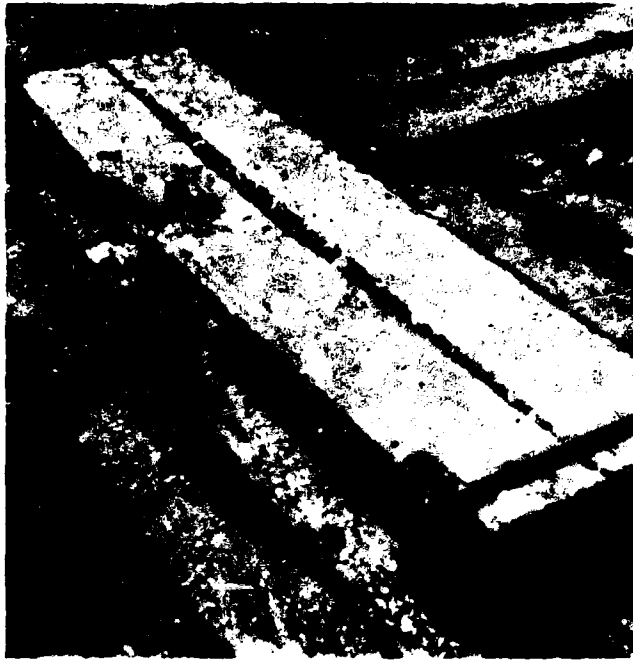
a. Beams 10 and 18 with yoke after failure of beam 18 (on left)

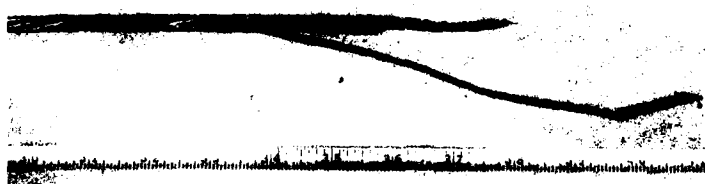
*f.* Strand 8, failure area, landward portion
