MISCELLANEOUS PAPER NO. 4-850

**EVALUATION OF GUIDE RAIL IN  
CONJUNCTION WITH KAISER AND  
HARVEY LANDING MAT (AM2)**

**C. D. Burns  
W. R. Barker**

October 1966

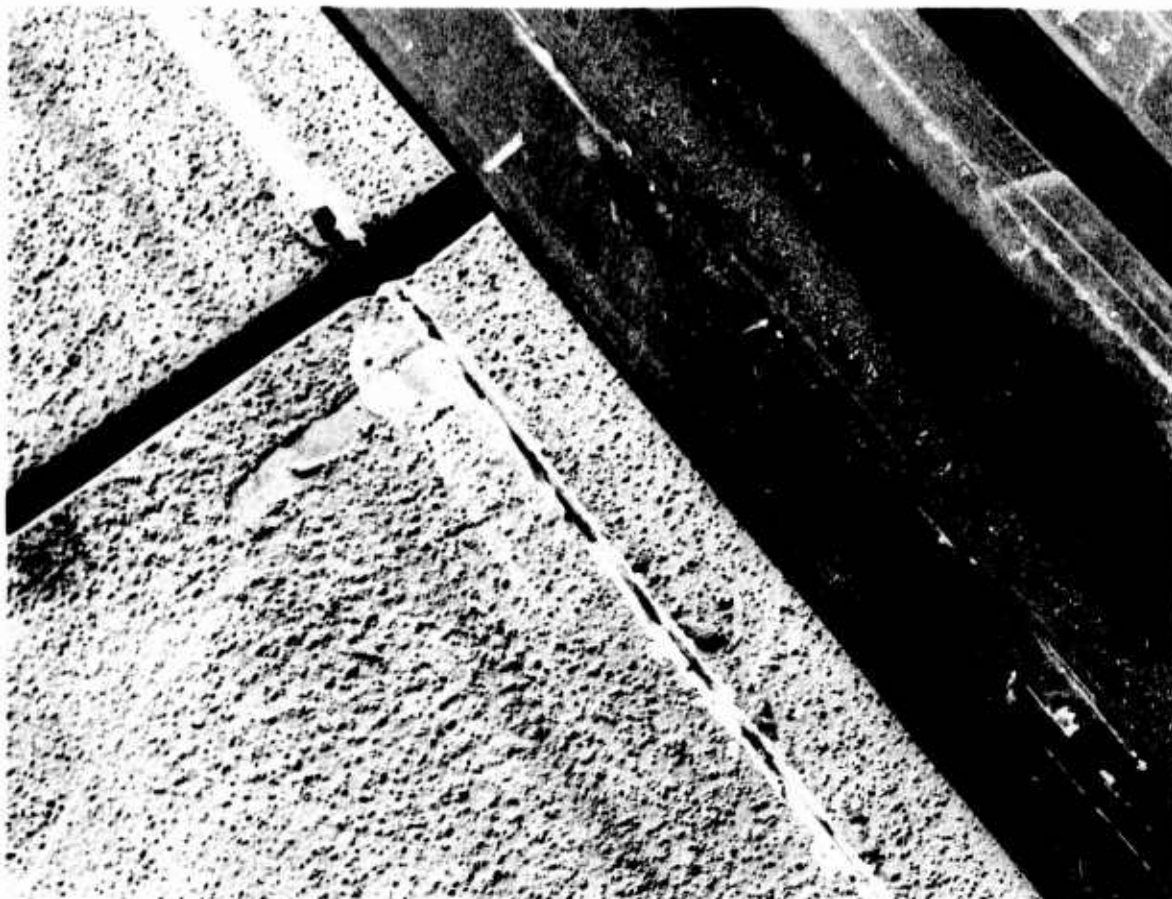
25. Visual observations. After the first few passes of the load wheel, small hairline cracks were noted on several mat planks adjacent to the guide rail where the AM2 end connector was welded to the plank extrusion. By the end of 11 passes, the cracks were quite noticeable in three planks of item 4 (the low-strength clay item), and by 20 passes, the end-connector joints had completely separated on four test planks due to weld failure, and eight other joints were badly cracked. A close-up view of two of the failed joints is shown in fig. 7. A general view of item 4 at the end of 20 passes is shown in photograph 3, which shows that the general appearance of the mat and guide rail at the end of 20 passes was fairly good; the mat surface remained smooth and the bodies of the planks were not damaged. However, as the load passed over the failed joints, the planks deflected downward below the sheared end connector which was still connected to the guide rail. This resulted in a tire hazard; therefore, item 4 was considered unserviceable at the end of 20 passes.

Fig. 7. Close-up of end-joint failure, lane 1, item 4

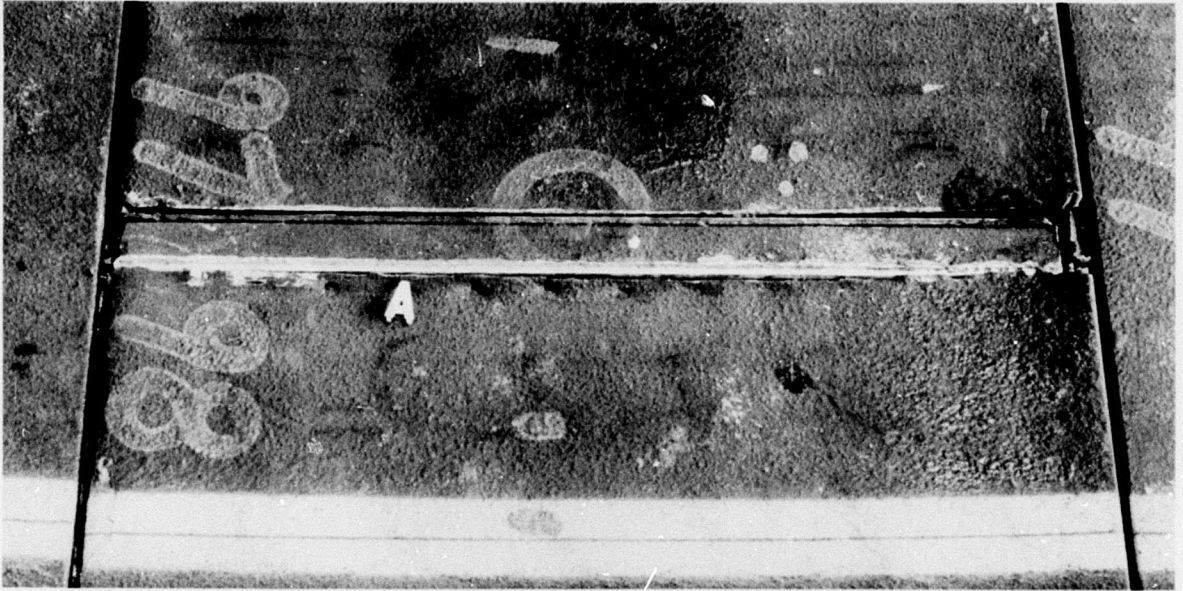
Fig. 10. Close-up of end-joint failure in item 4, lane 3

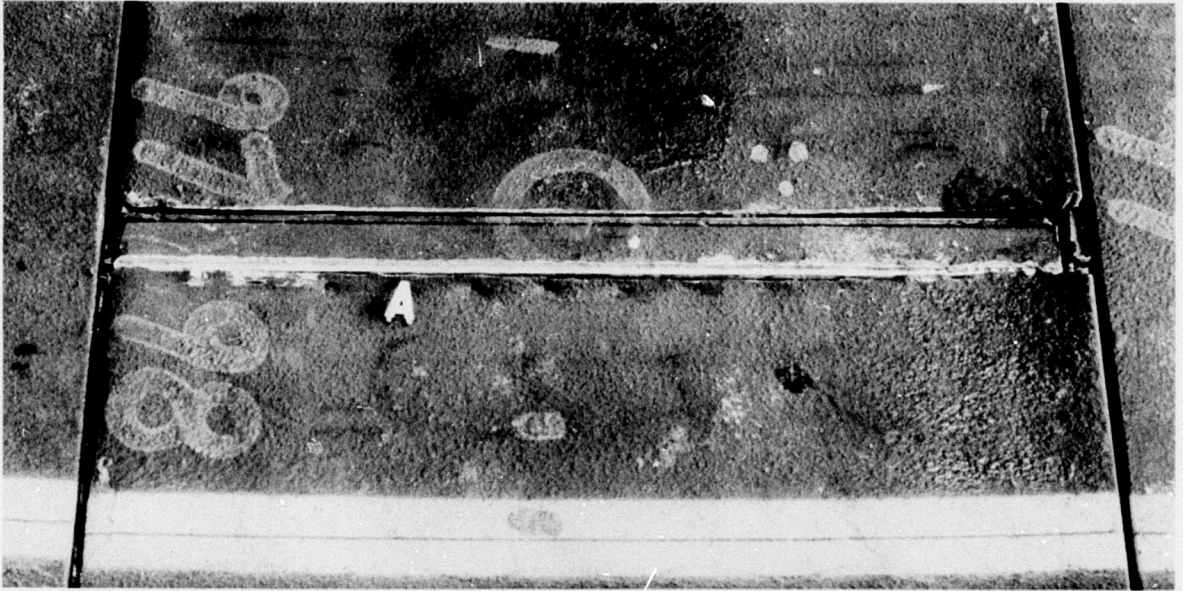
42. Visual observations. A general view of the test section prior to traffic is shown in photograph 21. The first evidence of mat distress was a weld crack which developed at one of the end joints in item 4 and was noted at the end of 10 coverages of traffic. After 20 coverages, this weld had completely failed, and cracks were noted at the joints of seven other planks. After 40 coverages, the end joints of eight planks in item 4 had completely failed. At this point traffic was discontinued. A general view of item 4 at the end of traffic is shown in photograph 22. A close-up of one of the end-joint failures is shown in fig. 10.

Fig. 10. Close-up of end-joint failure in item 4, lane 3

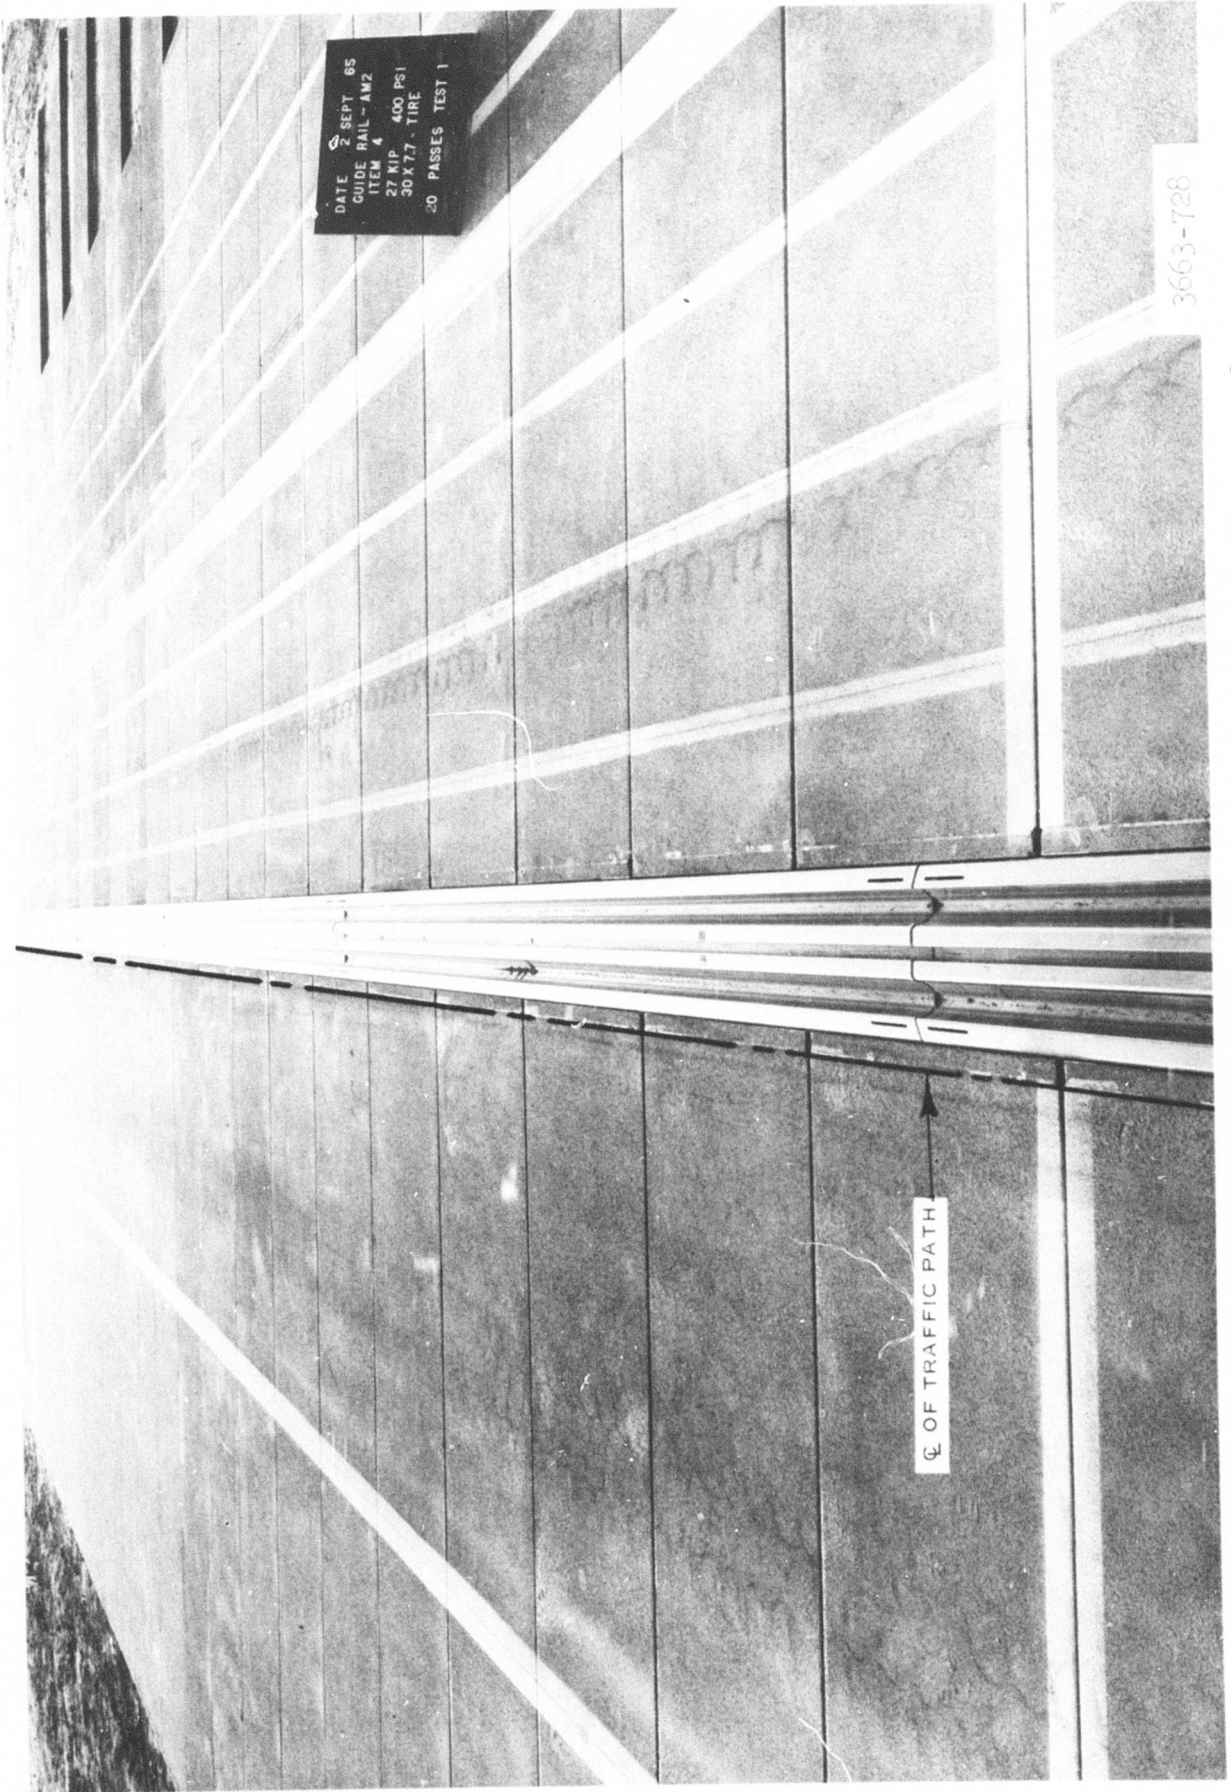
Photograph 3. Test item 4, Lane 1, after 20 passes of load wheel

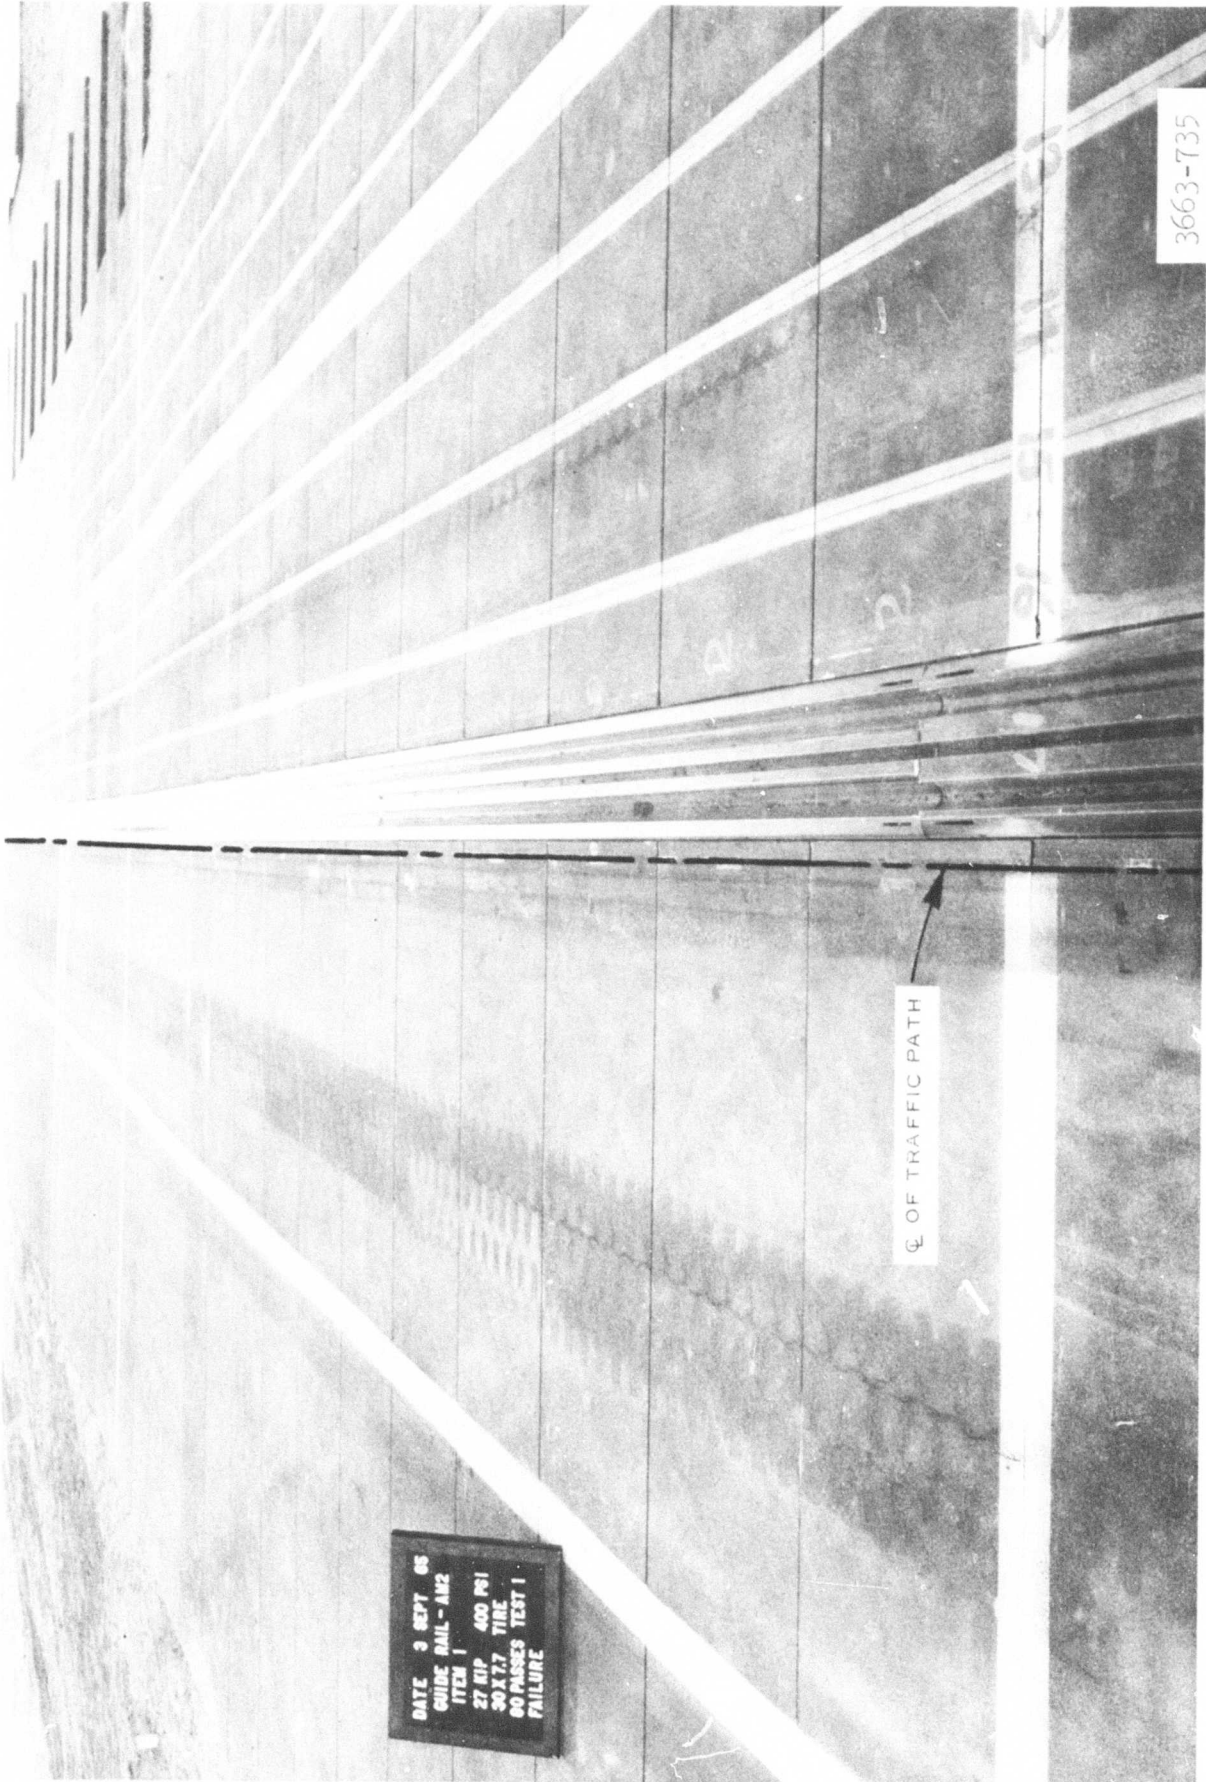
27. As traffic continued, weld failures developed quite rapidly in items 1, 2, and 3. By the end of 70 passes, four end joints had completely separated in item 3. At this point the item was considered failed. However, traffic was continued to 80 passes, resulting in the complete separation of eight joints. At this stage of traffic, six joints in item 1 (sand subgrade) and three joints in item 2 (high-strength clay subgrade) had failed. Traffic was continued on item 2 to 100 passes, at which time the end connectors of five additional planks separated, making a total of eight failed joints. At this stage, the entire test lane, with the exception of the Harvey and Kaiser mats in item 4, was considered unserviceable. General views of test items 1, 2, and 3 at failure are shown in photographs 4, 5, and 6, respectively. All mat failures were of the same

type and were caused by separation of end joints from the body of the mat planks at the weld seams. A close-up of joint failures in test item 3 is shown in photograph 7.

Photograph 4. Test item 1, lane 1, after 100 passes of load wheel

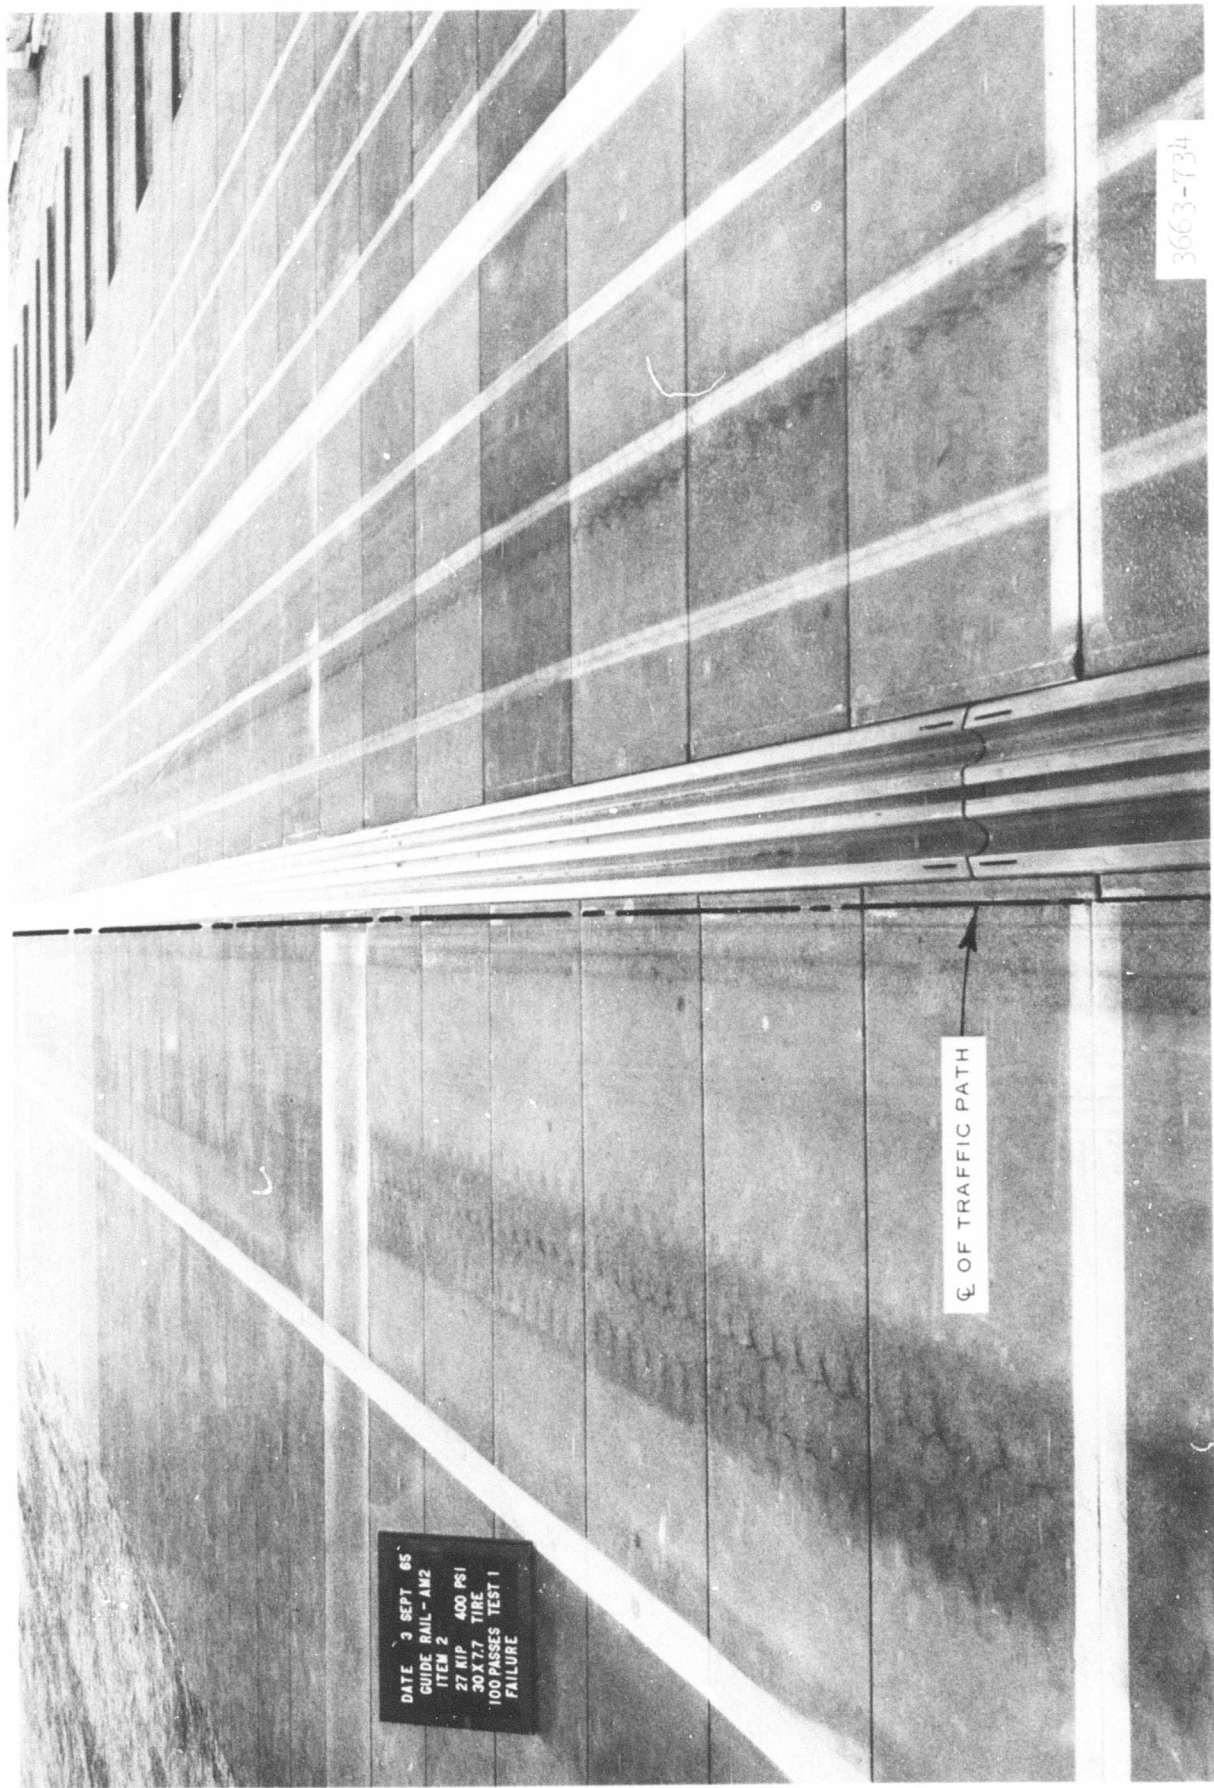
Photograph 5. Test item 2, lane 1, after 100 passes of load wheel

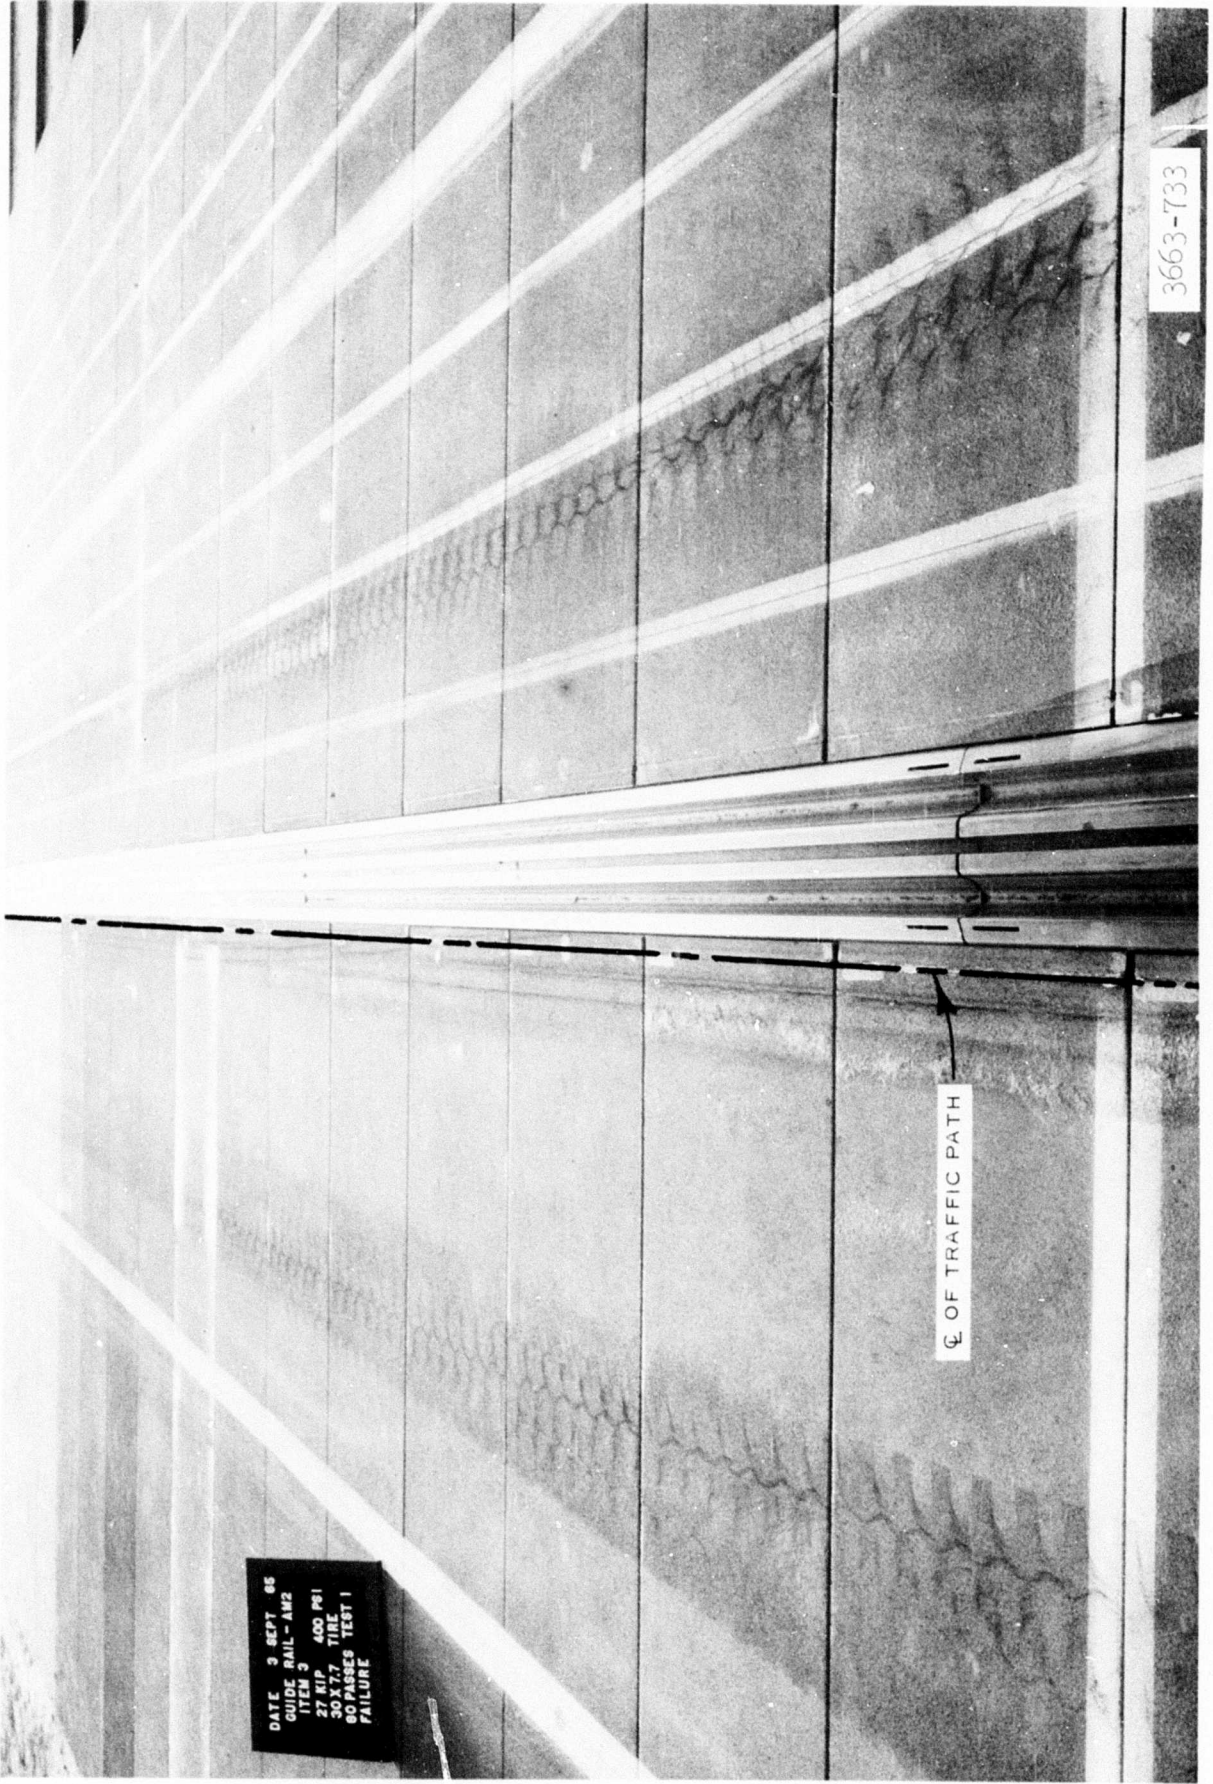
Photograph 6. Test item 3, lane 1, after 80 passes of load wheel

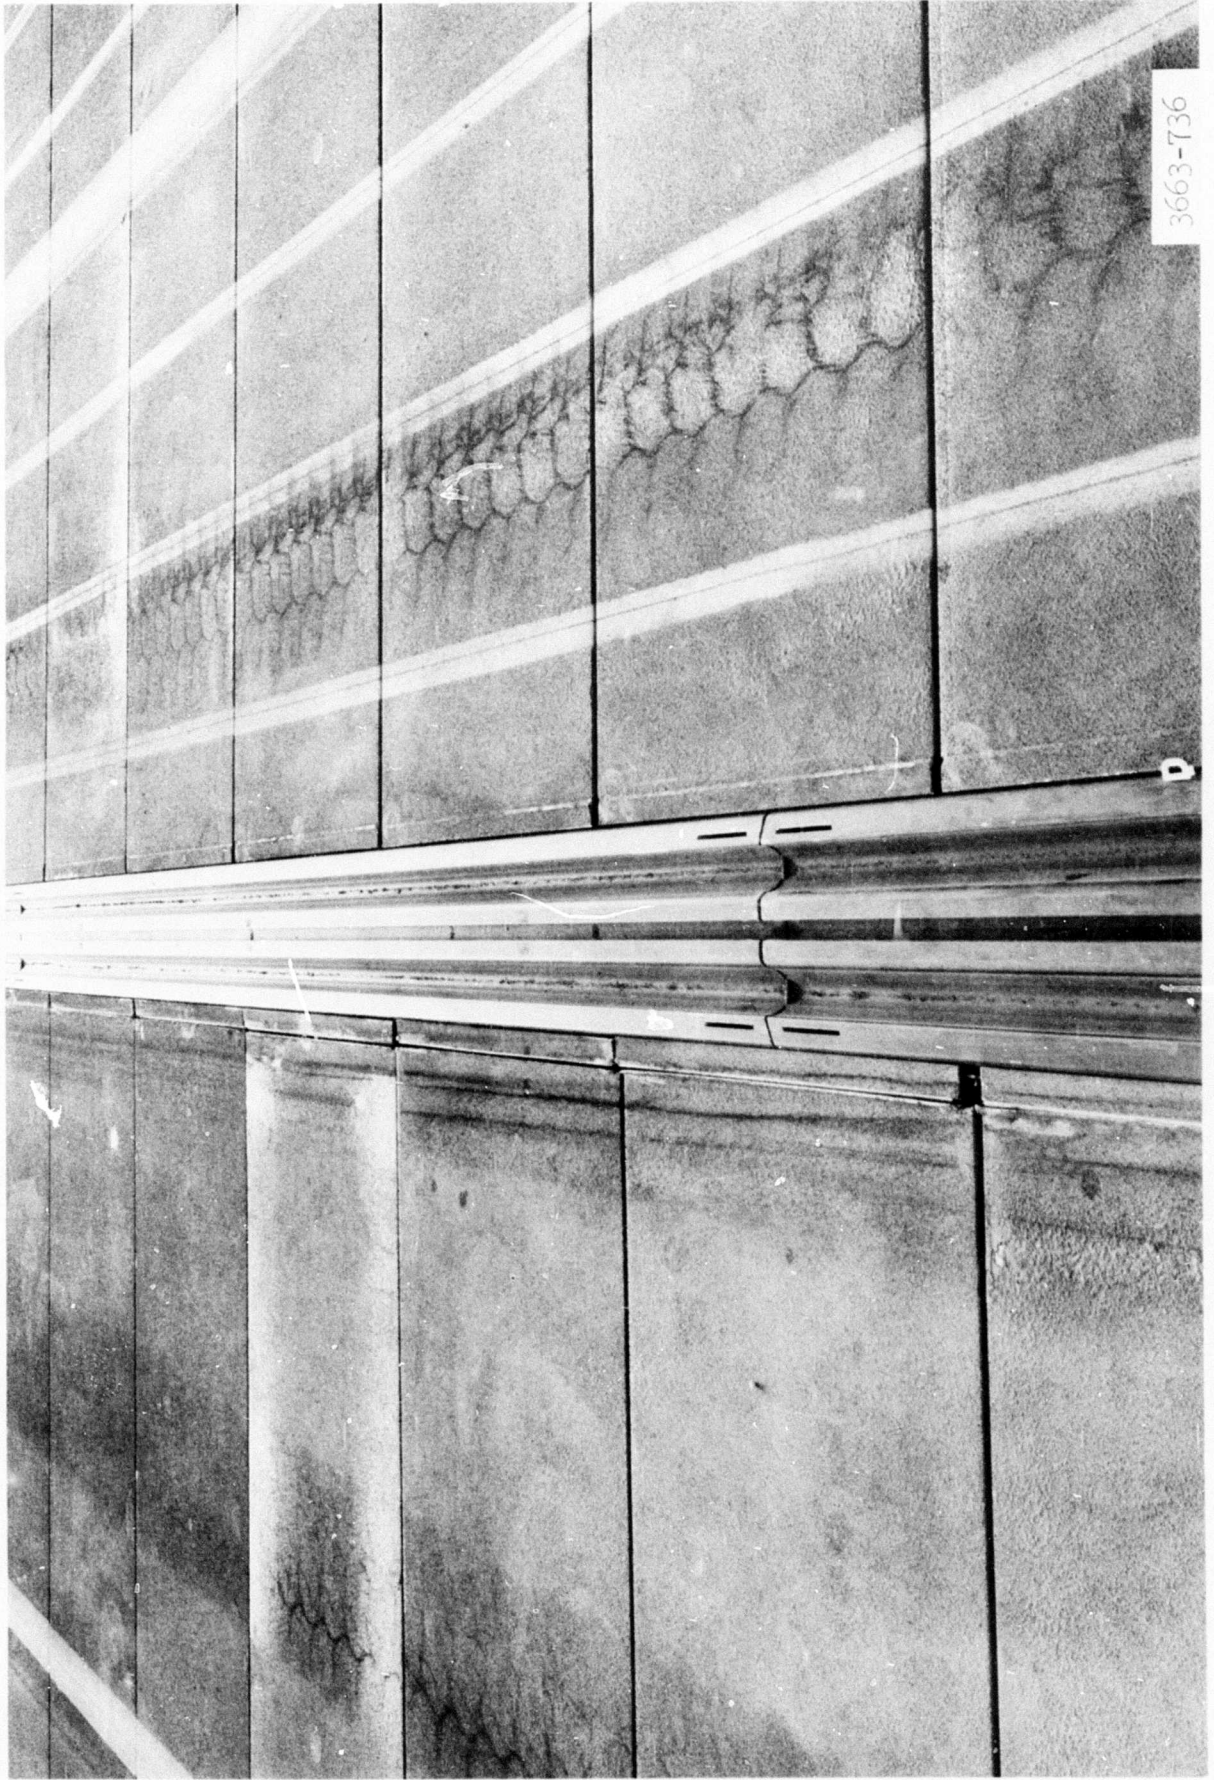
49. As can be noted in table 2, all items in lane 1 where traffic was applied at the junction of guide rail and Kaiser AM2 failed within 100 passes of the load wheel. These failures were caused by shearing in the weld seams where the end connectors were welded onto the main plank extrusions. A comparison of the behavior of the different test items reveals that the number of passes of the load wheel required to produce

Photograph 7. Close-up of end-joint failures, lane 1, item 3

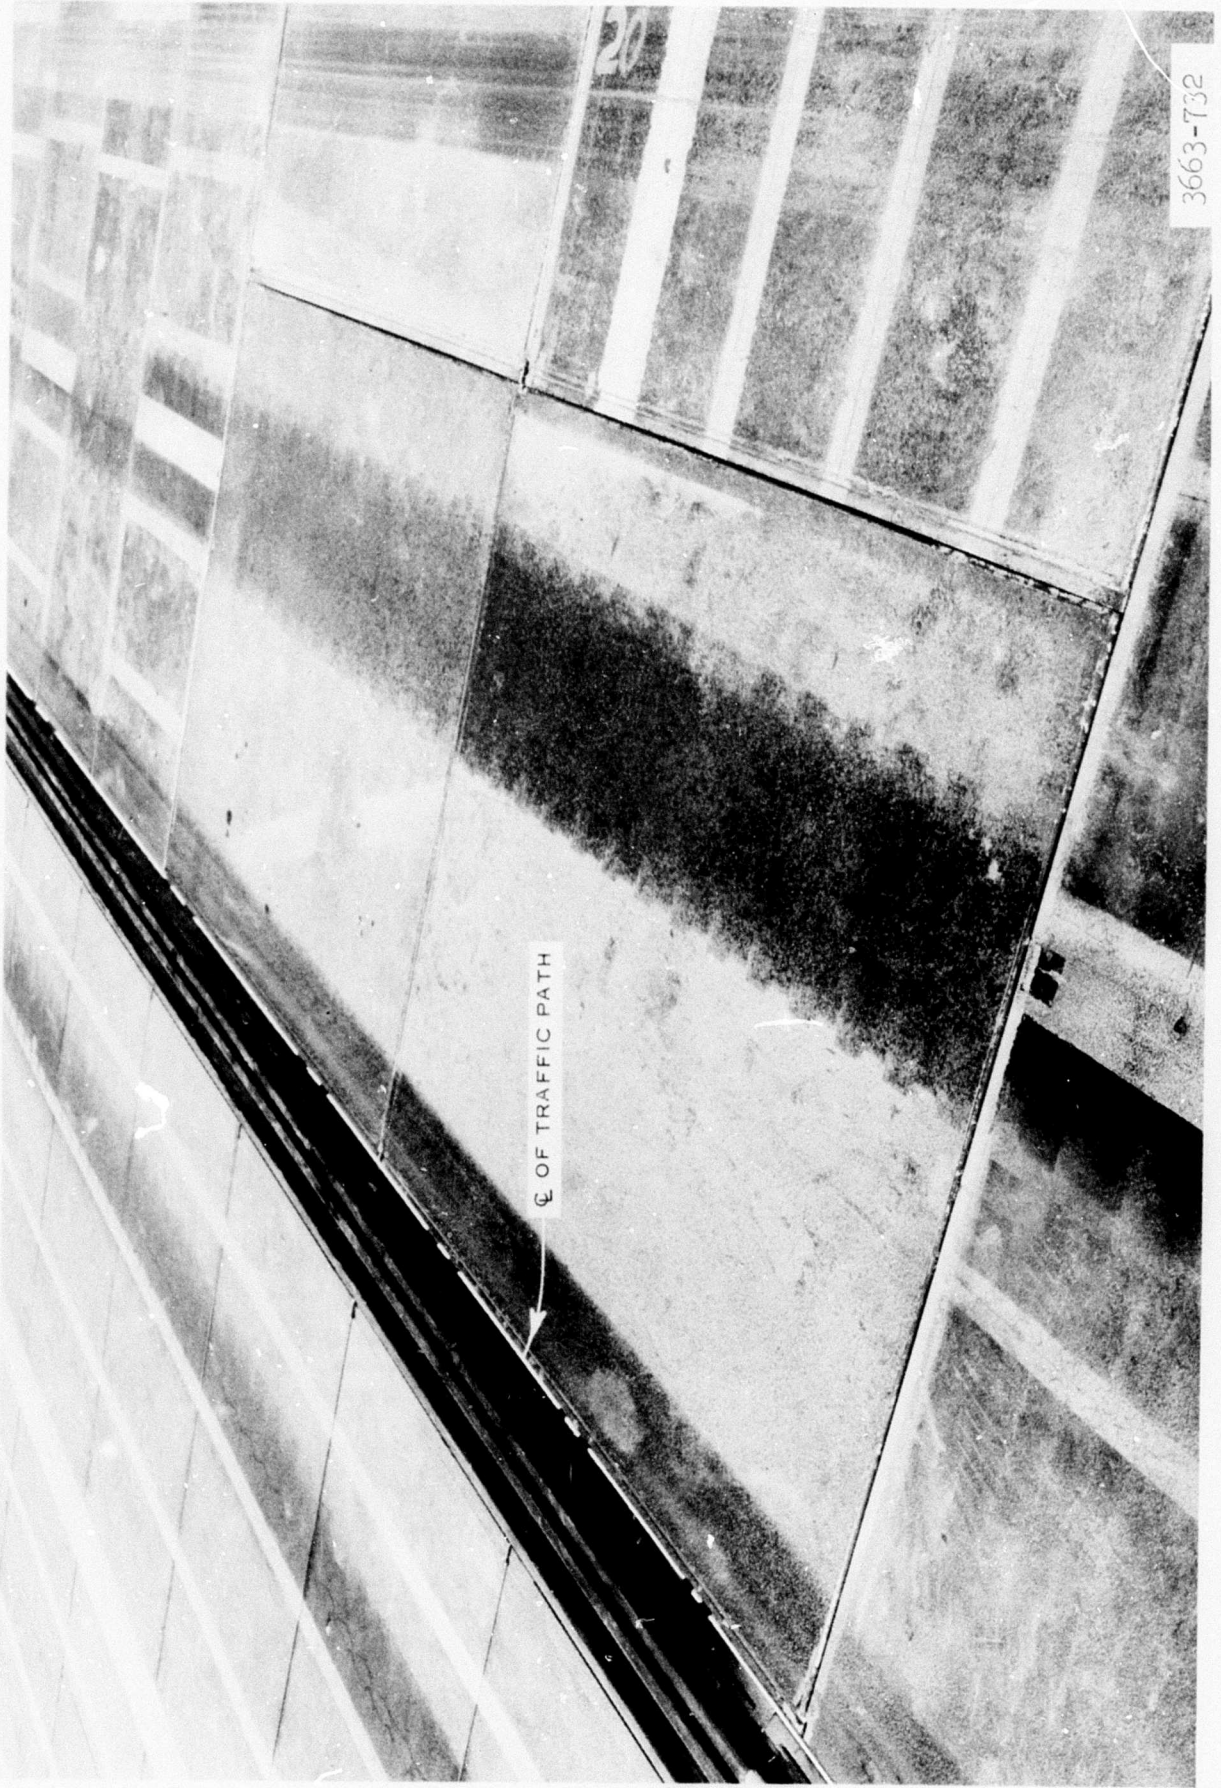
28. Traffic was continued for a total of 100 passes on the Harvey AM2 and Kaiser 4- by 4-ft mats, which were placed in item 4 after the failure of the Kaiser AM2 at 20 passes. These mats withstood the 100 passes of traffic with no evidence of mat distress, as indicated in photograph 8.

Photograph 8. Kaiser 4- by 4-ft aluminum honeycomb mat and Harvey modified AM2 in item 4, lane 1, after 100 passes

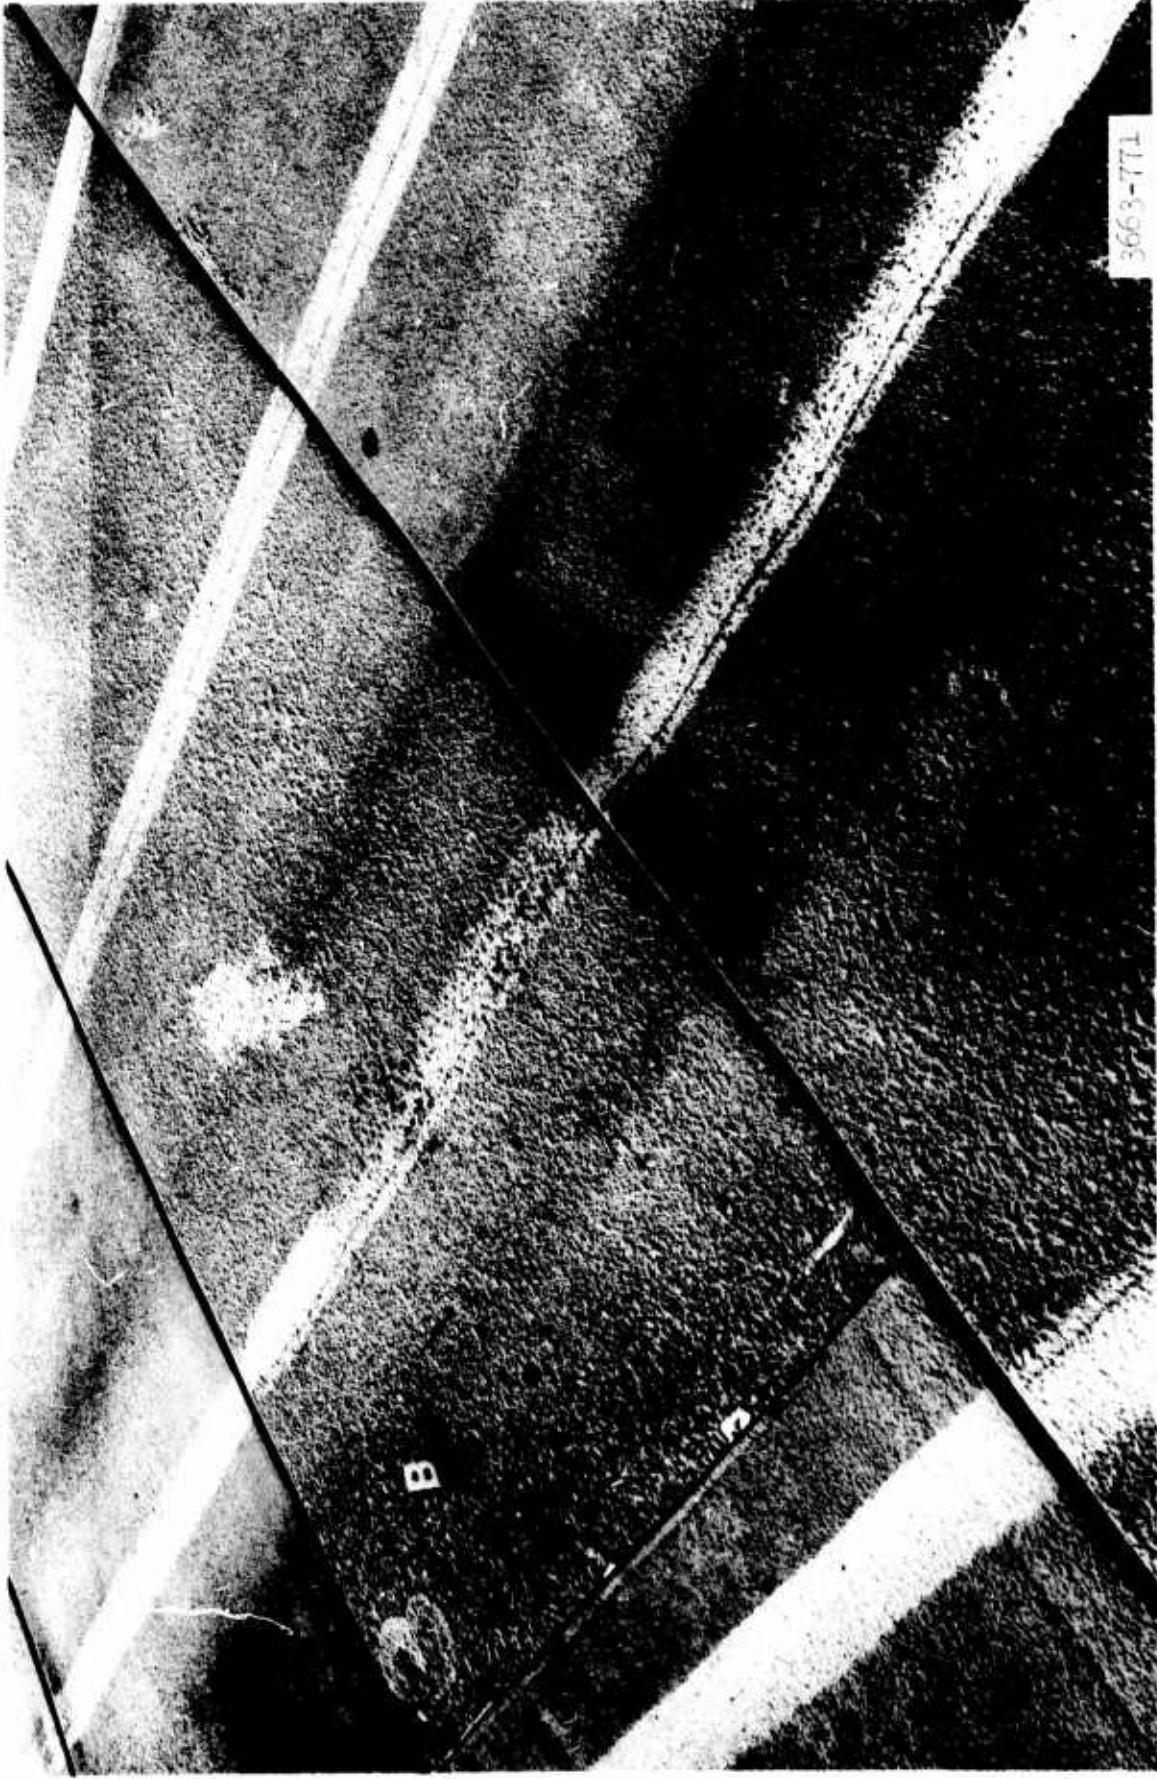
33. The first evidence of distress in the body of the mat planks was also noted at about 1000 passes of the load wheel. The distress was evidenced by depressions or dished areas on the surface of the mat planks, which normally developed first on the female edge of the plank, as indicated in photograph 11. This depression was an indication of structural failure within the mat core. As traffic was continued to a total of 1600 passes, the core failures developed quite rapidly in all test items, especially in items 1 and 4. By the end of 1600 passes, the riding surface was quite rough. In addition to the core failure, a number of weld cracks developed at the end joint 1.5 ft west of the center line of the traffic path, with two joints in item 4 completely separating. One of the weld failures is shown in fig. 8. A general view of the test lane at the completion of 1600 passes of traffic is shown in photograph 12. A close-up view showing the condition of the mat in test item 4 is shown in photograph 13. After removal of the mat from the test section, several planks were cut to determine the extent of core failures. Fig. 9 shows a

Photograph 11. Dish in mat plank indicating core failure
