MISCELLANEOUS PAPER NO. 4-850

**EVALUATION OF GUIDE RAIL IN  
CONJUNCTION WITH KAISER AND  
HARVEY LANDING MAT (AM2)**

**C. D. Burns  
W. R. Barker**

October 1966

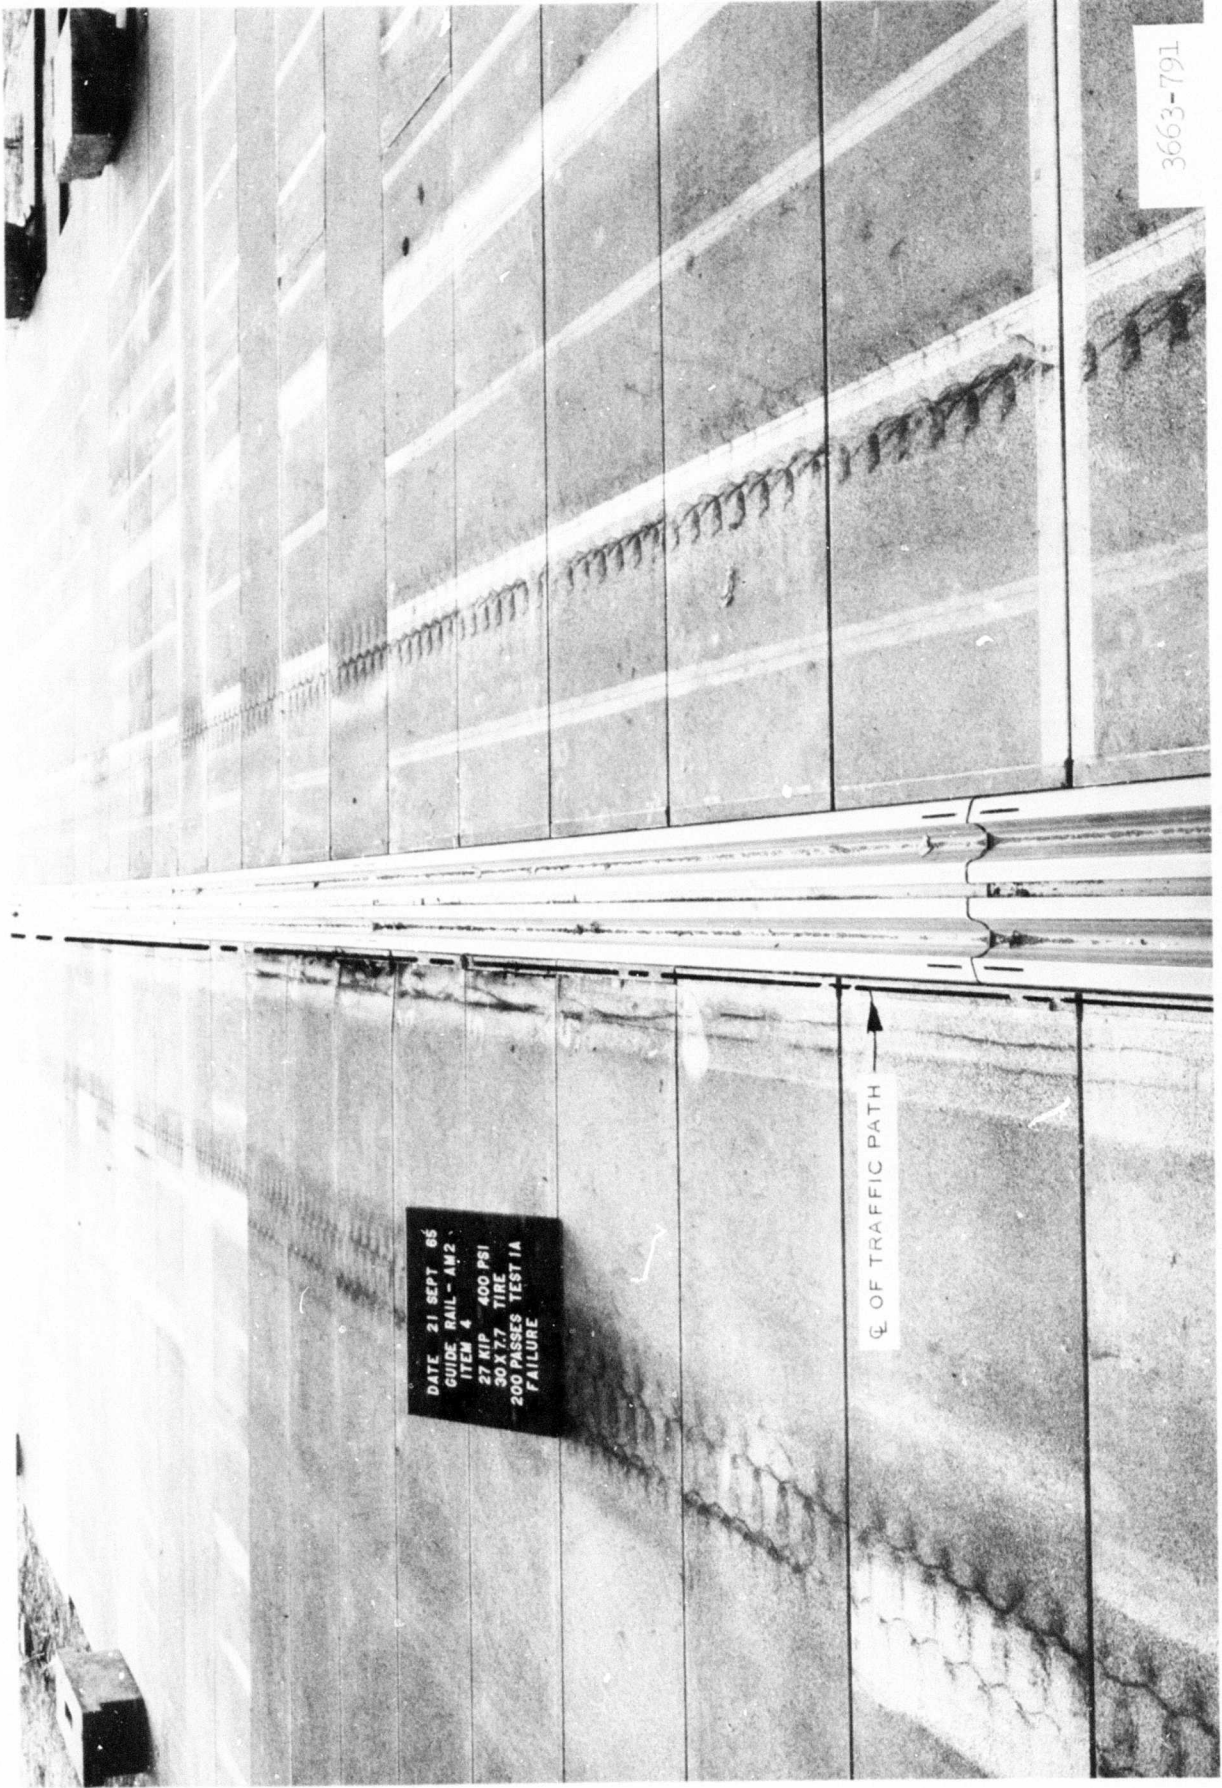
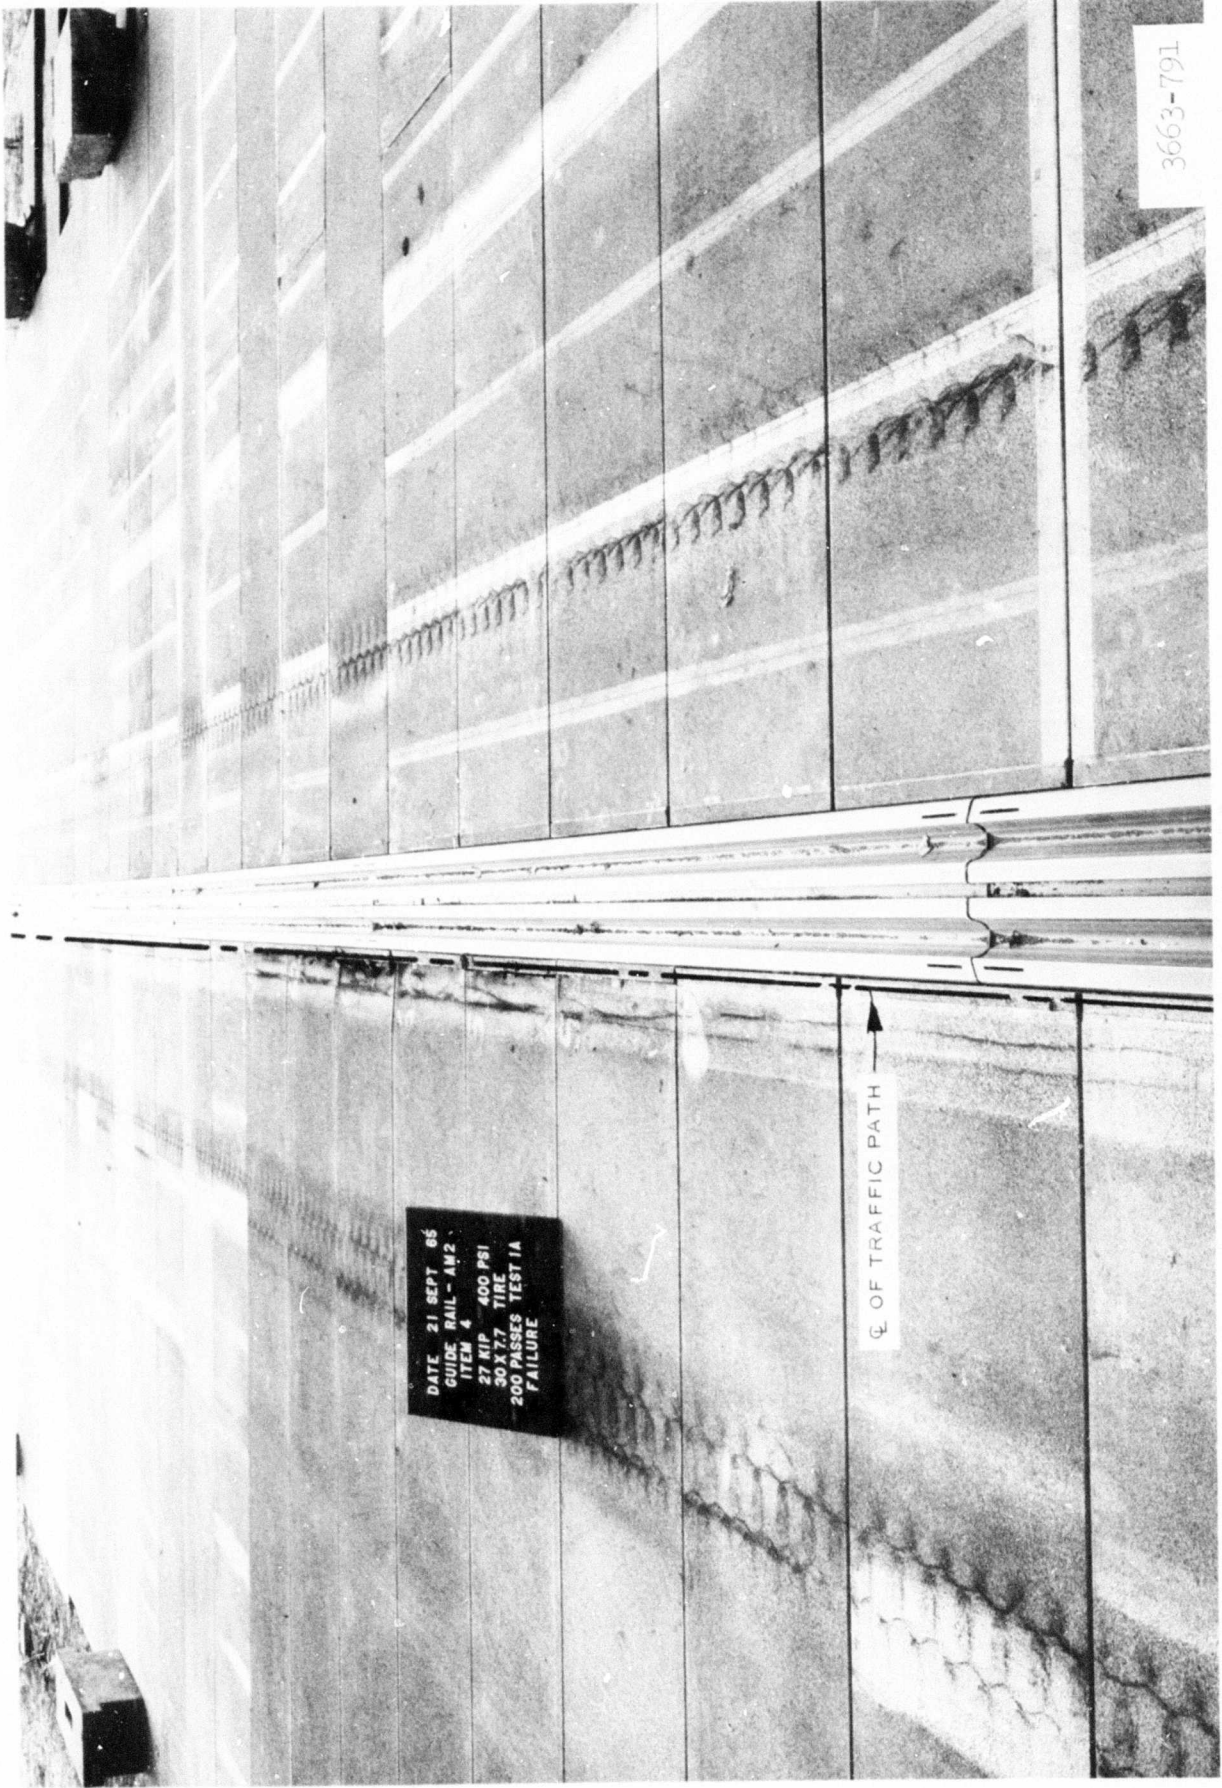
38. Visual observations. During the first few passes of the load wheel, cracks developed in end-joint welds in three of the six old AM2 planks without the modified end joints, and after 17 passes, these joints had completely separated. After 40 passes, all six of the old planks had failed. All other mat in the test lane was in good condition. After 200 passes, four of the Harvey modified AM2 planks in item 4 had failed because of weld failures at end joints. A general view of the failed end joints is shown in photograph 16. All other mat in the test lane was in satisfactory condition. The two Kaiser 4- by 4-ft planks of honeycomb mat in item 4 were still in good condition at the end of 200 passes; however, these planks were located at the extreme north end of item 4 and could not be subjected to further traffic without continuing traffic over the failed

AM2. The joint failures in the AM2 had created a hazard to the test load tire; therefore, no further traffic was applied on any of the mat in item 4.

Photograph 16. End-joint failures in test item 4

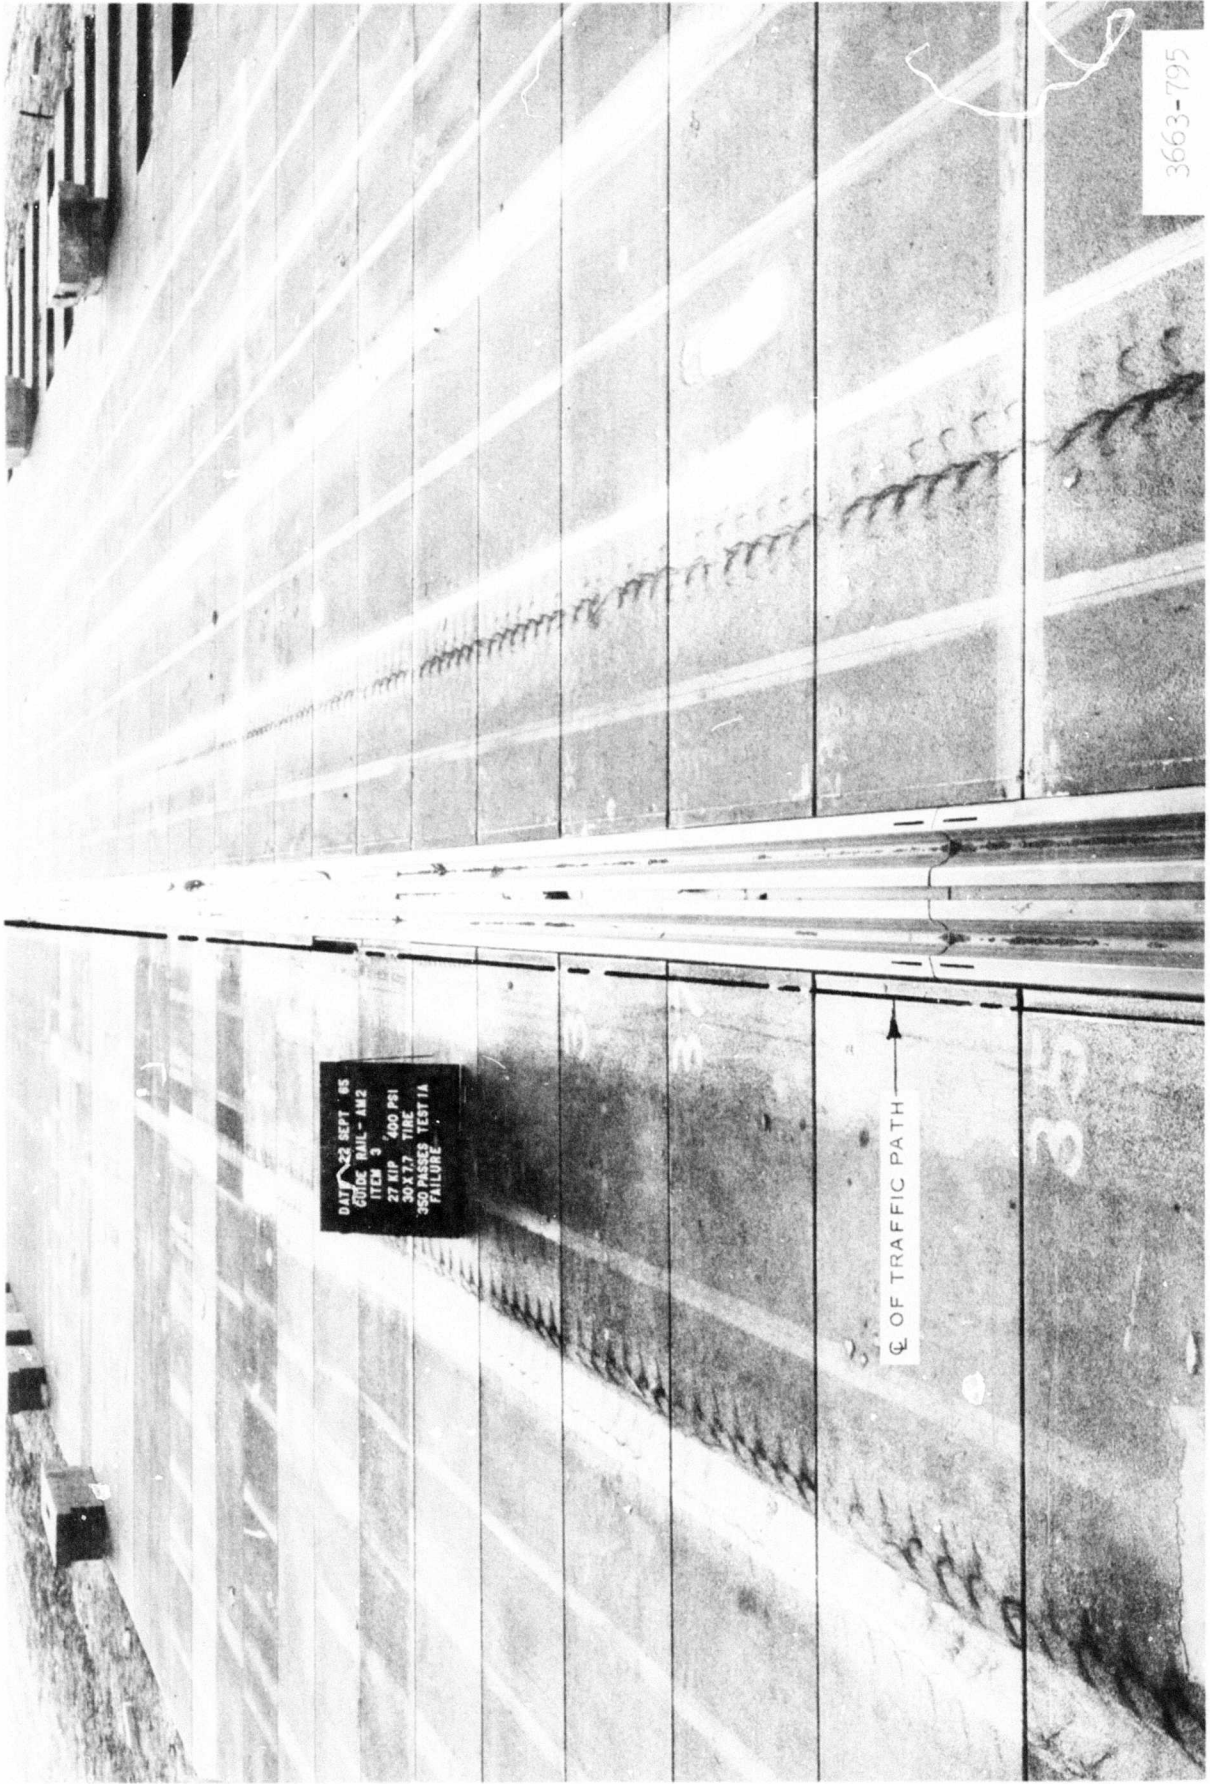
40. As traffic was continued, weld cracks began to develop in some planks of all test items. After 350 passes, the end joints had failed in eight planks in item 3 (photograph 18). At this point traffic was discontinued on this item. At this stage of traffic, only one joint failure had developed in item 1 and no failures had developed in item 2. After 800 passes, five end joints had failed in both items 1 and 2 with failure imminent in a number of other planks. Traffic was discontinued at this point. A view of items 1 and 2 at the end of traffic is shown in photographs 19 and 20, respectively. The traffic applied in the test lane resulted in no visual damage to the guide rail.

Photograph 18. Test item 3, lane 1-a, after 350 passes of load wheel

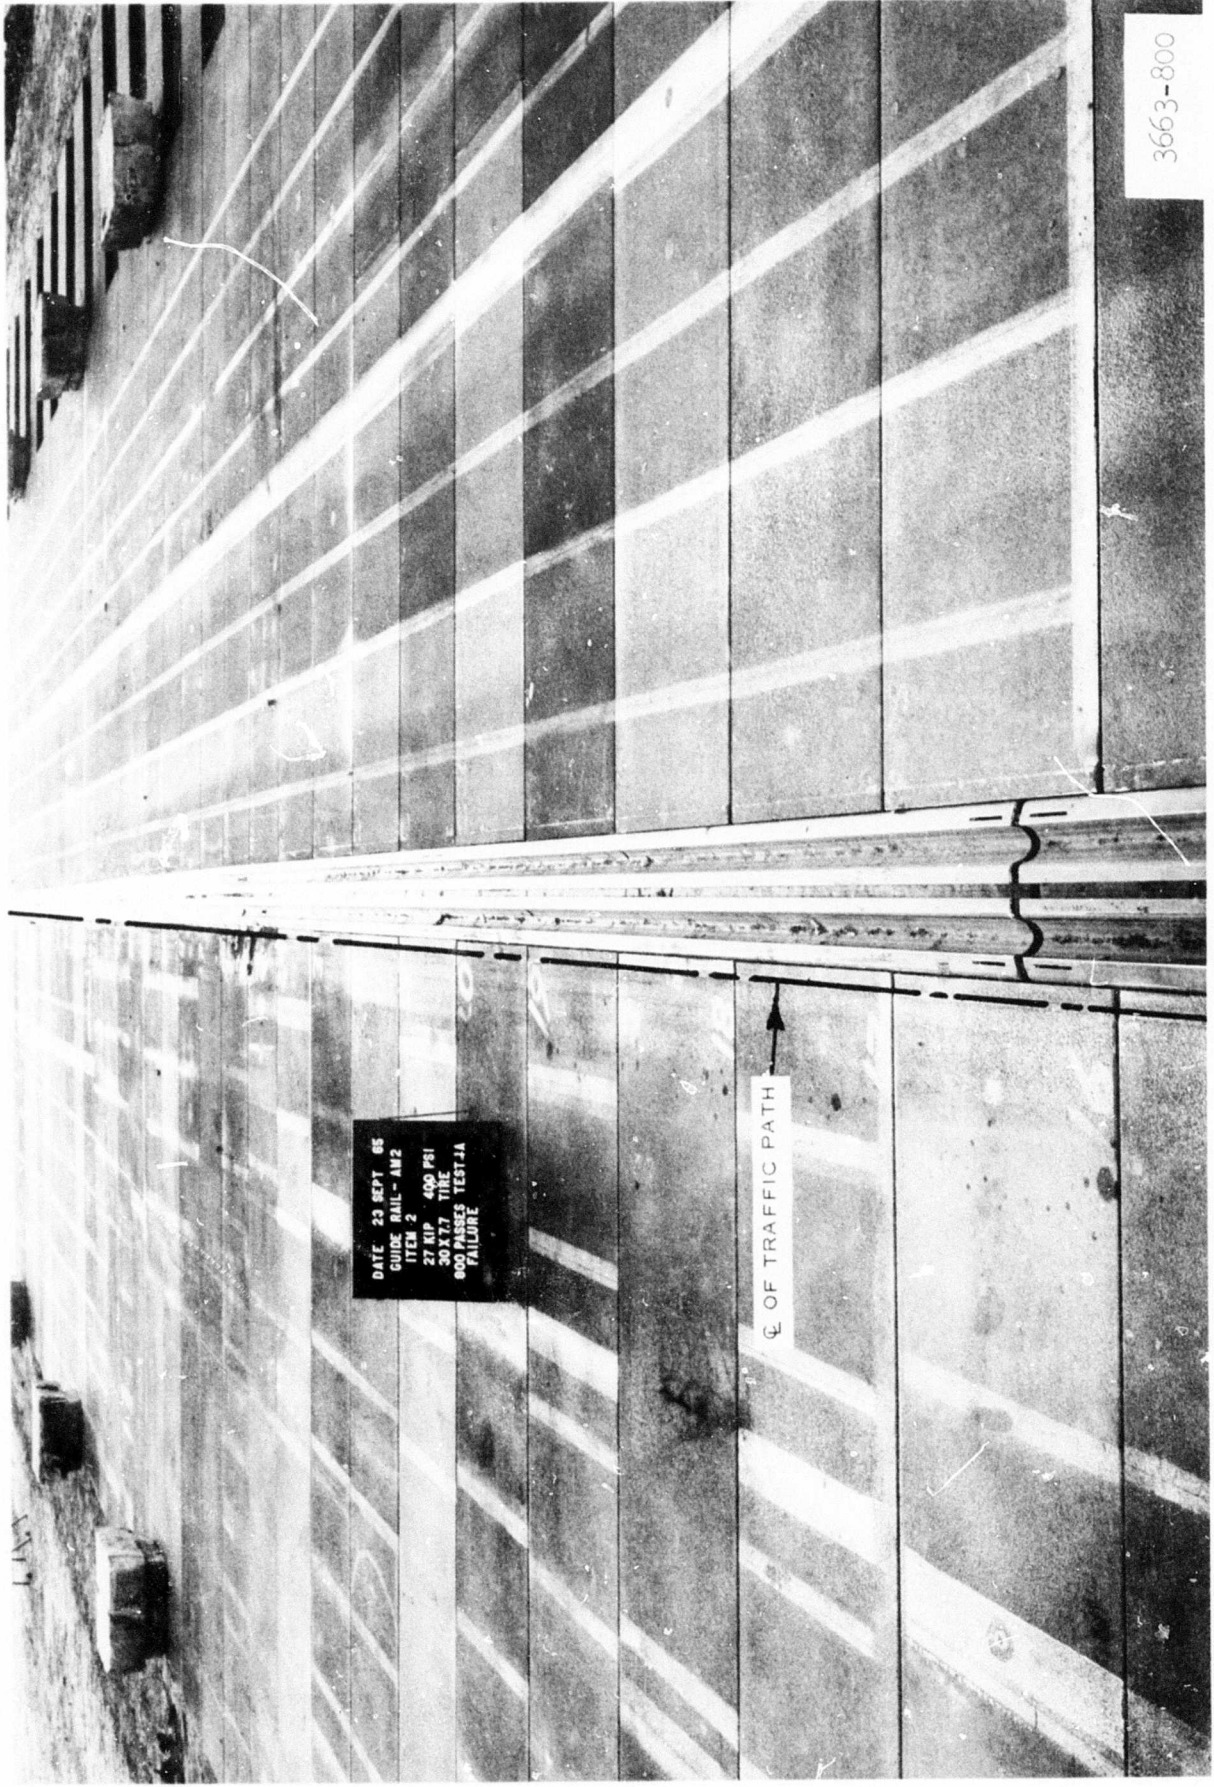
51. The only difference between lane 1 and 1-a was the type of mat used. As can be noted in table 2, mat failure developed in all items of lane 1-a within 800 passes of the load wheel. The failures in the Harvey modified AM2 were of the same type as that previously described for the Kaiser mat.

Photograph 20. Test item 2, lane 1-a, after 800 passes of load wheel

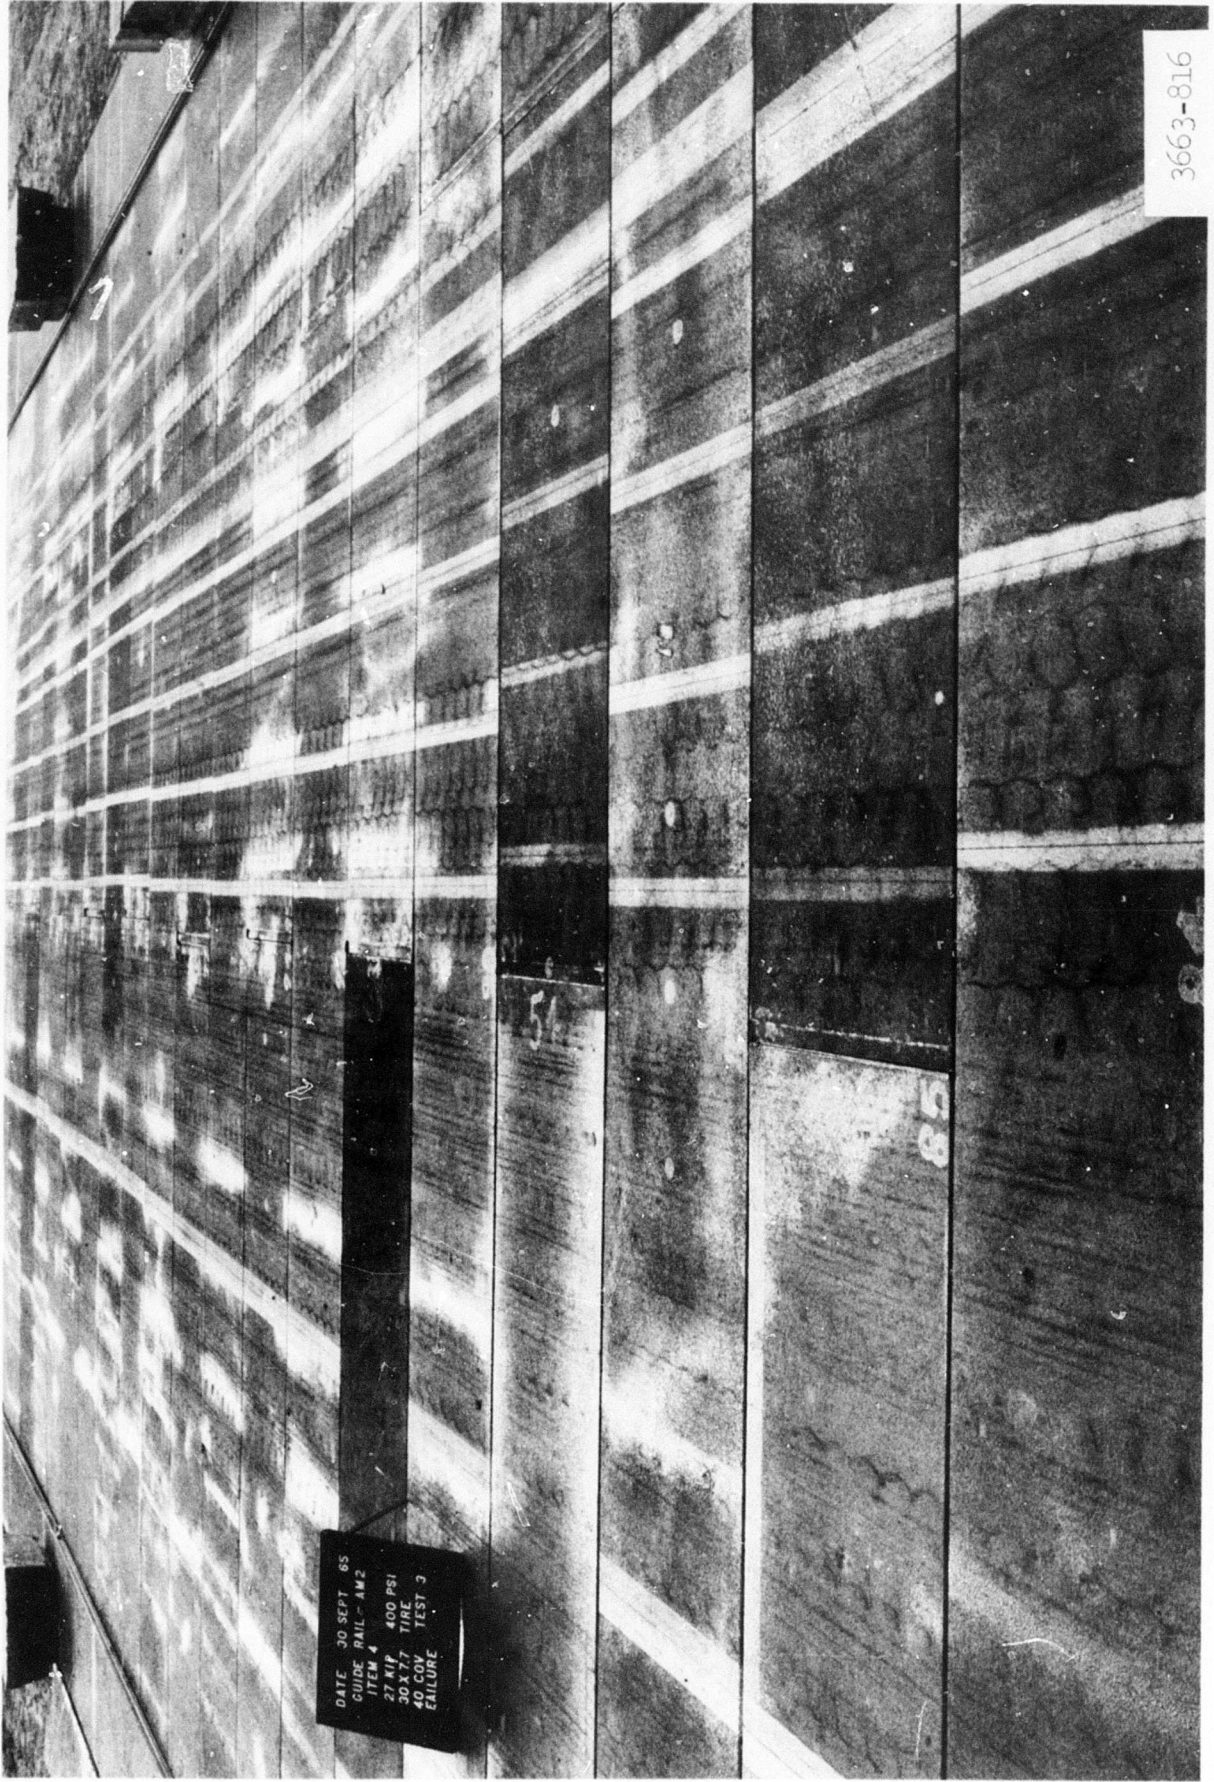
Photograph 22. Item 4, lane 3, after 40 coverages of load wheel

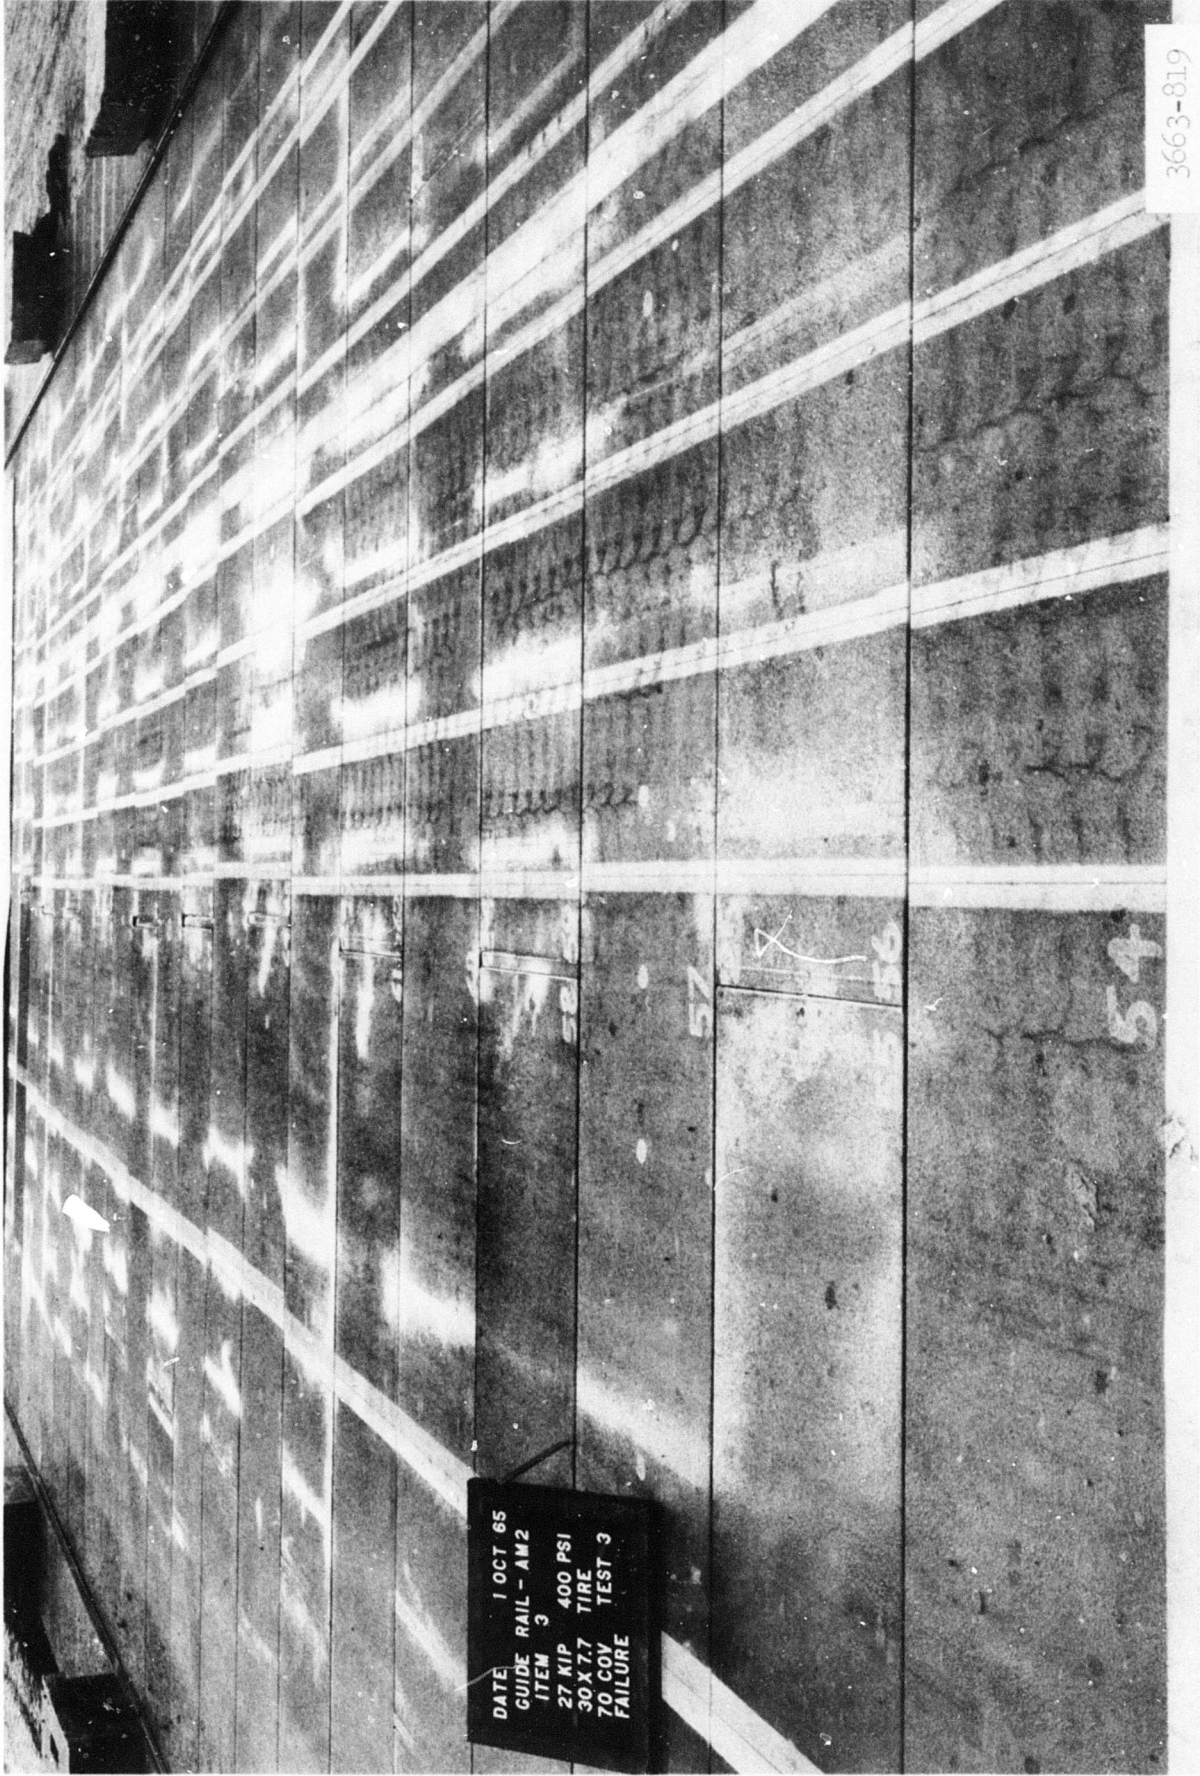
43. As traffic was continued on items 1, 2, and 3, similar end-joint weld failures developed in items 2 and 3, but at a more rapid rate in item 3. After 70 coverages, the end-joint welds on seven planks in item 3 had completely failed, and traffic on this item was discontinued. A general view of item 3 at the end of traffic is shown in photograph 23. Traffic was continued on items 1 and 2 to a total of 188 coverages, at which point nine end-joint weld failures had developed in item 2, but no failures or weld cracks had developed in any of the mat planks in item 1.

Photograph 23. Item 3, lane 3, after 70 coverages of load wheel
