# EVALUATION OF THREE-PIECE AM2 ALUMINUM LANDING MAT

W. N. Brabston

April 1967

U. S. Army Engineer Waterways Experiment Station  
CORPS OF ENGINEERS  
Vicksburg, Mississippi

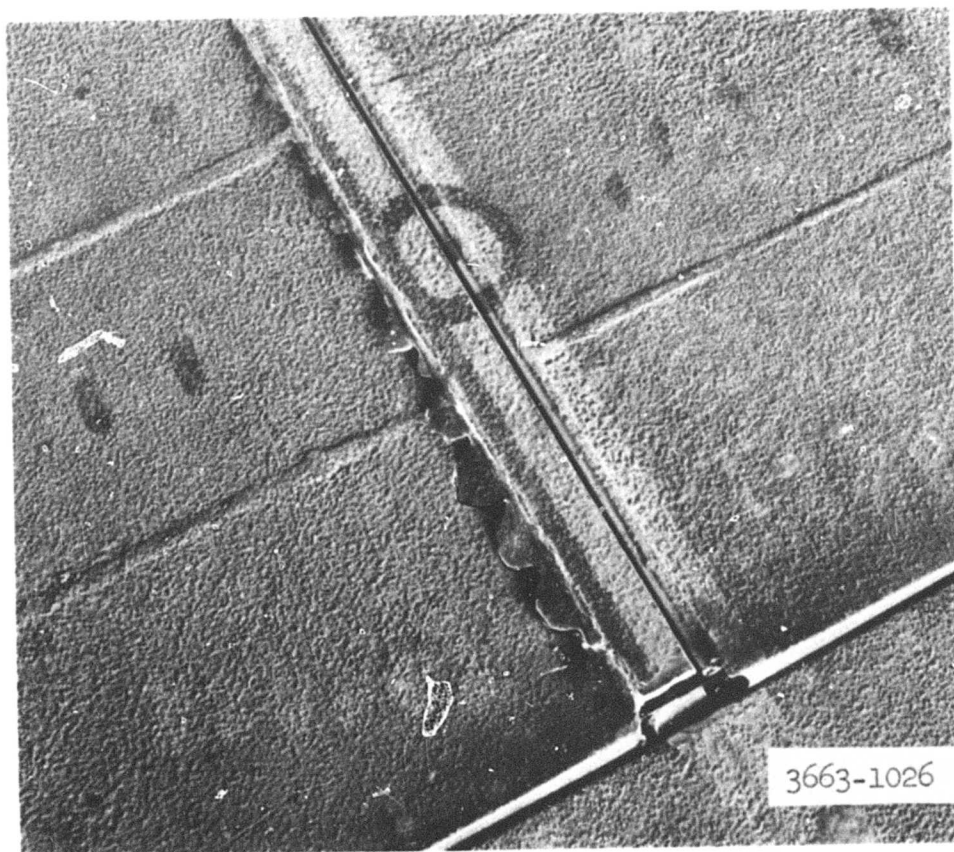
Photograph 3.  
End-connector  
weld failure  
on underside  
of mat re-  
sulting in  
top skin tear,  
item 1, lane 1

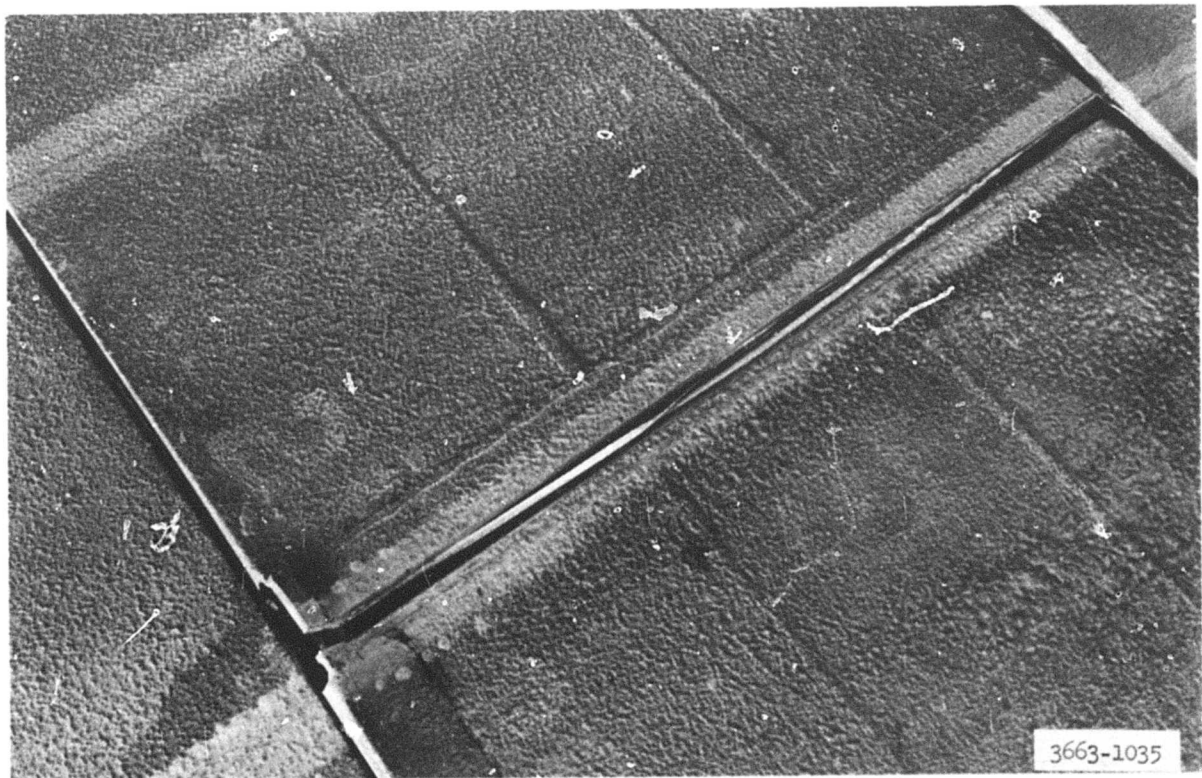
Photograph 7. Failure of top lip of underlapping end connector,  
item 1, lane 1

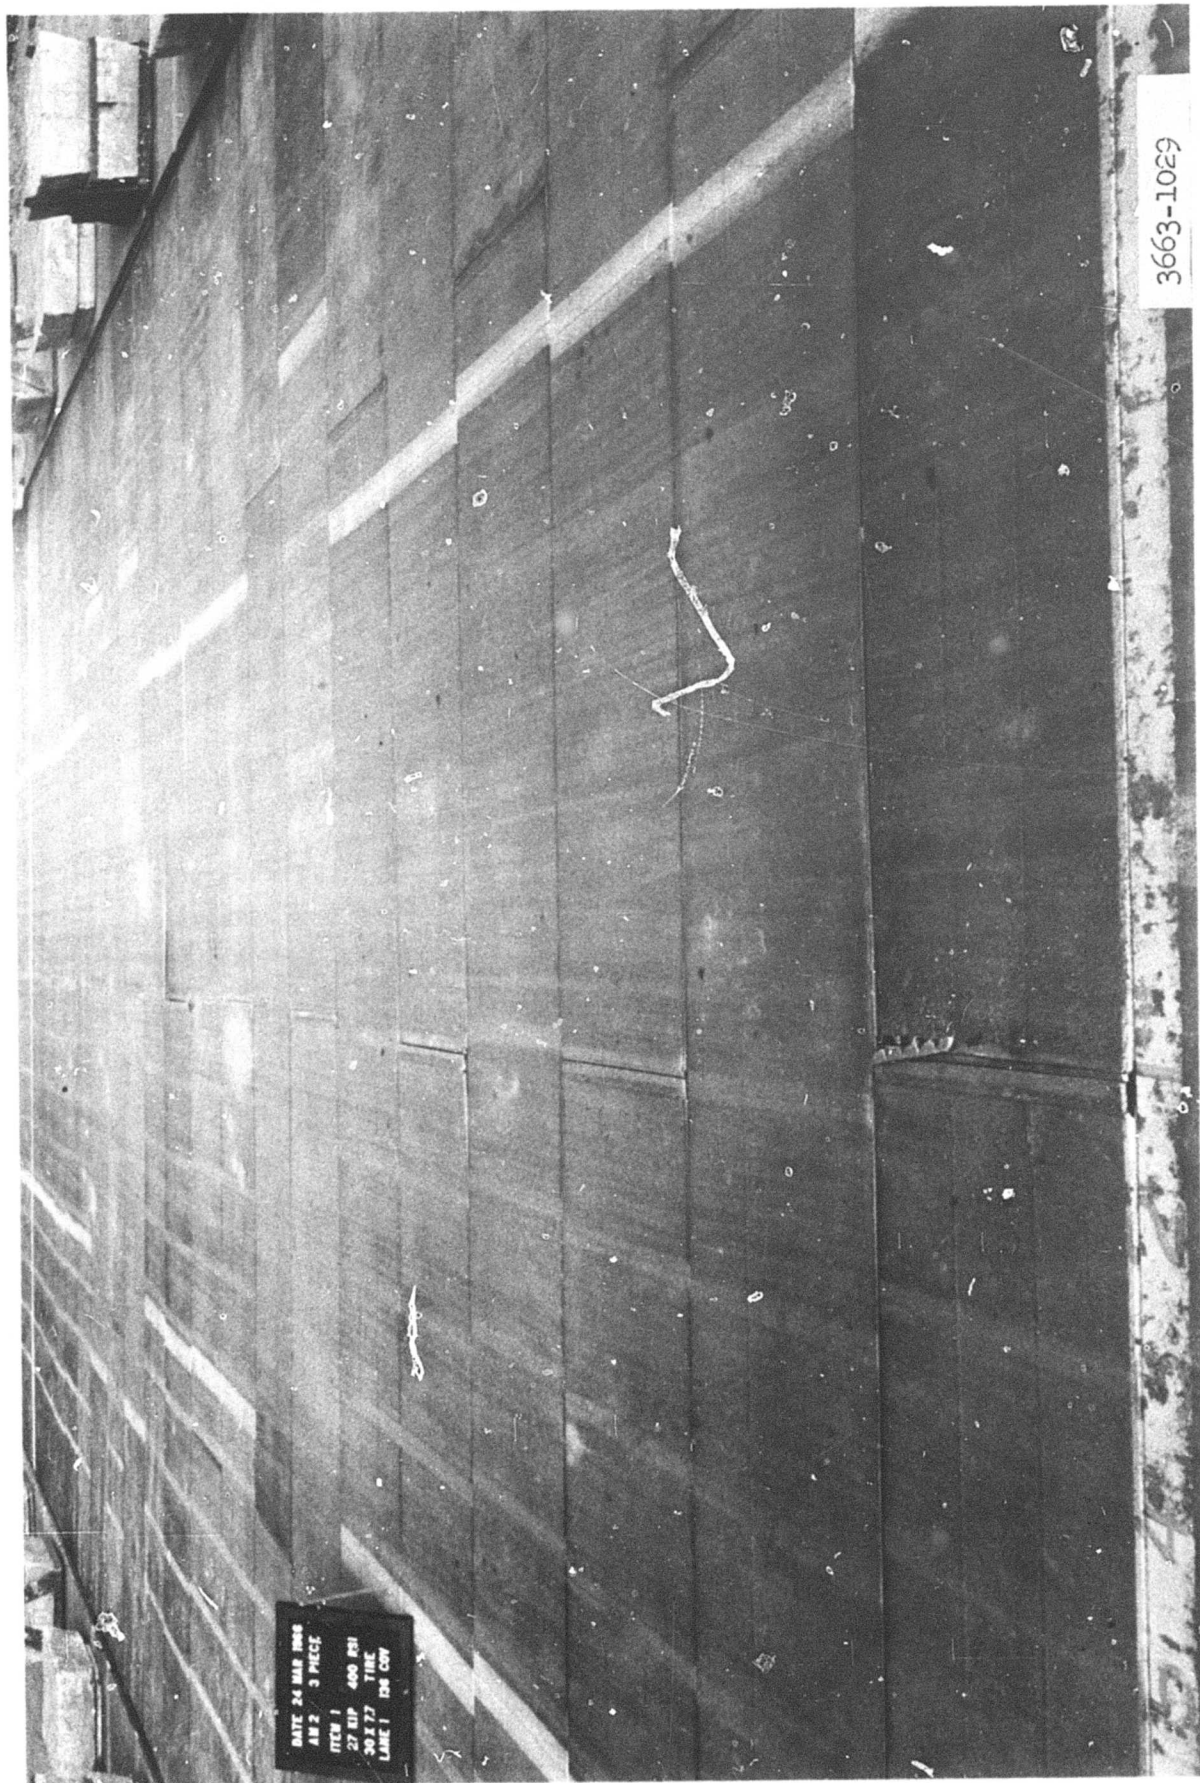
Photograph 8. Item 1, lane 1, at 136 coverages (failure)

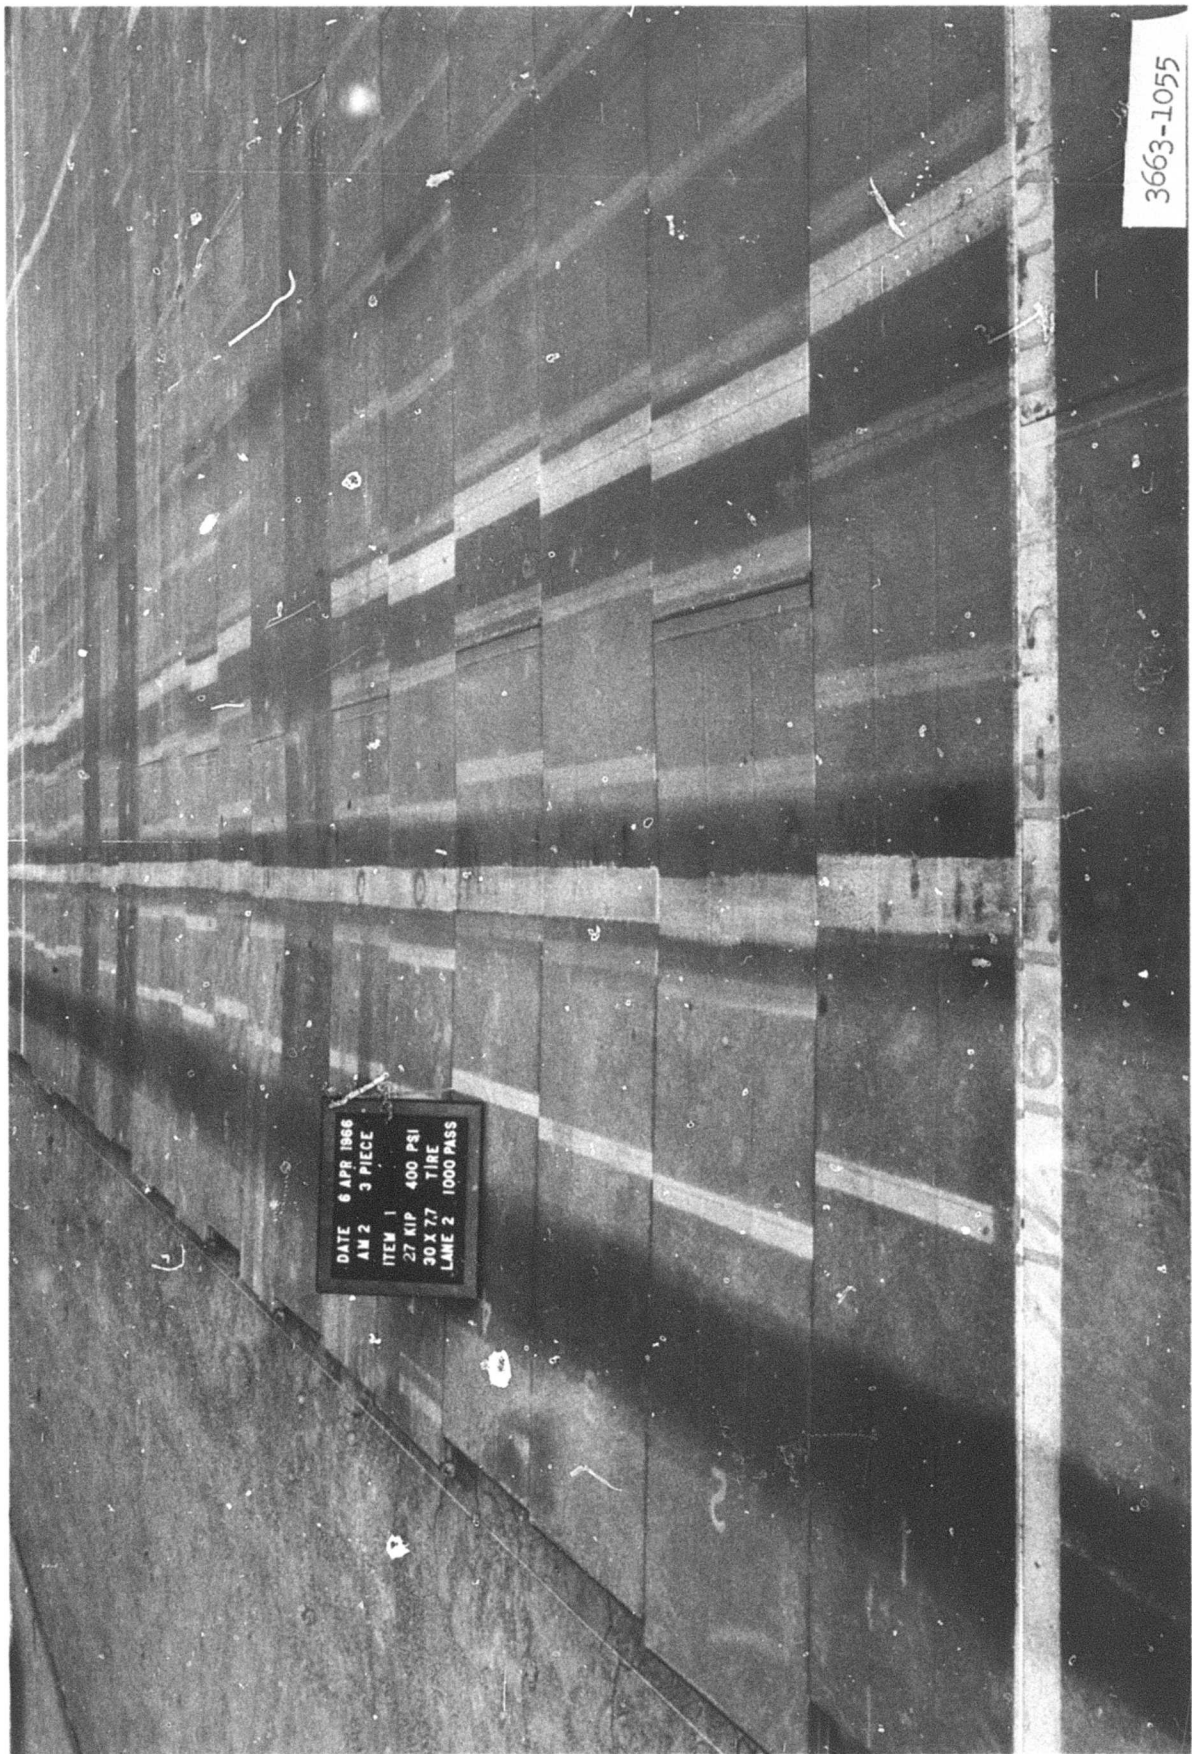
shifting of the planks during trafficking (photograph 20). At 1222 passes, planks 19 and 37 failed from breakage in the core of the extrusion on the south side of the plank and subsequent tearing of the aluminum skin near the longitudinal weld. After 1320 passes, planks 5, 9, 25, and 33 failed from core breakage and subsequent skin tear. Dishing in the failed extrusions of the four planks averaged  $3/8$  in. in depth, and the skin breaks averaged about 5 in. in length. All failed extrusions were on the south side of the plank. This brought to six the number of planks failed in item 1, and the item was considered failed (photograph 21). In addition to the failed planks, there were six planks with areas of apparent core damage (severe dishing), three of which had longitudinal weld cracks. Upon removal of the mat at the end of traffic, longitudinal weld cracks were found on the underside of eight planks. Most of the breaks on the underside of the planks occurred in areas directly below a failed or damaged core.

Photograph 20. Item 1, lane 2, after 1000 passes

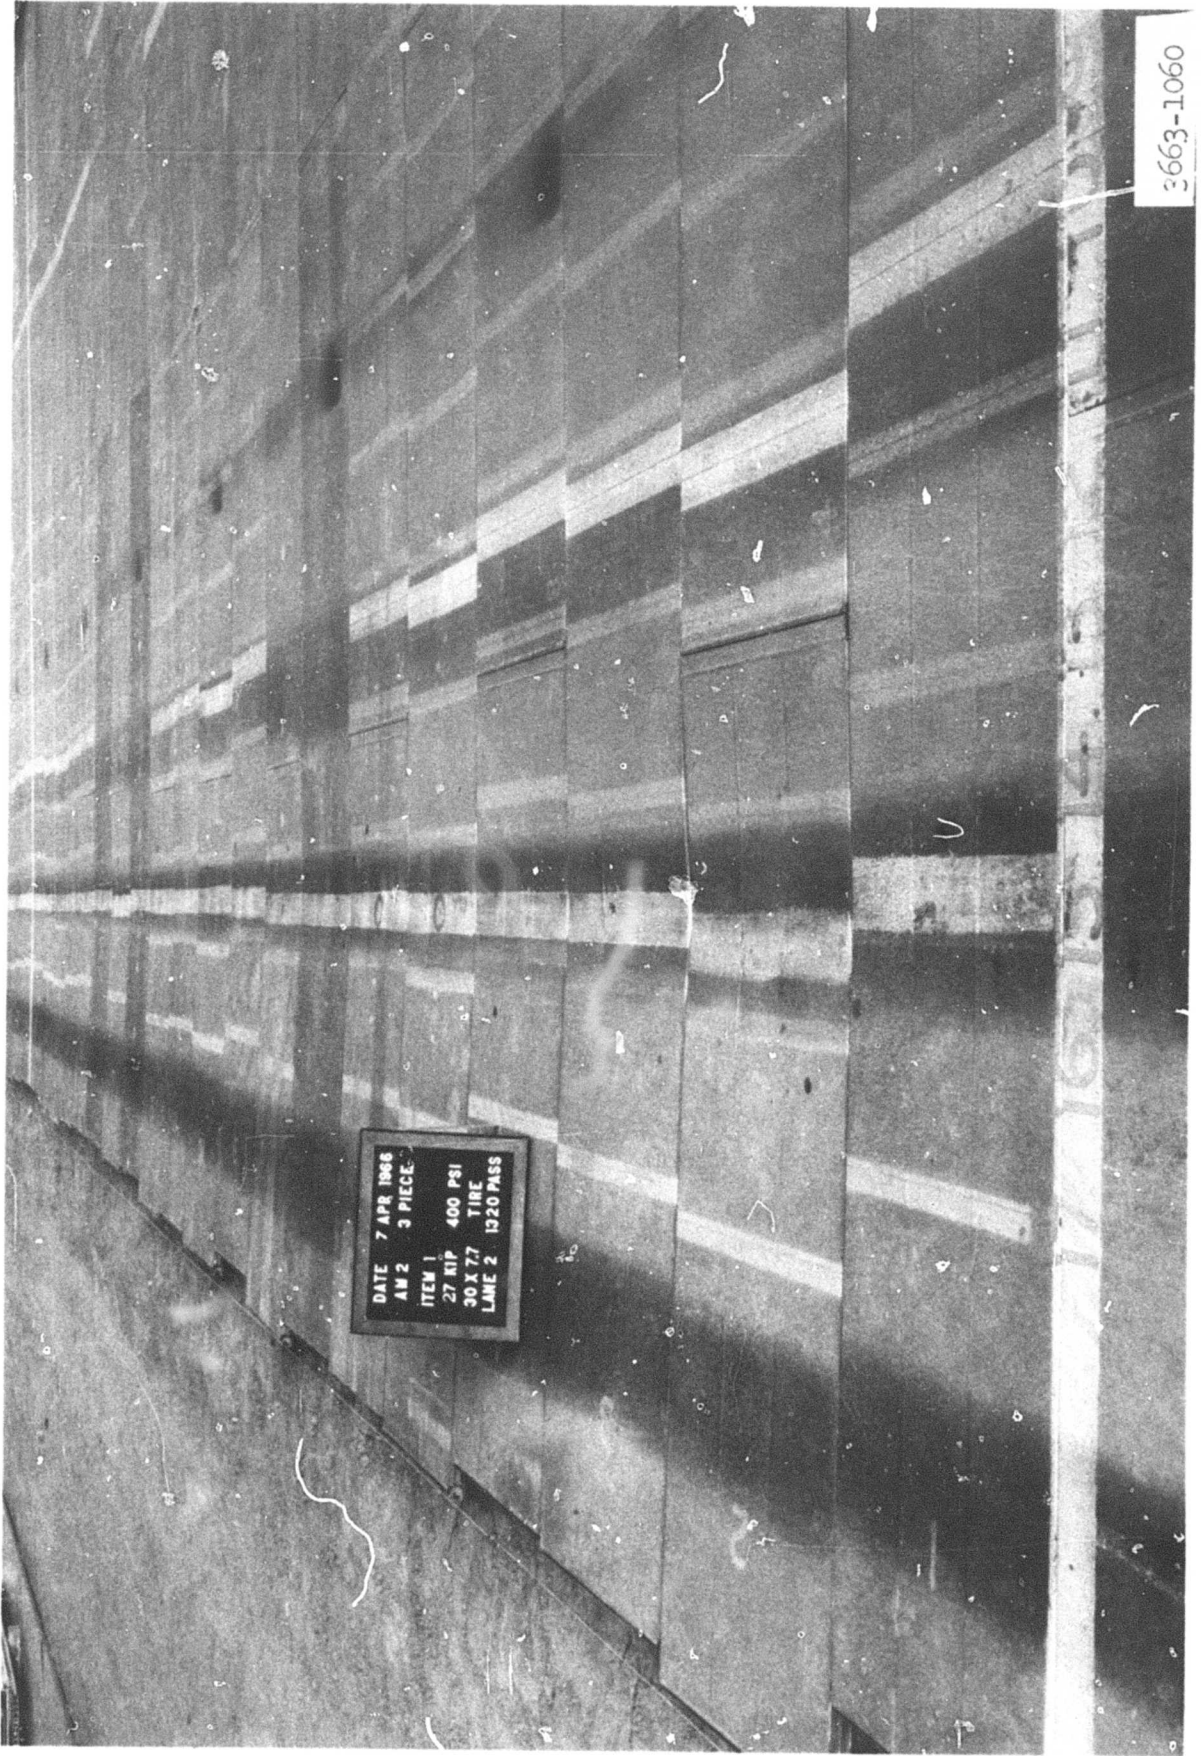
42. Item 1 failed at 1320 passes with six planks failed and six additional areas of apparent core damage. In item 2, there were 16 areas of apparent core damage when traffic was stopped at 1600 passes. Core damage varied from slight to severe, with almost half of the breaks incipient failures. Since the overall condition of the item was rated poor when traffic was stopped, item 2 was considered to have failed at 1600 passes for purposes of analysis. No damage was observed in item 3, and there was one core break in item 4 when traffic was stopped at the end of 1600 passes.

Photograph 21. Item 1, lane 2, after 1320 passes (failure)

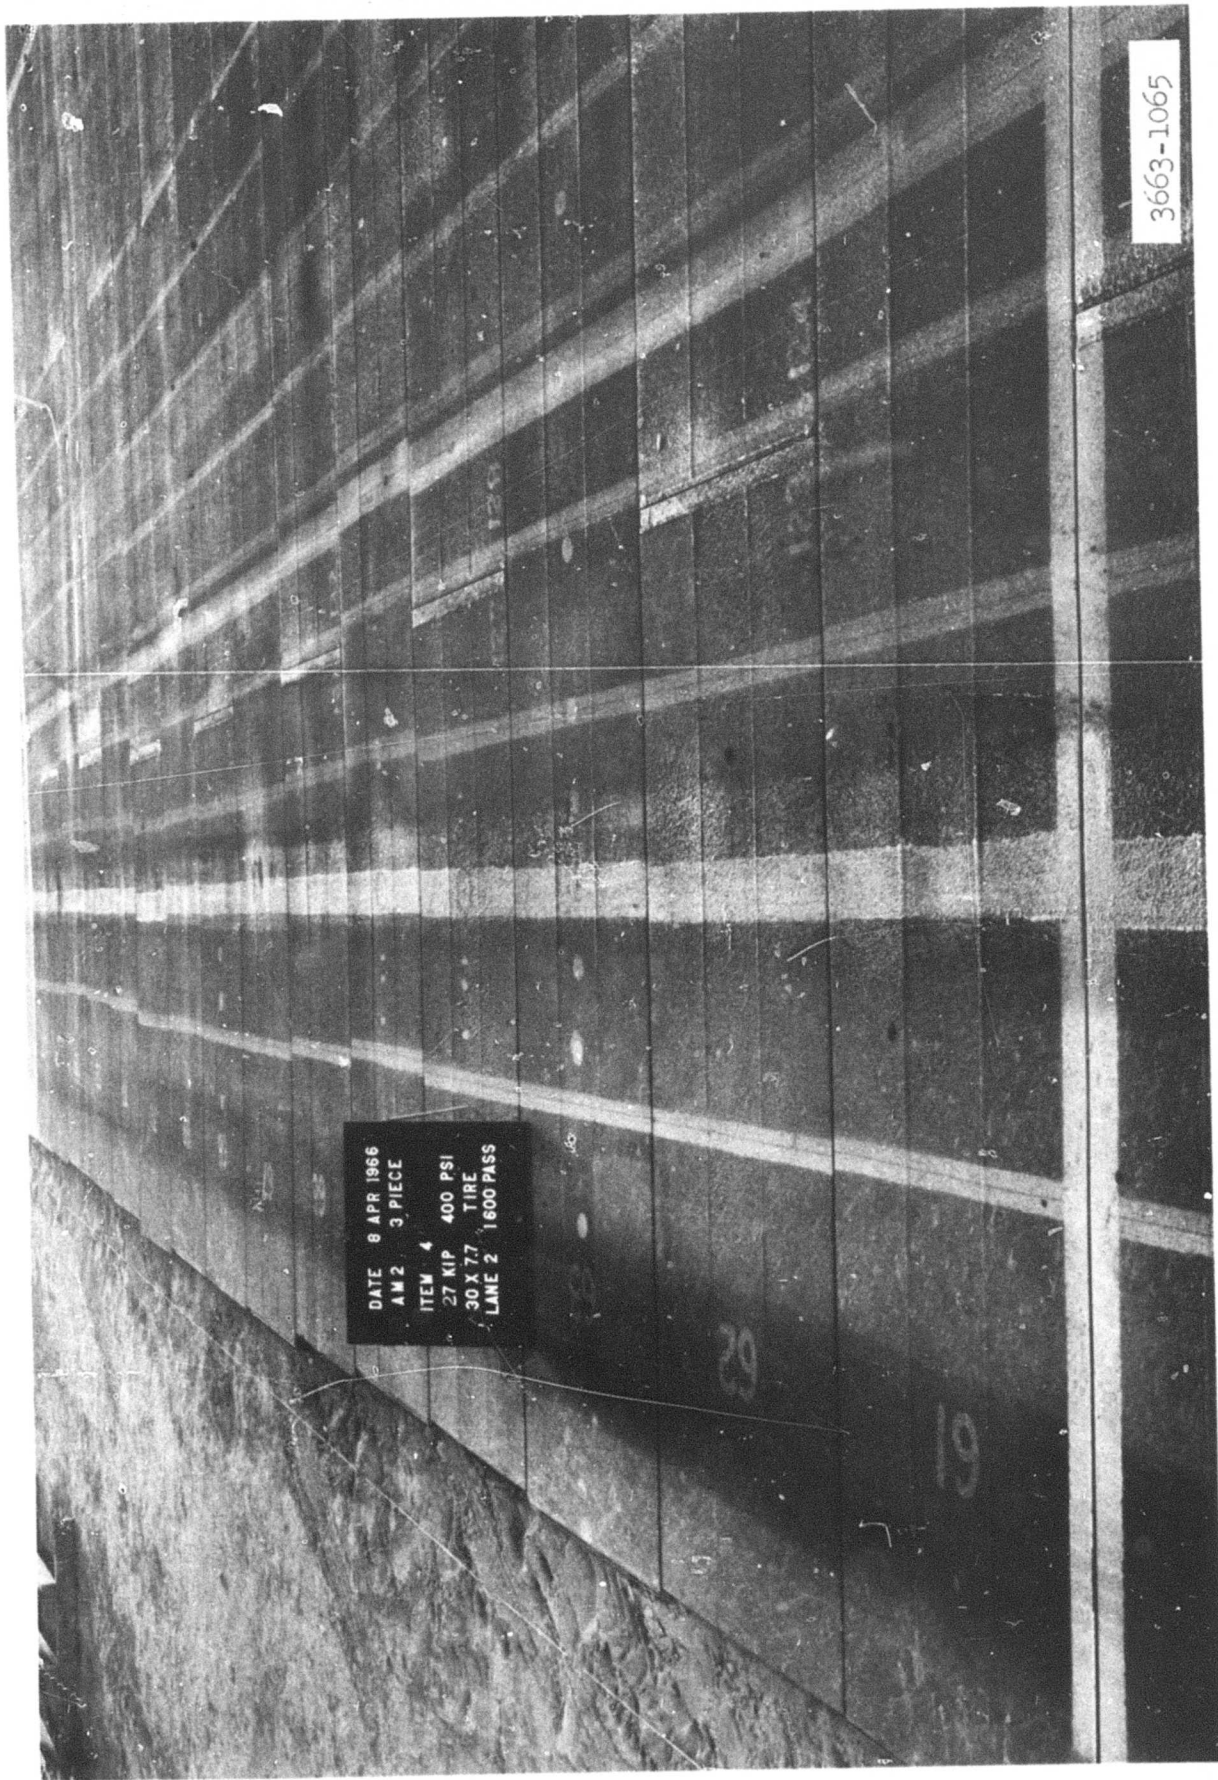
31. Item 4. Item 4 withstood 1600 passes of traffic with only one area of apparent core damage and no exterior mat breakage. When traffic was stopped, plank 147 had a  $1/4$ -in.-deep dish in the extrusion on the north side of the plank. Views of item 4 before and after traffic are shown in photographs 27 and 28, respectively.

Photograph 28. Item 4, lane 2, after 1600 passes

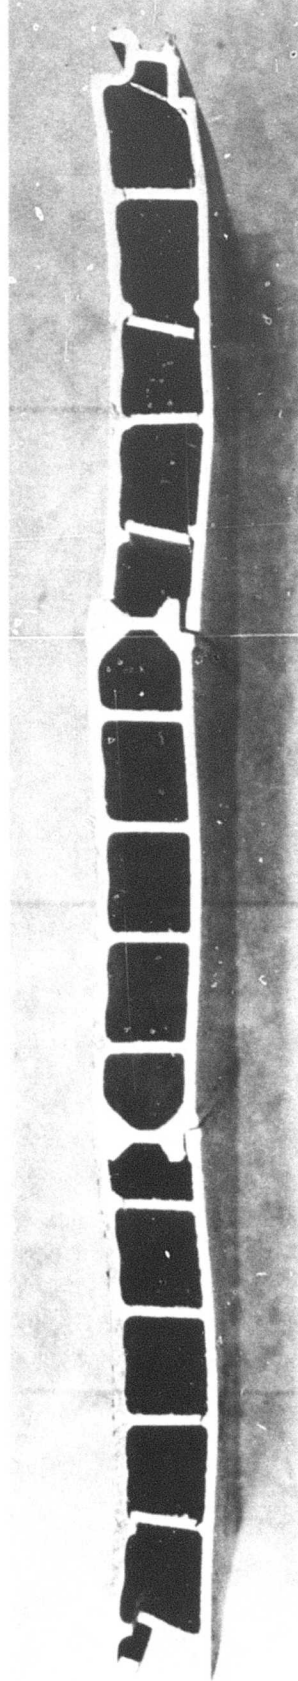
43. All mat breakage was the result of initial core failure in one or more of the individual extrusions making up a plank, particularly the extrusions with the side connectors (photograph 30). The six core failures in item 1 occurred in extrusions on the south side of the plank, which were the extrusions with the male side connectors. Of the 29 areas of apparent core damage in the test lane, 16 occurred in extrusions having the male side connector, 7 were located in extrusions having the female side connector, and 6 occurred in the center extrusions. Of the planks that were considered failed during the test, the metal skin on top of each plank generally failed before the adjacent longitudinal weld (photograph 23). In item 1, there were six skin tears at failure versus three longitudinal weld cracks on top of the mat. However, longitudinal weld cracks were found on the bottom of eight planks when the mat was removed at the end of traffic. There was no indication of the period during which these cracks occurred. Since the single-path traffic lane was 2 ft from the closest line of end joints, obviously no end connectors were located in the traffic lane and, therefore, no end-connector failures occurred.

Photograph 30. Cut section of mat from single-line traffic lane showing core damage
