MISCELLANEOUS PAPER NO. 4-852

# EVALUATION OF HARVEY TWO-PIECE LANDING MAT (AM2)

November 1966

U. S. Army Engineer Waterways Experiment Station  
CORPS OF ENGINEERS  
Vicksburg, Mississippi

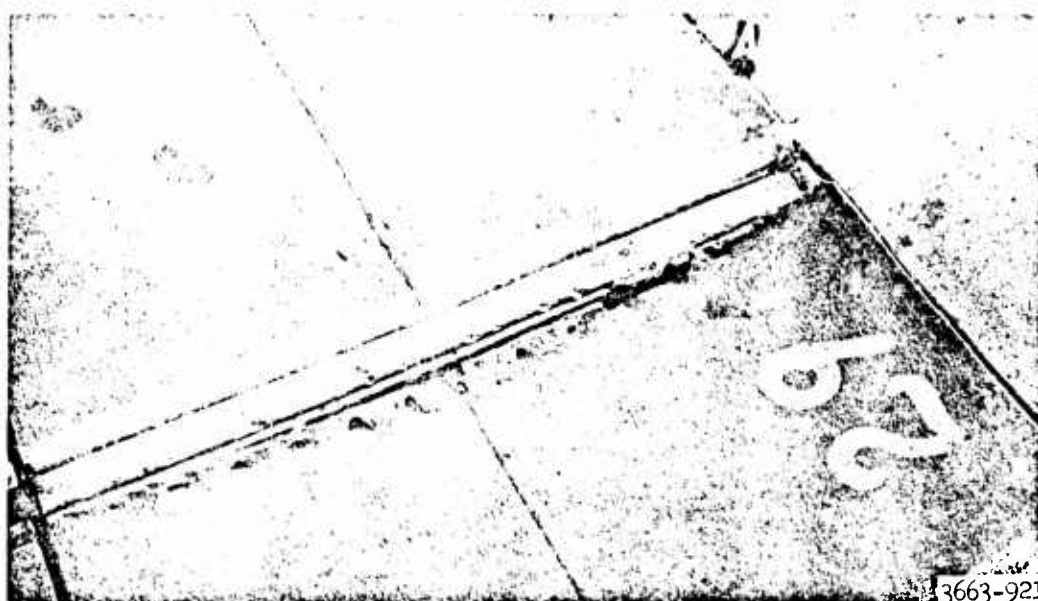
21. Visual observations. A general view of the test lane prior to traffic is shown in photograph 1. The first defect to show up in the mat was a hairline crack in the weld of an underlapping end connector strip on one plank in test item 3. This crack was noted after two coverages. After 14 coverages, several small weld cracks were noted at the corner of the end connector strips on several planks in test item 1. These

cracks developed quite rapidly as traffic continued, and by the end of 40 coverages, the end joints on three planks in test item 1 had completely failed. A close-up of a joint failure on plank 29 is shown in fig. 3. A general view of test item 1 after 40 coverages is shown in photograph 2.

Fig. 3. Typical end-joint failure

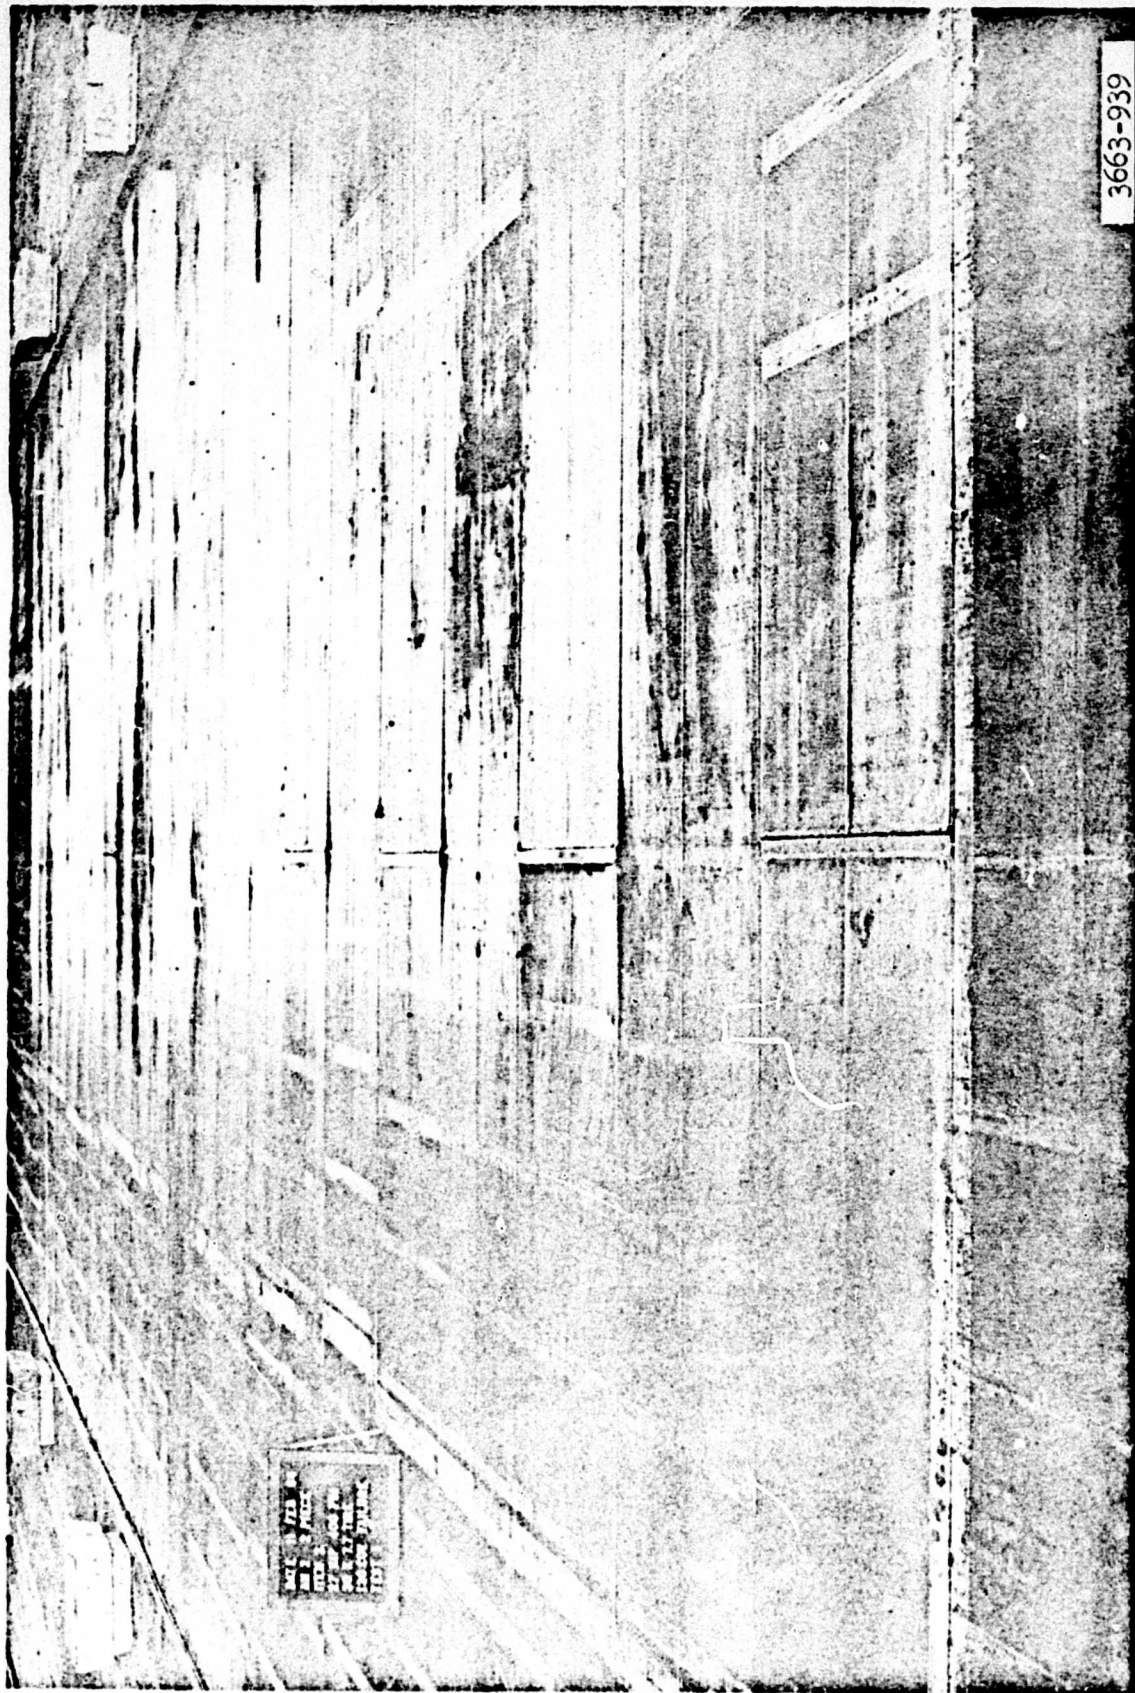
view of test item 2 at the end of 130 coverages is shown in photograph 4. All of the failures in item 2 were of the same type; the weld between the end connector strip and the body of the plank failed, allowing the end connector to separate from the plank.

Photograph 4. Lane 1, item 2, at failure after 130 coverages

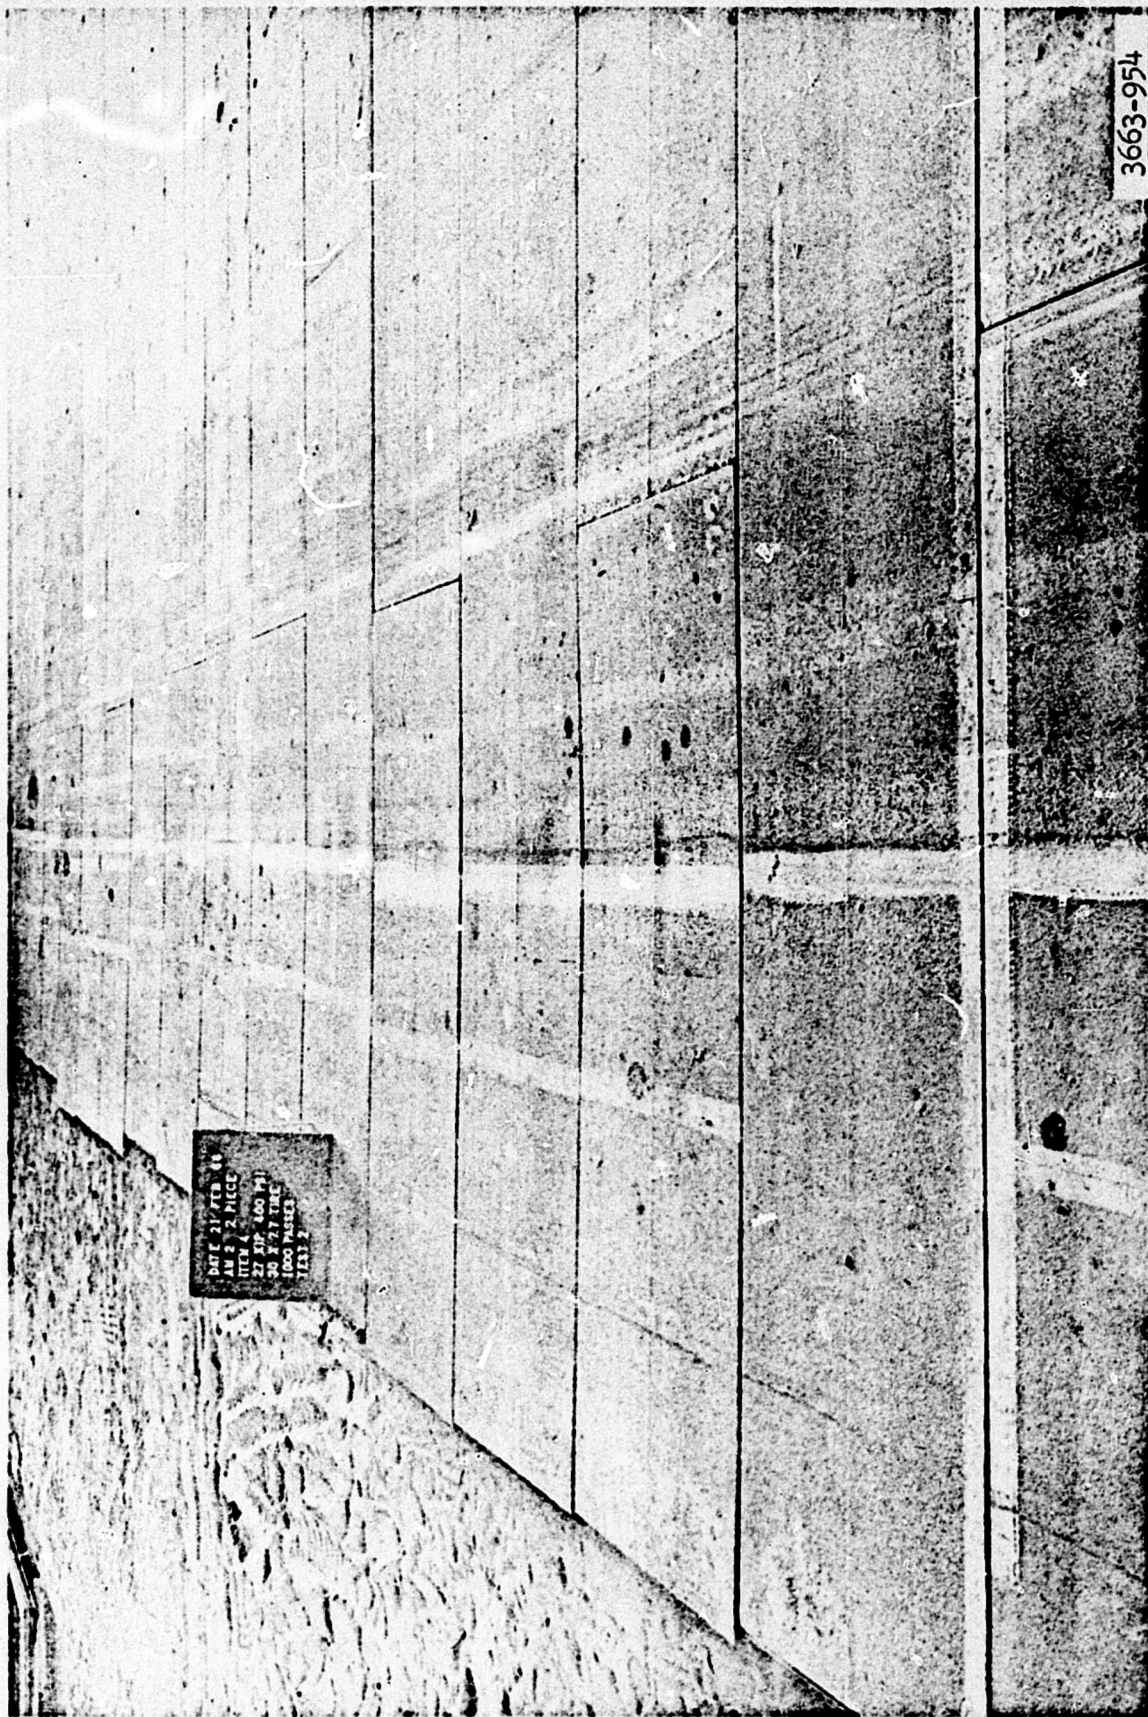
Photograph 13. Lane 2, item 4, after 1000 passes

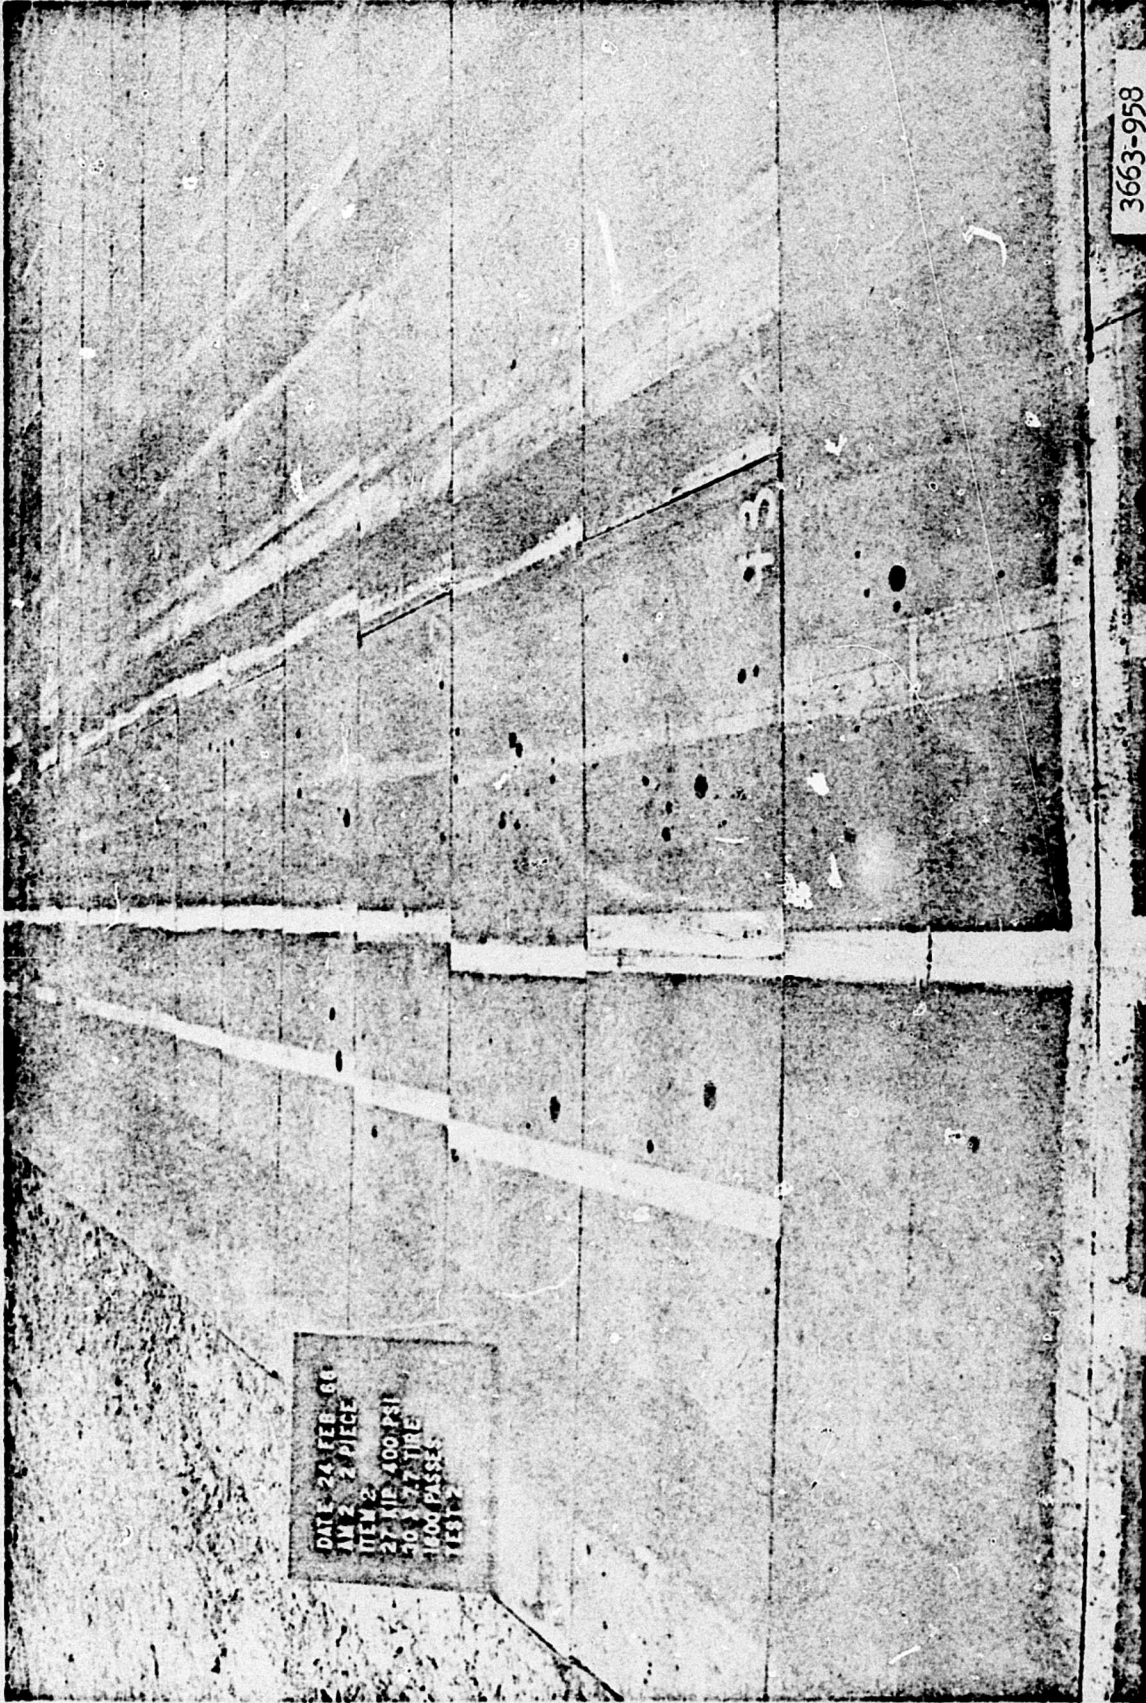
Photograph 14. Lane 2, item 2, at failure after 1600 passes
