Technical Note N-1217

AIRFIELD PAVEMENT CONDITION SURVEY,  
USNLF MONTEREY, CALIFORNIA

January 1972

NAVAL CIVIL ENGINEERING LABORATORY  
Port Hueneme, California 93043

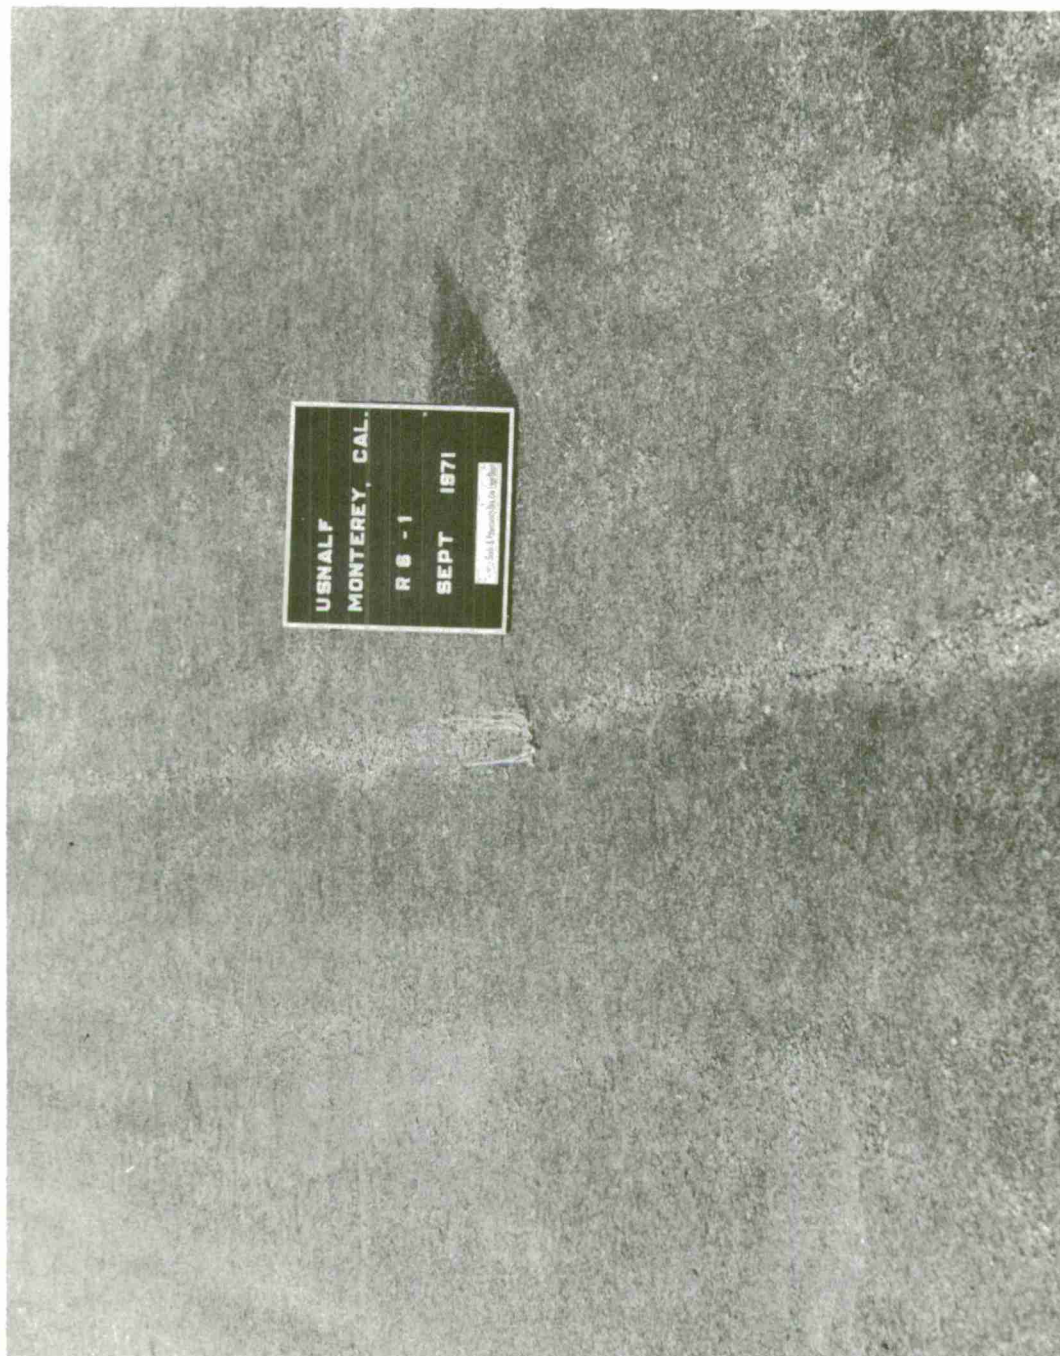
Figure 5. Longitudinal construction joint crack, Discrete Area R6-1.

| Defect Type | Length or Area of Sampled Defects | Total Length or Area of All Defects: (c) x Ratio | Defect Density (per 10 sq. ft.) 10 d/a | Defect Severity Weight | Weighted Defect Density: (e) x (f) |
|---|---|---|---|---|---|
| Cracks, primarily on construction joints, were 1/8" wide, unsealed and had vegetation growing through them. Pattern cracking was of dendritic type with 2' to 4' branches and unsealed. The surface was rough with evidence of loss of fines, and approximately 25 percent of the aggregate on the surface was stripped of bitumen (see Figures 5 and 6). | | | | | |

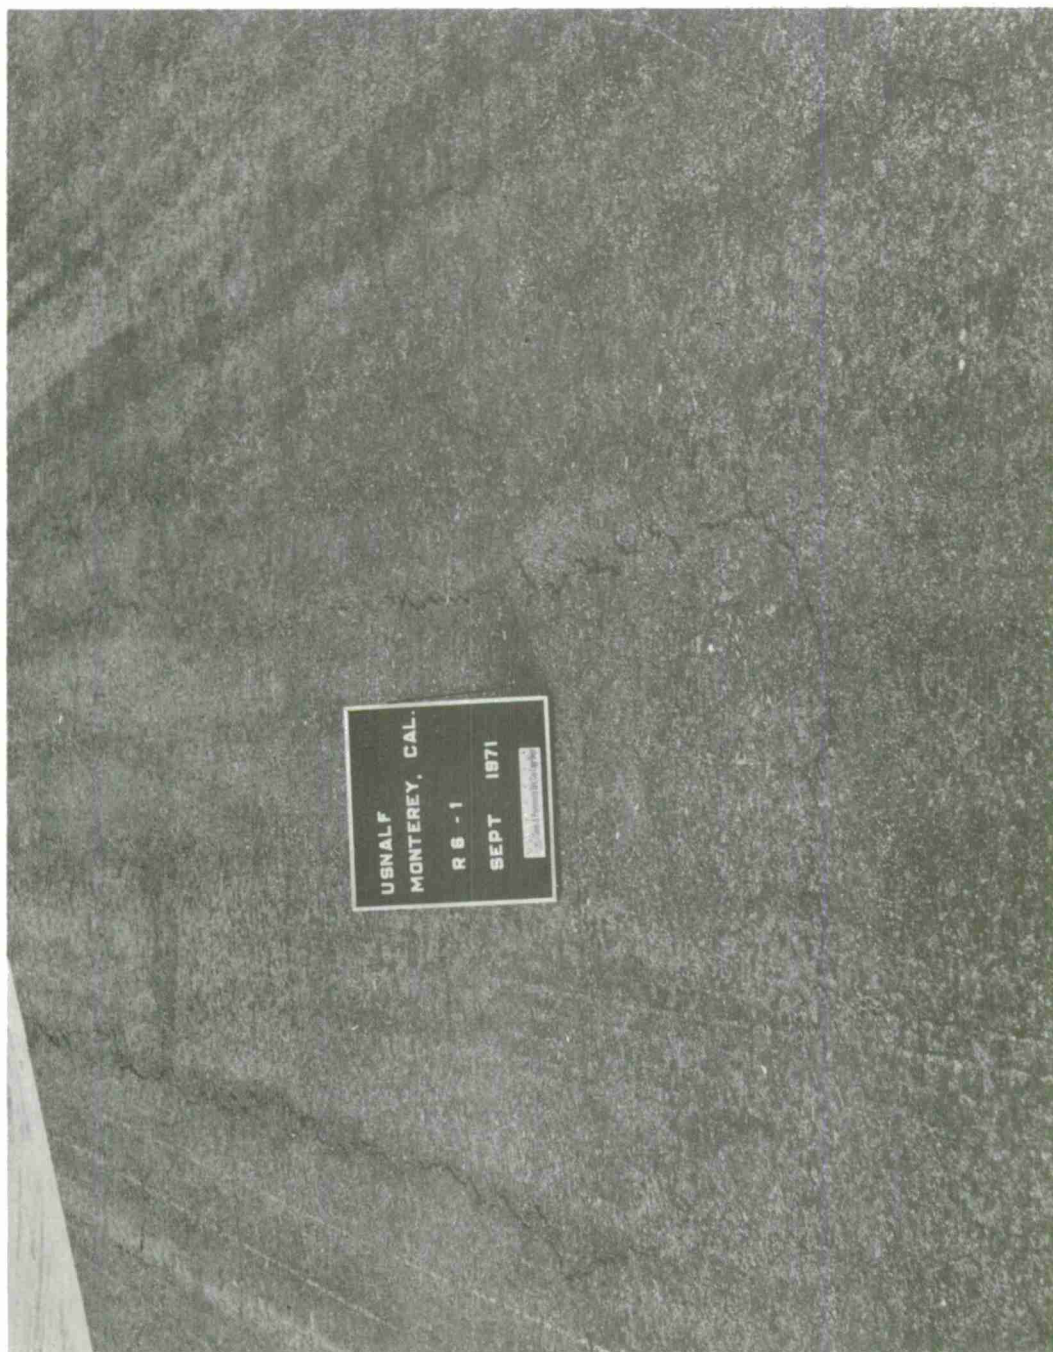
Figure 6. Pattern cracking, Discrete Area R6-1.

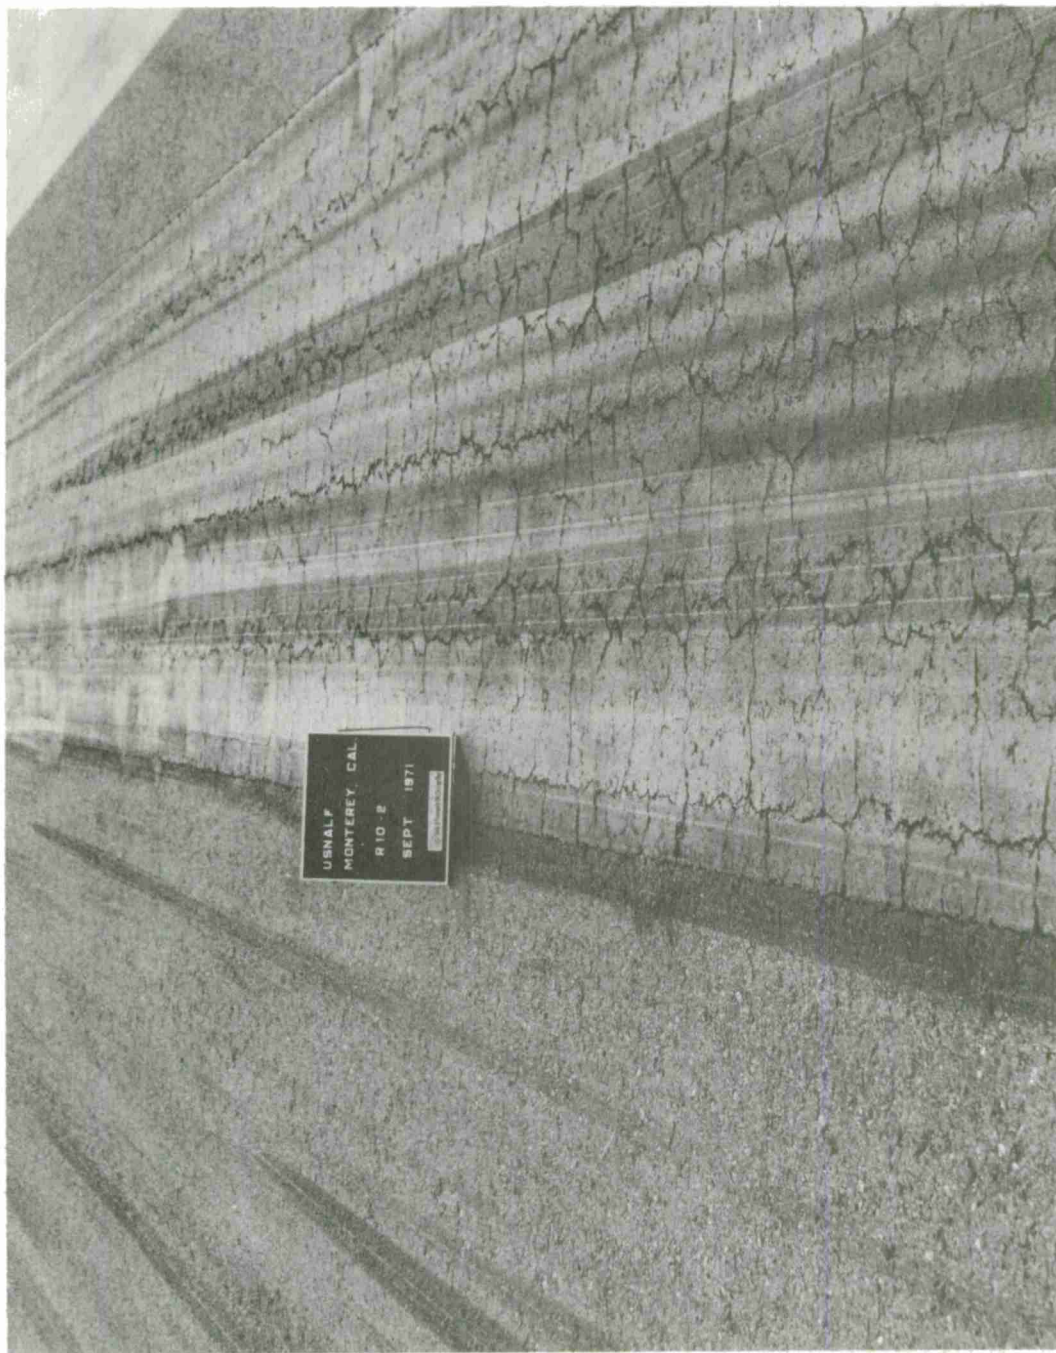
Figure 8. Pattern cracking under paint stripe, Discrete Area R10-2.

| Defect Type | Length or Area of Sampled Defects | Total Length or Area of All Defects: (c) x Ratio | Defect Density (per 10 sq. ft.) 10 d/a | Defect Severity Weight | Weighted Defect Density: (e) x (f) |
|---|---|---|---|---|---|
| <p>Remarks on Pavement Condition</p> <p>Pattern cracking occurred under a painted stripe which had been covered with asphalt seal. Otherwise surface appearance was good with very little stripping (see Figure 8).</p> | | | | | |

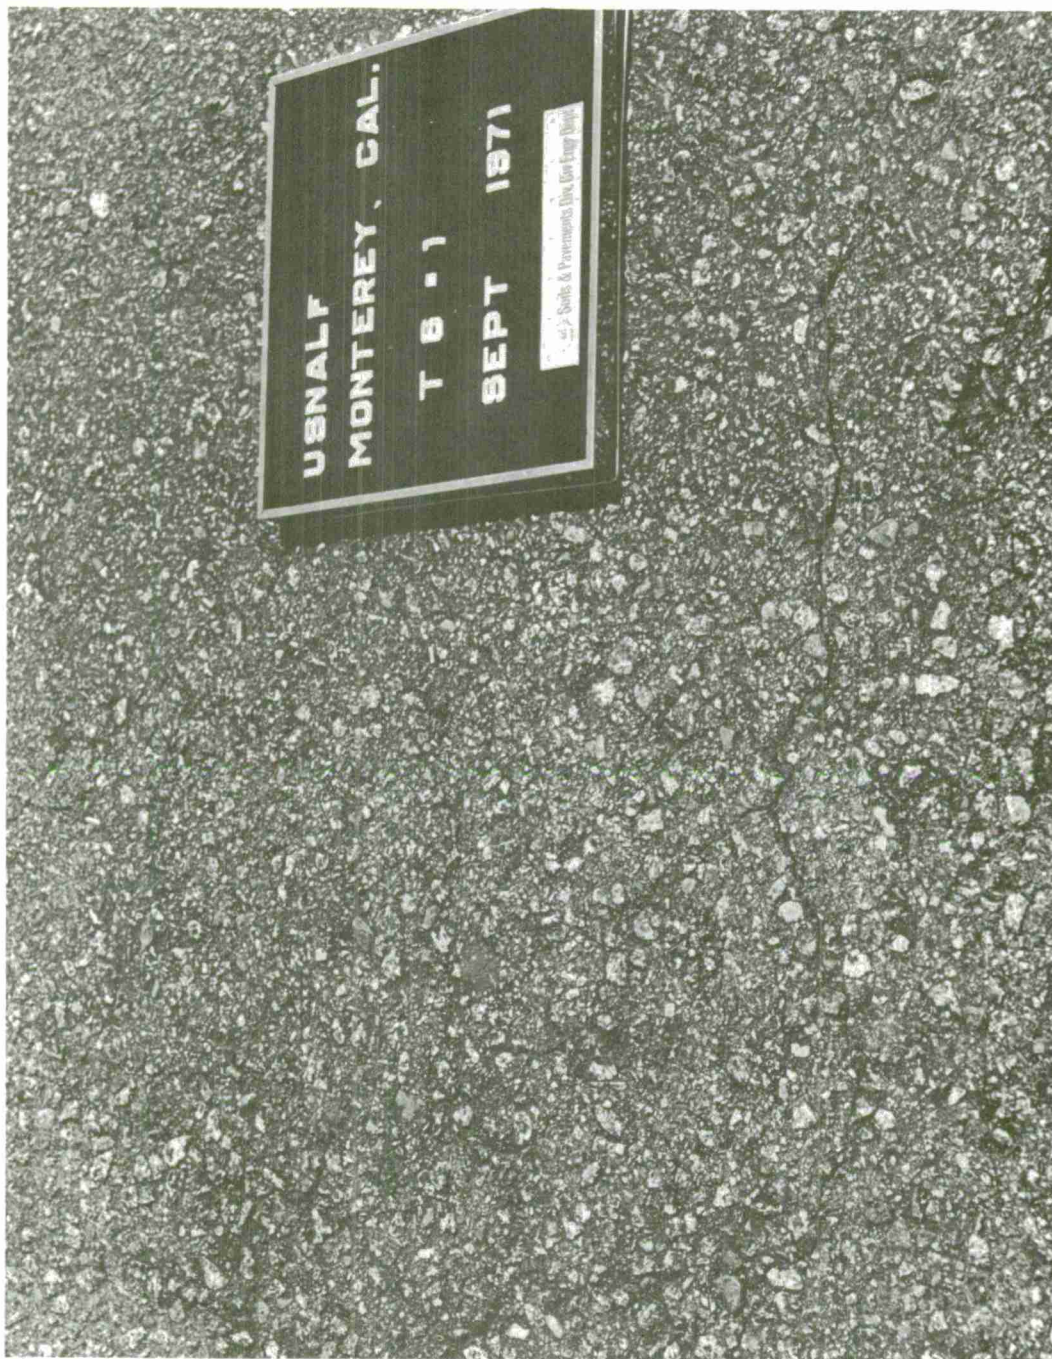
Figure 9. Surface condition showing exposed aggregate, Discrete Area T6-1.

| Defect Type | Length or Area of Sampled Defects | Total Length or Area of All Defects: (c) x Ratio | Defect Density (per 10 sq. ft.) 10 d/a | Defect Severity Weight | Weighted Defect Density: (e) x (f) |
|---|---|---|---|---|---|
| <p>Remarks on Pavement Condition</p> <p>Pattern cracking was of the dendritic type with 4" to 12" sides. Transverse and longitudinal cracks between 1/8" to 1/4" wide were unsealed, and some cracks had vegetation growing through them. Approximately 70 percent of the surface aggregate was stripped of bitumen (see Figure 9).</p> | | | | | |

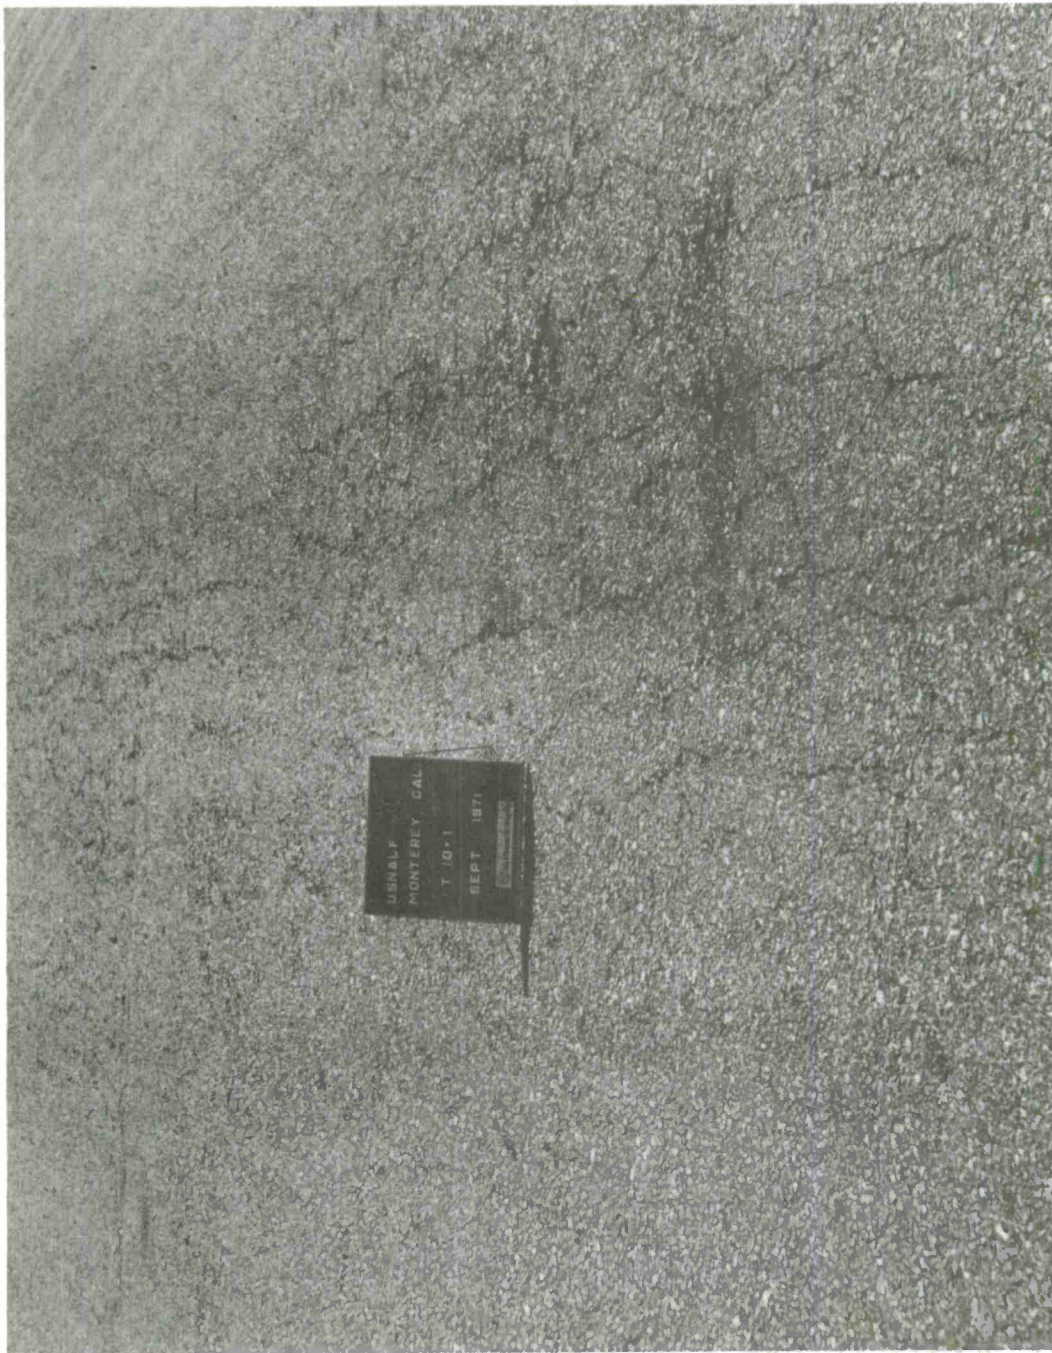
Figure 10. Pattern cracking, Discrete Area T10-1.

| Defect Type | Length or Area of Sampled Defects | Total Length or Area of All Defects: (c) x Ratio | Defect Density (per 10 sq. ft.) 10 d/a | Defect Severity Weight | Weighted Defect Density: (e) x (f) |
|---|---|---|---|---|---|
| Pattern cracking was a combination of shrinkage and dendritic types forming polygons with 6" to 2' sides. Approximately 3/4 of the surface aggregate was stripped of bitumen (see Figure 10). | | | | | |

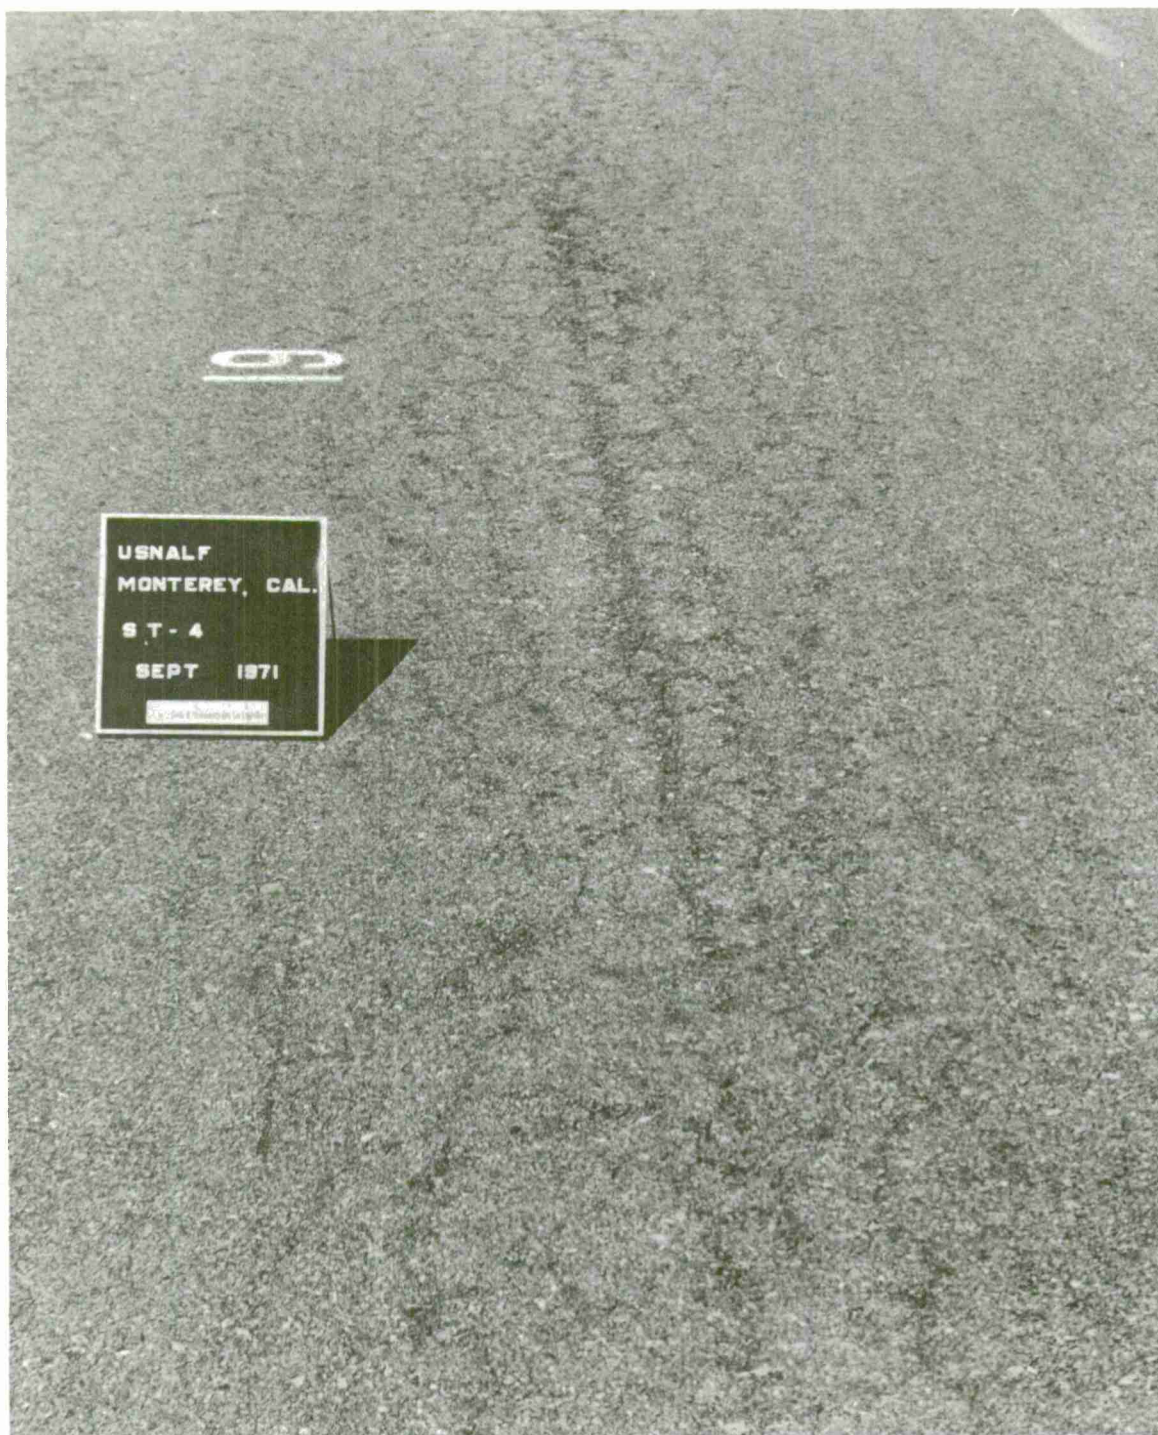
Figure 11. Pattern cracking, Discrete Area ST-4.

| Defect Type | Length or Area of Sampled Defects | Total Length or Area of All Defects: (c) x Ratio | Defect Density (per 10 sq. ft.) 10 d/a | Defect Severity Weight | Weighted Defect Density: (e) x (f) |
|---|---|---|---|---|---|
| Pattern cracking was of the dendritic type with 4" to 12" legs.<br>Most cracks were 1/8" wide. Cracks were not sealed (see Figure 11). | | | | | |

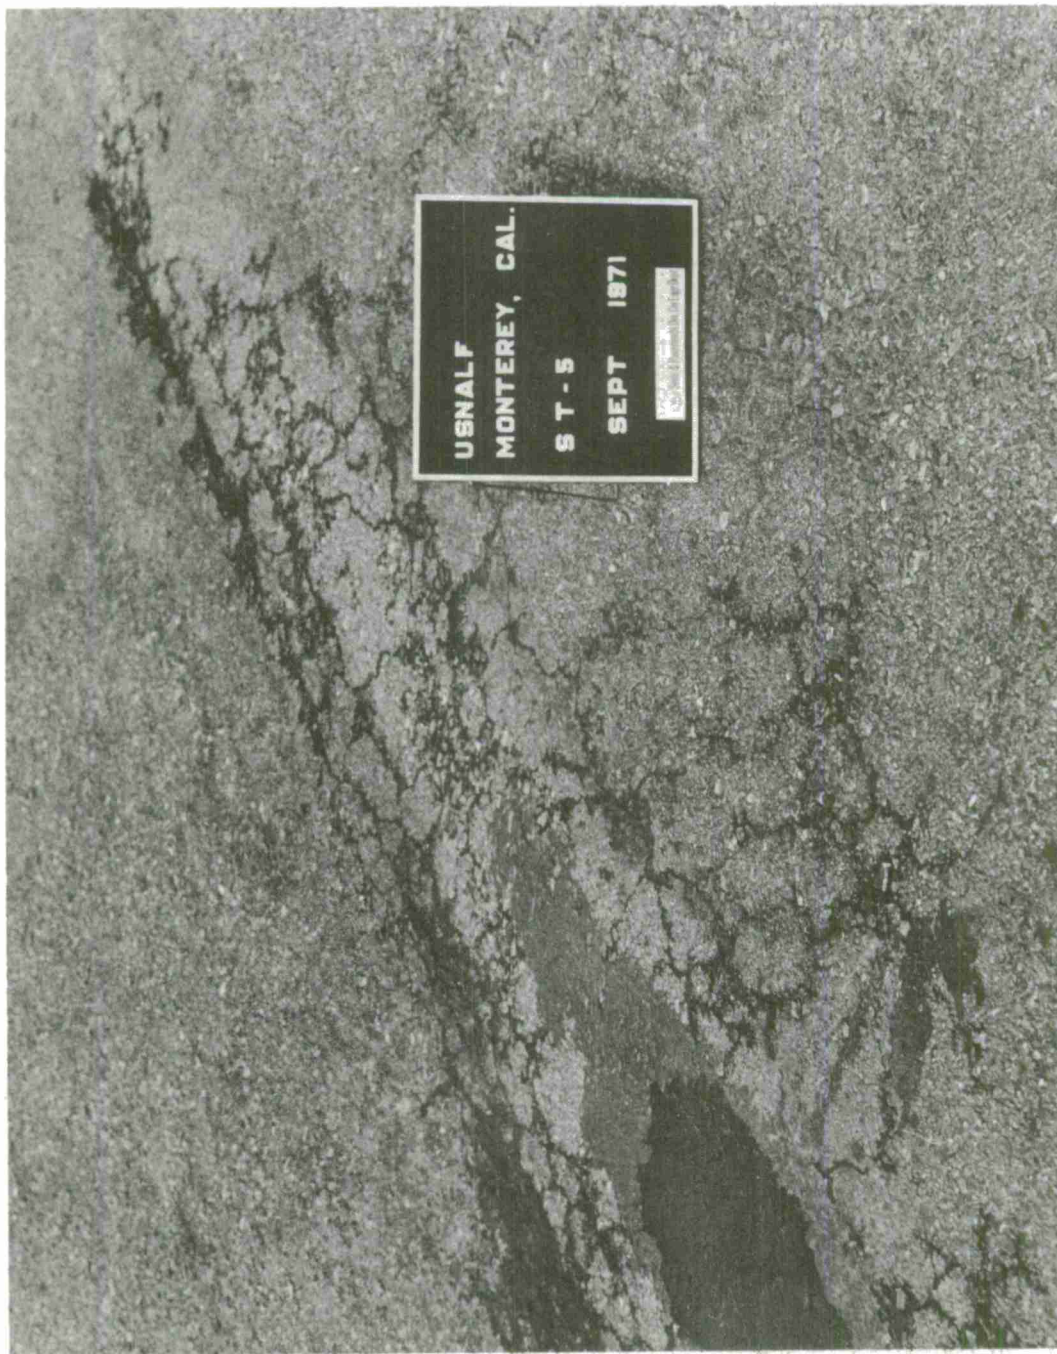
Figure 12. Broken up area, Discreet Area ST-5.

| Defect Type | Length or Area of Sampled Defects | Total Length or Area of All Defects: (c) x Ratio | Defect Density (per 10 sq. ft.) 10 d/a | Defect Severity Weight | Weighted Defect Density: (e) x (f) |
|---|---|---|---|---|---|
| Approximately 90 percent of the surface aggregate was exposed, and the surface was quite rough. See Figure 12 for example of broken up area. | | | | | |

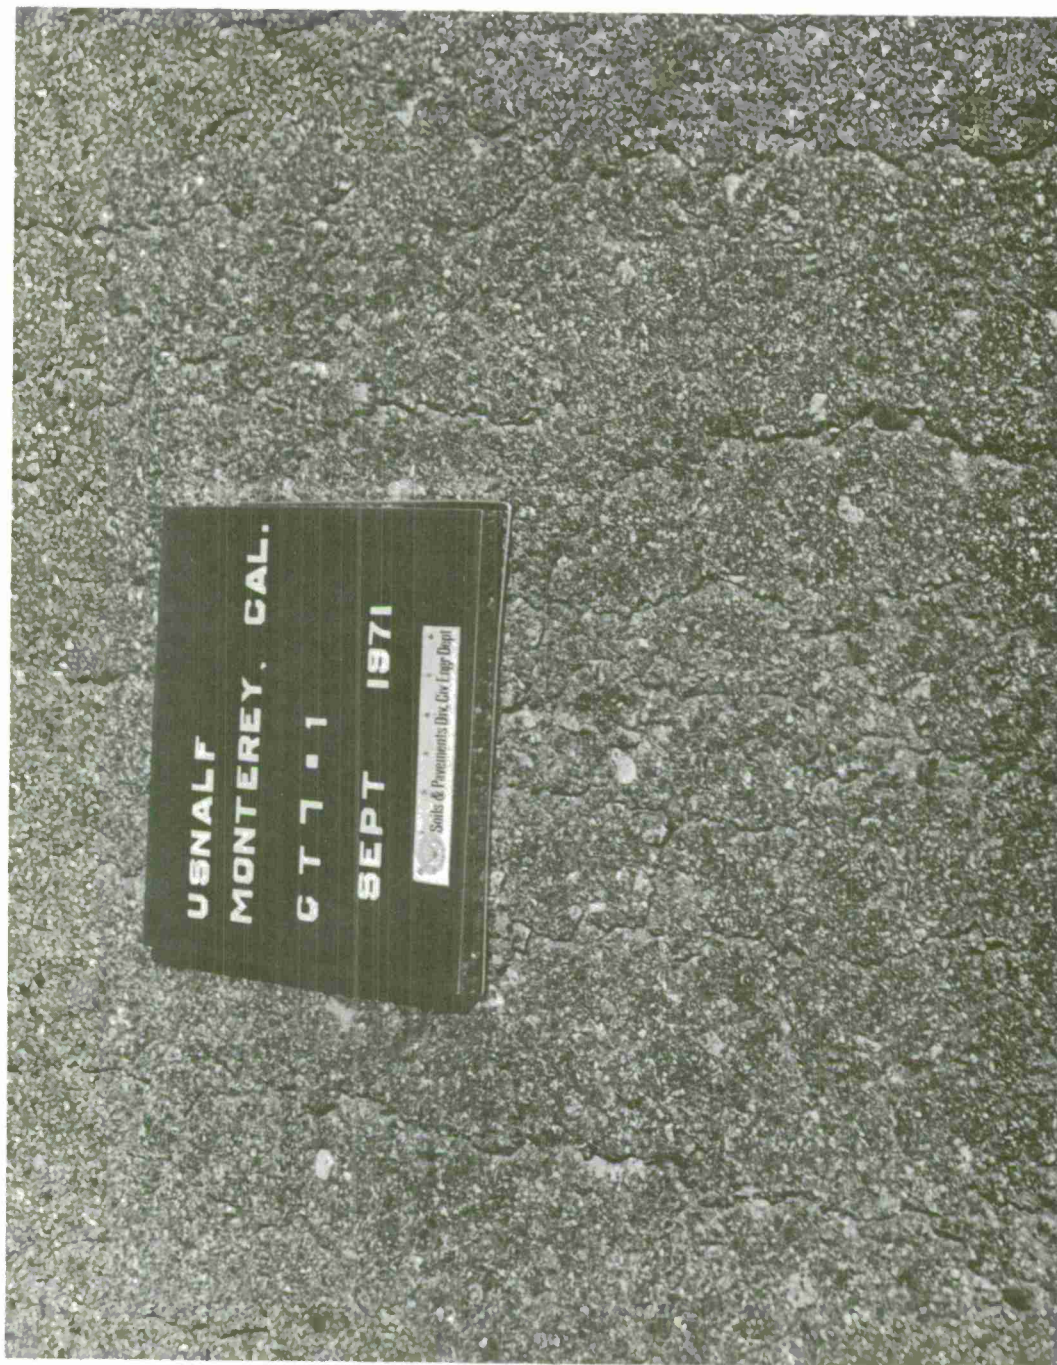
Figure 13. Pattern cracking, Discrete Area CT7-1.

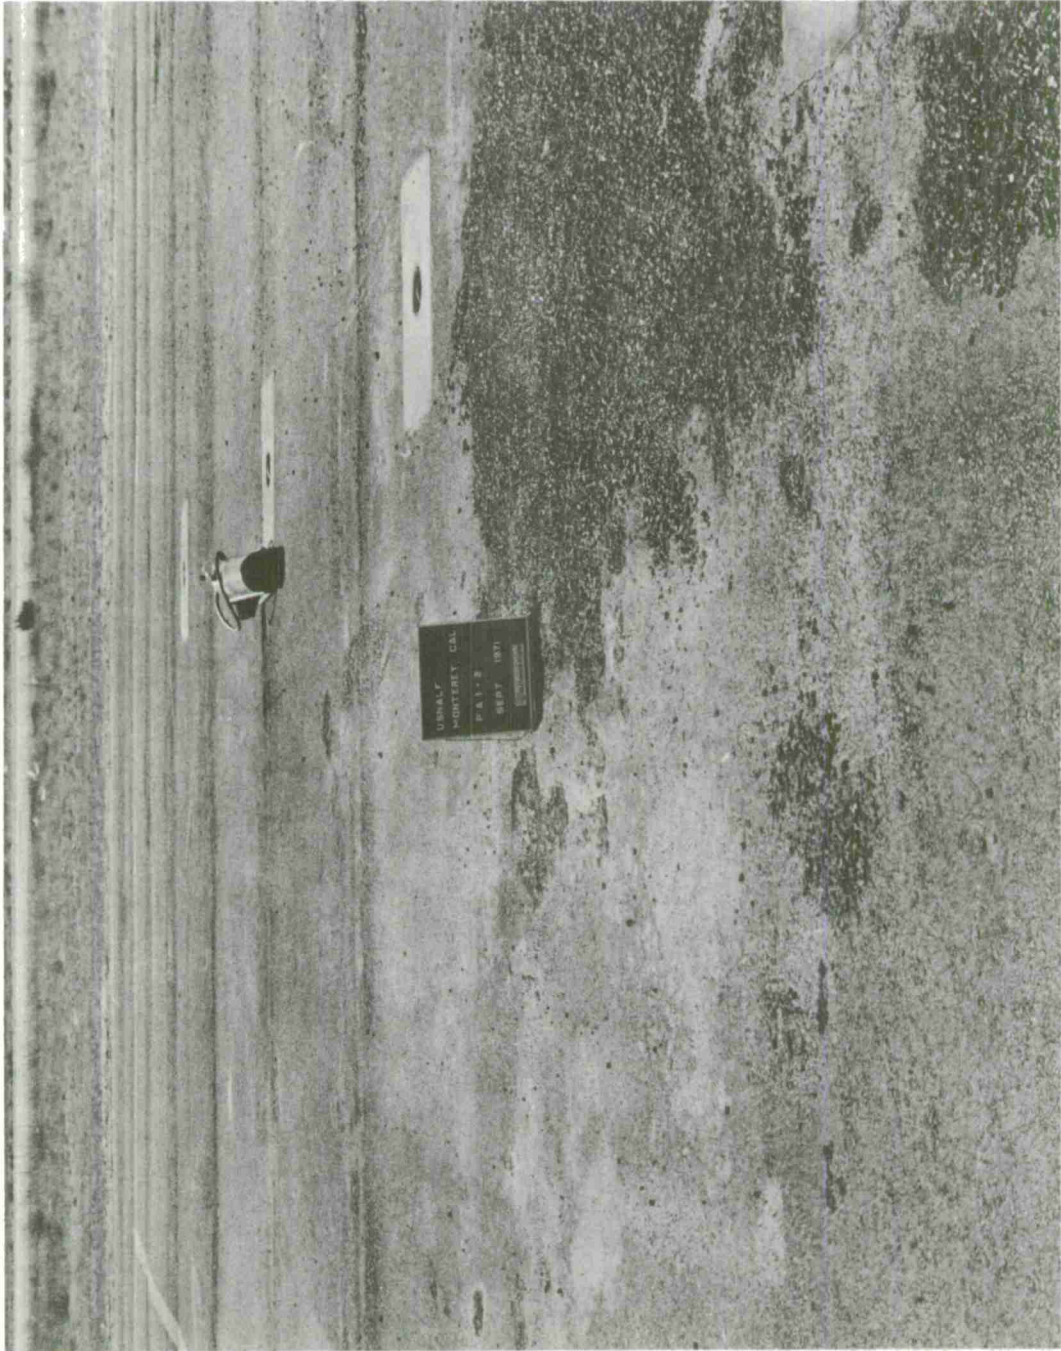
Figure 14. Erosion caused by fuel spillage, Discrete Area PA1-2.

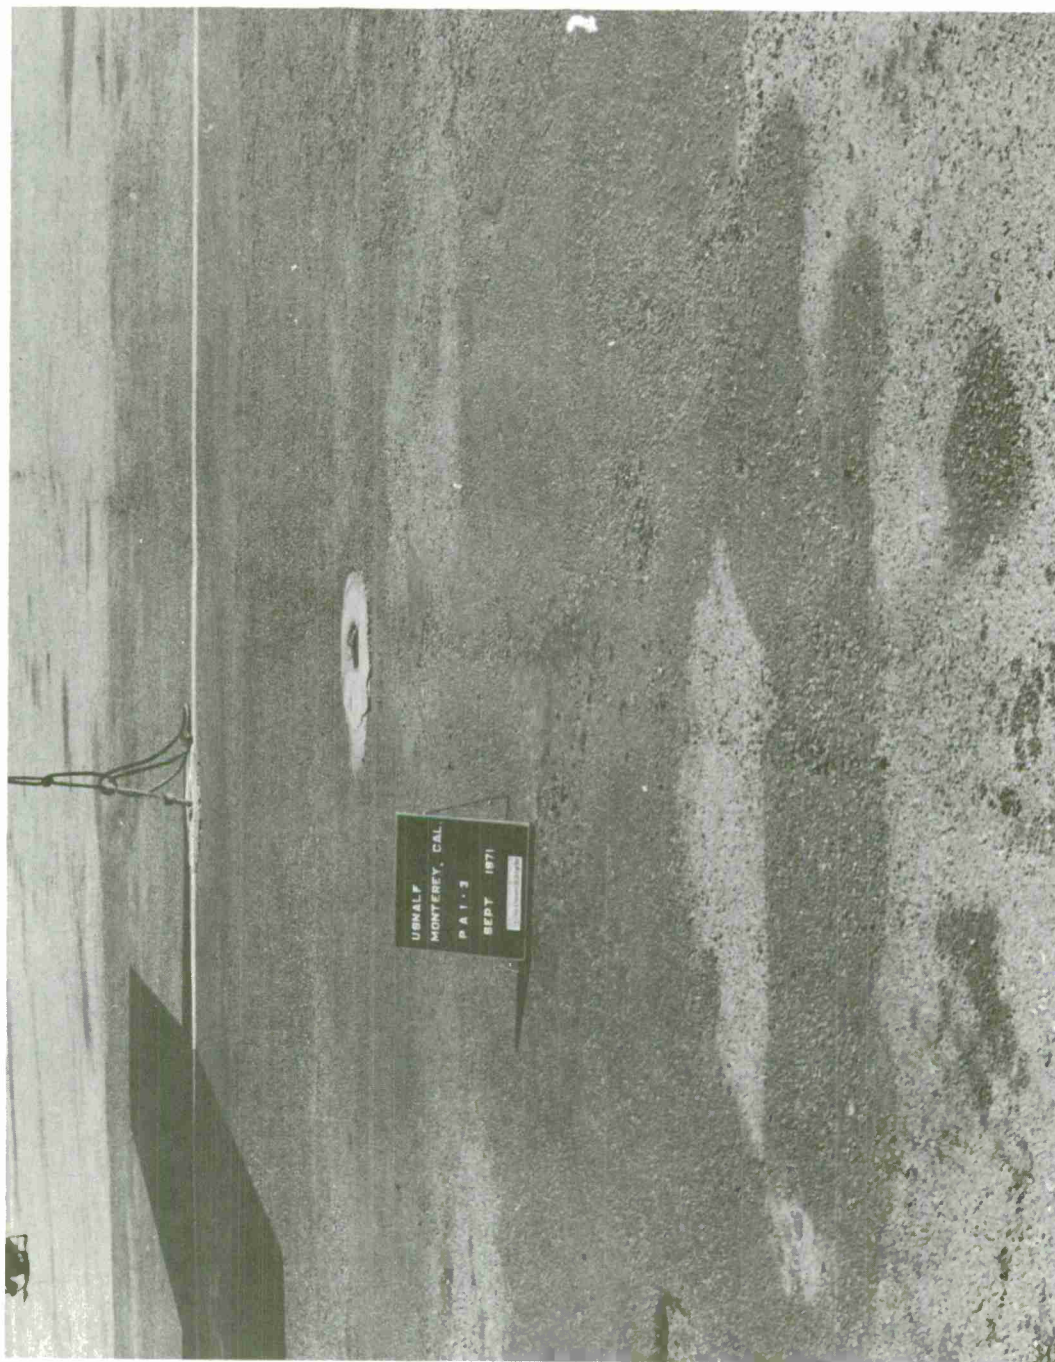
Figure 15. Fuel spillage and raveling, Discrete Area PA1-3.

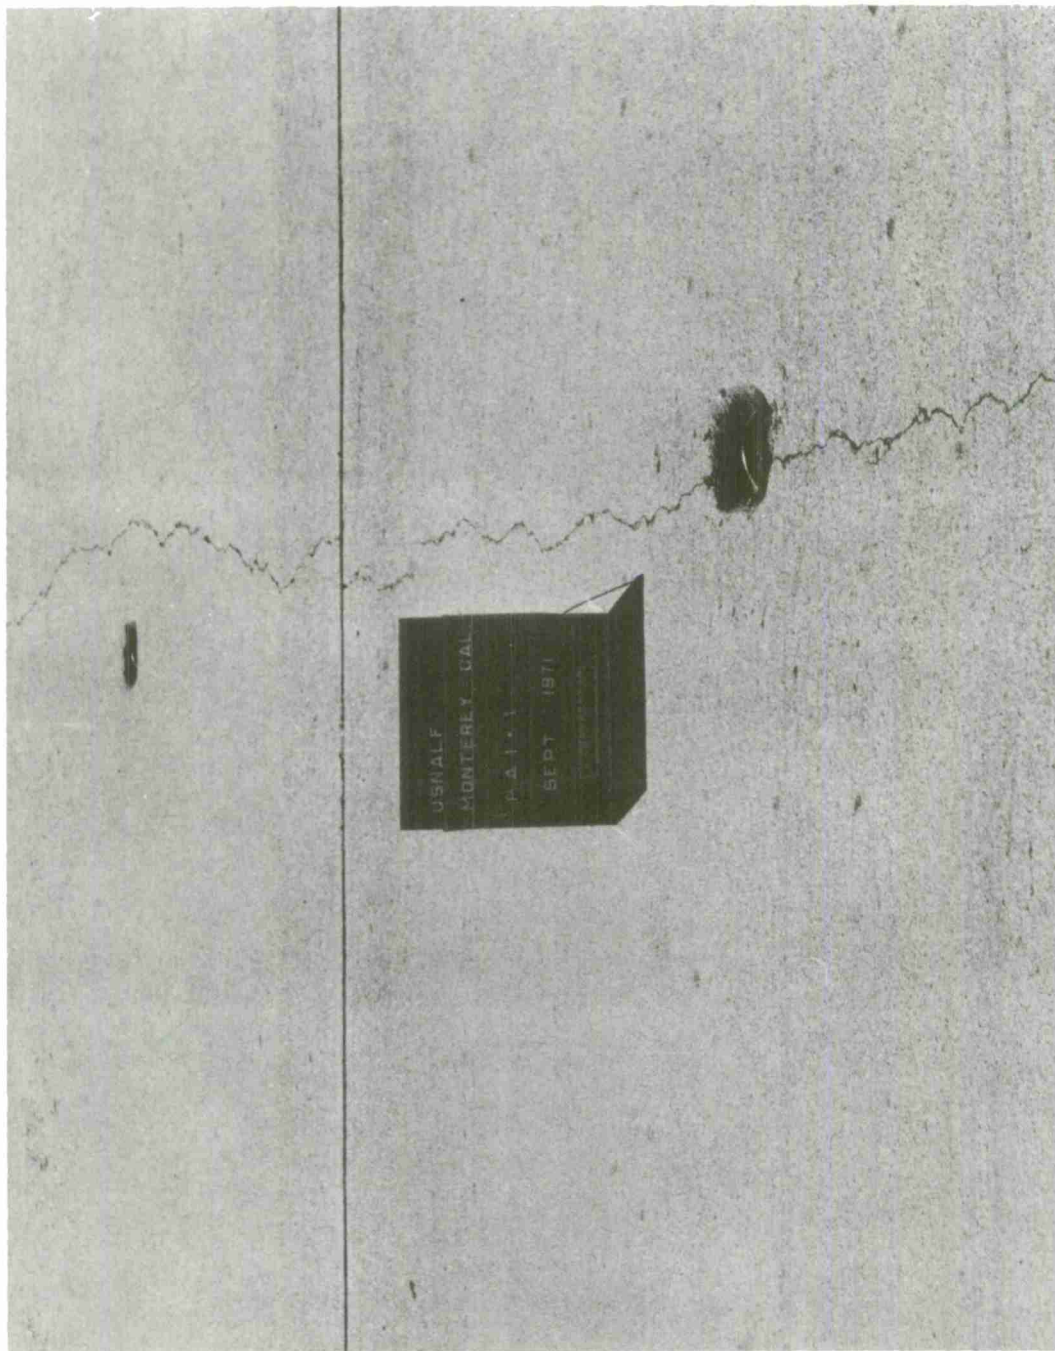
Figure 16. Transverse crack, Discrete Area PA1-1.

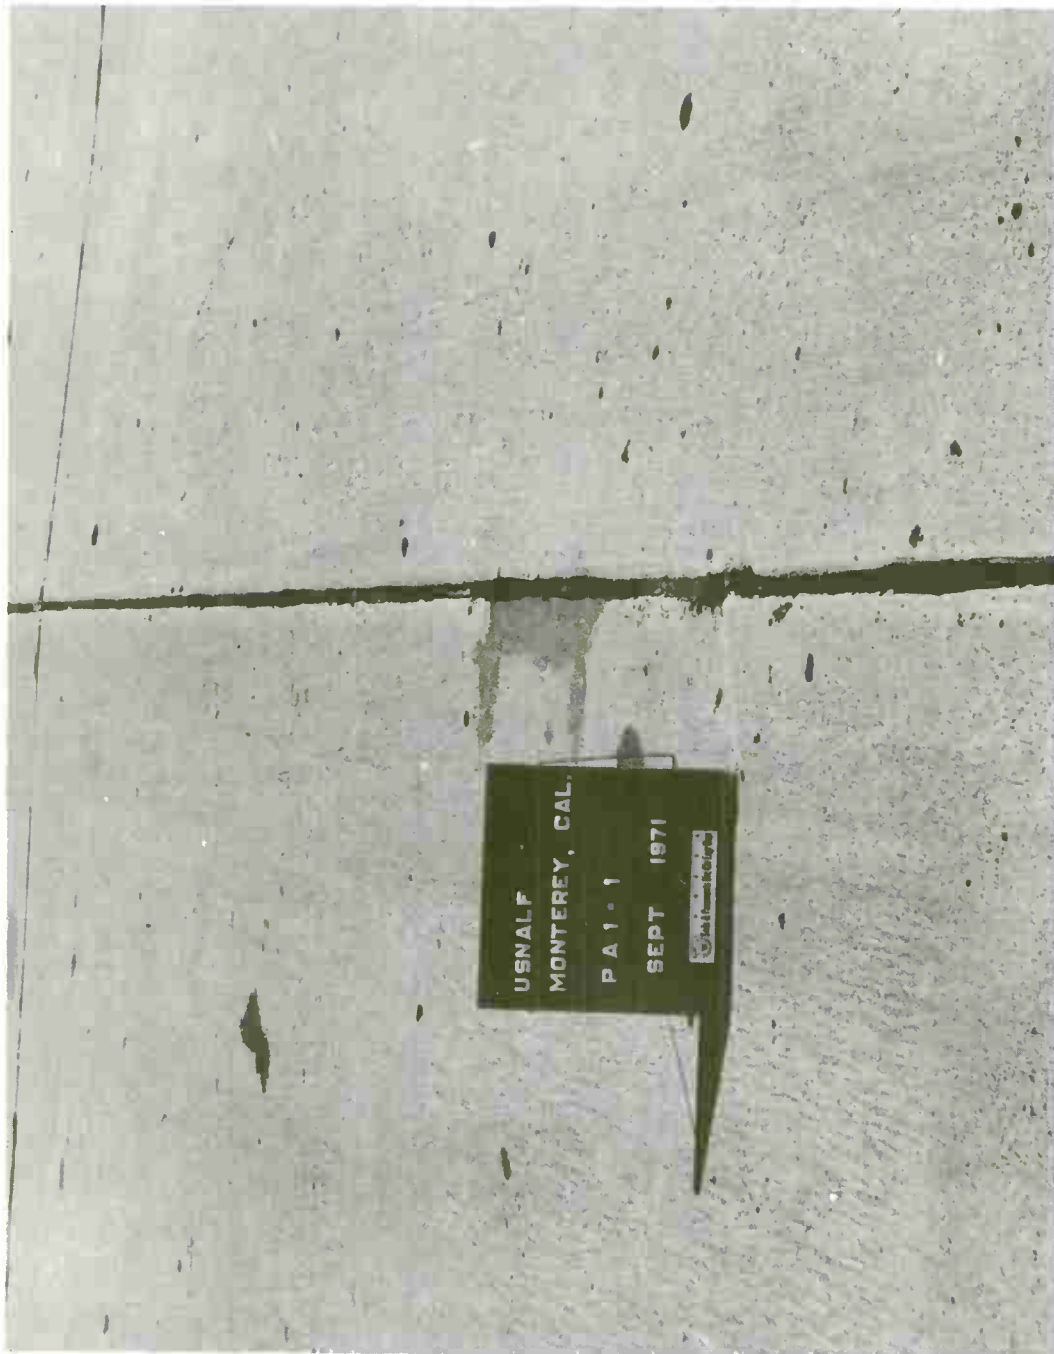
Figure 17. Vegetation growing in joint, Discrete Area PA1-1.

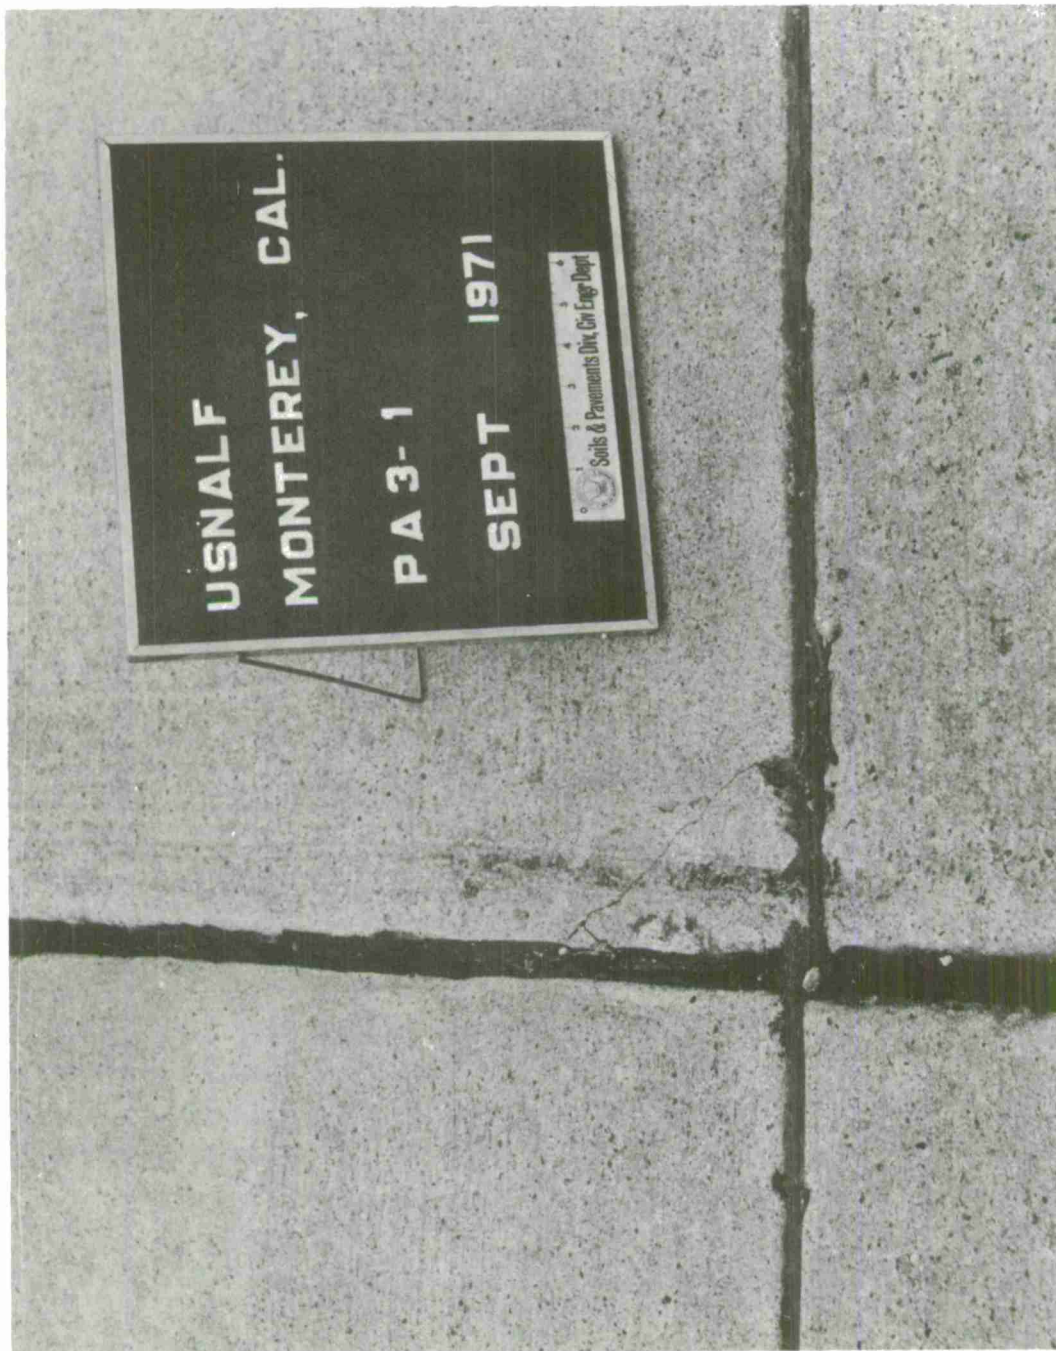
Figure 18. Spall on slab corner, Discrete Area PA3-1.

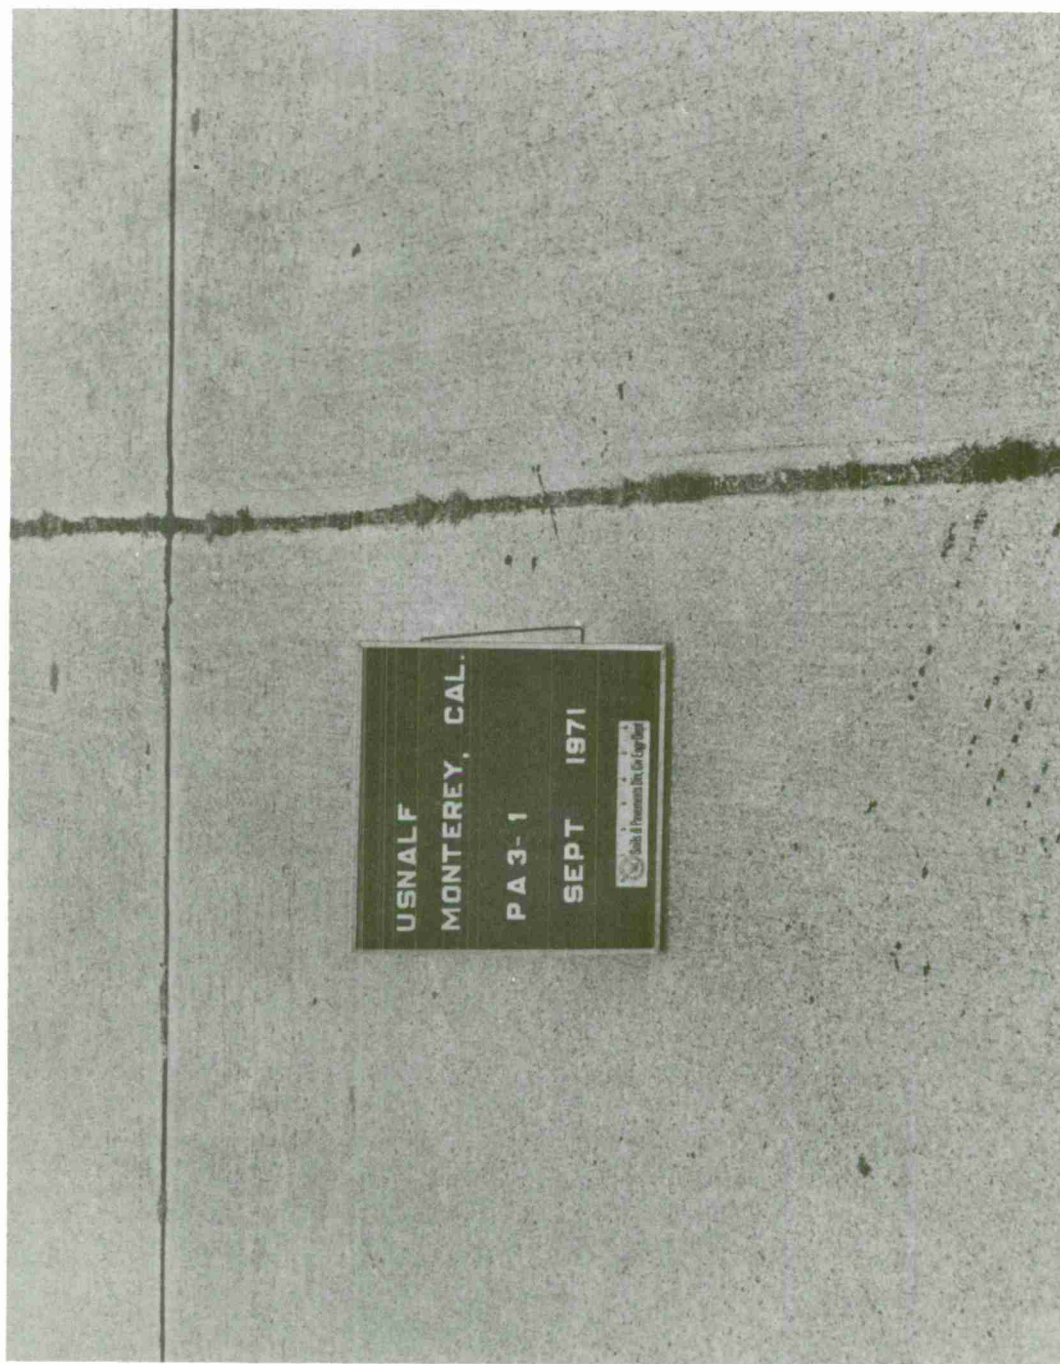
Figure 19. Vegetation growing through joint, Discrete Area PA3-1.

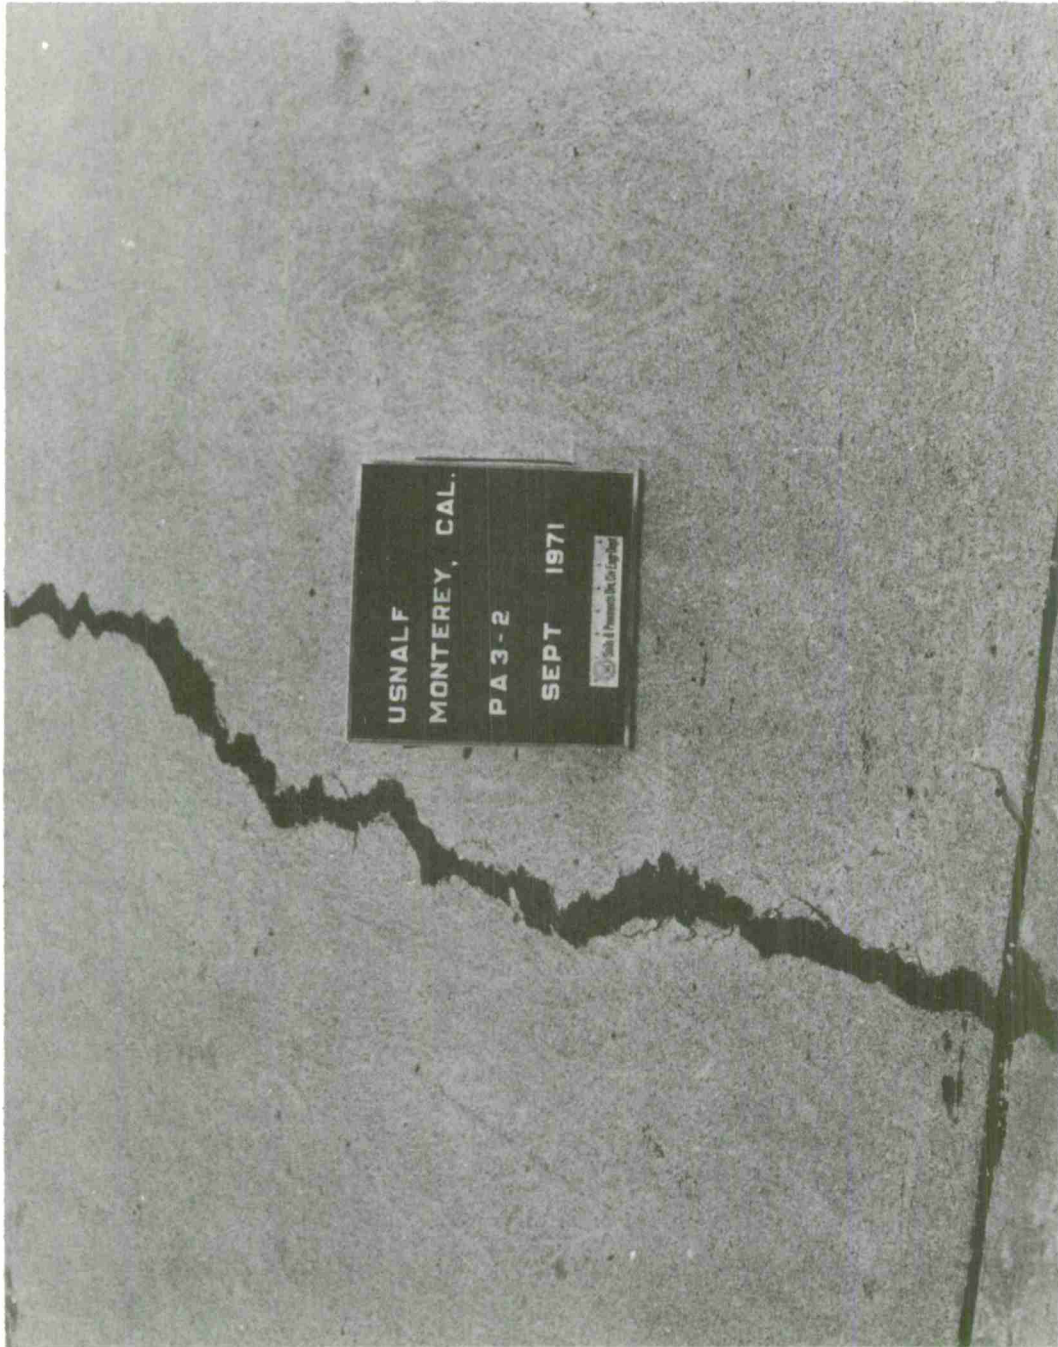
Figure 20. Spalling along transverse crack, Discrete Area PA3-2.
