Technical Note N-1217

AIRFIELD PAVEMENT CONDITION SURVEY,  
USNLF MONTEREY, CALIFORNIA

January 1972

NAVAL CIVIL ENGINEERING LABORATORY  
Port Hueneme, California 93043

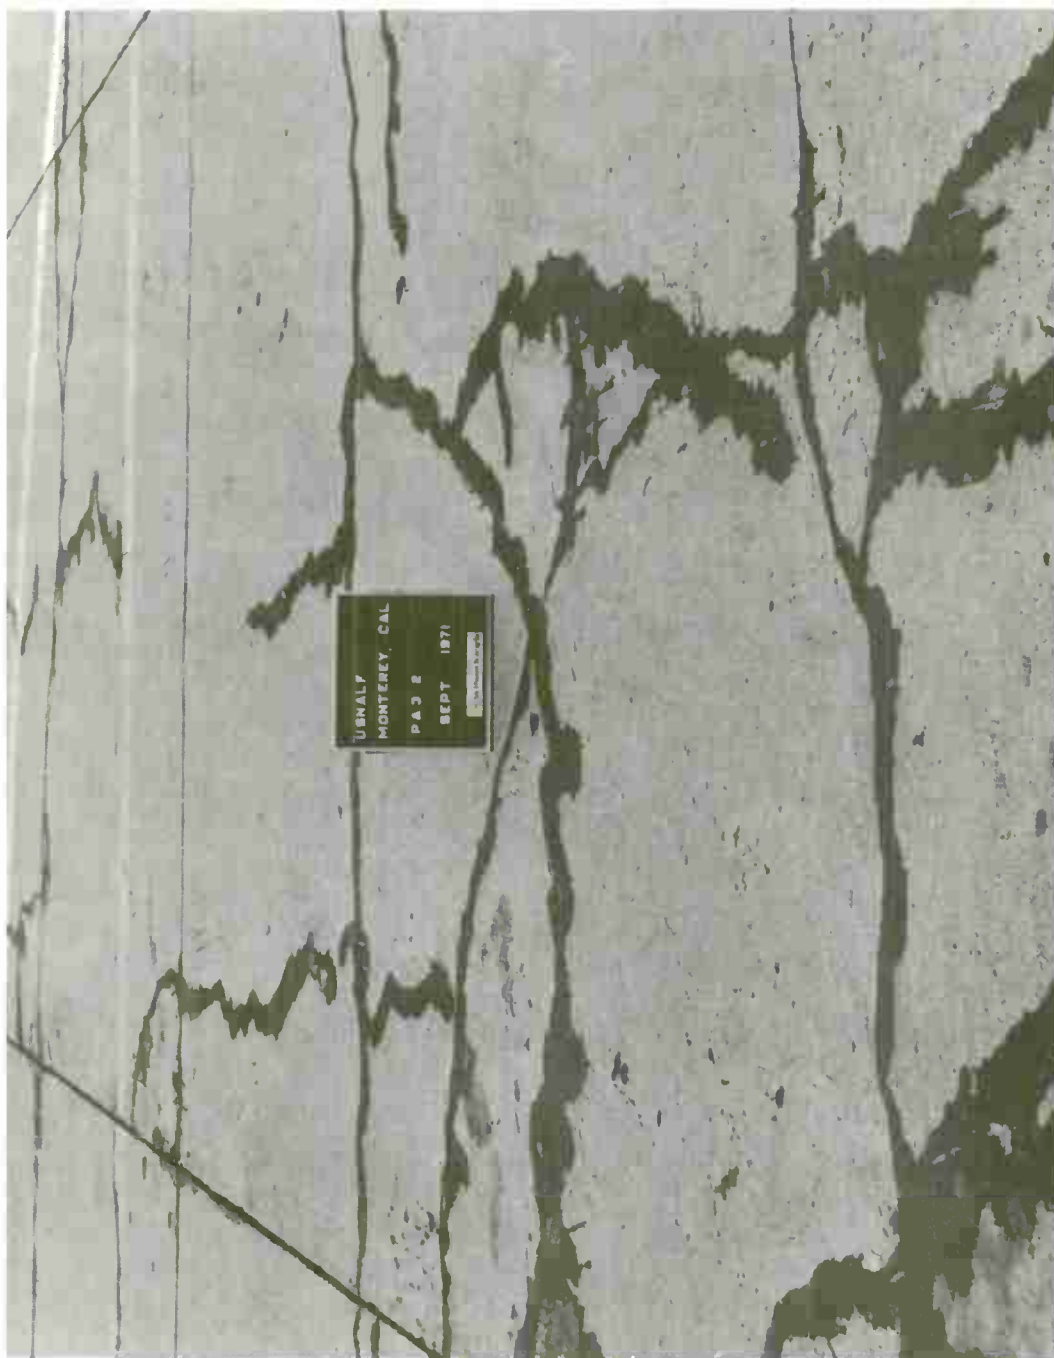
Figure 21. Shattered slab, Discrete Area PA3-2.
