Assessments of House Damage from Event Dial Pack and 100 ton AN/FO Test

Interim Report

Prepared by: C. Wilton, URS Research Company

DEFENSE NUCLEAR AGENCY
WASHINGTON, D.C.

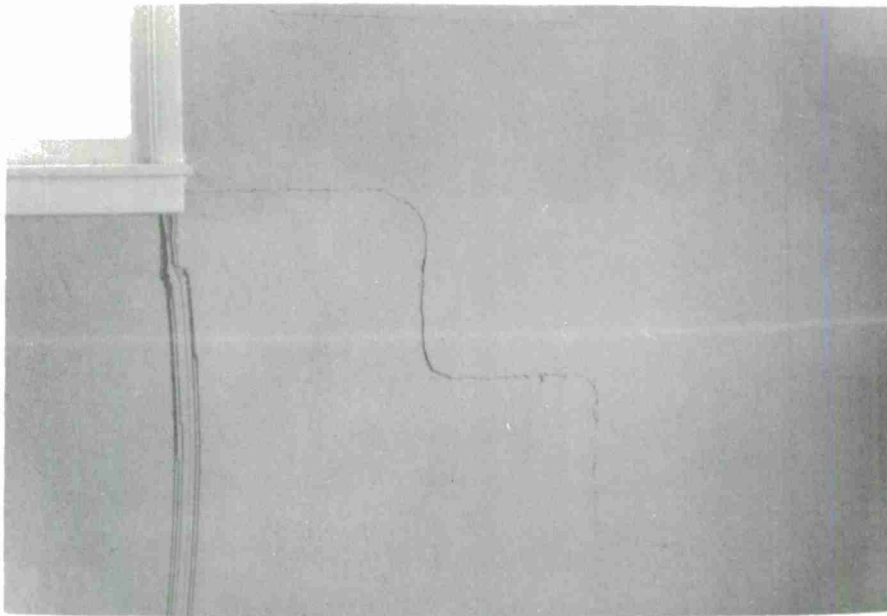
Minor plaster cracks were noted throughout the house. Especially numerous were those around the windows and over the doorways. Examples of these are shown in Appendix A, Figures A-1 and A-2. More severe plaster cracks were found in the front wall of the house near the bottom corner of the windows. See Figures A-3 and A-4 (photographs of the lower left corner of the front windows of the north and south bedrooms). Upon removal of small sections of the plaster and sheetrock in these areas, it was found that the vertical studs (2 by 4's) were cracked at this point (see Figures A-5 and A-6). No further unrepaired damage was noted.

Fig. A-1. Pretest Plaster Cracks, Kitchen North Wall (vertical marks are water stains, not cracks)

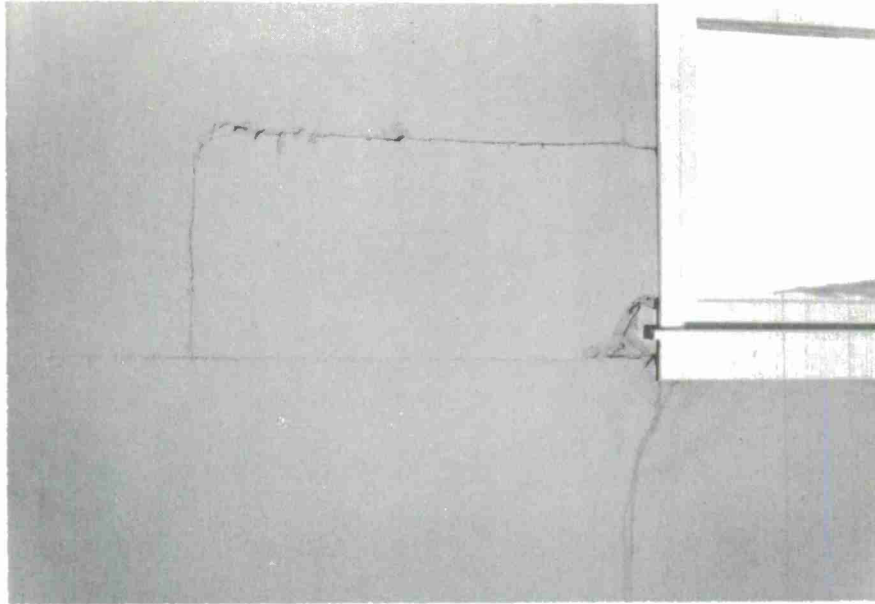
Fig. A-3. Pretest Plaster Cracks, South Bedroom, Front Window

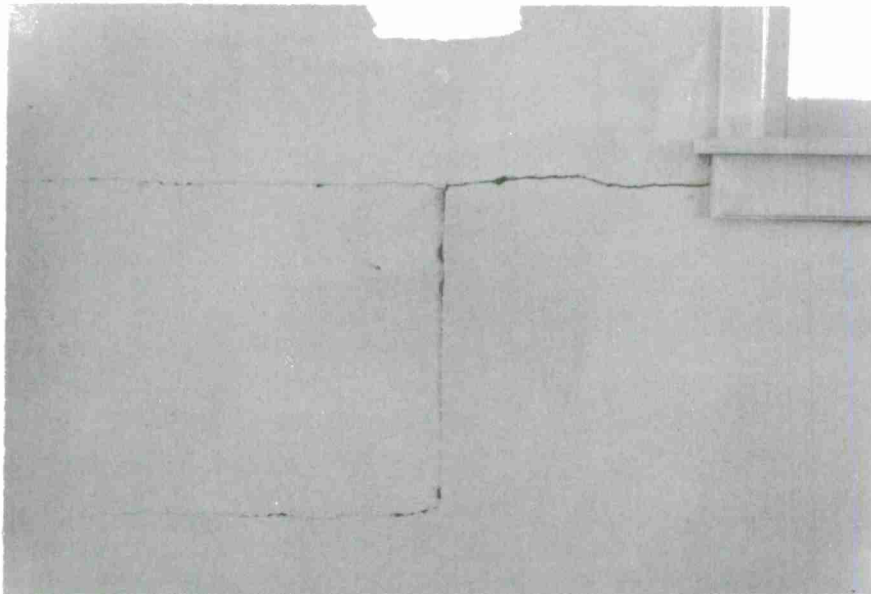
Fig. A-4. Pretest Plaster Cracks, North Bedroom, Front Window

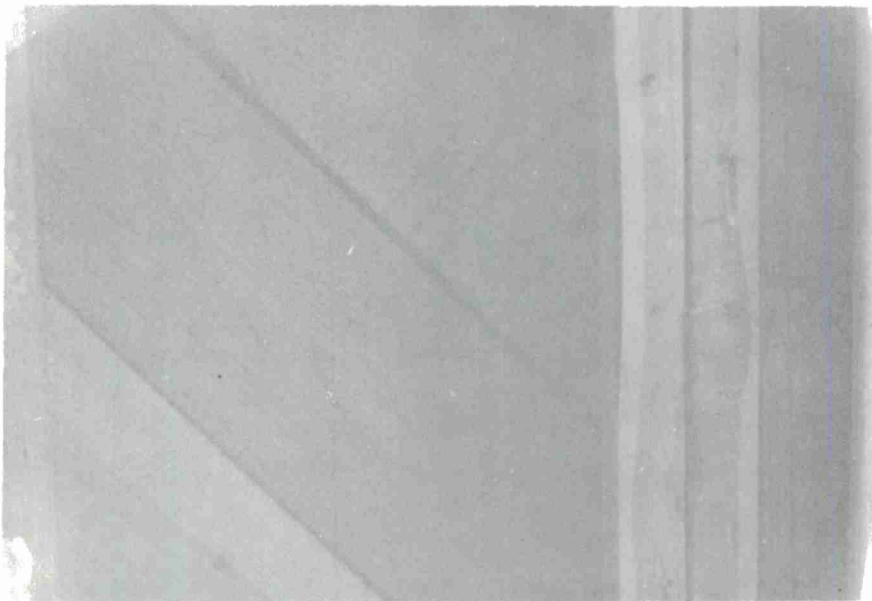
Fig. A-6. Pretest Close-up of Cracked 2 by 4, South Bedroom, Front Window

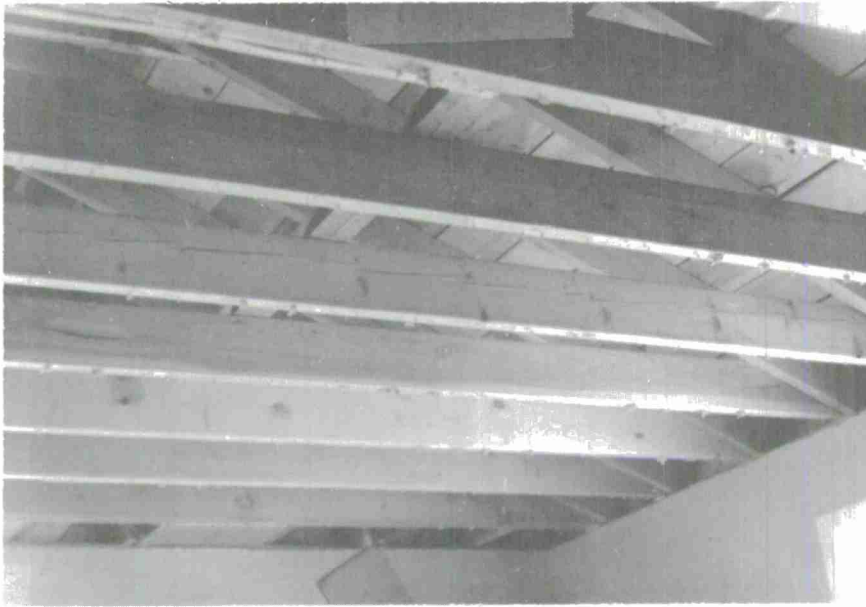
Fig. A-7. Posttest Ceiling Damage, Upstairs Rear North Bedroom

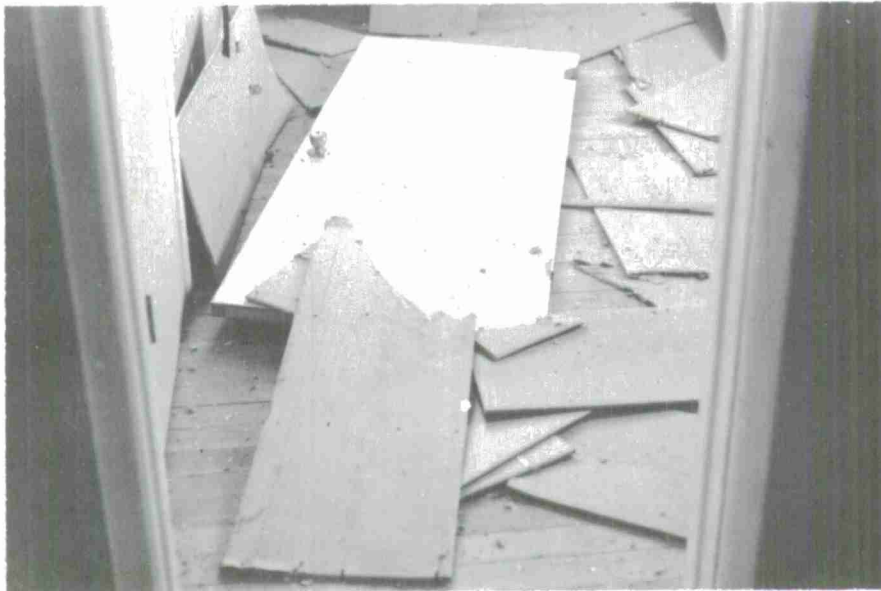
Fig. A-8. Posttest Door and Ceiling Sheathing on Floor of Upstairs Rear North Bedroom

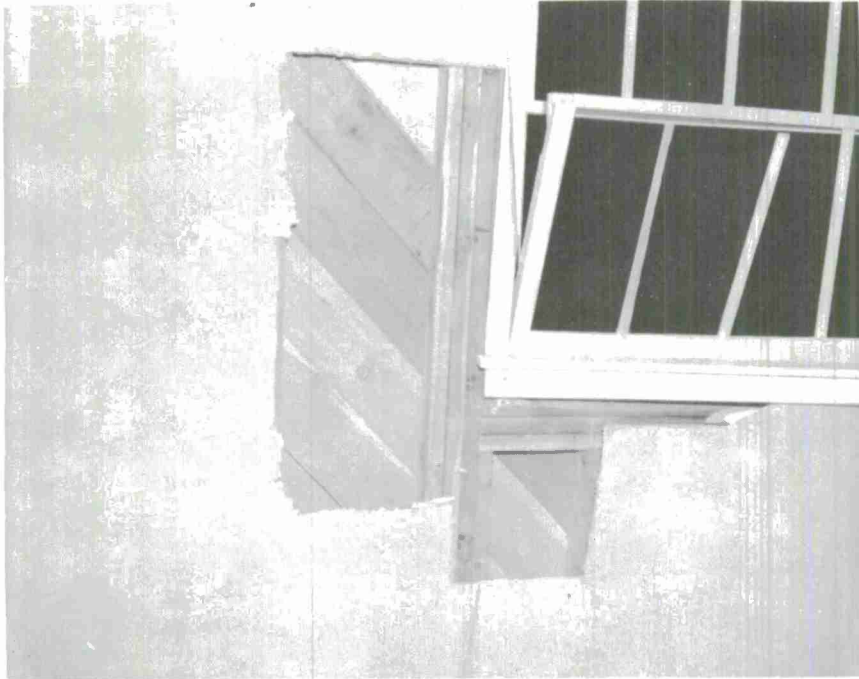
Fig. A-9. Posttest Upstairs Front Bedroom, North Side

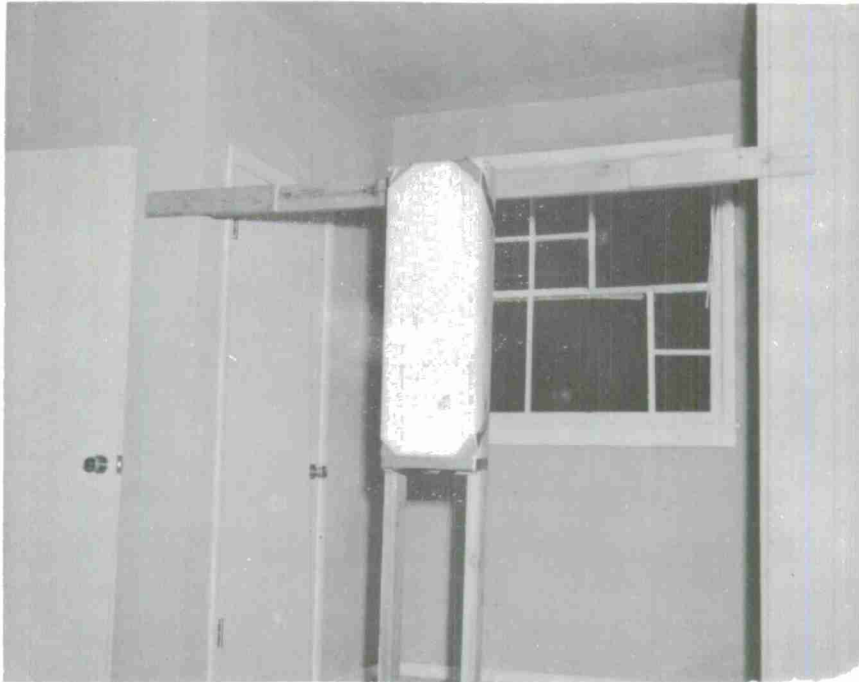
Fig. A-11. Posttest East Wall, Master Bedroom

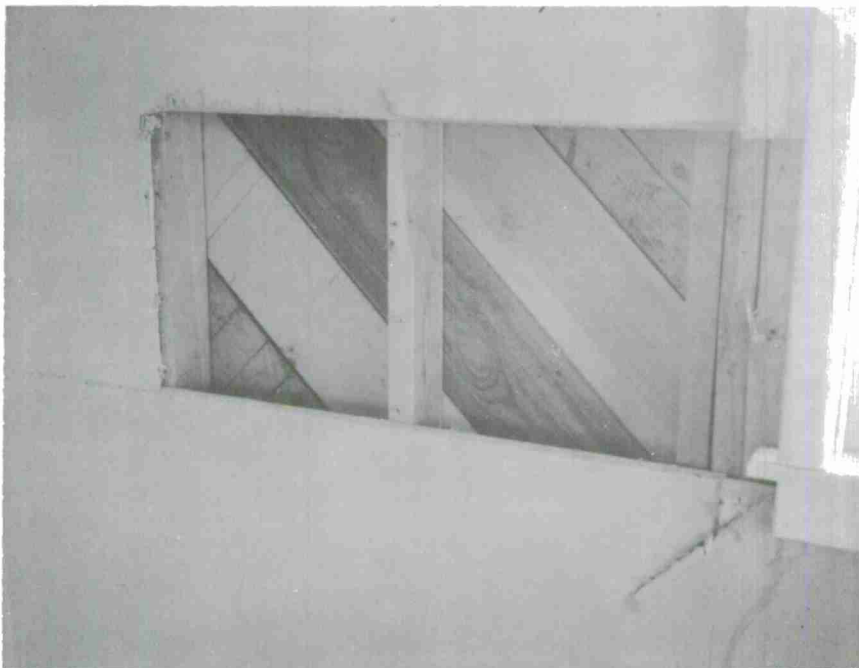
Fig. A-12. Posttest Dining Room, West Wall

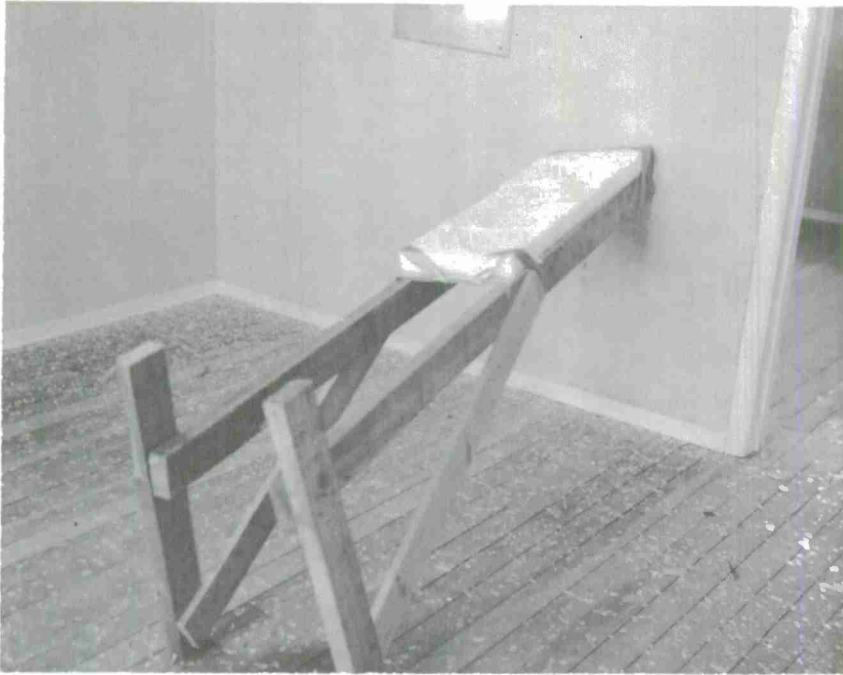
Fig. A-13. Dining Room East Wall, Showing Damaged Glass Trap

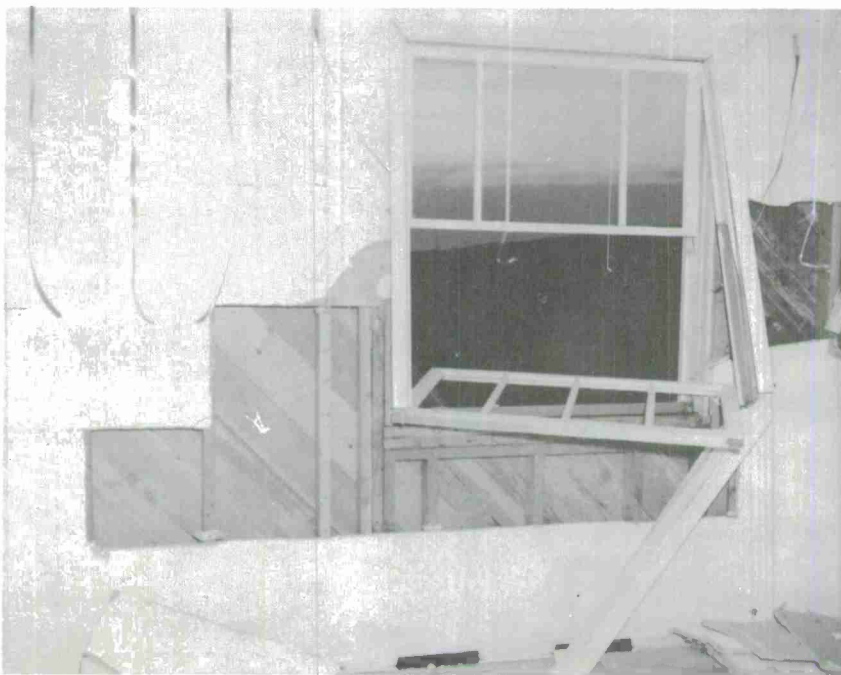
Fig. A-14. Living Room, West Wall

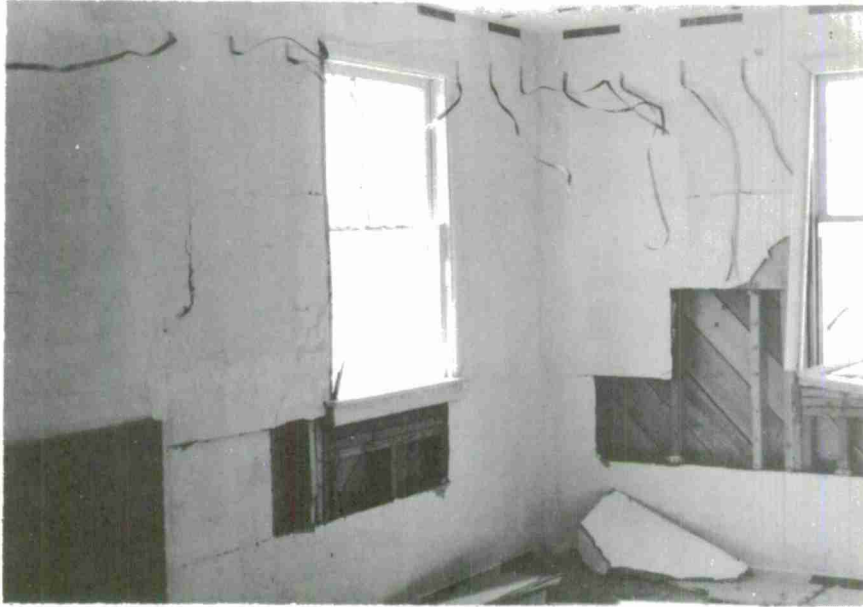
Fig. A-15. Posttest Living Room, Southwest Corner

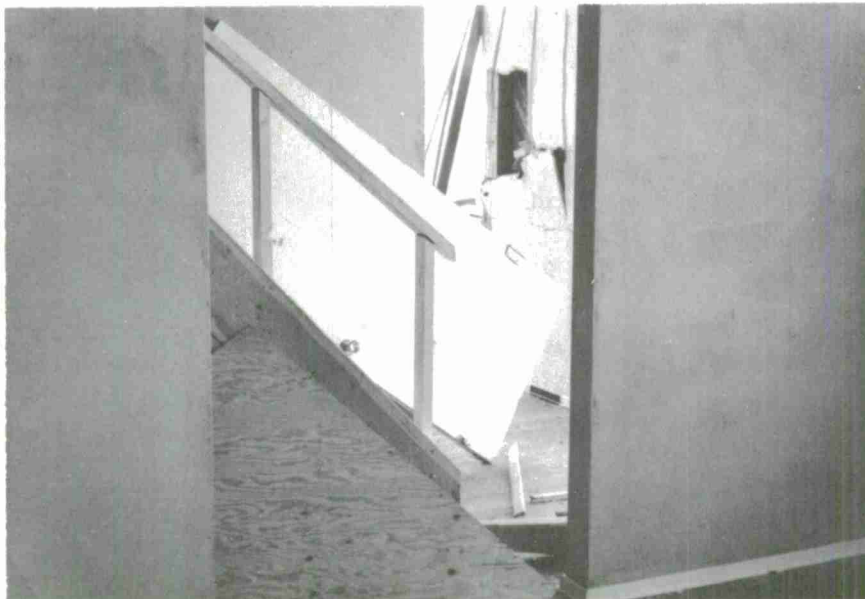
Fig. A-16. Posttest View from Dining Room into Hall
Showing Location of Door

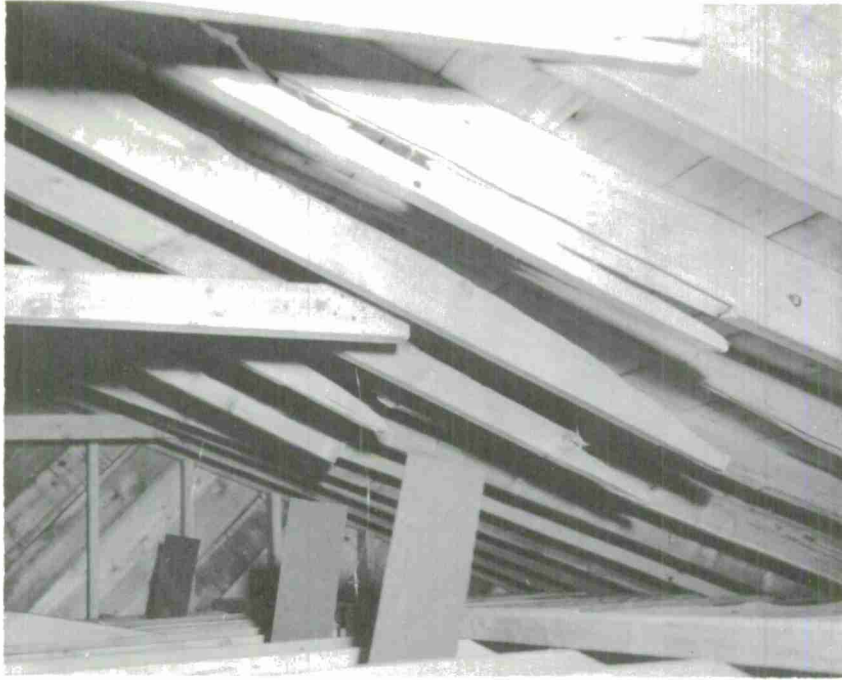
Fig. A-17. Posttest Attic, Westside, View Looking North

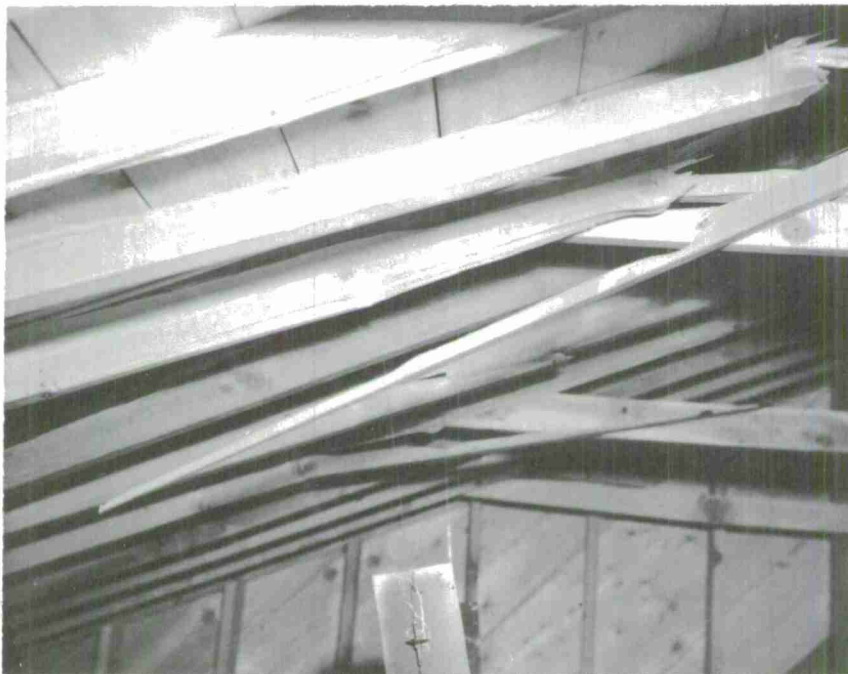
Fig. A-18. Posttest Attic, Westside, View Looking South

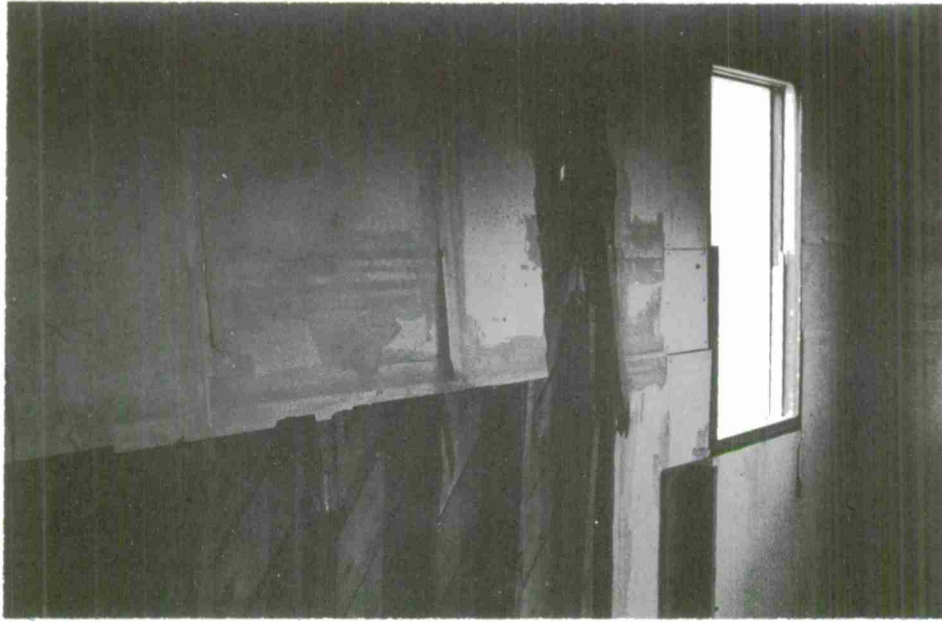
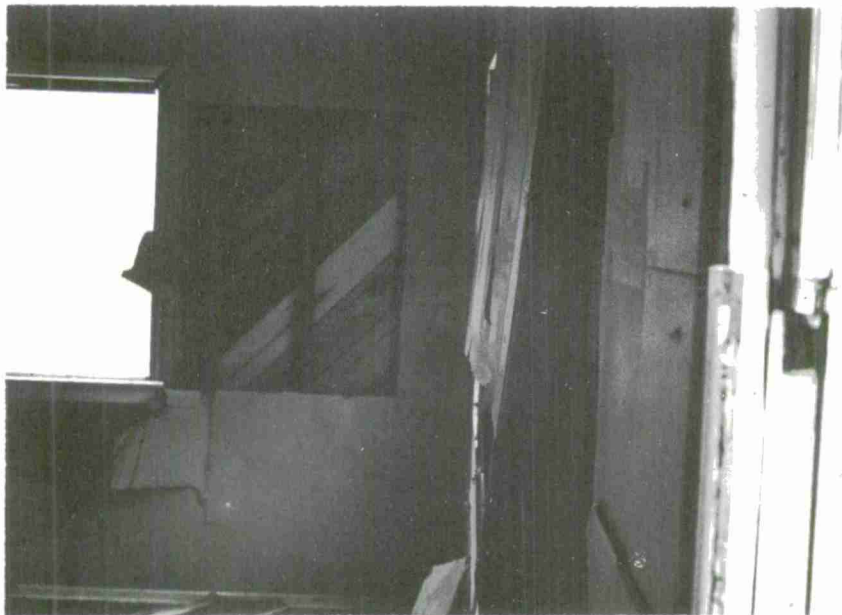
Both windows were blown inward. There was failure of eighteen 2 by 4 studs out of a total of 26, all in flexure and in the inward direction. About 40 percent of the sheetrock was removed and repair would require complete

replacement (see Figures B-1 and B-2). There was indication of shear motion in the wall; i.e., motion along the seams.

Fig. B-1. Posttest Living Room, North Wall Looking East

Fig. B-2. Posttest Living Room, North Wall Looking West

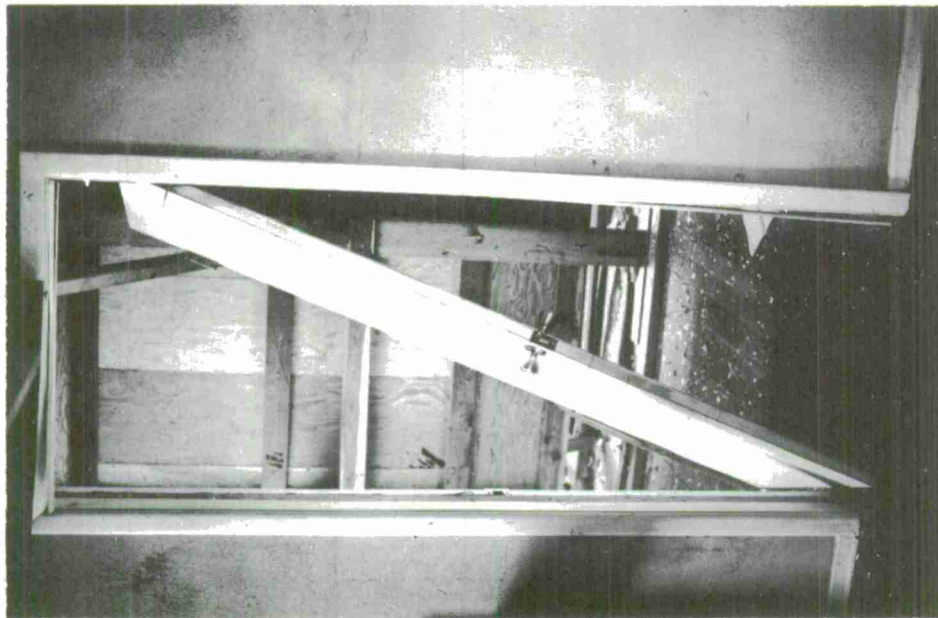
The door between the dining room and the kitchen was blown inward off its hinges and came to rest in the doorway (see Figure B-4). Several flexural cracks were noted and removal and replacement of approximately 25 percent of the plaster would be required to fix the damaged door casing, etc.

Fig. B-4. Posttest Dining Room, West Wall

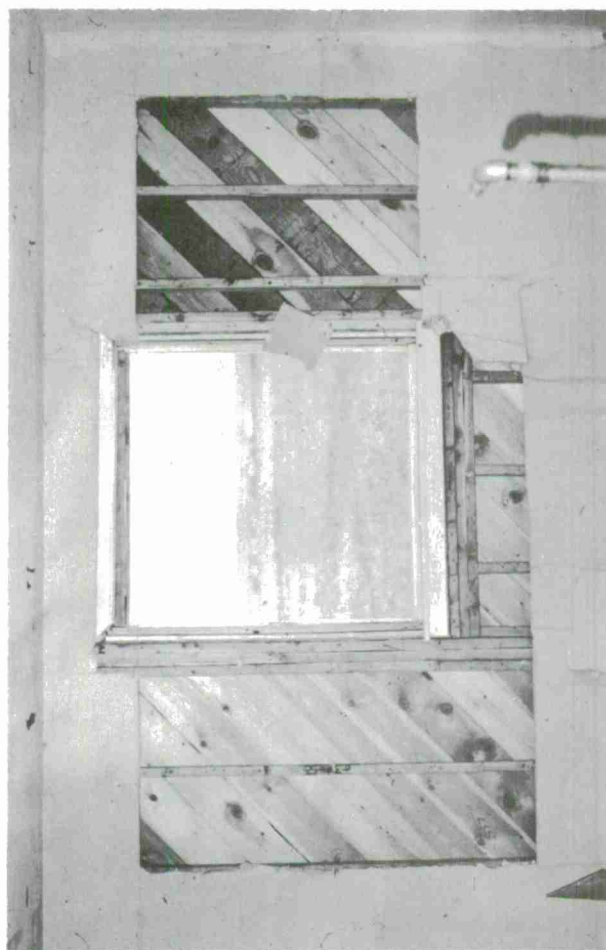
The window was blown inward and nine out of a total of ten studs were broken inward in flexure. Approximately 50 percent of the plaster was removed (see Figure B-3).

Fig. B-3. Posttest Living Room, West Wall

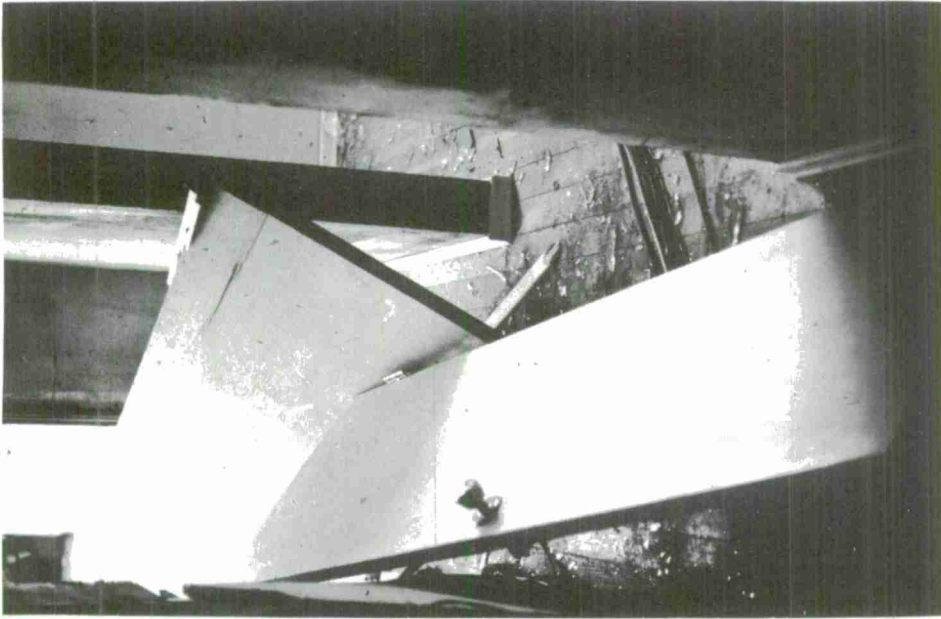
The front door was blown into the house and both closet doors were damaged (Figure B-6).

Fig. B-6. Posttest Entry Hall Looking East

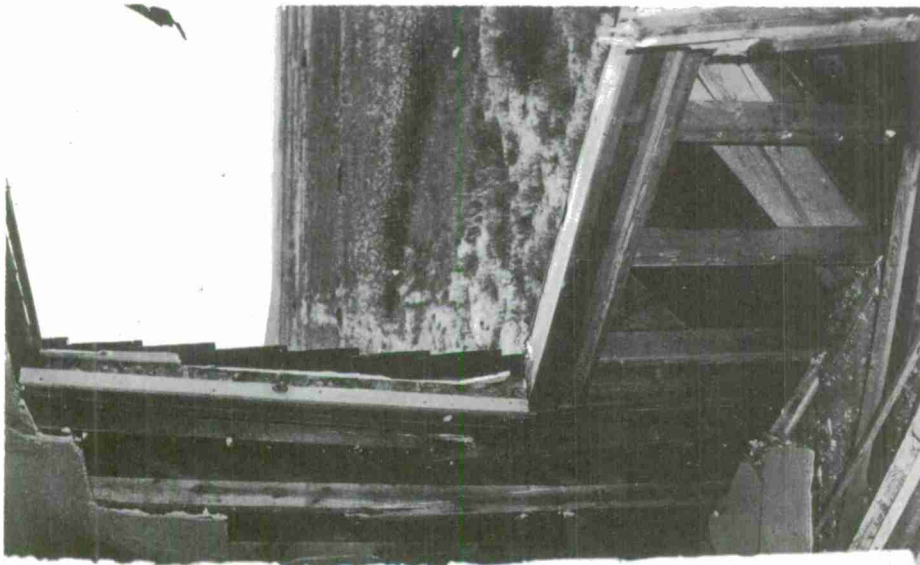
Heavily damaged with window blown in, 90 percent of the sheetrock removal and six of seven studs were broken (Figure B-5).

Fig. B-5. Posttest Kitchen, West Wall

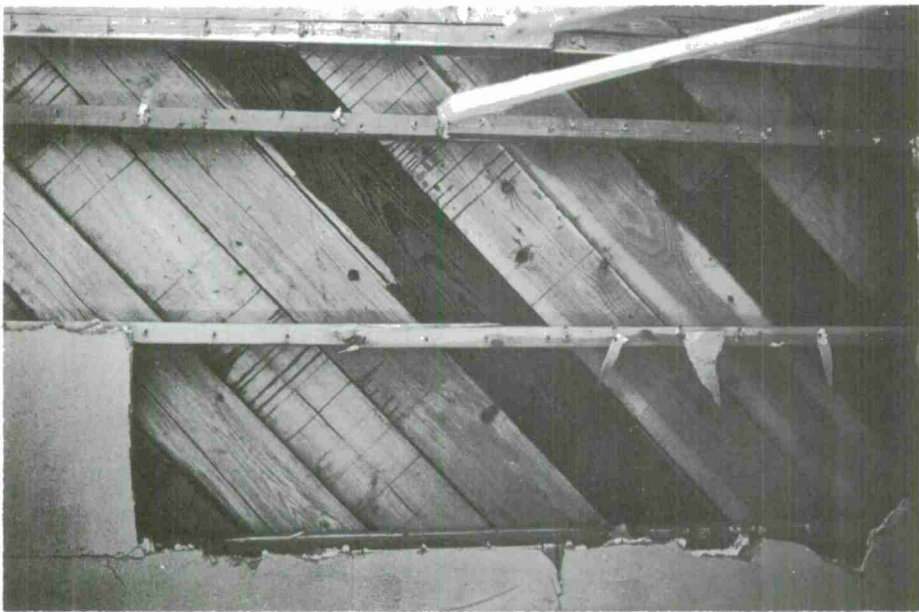
The window was blown inward. Twelve out of a total of 21 studs were broken inward in flexure. All sheetrock was damaged severely and 75 percent was blown inward (Figure B-7). There was also evidence of shear deformation in the remaining sheetrock.

Fig. B-7. Posttest Master Bedroom,
North Wall

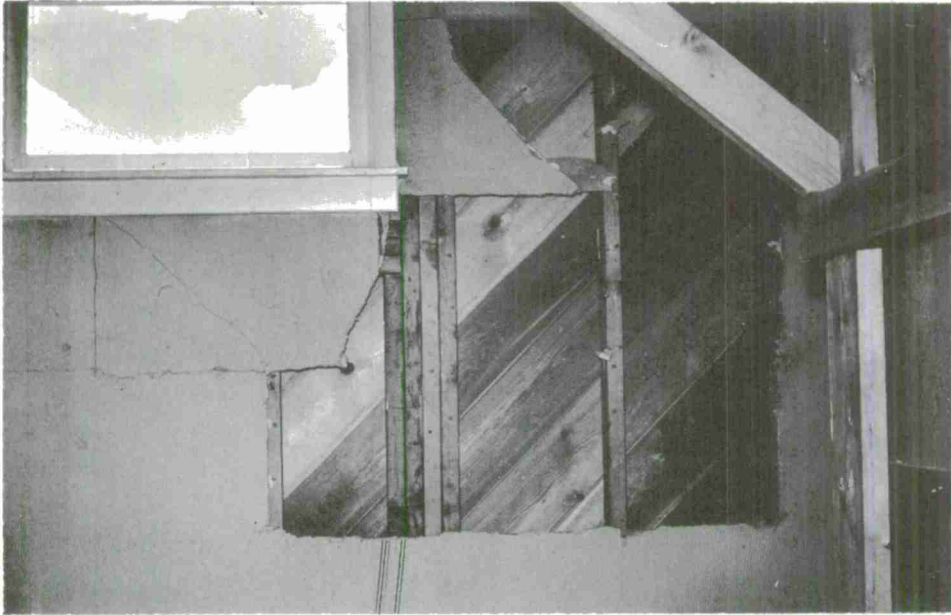
The window was blown into the room. Four out of ten studs were broken in flexure. The plaster showed both flexure and shear failure and would require about 75 percent replacement (Figure B-9).

Fig. B-9. Posttest in Third Bedroom, South Wall

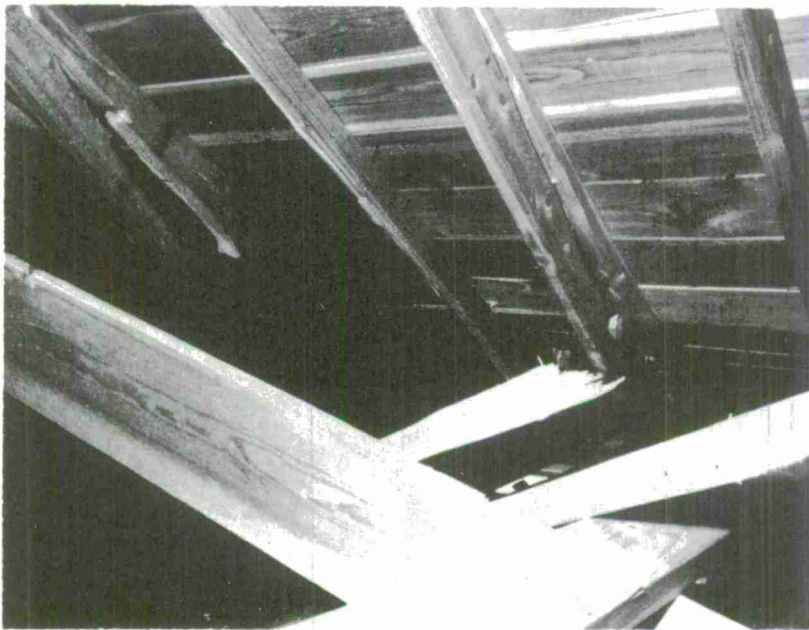
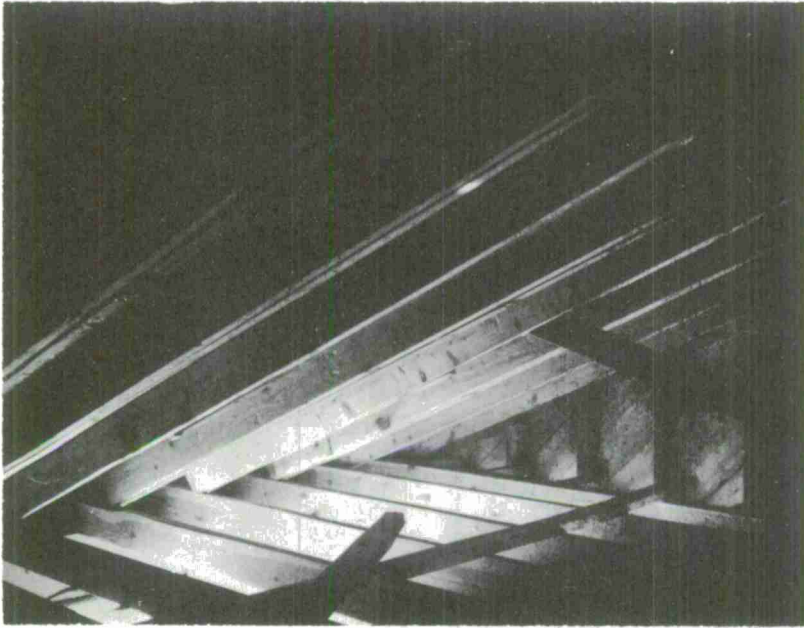
All rafters on the blastward side were broken in flexure. Also, all the blastward rafters were pulled loose from the ridge, apparently in tension rather than in shear. No failure was detected in any of the leeward rafters (Figures B-10 and B-11).

All nine 2 by 4 in. crossties were removed during the failure. All rafter to tie joints failed in shear, and four of the ties were broken in flexure.

Fig. B-10. Posttest Roof System, Blastward Side

Fig. B-11. Posttest Roof System, Leeward Side

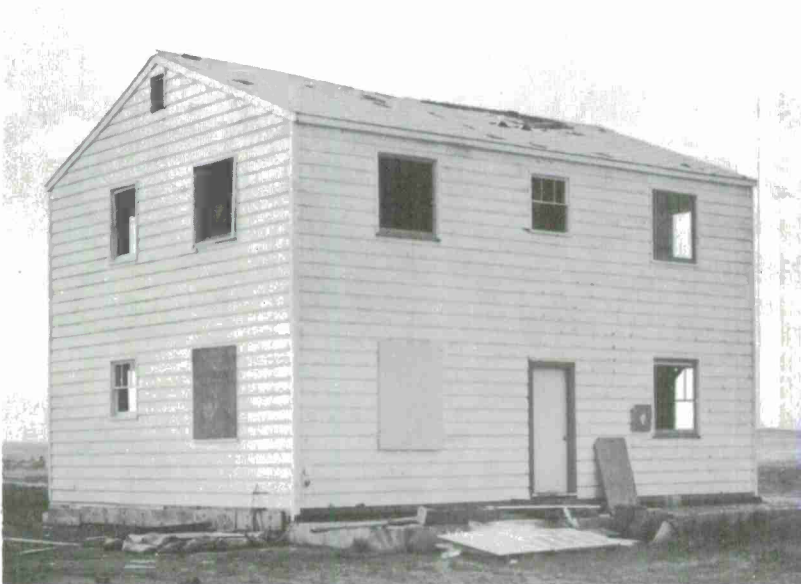
Some siding damage was noted at the corner of each window (Figure B-12).

Fig. B-12. Posttest House Exterior, East and South Sides

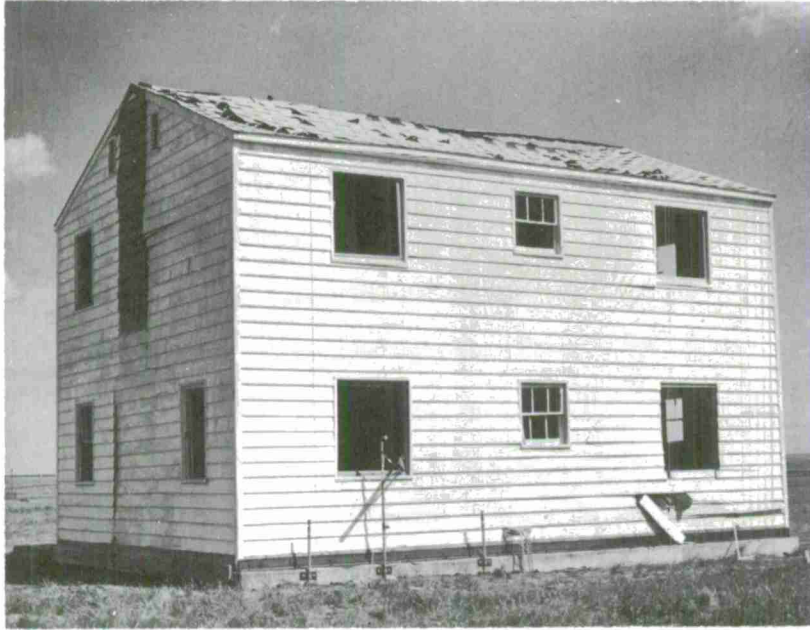
Considerable siding damage was observed under each window in the region of stud failure (Figure B-13).

Fig. B-13. Posttest House Exterior, North and West Sides
