## **USAAMRDL TECHNICAL REPORT 71-47**

# **EVALUATION OF THE UH-1D/H HELICOPTER CRASHWORTHY FUEL SYSTEM IN A CRASH ENVIRONMENT**

**November 1971**

**CONTRACT DAAJ02-69-C-0030  
DYNAMIC SCIENCE ENGINEERING OPERATIONS  
A DIVISION OF MARSHALL INDUSTRIES  
PHOENIX, ARIZONA**

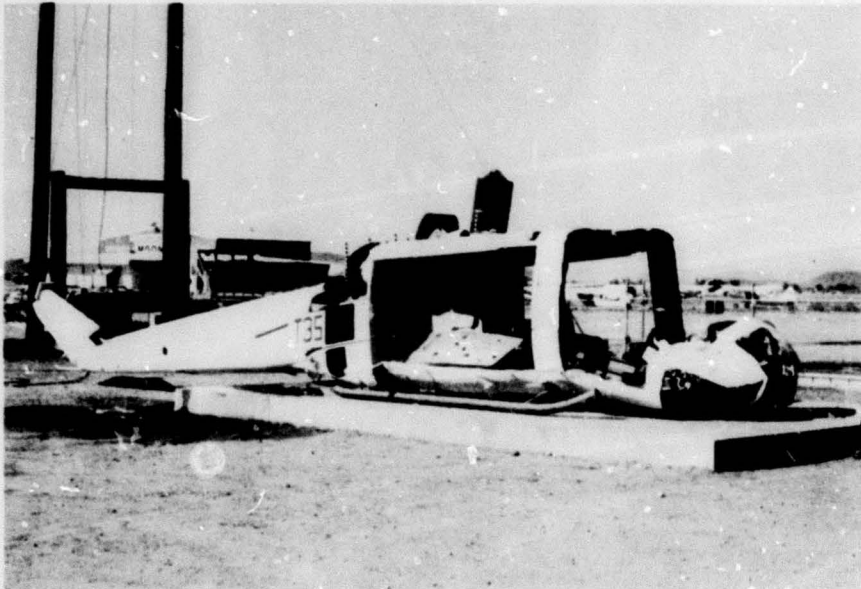
Figure 11. Fuselage Deflection - Front and Right Side (Test 1).

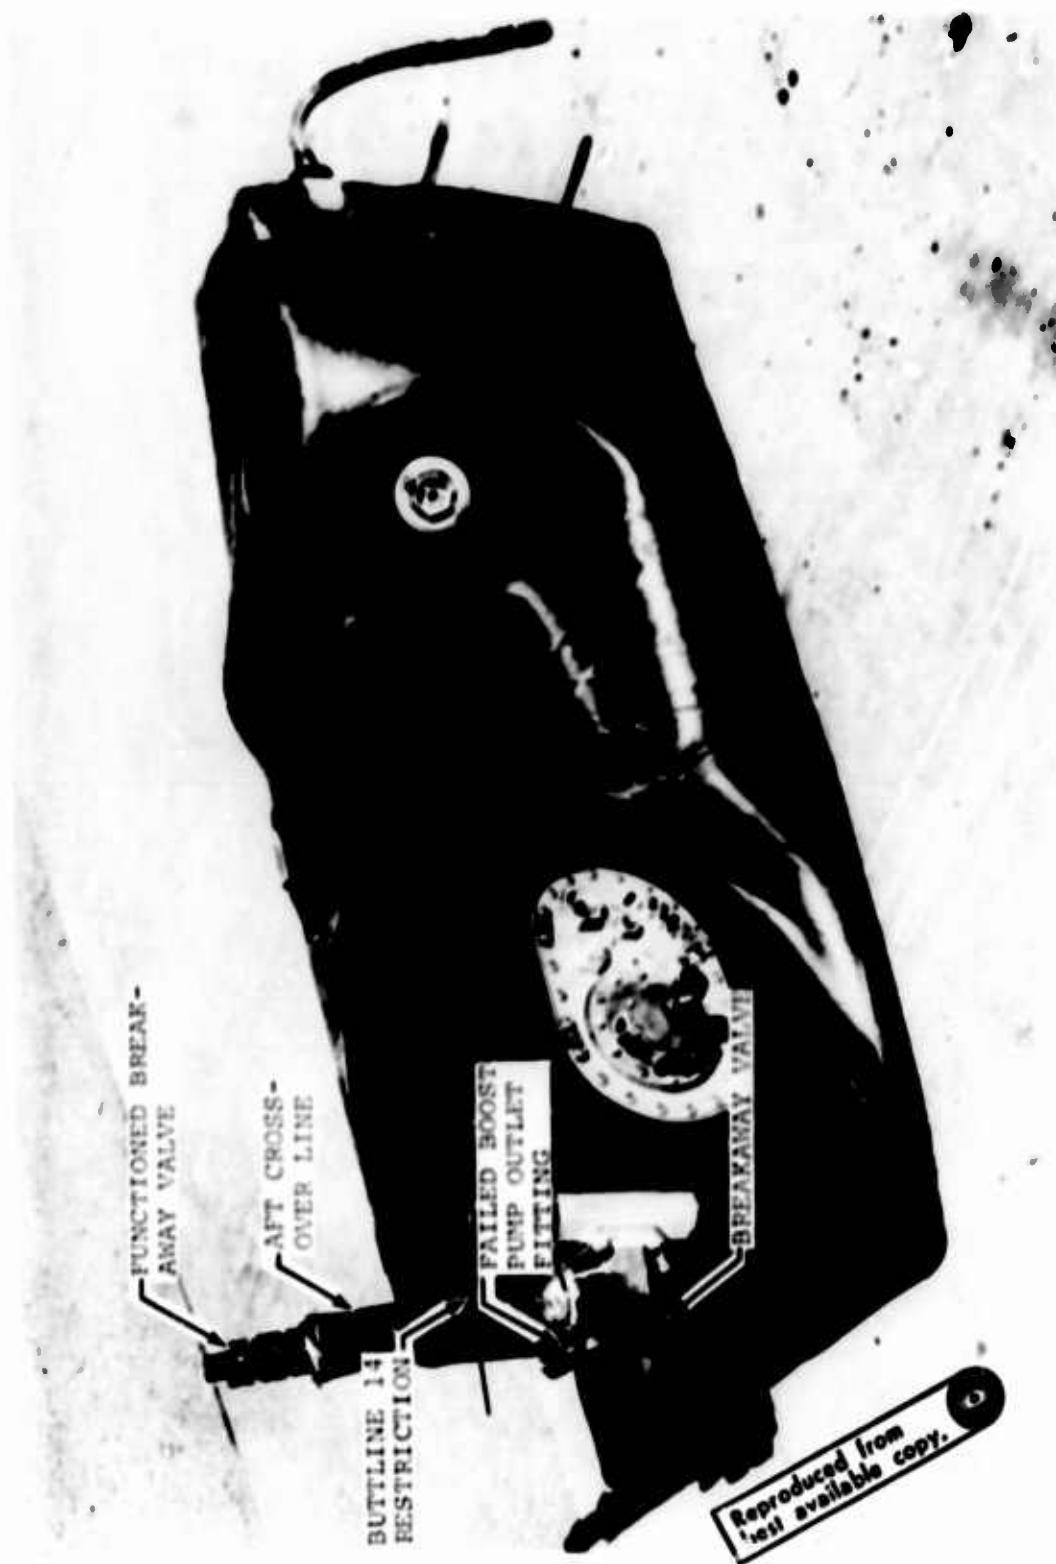
Figure 19. Aft View of Left-Hand Underfloor Cell (Test 1).

The boost line outlet from this same point failed as indicated in Figure 19. This could be expected when considering the amount of cell deflection and the fact that the boost line had no slack (as does the forward crossover) or breakaway valve. The boost pump plate was intact, but some leakage resulted from the drain valve which was opened on impact by the left forward stump. The force of the impact apparently depressed the valve and rotated it to a full ON position. The leakage from this point amounted to less than a gallon per minute (Figure 16).

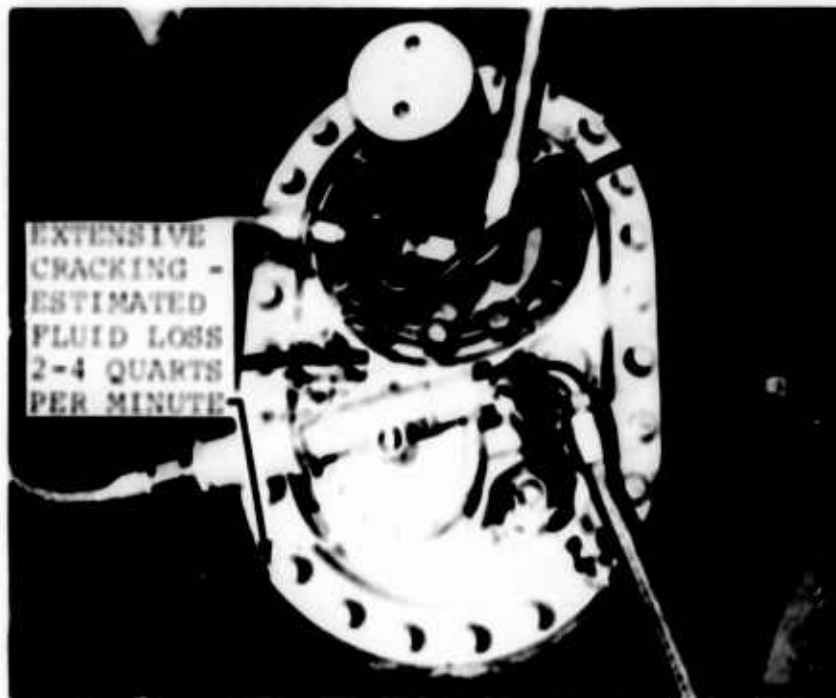
Figure 21. Damage to Right-Hand Boost Pump Plate (Test 1).

Like the left-hand tank, the right-hand tank sustained the impact without any noticeable damage to the tank itself. The rock directly under the boost pump broke the boost pump fitting in four places and cracked the base of the boost pump in three places (Figure 21). Fluid loss as a result of the damage was estimated at 2 to 4 quarts per minute. The vent valve in this cell also sheared off during the impact and both halves closed completely. The forward tie-down bolt was pulled out of the structure and remained in the tank wall. The forward cross-feed tube outlet remained in place and showed no extensive deformation in the tank area.

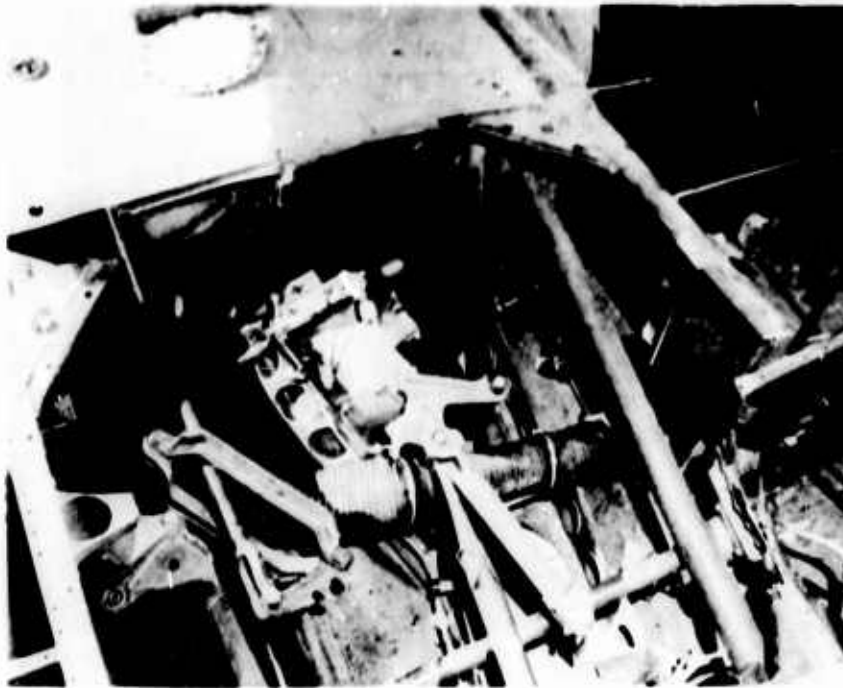
Figure 25. Forward Cross-Feed Line Failure (Test 1).

The forward cross-feed line was struck in its midsection by a boulder which caused it to separate at the fitting (Figure 25).

| TABLE I. TEST 1 COMPONENT REACTIONS AND HAZARD RATINGS | | |
|---|---|---|
| Forward cross-feed | Failed center | Low Hazard |

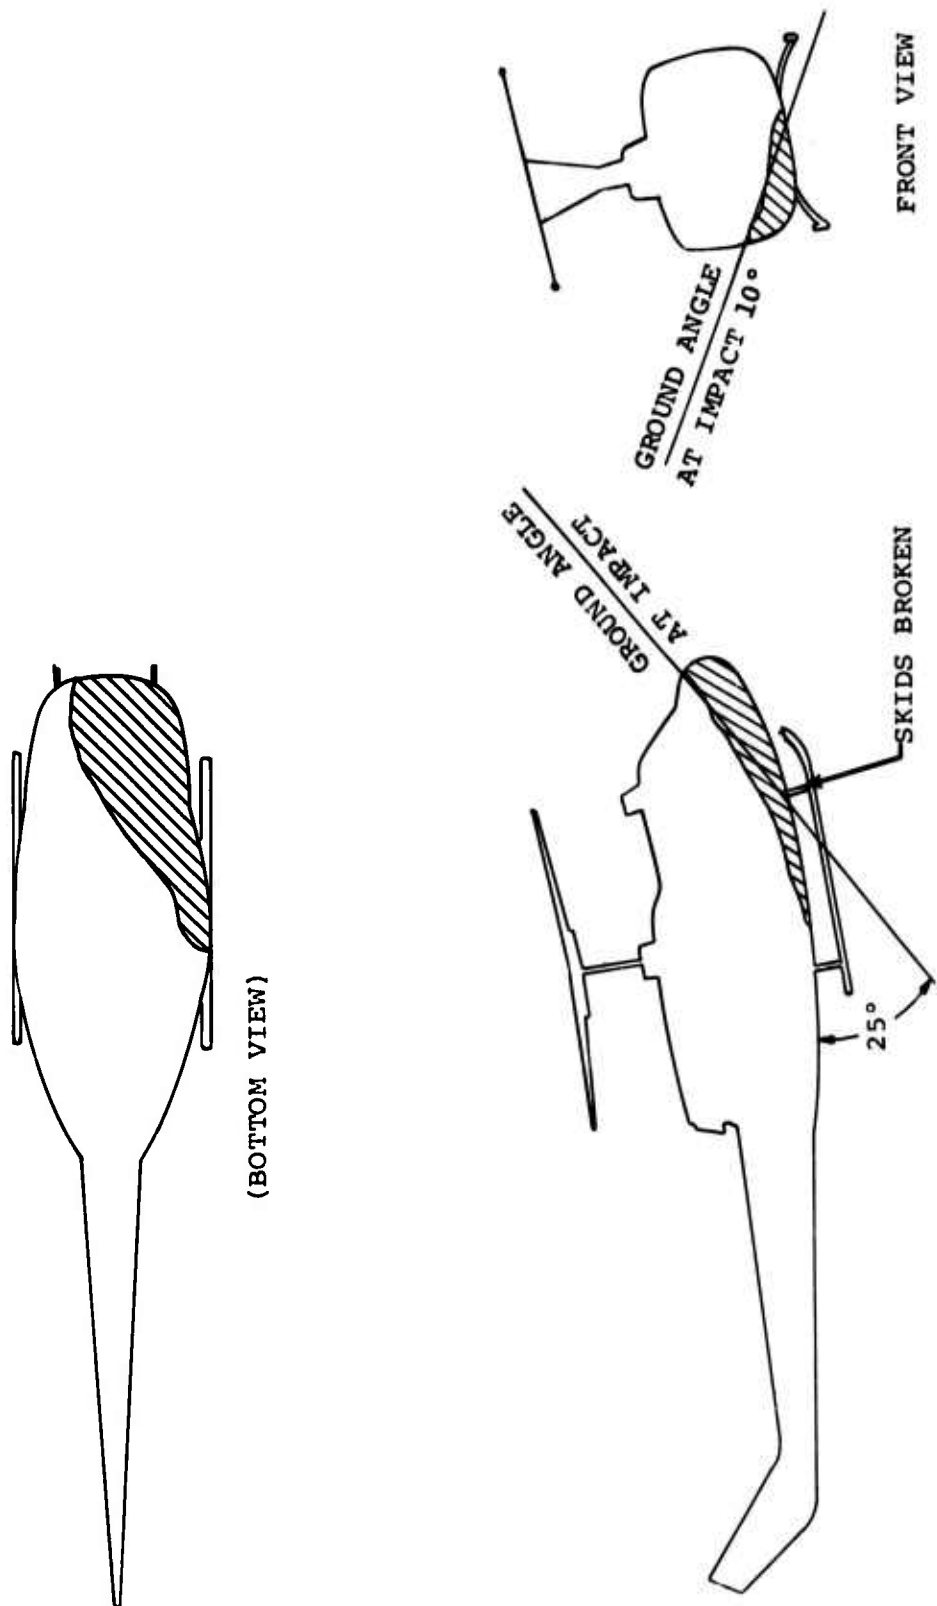
The top half of the transmission failed, and its tie-bolts broke away from its base. The engine buckled its mounts and was displaced downward and to the right, but the fuel lines remained in place. The landing skid was severely damaged, and the tail boom was also badly buckled. The remainder of the aircraft suffered considerable deformation of the right forward area. The major portion of this damage did not extend to the left side of the aircraft, as Figure 35 indicates. The high-speed films revealed two reasons for the minimal damage to the fuselage. As the vehicle rotated into a nose-down attitude, its effective drop height was diminished by approximately 6 feet, as Figure 34 illustrates. Second, the whipping of the cable induced by the initial jerk of the trolley put a considerable bind on the guides throughout the entire sequence, thereby greatly increasing the friction in the system and causing a further reduction of the velocity. The actual striking velocity was determined by scaling the high-speed

Figure 35. Impact Damage (Test 2).

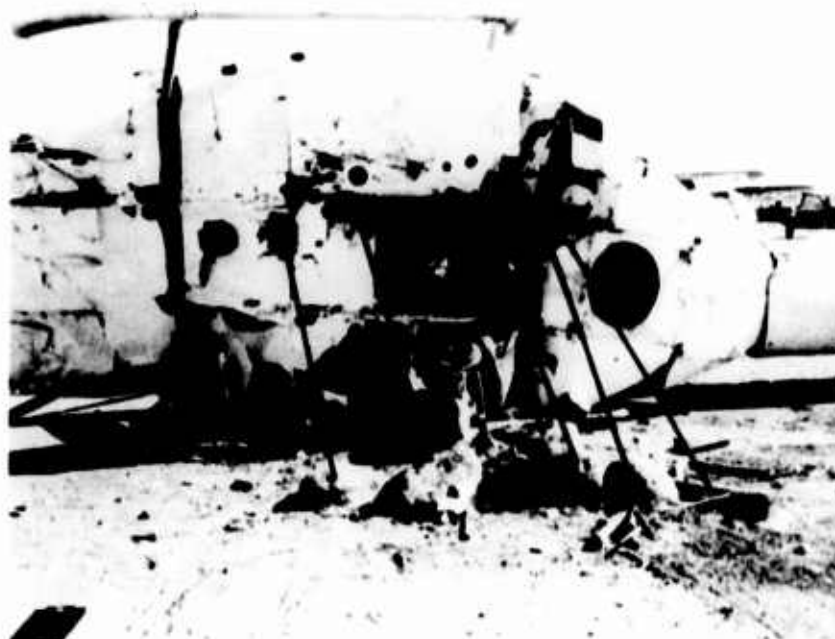
Figure 44. View Showing Impact Points on Underside of Fuselage (Test 3).

further data could be collected from the top side, the aircraft was rolled onto its right side and the damage assessment continued. The underside of the cell had received a glancing blow from a boulder on its very inboard edge. The only reaction from this was the separation of the frangible connector of the forward drain line. Figure 44 shows this and other impact points on the bottom of the fuselage. Another boulder struck the inboard side of the aft inlet/outlet fitting of this cell. This and/or the rock directly behind it caused the inlet/outlet breakaway valve to separate. The forward half of the valve sealed, but the aft half lost its poppet. The line connected to this valve was not draining because both aft drain valves on this side had functioned and sealed. A close inspection of the inlet/outlet breakaway valve showed that the boot had failed at the seat, allowing the poppet unimpeded ejection.

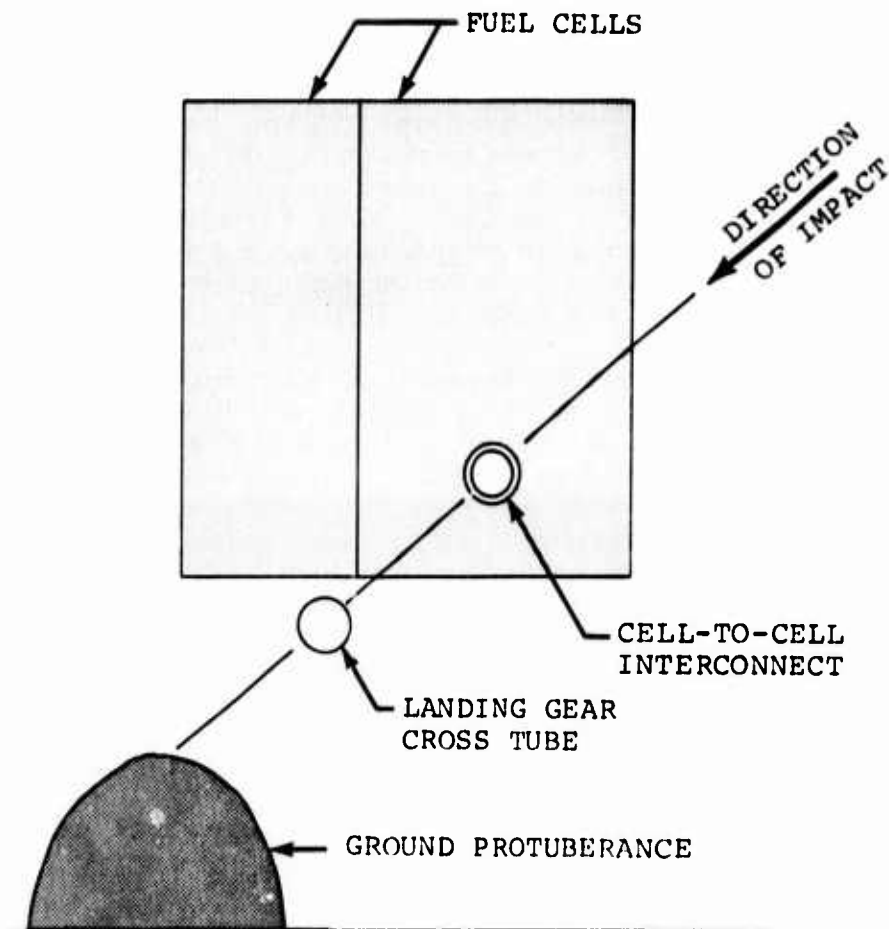
Figure 46. Relationship of Landing Gear Cross Tube and Aft Cells.

protuberance higher than 14 inches. Fortunately, the probability of a direct strike in this area is relatively low, especially if there is a forward component in the striking attitude. The reason is that the relatively small critical impact area of the fuel cells is hidden behind the landing gear cross tube (Figure 46). Impact on this cross tube would be sufficient to transmit the concentrated impact load uniformly to both cells, thus greatly diminishing the hazard. This is not to say that cell-to-cell breakaway valves are not desirable. The threat still remains that failure of one of these fittings would greatly increase the probability of catastrophic fire.
