FAA-AM-72-7

## EVALUATION OF A FIBERGLASS INSTRUMENT GLARE SHIELD FOR PROTECTION AGAINST HEAD INJURY

February 1972

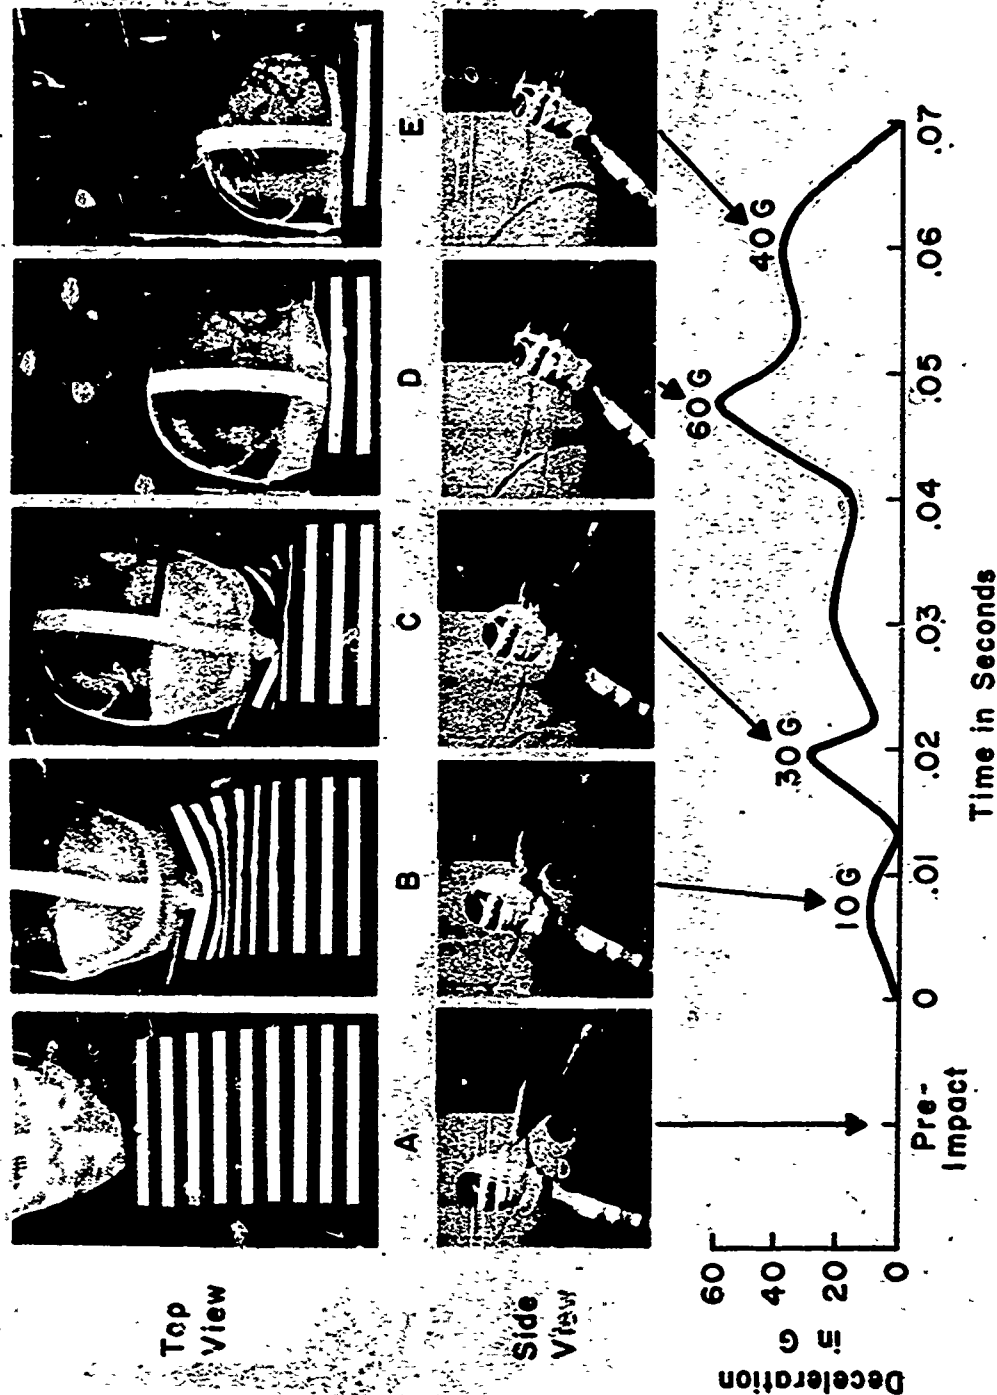
Figure 4 presents a pictorial sequence of events correlated with deceleration measured during Test One (30 ft./sec. head impact velocity). The initial head contact with the edge of the glare shield was with the maxilla just below the

nose producing an initial deceleration peak of 10 G's followed by a second peak of 30 G's as the shield began to collapse. Chalk deposited on the head form from the edge of the glare shield during this phase of the impact was lifted by means of masking tape and the area of facial contact determined to be 3.75 square inches. Based on previous research,<sup>7</sup> it appears unlikely that major facial fractures would occur during this initial head impact. From 0.025 seconds to 0.04 seconds, the glare shield folded down over the instruments and prevented head contact with them. However, beginning at about 0.04 seconds, the fiberglass broke about 6½ inches from the edge of the glare shield. The thin edge of the shield, supported by the instrument panel flange penetrated the ¼-inch padding and cut the rubber head form covering, as shown in Figures 5 through 8. A peak head form deceleration of 60 G's was produced as the rigid head form contacted this thin edge. In Reference 7 it is stated that the forehead can tolerate 80 G's on one square inch without bone fracture. If we assume that the forehead contacted a four-inch length of this 0.035-inch-thick fiberglass edge, we can calculate a contact area of 0.14 square inch and any impact deceleration in excess of 12 G's would be expected to produce

FIGURE 4. Results of a 30-ft./sec. head impact against the fiberglass glare shield.
