FIRE TESTING OF INDEPENDENT FIBERGLASS  
FUEL TANKS WITH AND WITHOUT PROTECTIVE  
COATING OF FIRE RETARDANT PAINT

UNITED STATES COAST GUARD  
OFFICE OF RESEARCH AND DEVELOPMENT  
APPLIED TECHNOLOGY DIVISION

LTJG J. D. RICHART, USCG  
MERCHANT MARINE TECHNICAL DIVISION  
OFFICE OF MERCHANT MARINE SAFETY

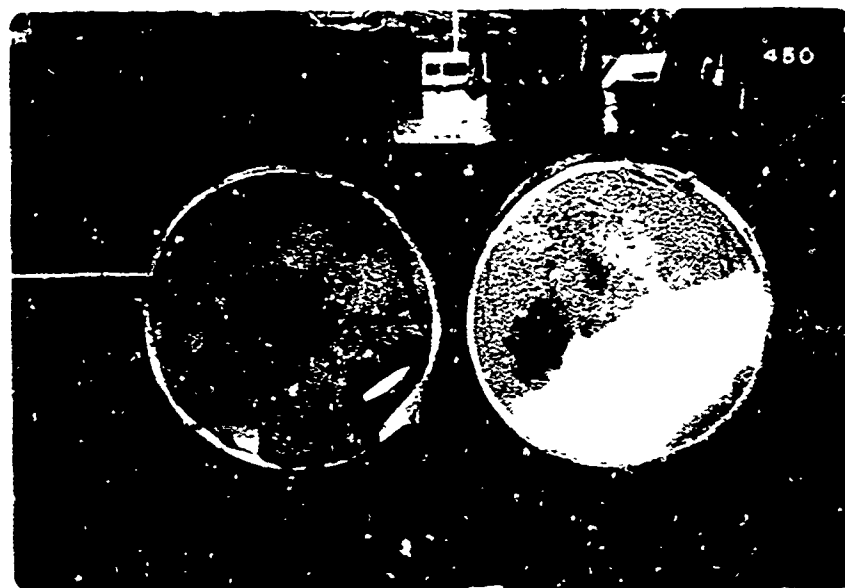
Results of tests conducted on the eight independent fiberglass fuel tanks are summarized in Table I. Tests #1 and #2 were both for 2m30s and the time-temperature data were close to the YSB criteria for the 2m30s gasoline fire test (see FIG. 1, reference (1)). Photographs (3) and (4) show the internal appearance to be very good for both tanks. The unpainted tank has charred somewhat, causing some degradation of wall soundness, but both tanks could withstand several minutes more fire exposure before failure.

PHOTOGRAPH # 4: Test #2, tank  $\frac{1}{4}$  full of diesel fuel, painted, 2m30s of fire exposure. Note soundness of tank wall.

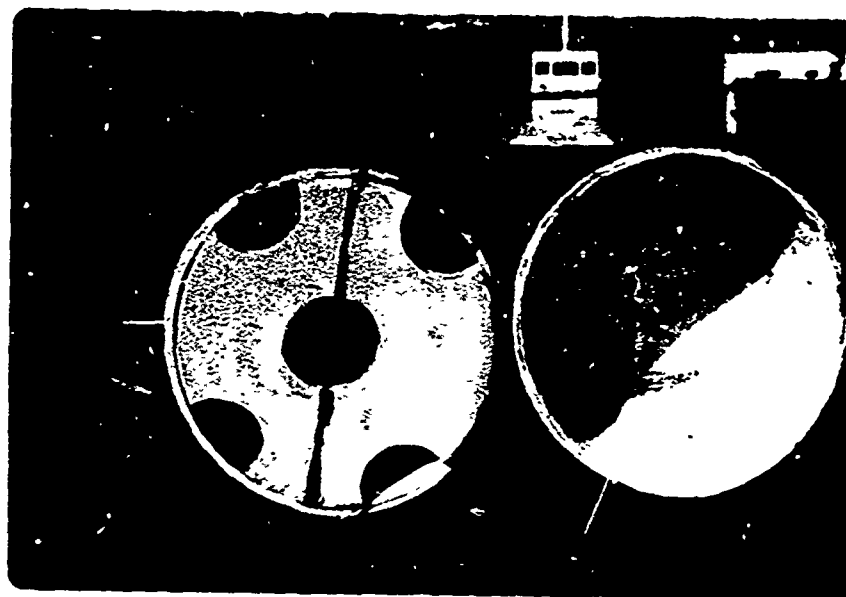
PHOTOGRAPH # 11: Test #4, painted tank after opening, showing excellent internal appearance of baffle and tank wall.

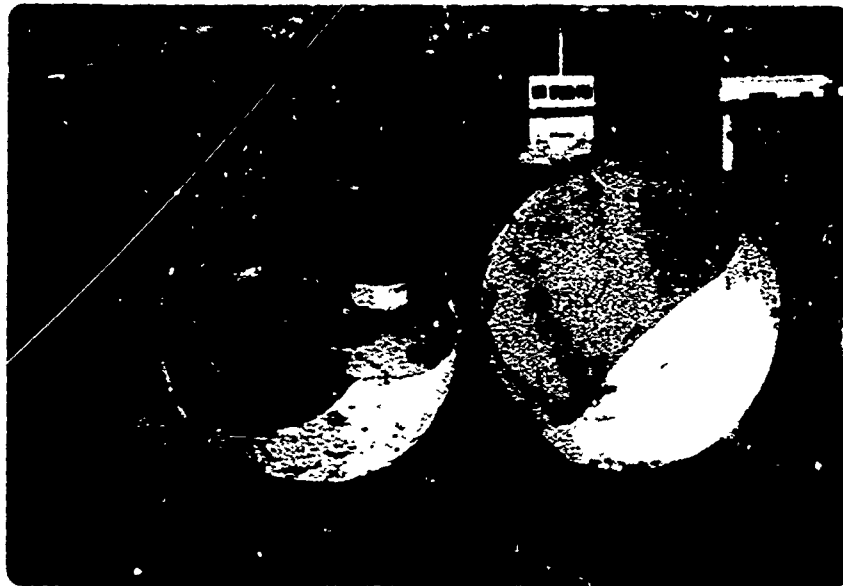
tank. No . photograph (14). The interior appearance of the tank, p otograph (15), was good and there was no significant delamination of the tank wall. The leak which caused termination of the test may have occurred at a nail site around the baffle region. However, indications were that the test would have been stopped before the desired 10 minute point for other reasons. The internal temperature, shown on FIG. 7, was rising rapidly at the seven minute mark. The fuel drum was red hot along its entire length at the time of extinguishment.

PHOTOGRAPH # 15: Test #5, painted tank's internal appearance. Baffle broke loose upon cutting tank in half, but appears in good shape.

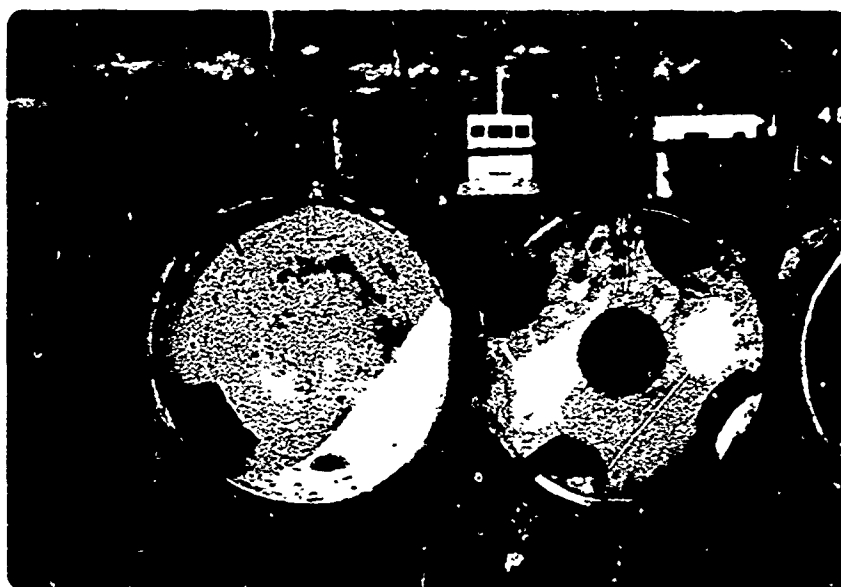
PHOTOGRAPH # 19: Test #6, unpainted tank's internal appearance after fire. Note delamination in right half of tank.

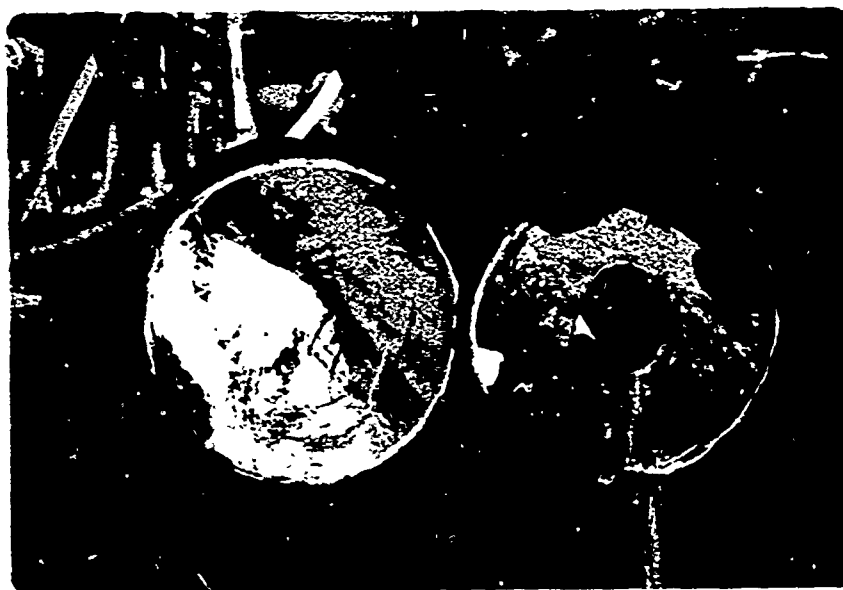
PHOTOGRAPH # 24: Test #7, internal appearance of unpainted tank after fire. Note baffle and charred wall about 3/8 inch of which is delaminated in upper right half of tank.

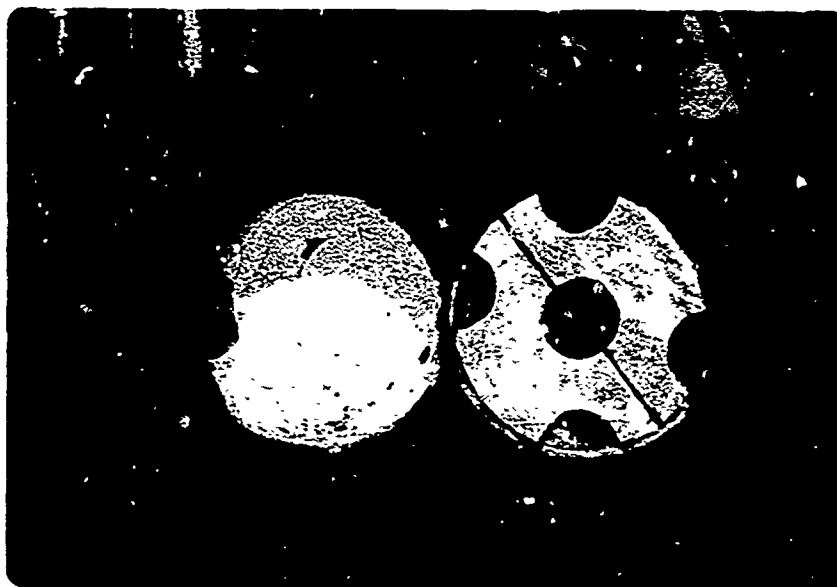
PHOTOGRAPH # 28: Test #8, painted tank after 11m00s fire. Delamination took place along outside  $\frac{1}{4}$  inch of wall. Otherwise, the interior was in good condition. Compare the baffle to its counterpart in Test #7.
