MISCELLANEOUS PAPER NO. 6-761

# SONISCOPE INVESTIGATION OF ELMENDORF AFB HOSPITAL ANCHORAGE, ALASKA

December 1965

The hospital building at Elmendorf AFB, Anchorage, Alaska, was damaged by the earthquake of 27 March 1964. Developments occurred during the progress of work designed to repair the damaged concrete which led to a request for a soniscope investigation. The U. S. Army Engineer Waterways Experiment Station (WES) furnished a soniscope crew to make velocity measurements on concrete of suspected inferior quality in areas designated as most critical from a structural standpoint.

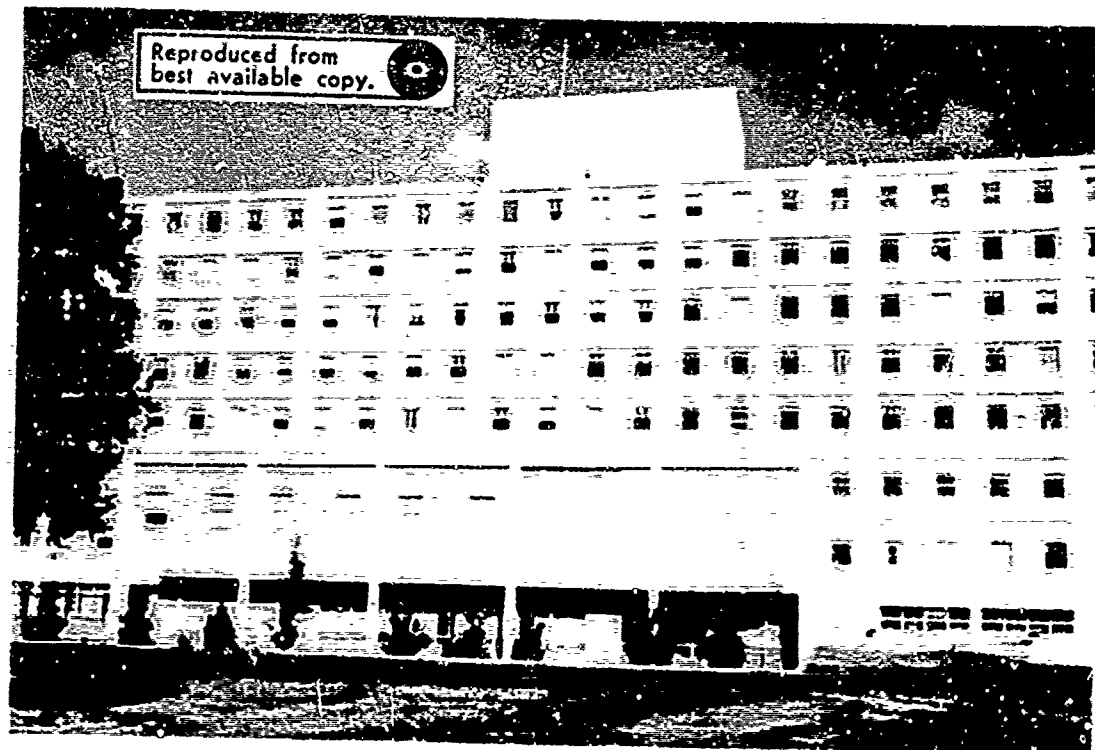
Fig. 1. South side of Elmendorf AFB Hospital

1. The hospital building at Elmendorf AFB, Anchorage, Alaska, was one of the many structures damaged by the earthquake which occurred on 27 March 1964 (fig. 1). During the progress of work designed to repair the concrete by grouting with epoxy resin, it became apparent that the work was not completely successful. Complete filling could be obtained in the fine cracks, but the wider cracks were not always completely filled. Cores drilled from cracked areas showed compressive strengths ranging from 100 to 5000 psi. These developments led to a request for a soniscope investigation. It was thought that a well-planned series of pulse velocity readings would permit an intelligent estimate of the condition of the structure and of the success of the grouting operations which were in progress.

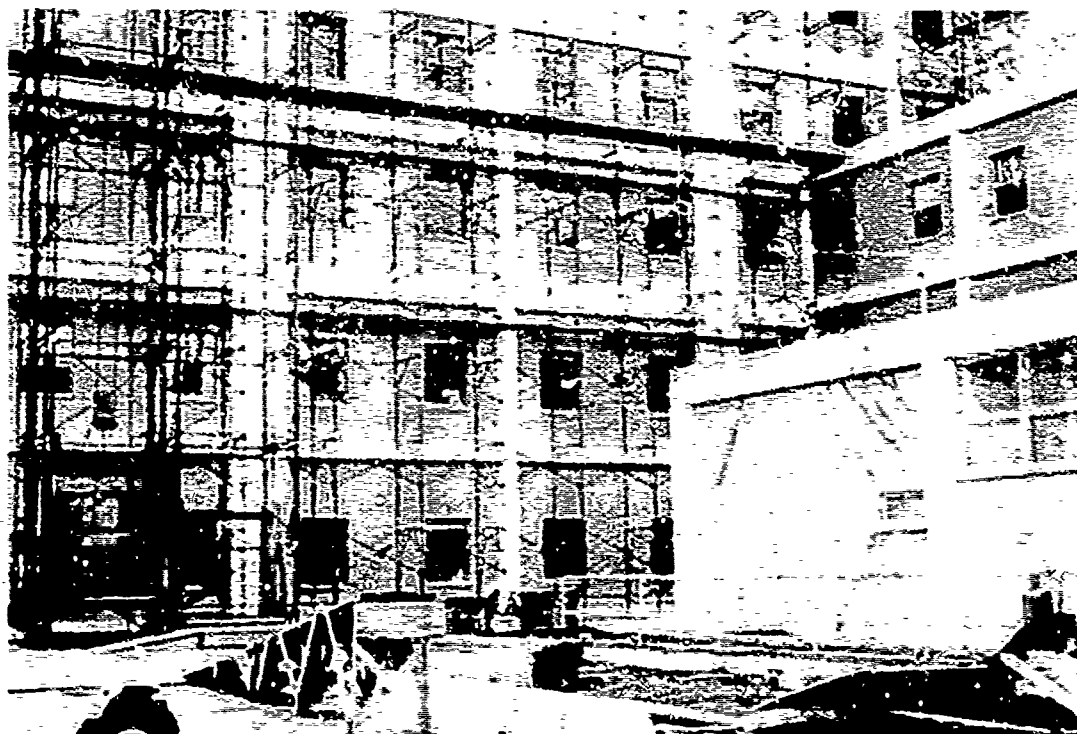
Fig. 5. Third-floor spandrel beam (first wide beam)  
and columns 8 (wide), 10, and 12 (wide)

14. Readings were taken through the outer 6 in. of column-beam connections at columns 8, 10, and 12 (fig. 5) to determine the extent of penetration in the outer face. The locations of these stations and the results of tests are recorded in tables 18, 19, and 20.
