Report No. FAA-RD-72-25

# SONIC BOOM AND NATURAL DETERIORATION EFFECTS ON BUILDINGS: WHITE SANDS, N.M. STRUCTURE RESURVEY

J.H. WIGGINS, JR.

FEBRUARY 1972  
FINAL REPORT

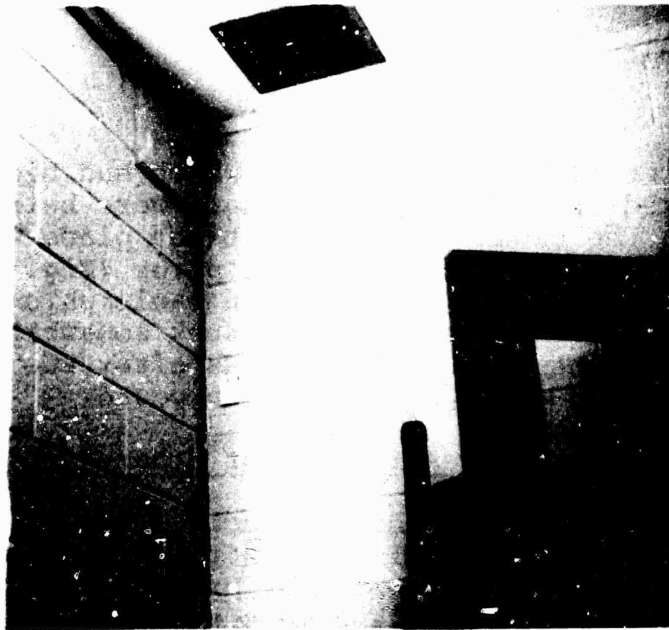
Mr. Bradley noted to me that the ORC Station had been completely redecorated, painted and all cracks caulked about 6 months prior to Feb. 24, 1972. Yet this concrete block building showed new cracks which had been photographed in the chief's office (Fig. 1) and new cracks in the power room (Fig. 2) and bathroom facilities. No booms of any significance had taken place since the time of redecoration.

Fig. 1 An old crack has opened up in the Station Chief's office at the ORC Station 6 months after redecoration.

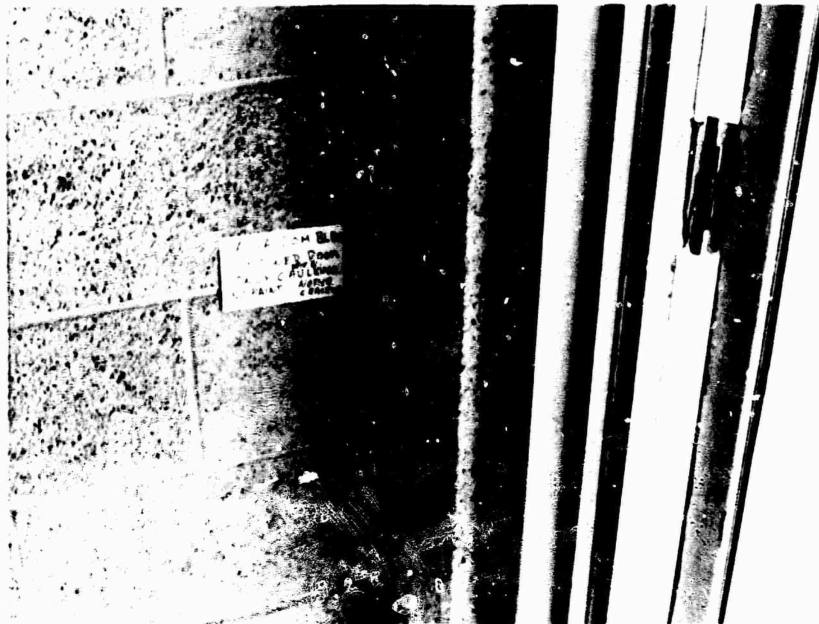
Fig. 2 Cracking has continued after caulking but not repainting in the ORC Station Power Room after 6 months time.

quarter to a half inch wide which had been recently caulked but not painted. There were hair-line cracks about the caulking that had taken place since the caulking was made six months prior (Fig. 2). He also mentioned that a subterranean vault which contains the cabling for the station had sunk somewhat requiring replacement of the vinyl tiles after the depressions were build up by a grouting compound.

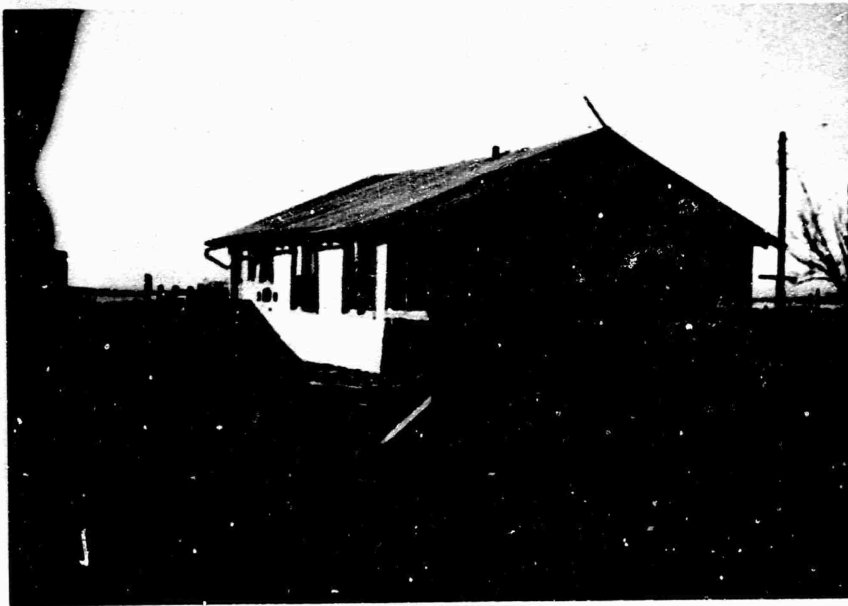
I visited the "Abandoned Ranch" shown in Figs. 3 and 4. Its condition is still bad with the additional glass damage. It was reported by Mr. Withers that the glass was broken by vandals some time earlier.

Fig. 3 "Abandoned Ranch" is still in bad condition. The windows were broken by vandals, as reported by Mr. Withers. All were new and unbroken at the beginning and end of the program.

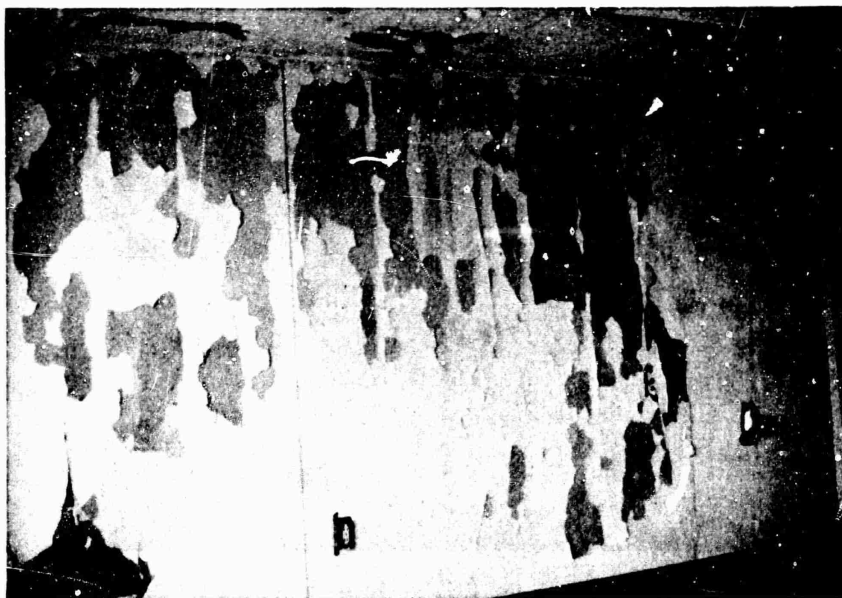
Fig. 4 The interior of the "Abandoned Ranch" is still in bad condition.

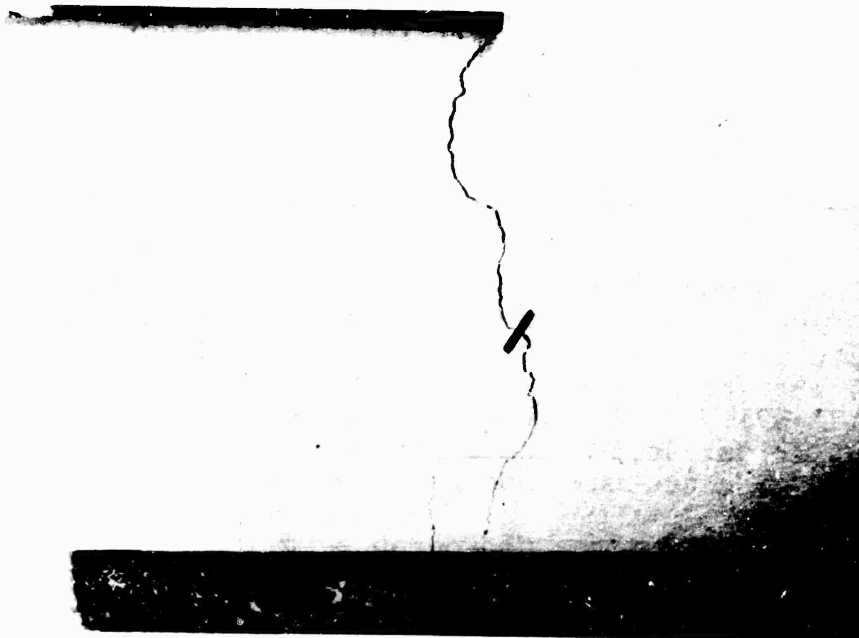
On the exterior of the ranch house a crack was found which Mr. Paul Freund monitored throughout the program which flew 10 psf. and larger boom intensities over the property. No movement was noted during the program beyond the mark in Fig. 7. In the last seven years, however, settlement has caused the crack to extend.

Fig. 7 Crack extension over the last seven years at Wither's ranch.

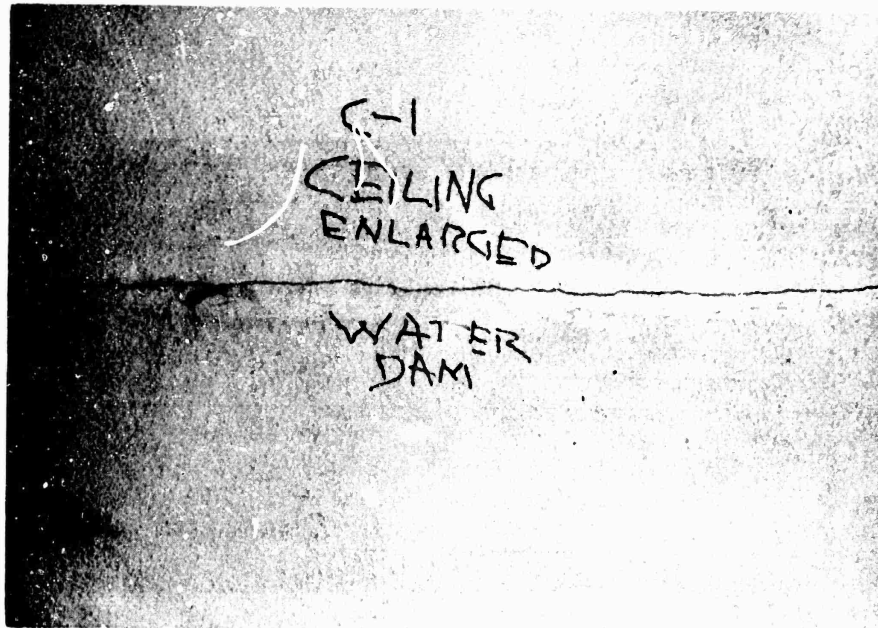
Fig. 13 Typical enlarged crack in C-1

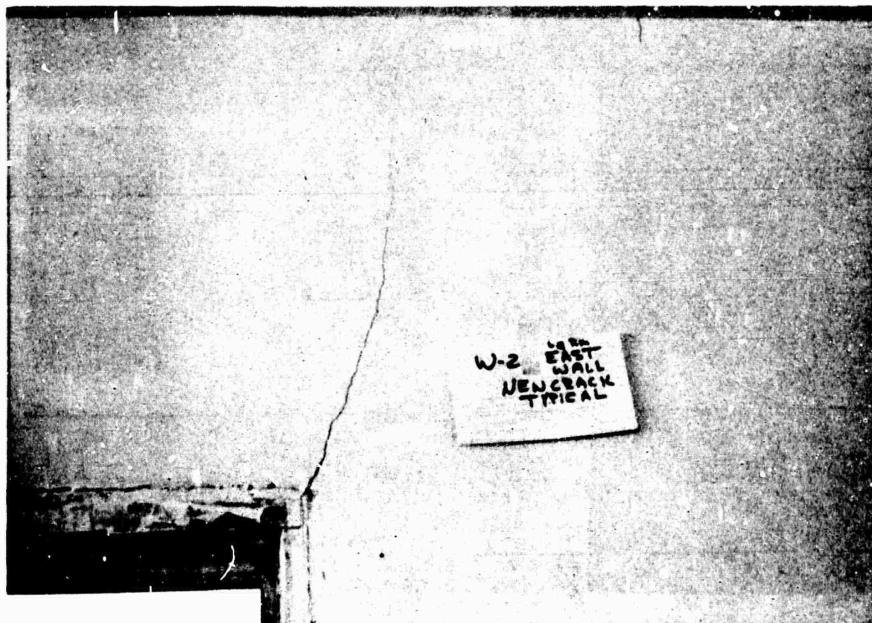
Fig. 20 W-2, Typical new crack

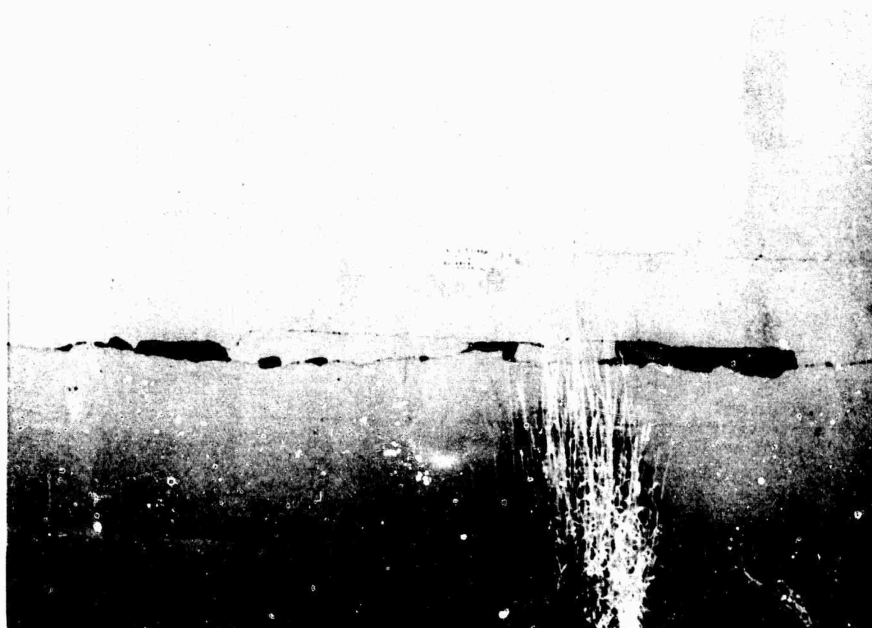
Fig. 25 W-3, Typical Exterior Damage

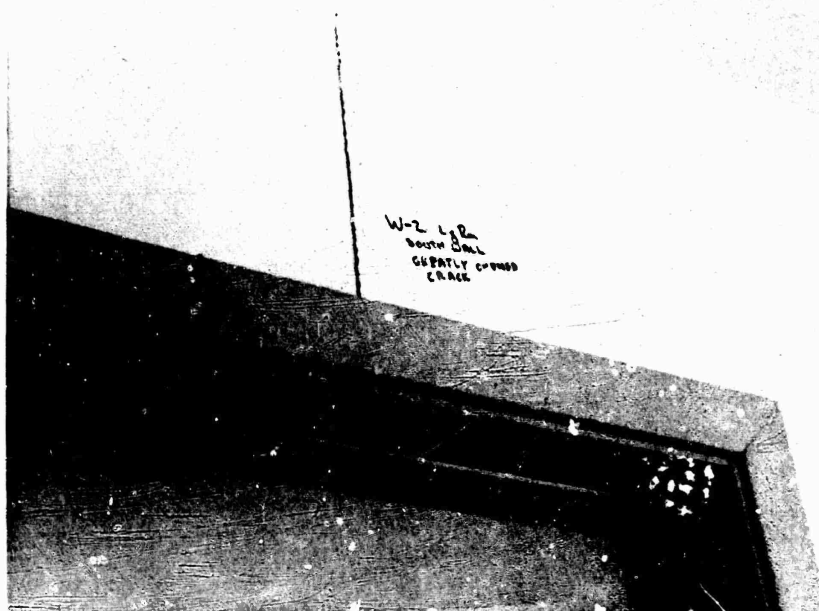
Fig. 26 w-3, Old Crack Marked 5-20-65 Has Greatly Enlarged

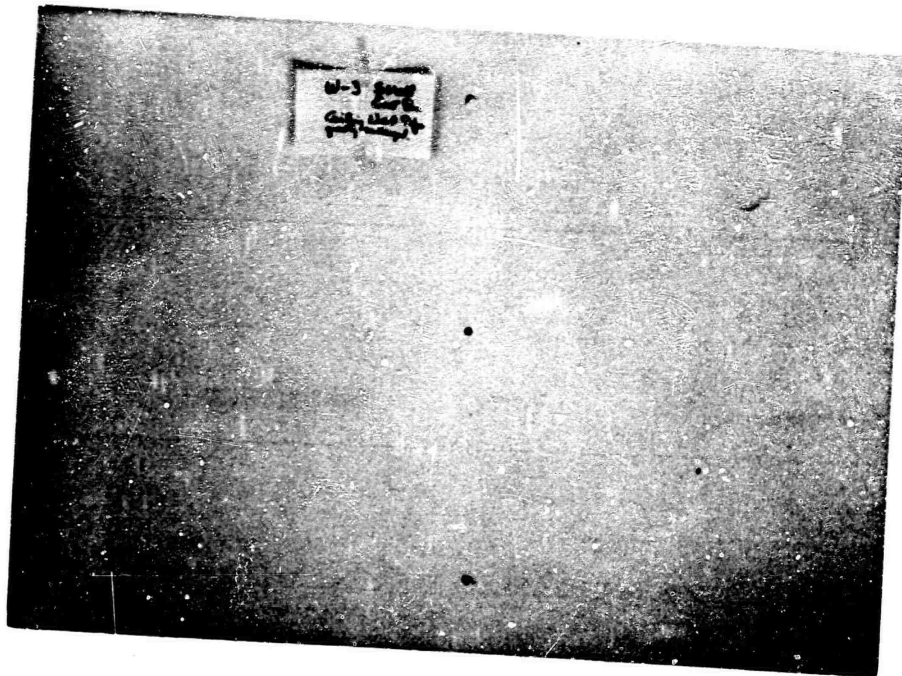
Fig. 27 W-3, New Nail Pops Recorded after the 5-2-65 Inspection. No Nail Pops Occurred as the Result of Booms up to 23.4 psf overpressure During Part B

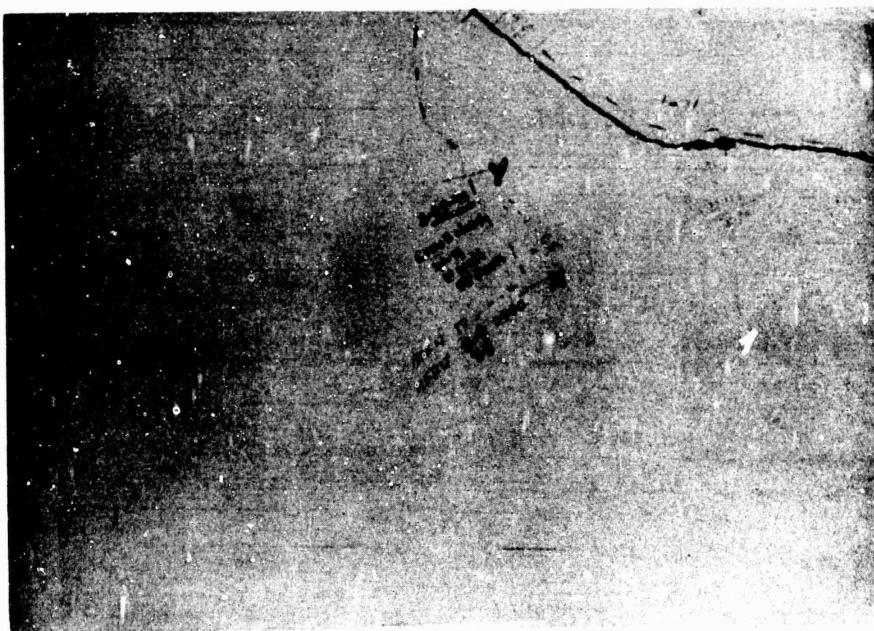
Fig. 32 W-4, Crack Which Had Opened to Point x  
on 2-9-65, Had Closed to Point y on 2-25-72

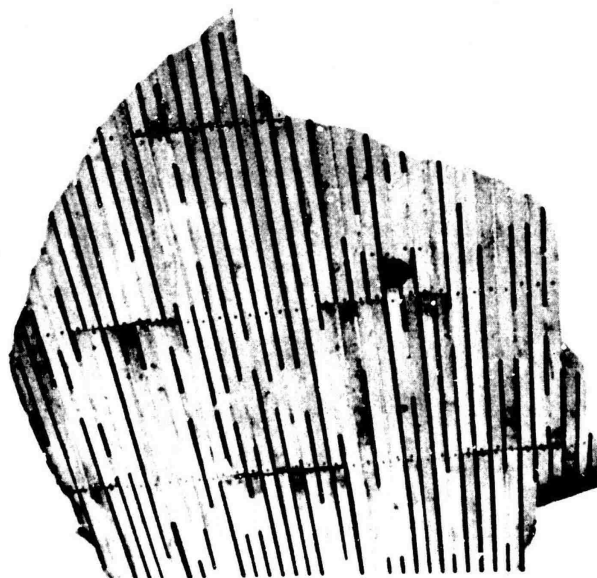
The upper living room ceiling in 2S-5 had collapsed and the second floor east wall had also been broken out about 2 inches. The brick work on the fireplace in 2S-5, however, was in absolutely perfect condition and suffered no damage during the last seven years. The wooden floors were quite weathered and some of the ceilings showed minimal leakage. There was some water damage in many of the buildings.

Fig. 38 2S-5, Fallen Ceiling in Second Story,  
Plaster on Wood Lath

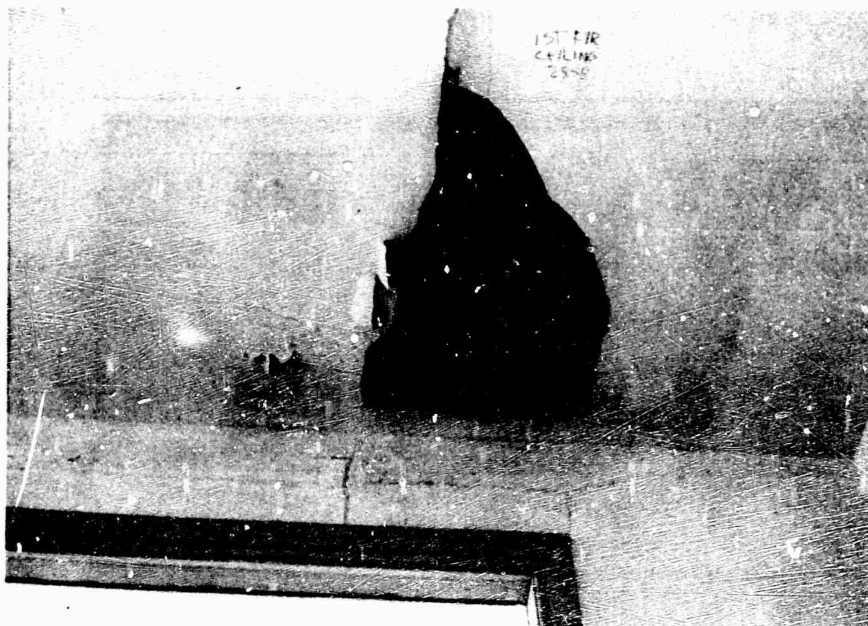
Fig. 39 2S-5, Ceiling in 1st Floor. Note Extreme Contraction of Wood Lath Giving Low Bond Strength to Plaster Keys.

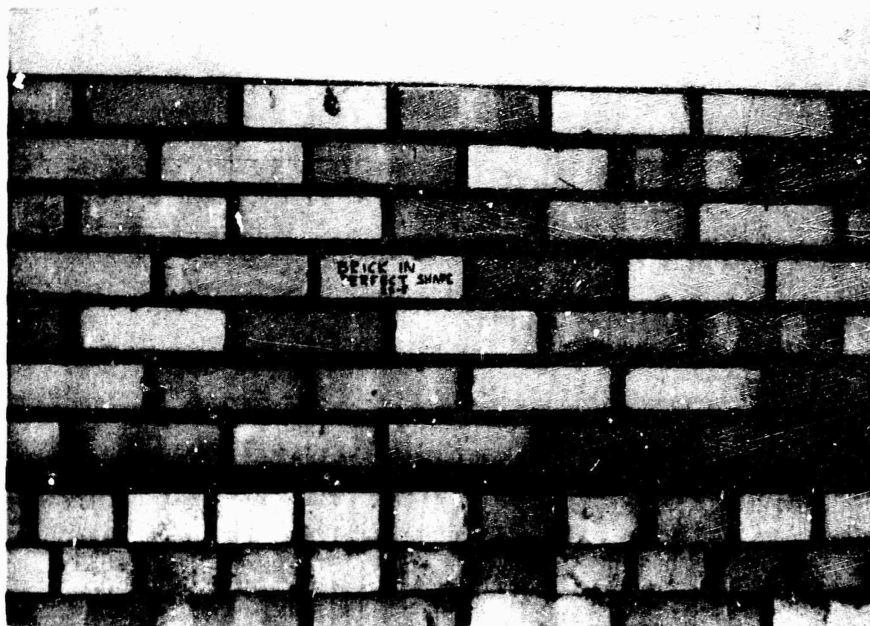
Fig. 40 2S-5, Fireplace Masonry in Perfect Condition

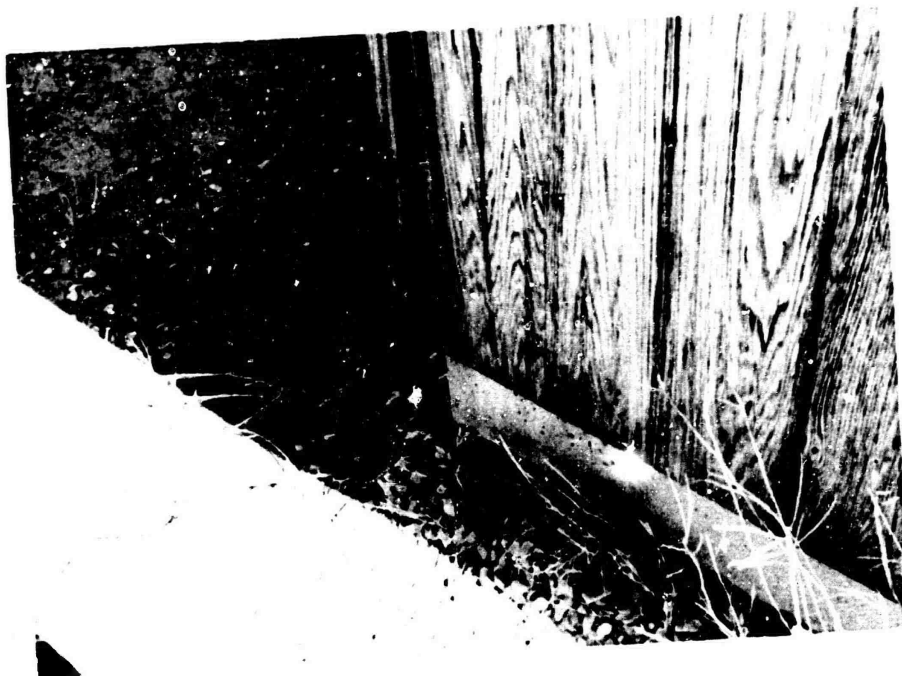
Fig. 45 PF-6, Closeup of Northwest Corner Damage

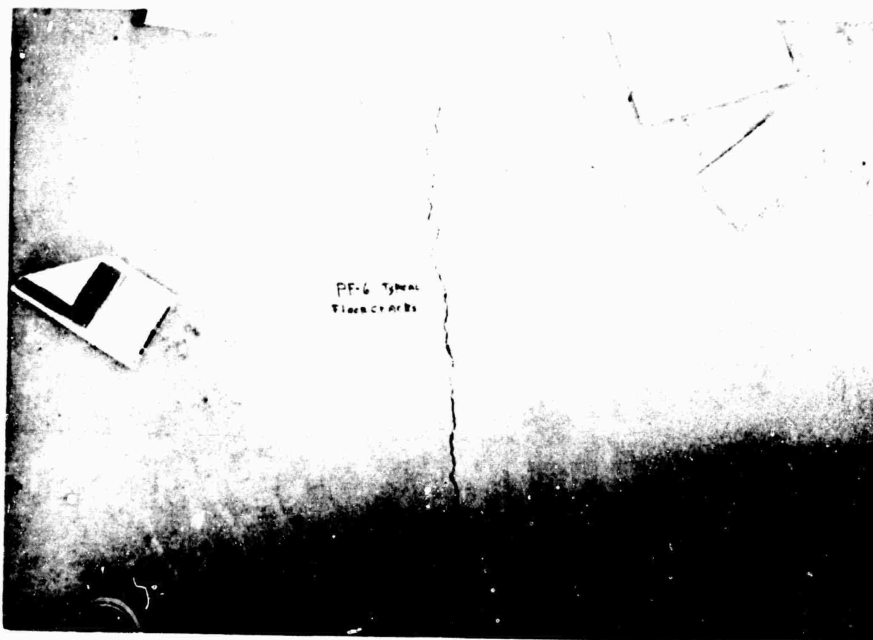
Fig. 47 PF-6, Floor Cracks in Building Not Found in C-1, W-2 due to Different Slab Design (See SST 65-15 (Vol. 2) Dwg B-3 and B-9).

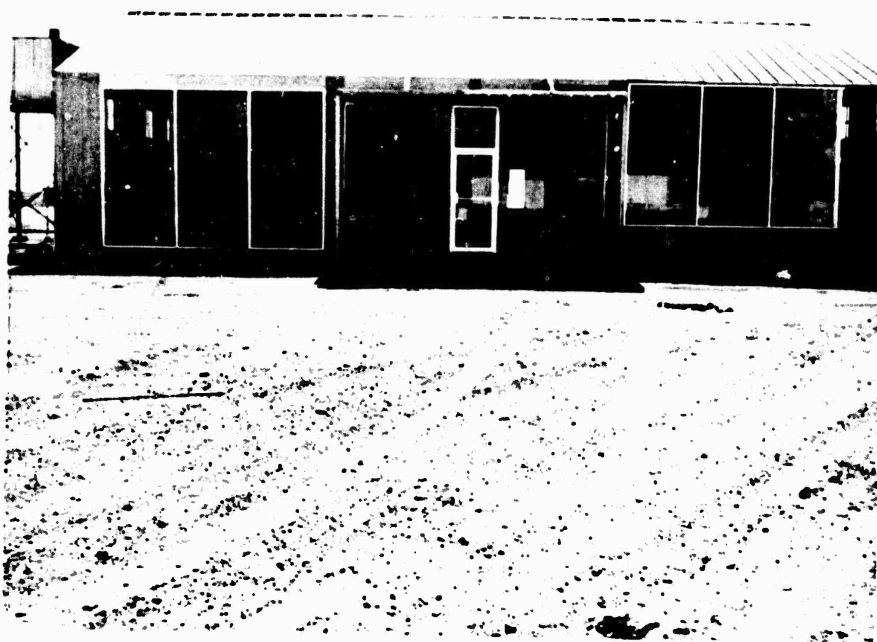
The Store-Front had two windows broken. The center solar gray glass (panel b) in the left three panels had broken. The mechanism of damage to the large window on the right

Fig. 48 Store Front, Window on Right and Solar pane on left are Broken

side of the Store-Front building did not look like sonic boom damage since it was highly localized in the top center portion of the frame. Using the techniques described by Wiggins\* the probabilities computed for these two windows to be broken by sonic boom and not panels d and e leaves doubts as to sonic boom being the cause of damage.

These probabilities suggest that booms did not break the panes of glass. Further, since the broken panes were boarded up, panes d and e are considered to be the original panes used on the program and have not been replaced since 5-20-65.

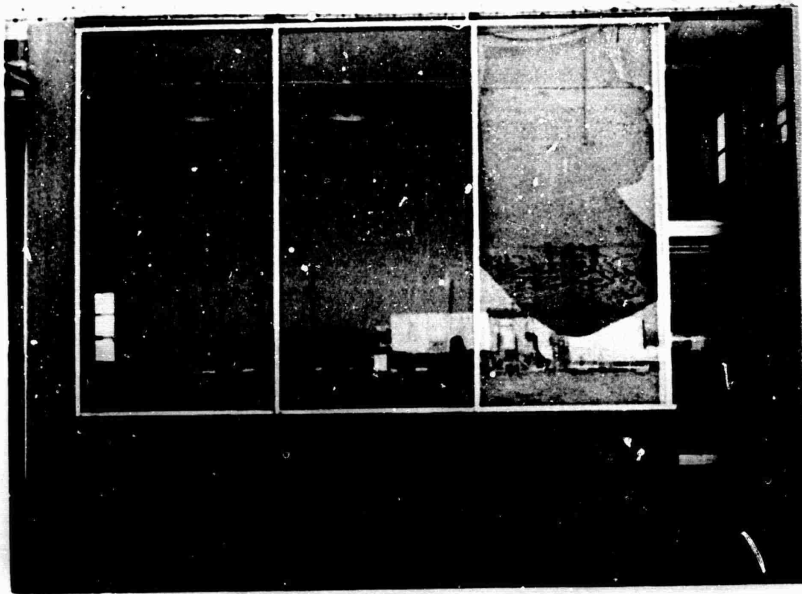
Fig. 49 Store Front, 5' 0" x 9' 6" x 13/64"  
(actual thickness) Broken Pane

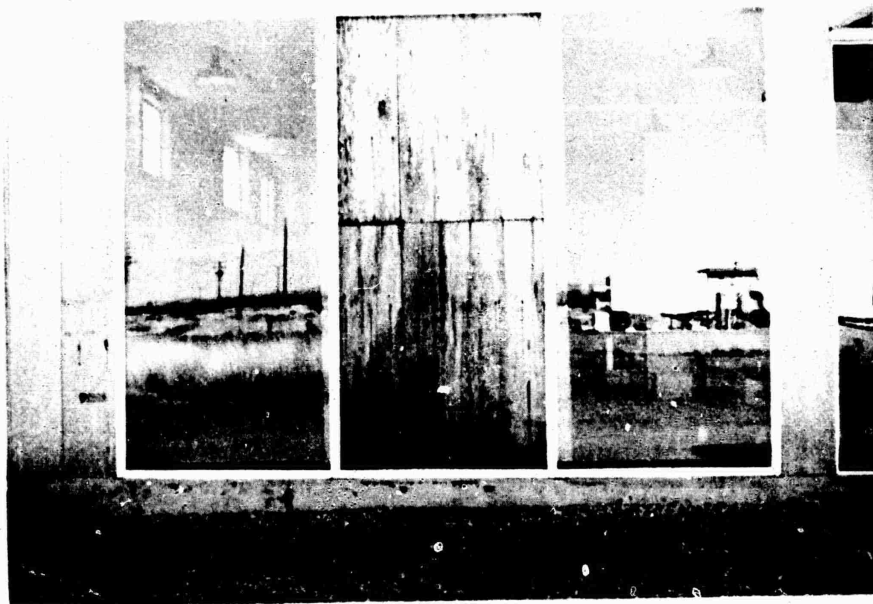
Fig. 50 Store Front, 5' 3" x 10' 8" x 13/64"  
(actual thickness) Broken Pane

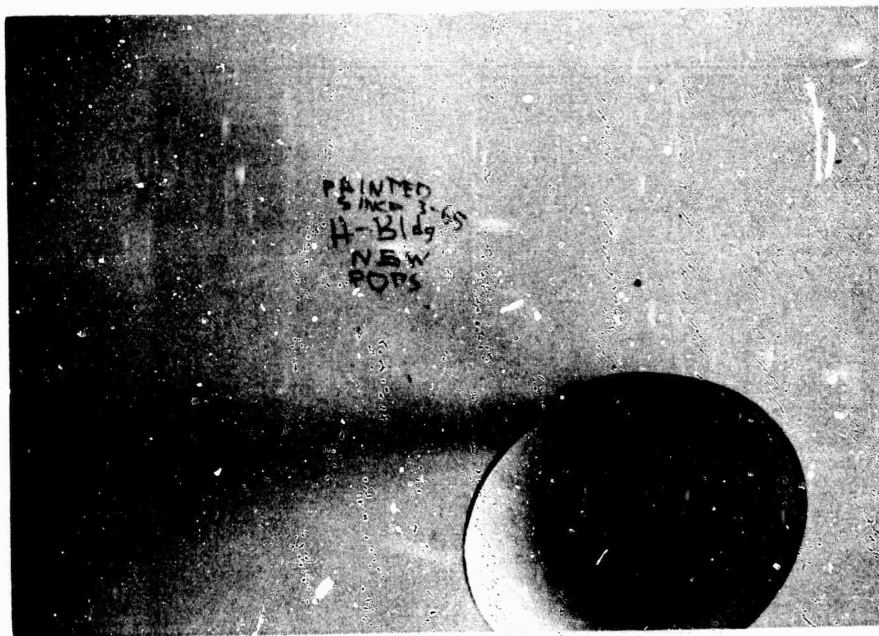
Fig. 51 H-Building, New Nail Pops after Redecoration Between Inspection Periods.

Part of the H building had been repainted and nail-pops and ceiling damage sufficient to warrant replacing part of the ceiling had occurred since the boom program. Even so nail-pops have reappeared in the ceiling and walls.

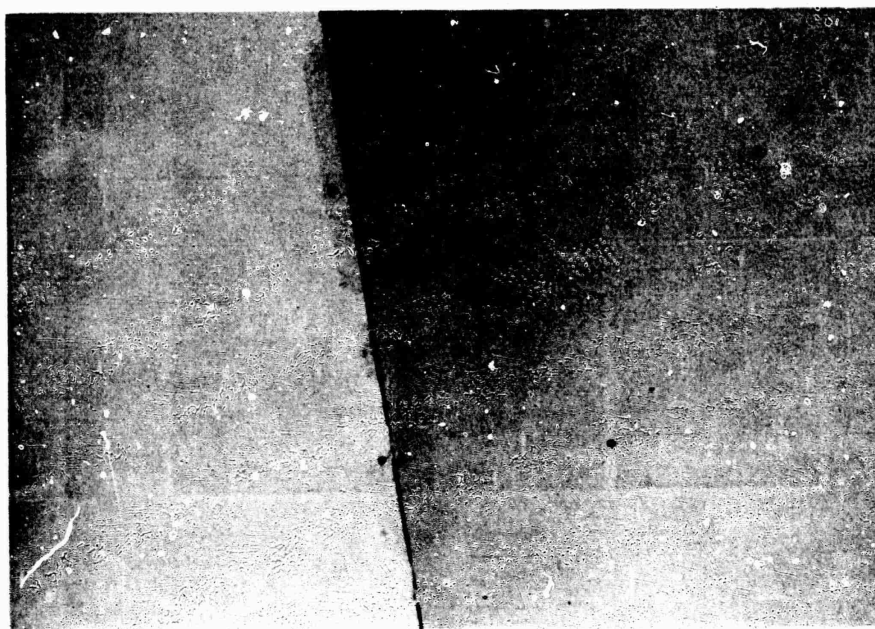
Fig. 52 H-Building, Replaced Ceiling Since Program and Since Redecoration.
