# CONDITION SURVEY, CAMPBELL ARMY AIRFIELD, FORT CAMPBELL, KENTUCKY

P. J. Vedros, S. J. Alford

June '972

Conducted by U. S. Army Engineer Waterways Experiment Station

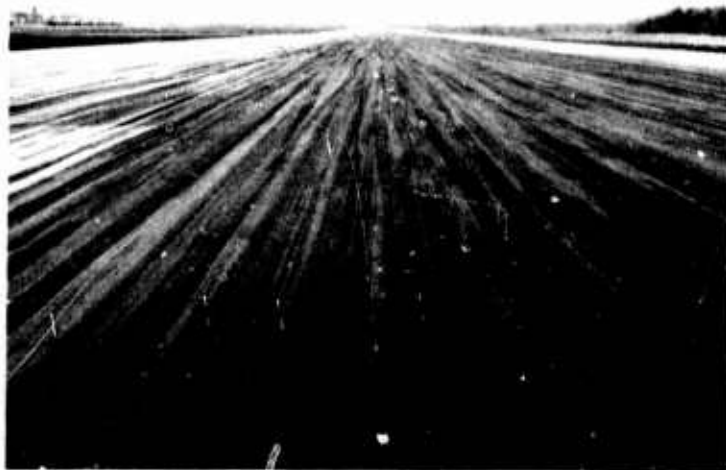
Photograph 2. General view of asphaltic concrete along NE-SW runway

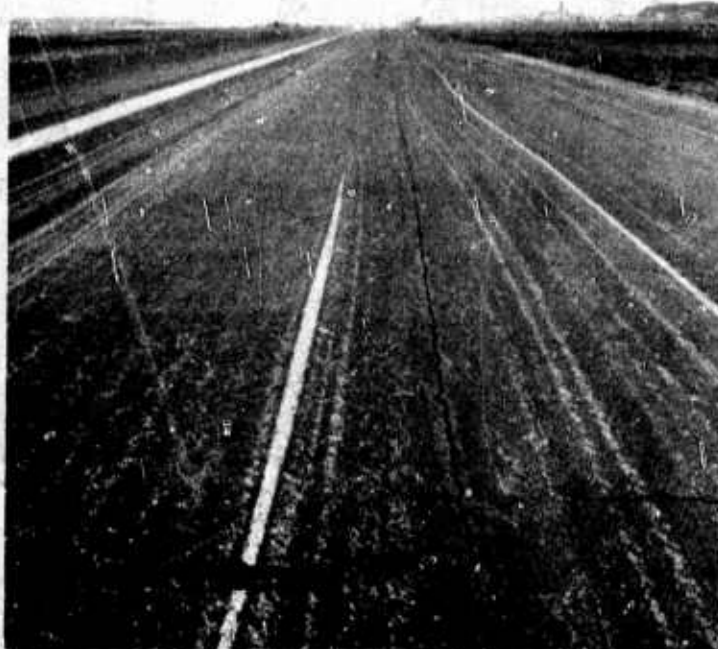
the surface. These areas will be patched with an epoxy grout in the near future. A general view of the asphaltic concrete portion of the runway is shown in photograph 2. The surface condition along the parallel taxiway indicated more cracking and longitudinal joint opening (photographs 3 and 4) than observed on the runway. The runway and taxiways 2 and 5 were overlaid in 1967, and the pavement surface is in better condition than the other facilities that had not been overlaid, as can be seen by comparison of photograph 2 with photographs 3 and 4. The pavement surface on runways 18-36 (north-south) and 14-32 (northwest-southeast) and taxiways D, F, and J was generally in fair to poor condition. The pavements were constructed in 1942-43 and appear to be very dead and dried out. Failures had occurred in a marked-off landing area on runway 18-36, which was being used by C-130 aircraft. Photographs 5-7 indicate the condition of these pavements and types of failures. Future plans consist of building helicopter hangars adjacent to the east side of runway 14-32 and north side of taxiway F, and these facilities will be overlaid or strengthened at that time. The PCC hardstands were in excellent condition. The PCC apron (designated southwest parking apron, plate 1) was in good condition with less than 3 percent of the slabs containing structural defects (photograph 8). There were one or two areas near drainage catch basins where the slabs were tilted. The Alpha and Charlie parking aprons were in fair condition. The pavements had numerous shrinkage cracks and openings at the joints, as shown in photographs 9 and 10.

Photograph 3. Longitudinal joint opening and shrinkage cracking in parallel taxiway

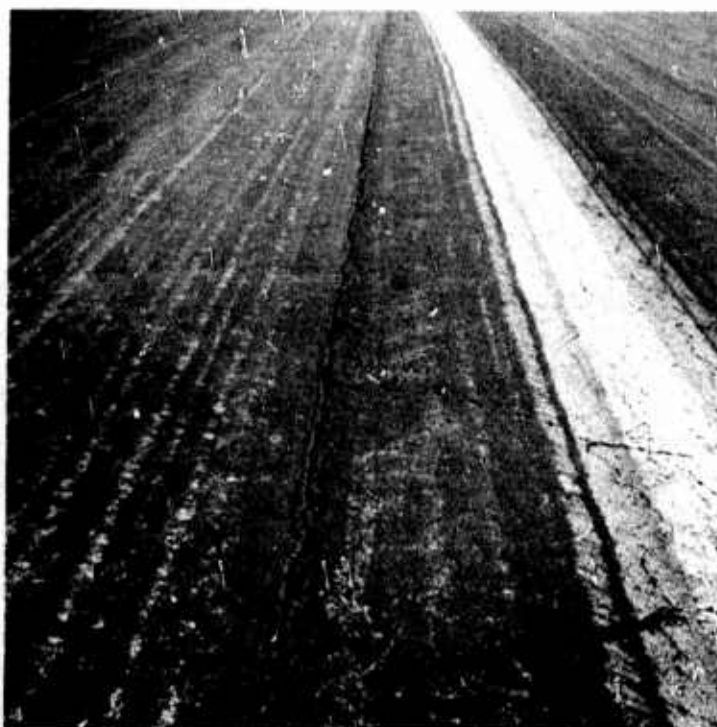
Photograph 4. General condition of surface of pavement that was not overlaid in 1967

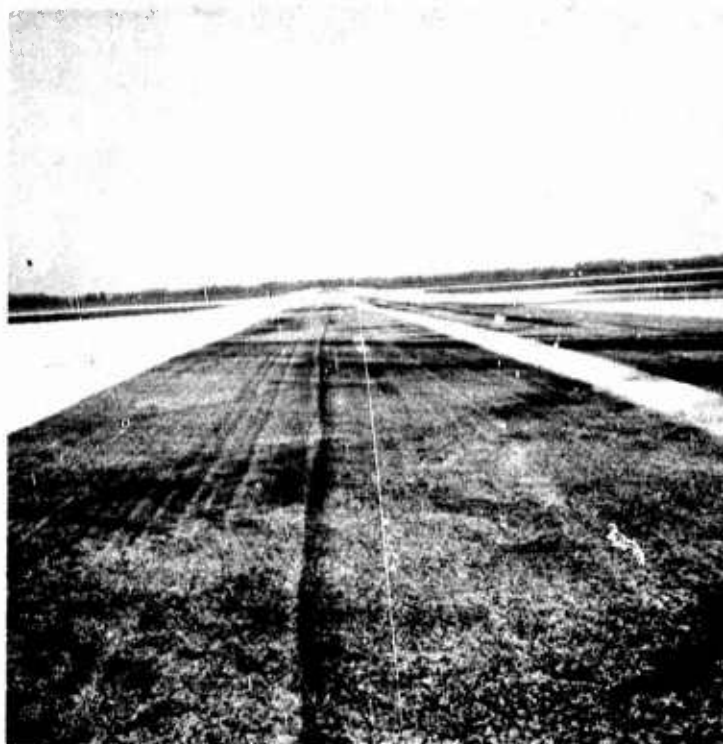
Photograph 5. General condition  
of surface of runway 18-36

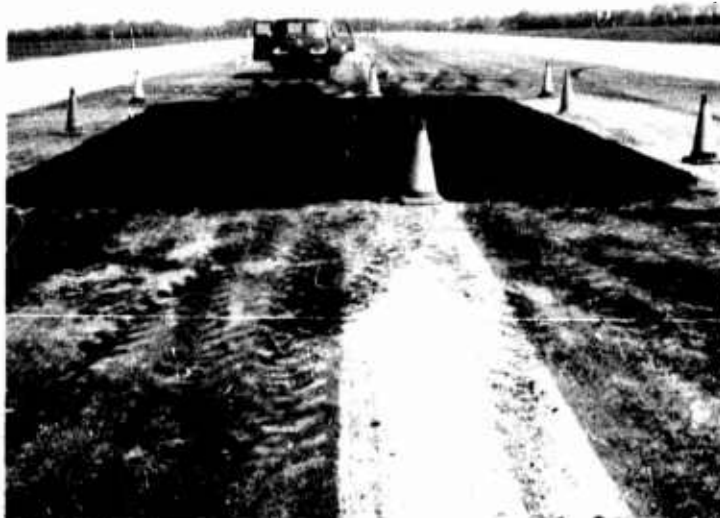
14. Detailed traffic records were not available. The airfield pavements were originally designed for and used by all types of Air Force aircraft; even though the airfield has been transferred to the Army, the field is still used by all types of Air Force aircraft. It was reported that the facilities receive normal use by light Army aircraft and considerable traffic from transient aircraft, such as heavy cargo and fighter planes. For the past two years, C-130 aircraft from another airbase have been using the airfield for training exercises. This has consisted of five-days-a-week operations of practicing assault and touch-and-go landings. The assault landings have been made on runway 18-36, and at the time of this survey, failures were occurring in the pavement surface from this type operation.

Photograph 6. Area on runway 18-36 that was  
patched after failure from C-130 operations

15. Maintenance over the years has consisted of crack sealing and applications of slurry or other types of seal coats. No maintenance has been performed on the pavements since the last overlay placed in 1967, except the failed area that was being patched on runway 18-36 at the time of this survey. There is a need for crack sealing and repair of the spalled areas.

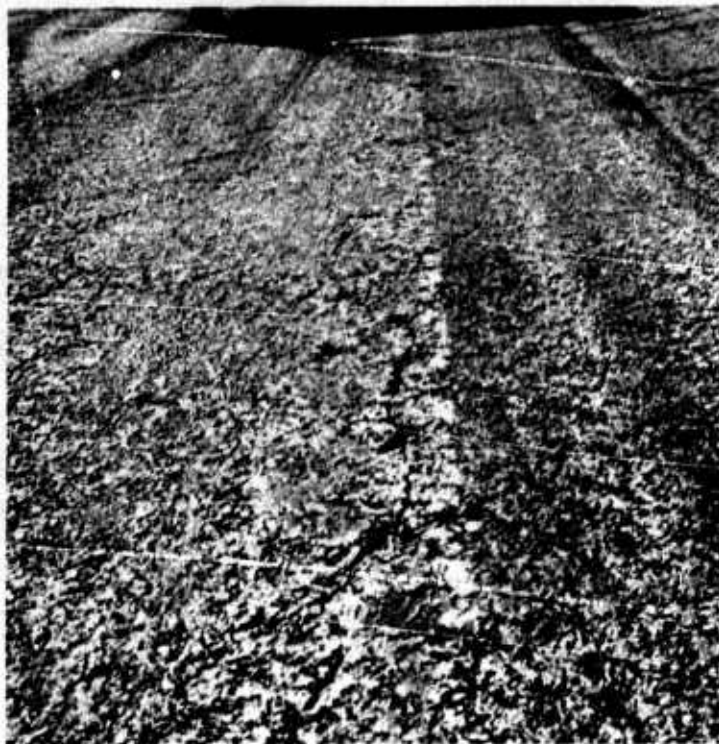
Photograph 7. Typical failure  
resulting from C-130 operations

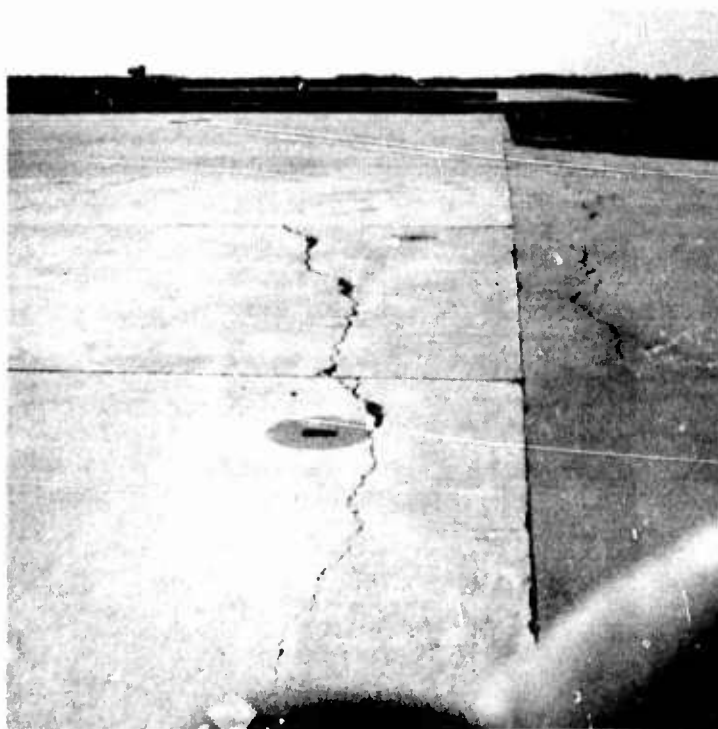
Photograph 8. Cracking in slabs near juncture  
of asphalt and rigid pavement on southwest  
parking apron
