MISCELLANEOUS PAPER S-72-22

# CONDITION SURVEY, FORNEY ARMY AIRFIELD FORT LEONARD WOOD, MISSOURI

June 1972

Conducted by U. S. Army Engineer Waterways Experiment Station  
Soils and Pavements Laboratory  
Vicksburg, Mississippi

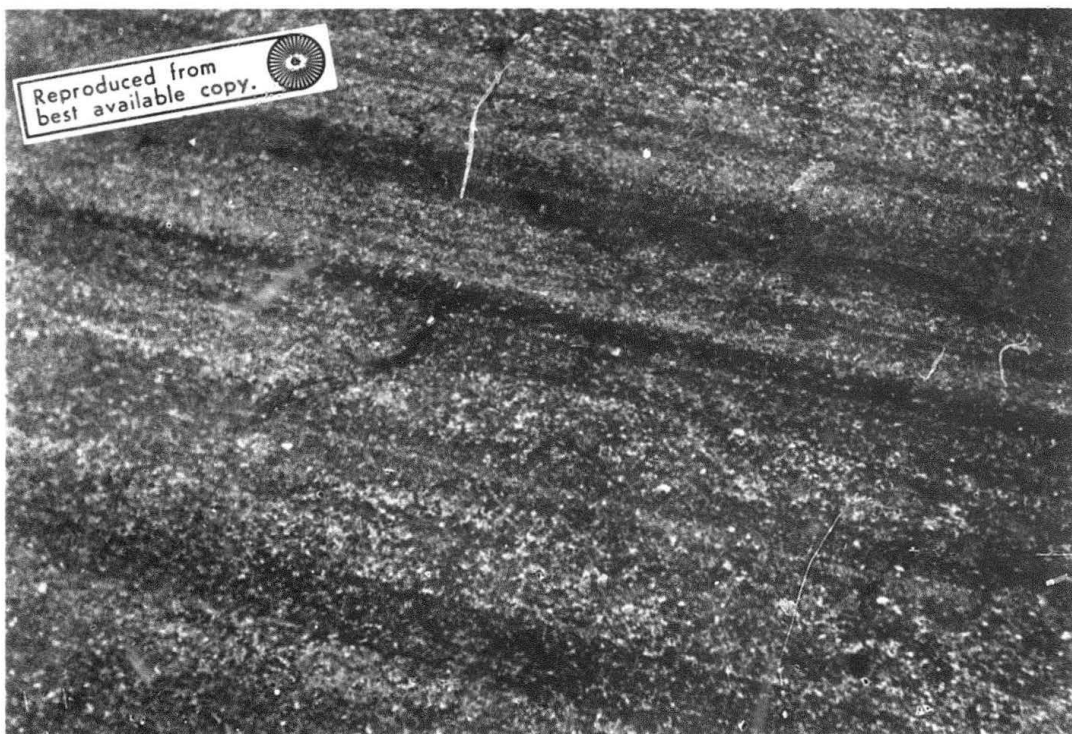
(photograph 3); however, distress in this area was not as severe as that in the area near the middle of the runway.

Photograph 3. Distressed area near north end of runway

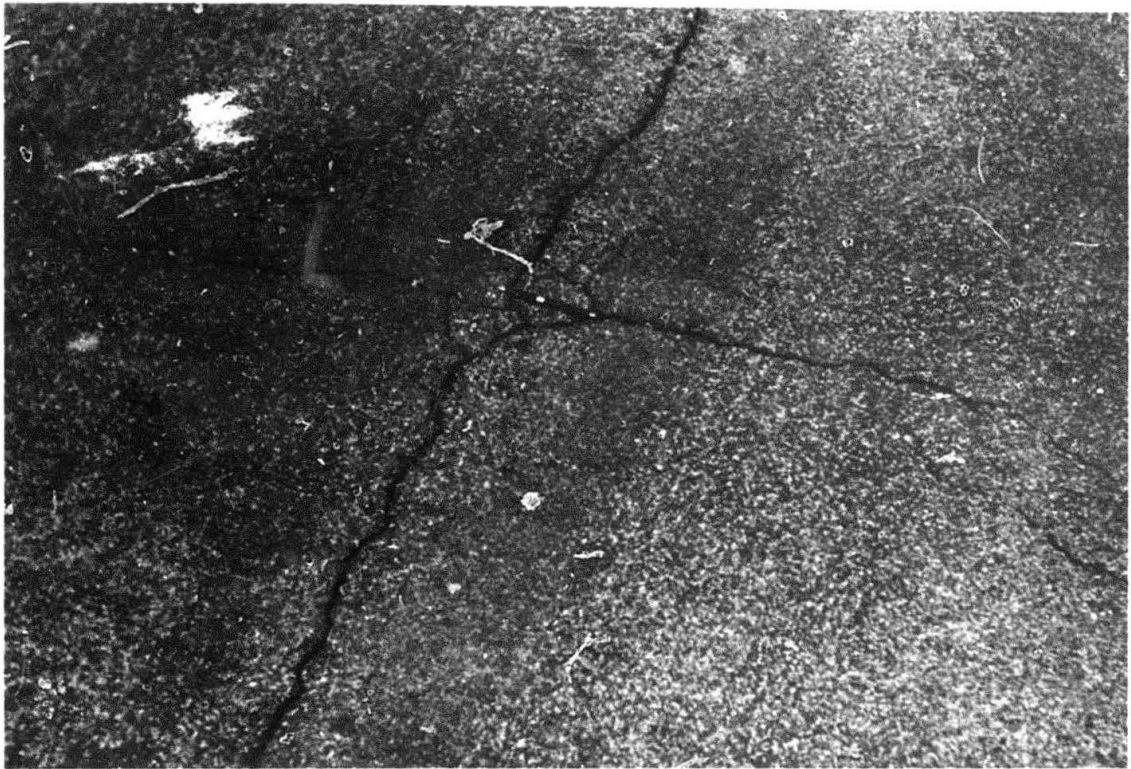
9. The taxiway and apron contained numerous cracks. Views of typical pavements of the taxiway and apron are shown in photographs 4 and 5, respectively. The cracks in the taxiway were approximately 25 ft apart in each direction and appeared to be contraction cracks. Neither the taxiway nor the apron showed any structural distress.

Photograph 4. Typical condition of taxiway pavement
