FIELD STUDY OF FENCING MATERIALS IN A MARINE-ATMOSPHERIC ENVIRONMENT -  
RESULTS OF UP TO THREE YEARS OF ATMOSPHERIC EXPOSURE AND CORROSION RATE  
DETERMINATION

Technical Note N-123

Eddy S. Matsui

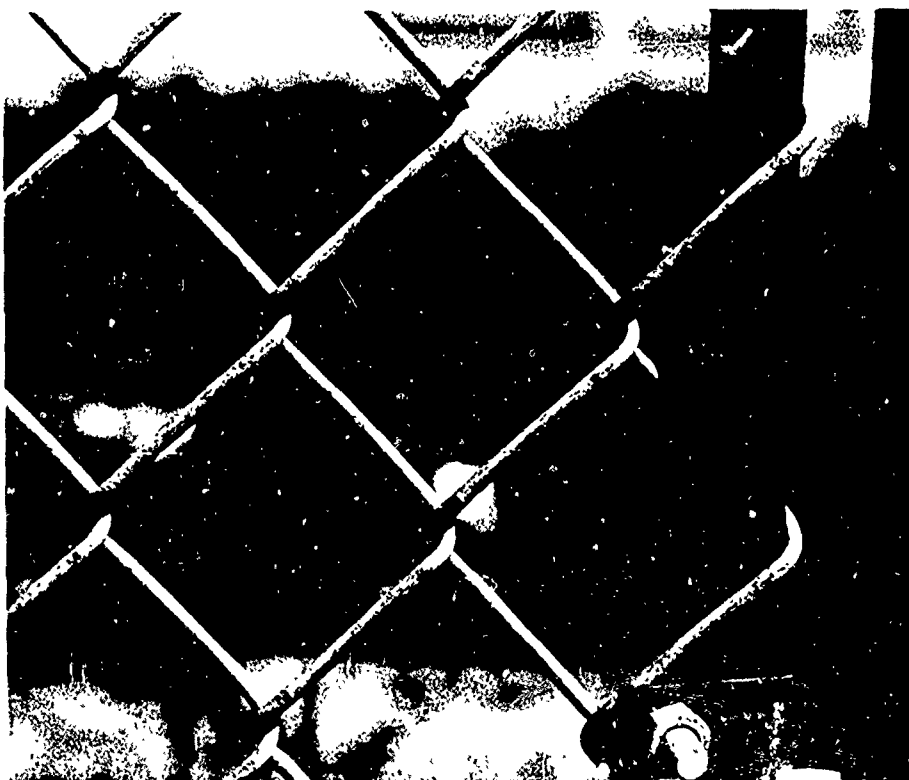
Systems 1 and 2 - Light and Heavy Zinc-coated Fabrics: The surface of the zinc-coated fabrics exhibited a bright metallic appearance when inspected at the time of installation (Figure 3). At the time of the fifth inspection (2 years after installation), the surface of both fabrics were nearly completely covered with a white corrosion product, a blend of fine air-borne sand and dirt that formed a rough surface on the fence wire. Very faint speckles of rust stains, in the form of pin-hole rust, appeared on the surfaces of the wire. Some of the rust stains were superficial and were probably caused by iron contaminated air-borne sand and dirt. The air-borne sand and dirt accumulated on the windward side more than the leeward side of the wire.

Figure 3. System 1. Newly installed zinc coated steel.

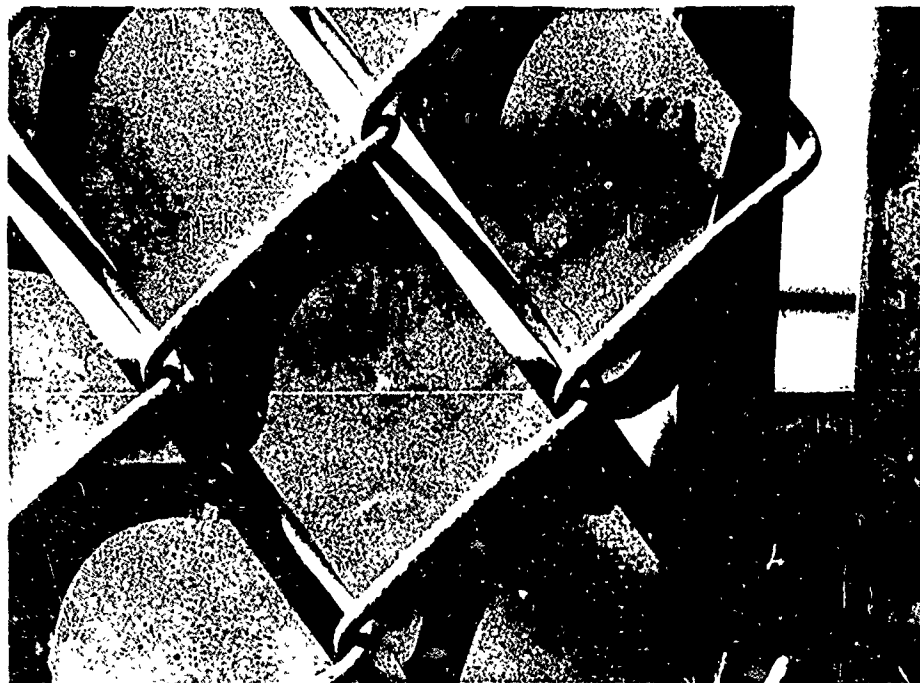
Systems 10, 11, 12 and 13 - Fence Fabrics with Slats: After 3 years of exposure, none of the anodized aluminum slats in System 10 showed any sign of corrosion (Figures 15 & 16). The redwood pickets in System 11 showed no sign of deterioration for the first three years of exposure except a slight fading of color (Figure 17). The condition of the zinc-coated fabrics with anodized aluminum and redwood slats (Systems 10 & 11) was slightly better than that of the zinc-coated fabric without the slats (System 2). The wires accumulated less white corrosion product, fine sand, and dirt. This is probably due to the shielding effect of the slats. Contact between the aluminum slats and zinc-coated wire did not appreciably affect the corrosion process.

Figure 15. Newly installed anodized aluminum slats on zinc-coated wire.

Figure 16. System 10. Anodized slats and zinc-coated wire after 3 years of exposure.

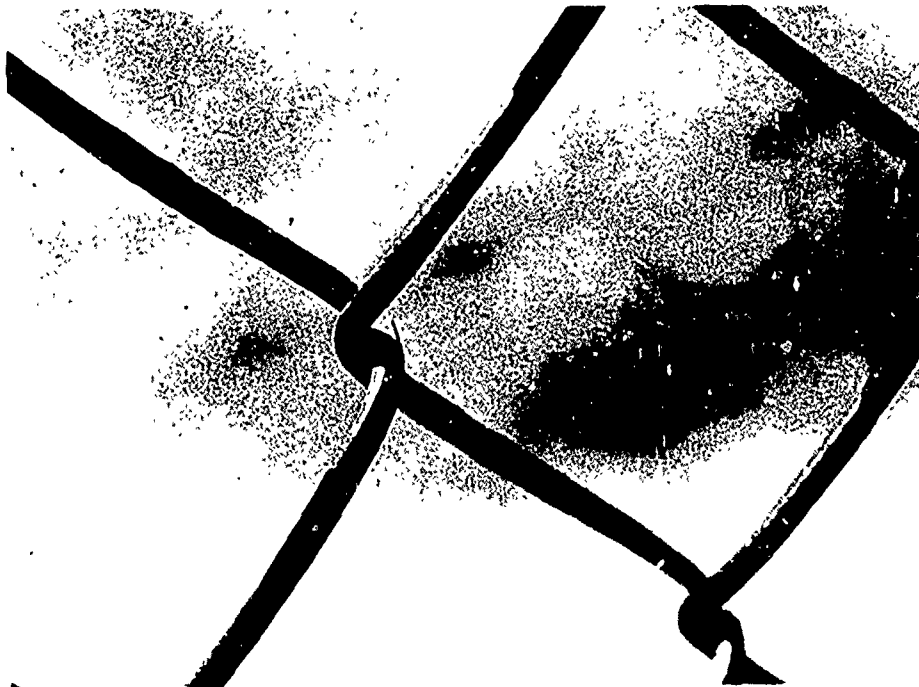
During the 12 months of atmospheric exposure, the fabric showed no evidence of cracking, color fading, or any other form of visible deterioration in the vinyl-coating (Figure 22). However, rust and blisters appeared in the areas where the fabric was damaged by an external mechanical force.

Figure 22. System 14. Blister formation around damaged area - after 12 months of exposure.

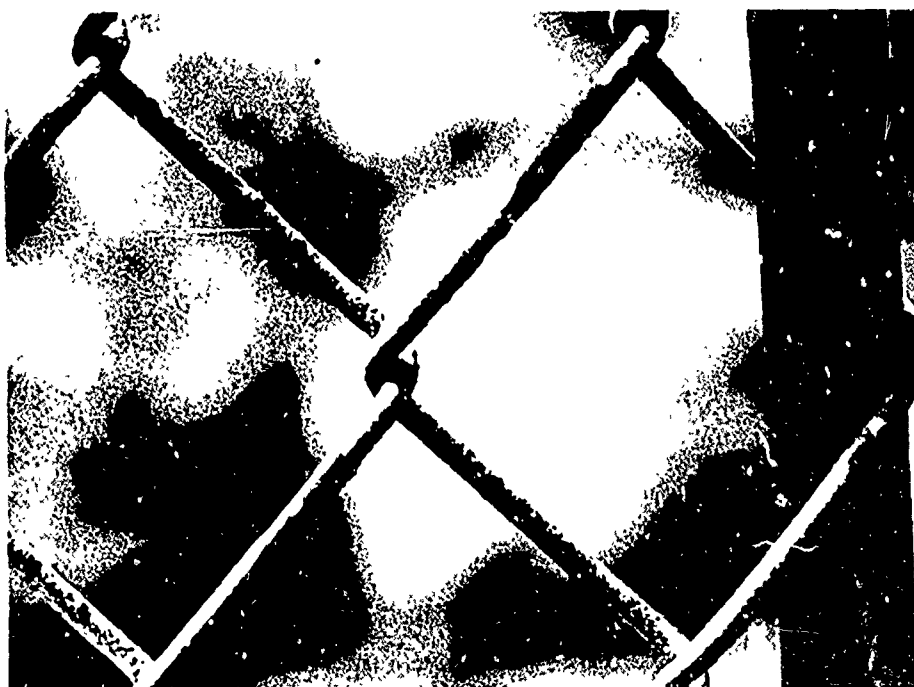
Figure 23. System 15. Aluminum-welded steel - after 12 months of exposure.

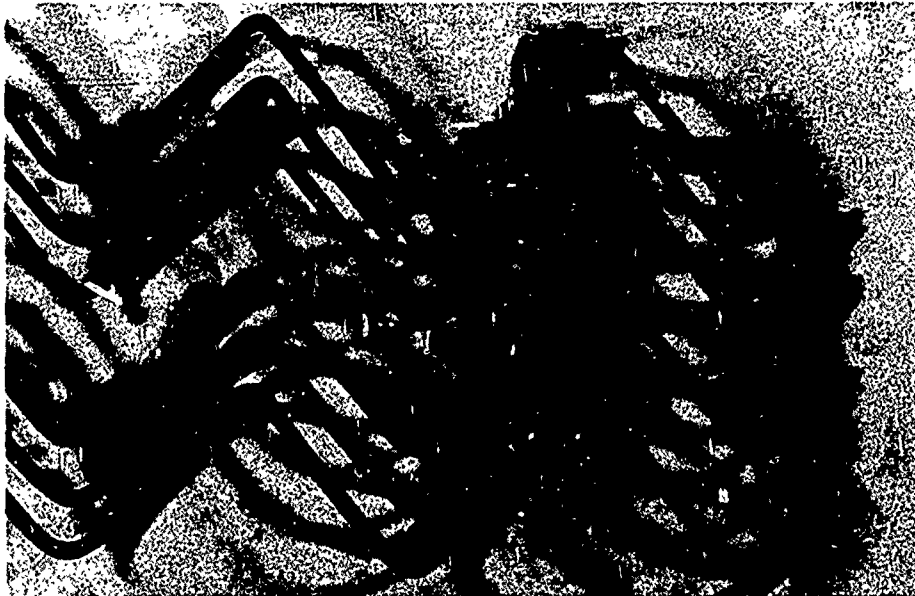
Despite the remaining aluminum coating on wires (Figure 30), the underlying steel core of fence wires was pitted extensively after 24 months of exposure by corrosion attack. The aluminum-coated and zinc-coated wires were stripped of their coatings after 24 months of atmospheric exposure as shown in Figure 31. Figure 31 indicates that the zinc coating protects the underlying steel core until all of the zinc is sacrificially used up, and that the aluminum coating is not as effective in providing sacrificial protection as the zinc coating to protect the underlying steel core. As a result, the underlying steel core was attacked and pitted by corrosion while some of the aluminum coating still remained on the surface of the wire.

Figure 30. Systems 3 & 4. Remaining aluminum coating after corrosion product removed - after 24 months of exposure.

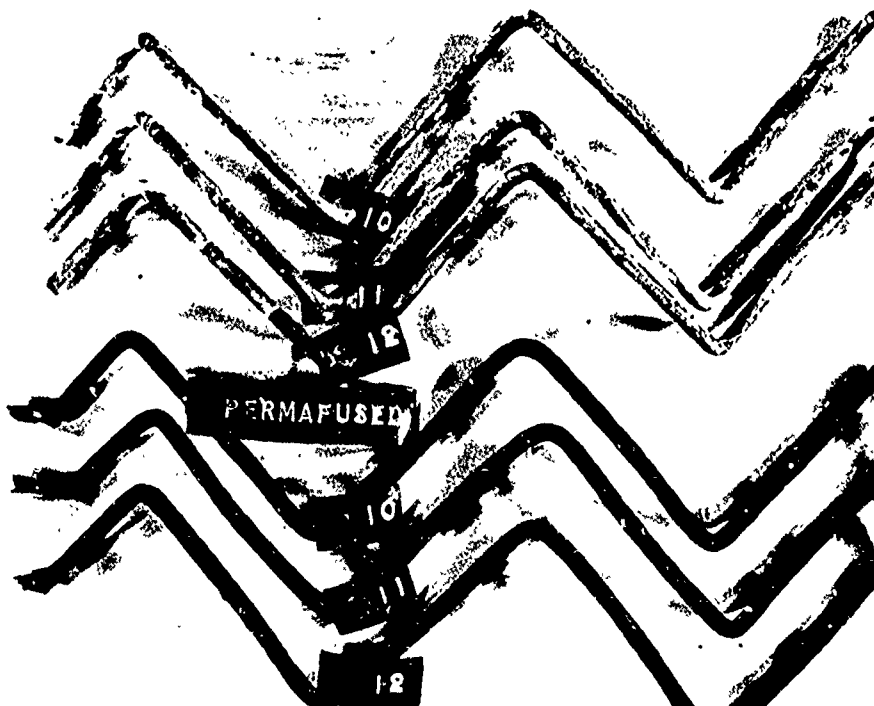
Aluminum-welded wire, System 15: After 4 months of salt-spray exposure, approximately 25% of the surface was covered with a white corrosion product (Figure 35). Except for a small amount of red rust at the cut ends and scribed areas, there was no other red rust on the wires. System 15 was very corrosion-resistant and lost very little of the aluminum coating in comparison with the aluminum-coated wire (System 4) which received extensive pitting corrosion during the comparable length of salt-spray test (Figure 36 vs 37).

Figure 35. Systems 14 & 15 - after 4 months of salt-spray test.
