USAAVSCOM TECHNICAL REPORT 72-12

FATIGUE TEST OF  
THE MAIN ROTOR RETENTION COMPONENTS  
USED ON MODEL OH-58A/206A-1 HELICOPTER  
(P. I. P. TASK 69-29)

MODEL OH-58A/206A-1

REPORT NO. 206-098-164      DATE 4-30-71  
 FATIGUE TEST OF THE MAIN ROTOR  
 RETENTION COMPONENTS USED ON  
 MODEL OH-58A/206A-1 HELICOPTER

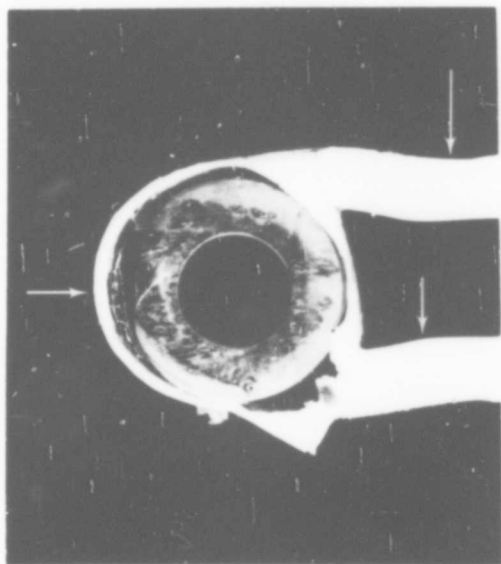
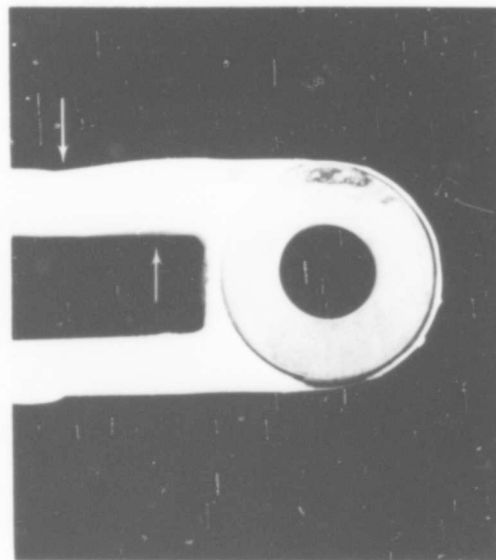
FIG. 9

Two straps, specimen Nos. 3 and 4, completed 20,292 start-stop cycles without failure but testing was stopped because the straps were severely buckled in compression, Fig. 9, as a result of a second hydraulic cylinder failure which resulted in a high compressive shock load.

TYPICAL DAMAGE OF THE 206-010-105-3 STRAP ASSEMBLY  
DUE TO THE TEST MACHINE (HYDRAULIC CYLINDER) FAILURE

Strap shown is specimen No. 3 after 20,292 cycles. Note the fretting of the faces of both the end spools. Arrows indicate the areas of damage due to buckling. Strap specimen No. 4 also had similar damage. The damage on strap specimens Nos. 1 and 2 was similar, but not as severe.

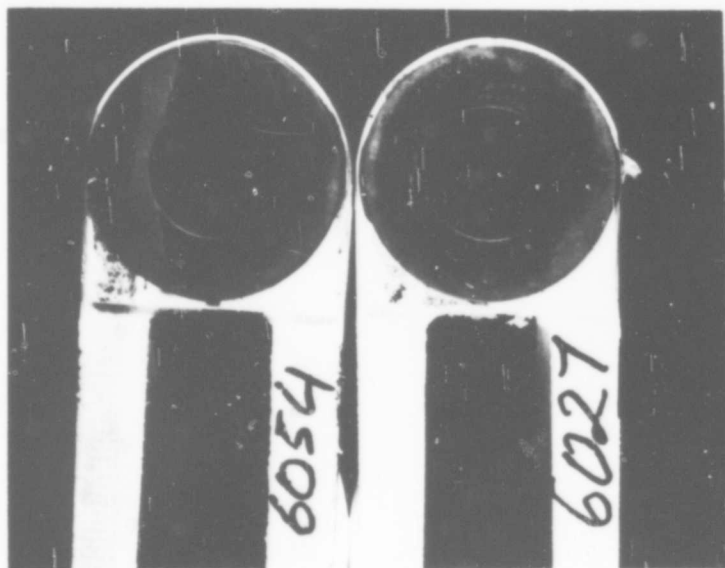
FIG. 10

TYPICAL CONDITION OF THE 206-010-105-3 STRAP ASSEMBLY  
OUTBOARD END SPOOL AREA AFTER 14,000 CYCLES

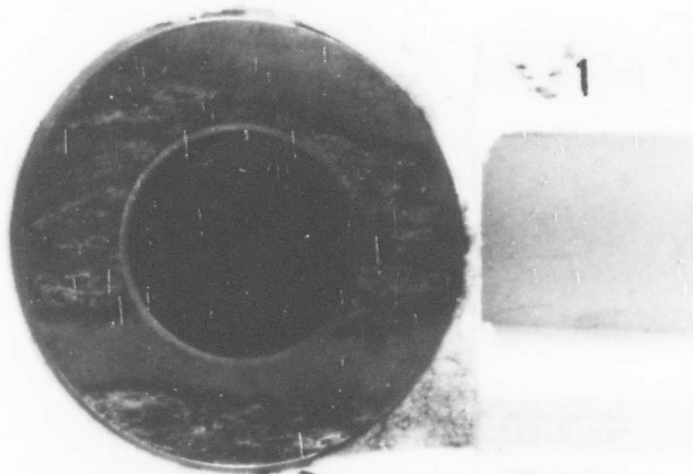
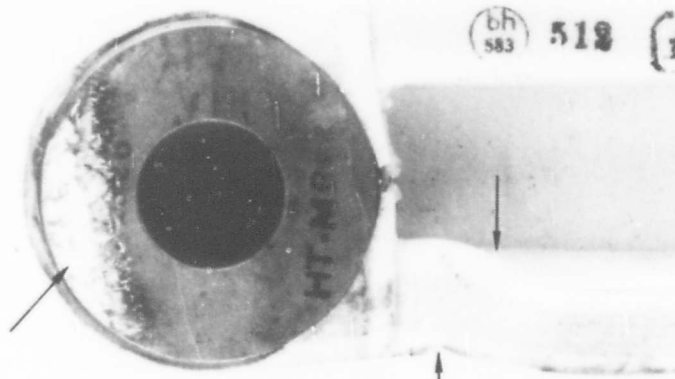
Strap specimen Nos. 5 and 6 completed 34,525 cycles without failure, and specimen Nos. 7 and 8 completed 72,326 cycles without failure. The inboard end of strap specimen No. 7 was damaged, as shown in Fig. 11, due to the failure of corresponding -86-1 strap fitting, Specimen ML-4, after 72,326 cycles, Fig. 15.

TYPICAL CONDITION OF THE 206-010-105-3 STRAP  
ASSEMBLY AFTER 72,326 START-STOP CYCLES

The -105-3 strap, S/N 6711, shown was used with 206HA86-1 fitting, ML-4. Arrows indicate the damage at the inboard end due to failure of the mating strap fitting shown in Fig. 15.

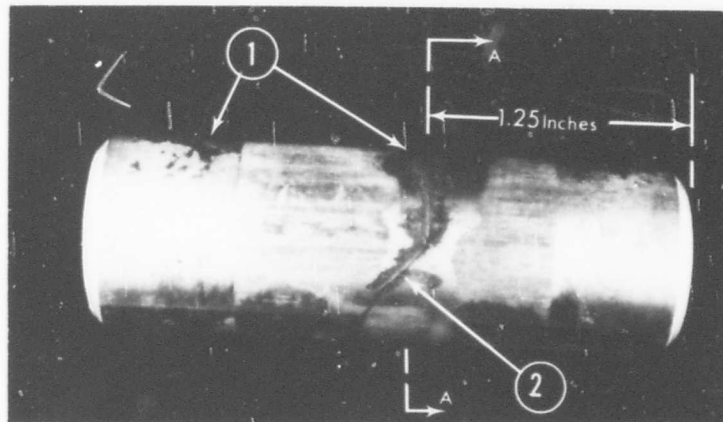
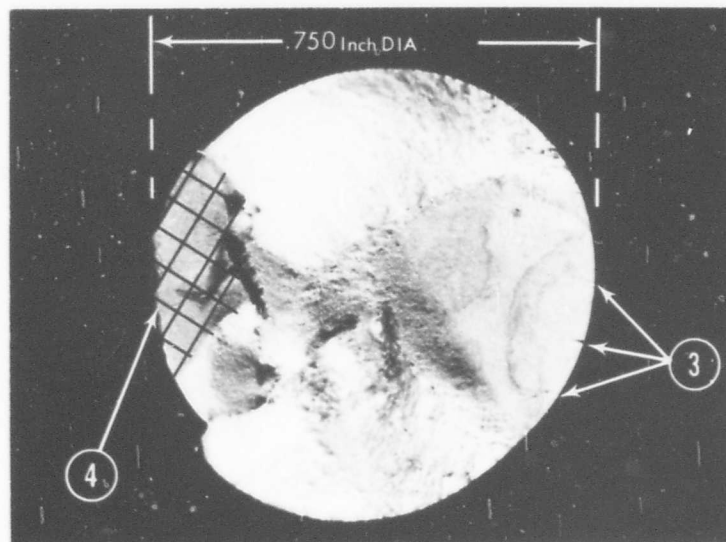
One of the eight pins, specimen No. 2, subjected to  $10^7$  twist cycles and 34,568 start-stop cycles was found to have a fatigue crack upon inspection after completion of 34,568 start-stop cycles. The fatigue crack originated in a heavily fretted area, Fig. 12. This pin was used with two -155-7 fittings during the test. The original -155-7 fitting was found to contain fatigue cracks after 13,400 start-stop cycles and a new fitting identified as Part No. 206HES-1818-1 was installed to complete the 34,568 cycles on the strap and pins.

FAILURE OF THE 206-010-123-1 RETAINING PIN,  
S/N Q1-2382 USED WITH STRAP SPECIMEN NO. 2

Failure was noted during inspection after 34,568 start-stop cycles.

1. Areas of severe fretting
2. Fatigue crack
3. Fatigue origins at areas of severe fretting
4. Area of static failure.

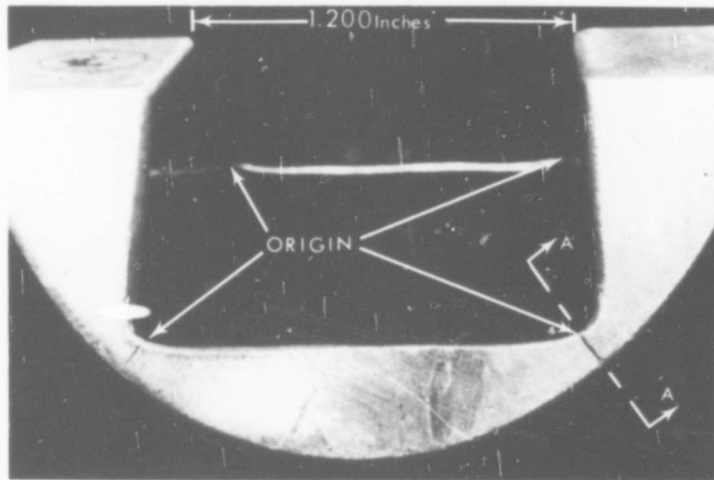
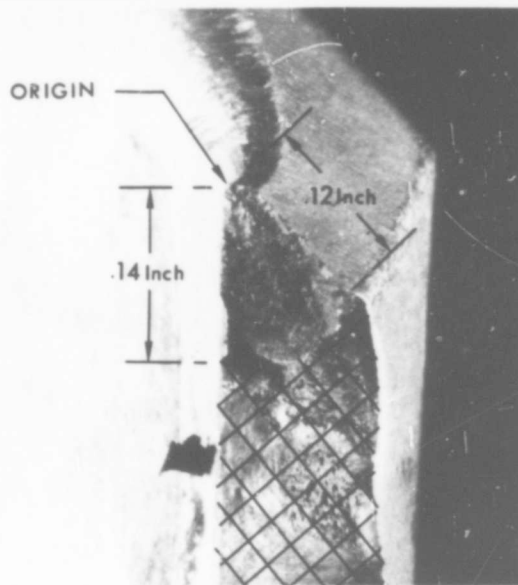
During the start-stop cycle test, each of the four fittings, specimen Nos. 1 through 4, showed fatigue cracks at the top corners of the rectangular cavity after 13,400 cycles, Fig. 13. The fatigue cracks were located at all of the four corners for three specimens, the crack-lengths varying from  $1/8$  to  $3/8$  of an inch. The fourth specimen, S/N J11-2098, had fatigue cracks at three of the four corners. The first inspection on specimen Nos. 1 and 2 was conducted after 13,400 start-stop cycles, and hence the exact number of cycles to failure was not known. During the test specimen Nos. 3 and 4 were breakwired on the possible locations of failure to stop the test machine in the event of a fitting failure. The breakwire on specimen No. 3, S/N J11-2098, failed after 6550 cycles. Inspection of specimen No. 3 after 13,411 cycles, revealed fatigue cracks at three corners of the fitting. The longest crack was located at the location of the breakwire failure. Since the breakwire was open at this place after 6550 cycles, specimen No. 3 is considered to have failed after 6550 start-stop cycles.

The metallurgical examinations of all the -155-7 fittings revealed that all the fatigue cracks origins were located at the chamfered radii of the corners. Typical origin and extent of fatigue crack is shown in Fig. 13. The material properties of all fittings was checked subsequent to test and found to be within blueprint specification except for fitting S/N J11-2070.

TYPICAL FAILURE OF THE 206-010-155-7 FITTING

The specimen shown, S/N J11-2088, was used with strap specimen No. 2. Fatigue cracks were discovered during inspection after 13,906 start-stop cycles. The cross-hatched area shown in the lower photograph denotes static failure. See Fig. 3 for overall view of the fitting.

Following the failures of the -155-7 fittings, two -155-7 fittings, specimen Nos. 5 and 6 were modified by Engineering Order 206HES1818, and used to complete the required number of start-stop cycles on strap specimen Nos. 1 through 4.

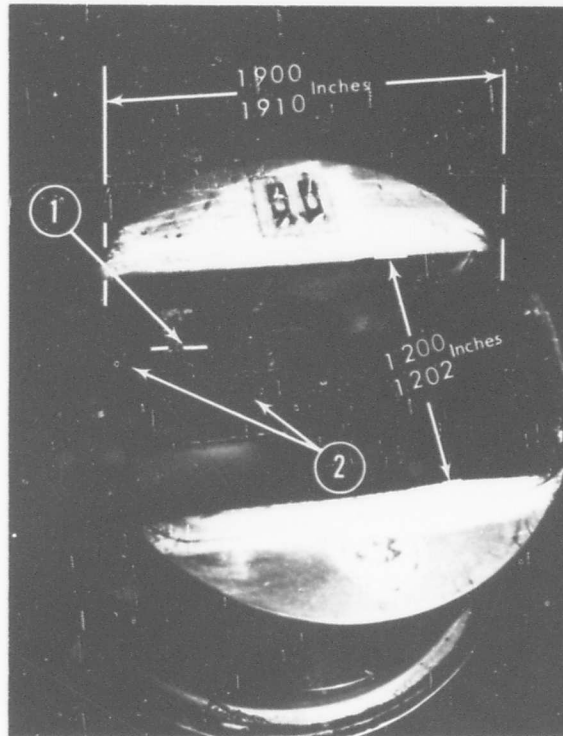
FIG. 14

Test No.	Strap Spec. No.	Fitting Specimen No. and Part No.	Fitting Serial No.	A Test Loads		Applied Test Cycles	Summary of Results
				Type of Loading	Twist Angle, Steady Oscillatory		
2	1, 3	5 -155-7	ML-1	Start-Stop	23 None	28,000	Failed at all the four corners. Crack location similar to earlier cracks after 13,175 cycles.
2, 4	6 -155-7	ML-2	Start-Stop	23 None	28,000	Fatigue cracks found at all four corners similar to specimen No. 5, but the breakwires did not break.	
3	5 206HA86-1	ML-1	Twist Start-Stop	20	14	10,000,000	No failure.
				23	None	34,525	No failure. Minor fretting at the hole and innerface. Ref. Fig. 14.
6	2 206HA86-1	ML-2	Twist Start-Stop	20	14	10,000,000	No failure.
				23	None	34,525	No failure. Minor fretting at the hole and innerface.
4	7 206HA86-1	ML-3	Twist Start-Stop	20	14	10,000,000	No failure.
				23	None	72,326	Failed at the pin hole. There were no failures when inspected last at 34,500 cycles. Ref. Fig. 14.

TYPICAL CONDITION OF THE 206HA86-1 FITTING  
AFTER 14,380 START-STOP CYCLES

1. Typical location of fatigue cracks for Specimen ML-3 used in Set No. 7.
2. Areas of minor fretting

The fitting shown, ML-1, was used with strap specimen No. 5. Fig. 16 shows the details of the failure of specimen ML-3 used with strap specimen No. 7.

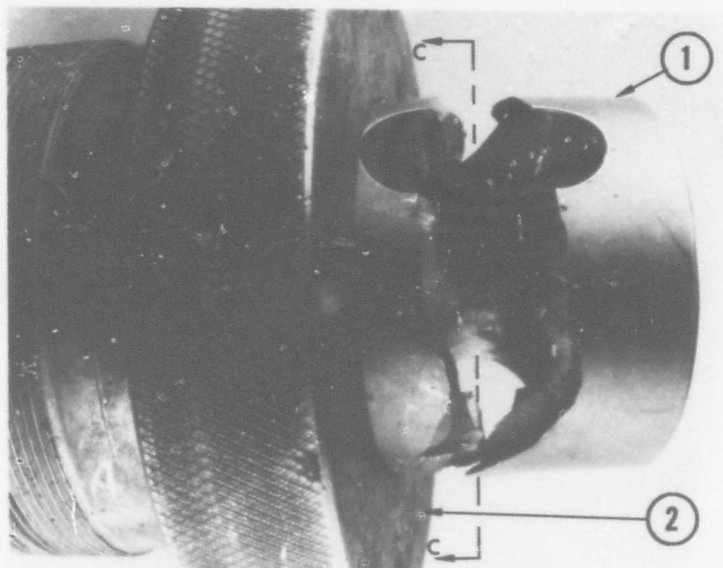
8	4 206HA86-1	ML-4	Twist Start-Stop	20	14	10,000,000	No failure.
				23	None	72,326	Failed circumferentially across the hole. There were no failures when inspected after 34,500 cycles. Ref. Fig. 15 and 16.

FAILURE OF THE 206HA86-1 FITTING, S/N ML-4,  
AFTER 72,326 START-STOP CYCLES

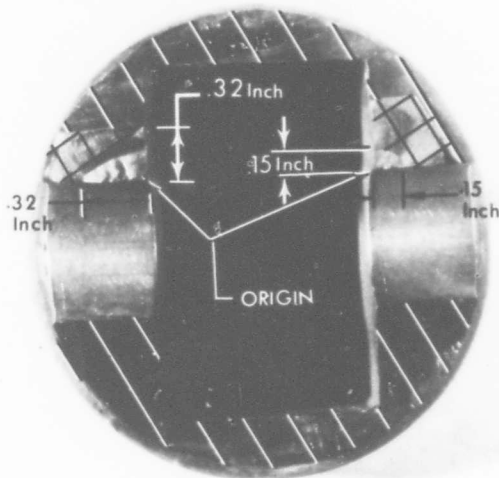
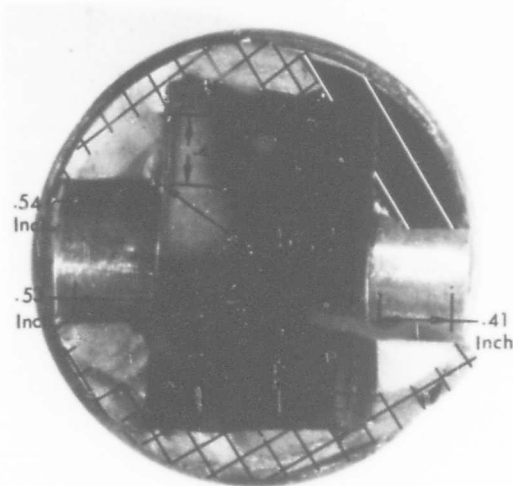
FIG. 16

At the end of the test program, the start-stop phase of the test for the last two sets of the retention components with the 206HA86-1 fittings was continued until a failure occurred. After 72,326 start-stop cycles, the 206HA86-1 fitting, ML-4, used with strap specimen No. 8 failed as shown in Fig. 14. The -1 fitting, ML-3, used with set No. 7, showed fatigue cracks at the pin hole as shown in Figs. 14 and 16.

The metallurgical examination of the failed 206HA86-1 fittings indicate that all the fatigue origins were located at the inside chamfer radius of the pin hole in the fitting.

DETAILS OF FAILURES OF THE 206HA86-1 FITTINGS,  
S/N ML-3 AND ML-4

Top photograph shows failure details of fitting ML-3. Bottom photograph shows View C-C of fitting ML-4 shown in Fig. 15. The crosshatched areas indicate the static failure during the test or the metallurgical examination. The straight section lines indicate the areas saw cut during metallurgical examination.
