RADC-TR-72-148  
Technical Report  
July 1972

## ELECTRICAL OVERSTRESS FAILURES IN SILICON DEVICES

**ELECTRICAL OVERSTRESS FAILURES IN SILICON DEVICES**

**Clyde H. Lane**

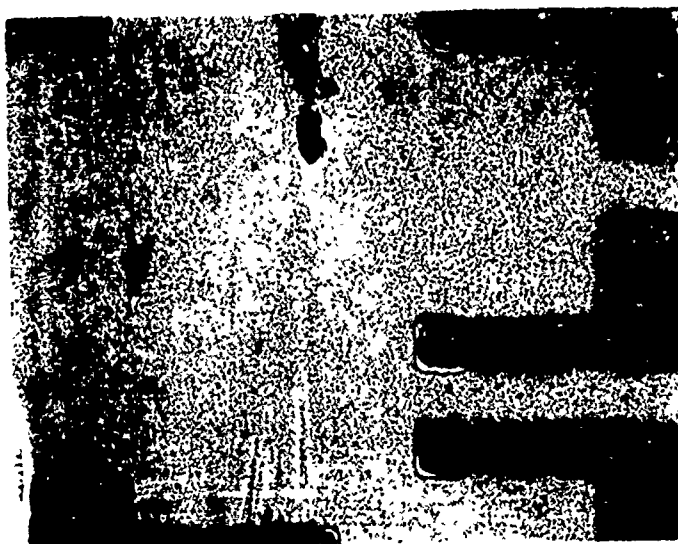
gold metallization also had a thin organic film on the oxide surface. It was alloyed at 340°C for 2 hours. The turnover and breakdown voltages were the same as for aluminum metallization to 0.5 ohm-cm p-type silicon. Figure 20 shows an incomplete zap involving gold. The same features characterize this failure mechanism as had been observed with aluminum, namely, greater heating on the negative side with obvious plasma formation and zap initiation from the positive side. Voltage was applied again and, as with aluminum, the initial spear did not lengthen but a new spear was generated. There was additional gold migration from the negative side during the second pulse. The extent of gold migration from the negative side exceeded that seen in aluminum contact metallization. The organic film in this case provided a nice thermo-graph seen as a hazy halo surrounding the fold spear. It was noticed that the gold does not take on a triangular shape at the tip as does aluminum, and it may not follow a 211 direction at all, as the aluminum often does. Figure 21 shows a gold protrusion from the positive side. This is the very start of a zap. More power would have pushed that gold out in the form of a spear toward the negative electrode. Gold was removed from the surface for this photograph showing that gold is beneath the silicon dioxide surface. The discolored region is the result of incomplete removal of the overheated thin organic film.

Figure 20  
Multiple Partial Zap Paths From the  
Positive Electrode and Slow Gold  
Migration from the Negative Electrode
